## APPENDIX 6 - Gas Membrane Installation/Validation Information

# GeoShield Verification Report 3

PROJECT: New Aldi

SPECIFICATION: Verified in accordance with CIRIA 735.

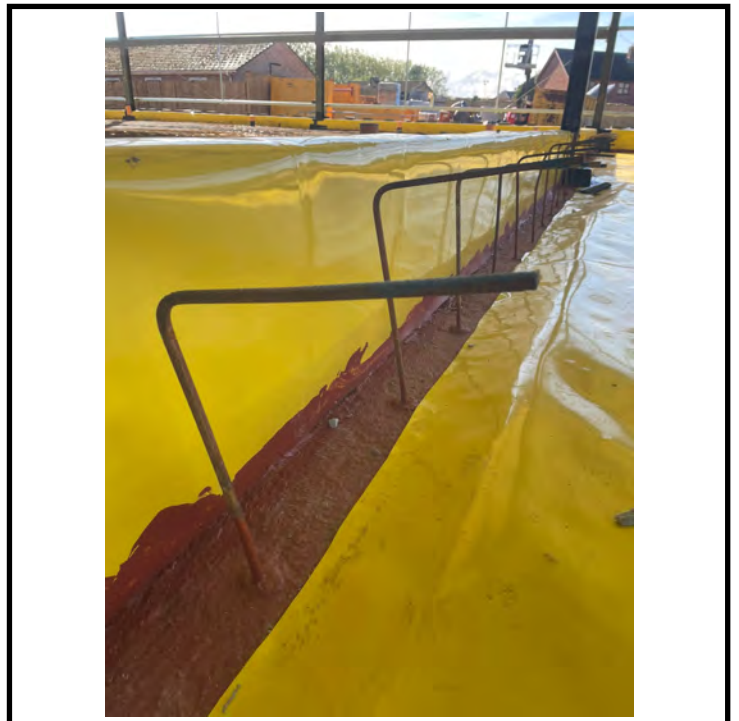
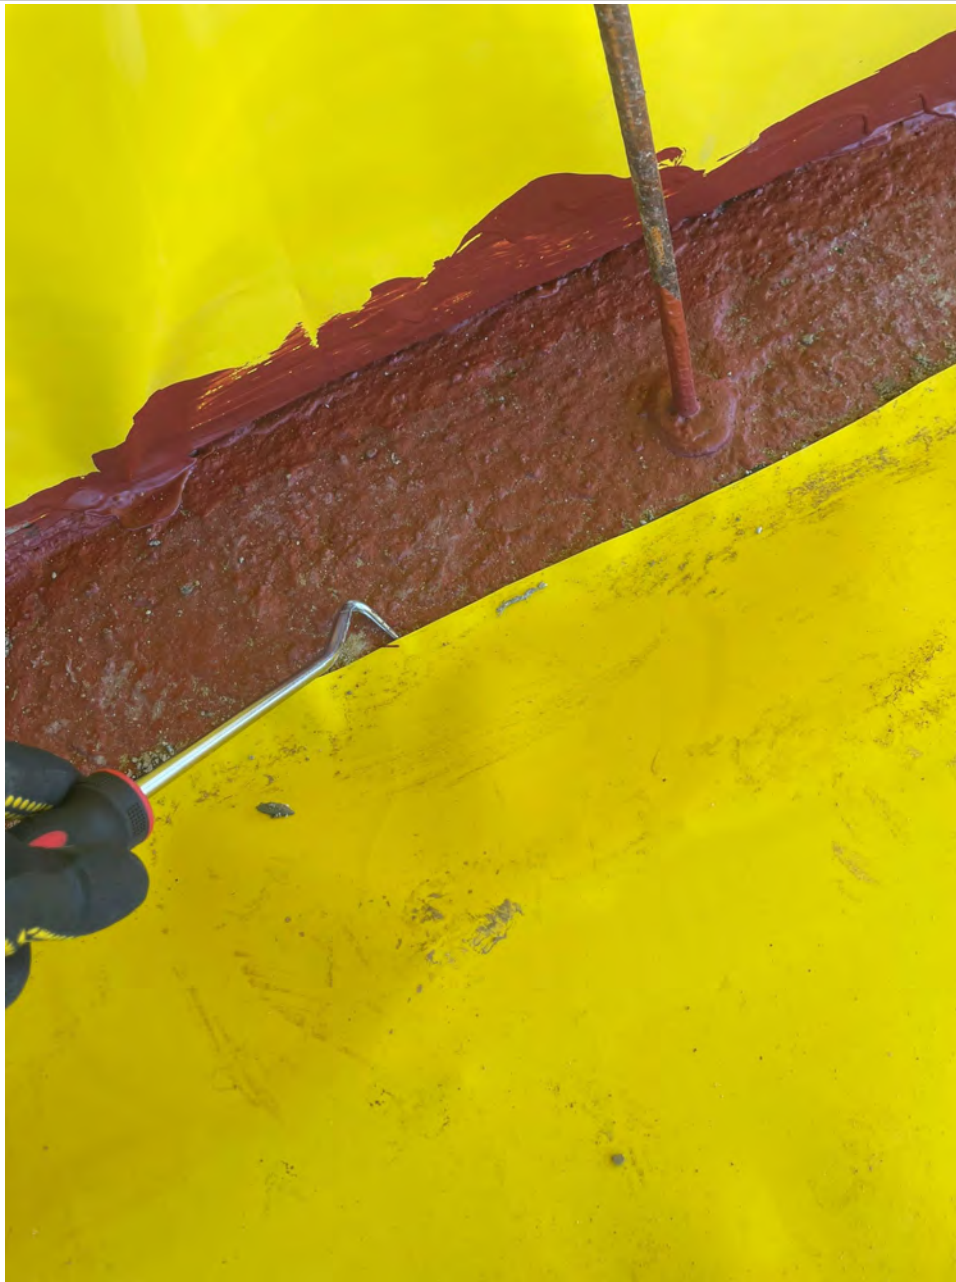
## VERIFICATION ITEM ONE

JUTA GP5+ Gas Barrier has been installed across the footprint of the area Gridlines E/ 6. The JUTA GP5+ Gas Barrier has been lined out across the entirety of the area, ensuring a sufficient overhang has been left around the perimeter to enable further works to be carried out at a later date. A liquid gas

barrier has been applied to areas where steel rebar has been placed, shown in the photograph above, with the JUTA GP5+ Gas Barrier being terminated using double sided butyl tape. All lap joints between the adjacent sheets of JUTA GP5+ Gas Barrier have been overlapped a minimum of 100mm, conforming to

design details. All overlaps have been welded using a hot air leister and silicone roller with adequate pressure applied to ensure a continuous seal is achieved. Alternatively, the overlaps have been welded using a Twinny Wedge Welder creating dual welded lap joints. All aspects of the installation were subjected to mechanical point stress testing. No faults were identified during these testing procedures.

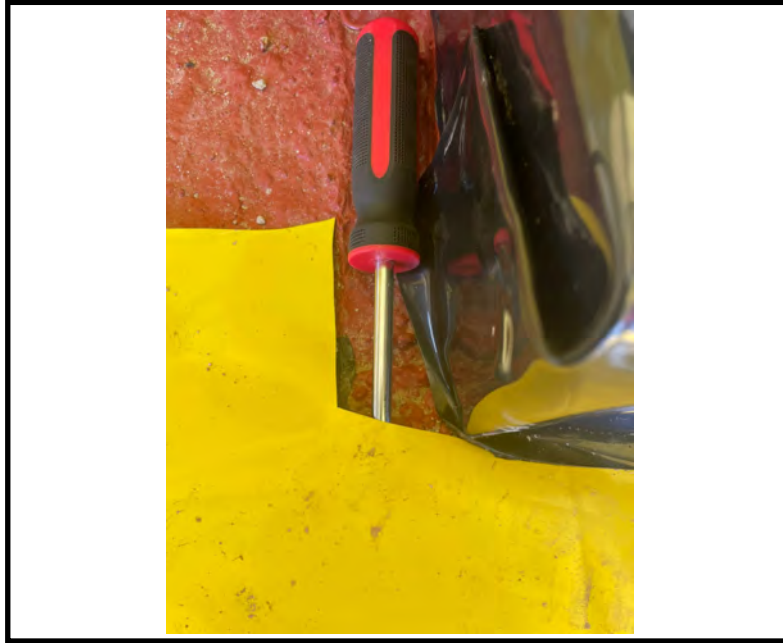
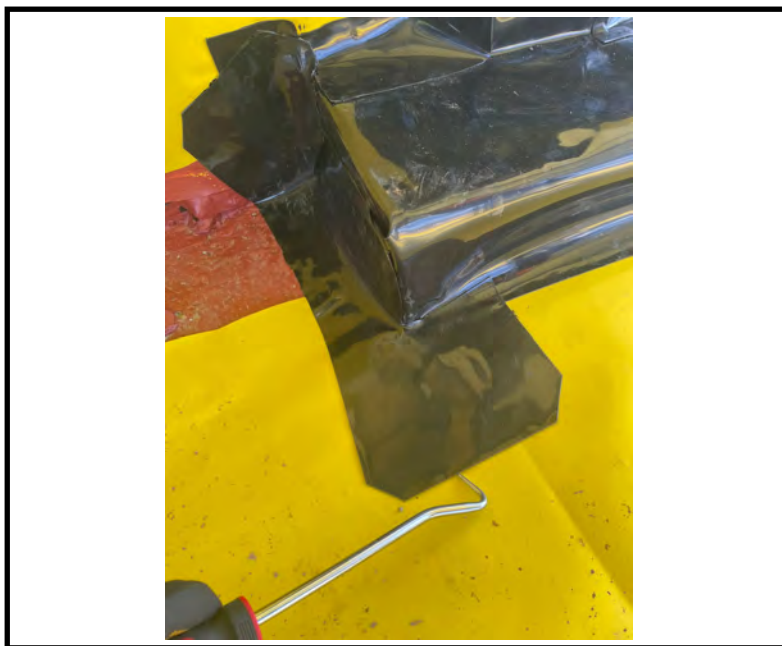
## VERIFICATION ITEM TWO

The above photograph displays a probe demonstrating a fault identified where there hadn't been enough Juta Titan Tank installed to create a gas tight seal, this was brought to the attention of the installers. The installers opted to heat weld

a further strip of Juta Titan Tank with a hot air leister and adequate pressure was applied with a silicone roller to ensure a gas tight seal was achieved. A further pick and probe test was conducted which confirmed no further faults.

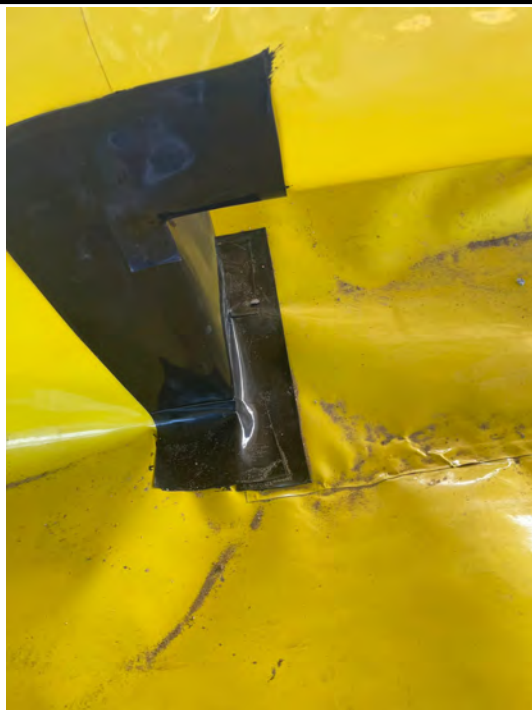
## VERIFICATION ITEM THREE

A number of corners throughout the referenced area have also been sealed as per manufacturer's specifications. This has been achieved using JUTA Titan Tank. Where the JUTA GP5+ Gas Barrier has been cut to minimise voided areas and gaps across the footprint of the area, each corner junction has been reinforced by

heating strips of JUTA Titan Tank and placing into position around each corner, onto the JUTA GP5+ Gas Barrier. Heat and firm rolled pressure is applied to aid in the adhesion ensuring the JUTA Titan Tank has fully bonded. Visual inspections, supported by a mechanical point stress test identified several corners not sealed.

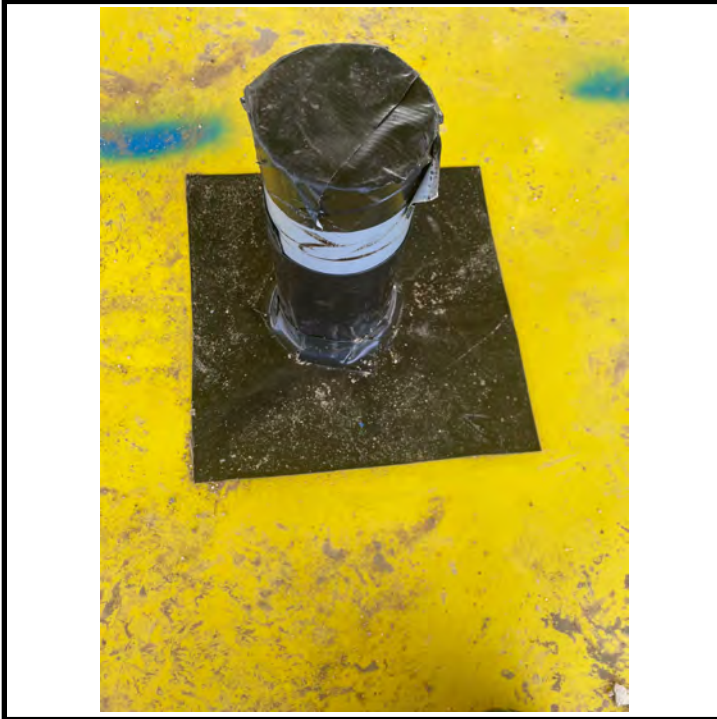
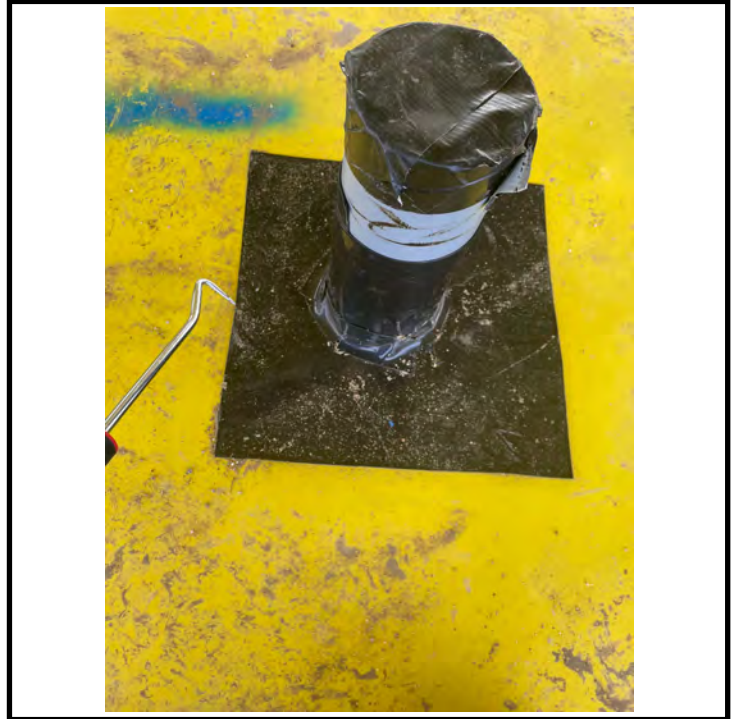
### Pipe Penetrations

Throughout the installation of the Juta GP5+ Gas Barrier to the referenced area, there were a number of pipe penetrations that have been sealed in accordance with manufacturer's specifications and design guidelines. This has been achieved using Juta TitanTank which is a self adhesive membrane. The installers have first

cut the Juta GP5+ Gas Barrier tight around the base of each pipe penetration to minimise voided areas. Next, strips of Juta Titan Tank are placed intricately in a top hat formation around the pipe penetration and onto the Juta GP5+ Gas Barrier. Heat and rolled pressure is applied to activate the bitumen backing.

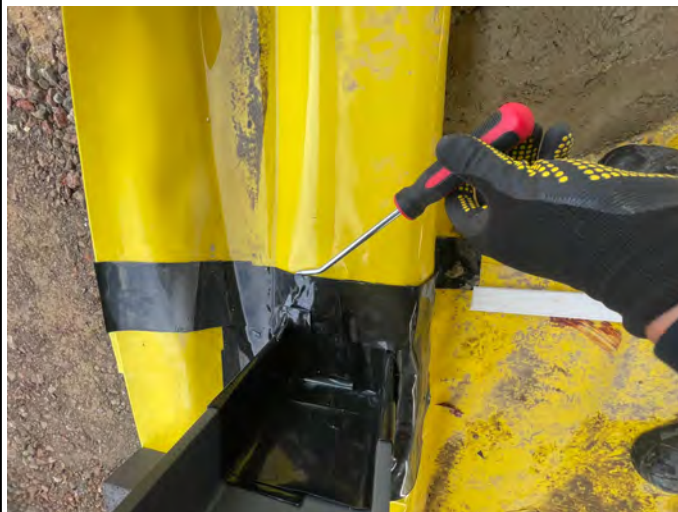
A probe demonstrating a fault identified.

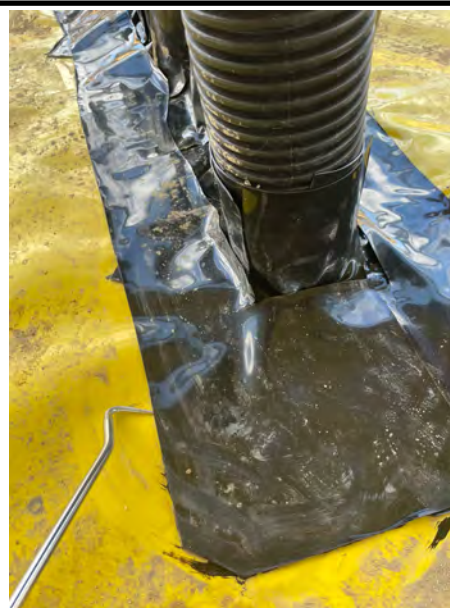
A pick and probe test being conducted upon a pipe penetration.

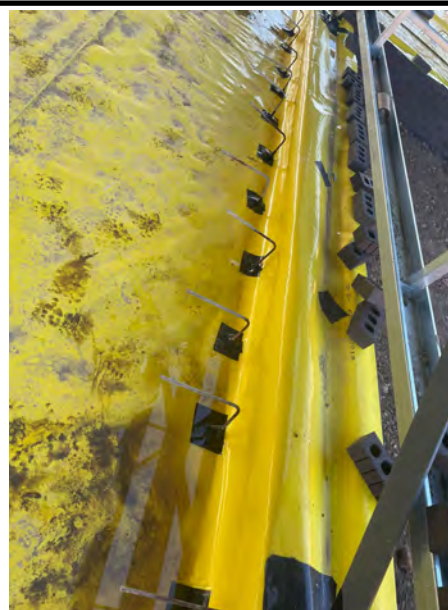
Steel Rebars sealed using Juta Titan Tank.

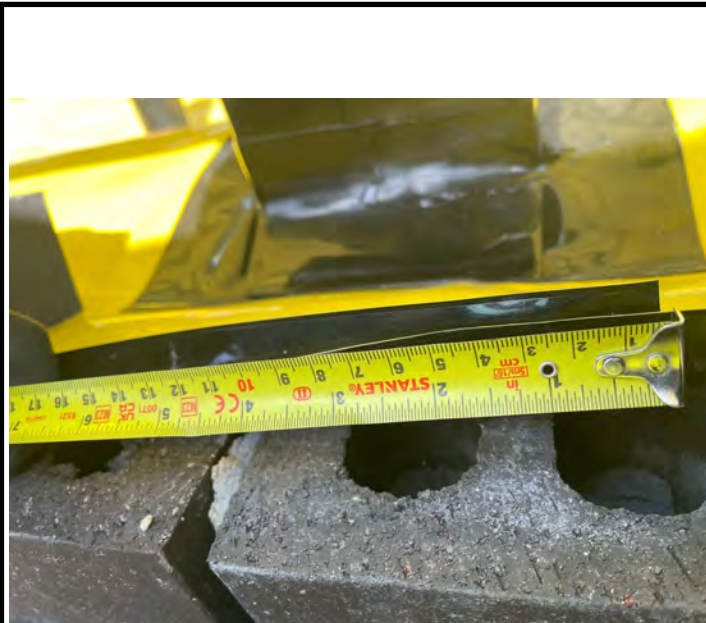
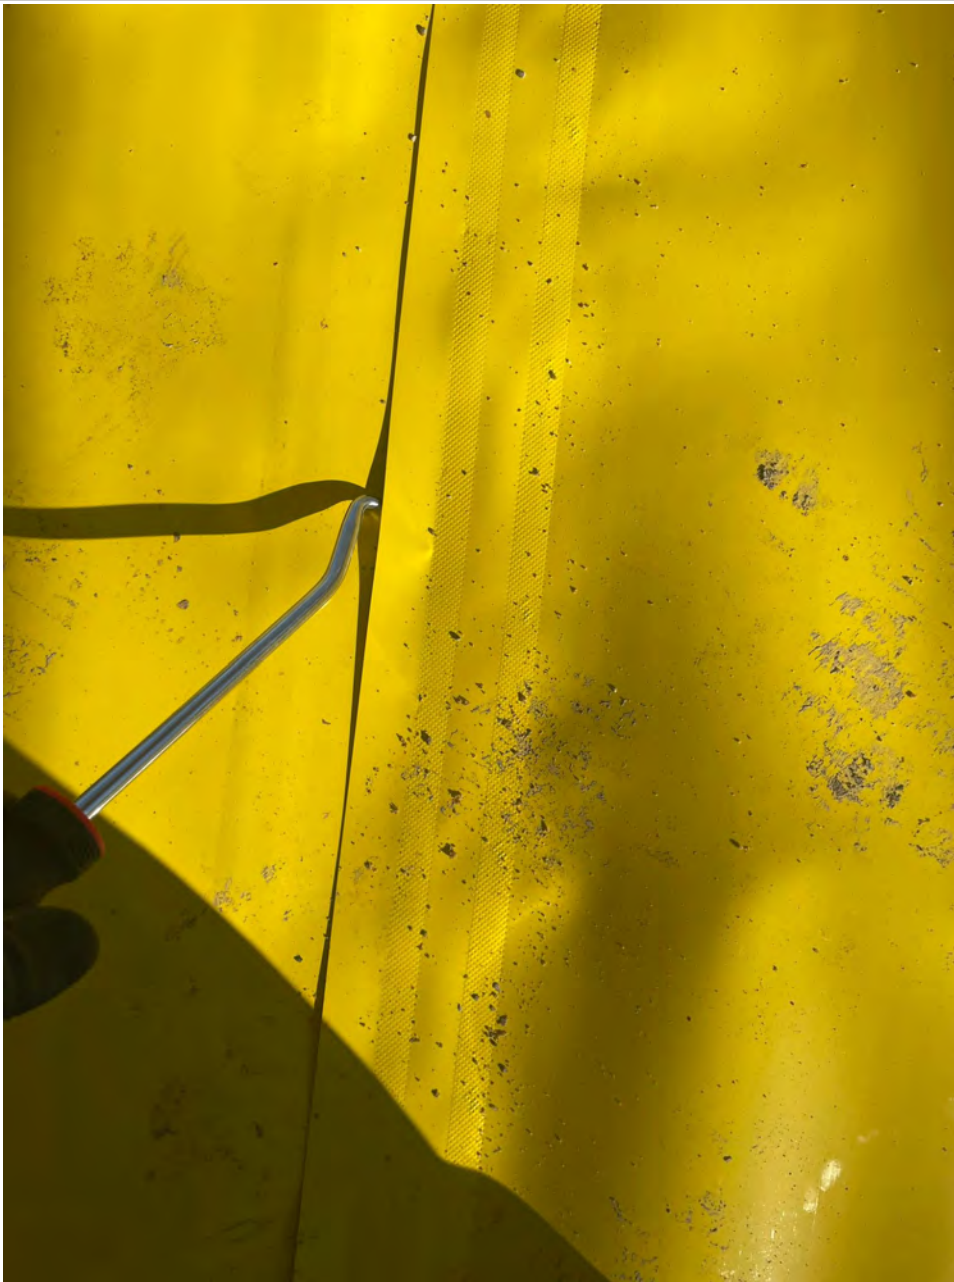
Installation of JUTA GP5+ Gas Barrier

JUTA GP5+ Gas Barrier has been installed across the footprint of the area referenced, gridlines A-E/1-10. The JUTA GP5+ Gas Barrier has been lined out across the entirety of the area, ensuring a sufficient overhang has been left around the perimeter to enable further works to be carried out at a later date. A liquid gas

barrier has been applied to areas where steel rebar has been placed, shown in the first photograph above, with the JUTA GP5+ Gas Barrier being terminated using double sided butyl tape. All lap joints between the adjacent sheets of JUTA GP5+ Gas Barrier have been overlapped a minimum of 100mm, conforming to

design details. All overlaps have been welded using a hot air leister and silicone roller with adequate pressure applied to ensure a continuous seal is achieved. Alternatively, the overlaps have been welded using a Twinny Wedge Welder creating dual welded lap joints. All aspects of the installation were subjected to mechanical point stress testing and non destructive air lance integrity testing, a number of faults were identified.

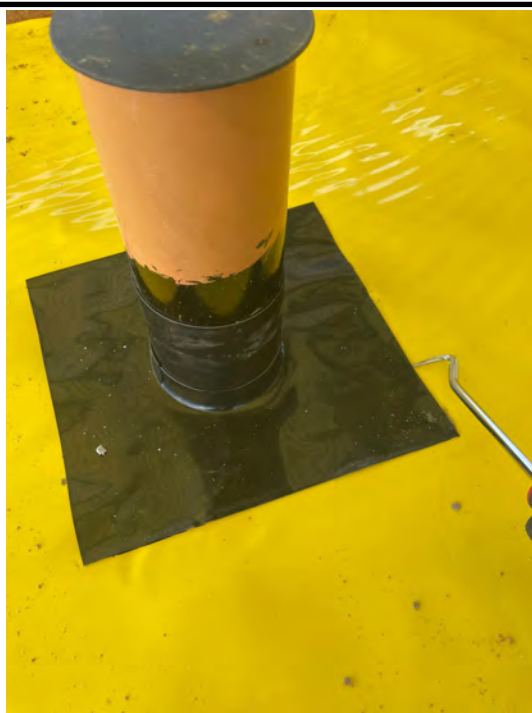
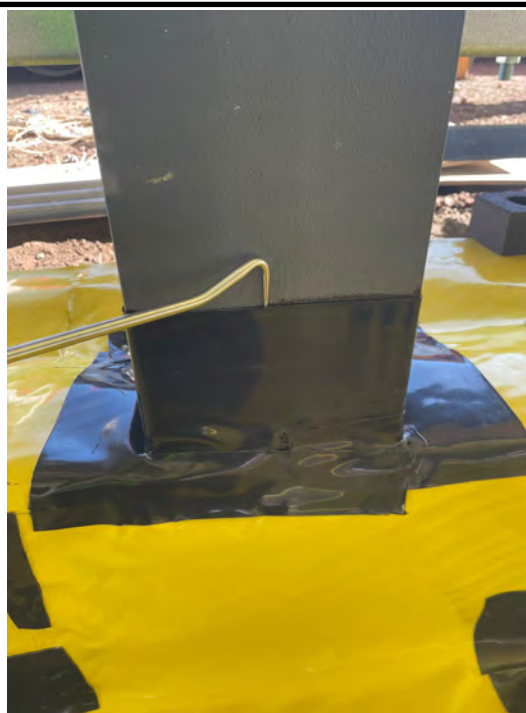
Sealed Details (Pipe Penetrations & Steel Stanchions)

Throughout the installation of the JUTA GP5+ Gas Barrier to the referenced area, there were a number of details, such as pipe penetrations and steel stanchions that have been sealed. The installers cut the JUTA GP5+ Gas Barrier tight around each detail to minimise voided areas. Next, patches of JUTA Titan Tank are placed

intricately in a petal formation around the details, onto the JUTA GP5+ Gas Barrier, with a 300mm square of JUTA Titan Tank placed over the top to form a top hat detail. Heat and pressure are applied to aid in the adhesion. Thorough visual inspections, supported by mechanical point stress testing identified several details not sealed.

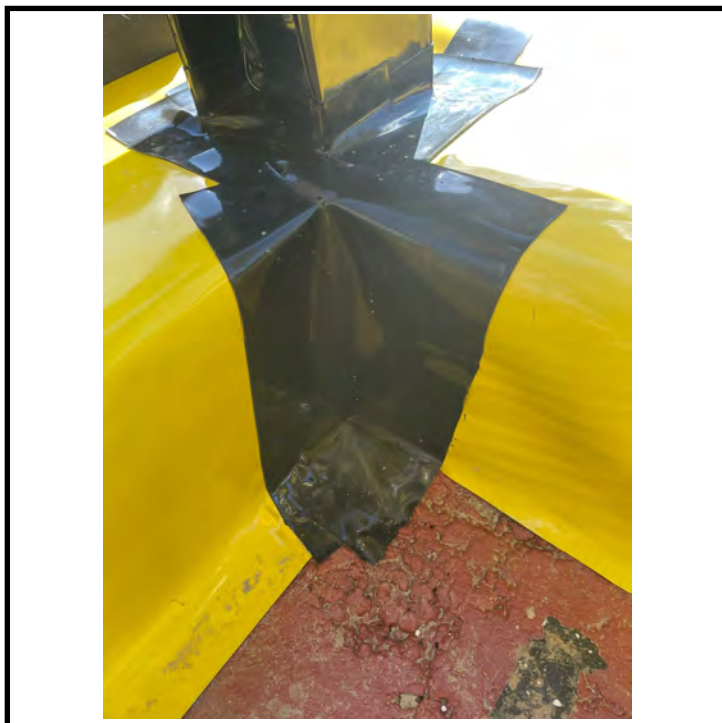
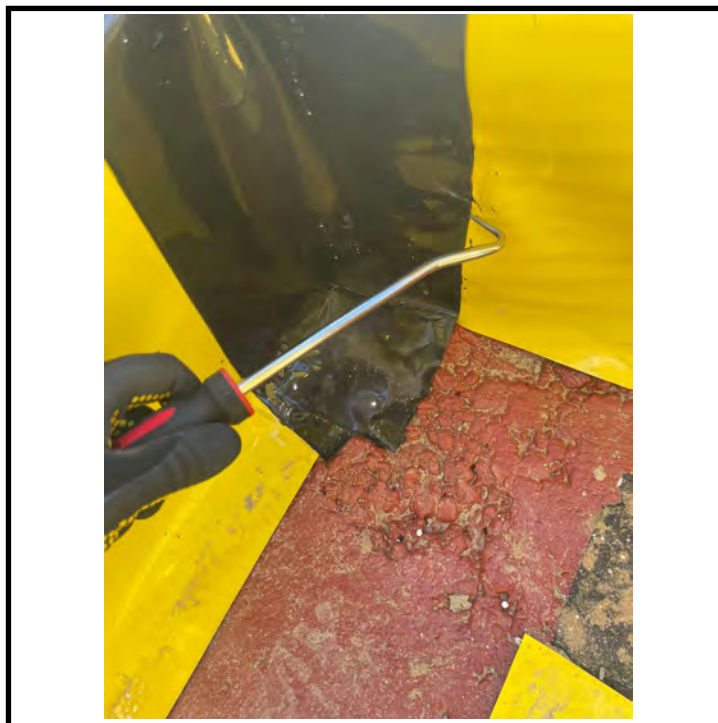
### Sealed Details (Corners)

A number of corners throughout the referenced area have also been sealed as per manufacturer's specifications. This has been achieved using JUTA Titan Tank. Where the JUTA GP5+ Gas Barrier has been cut to minimise voided areas and gaps across the footprint of the area, each corner junction has been reinforced by

heating strips of JUTA Titan Tank and placing into position around each corner, onto the JUTA GP5+ Gas Barrier. Heat and firm rolled pressure is applied to aid in the adhesion ensuring the JUTA Titan Tank has fully bonded. Visual inspections, supported by a mechanical point stress test identified several corners not sealed.

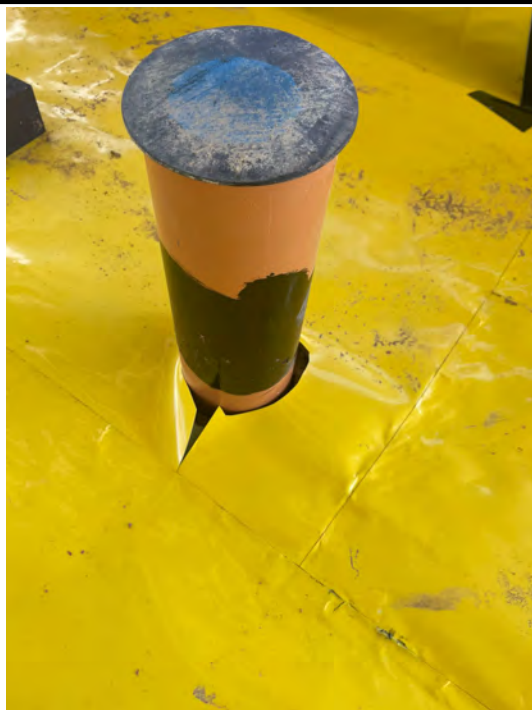
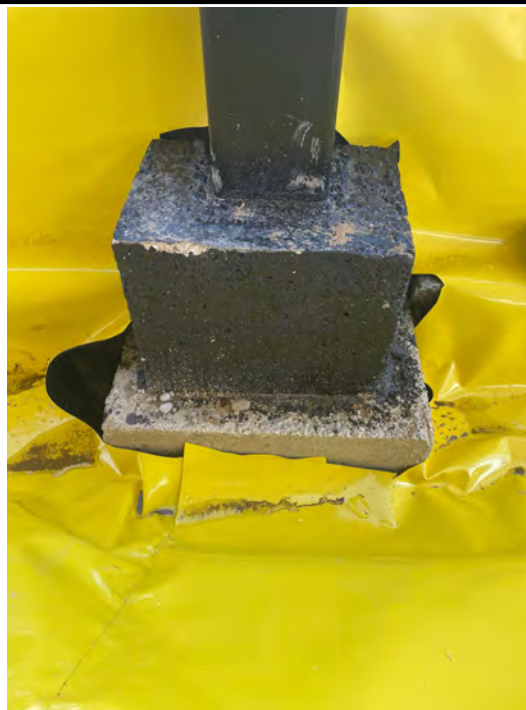
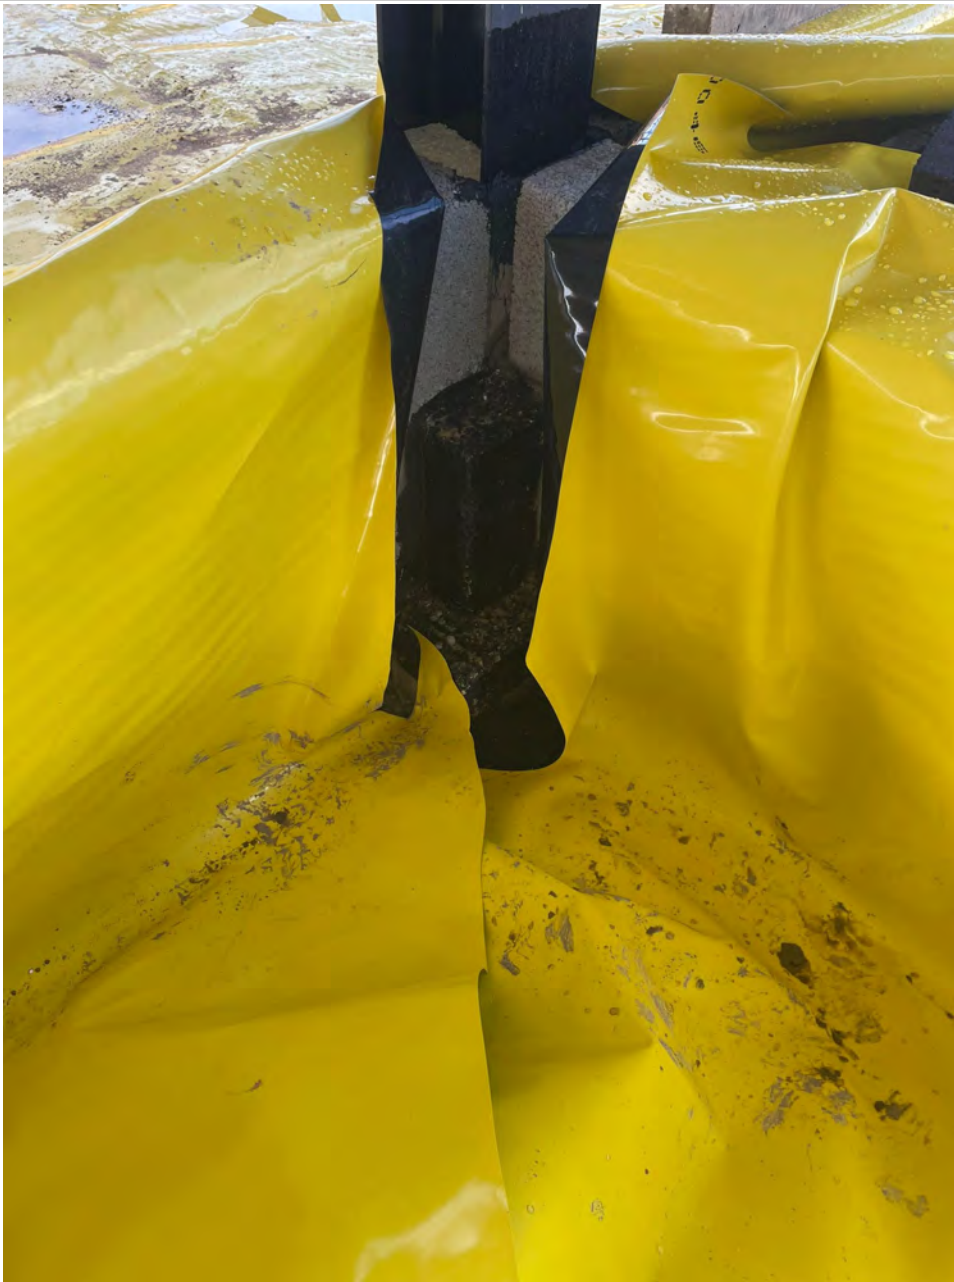
### Outstanding Remedations

As mentioned within this report, visual inspections, mechanical point stress testing and non destructive air lance integrity testing conducted upon all aspects of the installation, identified a large number of areas that have not been sealed. Several steel rebars penetrating the membrane have not received a

coverage of liquid gas barrier. A large number of pipe penetrations, corners and steel stanchions have not been sealed with JUTA Titan Tank.  
All miswelded overlaps identified, have been remediated on site in the presence of GeoShield.

All areas were brought to the attention of the installers from DD Lining Services. Due to the large number of areas identified that have not been sealed, these could not be remediated on site in the presence of GeoShield. All areas will need to be sealed and inspected during a future visit. The referenced area could therefore, not be signed off during the visit today.

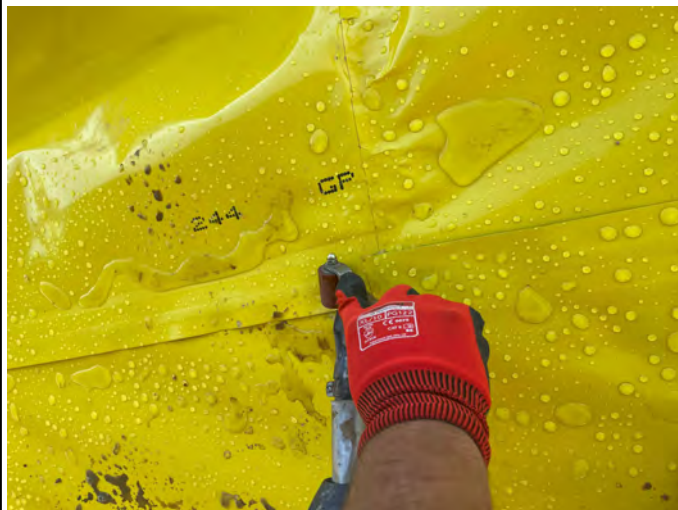
Firm rolled pressure being applied to remediate a lap joint.

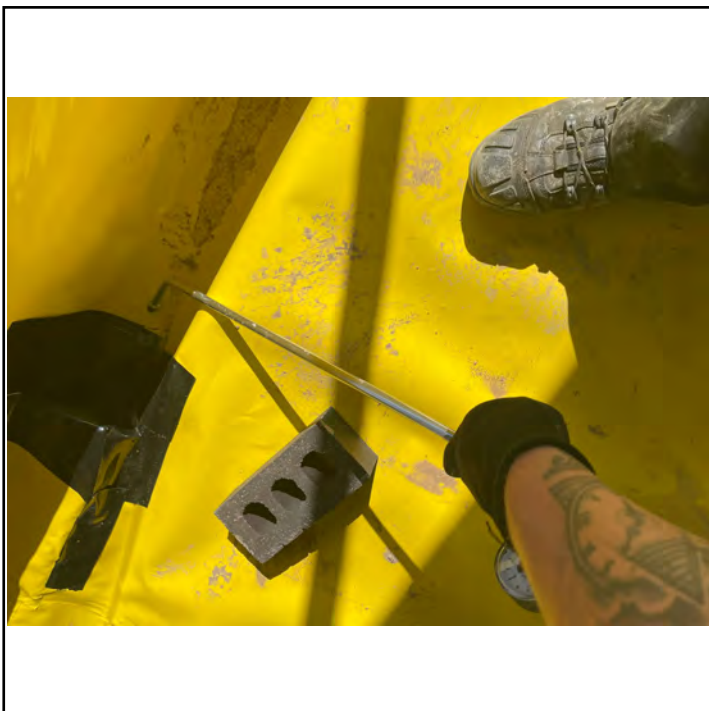
Air lance test on a corner.

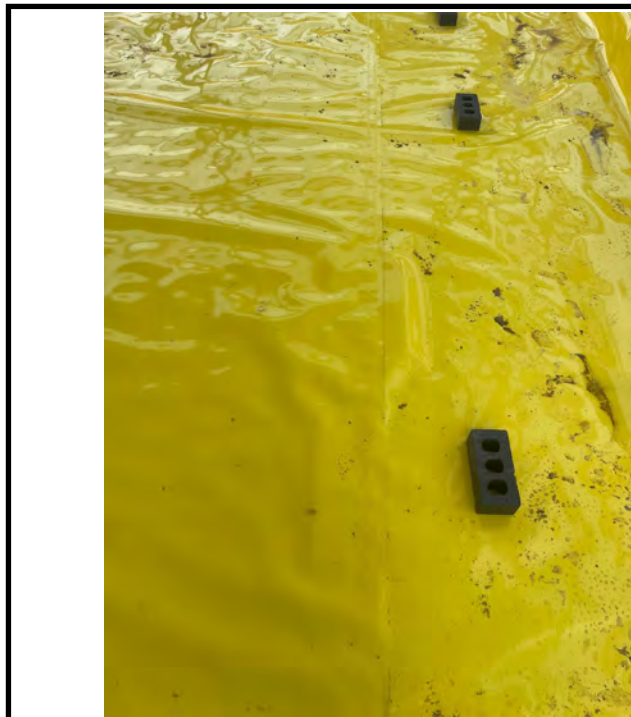
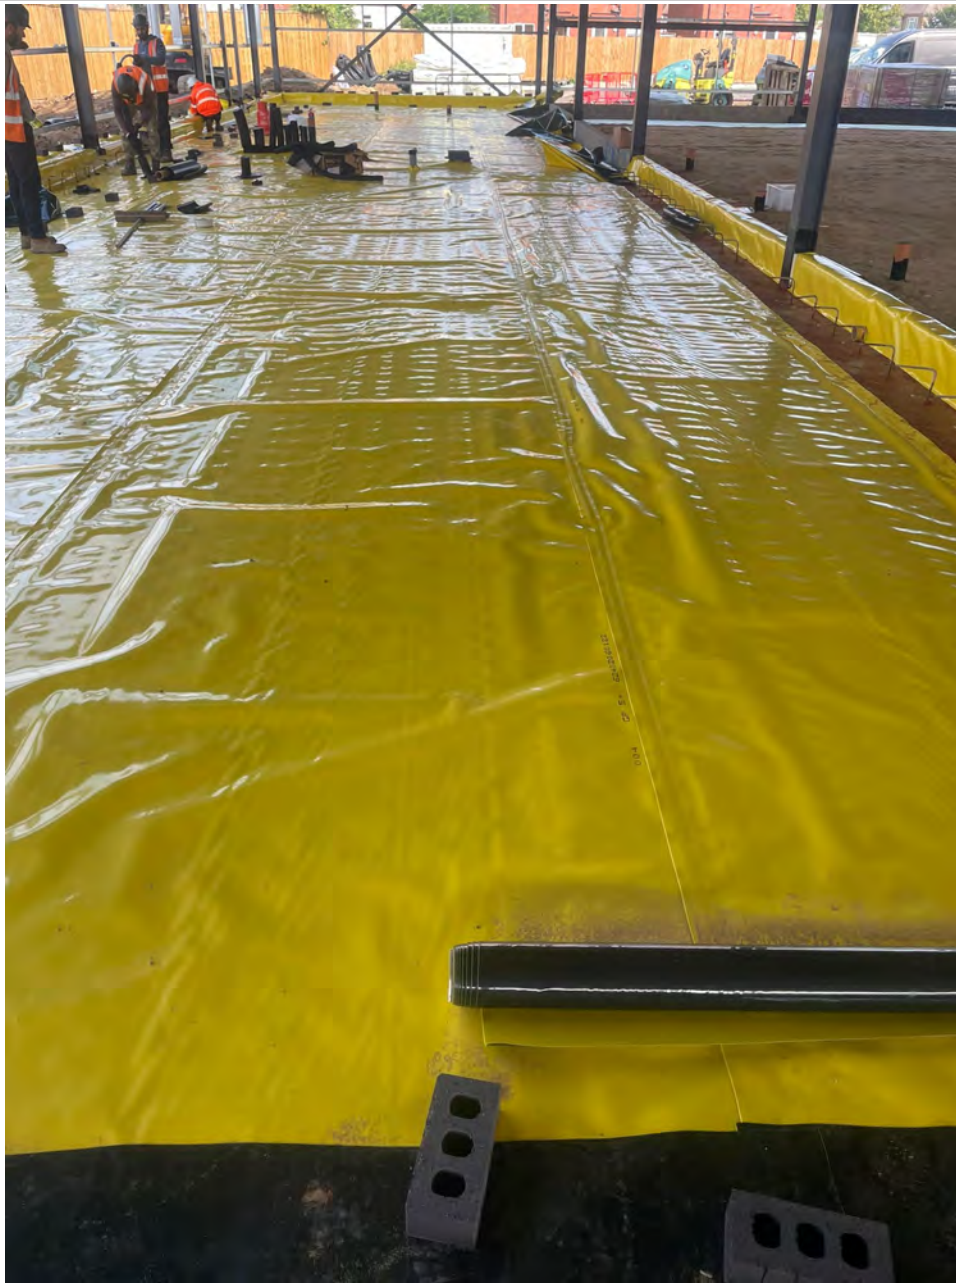
Installation of JUTA GP5+ Gas Barrier

JUTA GP5+ Gas Barrier has been installed across the footprint of the area referenced, gridlines F-E/1-6. The JUTA GP5+ Gas Barrier has been lined out across the entirety of the area ensuring a sufficient overhang has been left around the perimeter to enable further works to be carried out at a later date.

All lap joints between the adjacent sheets of JUTA GP5+ Gas Barrier have been overlapped a sufficient amount, conforming to manufacturer's specifications. All overlaps have been welded using a hot air leister and silicone roller with adequate pressure applied to ensure a continuous seal is achieved,

the overlaps have been welded using a Twinny Leister Machine creating dual welded lap joints. All details throughout the referenced area, such as pipe penetrations, corners and steel stanchions have not been sealed. These will be sealed and inspected at a later date prior to sign off of the area being achieved.

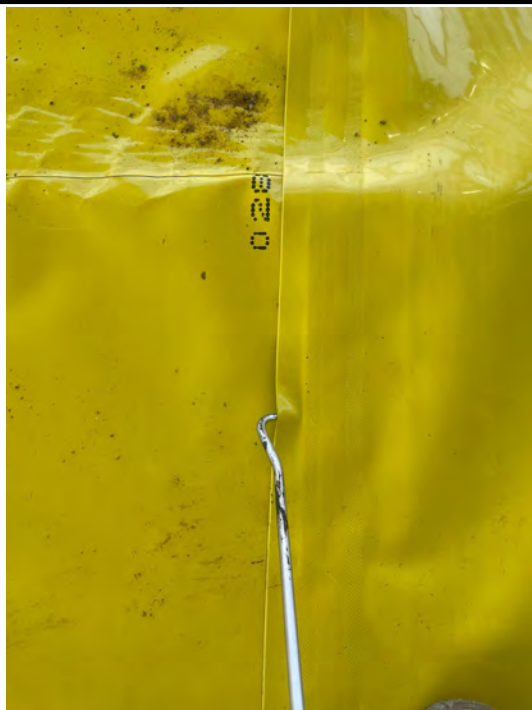
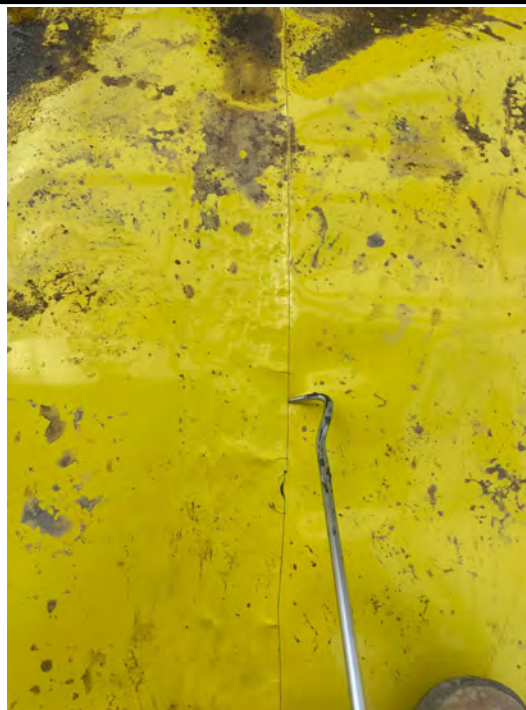
### Testing Procedures

During this verification visit, thorough visual inspections, supported by mechanical point stress testing, also known as pick and probe testing, were conducted across all lap joints. The mechanical point stress testing tool was run along all overlaps of the dual welded and hand welded JUTA

GP5+ Gas Barrier to ensure a complete adhesion had been achieved.

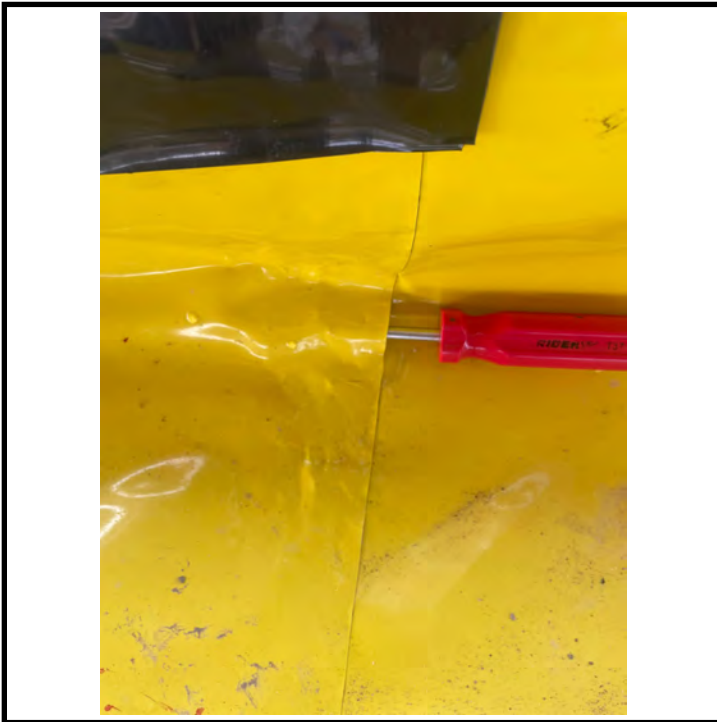
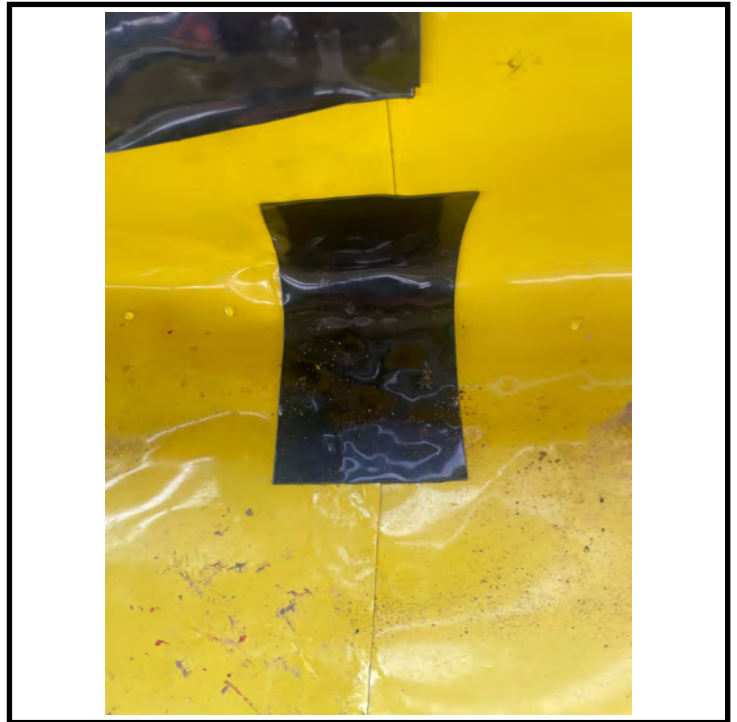
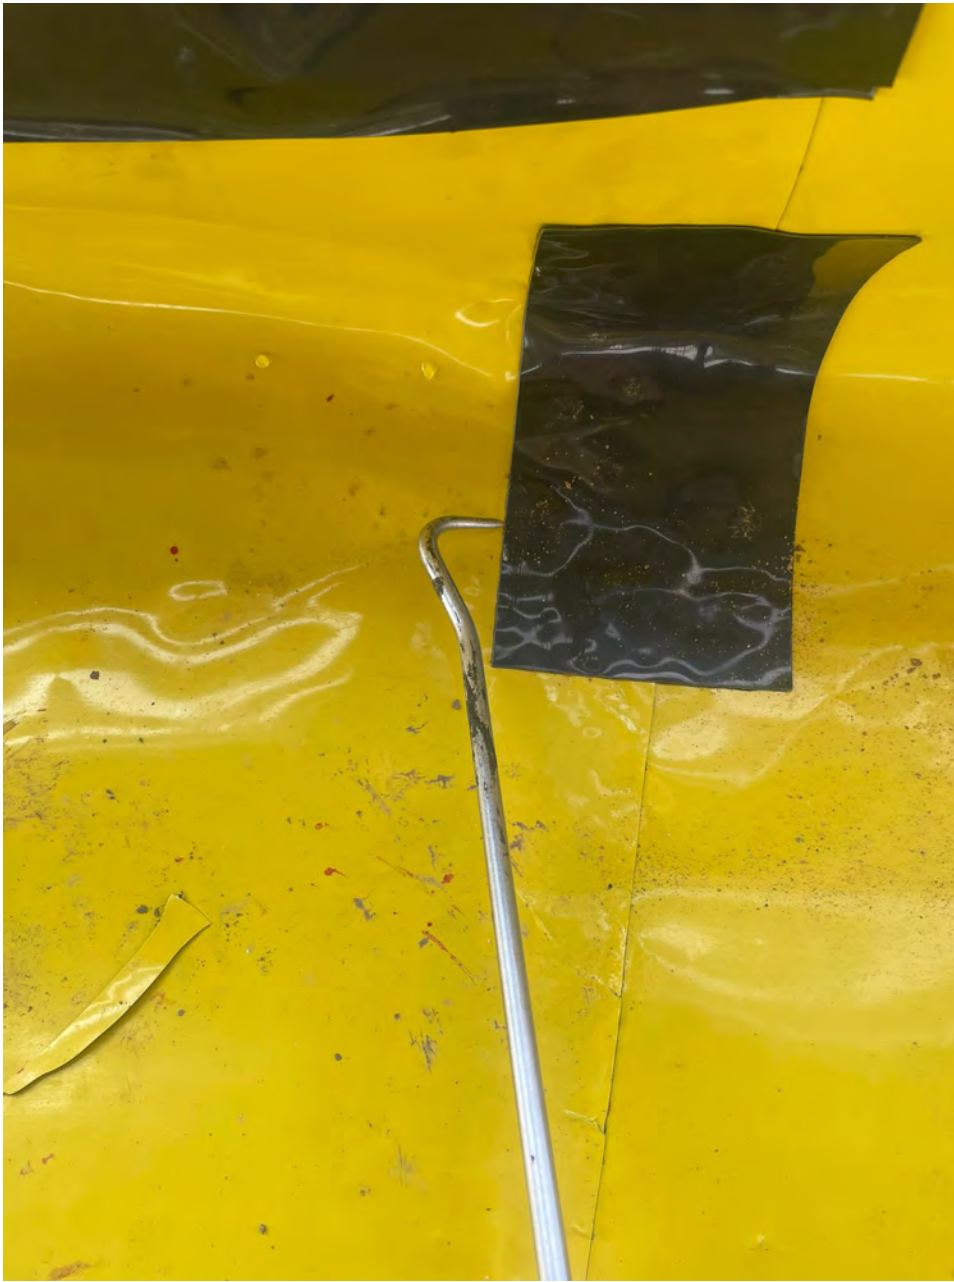
### Fault Identified & Remediated

As mentioned within this report, during the visual inspections and mechanical point stress testing conducted upon the welded overlaps of the JUTA GP5+ Gas Barrier, one miswelded area was identified. The fault was brought to the attention of the installers from DD Lining Services in order that preparation could be made

to conduct remedial action in the presence of GeoShield. The dedicated applicators opted to apply a patch of JUTA Titan Tank over the miswelded overlap, with heat applied to re-activate the bitumen adhesive backing of the material.

Firm rolled pressure applied with a silicone roller ensured the JUTA Titan Tank had fully bonded. Thorough visual inspections, supported by mechanical point stress testing were conducted upon the remediated area, where no further faults were found.

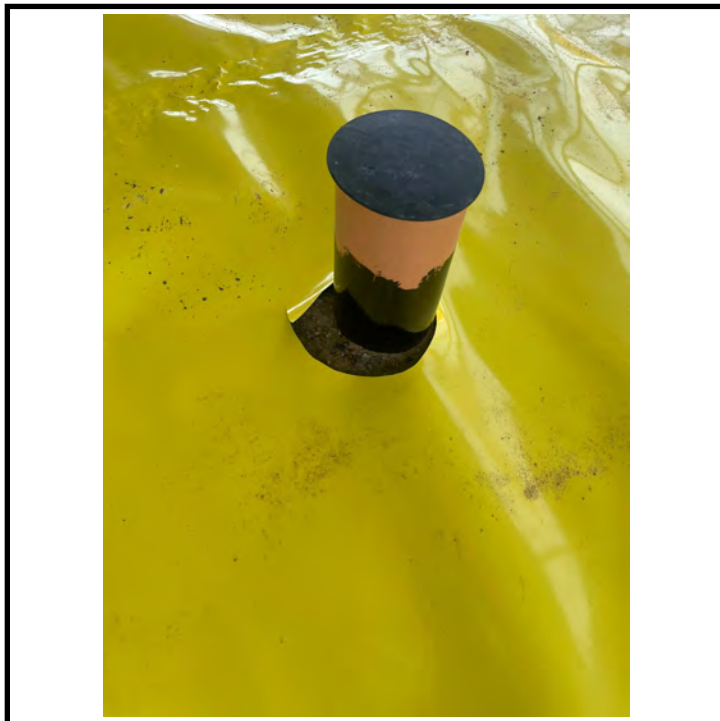
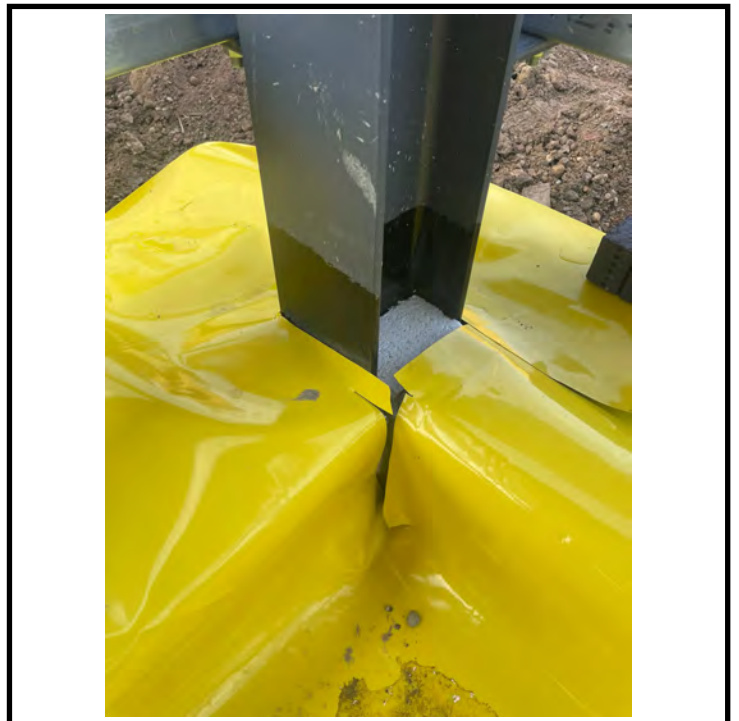
### Outstanding Remediations

As mentioned, all details such as pipe penetrations, steel stanchions and corners throughout the referenced area have not been verified during the visit today.

Several areas have yet to be sealed, as shown in the photographs above. These areas will be sealed and inspected at a future visit prior to sign off of the referenced area being achieved.

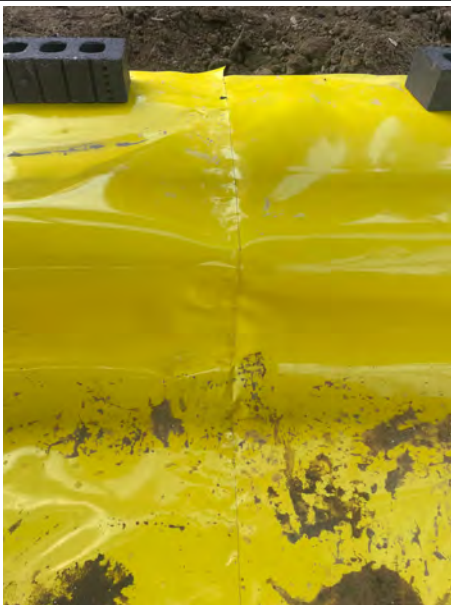
A hand welded overlap of the JUTA GP5+ Gas Barrier.

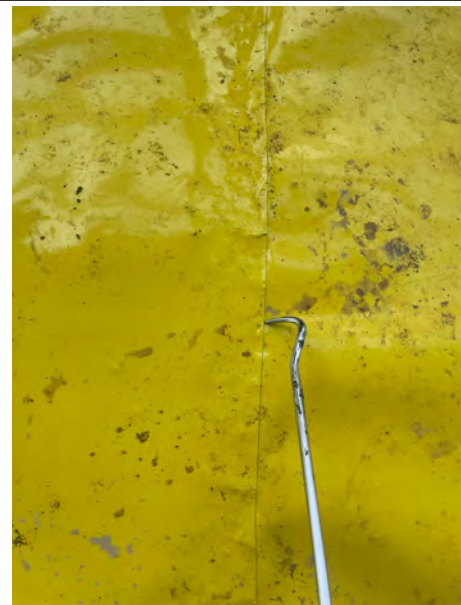
A pick and probe test being conducted upon a hand welded overlap.

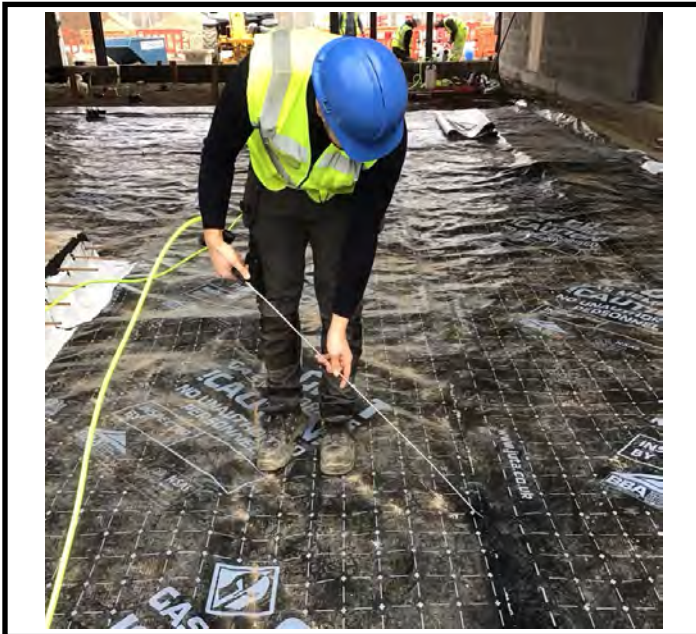
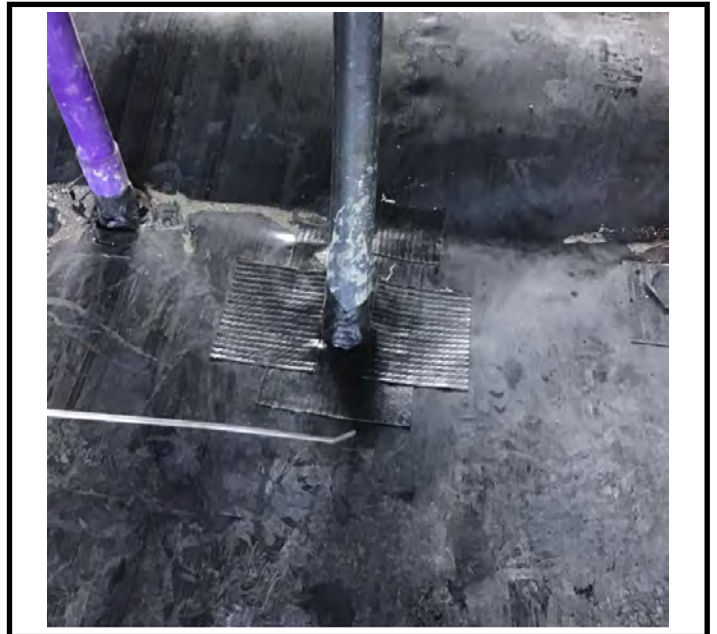
### Air Lance Testing

4.3.3 - Air lance testing identifies unbonded areas of seam by directing a high pressure jet of air at the seam. The air is at a minimum pressure of 345kPa via a 4.8mm nozzle and is located no more than 50mm from the seam being tested.
