ARCHAEOLOGICAL MONITORING AND RECORDING  
AT HOLLY LODGE, SPALDING ROAD,  
HOLBEACH, LINCOLNSHIRE.

**National Grid Reference: TF 3484 2487**  
**Site Code: HLHO17**  
**Accession No: LCNCC: 2017.200**  
**Planning Reference: H09-0257-17**

PREPARED FOR MR. ANDY ROWE OF ABR LTD.

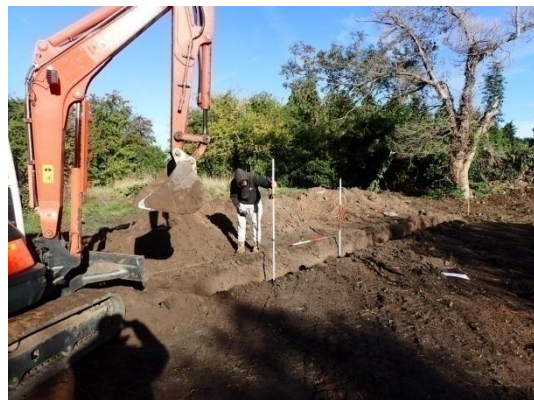
**Plate 5: Representative Section 1,** from the east

- 7.1.1 The foundations for House Plot 7 had already been set out prior to arrival [**Plate 1**]. The foundations for this house plot were excavated under archaeological supervision to varying lengths, to widths of 0.60m-0.80m and to depths of between 0.70m-1.20m below ground levels [**Plates 2-4, 6-7, 10, 13, 19, 21-24 and 26-30**]. Where these monitored mechanical excavations attained their greatest depths at below 1.0m-1.20m within the western and part of the southern margins of this new build area, these excavations extended through a topsoil horizon (**001**), an alluvial horizon (**002**) and a second alluvial horizon (**003**), which extended to the base of these excavations. This deposit sequence was recorded within **Representative Section 1** [**Plate 5**]. Archaeological levels were thus reached at these greater depths.

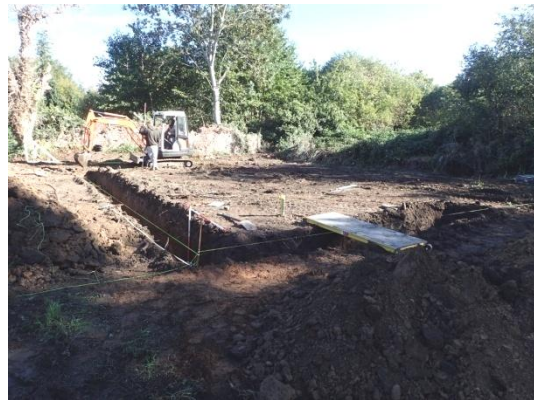
**Plate 8:** View of the pit cuts [004] with fill (005) & [006] with fill (007), from the south

- 7.1.3 A sequence of two late medieval intercutting pits - pit cut [**004**] with fill (**005**) and pit cut [**006**] with fill (**007**) were identified in the base of the first north-south orientated foundation trench following the completion of this mechanical excavation and where these excavations attained their greatest depths [**Plates 8-9**]. The relationship between the two pits could not be precisely determined as their respective fills were identical and no definite division between the two pits could be seen in section. The profiles of these pits were recorded within **Section 2** [**Plates 11-12**]. Although the fill (**005**) did not produce any finds, the fill (**007**) yielded finds of two sherds of late medieval pottery of mid 15th to mid 16th century date and one fragment of roof tile of 19th-20th century date.

- 004** Cut of a pit identified during the excavation of the foundations for House Plot 7. One of two intercutting pits, though the relationship with adjacent pit cut **[006]** could not be definitely determined. Left (north side) only recorded in profile in **Section 2**. Sharp break of slope at top, steeply sloping and slightly rounded side. Break of slope and base not reached. Cut into **(003)**. Length - >0.70m width - 0.85m, depth - >0.22m.

- 006** Cut of a pit identified during the excavation of the foundations for House Plot 7. One of two intercutting pits, though the relationship with adjacent pit cut **[004]** could not be definitely determined. Right (south side) only recorded in profile in **Section 2**. Sharp break of slope at top, steeply sloping and slightly rounded side. Break of slope and base not reached. Cut into **(003)**. Length - >0.70m, width - 0.82m, depth - 0.23m.

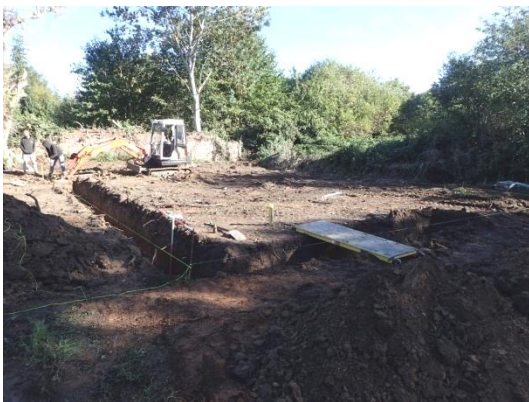
**Plate 12:** Section 2 of the pit cuts [004] with fill (005) & [006] with fill (007), from the north-west

*However, from the profiles of these two intercutting pits, which were recorded within **Section 2**, it is likely that the pit cut [004] truncated the pit cut [006]. Thus, making the pit cut [006], the earliest of these two intercutting archaeological features. The fill (007) of the pit cut [006] yielded finds of two sherds of late medieval pottery, which at the greater depths at which these features were encountered, would ascribe a corresponding late medieval date to these two intercutting pits with the fragment of early modern roof tile perhaps representing contamination from the upper levels.*

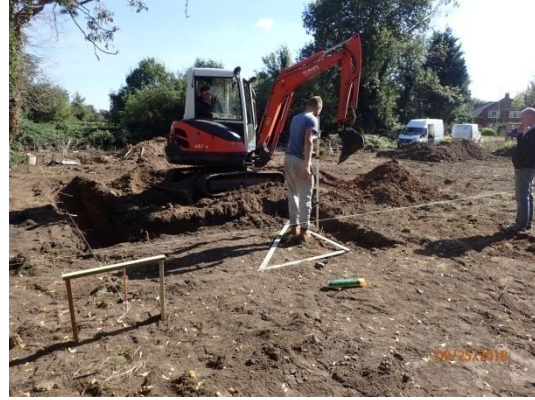
**Plate 35: Representative Section 5,**  
from the south

- 7.2.1 House Plots 5 and 6 lay to the east of House Plot 7 and occupied the remainder of the northern portion of the development site [**Plates 31-32**]. The foundations for these house plots were excavated under archaeological supervision to varying lengths, to widths of 0.60m-0.80m and to depths of between 0.90m-1.10m below ground levels [**Plates 33-34, 36-40, 42-45, 47-50, 52-54 and 56-57**].
- 7.2.2 These monitored mechanical excavations extended through the topsoil horizon (**001**), the alluvial horizon (**002**) and the second alluvial horizon (**003**), which extended to the base of these excavations. This deposit sequence was recorded within **Representative Sections 5-9** [**Plates 35, 41, 46, 51 and 55**].
- 7.2.3 No archaeological activity or finds were identified during the course of the archaeological monitoring of these two house plots.
