# ANTHONY-JOHNSON

Adjacent to Pentland House,  
Chapel Drove,  
Holbeach Drove,  
Spalding.

It is proposed that an existing agricultural building be converted to residential use. The purpose of this survey is to therefore review the suitability of the structure for conversion to residential use and consider the retention of structural elements contained in the current structure.

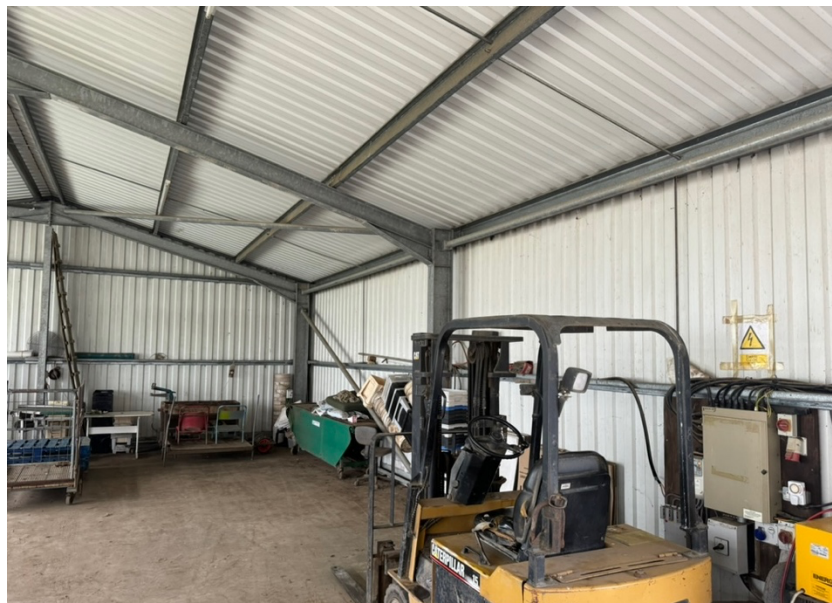
Figure 1: The internal structure of the building, showing the construction using steel frames and cladding.

The building is formed internally of steel portal frames, running front to back and set at suitable centres. S purlins, set to the head of portal frames, run side to side at suitable centres between adjacent portal frames. These provide support to corrugated steel cladding, laid to falls to the roof, running from apex to eaves level. The same cladding runs

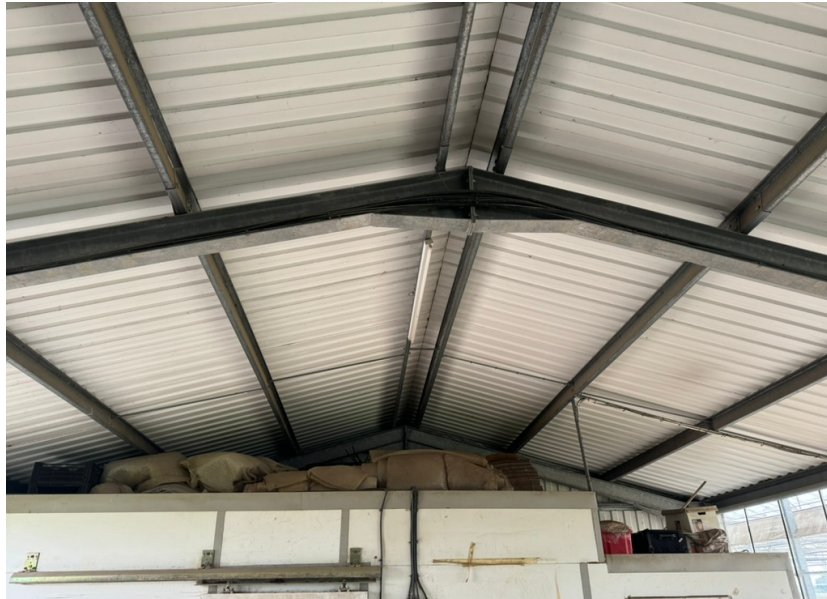
Figure 2: The ridge haunch of a portal frame in the building.

The portal frames are formed with suitable haunches at eaves and apex, thereby providing moment resisting connections, able to resist sway induced by wind loading in the direction of the frames. It is therefore anticipated that the bases of columns have been designed as pinned connections with no moment resistance, except for that needed to prevent collapse during a fire.

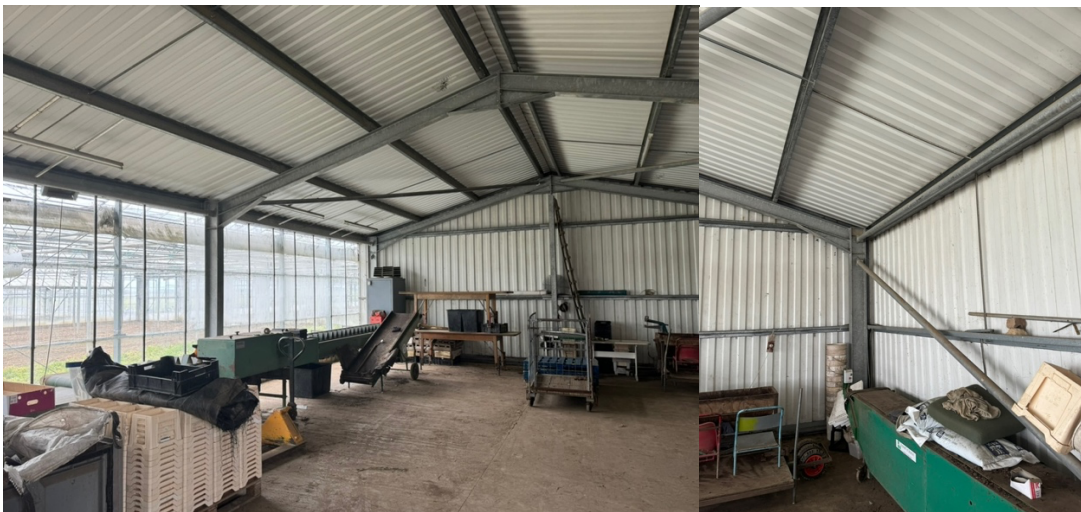
Figure 3: The rear windows provide a view into the greenhouses behind the building. The cross-braces are also visible here.

Figure 4: An eaves haunch of a portal frame in the building.

Sway introduced perpendicular to the portal frames by wind acting on each gable end is resisted by tubular cross-bracing, running from apex to eaves in adjacent portal frame bays. The sway is then transferred in purlins to side elevations back into tubular bracing, running from eaves level to ground level, in adjacent portal frame bays.

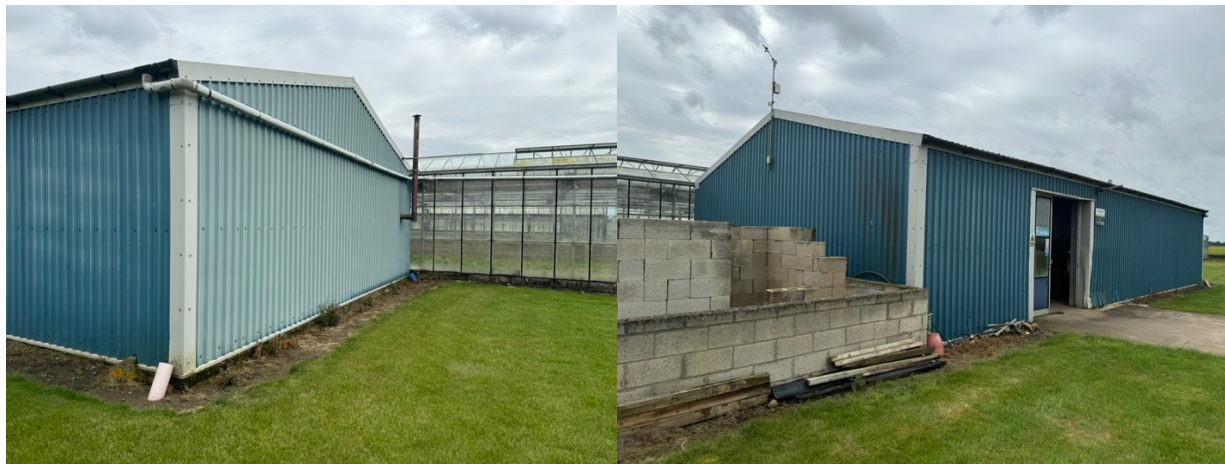
Figure 5 and 6: The exterior of the building

The steel structural elements were all found to be in very good condition, with steel portal frames and associated bracing having been galvanised, thus providing a suitable protective finish that is anticipated to last for decades, and will thus not require remedial works prior to conversion of the structure. Purlins were similarly found to be in good condition, and suitably sized, and they will likely be sufficient to allow for the replacement of existing steel cladding with a suitably insulated steel cladding.

Based upon the above observations, it is considered that the structure is suitable for conversion to residential use, without the replacement or removal of any internal structural elements. Steel framing and ancillary supports to cladding elements should all be retained, and subsumed into the proposed conversion.
