# **Arboricultural Impact Assessment**

Stukeley Gardens, Holbeach, Spalding, Lincolnshire

Report Reference: BG23.314.4

**January 2024**

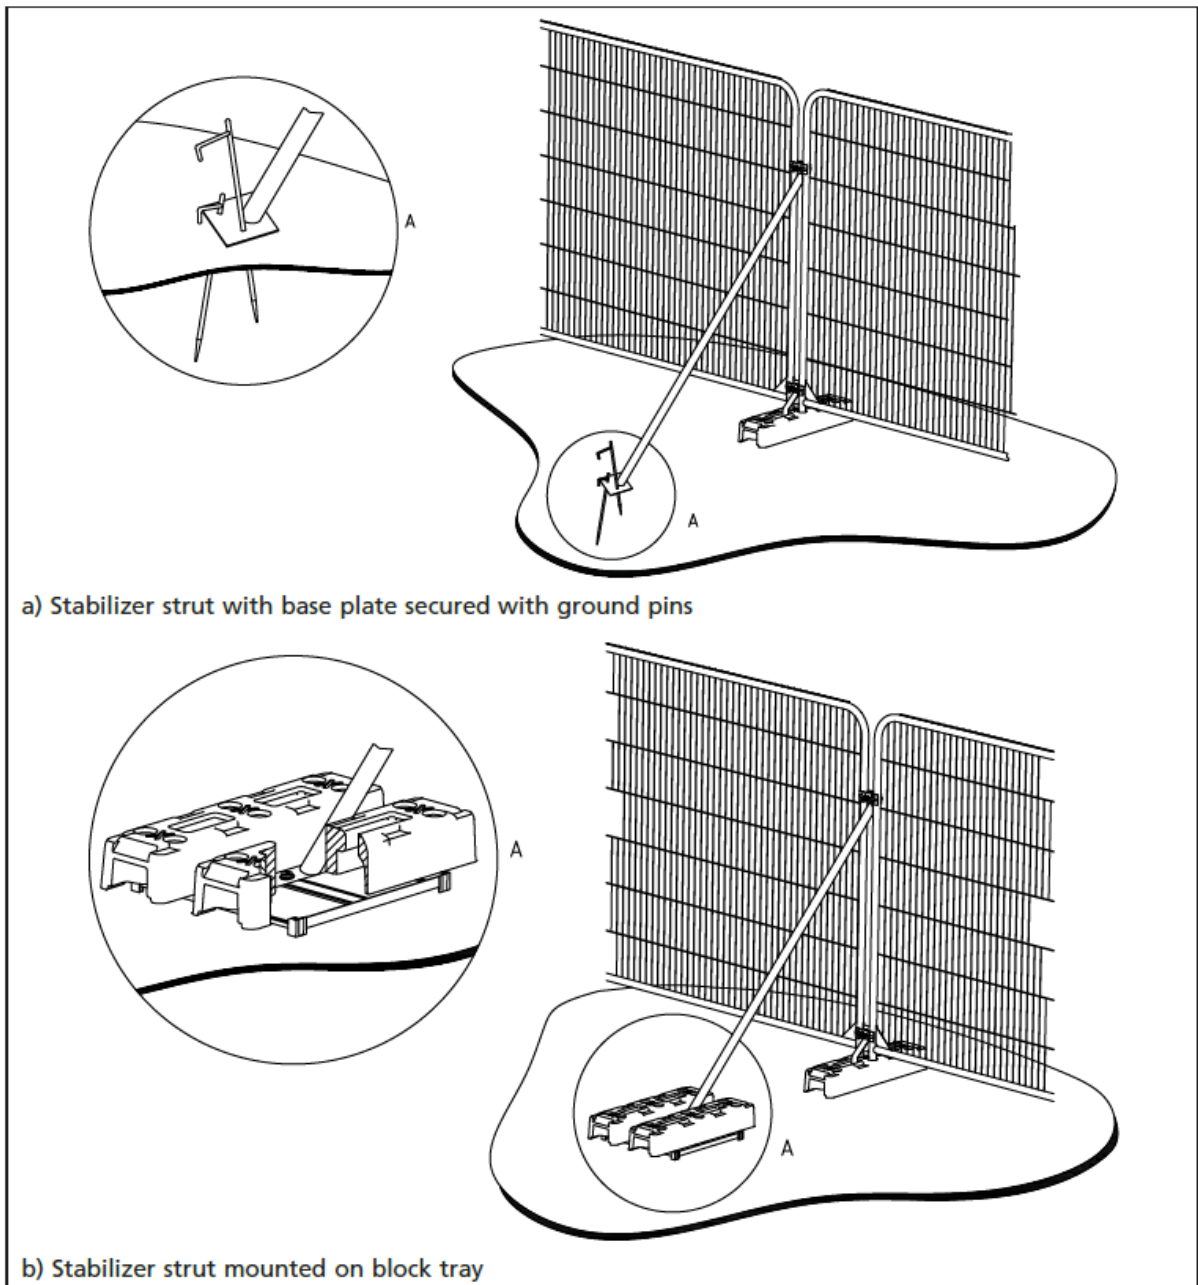
Figure 2: Alternative specification for tree protection fencing (Figure 3 in BS 5837:2012).

When the site circumstances prevent the use of driven poles (e.g. due to existing hard surfacing), the fencing specification should be as per Figure 2. This will consist of 2m tall welded mesh panels (e.g. Heras) on rubber or concrete feet, with the mesh panels held together with a minimum of two anti-tamper couplers. Distance between the fence couplers should be at least 1m and uniform across the fencing. Stabiliser struts on the inner side of the fence should be attached to a base plate secured with ground pins (Figure 2a) or mounted onto a block tray (Figure 2b).

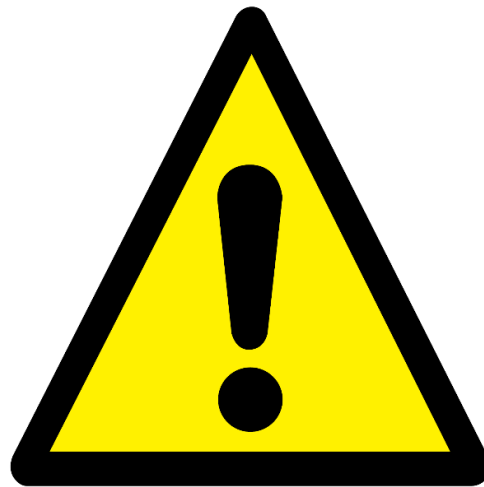
Figure 3: Tree protection fencing signage.

Tree protective fencing must have all-weather notices attached at regular intervals, such as those in Figure 3 and Figure 4. The notices must include wording such as 'CONSTRUCTION EXCLUSION ZONE – NO ACCESS' or 'TREE PROTECTION AREA – KEEP OUT'. The tree protective fencing must remain *in situ* and intact until completion of construction; they may be removed after agreement with the project arboriculturist and their removal discharged to the Local Planning Authority.

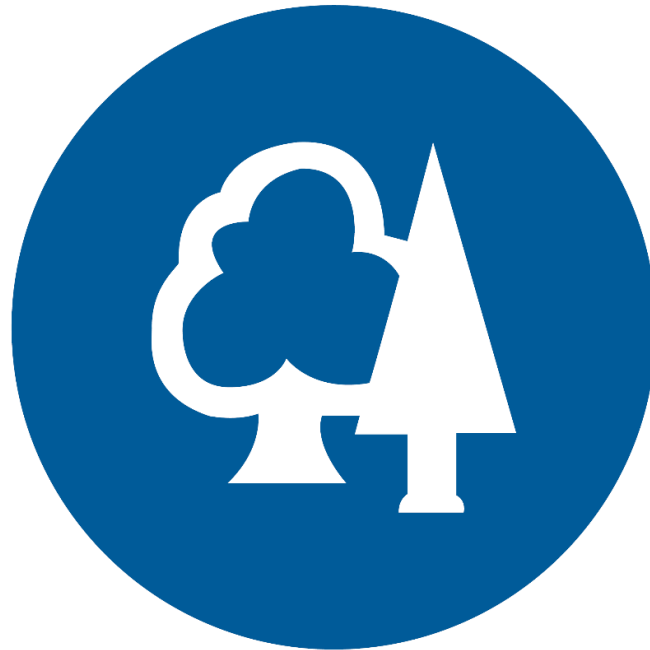
## **PROTECTIVE FENCING**

**Fencing must be maintained in accordance with the approved plans and drawings for this development**

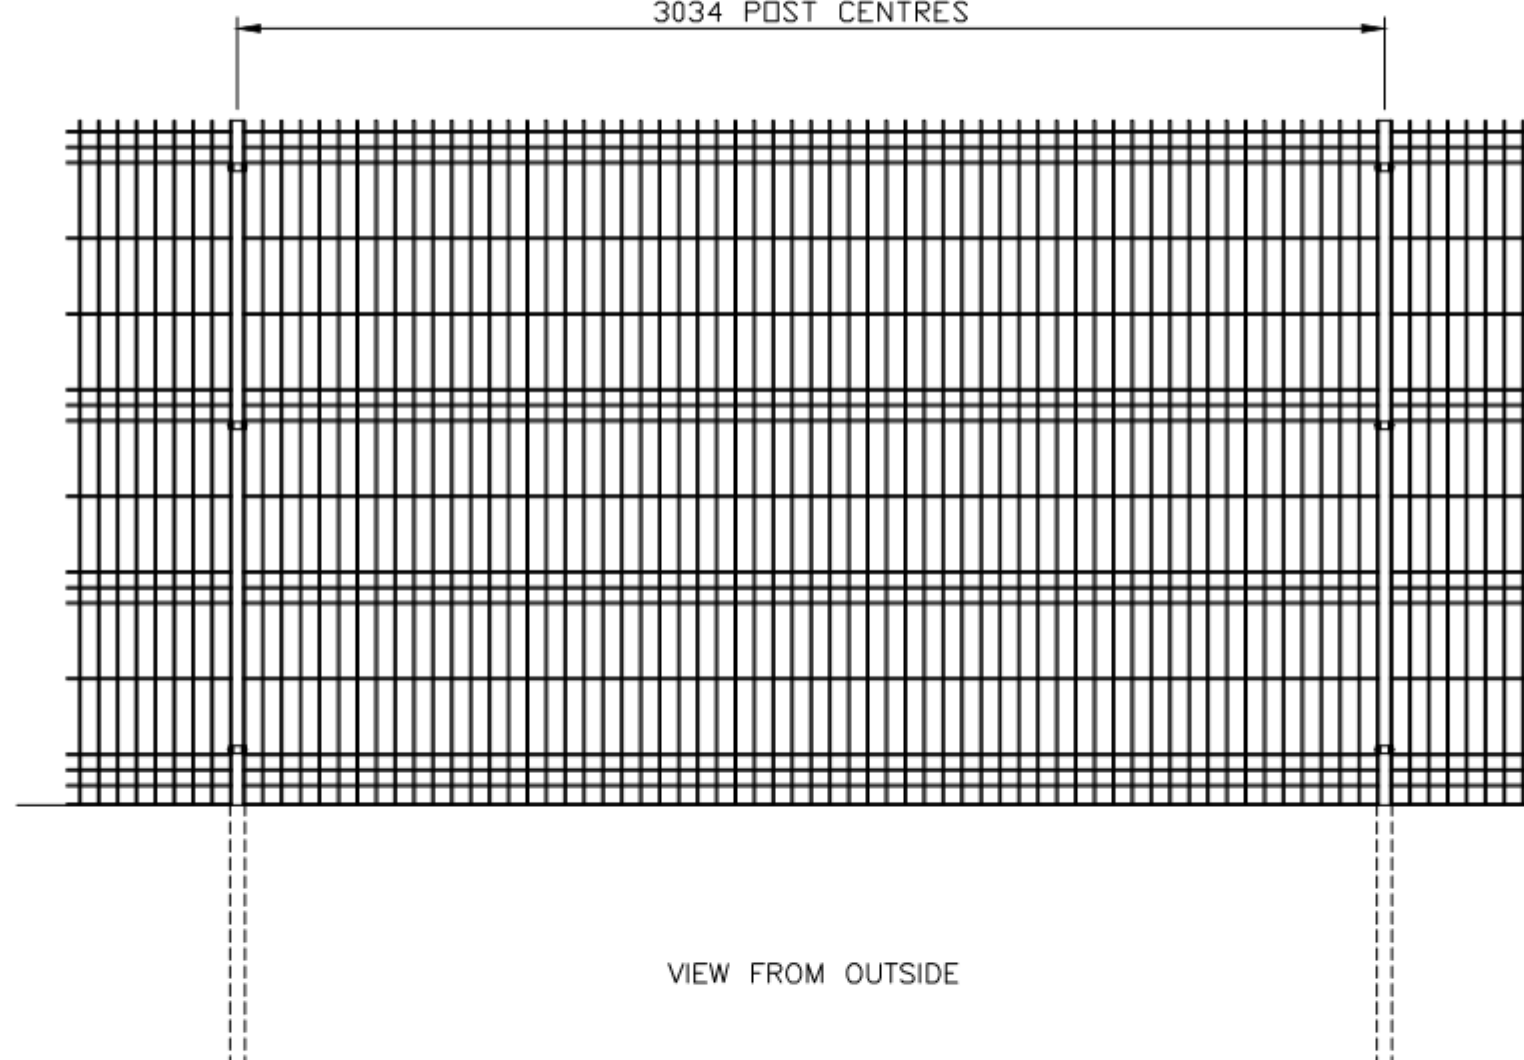
3034 POST CENTRES

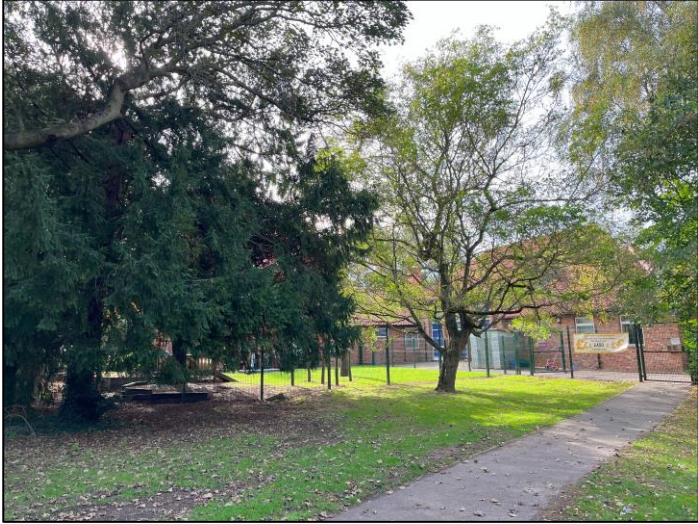
| Image | Description |
|---|---|
| <b>Site Photograph 1</b> | |

| Image | Description |
|---|---|
| | <p>Showing a portion of the site including T1 and T2. The hard surfacing footpath can be seen, running to the existing pedestrian school entrance (right).</p> |

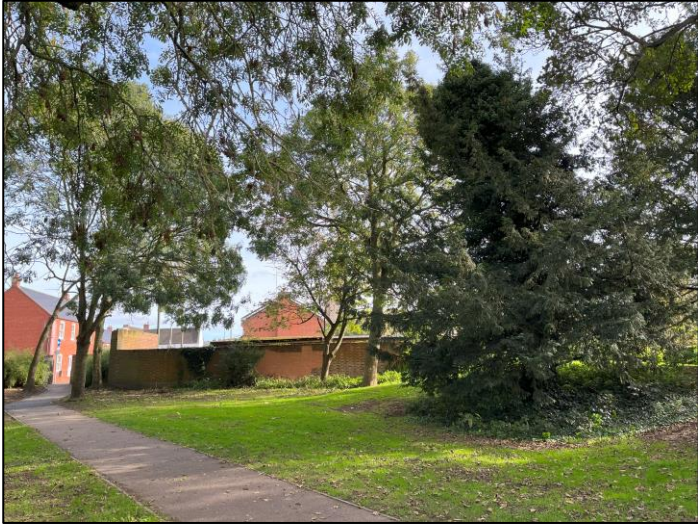
| Image | Description |
|---|---|
| <b>Site Photograph 2</b> | |

| Image | Description |
|---|---|
| | <p>Looking east, showing T7 – T9 (right), and T10 – T12 (left). The hard surfacing footpath can be seen running from Back Lane (left).</p> |
