Dam Gate  
Holbeach

**Combined Phase I Desk Study and  
Phase II Exploratory Investigation  
For  
Ashwood Homes**

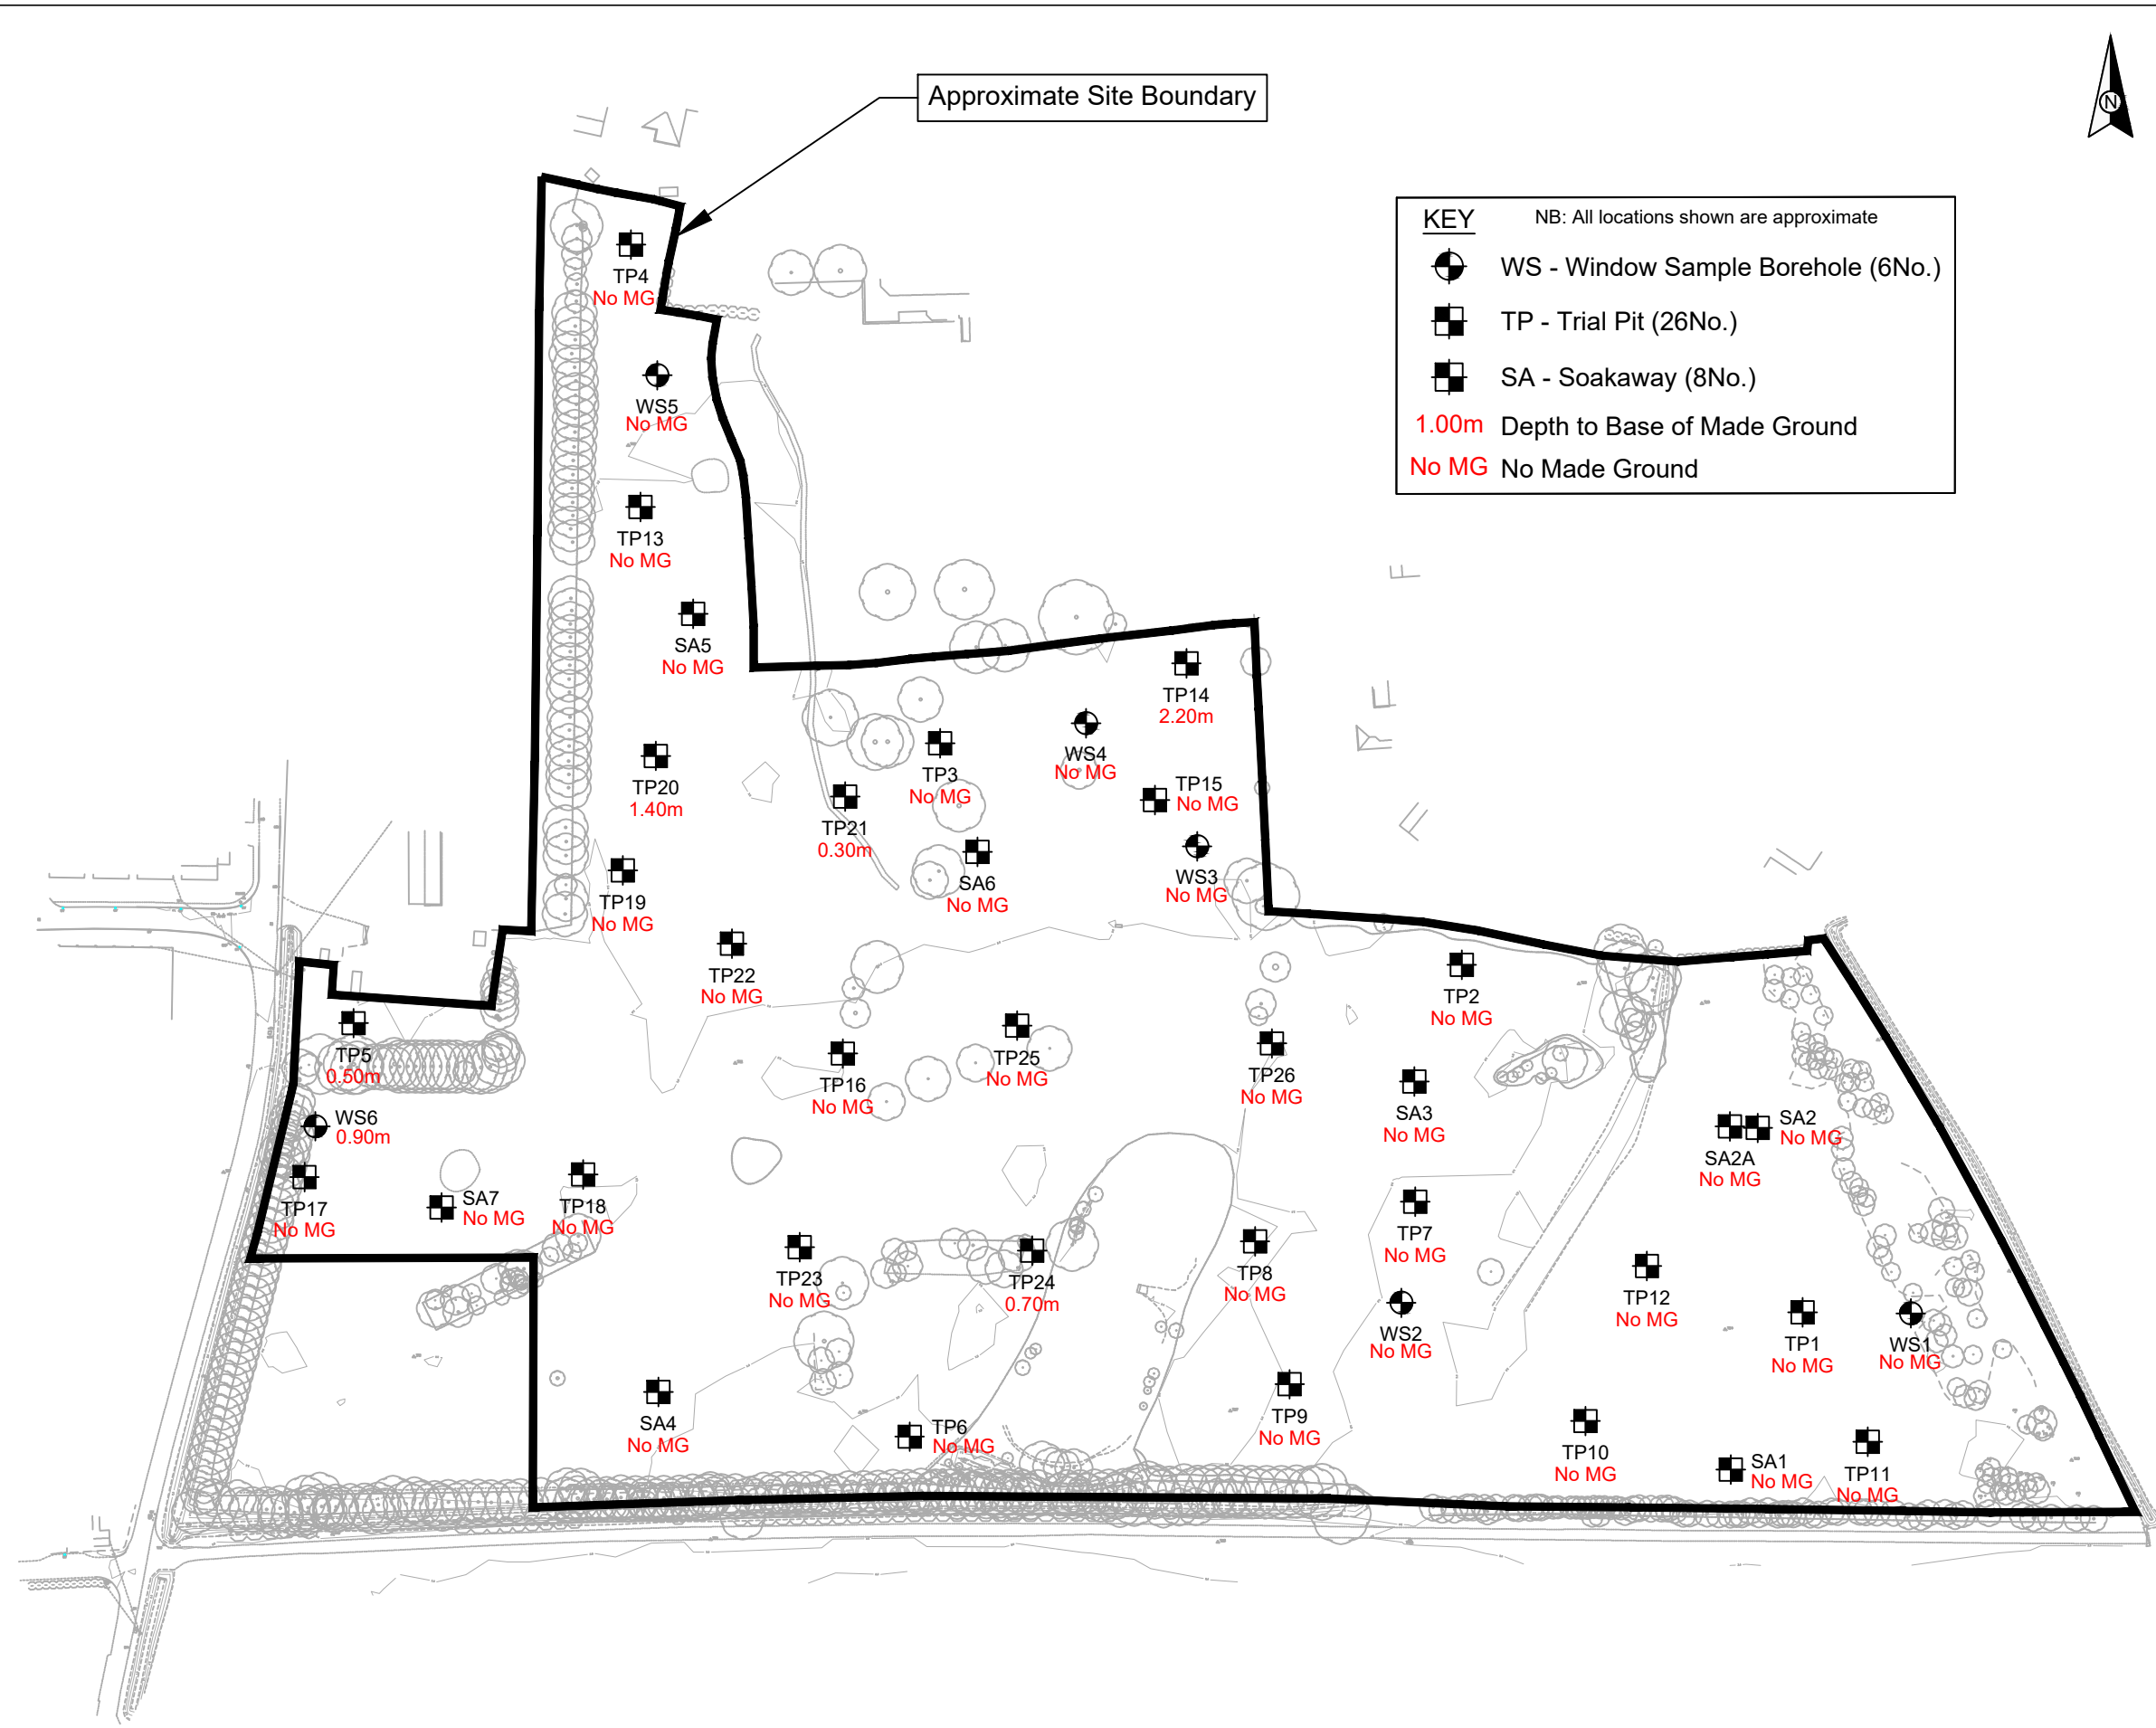
**Plan Showing Depth to Base of Made Ground  
(Figure No. D38108/05)**

| GEOTECHNICAL CONSIDERATIONS | |
|---|---|
| Ground Conditions | <p>Made Ground was encountered in localised areas of the site to depths of up to 2.20m begl and comprised a clay / silt which included peat and in addition to fragments of brick, glass bottles and pieces of plastic, metal and wood.</p> <p>Where Made Ground was absent, natural TOPSOIL was encountered to an average depth of approximately 0.30m begl. Underlying the Made Ground or natural topsoil, the Natural Strata initially comprised firm (locally stiff) silty sandy CLAY and / or firm sandy very clayey SILT. These soils were typically encountered to depths of between 1.40m and 2.70m begl and were noted to locally become softer with depth.</p> <p>With the exception of the eastern extremity of the site, very soft CLAY was encountered underlying the near surface Clay and Silt. In the majority of the exploratory holes, the very soft Clay was noted to be peaty.</p> |

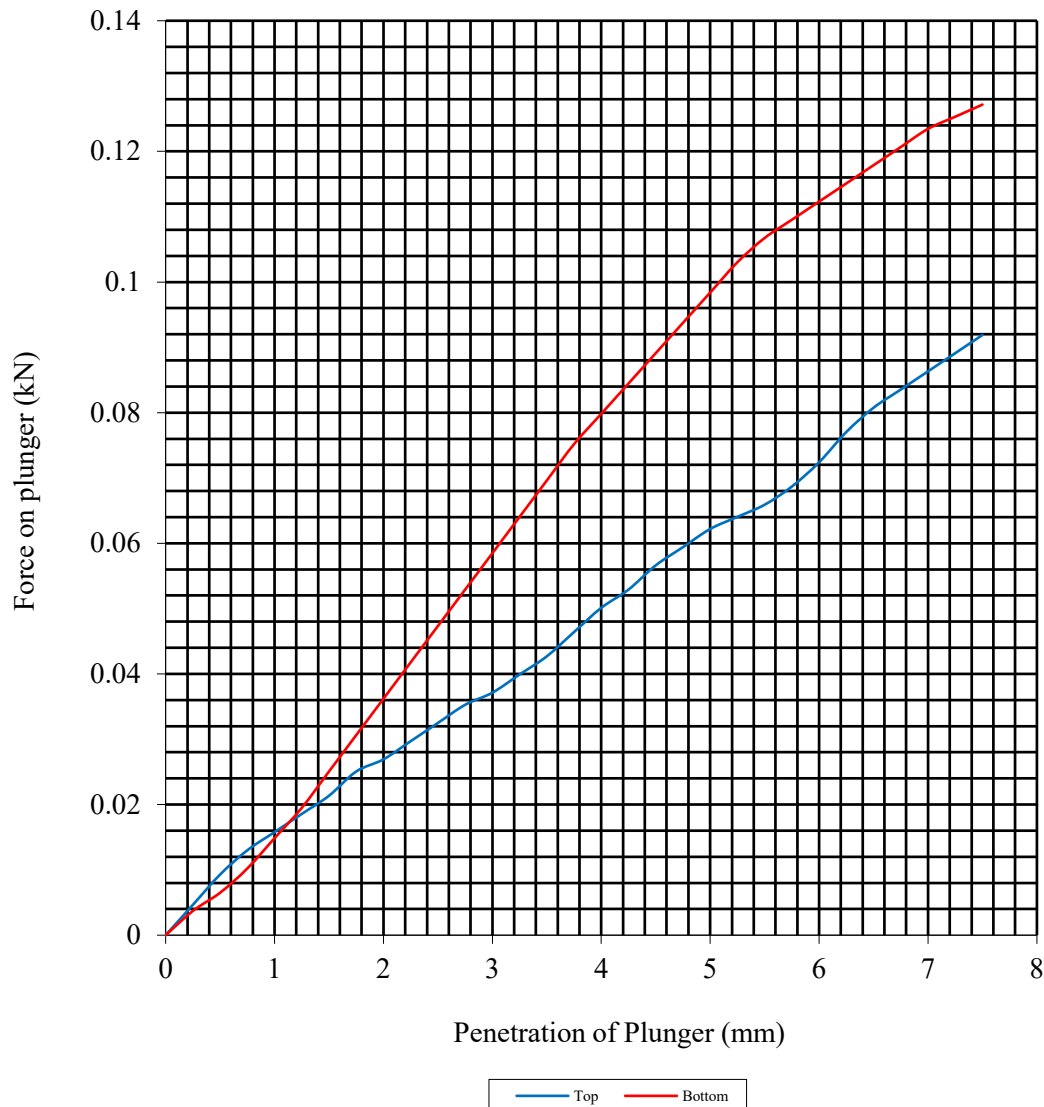
| Initial Sample Conditions | | Sample Preparation | | Final Moisture Content % | | C.B.R. Value % | |
| Moisture Content: | 24 | Surcharge Kg: | 4.20 | Sample Top | 26 | Sample Top | 0.3 |

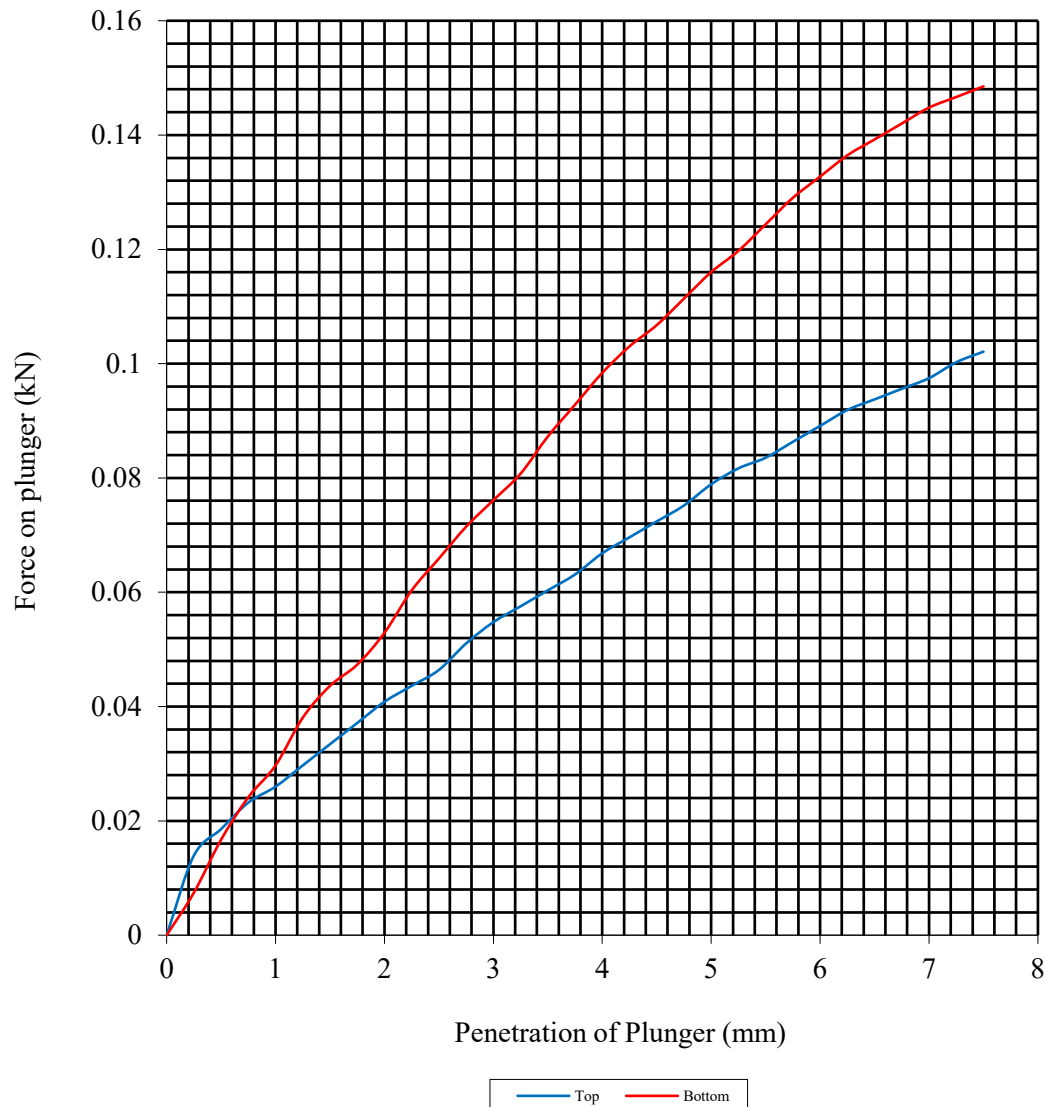
| Initial Sample Conditions | | Sample Preparation | | Final Moisture Content % | | C.B.R. Value % | |
| Moisture Content: | 26 | Surcharge Kg: | 4.20 | Sample Top | 36 | Sample Top | 0.4 |

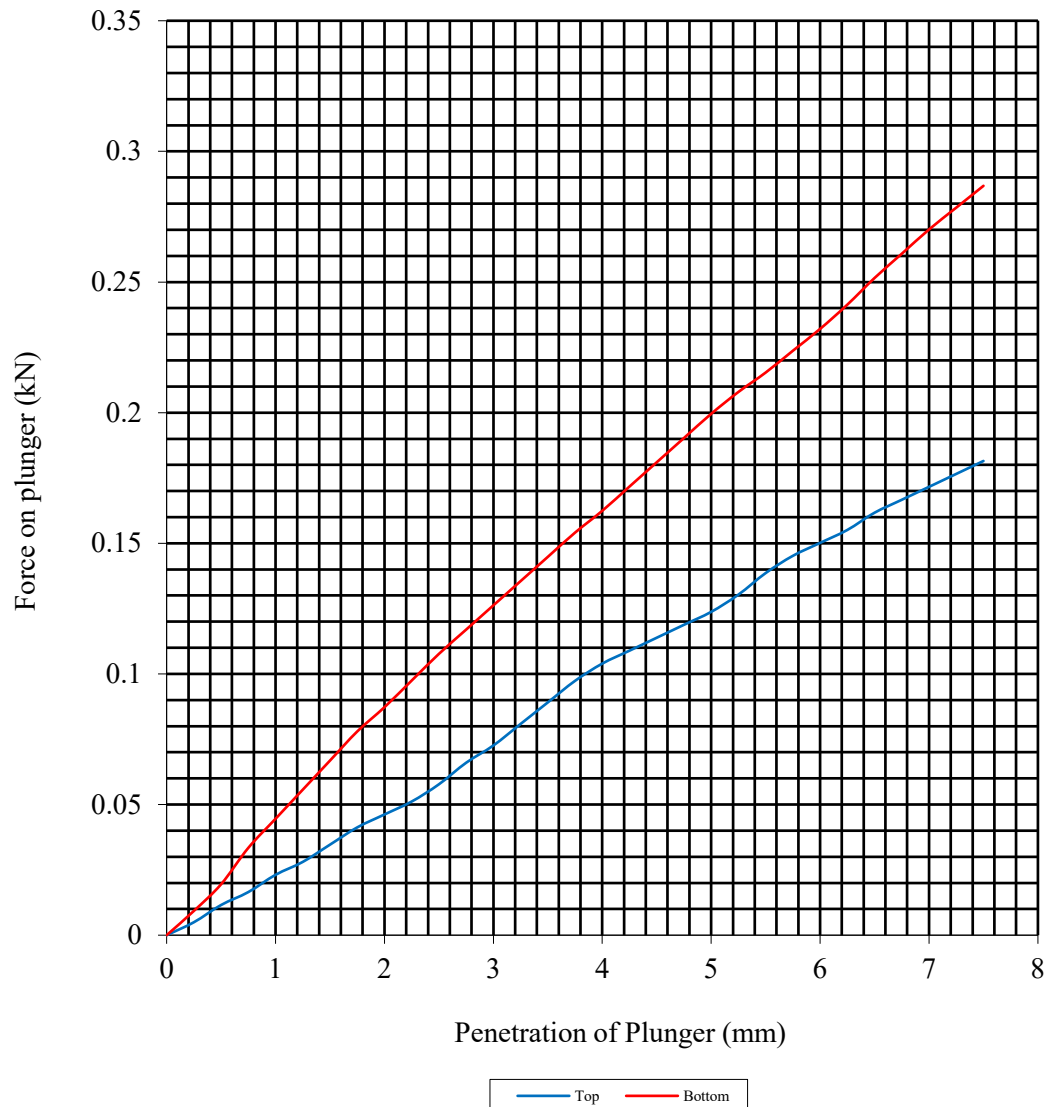
| Initial Sample Conditions | | Sample Preparation | | Final Moisture Content % | | C.B.R. Value % | |
| Moisture Content: | 24 | Surcharge Kg: | 4.20 | Sample Top | 25 | Sample Top | 0.6 |

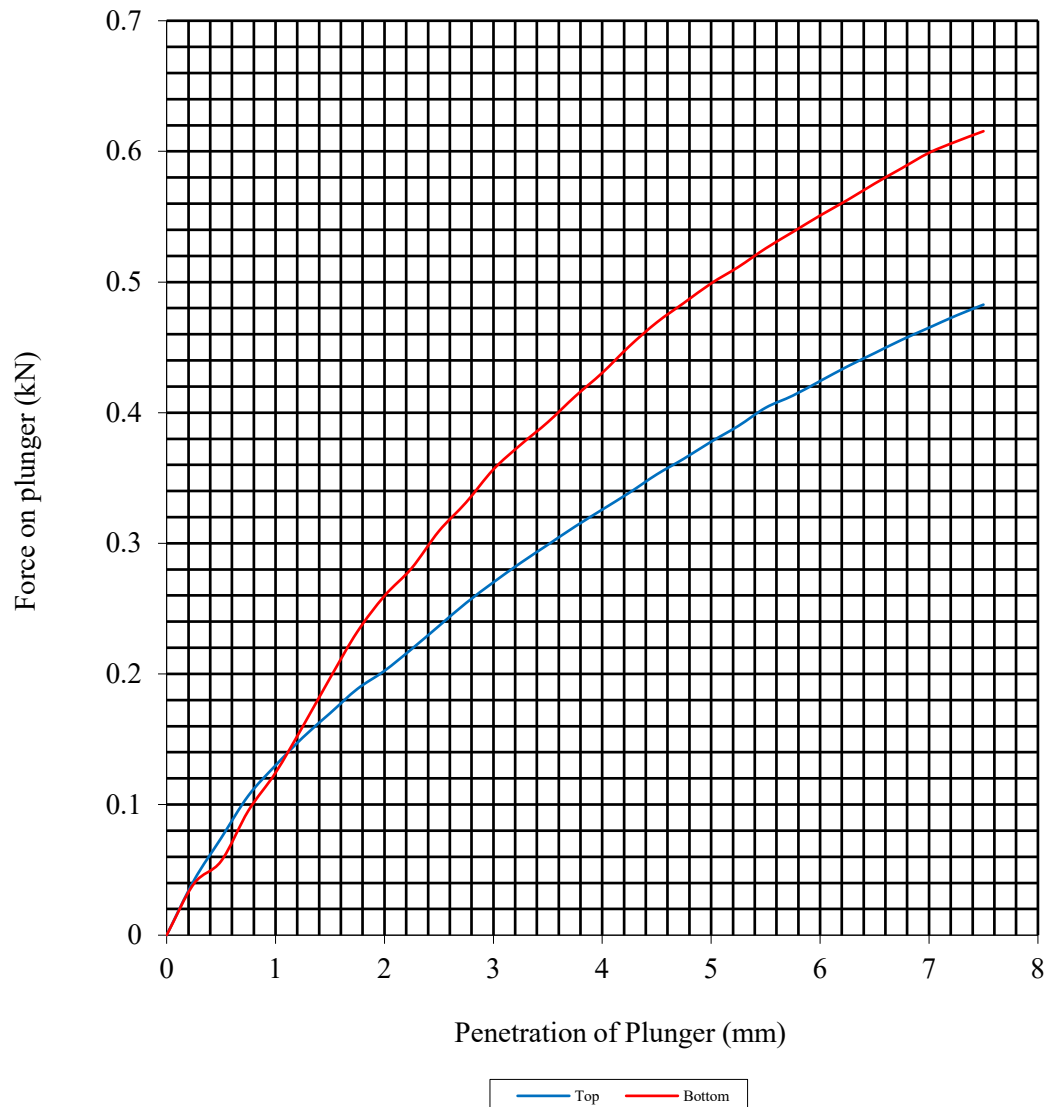
| Initial Sample Conditions | | Sample Preparation | | Final Moisture Content % | | C.B.R. Value % | |
| Moisture Content: | 24 | Surcharge Kg: | 4.20 | Sample Top | 27 | Sample Top | 1.9 |

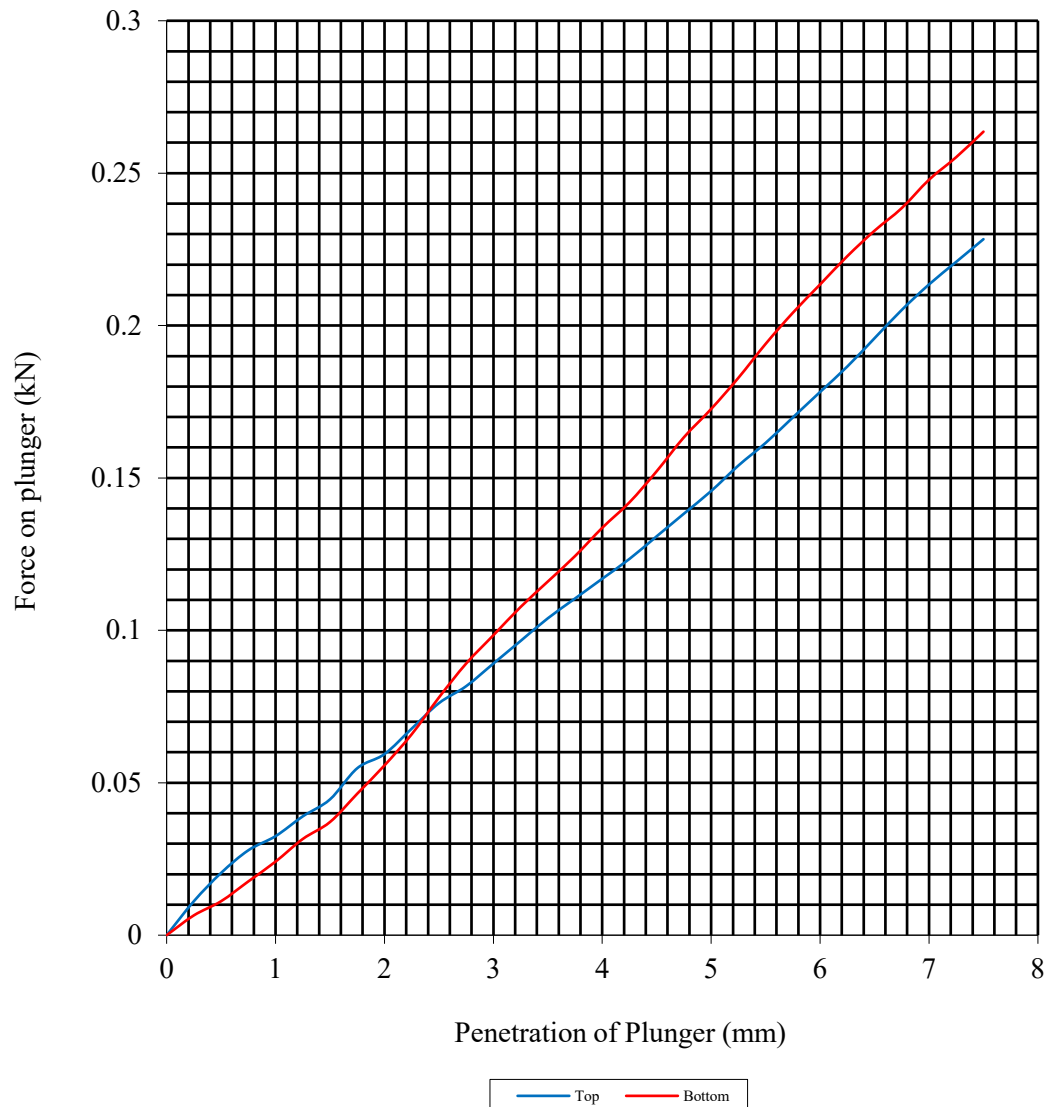
| Initial Sample Conditions | | Sample Preparation | | Final Moisture Content % | | C.B.R. Value % | |
| Moisture Content: | 23 | Surcharge Kg: | 4.20 | Sample Top | 24 | Sample Top | 0.7 |

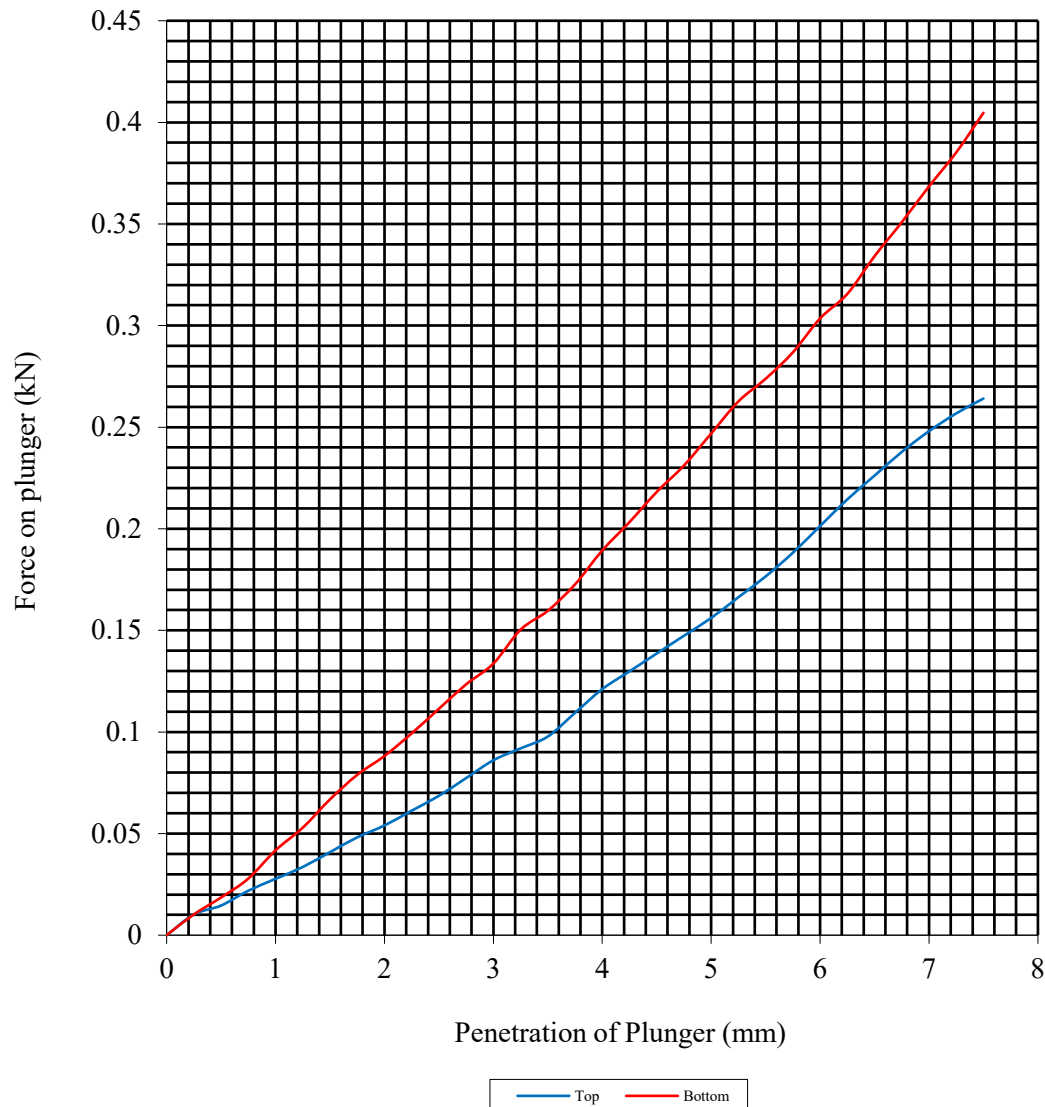
| Initial Sample Conditions | | Sample Preparation | | Final Moisture Content % | | C.B.R. Value % | |
| Moisture Content: | 21 | Surcharge Kg: | 4.20 | Sample Top | 23 | Sample Top | 0.8 |

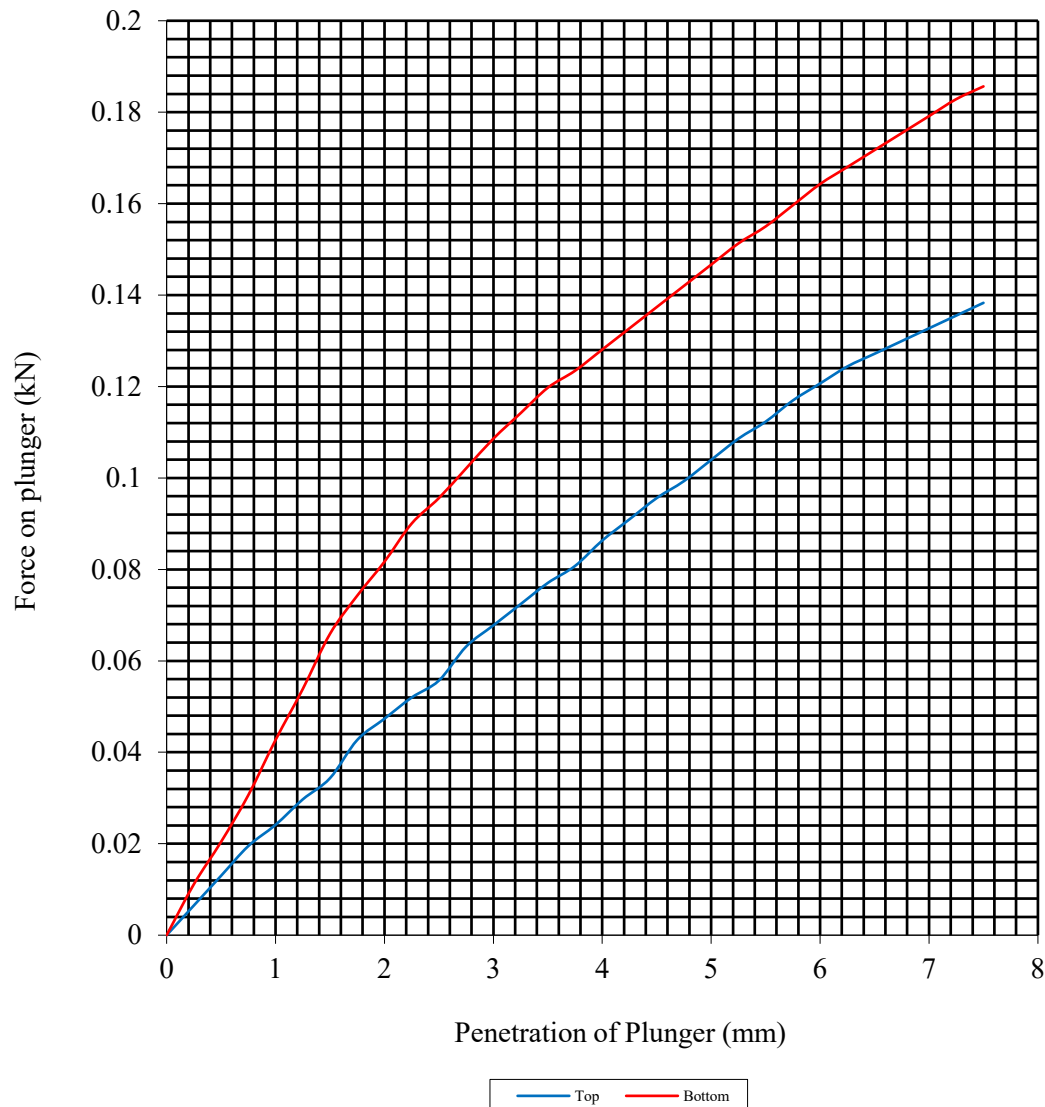
| Initial Sample Conditions | | Sample Preparation | | Final Moisture Content % | | C.B.R. Value % | |
| Moisture Content: | 32 | Surcharge Kg: | 4.20 | Sample Top | 34 | Sample Top | 0.5 |

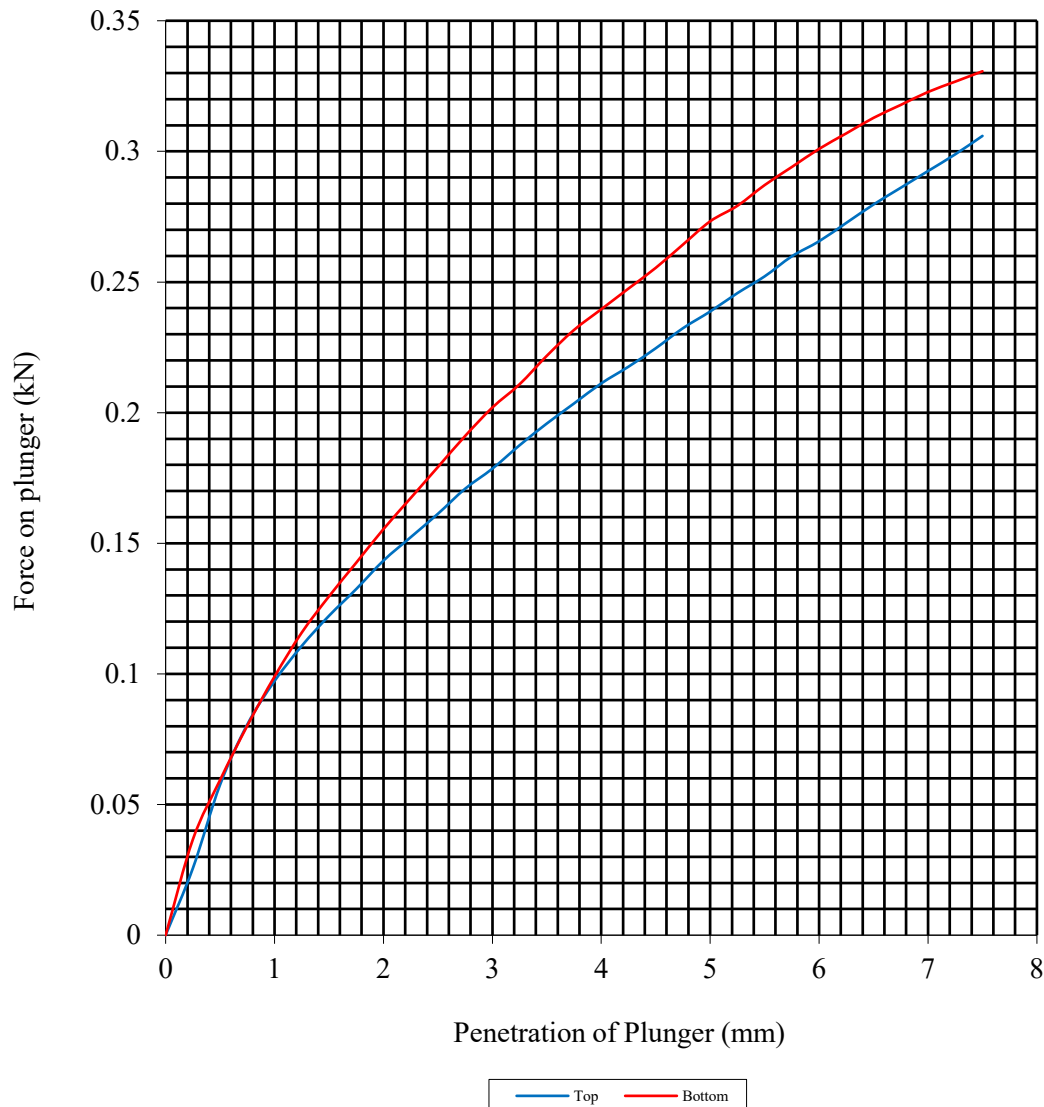
| Initial Sample Conditions | | Sample Preparation | | Final Moisture Content % | | C.B.R. Value % | |
| Moisture Content: | 31 | Surcharge Kg: | 4.20 | Sample Top | 32 | Sample Top | 1.2 |

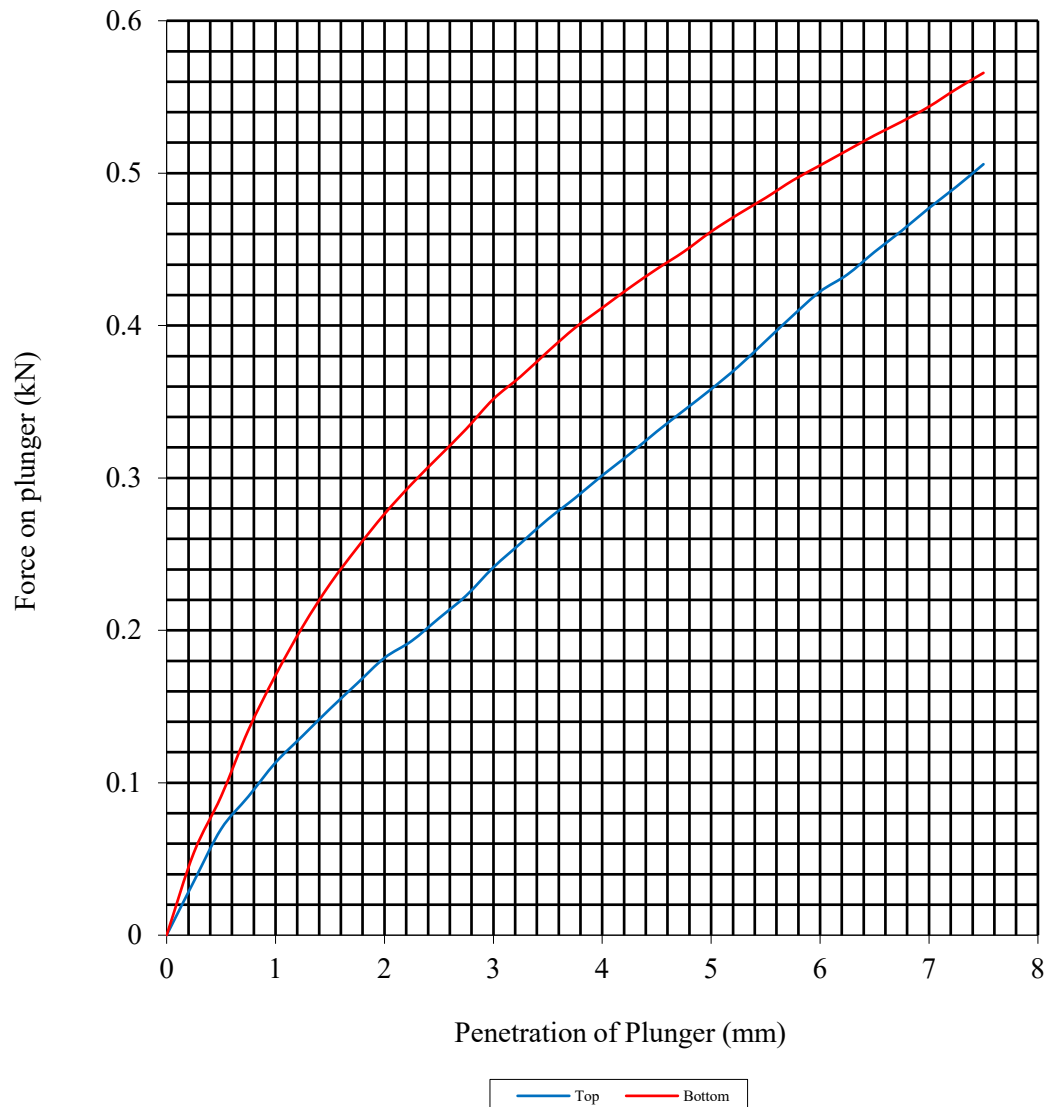
| Initial Sample Conditions | | Sample Preparation | | Final Moisture Content % | | C.B.R. Value % | |
| Moisture Content: | 22 | Surcharge Kg: | 4.20 | Sample Top | 25 | Sample Top | 1.8 |

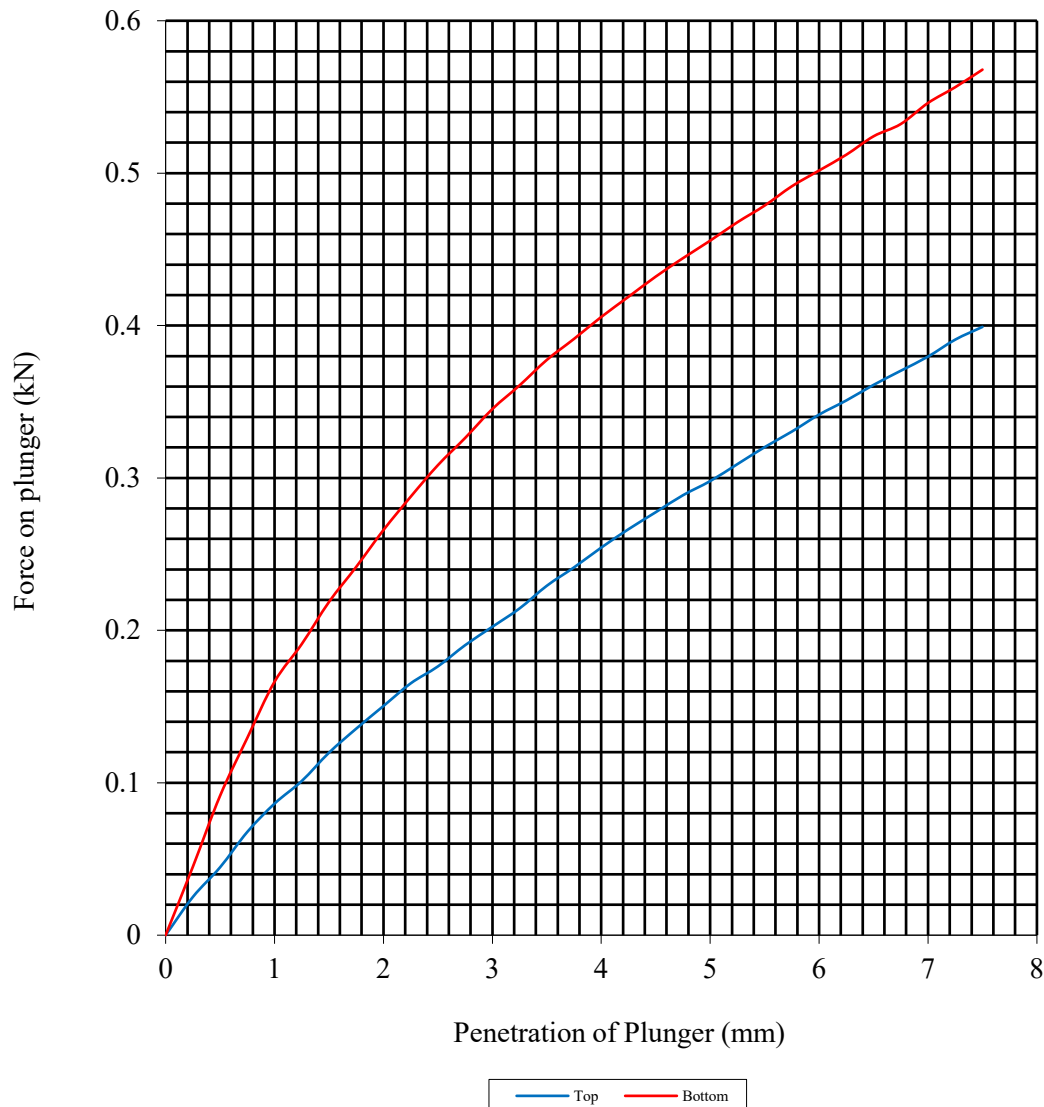
| Initial Sample Conditions | | Sample Preparation | | Final Moisture Content % | | C.B.R. Value % | |
| Moisture Content: | 23 | Surcharge Kg: | 4.20 | Sample Top | 25 | Sample Top | 1.5 |

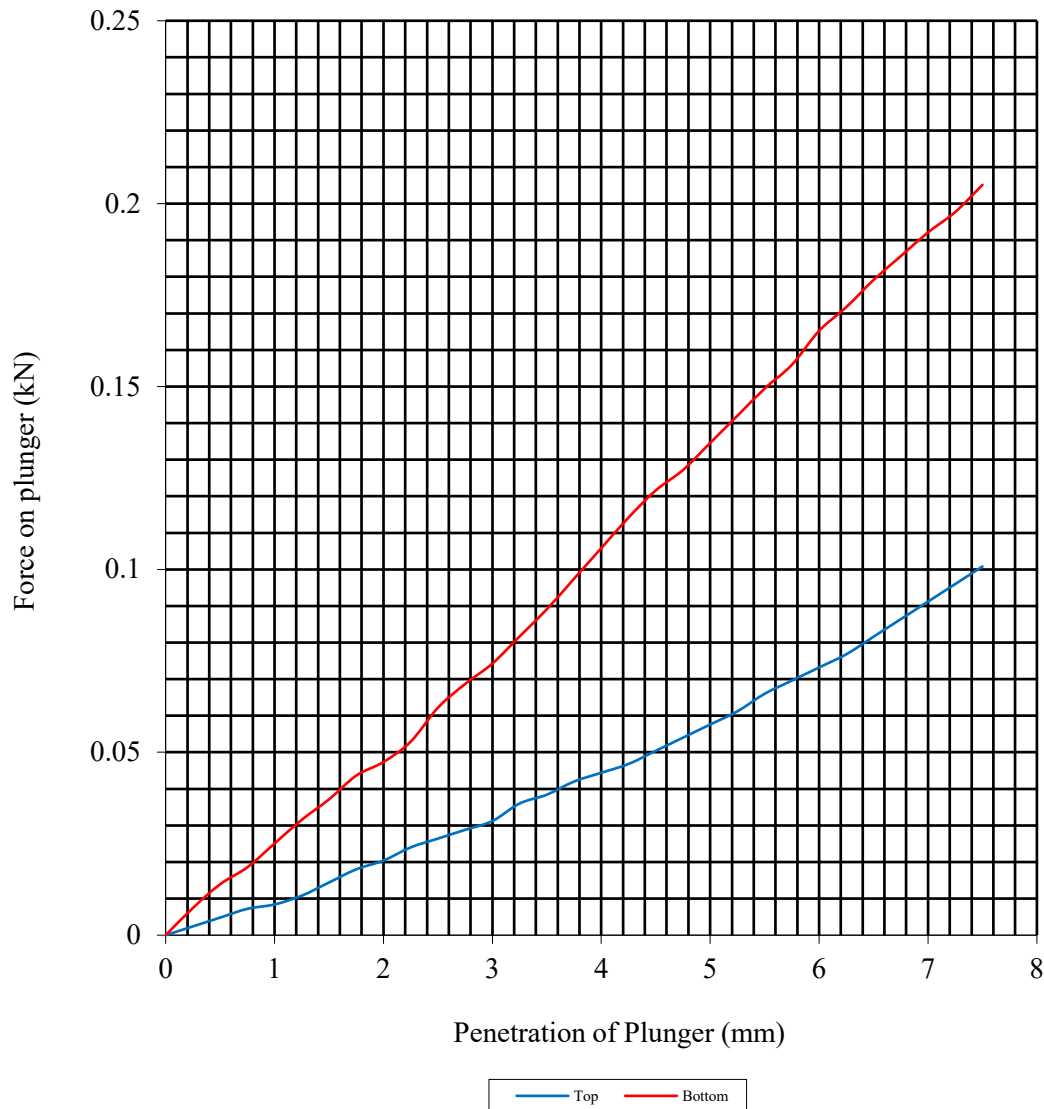
| Initial Sample Conditions | | Sample Preparation | | Final Moisture Content % | | C.B.R. Value % | |
| Moisture Content: | 29 | Surcharge Kg: | 4.20 | Sample Top | 30 | Sample Top | 0.3 |

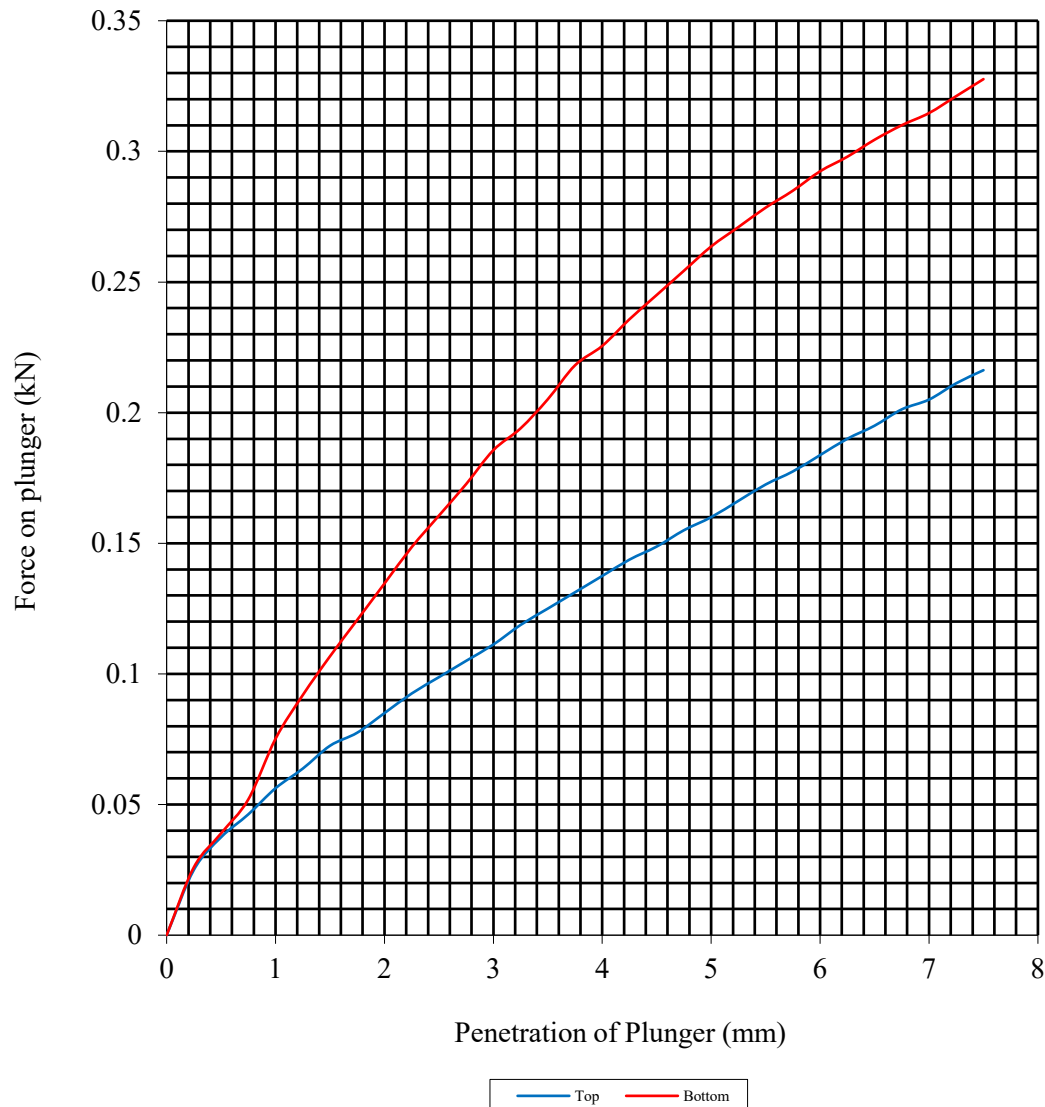
| Initial Sample Conditions | | Sample Preparation | | Final Moisture Content % | | C.B.R. Value % | |
| Moisture Content: | 26 | Surcharge Kg: | 4.20 | Sample Top | 28 | Sample Top | 0.8 |

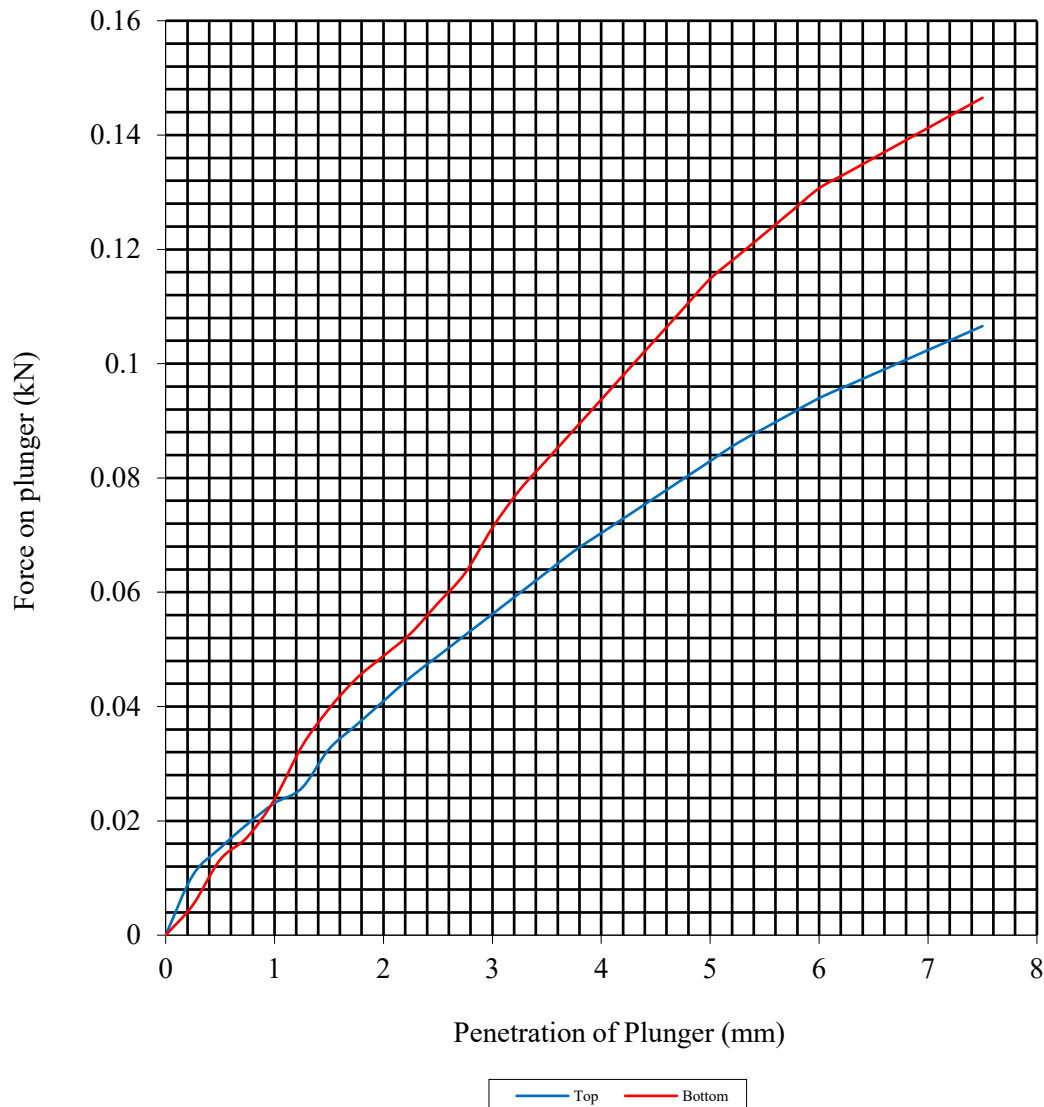
| Initial Sample Conditions | | Sample Preparation | | Final Moisture Content % | | C.B.R. Value % | |
| Moisture Content: | 22 | Surcharge Kg: | 4.20 | Sample Top | 24 | Sample Top | 0.4 |

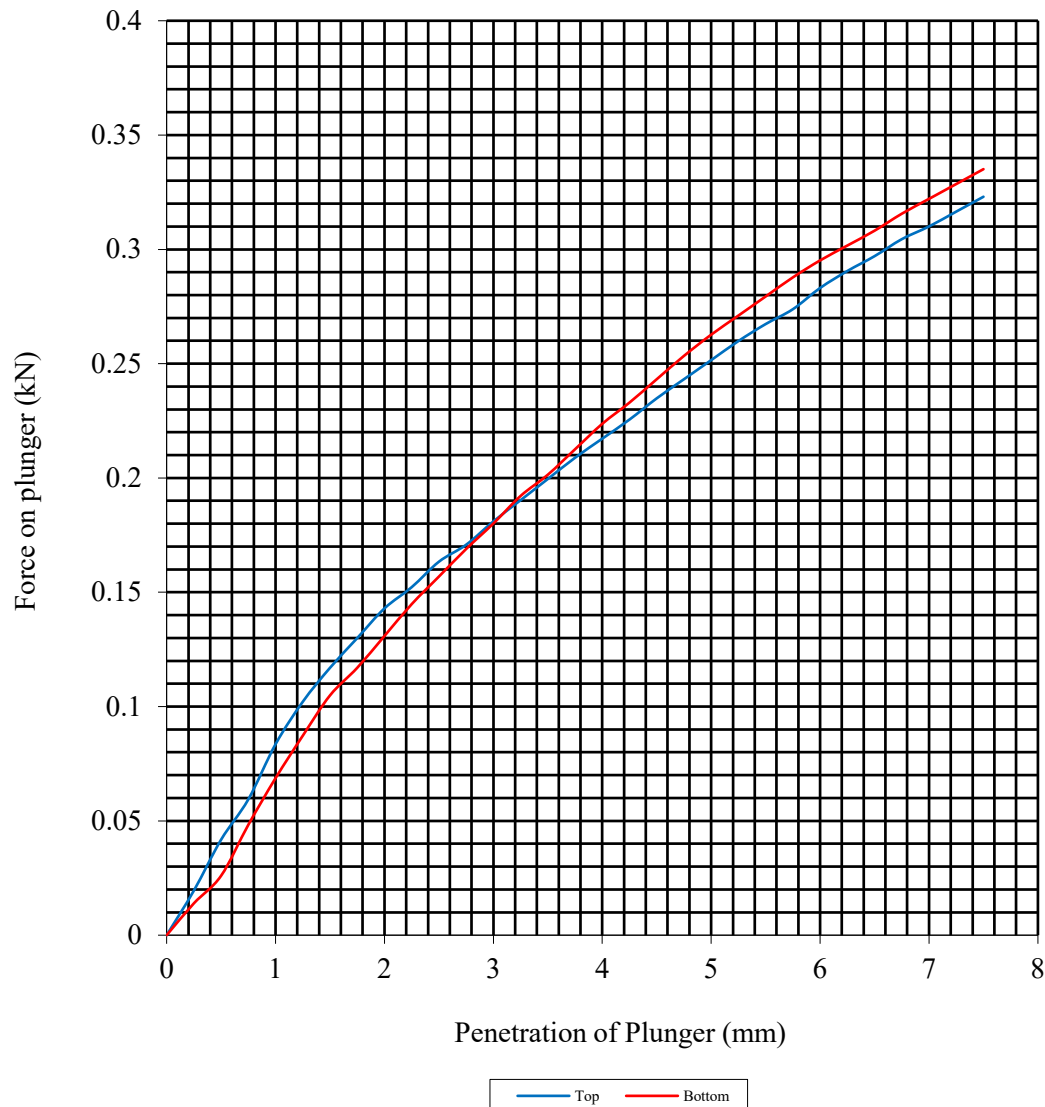
| Initial Sample Conditions | | Sample Preparation | | Final Moisture Content % | | C.B.R. Value % | |
| Moisture Content: | 29 | Surcharge Kg: | 4.20 | Sample Top | 33 | Sample Top | 1.3 |

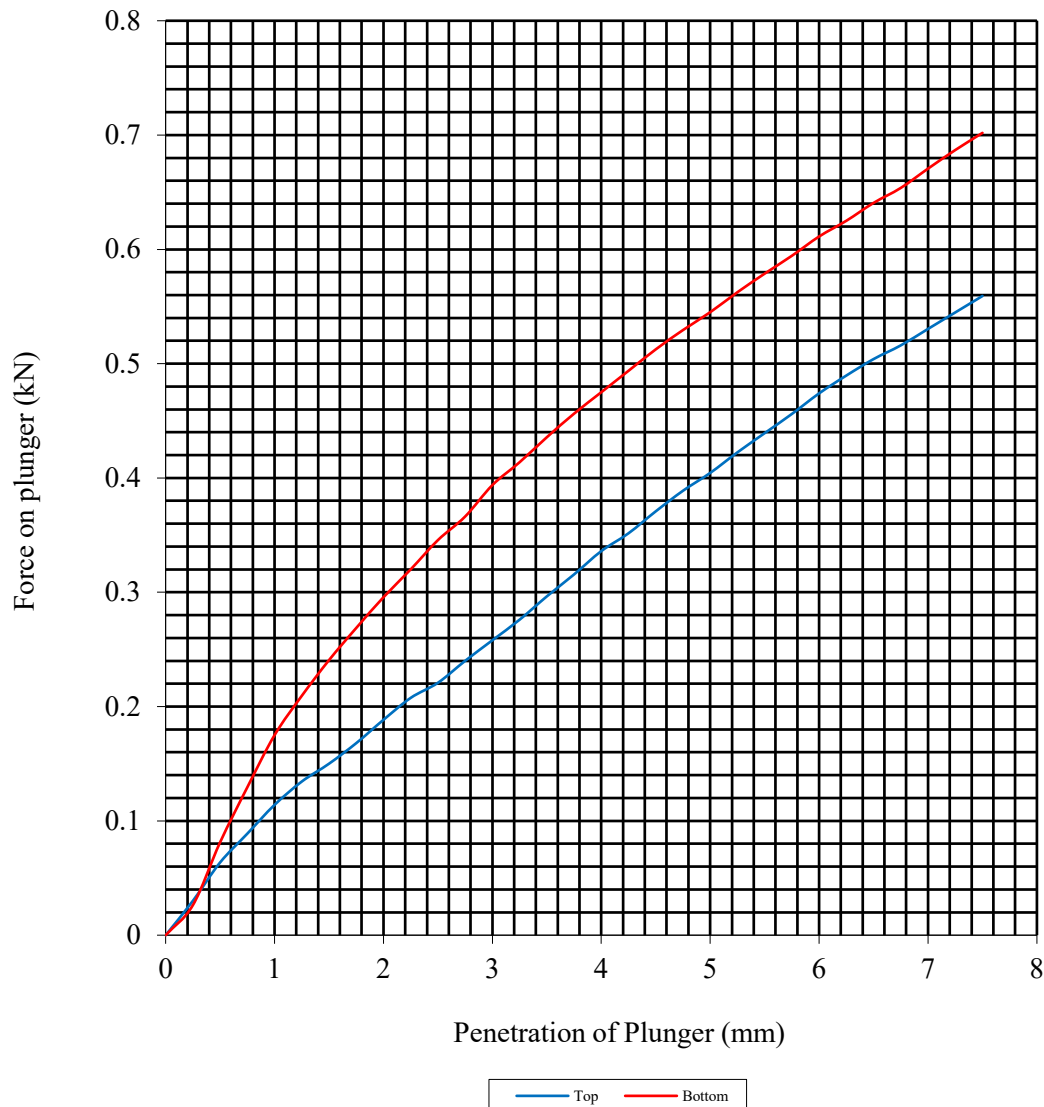
| Initial Sample Conditions | | Sample Preparation | | Final Moisture Content % | | C.B.R. Value % | |
| Moisture Content: | 23 | Surcharge Kg: | 4.20 | Sample Top | 25 | Sample Top | 2.0 |
