Dam Gate  
Holbeach

**Combined Phase I Desk Study and  
Phase II Exploratory Investigation  
For  
Ashwood Homes**

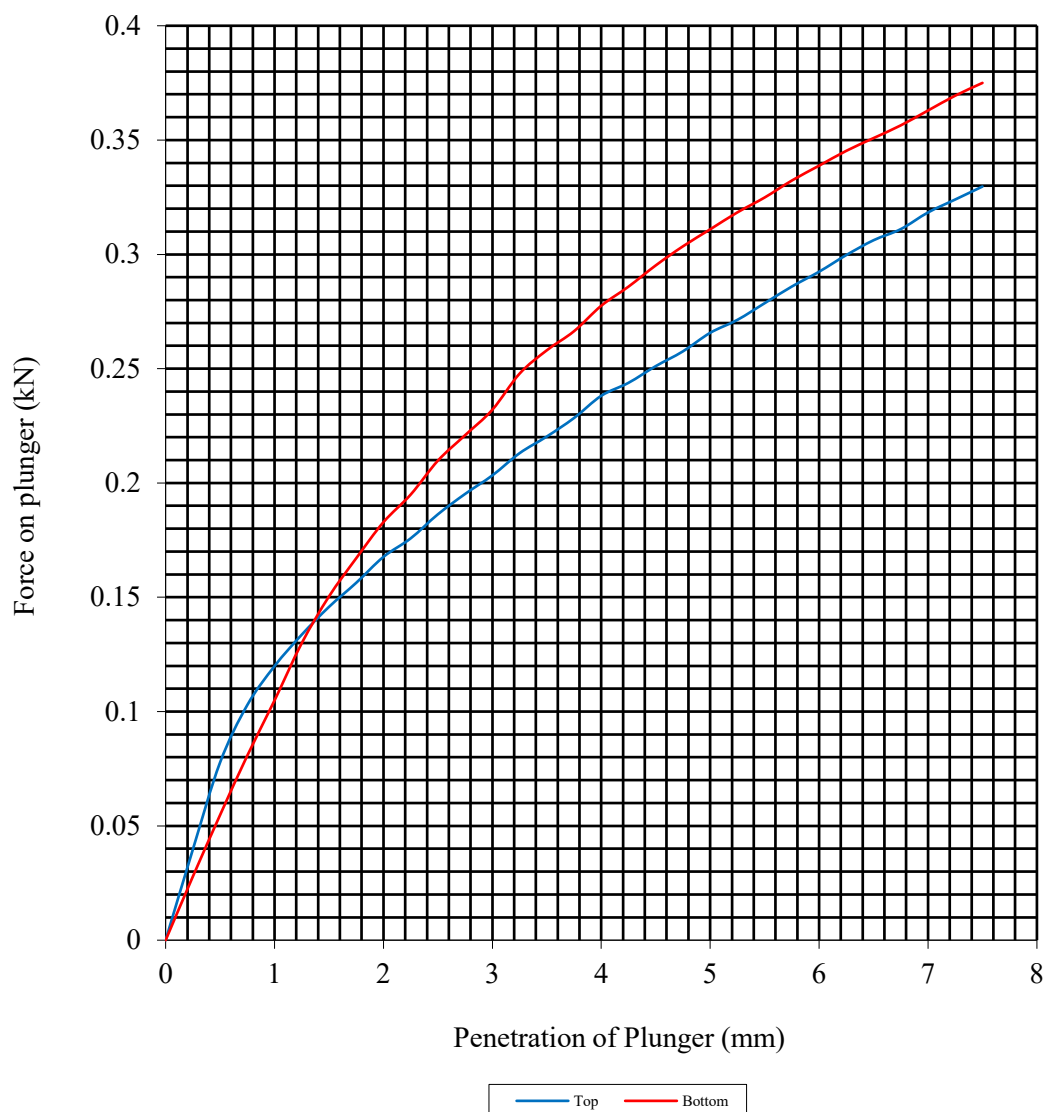
| Initial Sample Conditions | | Sample Preparation | | Final Moisture Content % | | C.B.R. Value % | |
| Moisture Content: | 33 | Surcharge Kg: | 4.20 | Sample Top | 35 | Sample Top | 1.4 |

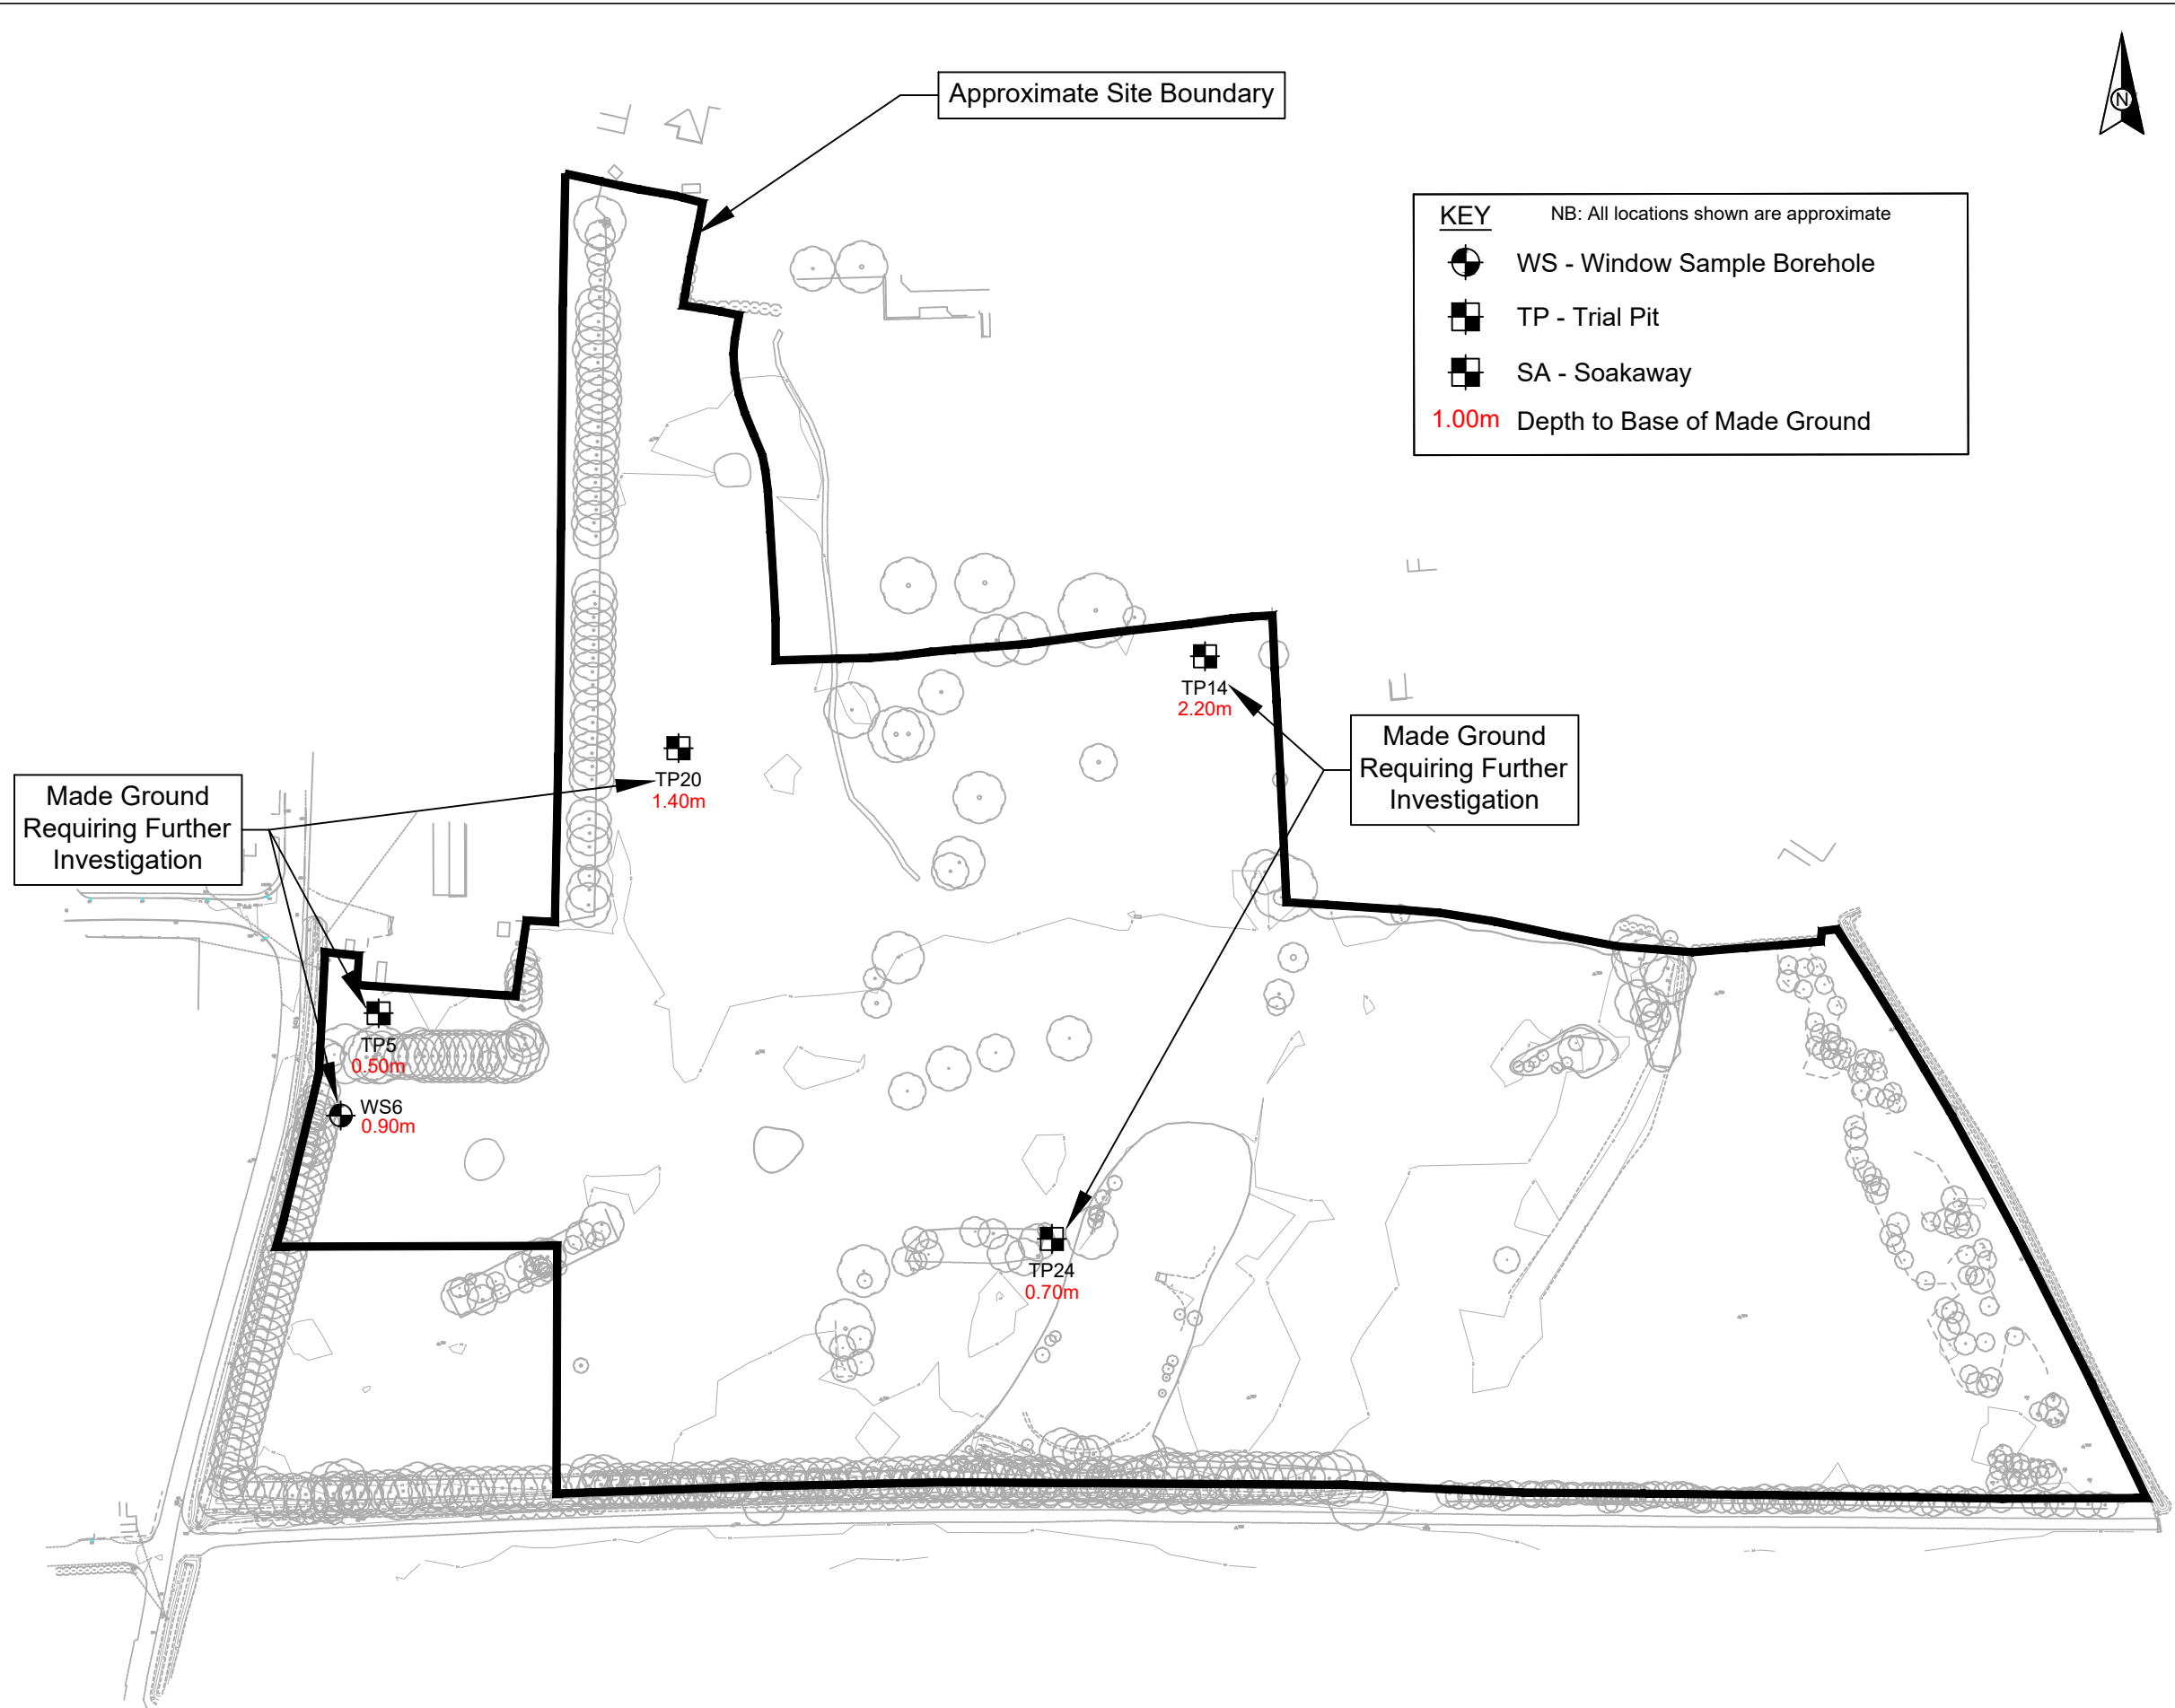
**Plan Showing Areas of Made Ground Requiring Further Investigation  
(Figure No. D38108/07)**

| Recommended Further Works | <p>Further intrusive works should be undertaken associated with the Made Ground from a foundation design and environmental perspective:</p> <ul style="list-style-type: none"> <li>• Localised areas of Made Ground should be delineated to a) determine areas of the site that are unsuitable for shallow foundations; and to b) determine areas of the site where remedial capping may be required.</li> <li>• Further sampling of the Made Ground may be undertaken to potentially confirm the exceedances within samples at TP5 and TP14 to be considered statistical hotspots and to therefore determine the potential suitability for retention and re-use or localised source removal.</li> </ul> <p>It would be prudent to undertake further gas monitoring at the site to include the installation of additional monitoring standpipes which may potentially result in a reduction in the area of the site / number of properties requiring gas protection measures.</p> |
