### Contaminated land matters

**Demolition of glasshouses and development of two houses.  
Previous Nursey land east of Kel Mar , Main Road, Holbeach  
Drove , Spalding, PE12 0PS**

**Compliance with Condition 6 of H09-0783-18 – Contaminated land**

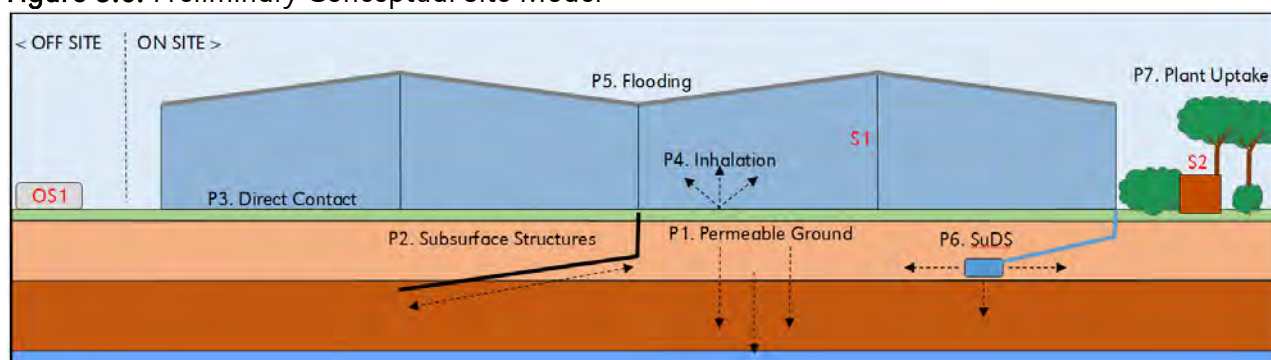
**Figure 5.6:** Preliminary Conceptual Site Model

A preliminary conceptual site model has been prepared based upon the site survey and desk study and is included at **Figure 5.6**.

- S1. Historic Horticultural Processes (Herbicides, Pesticides, Fungicides, Insecticides, and Fertiliser)
- S2. Bulk Storage Container (TPH)
- OS1. Bulk Storage Container (TPH)

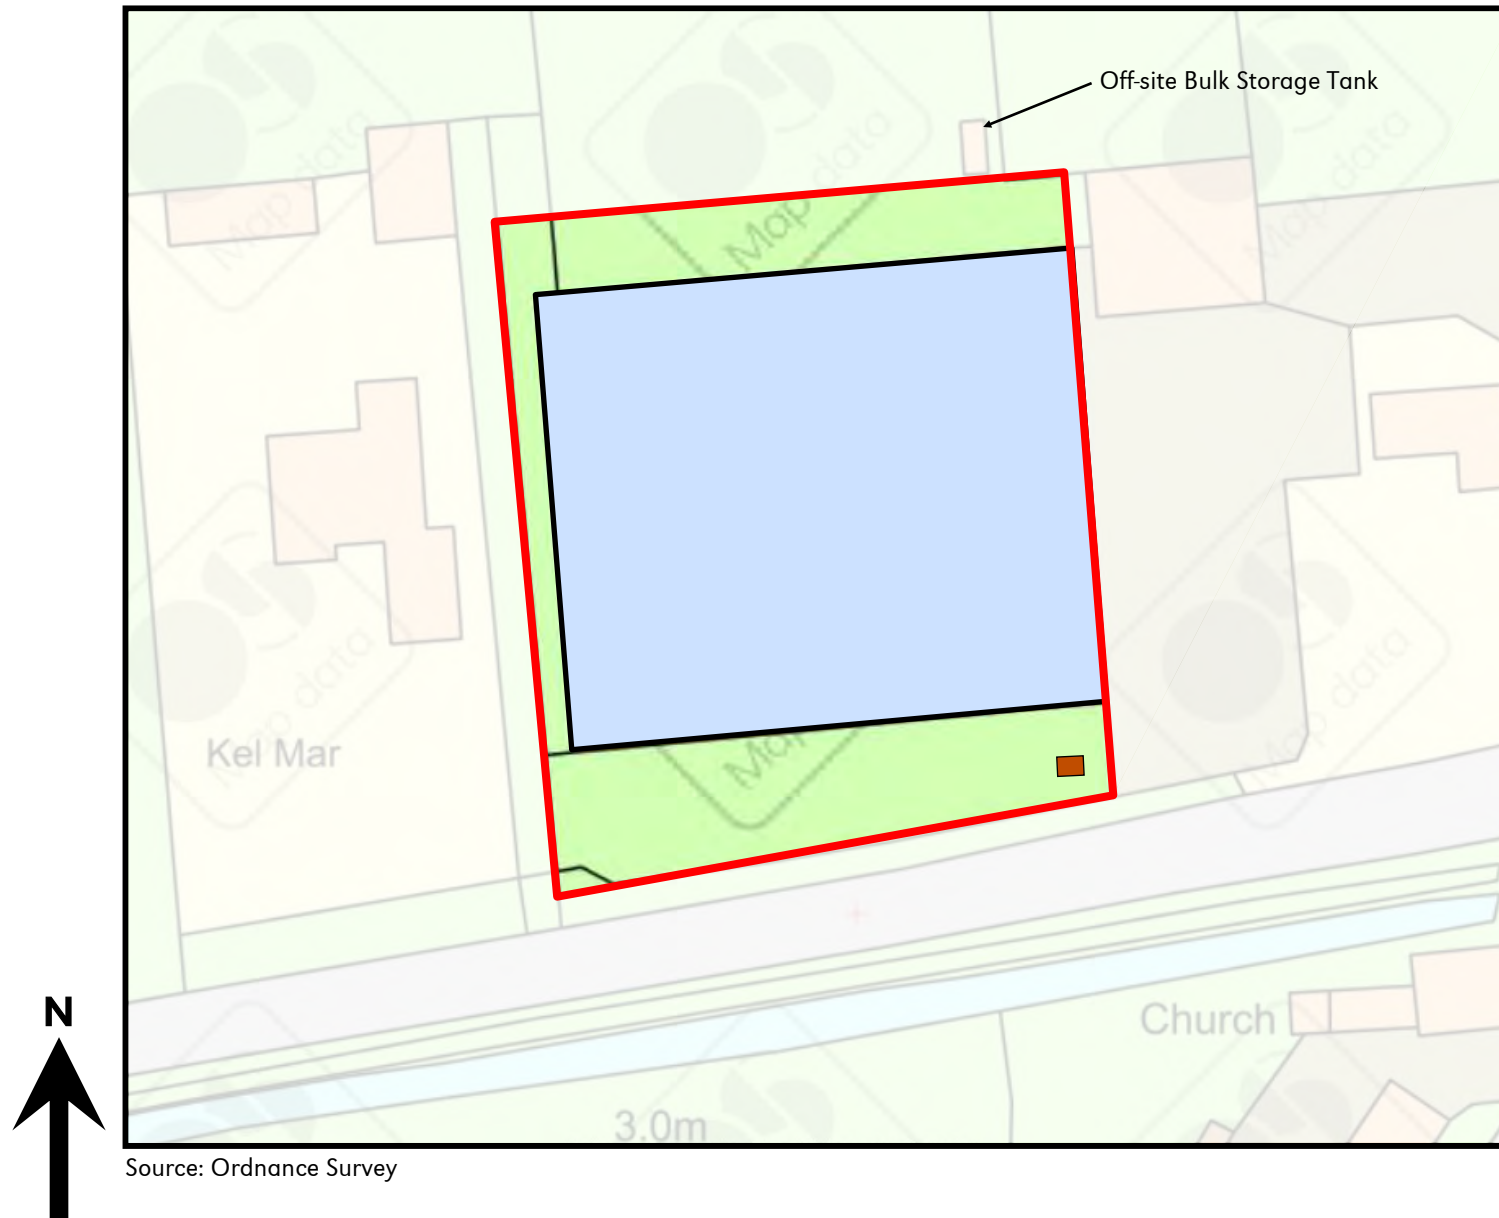
| Drawing No. | 25080/701 | Rev | 0 |

- Vegetated Area
- Glasshouse
- Bulk Storage Tank
- Site Boundary

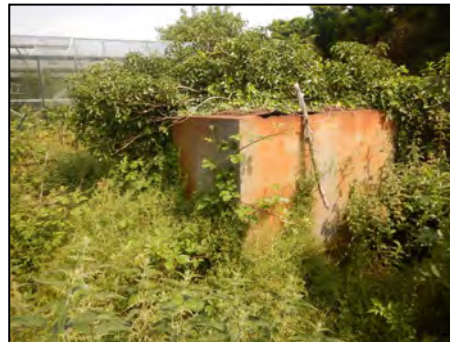
**Photo 15**  
Corroded empty bulk storage tank

The southern boundary is occupied by dense vegetative overgrowth and immature trees. An empty, heavily corroded bulk storage tank was identified towards the south-east corner. The tank did not appear to be connected to any pipework and appeared to have been dumped, this has been confirmed by the architect after consulting the landowner. No obvious visual or olfactory evidence of hydrocarbon contents were identified within it or its vicinity.
