## Phase 2: Site Investigation

**Wignall Gate, Holbeach**

## PHASE 2 SITE INVESTIGATION REPORT

### Wignall Gate, Holbeach

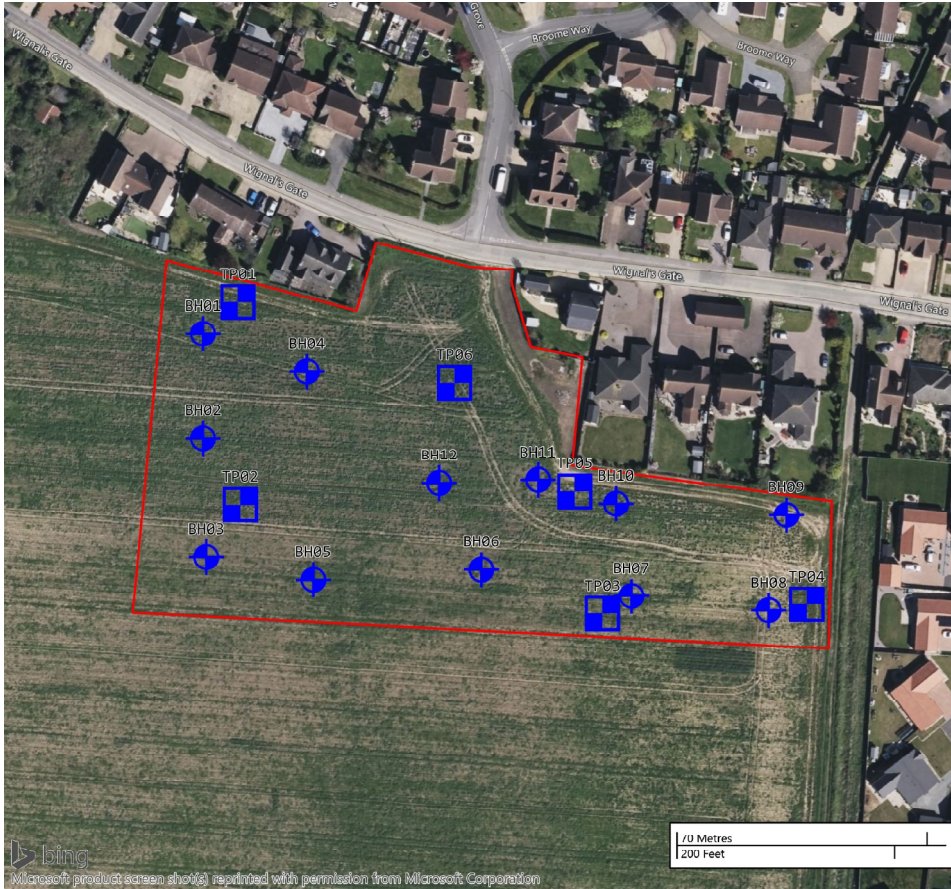
#### Figure Title

Soakaway Trenches: Trenches at 250mm maximum depth 1.5m from G.L.

Descriptions of the strata encountered in the boreholes and trial pits together with details of sampling and groundwater are presented in Appendix B of this report. A plan showing the location of the boreholes and trial pits can be found in Appendix A (Figure 2).
