## **GROUND INVESTIGATION REPORT**

**FOR  
FOOD ENTERPRISE ZONE,  
PLOT 12,  
HOLBEACH,  
LINCOLNSHIRE,**

**REPORT NO. NE3989  
DECEMBER 2020**

**SUB SURFACE NORTH EAST LIMITED**

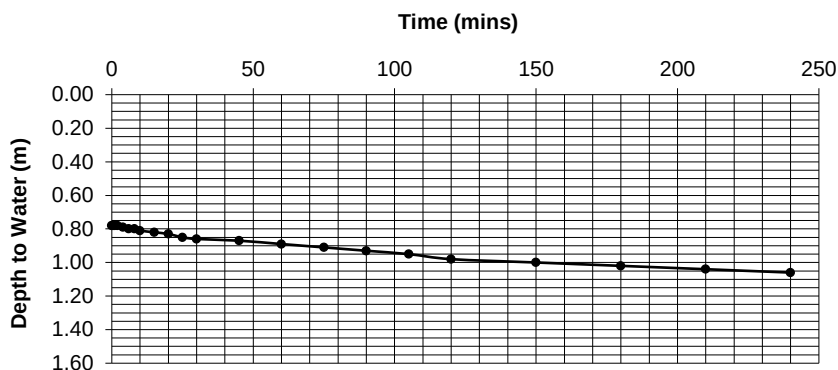
Test Number: 1

Length of pit: L = 1.80 m  
 Width of pit: W = 0.60 m  
 Depth of pit: D = 1.60 m  
 Base area of pit: A = 1.08 m<sup>2</sup>

On completion of TP1 and TP6, soakaway tests were undertaken in brown silty clay, becoming clayey silty found in TP1 and brown clayey silt with bands of sand and brown fine sand found in TP6. Water was added to the pits from a bowser and water levels were subsequently monitored over a period of four hours. Water levels were found to have fallen insufficiently to determine the Soil Infiltration Rates and details of the soakaway tests are appended.

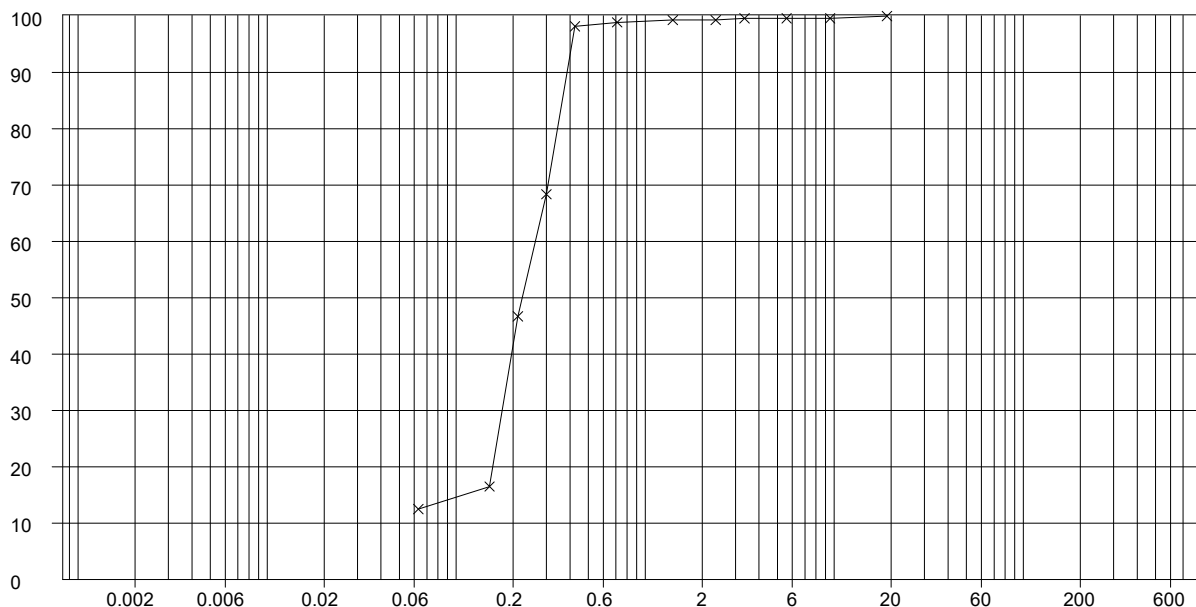
| Borehole /<br>Trial Pit | Depth<br>(m) | Sample | Laboratory Description |
|---|---|---|---|
| BH1 | 2.00 | B | Brown slightly silty fine to medium SAND with occasional lenses of silty clay. |

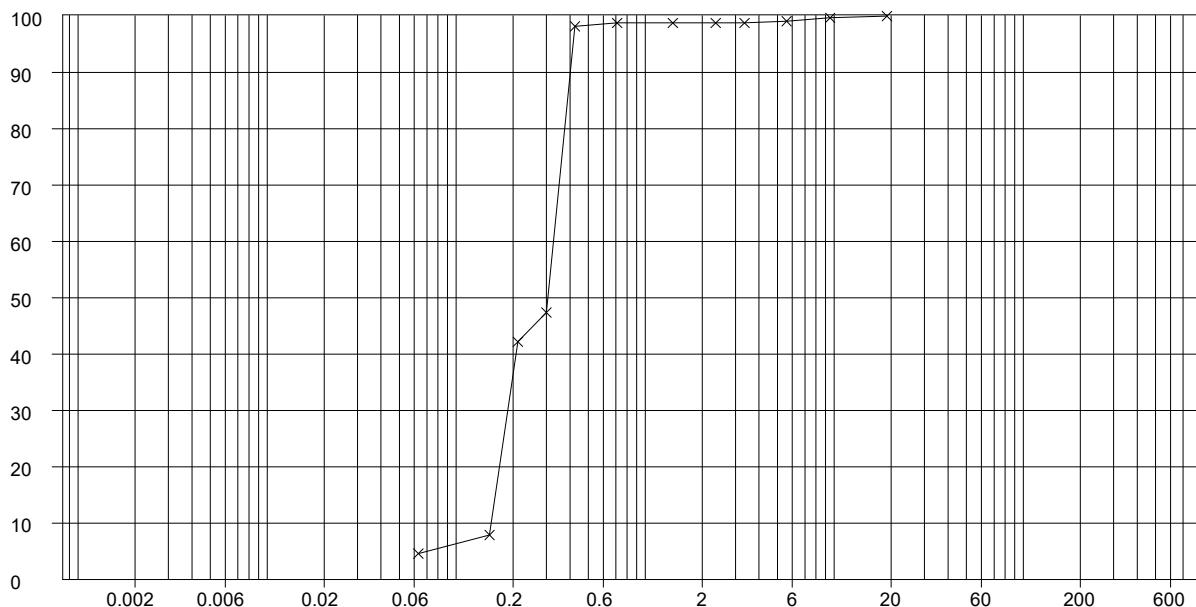
| Borehole / Trial Pit | Depth (m) | Sample | Laboratory Description |
|---|---|---|---|
| BH1 | 4.00 - 4.50 | B | Brown slightly silty fine to medium SAND with occasional fragments of shell. |

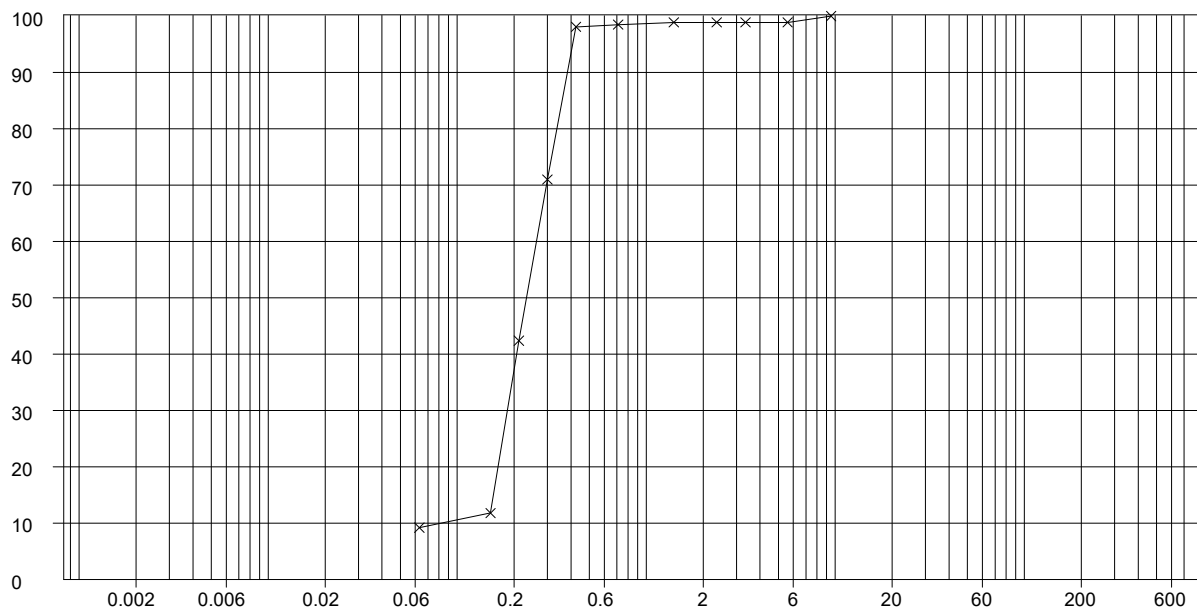
| Borehole /<br>Trial Pit | Depth<br>(m) | Sample | Laboratory Description |
|---|---|---|---|
| BH1 | 6.50 | B | Brown slightly gravelly silty fine to medium SAND. Gravel is subrounded medium sandstone and quartz. |

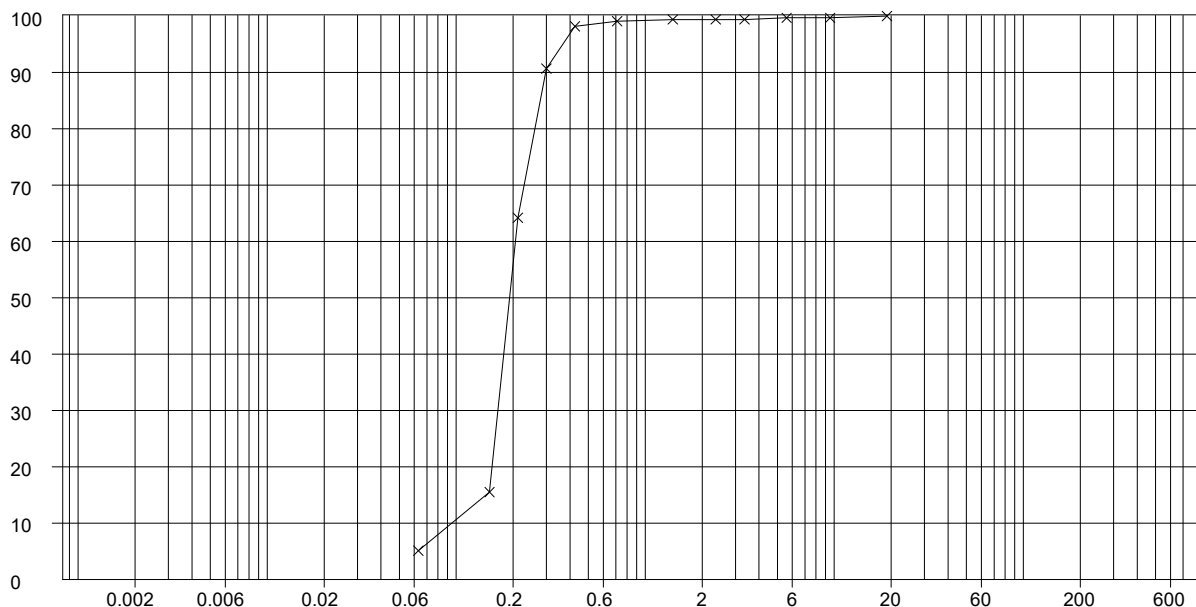
| Borehole /<br>Trial Pit | Depth<br>(m) | Sample | Laboratory Description |
|---|---|---|---|
| BH1 | 14.00<br>- 14.50 | B | Brown slightly gravelly silty fine to medium SAND with occasional fragments of shell. Gravel is subangular to subrounded fine to medium sandstone, siltstone and quartz. |

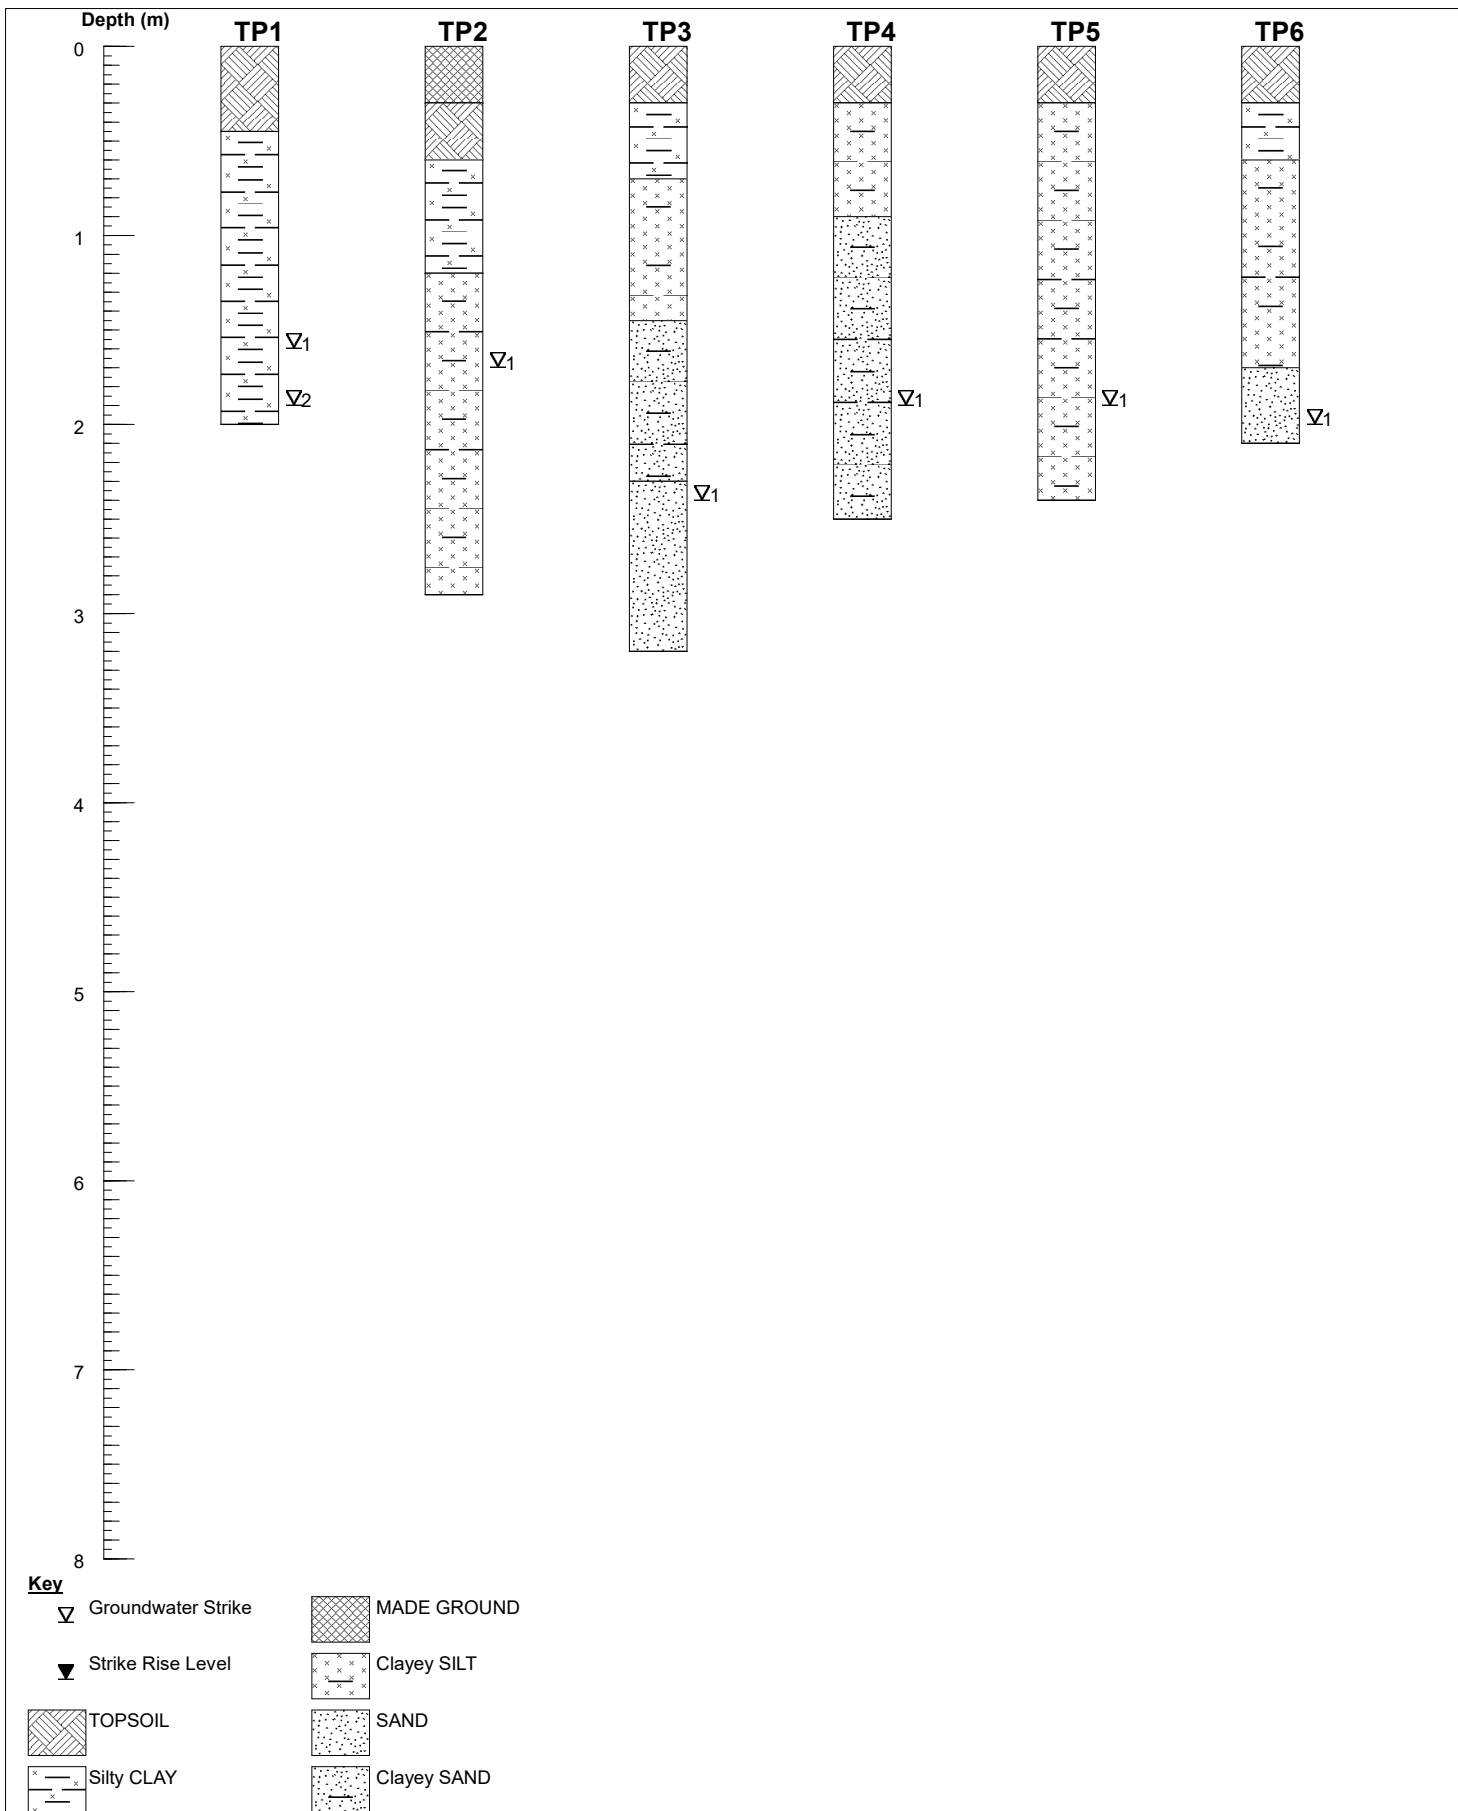
| <b>SS SUB SURFACE</b><br>SITE INVESTIGATION SPECIALISTS, GEOTECHNICAL & ENVIRONMENTAL CONSULTANTS<br>3 Peel Street, Preston, Lancashire, PR2 2QS. Tel: (01772) 561135 Fax: (01772) 204907 | <b>Nominal Section</b> | | | |

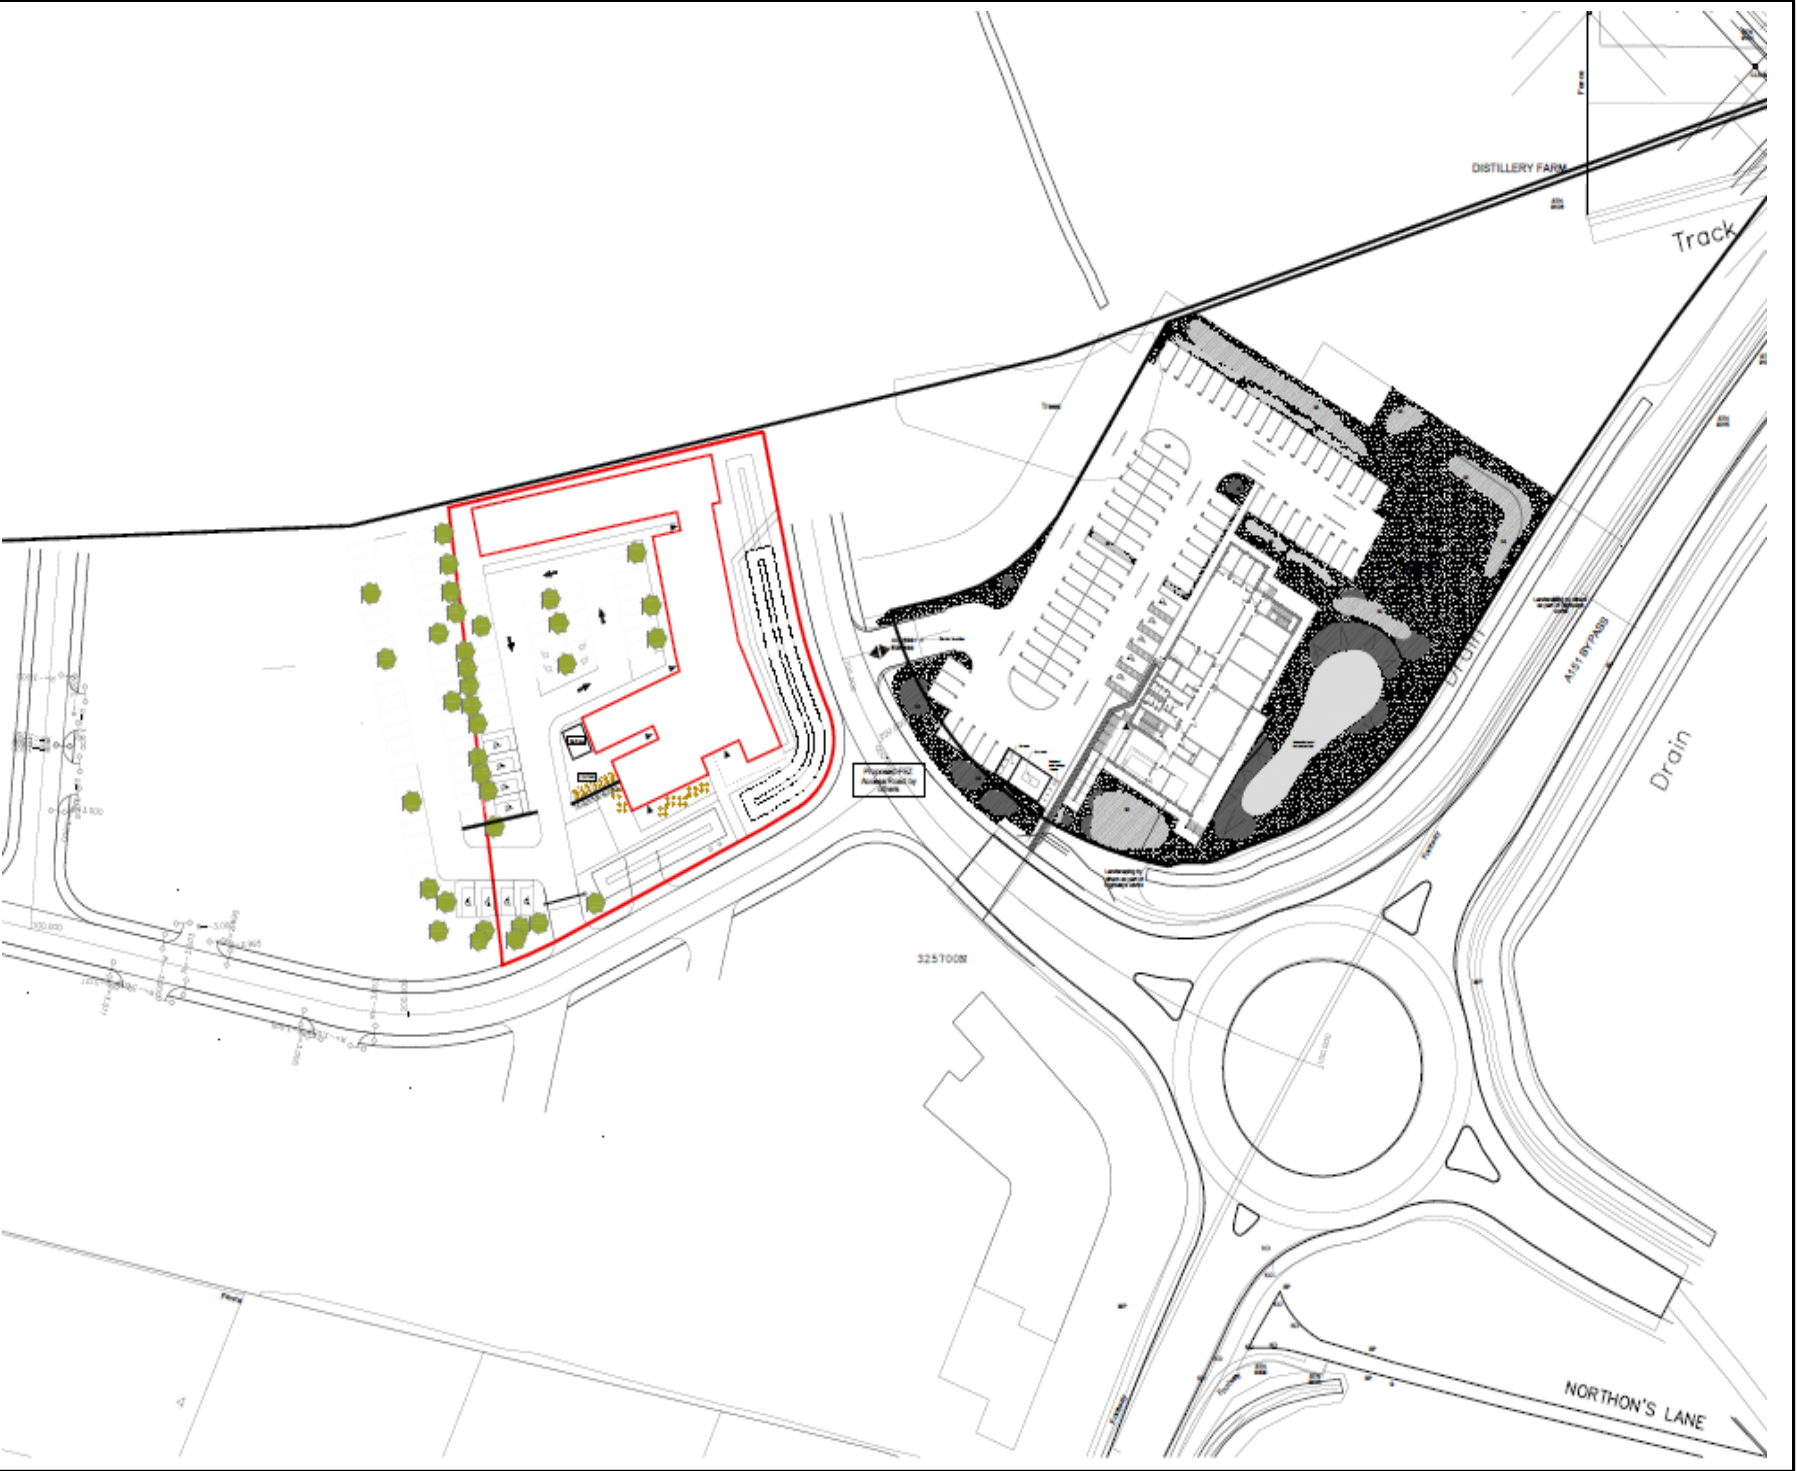
| GLEEDS COST MANAGEMENT SERVICES LTD | DM | - | - | 2 |

As shown on Figures 2 and 3, the irregular shaped site is accessed from a roundabout on the A151 and is bound by new access roads to the east and south, by a ploughed agricultural field to the west currently under construction and by a ploughed agricultural field to the north. At the time of the ground investigation the site comprises of a relatively flat ploughed agricultural field with sparse vegetation and a drainage ditch along parts of the western and southern boundaries. In the south west of the site was a contractor's compound, limiting the investigation in this area.

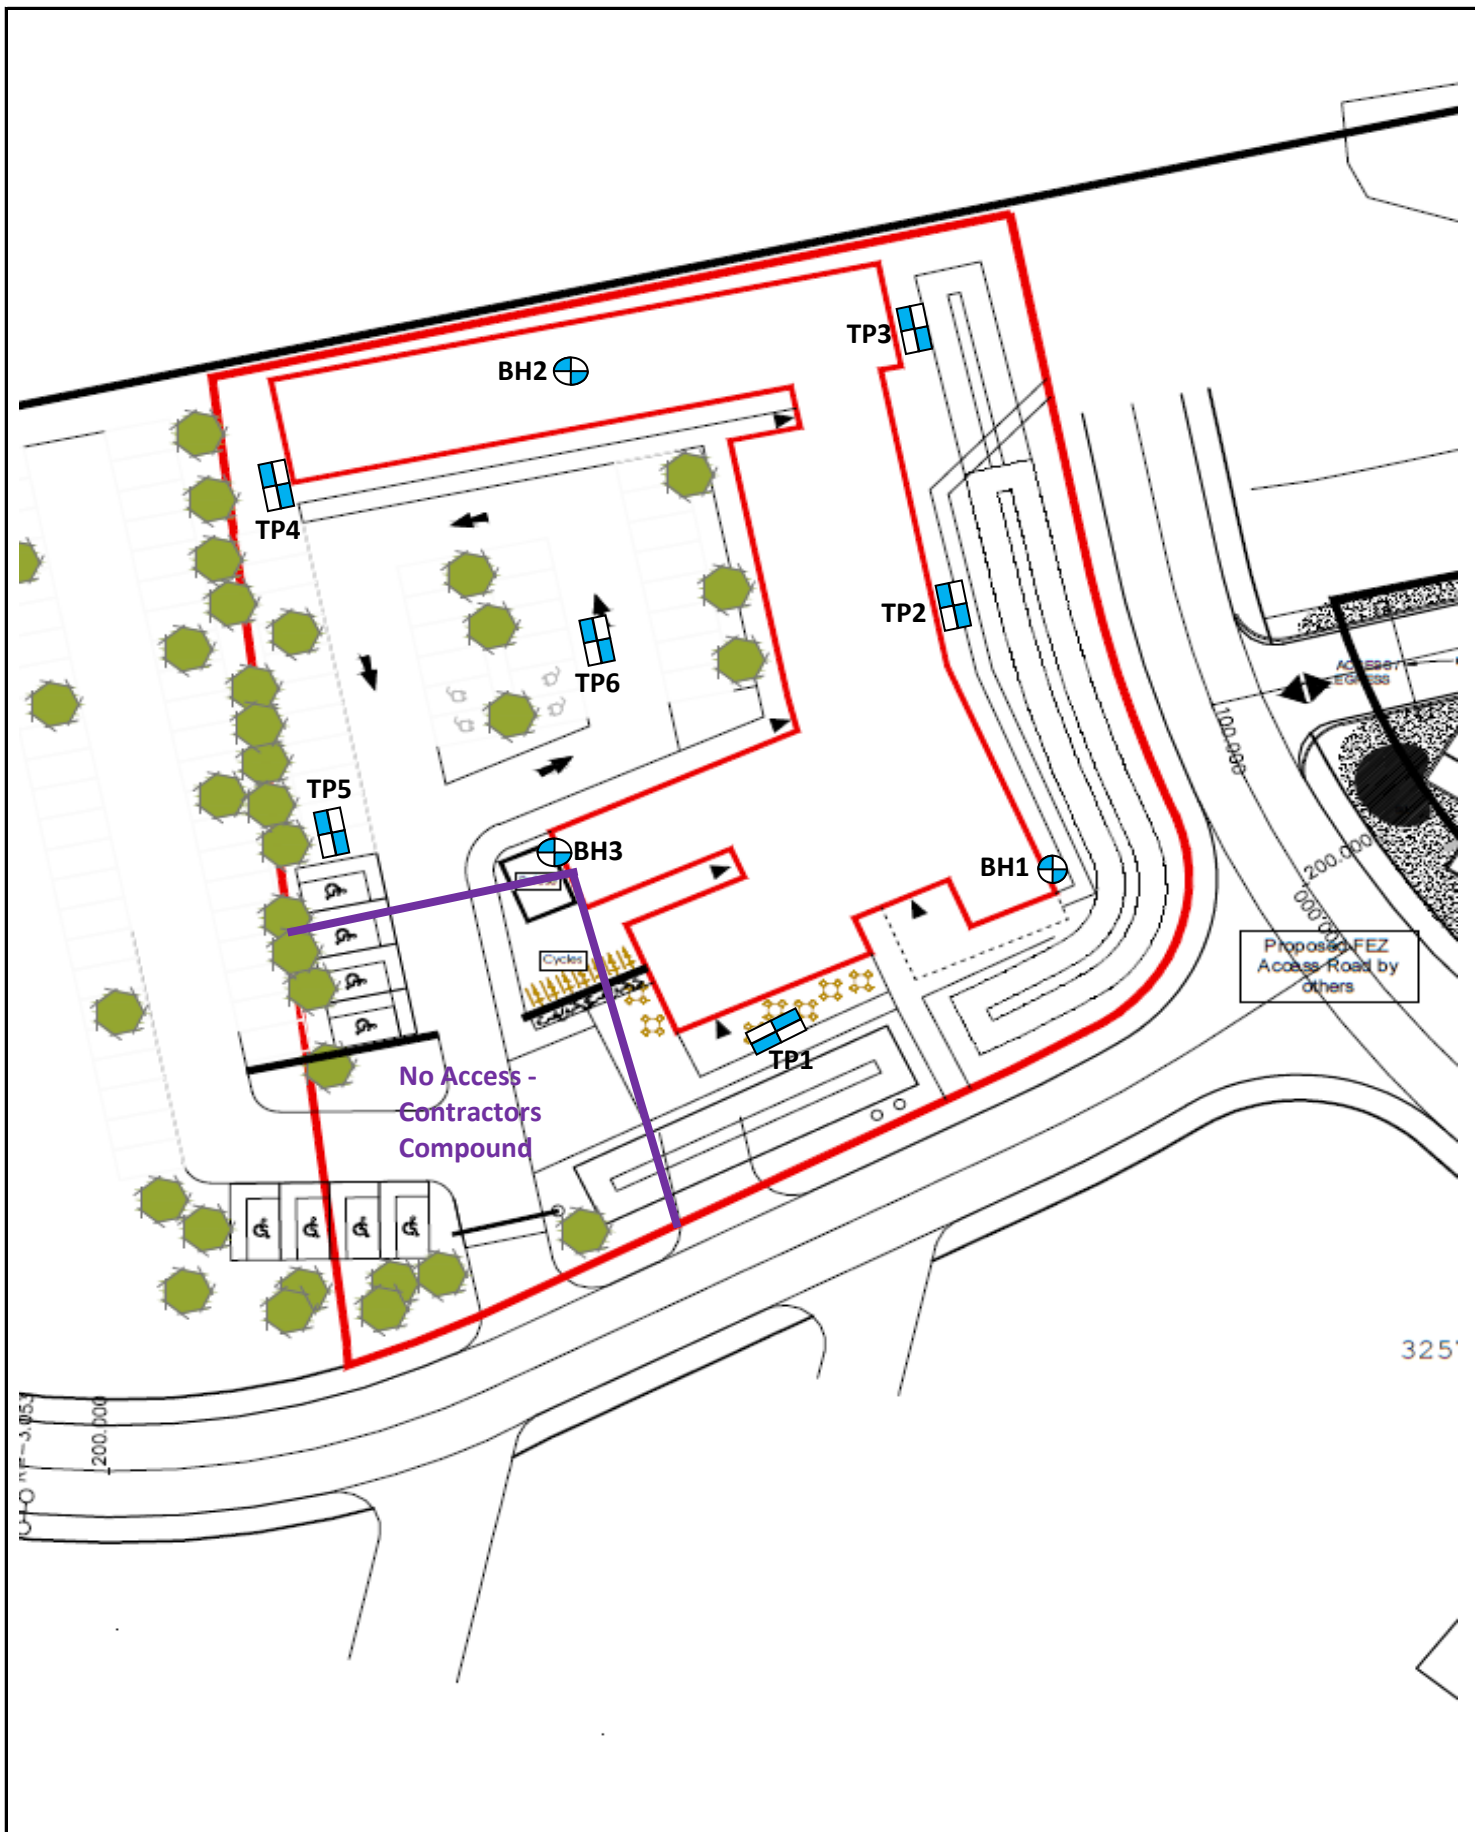
We understand that it is proposed to build a two-storey structure with associated parking facilities, as shown on Figure 3.

| <b>SUB SURFACE</b><br>SITE INVESTIGATION SPECIALISTS, GEOTECHNICAL & ENVIRONMENTAL CONSULTANTS<br>3 Peel Street, Preston, Lancashire, PR2 2QS. Tel: (01772) 561135 Fax: (01772) 204907 | Proposed Development and Exploratory<br>Hole Location Plan | | | |

Three 150mm diameter boreholes were put down by cable percussive boring techniques at the positions determined by the Clients Engineer and set out by Sub Surface North West Ltd, as shown on Figure 3. The boreholes were put down to depths of between 15.72 and 15.81 metres, samples taken were logged in accordance with BS EN ISO 14688-1: 2018 and the resulting Borehole Records are appended.

Six trial pits were taken out by a mechanical excavator at the positions determined and set out by Sub Surface North East Ltd, as shown on Figure 3. The trial pits were excavated to depths of between 2.00 and 3.20 metres, representative samples were taken and the materials were logged in accordance with BS EN ISO 14688-1: 2018. The resulting Trial Pit Records are appended. On completion the trial pits were backfilled with arisings with nominal compaction by the excavator and it is likely that loose or soft pockets will still remain.

We understand that it is proposed to build a two-storey structure with associated parking facilities, as shown on Figure 3. However, at the time of writing this report no specific details regarding the proposed foundations and design loadings were available and consequently the recommendations given are in general terms only.
