**ARCHAEOLOGICAL EVALUATION REPORT:**  
**TRIAL TRENCHING ON LAND TO THE REAR OF THE CHEQUERS HOTEL,**  
**15 HIGH STREET, HOLBEACH, LINCOLNSHIRE**

Planning Reference: H09-0909-21  
NGR: TF 35968 24864  
AAL Site Code: CHHO 21  
Museum Accession Number: LCNCC: 2021.196  
OASIS Reference Number: allenarc1-503134

By  
Allen Archaeology Ltd  
Report Number AAL 2022012

February 2022

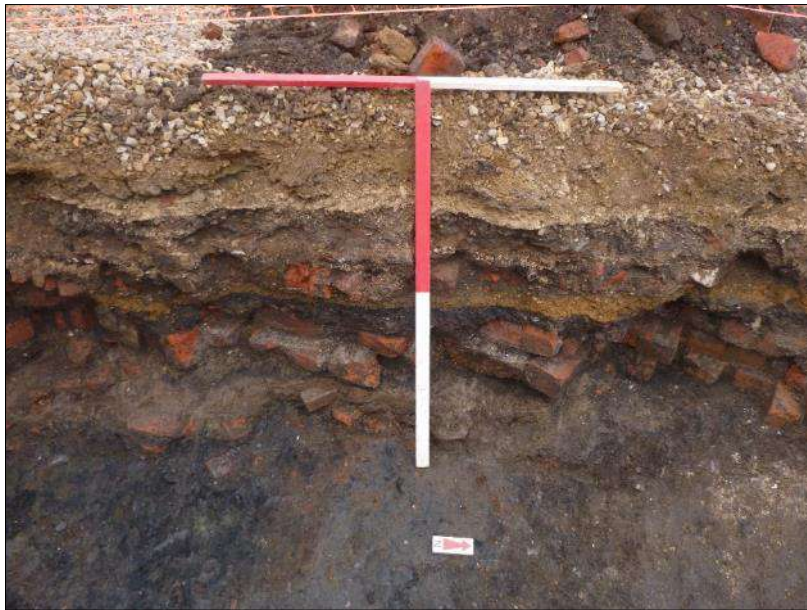
*Plate 1: The general sequence of modern surfaces and rubble demolition/levelling layers within Trench 2. East facing section, scales 1m*

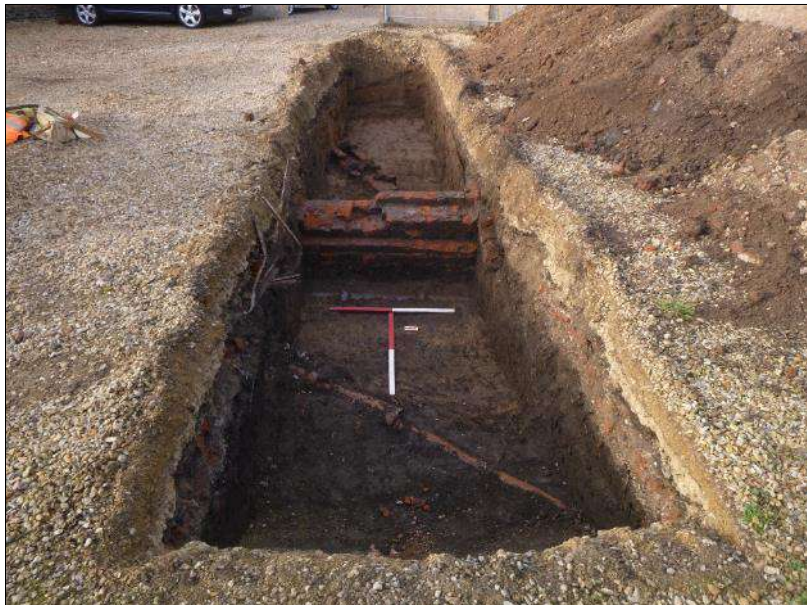
- 7.1 Trench 1 (Plate 2) was excavated in a northeast-southwest orientation on the north side of the proposed development area. A 0.75m deep sondage was excavated at the western end to confirm the underlying natural geology, a grey brown clay silt, 108 (Plate 3).

*Plate 2: Trench 1 looking west, scales 1m*

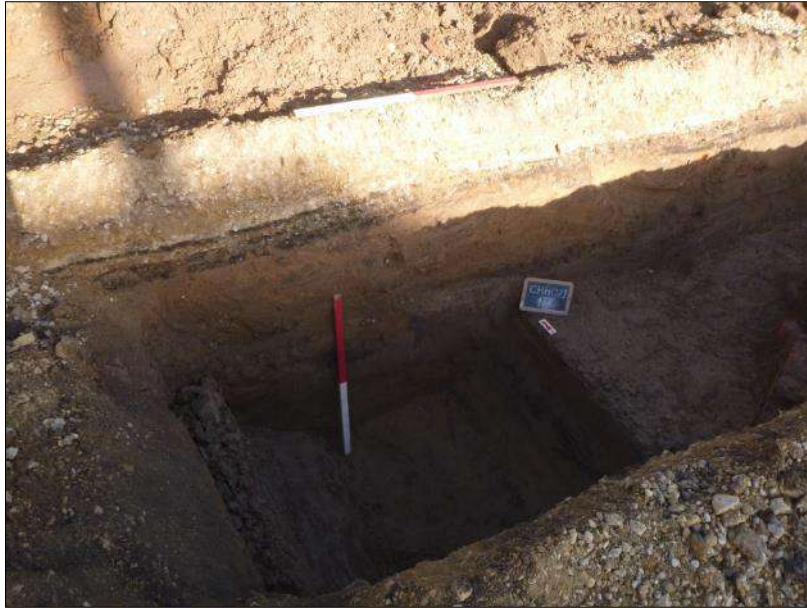
*Plate 3: Sondage through Trench 1 investigating the natural deposits, looking northeast, scale 1m*

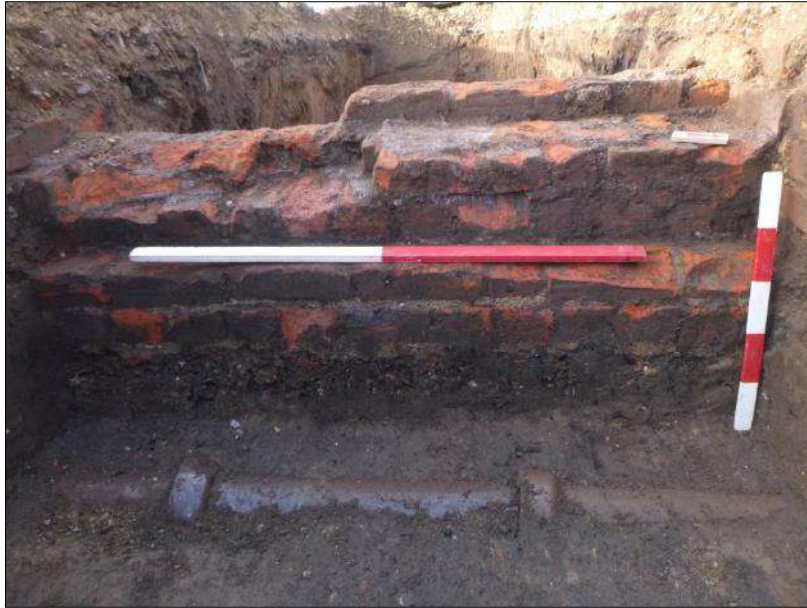
- 7.3 Wall [102] measured 0.48m wide, and was constructed from red brick, bonded with a dark grey mortar (Plate 4). The wall had three courses surviving and sat upon a brick foundation [113], 0.54m wide. The bricks forming this structure were handmade, spalled, with traces of a frog on the upper bed and were 0.28m x 0.12m x 0.08m in size. Beneath the foundation was a compact dark grey sandy clay 104, 0.14m thick containing large amounts of 19<sup>th</sup> - 20<sup>th</sup> century glass, pottery and pebbles, which was used as levelling and bedding material for the foundation.

*Plate 4: Wall [102], foundation [113], and wall [103] (right) with soil pipe 109 in foreground, looking west, scales 0.50m and 1m*

- 7.4 Abutting the eastern side of wall [102], overlying 105, and seen only in the northern section, was east-west orientated wall [103] (Plate 4). This brick wall had three surviving courses and was bonded with an orange brown lime mortar. The bricks were machine made and so and had a frog. The western end of [103] utilised the footings [113] of wall [102]. This wall appeared to have been partially removed during the demolition phase of the site as it only had a surviving length of 0.50m.

- 7.6 Soil pipe 109 ran parallel with and to the east of [102] (Plate 2 and 4). There was no visible cut for this feature and it was overlain by deposit 105.
- 7.7 At the east end of Trench 1 was 110, a north-northeast – south-southwest oriented soil pipe trench within a light yellowish brown clay, 112 (Plate 2).

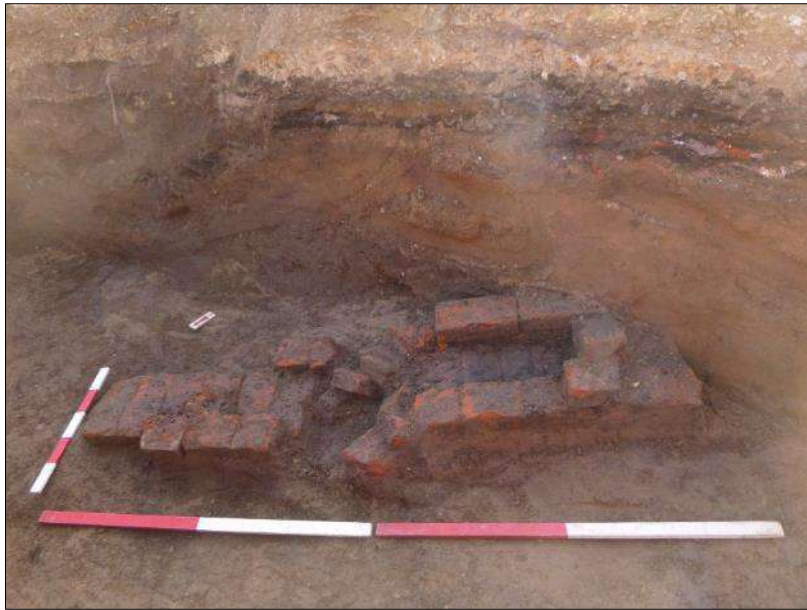
- 7.5 West of wall [102] was [106], an un-bonded northeast to southwest oriented brick structure that was possibly a drain (Plate 5). It was three courses high. The handmade bricks of this structure had longitudinal strike marks and had an uneven underside. The drain comprised a base 0.28m wide, made from bricks placed end to end, flanked by one brick wide walls, placed at right angles to the base bricks. The structure was sealed by layer 107.

*Plate 5: Brick drain [106], looking northwest, scales 0.50m and 2 x 1m*

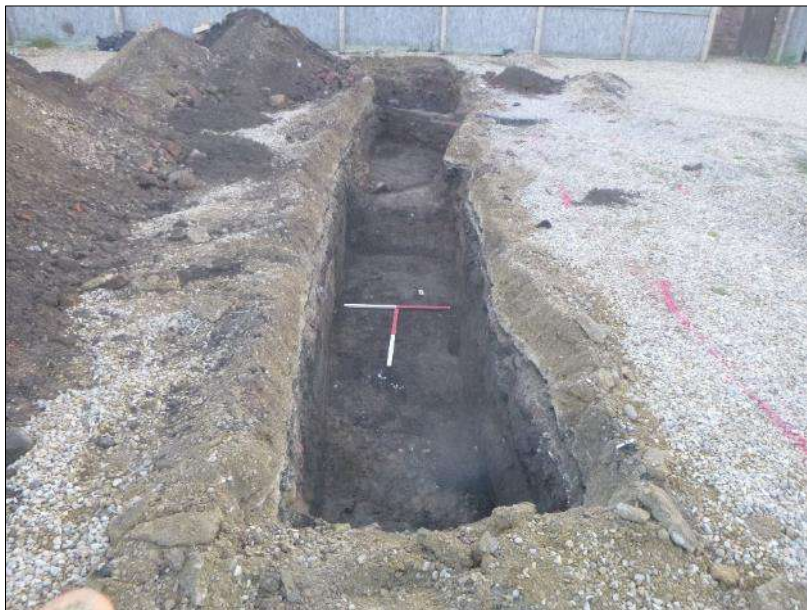
- 7.8 Trench 2 (Plate 6) was located towards the south of the site and oriented roughly north to south.

*Plate 6: Trench 2 looking south, scales 1m*

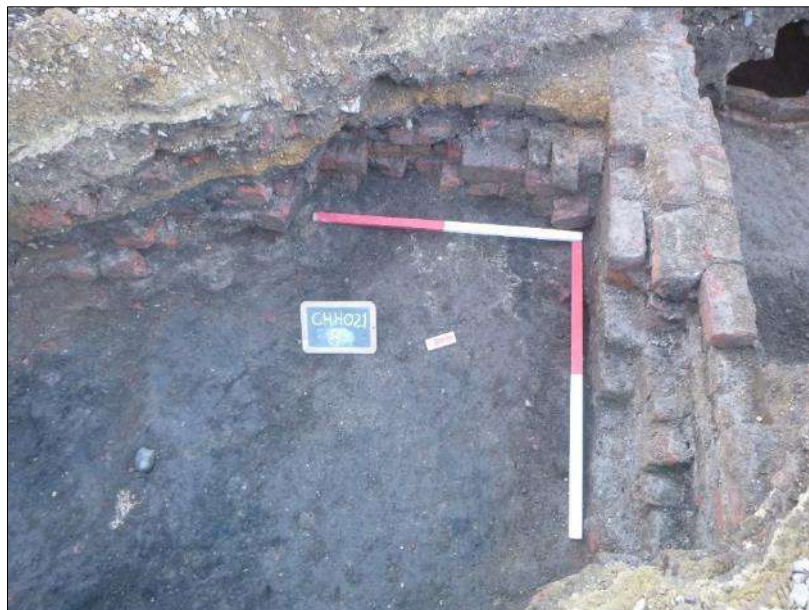
- 7.11 Cut [212], which was the foundation trench for wall [203] (Plate 7) was seen only to cut deposits to the north of the wall. Wall [203] was northwest to southeast oriented, seven courses high, and constructed of London Brick Company Phorpres and bonded with a lime mortar. There was no clear sign of any footings. Cut [212] was backfilled with a dark grey clay, 213.

*Plate 7: East facing section of wall [203] (centre), bricks 221 (left) and soakaway [205] (right), scales 1m*

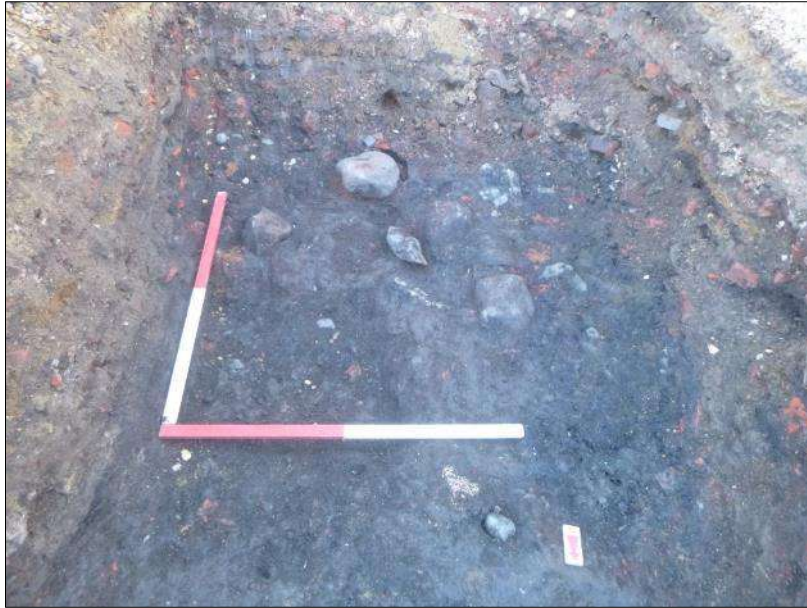
*Plate 8: Consolidation material 202 looking south, scales 2 x 1m*

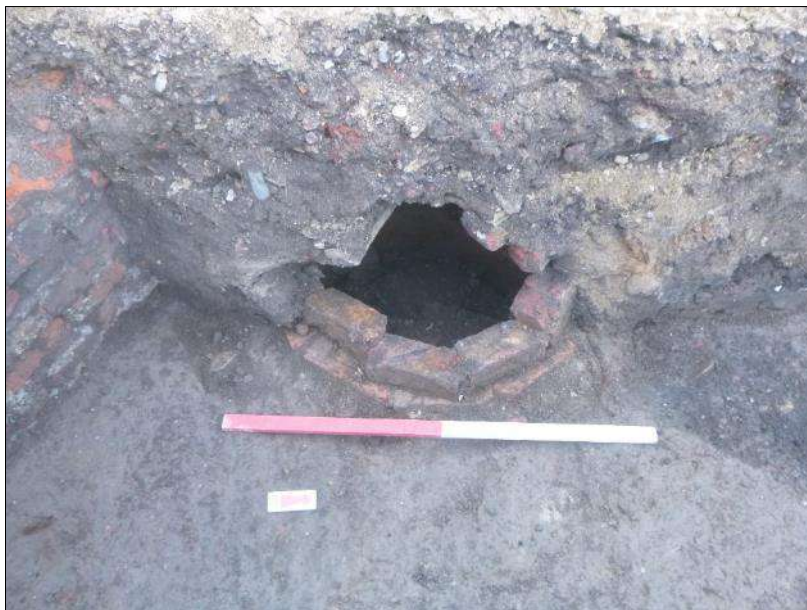
- 7.15 Layer 210, a compact, 0.07m thick orange brown sand, sealed 221 and appears to represent the bedding material for a later surface, which abutted [203], but which has since been removed.
- 7.16 On the north side of [203], cutting into 215/222, suggesting a contemporary date, was a soakaway, [205], protruding from the west side of the trench (Plate 9). This feature was circular and its construction cut, [214], was approximately 1.0m wide. Soakaway [205] had a domed brick roof with a limestone cap and was constructed of handmade red brick, with slight arrises and longitudinal strike marks. A slight cintring and associated blistering was noted on a header. The depth of [205] is unknown.

*Plate 9: Soakaway [205] looking west, scale 1m*

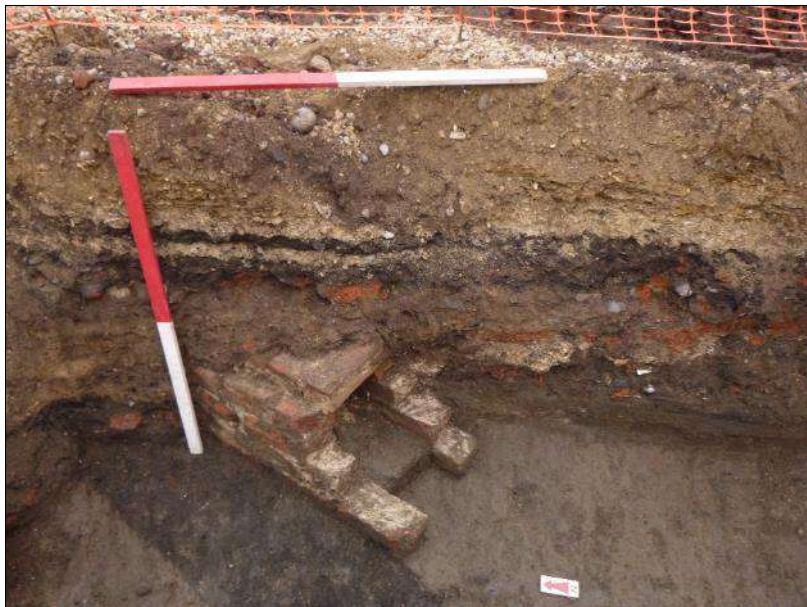
- 7.17 Soakaway [205] was fed by [206], a northeast to southwest oriented gully 0.39m wide and 0.30m deep (Plate 10). Gully [206] was backfilled with 207, a very dark sand clay and banded light brown sand and silt, 223.

- 7.18 A brick drain [204] was constructed parallel to, and southeast of [206]. It was built of the same red brick as wall [203], was 0.40m wide and 0.44m deep, four courses high with a capping course. A construction cut [218], was noted only on the northern side of the structure, filled with a compact, dark grey clay with frequent brick and limestone inclusions, 224. It is presumed that drain [204] was constructed so tightly to the southeast drain cut that the cut could not be seen. Drain [204] was constructed in the same manner as drain [106] in Trench 1, suggesting they are contemporary.

- 7.19 A brick floor surface 219, seen only in section, was at the same level as 204's capping. This surface, which was only seen for c.1m, was only one brick thick and had a cream mortar bedding and bonding. It is presumed that this surface would have butted [203].

*Plate 10: Gully [206], drain [204] (centre) and surface 219, (right, centre) looking east, scales 1m*
