**Re: Phase 2 Balmoral Way, Holbeach – Former Tanks Hotspot Remediation Validation Report**

GeoDyne Limited has been appointed by the Client, Ashwood Homes, to prepare a validation report following the removal of hydrocarbon impacted soils associated with the former above ground tanks hotspot, as recommended within our Remediation Strategy & Verification Plan for the site.

**Plan Showing Tanks Hotspot Excavation and Validation Sampling Point Locations  
(Figure No. D41012/V01)**

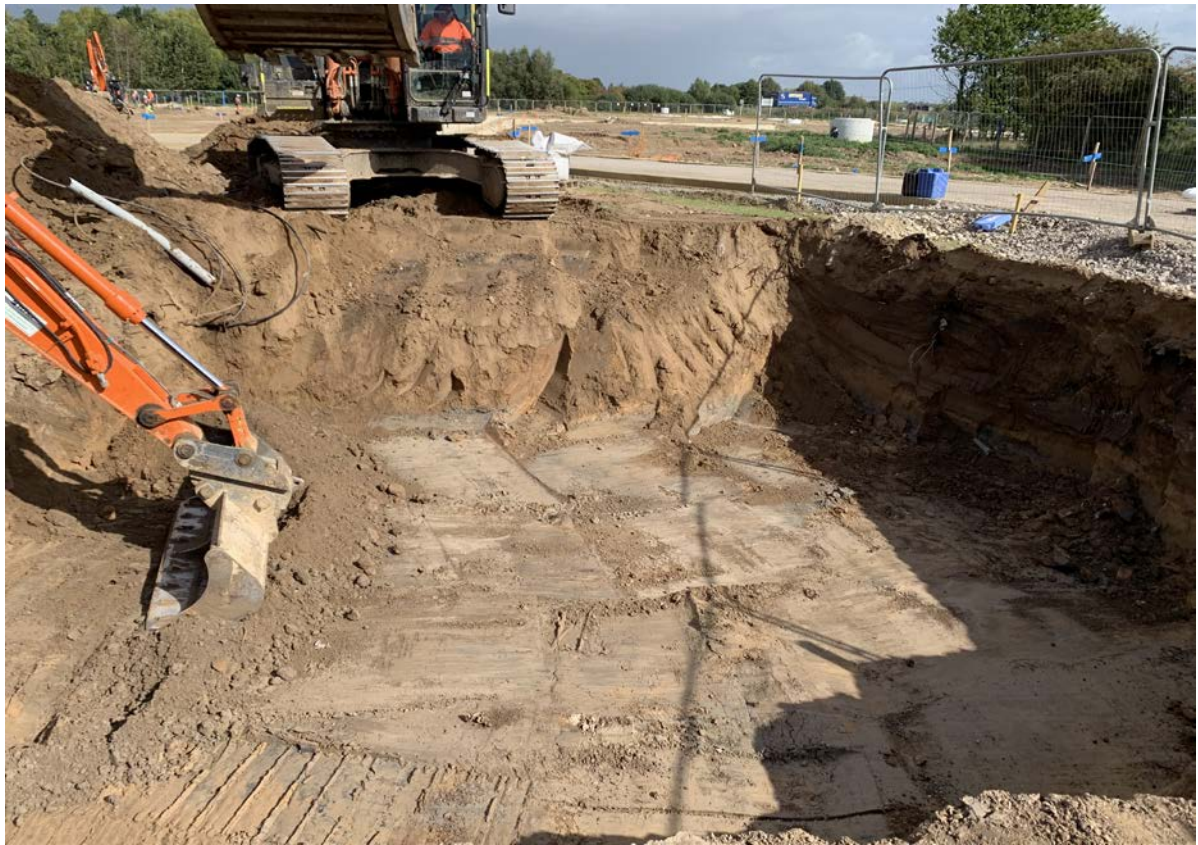
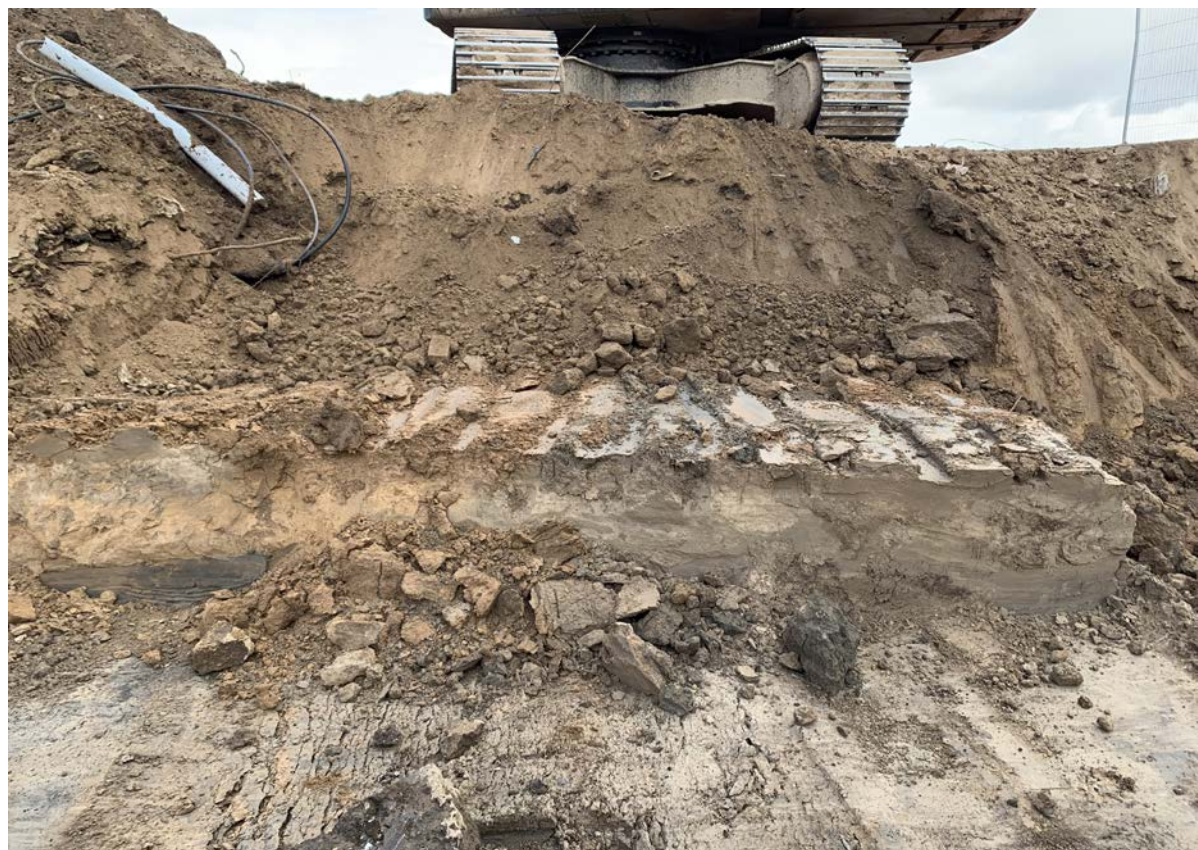
| Title | Excavation during removal of hydrocarbon<br>contaminated soils | Plate No. | 1 | |

Hydrocarbon impacted soils were excavated from the area around the former tanks, the locations of the former trial pit TP20 and WS3 and also delineation sampling points TPH1 and TPH3 where impacted soils had previously been identified. The excavation was extended in each direction until the surrounding soils exhibited a lower degree of hydrocarbon impaction. This included excavating soils up to the edge / line of the footpath associated with the new road to the south-east which was under construction at the time of the remediation works.

Photographs of the excavation during and following removal works are shown on Plate No. 1 and 2 contained within Appendix II.

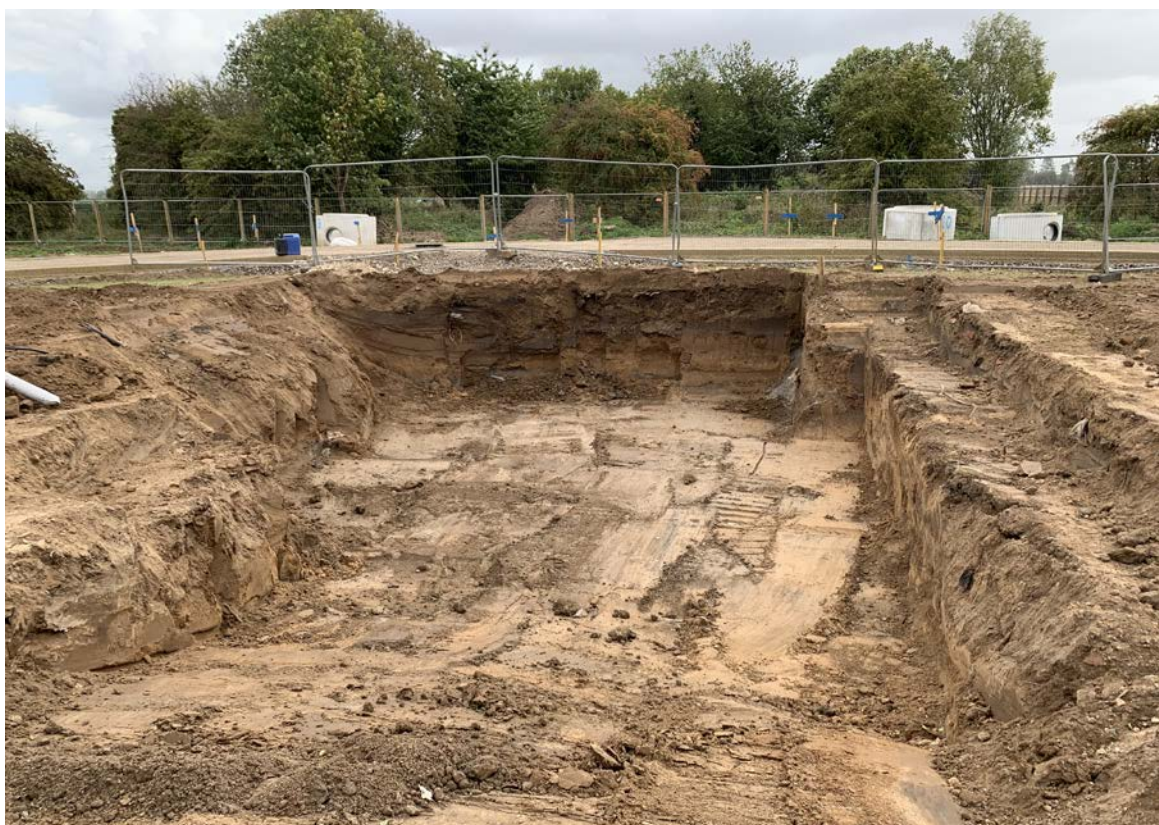
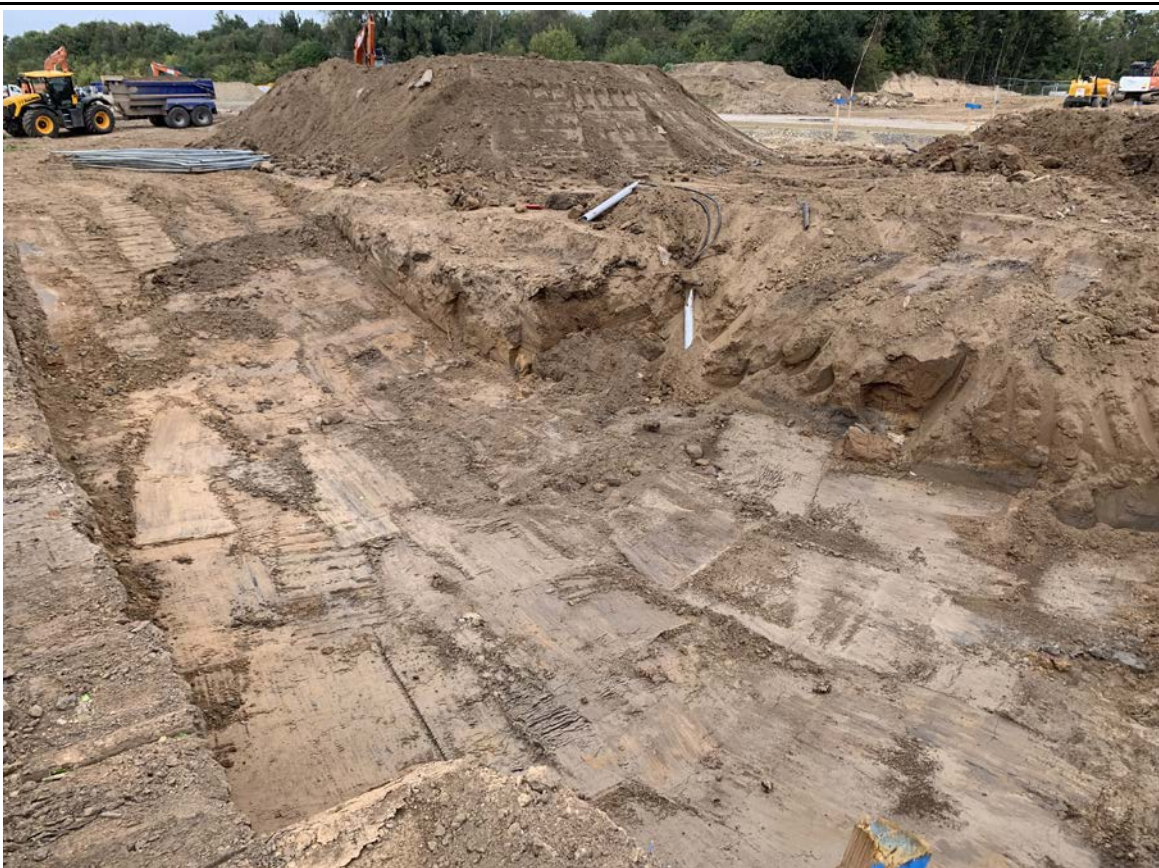
| | | Plate No. | 2 |

Based on the verification inspections and validation testing, it is concluded that the soil remediation works associated with the hydrocarbon impacted soils in the area of the former above ground fuel tanks hotspot at the site have been successfully completed in accordance with the Remediation Strategy & Verification Plan document for the site.
