North-East Area – Holbeach Meadows  
Holbeach

**Combined Phase I Desk Study &  
Phase II Exploratory Investigation  
For  
Ashwood Homes**

| <b>Project No: D42030A</b> | | <b>Date: 21<sup>st</sup> June 2022</b> | |

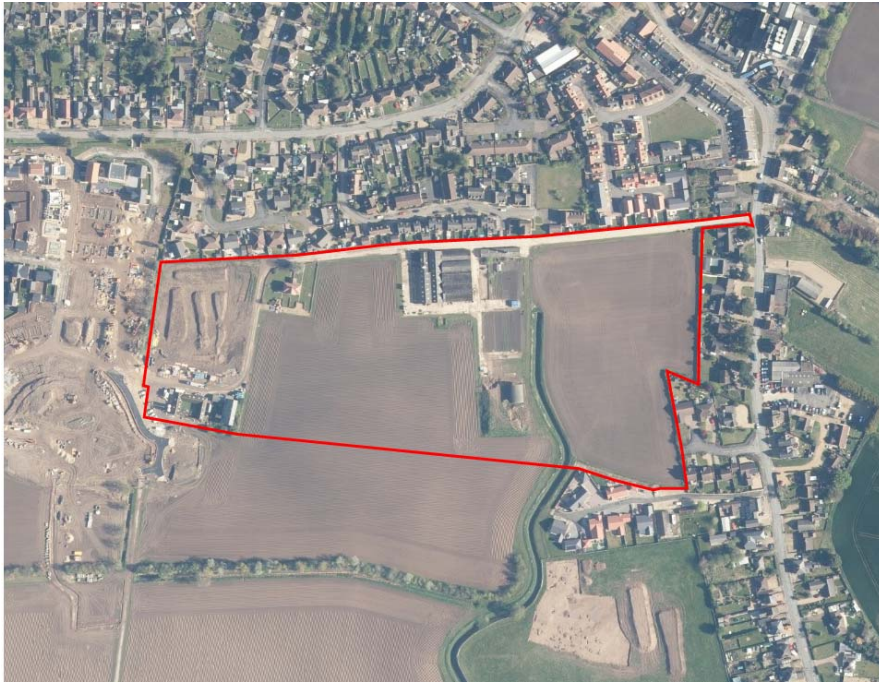
**Figure 1:** Aerial photograph of the site (2022 image).

An aerial photograph of the site, obtained from the Landmark Analysis tool commissioned as part of our works, is presented in Figure 1 below, with the current OS mapping plan for the site and surrounding area presented in Figure 2 below. The absence of topographic contour levels on the OS mapping is indicative of the generally flat nature of the site and its environs.
