Phase 1 & 2 site investigation report

Land off Seagate Road, Long Sutton

Produced for D. Brown Building Contractors Ltd

| <i>Report number:</i> | 1197/5350/P/P2 |

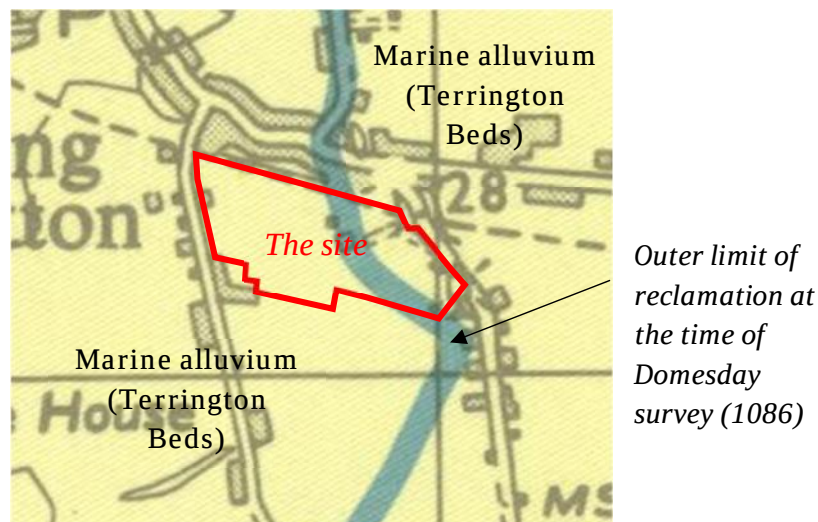
Figure 1: Extract of local geology map

BGS 1:50000 Series, King's Lynn and The Wash, Sheet 145 with part of 129, Solid & Drift Edition ©NERC

Glacial till (about 40m in thickness) is anticipated below the Tidal Flat Deposits at a depth of about 17m, based on nearby BGS historical records of deep boreholes, copies of which are shown below (in Table 6). The glacial till is expected to mainly comprise boulder clay – stiff gravelly clay.

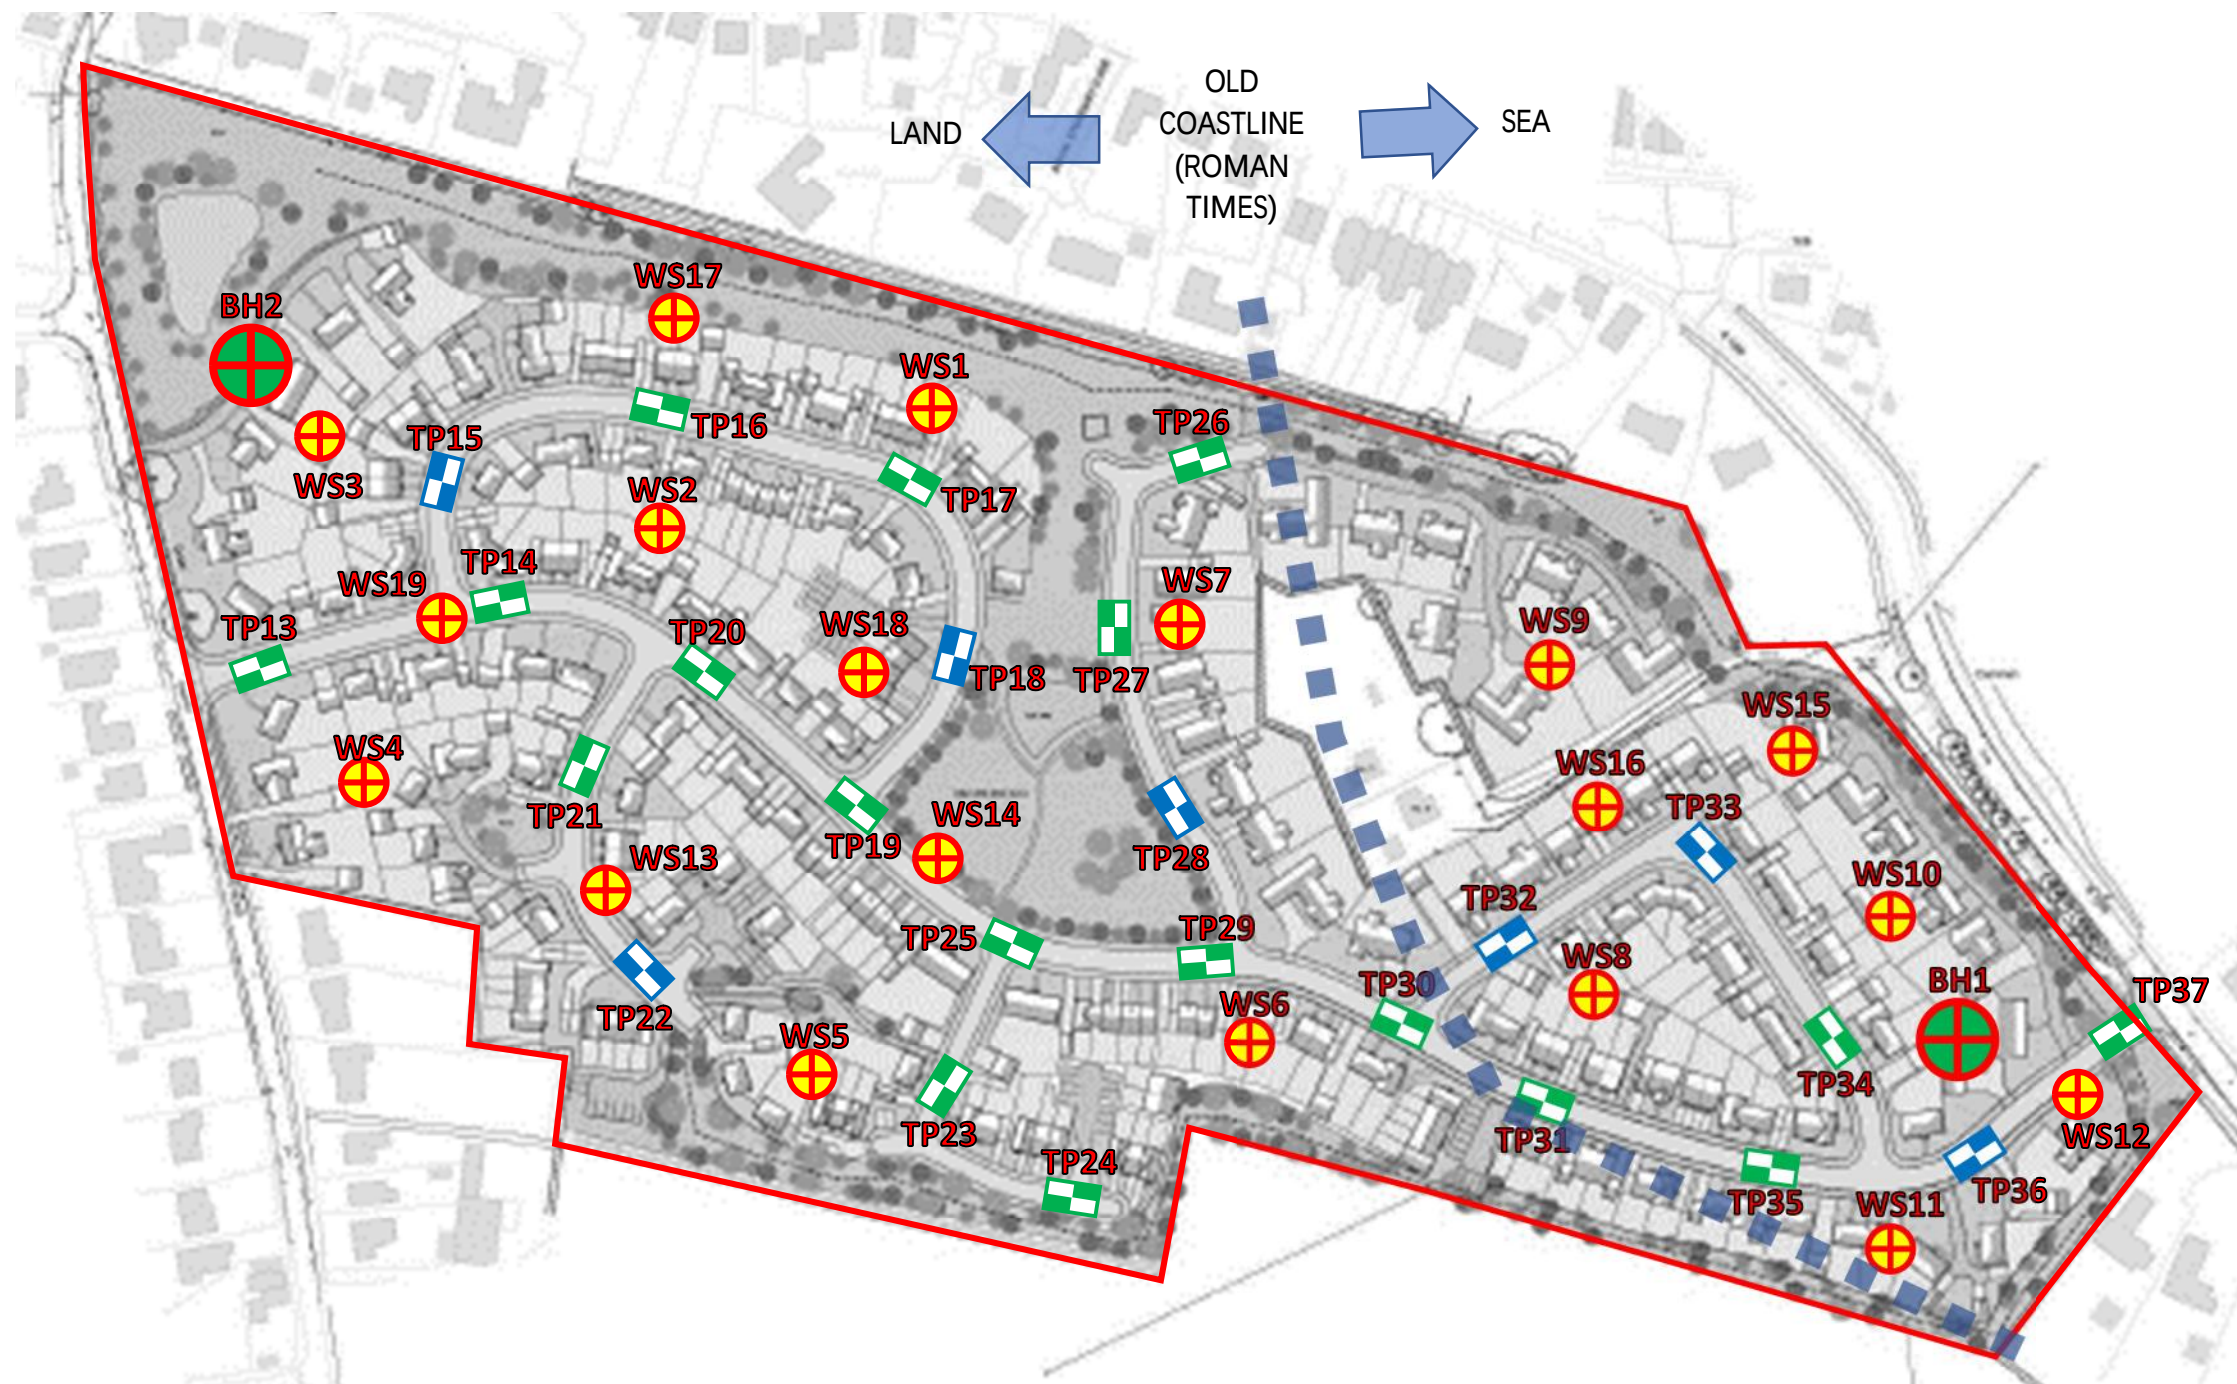
**Drawing Title:** Exploratory hole location plan  
**Drawing No.:** 1197-5350-SI-01 **Revision:** 0  
**Site:** Land off Seagate Rd, Long Sutton  
**Client:** D Brown Building Contractors Ltd  
**Project No.:** 1197/5350/P  
**Date:** 18/02/2020

1. Do not scale
2. Locations of all features are approximate only
3. Background image taken from Templeman Design drawing number 3359-TD-XX-DRG-AR-0002-PO, dated November 2017

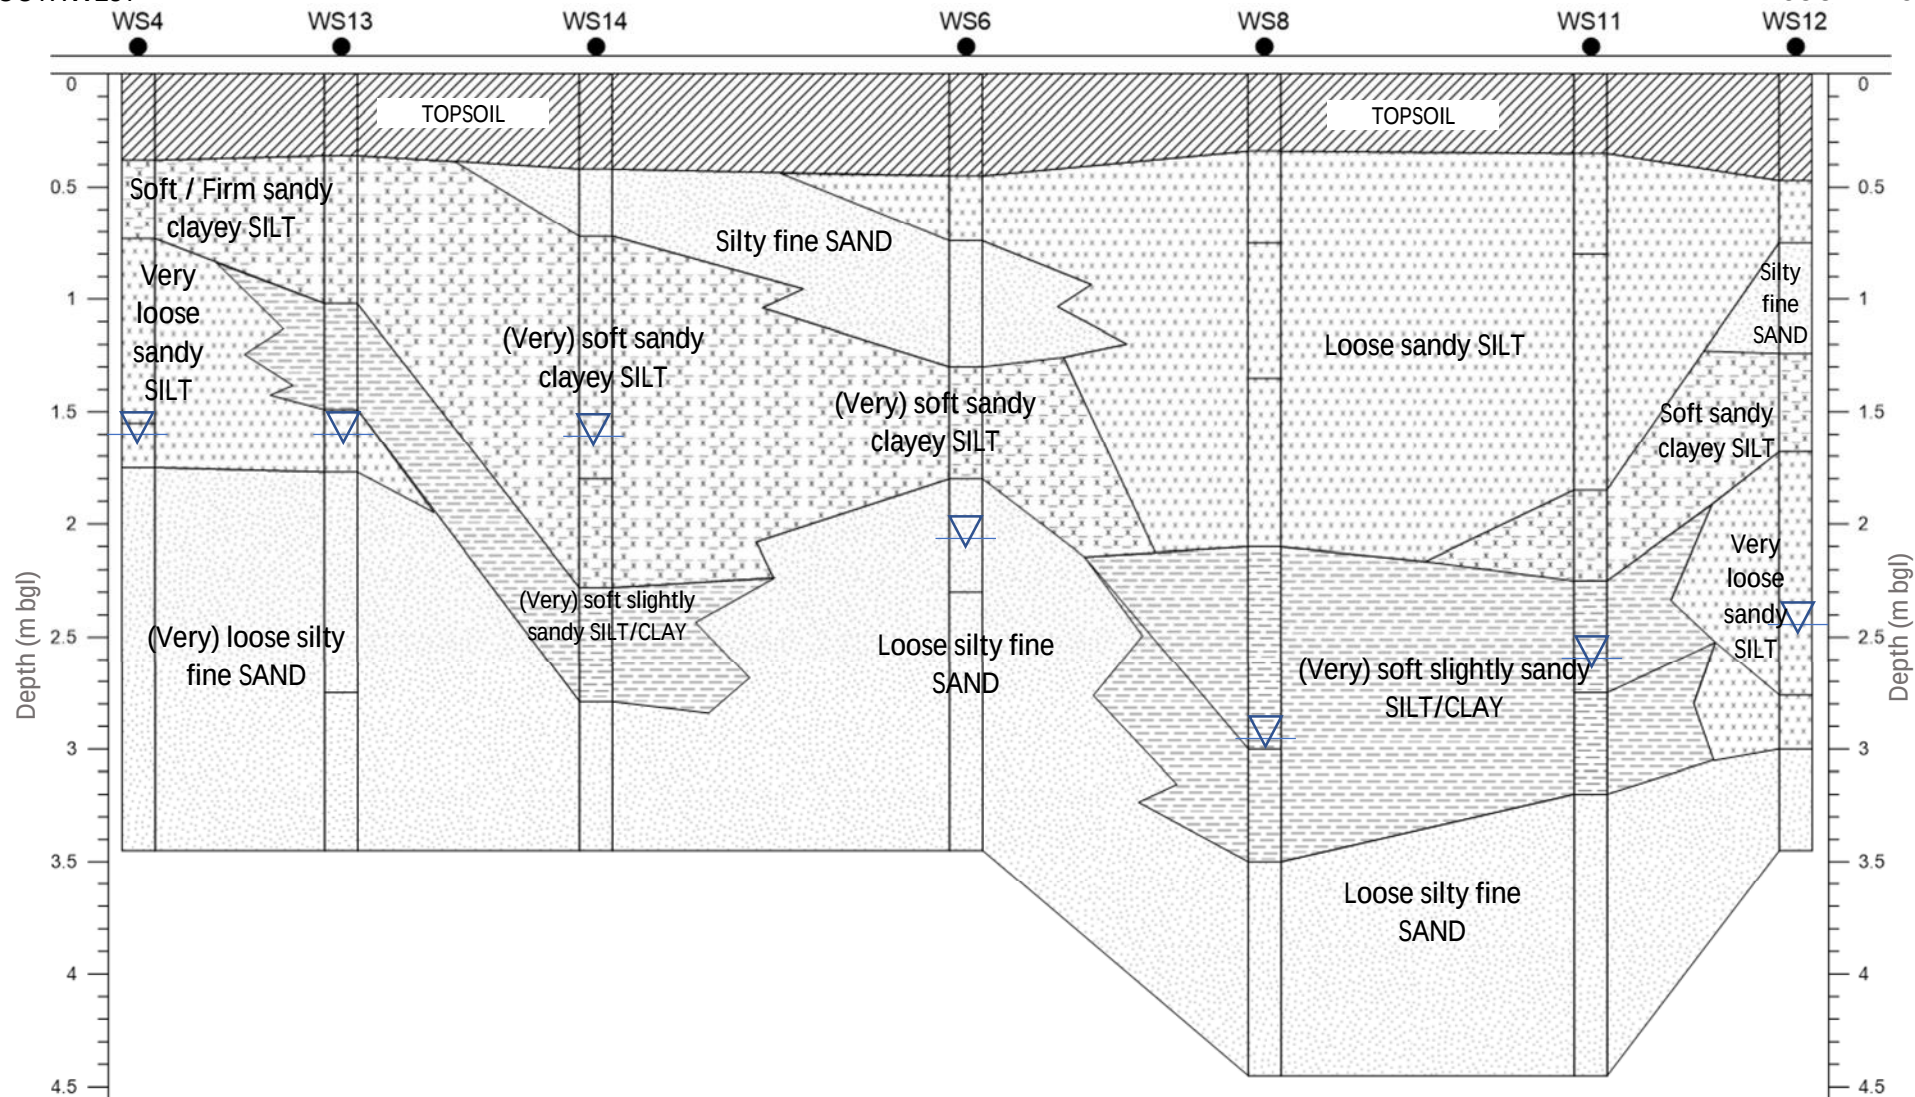
1. Do not scale
2. Strata boundaries and locations are inferred and approximate only
3. Strata descriptions are generic and unlikely to represent whole strata

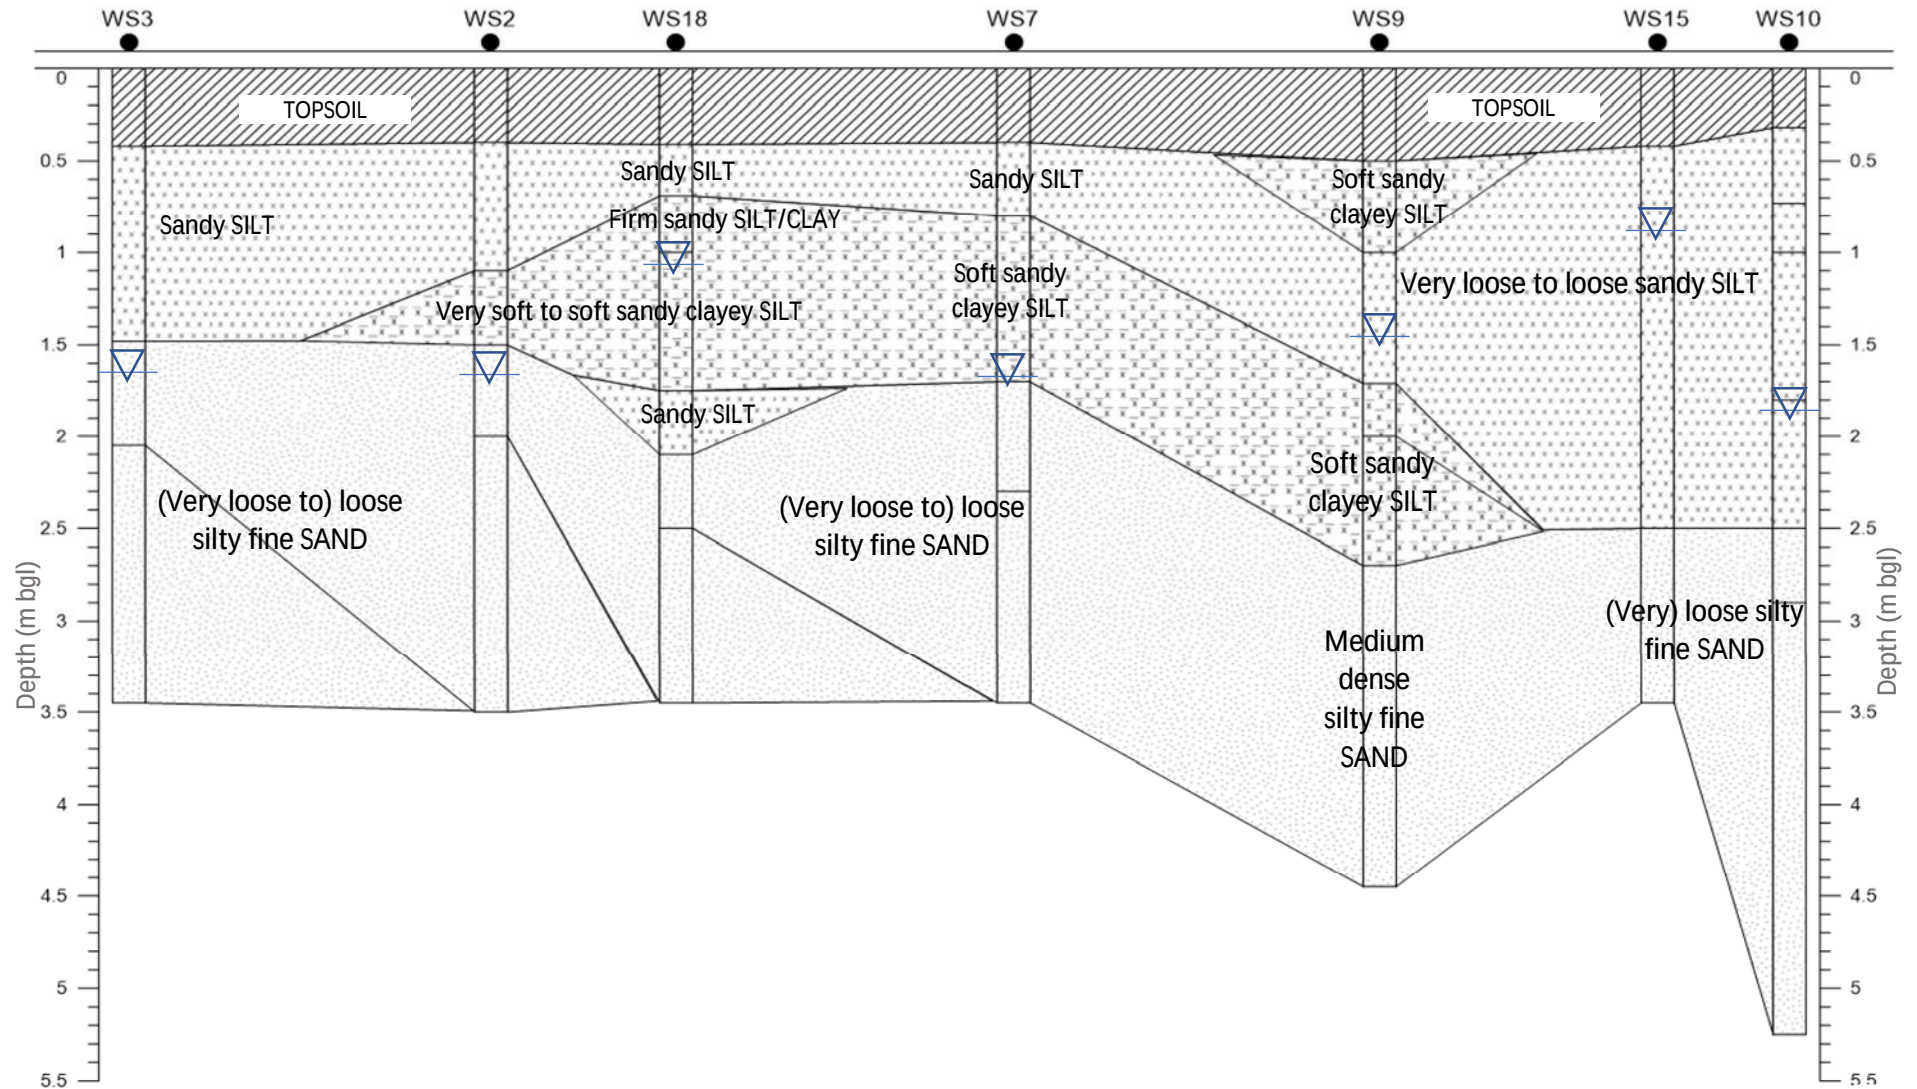
1. Do not scale
2. Strata boundaries and locations are inferred and approximate only
3. Strata descriptions are generic and unlikely to represent whole strata

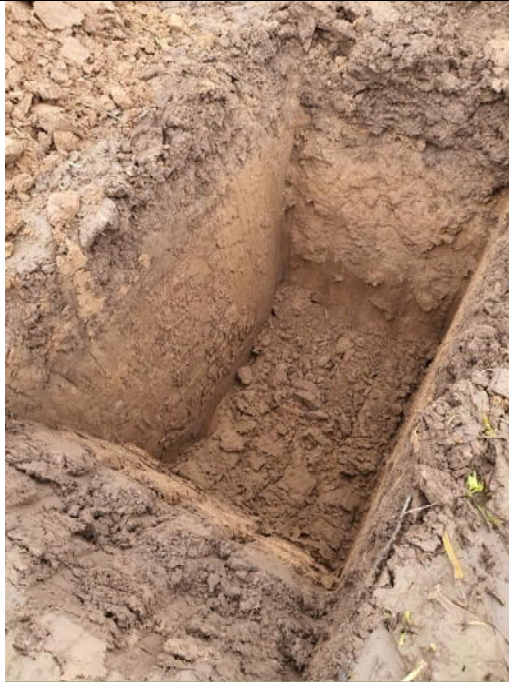
*Photo: 1*      *Date: 10 Dec 2021*  
*Photo direction: -*  
*Description: Inside of TP15*

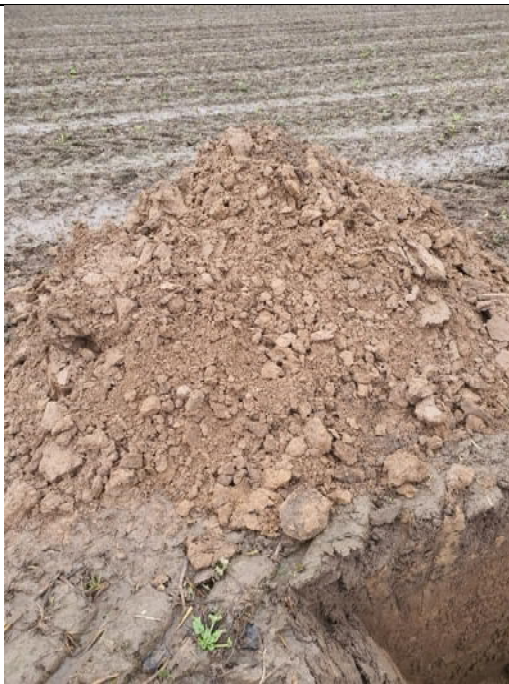
*Photo: 2*      *Date: 10 Dec 2021*  
*Photo direction: Southeast*  
*Description: Spoil from TP15*

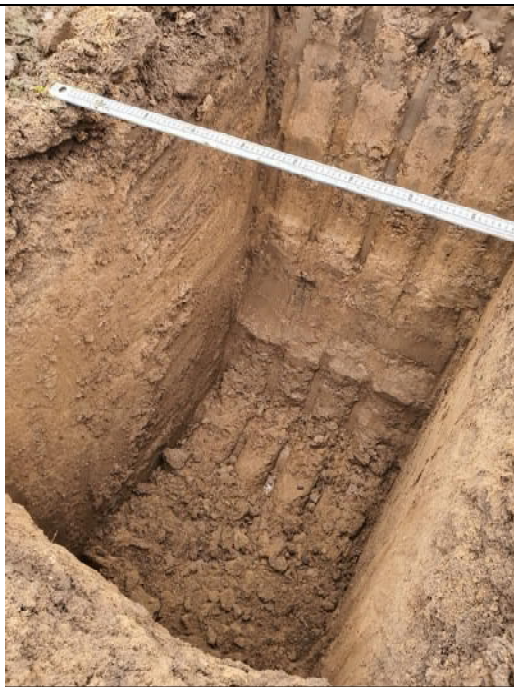
| <p><i>Photo: 3</i>      <i>Date: 10 Dec 2021</i><br/><i>Photo direction: -</i><br/><i>Description: Inside of TP18</i></p> | | <p>Camera position: </p> |

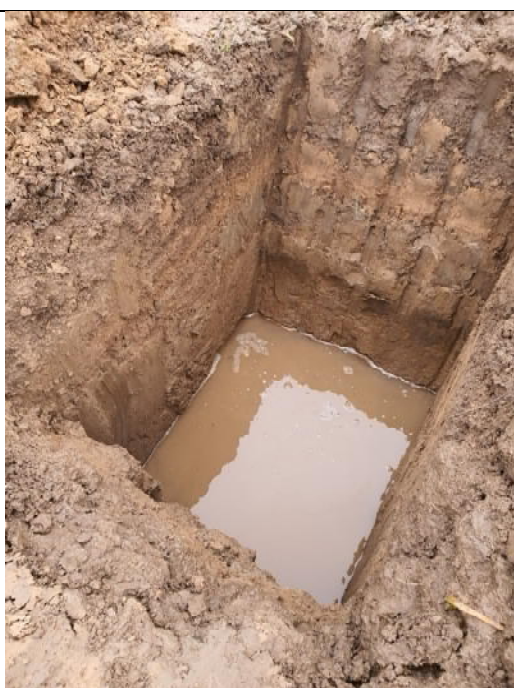
| <p><i>Photo: 4</i>      <i>Date: 10 Dec 2021</i><br/><i>Photo direction: Southeast</i><br/><i>Description: Inside of TP22 (during percolation testing)</i></p> | | <p>Camera position: </p> |

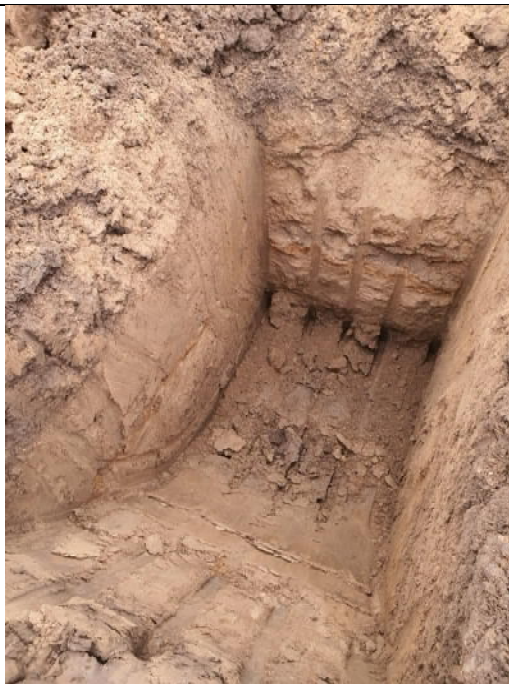
*Photo: 10*      *Date: 10 Dec 2021*  
*Photo direction: Southeast*  
*Description: Inside of TP36*
