**PROPOSED RESIDENTIAL  
DEVELOPMENT  
FORMER WINDMILL GARAGE  
WISBECH ROAD  
LONG SUTTON  
LINCS.**

**GEOENVIRONMENTAL  
DESK STUDY**

**Report Ref.: 0427/1**

April 2017

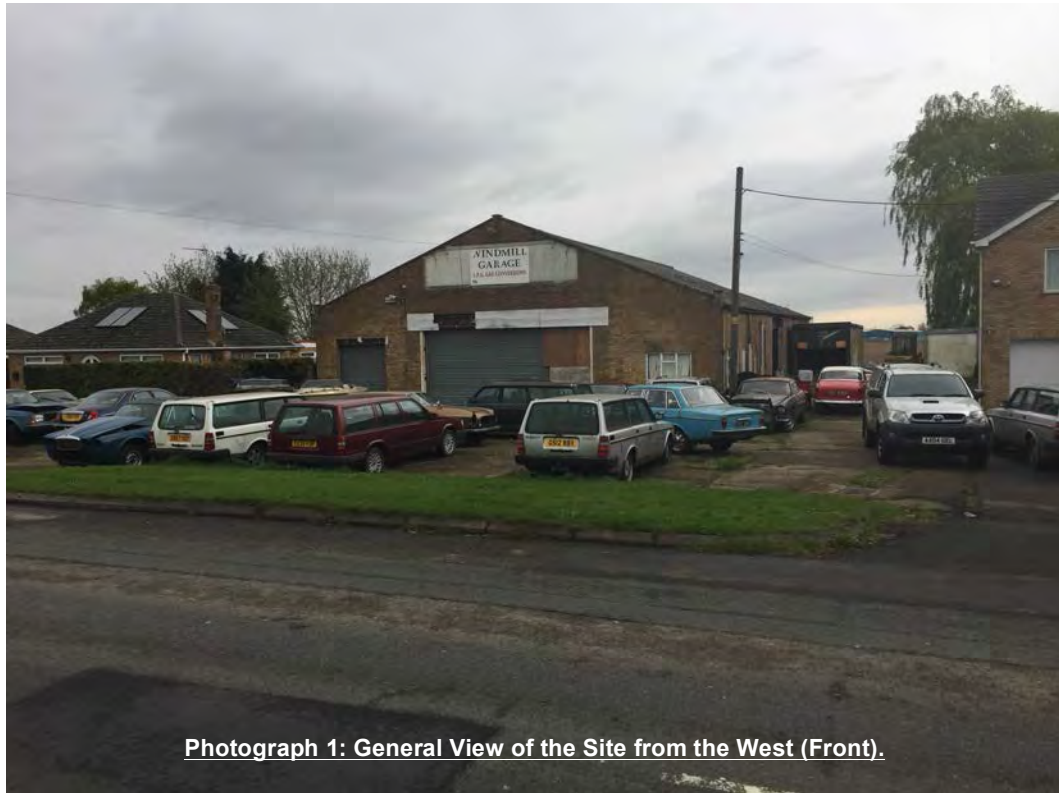
Photograph 1: General View of the Site from the West (Front).

At the time of the site walkover survey the site was capped mainly with concrete including the footprint of a large building with soft cover of long grass with occasional small patches of exposed soils to the periphery. A number of vehicles were being stored mainly at the front of the site as can be seen from Photograph 1 below.

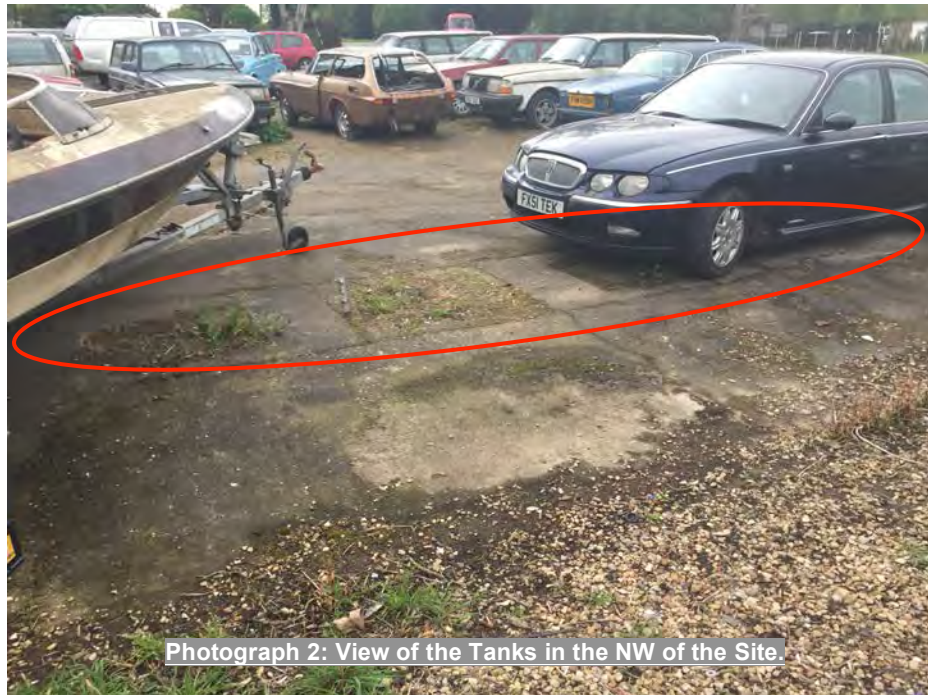
Photograph 2: View of the Tanks in the NW of the Site.

Near the northwestern corner of the building a series of metal covers were noted. It was understood from the Occupier that these were to four underground fuel storage tanks (circled red) that had been in use for fuel retail during the history of the site. These are shown in Photograph 2 below.

It was understood from the Occupier that these tanks, which were considered to be approximately 500 gallons each in capacity (3 x petrol and 1 x diesel), had not been used for at least 40 years and had been 'decommissioned' and infilled. There was no evidence of staining of surfaces around this feature at the site. This feature is shown more clearly in the aerial photograph supplied by the Occupier and included here as Photograph 3. The ventilation pipes were also still in place and were attached to the northwestern corner of the building, circled blue, in Photograph 3 below.

The site Occupier understood the need for the removal (with appropriate duty of care documentation), of these potential contamination sources as part of the redevelopment of the site.

It is recommended that 'duty of care' documentation is forwarded to the Environmental Health Team at the LPA to demonstrate that these sources have been appropriately 'managed'.

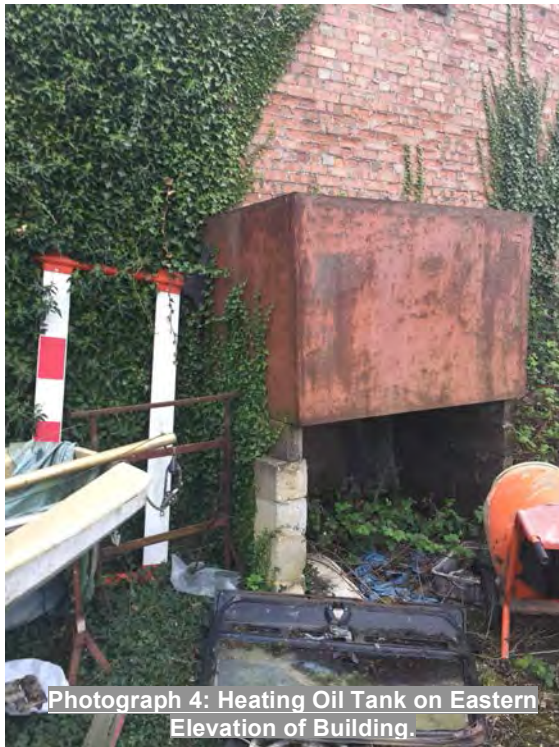
A further tank was noted against the rear (eastern) elevation of the building as shown in Photograph 4 below. This contained oil for heating the workshop.

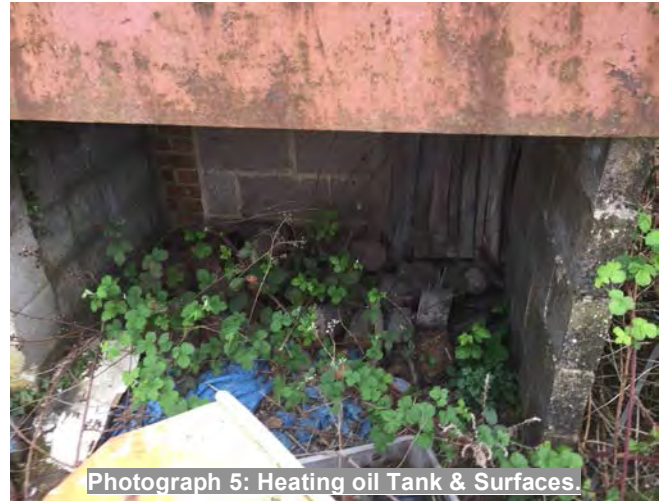
Photograph 5 shows the surfaces within and nearby the tank footprint. The reader should note there were no odours or staining of external surfaces or nearby soils associated with this potential source of contamination.

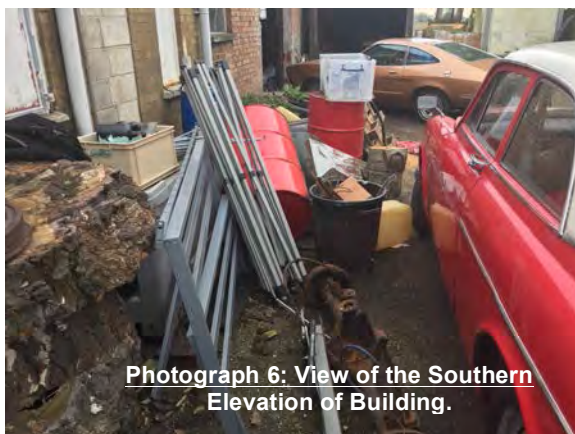
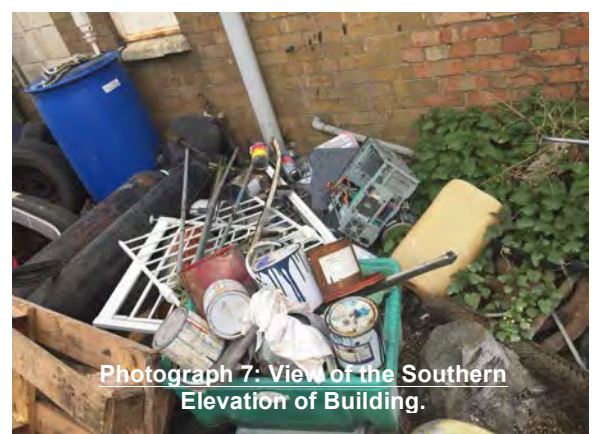
The southern elevation of the building was being used as a storage area as can be seen in Photograph 6 and 7 below.

Items being stored in this area included: wooden pallets, sectional metal, empty oil drums, plastic containers, logs, textiles, metal computer 'carcasses', gas cylinders, empty paint tins (within a plastic crate) and occasional car parts. The surfacing in this part of the site was asphaltic in nature therefore it is difficult to discern in the photographs that the exposed surfaces in this part of the site are relatively stain-free.

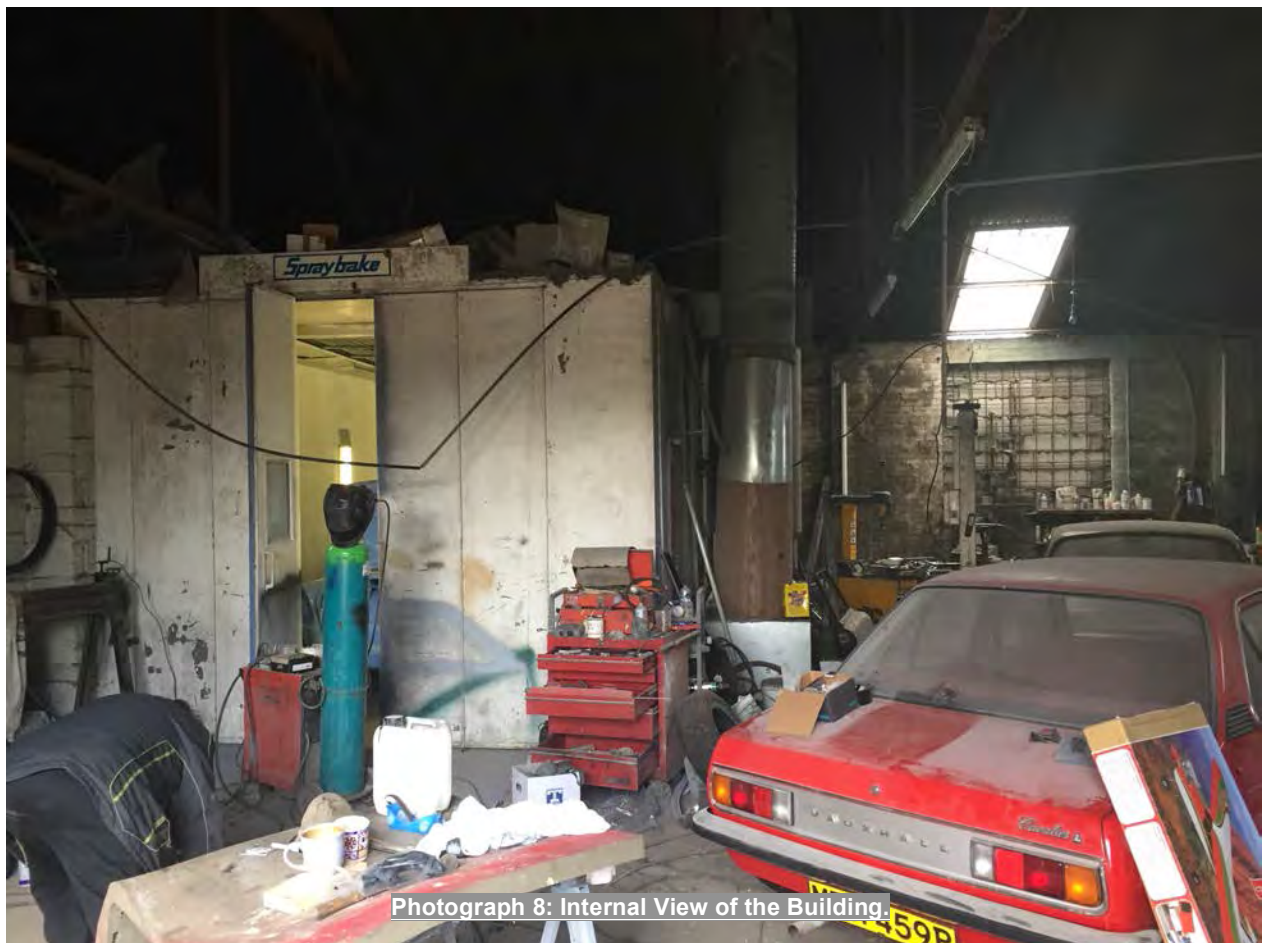
Photograph 8: Internal View of the Building.

Internal inspection of the building showed it was of 'double height' but single open area where vehicle repairs/storage was being carried out together with a repaint area where 'small scale' vehicle repainting activities were being carried out as a 'Spraybake' facility was included within the building as shown in Photograph 8 and 9 below.

There were several cars in the building together with hydraulic ramps and small power and hand tools as would be reasonably expected for such a facility.

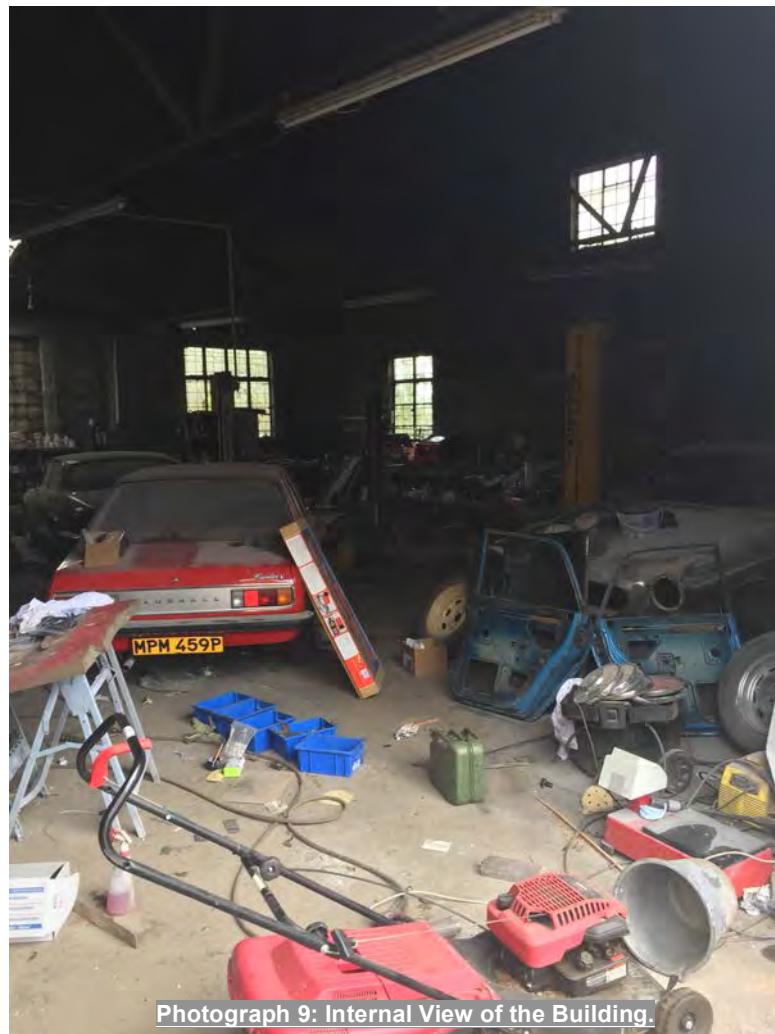
Photograph 9: Internal View of the Building.

The reader will note that where exposed the concrete slab floor was reasonably stain-free.
