**HISTORIC BUILDING SURVEY REPORT:**  
**ADDERLEY HOUSE STABLE BLOCK, 23 LONDON ROAD,**  
**LONG SUTTON, SPALDING, LINCOLNSHIRE**

Planning Reference: H11-1007-21  
NGR: TF 43463 22689  
AAL Site Code: LSLR 22  
Lincoln Museum Accession Number: LCNCC: 2022.46  
OASIS Reference Number: allenarc1-506277

By  
Allen Archaeology Ltd  
Report Number AAL 2022048

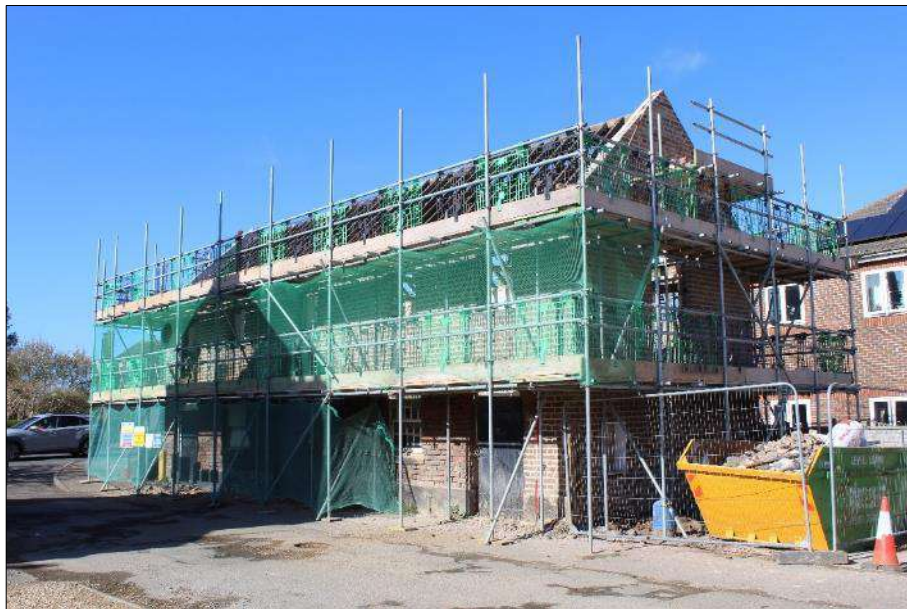
- 6.2 The two-storey stable and coach house with granary above (Plate 1) flanks the northwest side of a private lane positioned directly northwest of Adderley House. The structure is northeast-southwest orientated and measures approximately 14m x 5m.

*Plate 1 (shot 1): General view of stable and coach house, looking west-northwest, 2m scale*

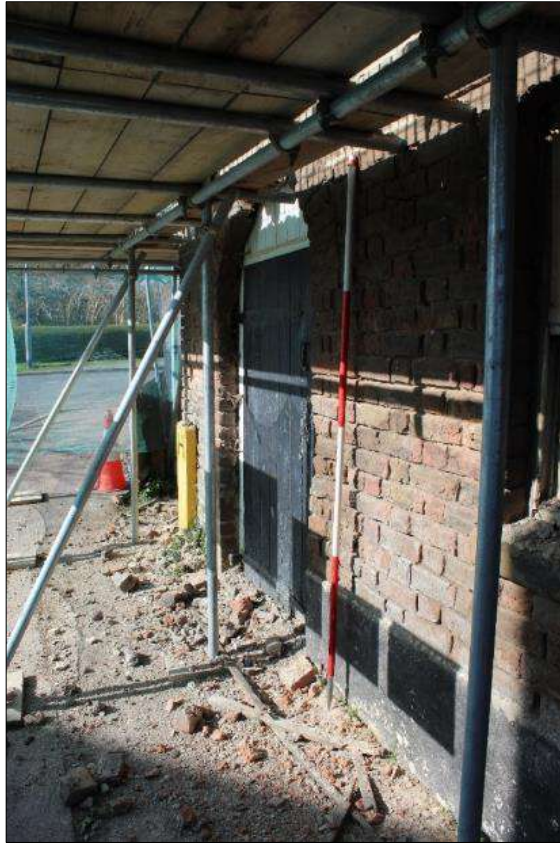
- 6.3 The elevation facing the lane has been built in handmade red bricks laid in Flemish Bond. English Garden Wall bond with three rows of stretchers between each course of headers has been used on all other elevations. Most bricks show a horizontal crease line from being thrown into the mould.
- 6.4 The building has a double pitched gabled roof and was presumably once covered in red clay tiles. Images from Street View shows a corrugated sheet roof, possibly asbestos sheets. On the southeast elevation there are three doorways with semi-circular brick arches, with the largest being a double door coach opening in the centre. The space under the arches, where fanlights are positioned in domestic doors are filled with tongue and groove panelling. The doors are all rectangular plank and batten doors hung on strap hinges (Plate 2).

*Plate 2 (shot 7): Representative shot of doorway. Looking west, 2m scale*

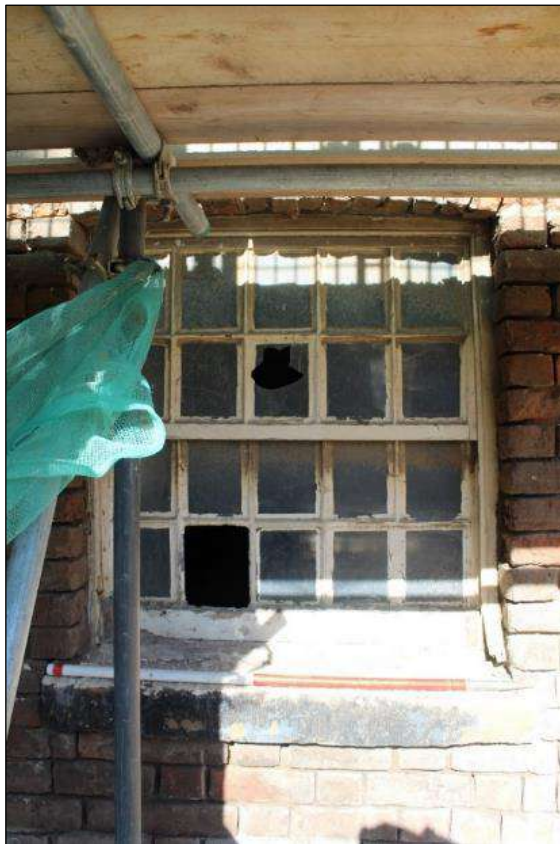
*Plate 3 (shot 4): Late Georgian window on ground floor, southeast elevation. Looking north-northwest, 1m scale*

- 6.5 The same elevation has two windows on the ground floor and five on loft level, all with stone sills. Only the ground floor has recessed, late Georgian 10 over 10 light sash windows (Plate 3).

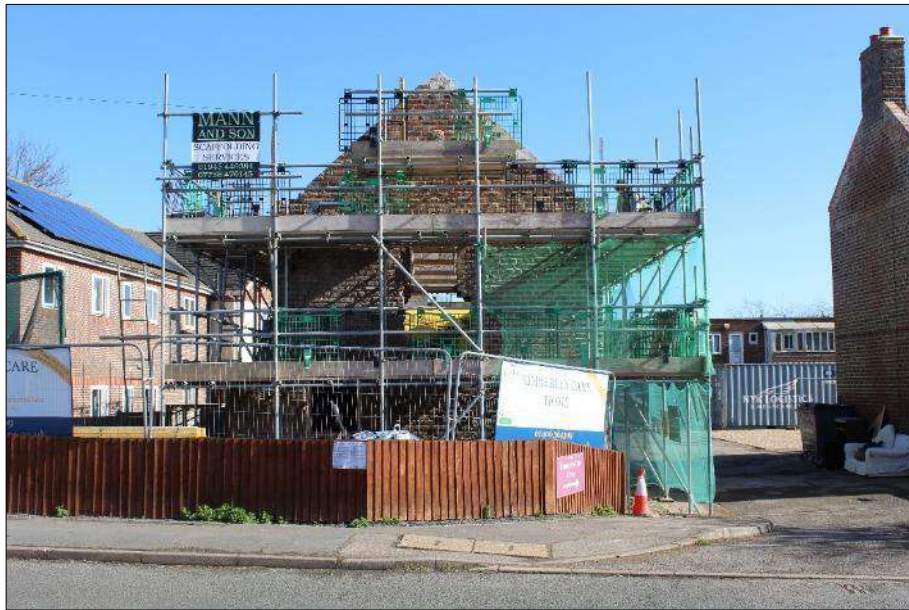
*Plate 4 (shot 10): View of the southwest elevation. Looking east-northeast*

- 6.6 Both the northeast and southwest gables have former loft openings to the granary on the first floor (Plate 4-Plate 5). There is also a window on the ground floor on the southwest elevation.
- 6.7 The northwest elevation has five window openings on the first floor, Street View shows modern two-pane casement windows (Plate 6). There are two doorways on ground floor.

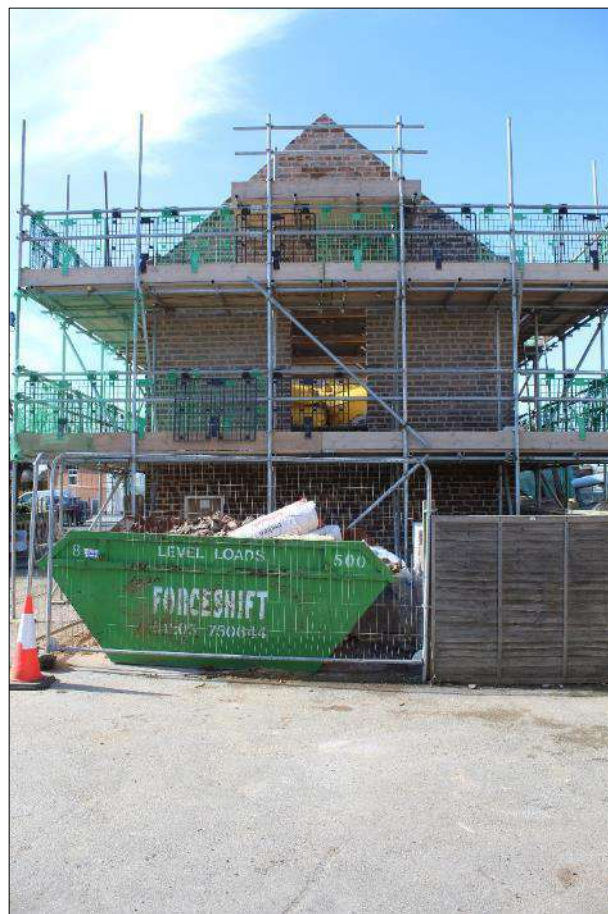
*Plate 5 (shot 24): Northeast elevation, looking west-southwest*

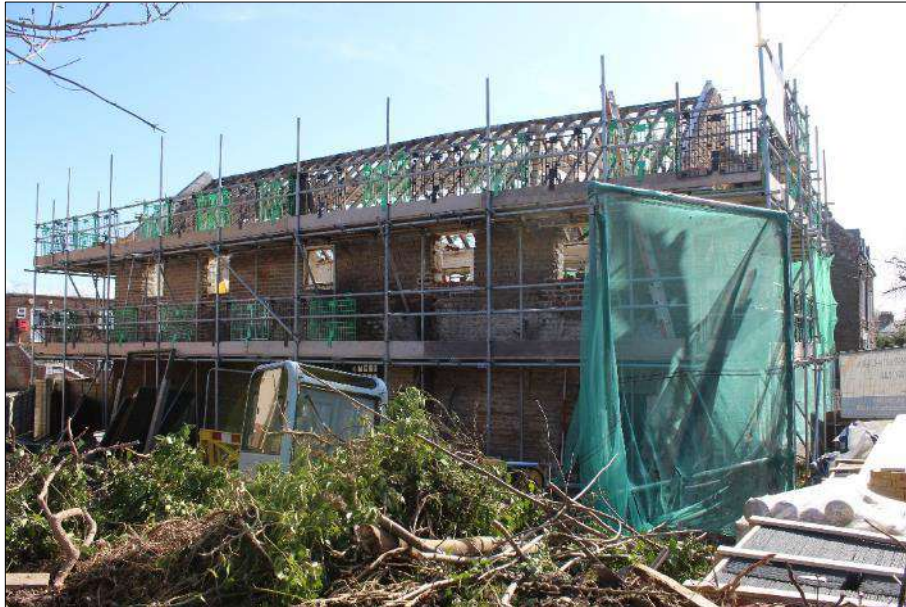
*Plate 6 (shot 18): Northwest elevation, looking east-southeast*

- 6.8 A later, single-storey brick extension with a single protruding chimney, once covered large parts of this elevation. Only a stub wall is left on the northwest corner which displays a straight joint with hand-made red bricks to the stable (Street View, Plate 7). Plate 5 from the heritage impact assessment report (Tann 2020) shows an English Garden Wall bond with three stretchers between each course of headers. Half of the roof was covered in corrugated (asbestos?) sheets whilst the other half to the northeast, was covered in slate or concrete tiles. The northeast half appeared to have later brick infill either suggesting a modification of an open shelter or a later extension.

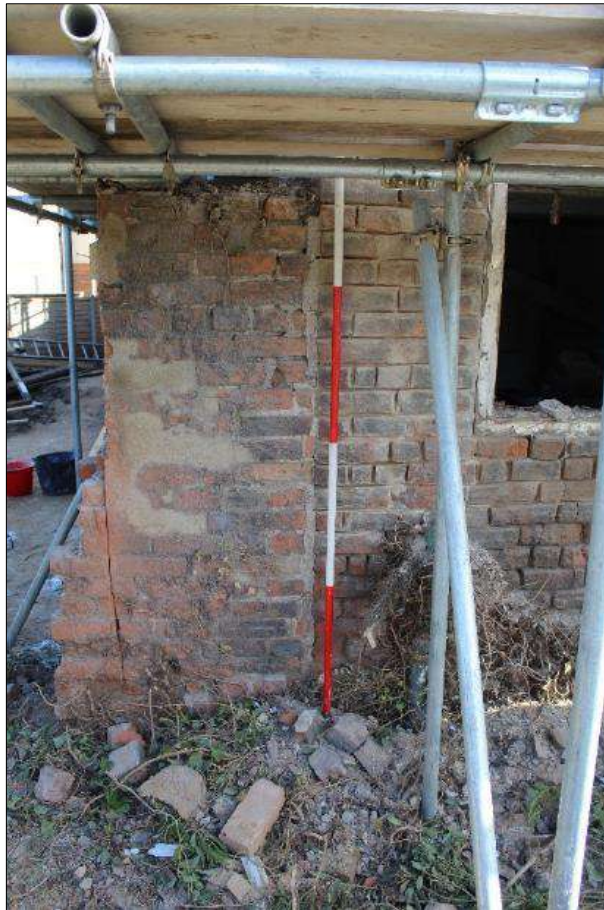
*Plate 7 (shot 16): Straight joint between former extension and the stable. Looking east-northeast, 2m scale*

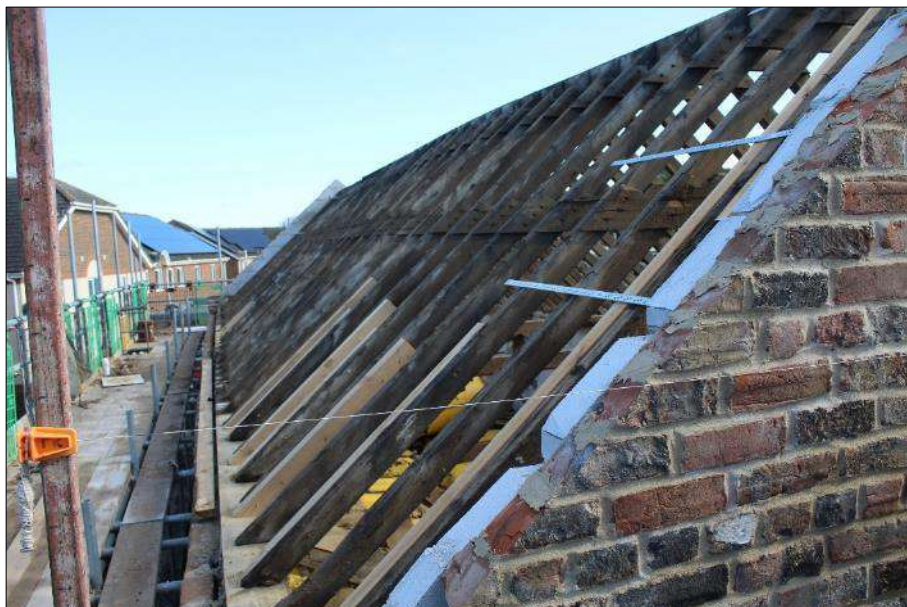
- 6.9 With the structure being covered in scaffolding and the roof covering removed, a view of the top side of the roof timbers was possible (Plate 8-Plate 9). Some of the timbers displayed axe marks from pre-processing of the timbers prior to being cut into rafters. The same timbers also showed regular kerf marks from being cut in a mechanised saw mill as opposed to criss-crossing marks from a manpowered pit saw.

*Plate 8 (shot 67): Repaired roof structure, looking east-northeast*

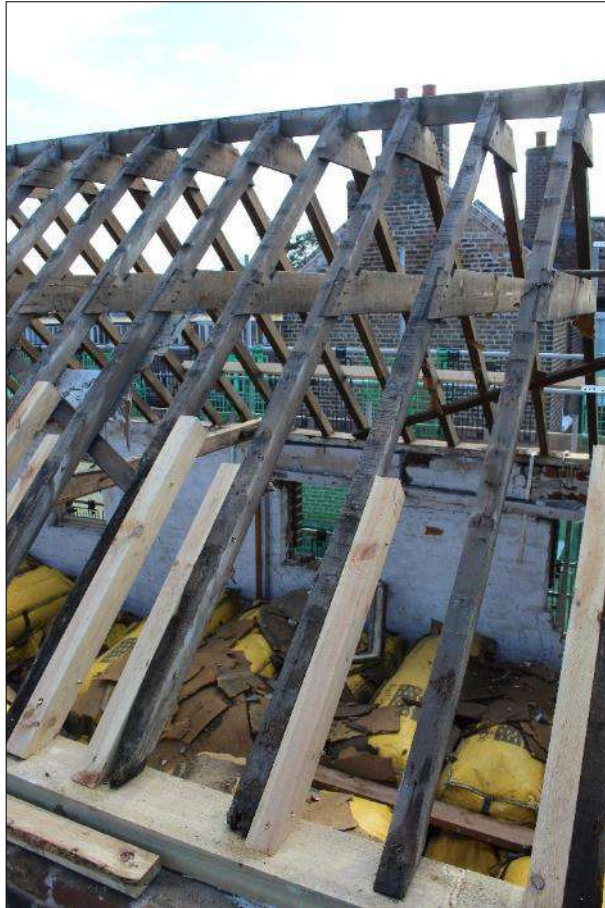
- 6.10 The common rafters are tied to a ridge plank and two collars towards the apex (Plate 9).

*Plate 9 (shot 68): Close-up of roof rafters, showing current repairs. Looking east-southeast*

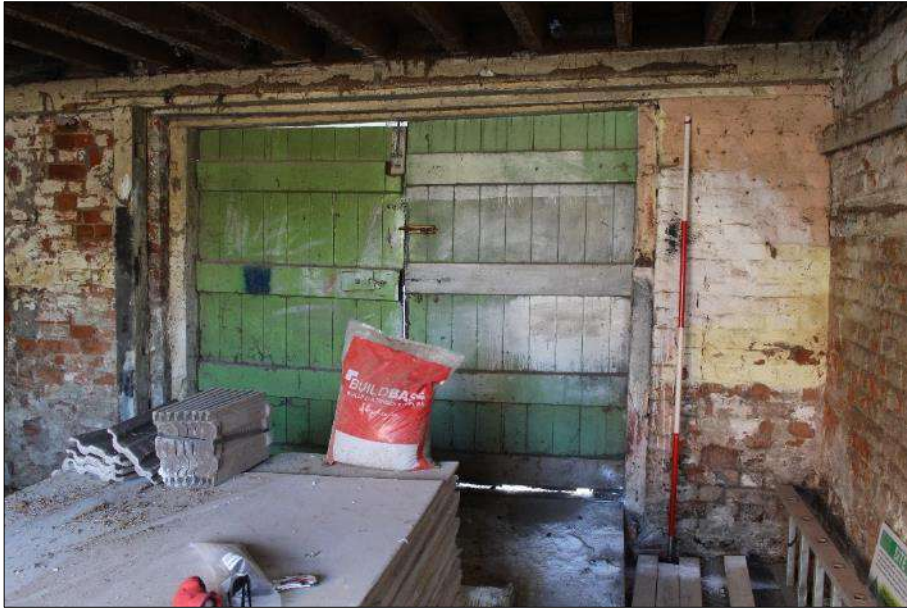
- 6.11 The ground floor has a single partition dividing it into two rooms, which may have allowed for three horses in each (Plate 11-Plate 12). The northeast room and former coach house and stable (1) measures c.9m x 4.5m and has two entrances facing the lane and a large square opening to the rear (Plate 10). A coach or gig is likely to have been stored just past the double doors with space for three stalls along the northeast or northwest wall, although this is merely hypothetical and based on the potential description of a six stall stable, as stated in the heritage impact assessment report (Tann 2020).

*Plate 10 (shot 25): Plank and batten double coach doors. Looking south-southeast, 2m scale*

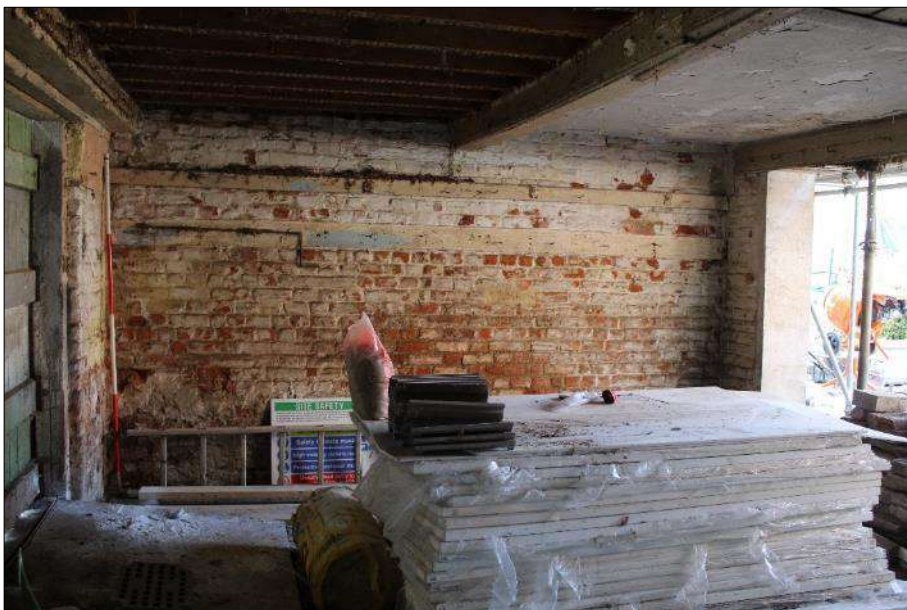
*Plate 11 (shot 26): General view of the ground floor, looking west-southwest, 2m scale*

- 6.16 A plank with nails for hangers is fixed to the partition wall (Plate 11), although it is unlikely this is an original fixture, likewise a series of hooks suspended along the main beam from a metal strap (Plate 12). There are no large, original fittings or fixtures one might expect in a stable and coach house and all stalls have been removed. A wooden post supporting a lintel above the door appears to have been reused and not found in its original position (Plate 16). It has empty

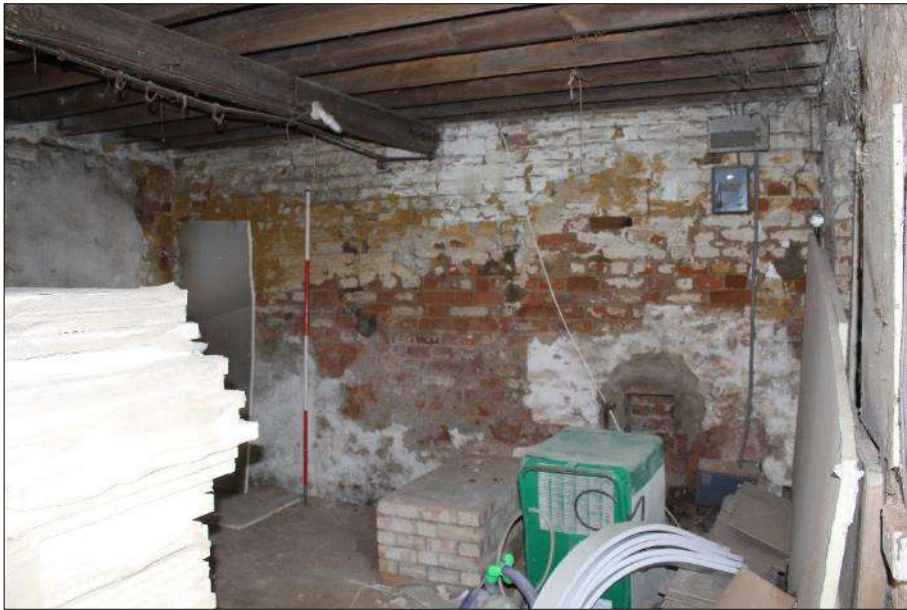
*Plate 12 (shot 28): General view of the ground floor, looking northeast, 2m scale*

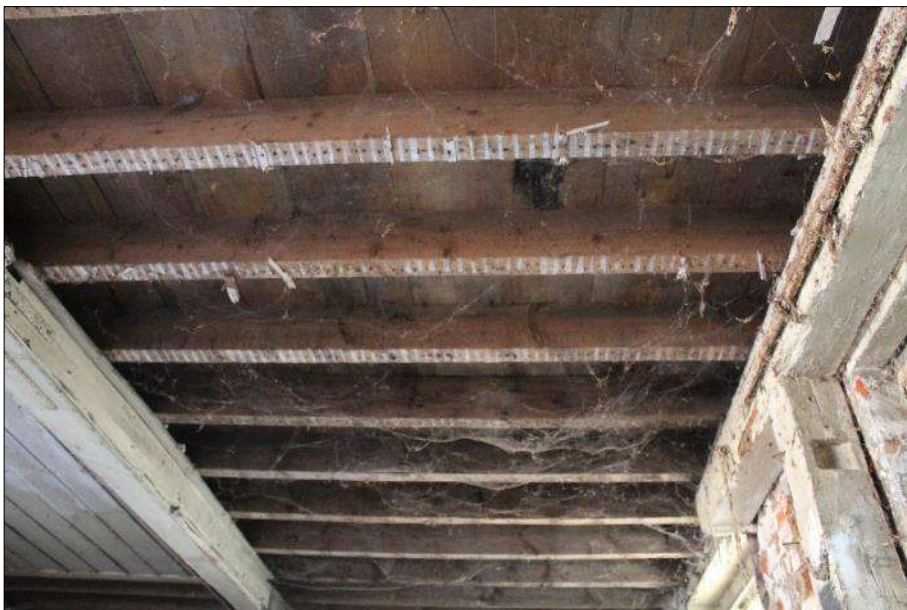
- 6.13 Part of a plastered ceiling has been retained in the northwest corner of the structure and where removed, it shows traces of former laths. Other parts, towards the northeast have a later plank board ceiling (Plate 13-Plate 14).

*Plate 13 (shot 34): Loft floor planks and joists. The latter showing traces of former laths from a removed plastered ceiling. Looking east-northeast*

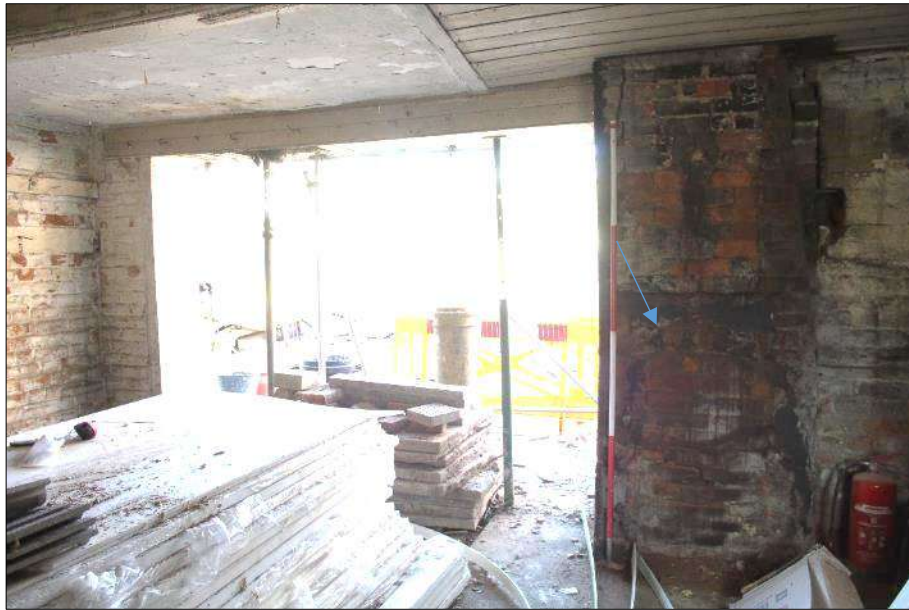
- 6.14 Along the northwest wall, adjacent to the large square opening is a blocked up former fireplace with a segmental arch. A fireplace usually relates to a harness room which apart from warming a cold coachman or groom, may have allowed to prepare mashes for the horses. There is likely to have been a second partition, presumably on the alignment of the fireplace. There is a patch of disturbed brickwork on the northeast side of the fireplace which may be the trace of such. There were no brickwork butting out from the opposing wall, suggesting if there was a partition here it did not run the full width of the structure.

*Plate 14 (shot 33): Blocked up fireplace on the northwest wall. Arrow points to segmental arch. Looking west-northwest, 2m scale*

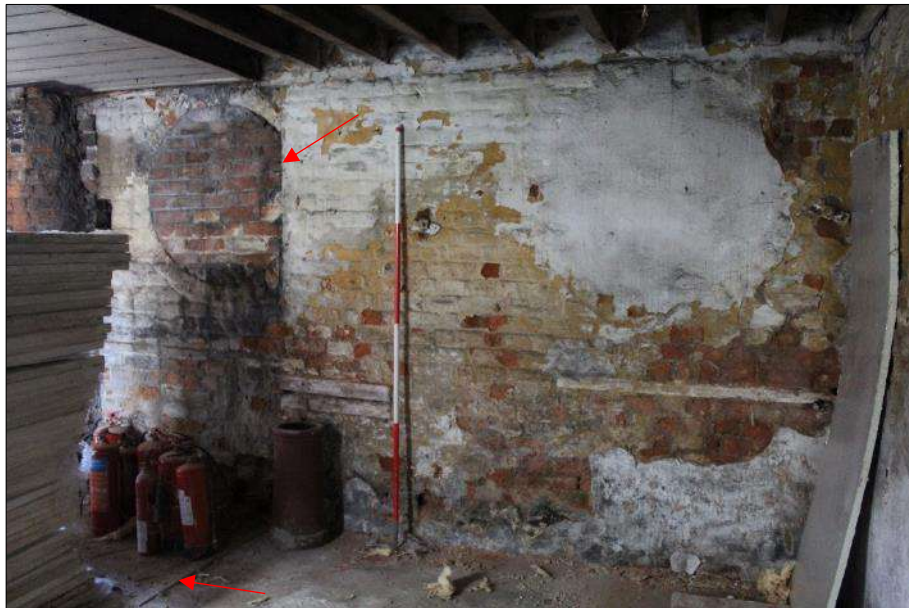
- 6.15 Along the northwest wall are also two bricked up porthole openings, often seen in stables (Plate 15). A second stud partition or former fitting was once present between the fireplace and the adjacent porthole.

*Plate 15 (shot 30): Bricked up portholes on the northwest wall, arrows point to area of former partition or fixture. Looking west-northwest, 2m scale*

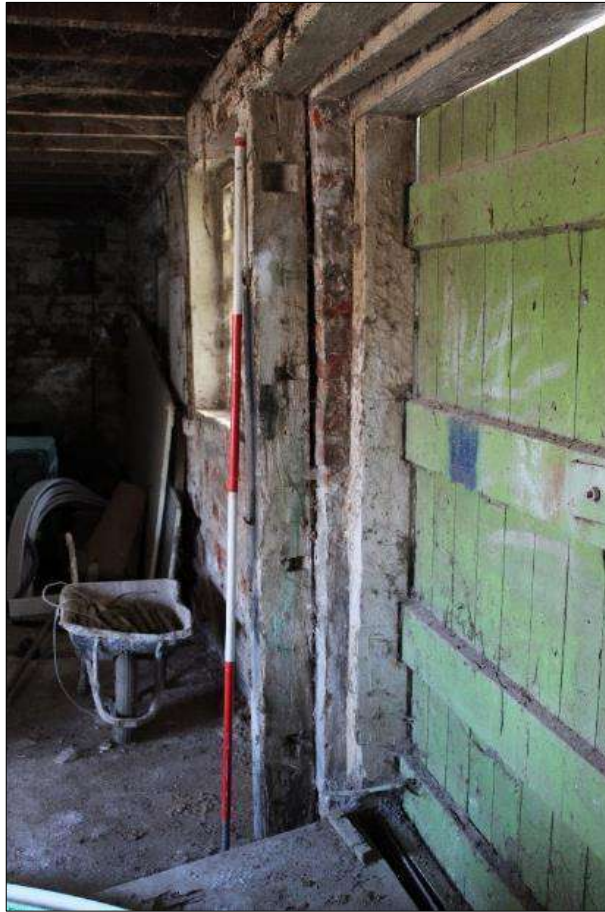
mortices that could have allowed for sturdy pegs from which harnesses and other tackle might have been hung.

*Plate 16 (shot 35): Post (reused timber) with empty mortices. Looking east-northeast, 2m scale*

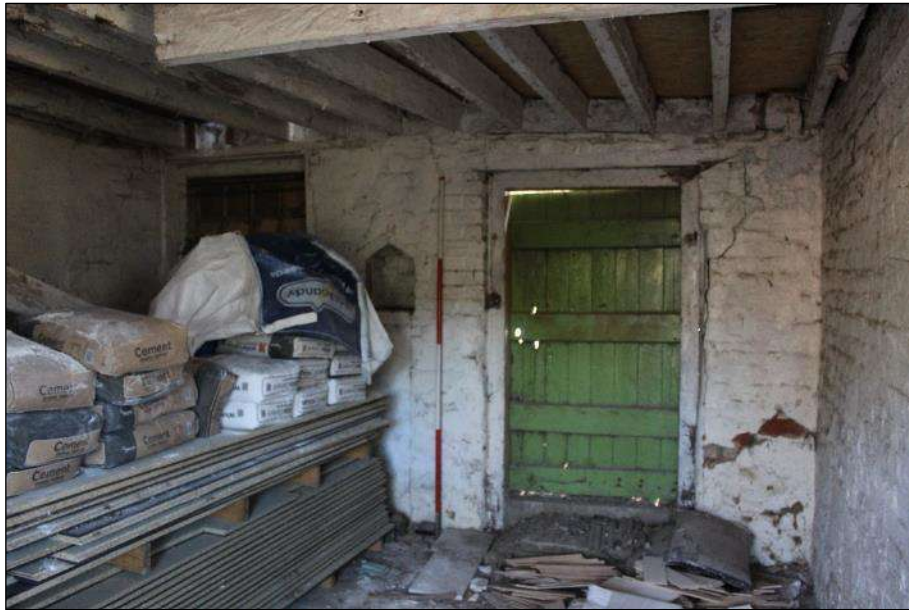
- 6.17 The southwest room measures approximately 4.5m x 4m and has one entrance facing the lane and another to the rear. The former is fitted with a plank and batten door which is hung on strap hinges on the outside. With a passageway running along the southwest wall, any stalls would have been positioned along the northeast partition. There is just enough room to allow for three horses although two would have been more ideal according to *Mrs Beeton's Book of Household Management* from the late 19<sup>th</sup> century (Beeton, 1861). Between the door and the window is a small irregular pentagonal niche. Small niches are commonly found in stables as well as in cart sheds and were used for holding a light or medicine, curry combs for horses or lubricants and tools for carts and waggons (Peters 1981).

*Plate 17 (shot 38): General view of the southwest room. Looking south-southeast. 2m scale*

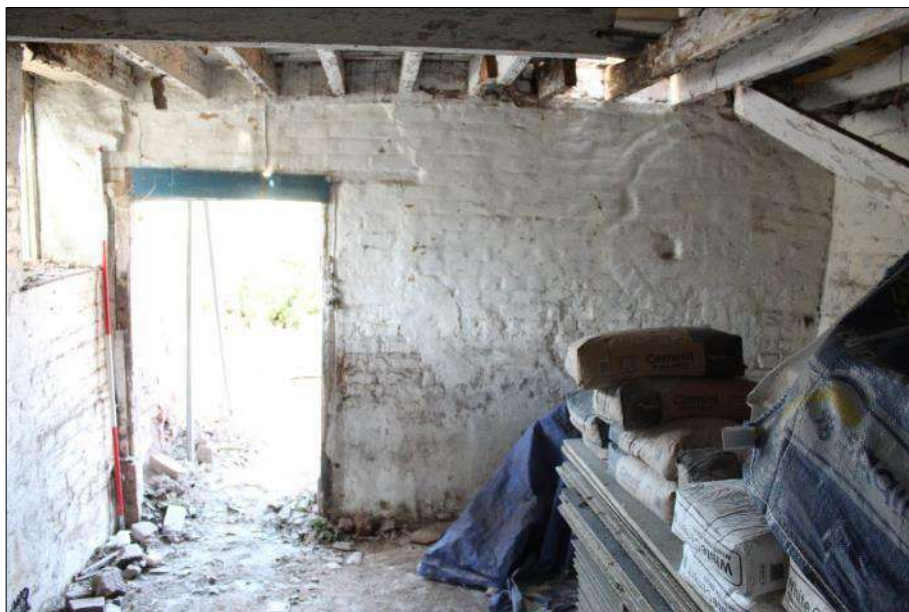
- 6.18 Part of the walls are rendered and all are white painted. The floor is covered in debris making it impossible to see what lay beneath. All floor joists from the loft above are white painted and some have recently been cut, presumably to be replaced (Plate 18). There were no indications of a former staircase or hatch in the ceiling. On the northwest wall is a bricked-up porthole window as also seen in the adjacent room.

*Plate 18 (shot 45): General view of southwest room showing bricked up porthole window. Looking north-northwest, 2m scale*

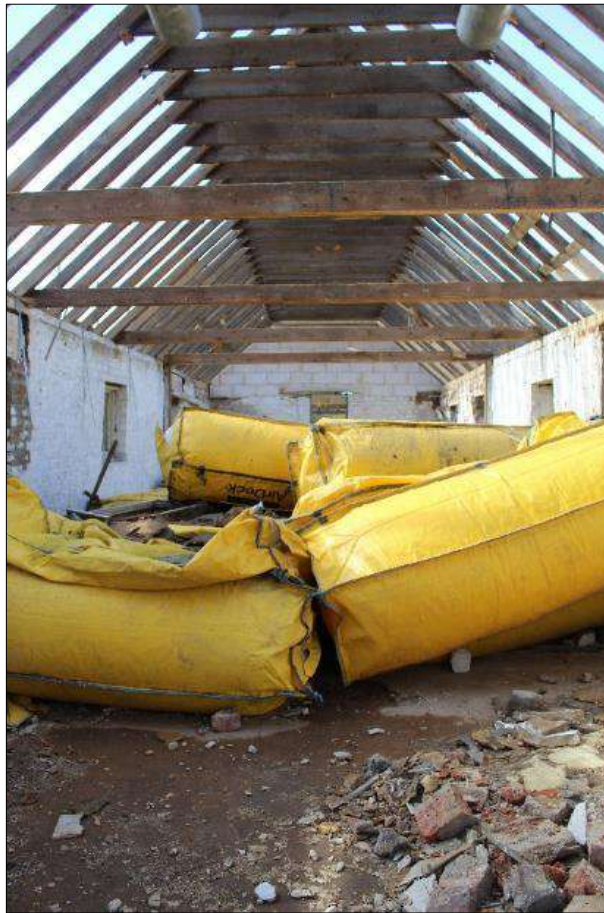
- 6.19 The loft was largely covered in building material which limited the survey. It has no partitions as seen on ground floor, nor could any traces of such be observed in the remaining building material (Plate 19-Plate 20). As no evidence of a staircase could be found within the structure the access may have been from the exterior, on the northeast and/or southwest elevation.

*Plate 19 (shot 54): General view of the loft. Looking west-southwest*

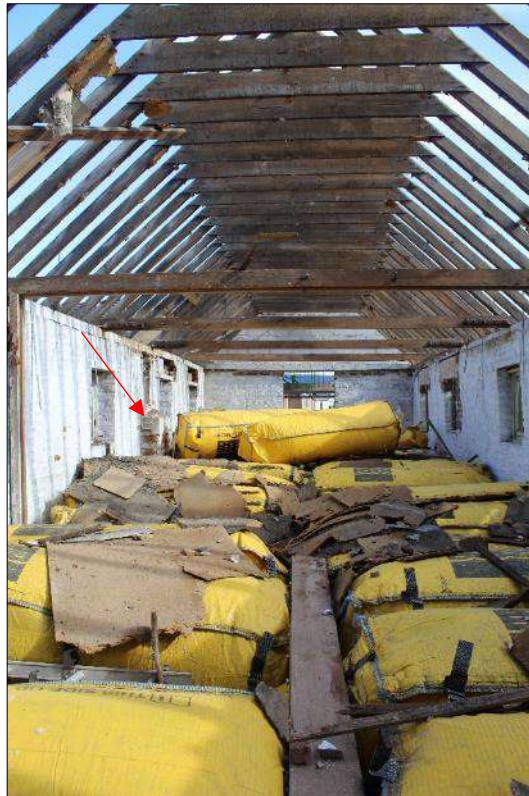
- 6.20 The window lintels have been reinforced during the latest work and breeze blocks raised along the inner skin of bricks on the southwest gable. Part of a chimney breast is seen along the northwest wall and aligns with the fireplace below.

*Plate 20 (shot 62): General view of the loft, arrow points to remains of a chimney breast.  
Looking east-northeast*
