## **CONTAMINATION INVESTIGATION REPORT**

**PEAR TREE FARM**  
**ST JAMES ROAD**  
**LONG SUTTON**  
**LINCOLNSHIRE**

**Report Reference C15075**

**PROPOSED RESIDENTIAL DEVELOPMENT**

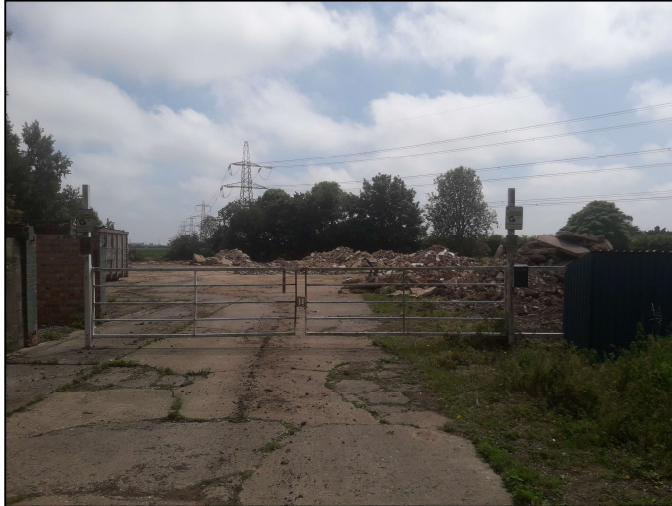
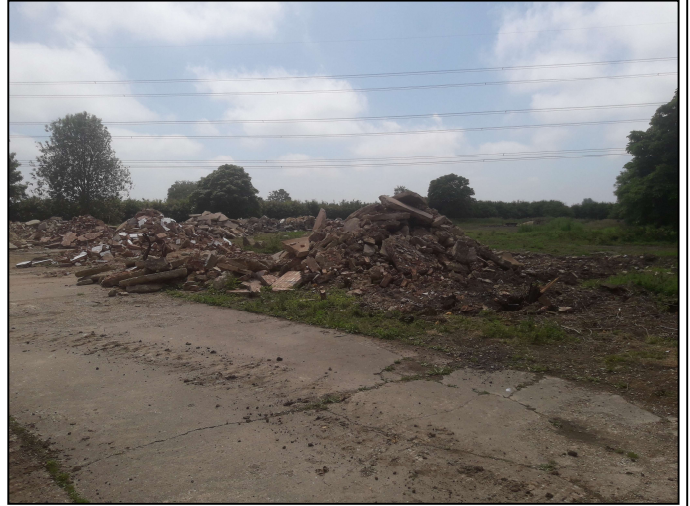
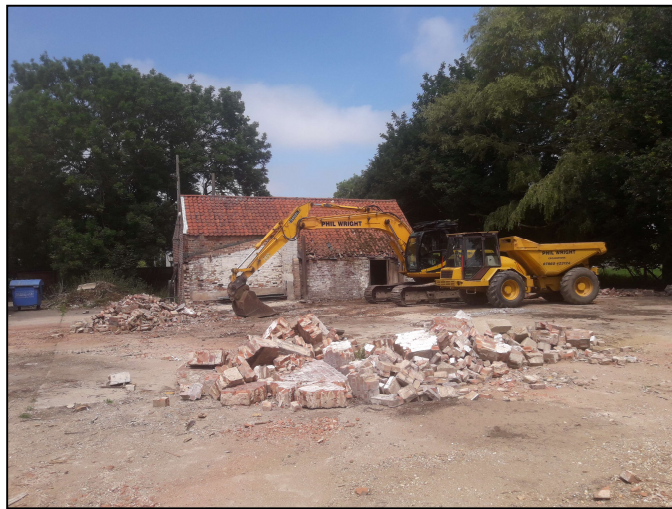
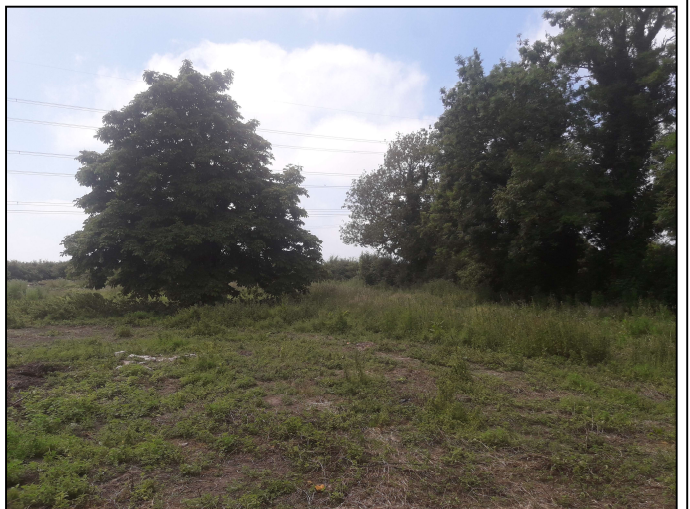
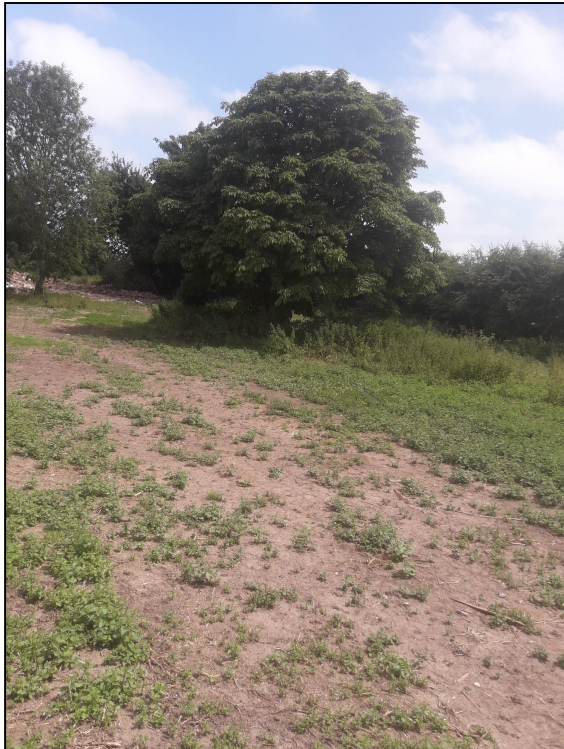
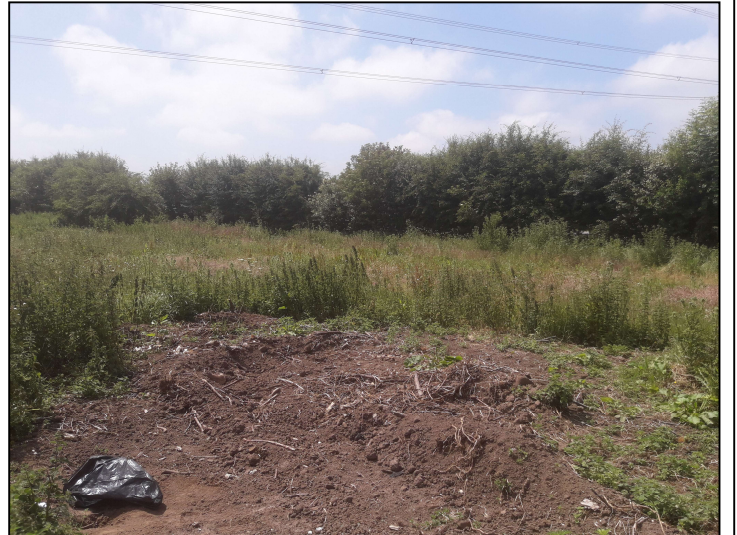
## Site Photographs

At the time of the investigation in June 2020, the eastern part of the site contained a concrete surfaced yard area with piles of broken concrete from recent demolition and a couple of brick outbuildings. A demolition contractor's excavator and skip were also present in this area. The western part of the site was generally grassed with occasional mature trees including Horse Chestnut and Ash. Trees and hedgerows were present along the site boundaries, which included Ash, Sycamore and Field Maple amongst others. Overhead power lines cross the extreme western tip of the site.
