Appendix 2 – Screening Assessment Form (Version 10.3)

Site Name	Broadwater Farmyard			
Site Address	Broadwater Lane, Moulton, Spalding, PE12 0XX.			
Site Grid Reference	Easting	530810	Northing	320924

HISTORIC STUDY FOR YALPAG ASSESSMENT

SITE PHOTOGRAPHS FOR YALPAG ASSESSMENT

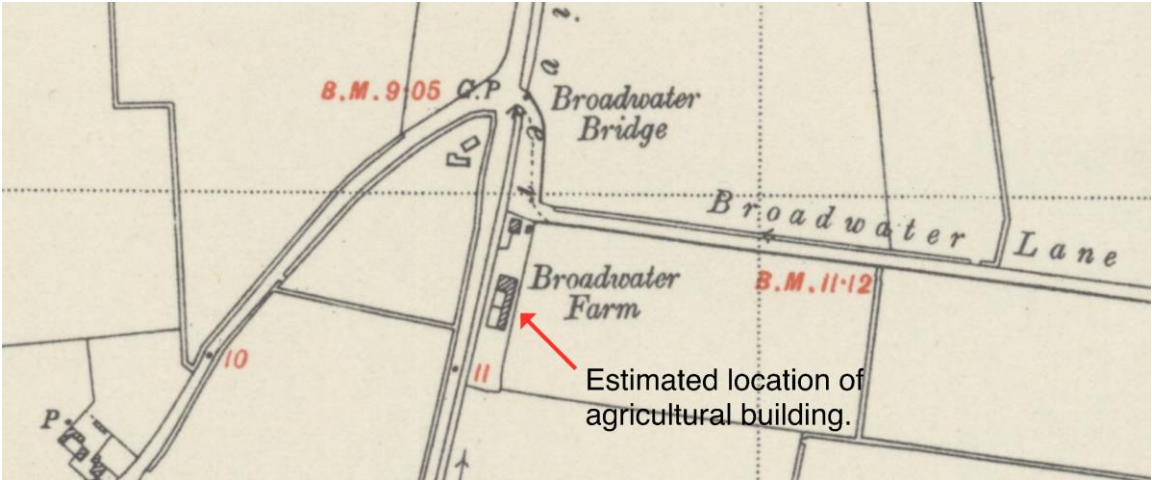
Fig. 3 Ordnance Survey map of 1938

The 1938 map shows the same details for this site as the 1903 edition. It is noted that additional buildings are now present on the west side of Engine Bank, north-west of this site.

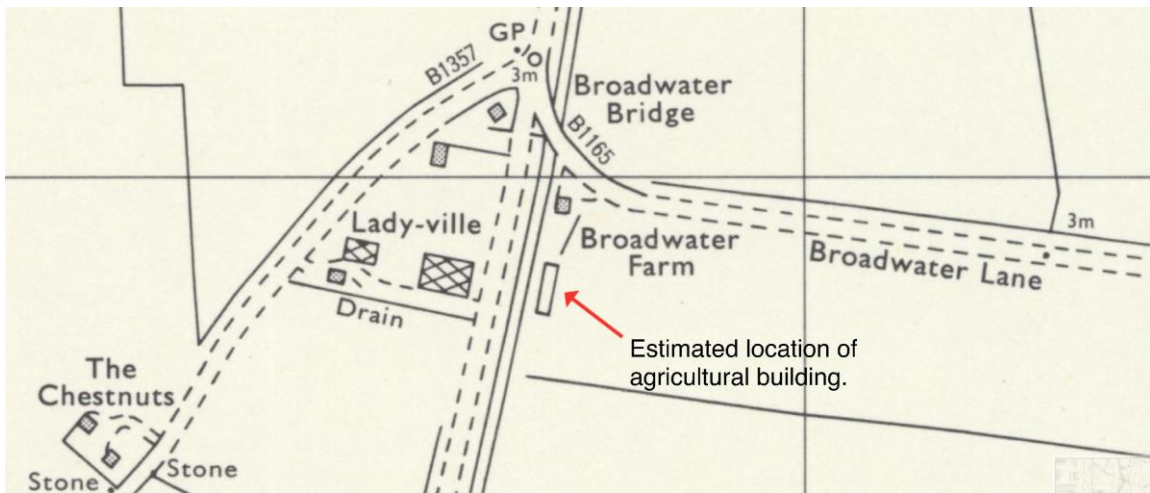
Fig. 5 Ordnance Survey map of 1971

The 1971 map is at smaller scale than some of its predecessors and consequently there is less detail. Buildings are depicted as rectangles rather than reflecting actual footprint shape. Consequently, it is not easy to accurately interpret changes that may have occurred. To the west of the site, a further residence 'Lady-Ville' is now recorded on the map and appears to have glasshouses along its south side. There is a further block north of this, which again appears to be a separate residence. The three small structures at the north end of the barn site now appear as a single block, though whether this accurately reflects development on site cannot be concluded. The site of the existing barn now shows a simple rectangle. This could indicate that the earlier barn and range has been demolished in favour of a simpler structure, though there is no further evidence to corroborate this.

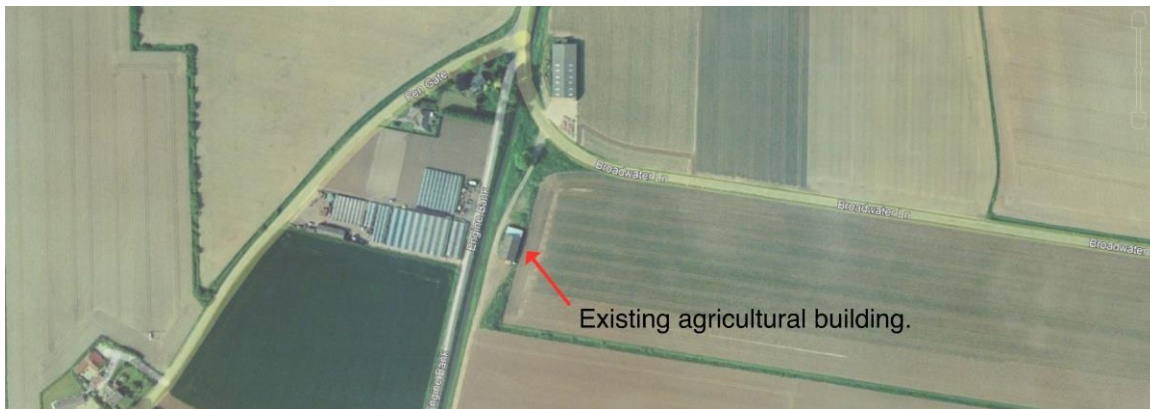
Fig. 6 Aerial photo from approximately 1999

The 1999 image shows the barn as it exists in 2023. The agricultural shed to the north of Broadwater Lane is now evident, as are the dwellings west of Engine Bank. 'Lady-Ville' now has a larger expanse of glass houses, again west of the Moulton River.

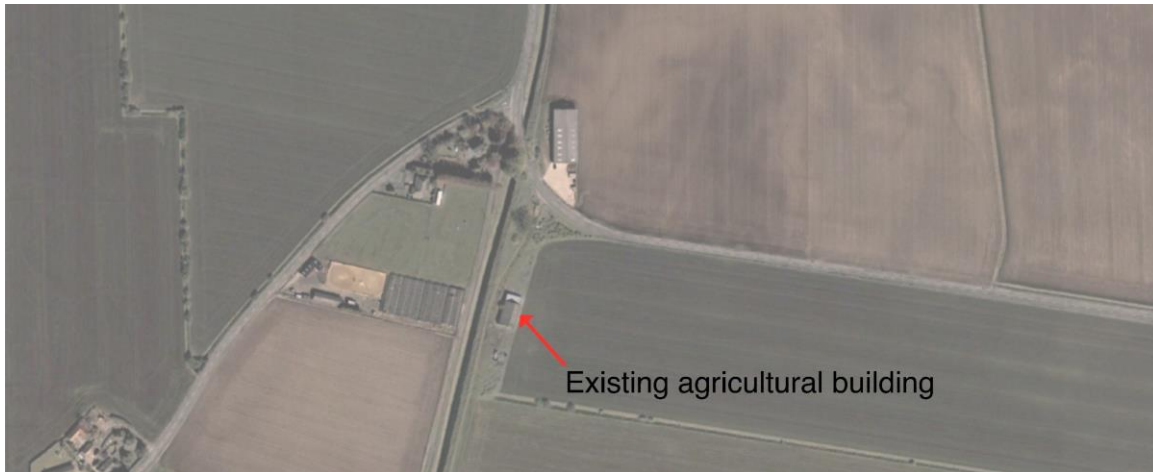
Fig. 7 Aerial photo from approximately 2004

The 2004 image is largely the same as that from 1999 except that some of the glasshouses at 'Lady-Ville' appear to have been removed. The proposed development site is unchanged.

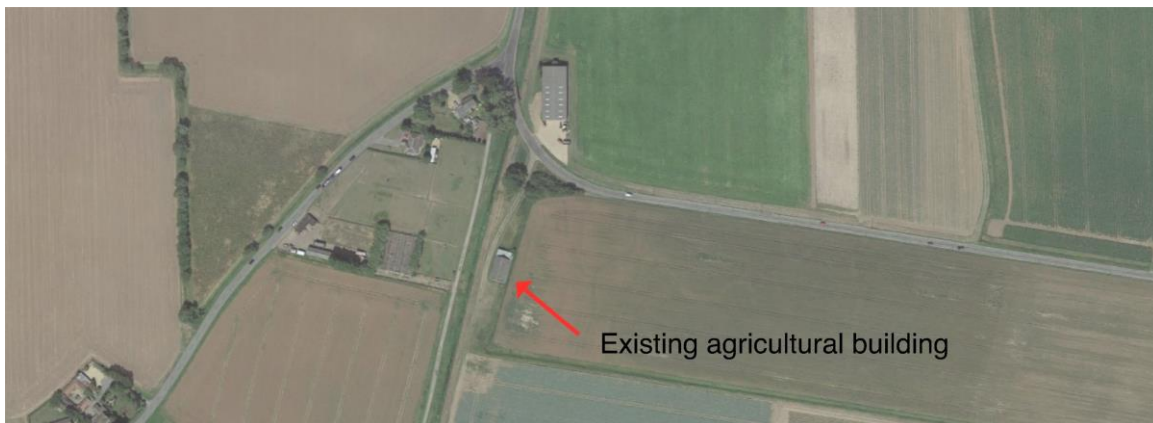
Fig. 8 Aerial photo from approximately 2020

The 2020 image is largely the same as that from 2004 except that the agricultural use of 'Lady-Ville' appears to have reduced, with a large area now used for grazing animals. The proposed development site is unchanged.

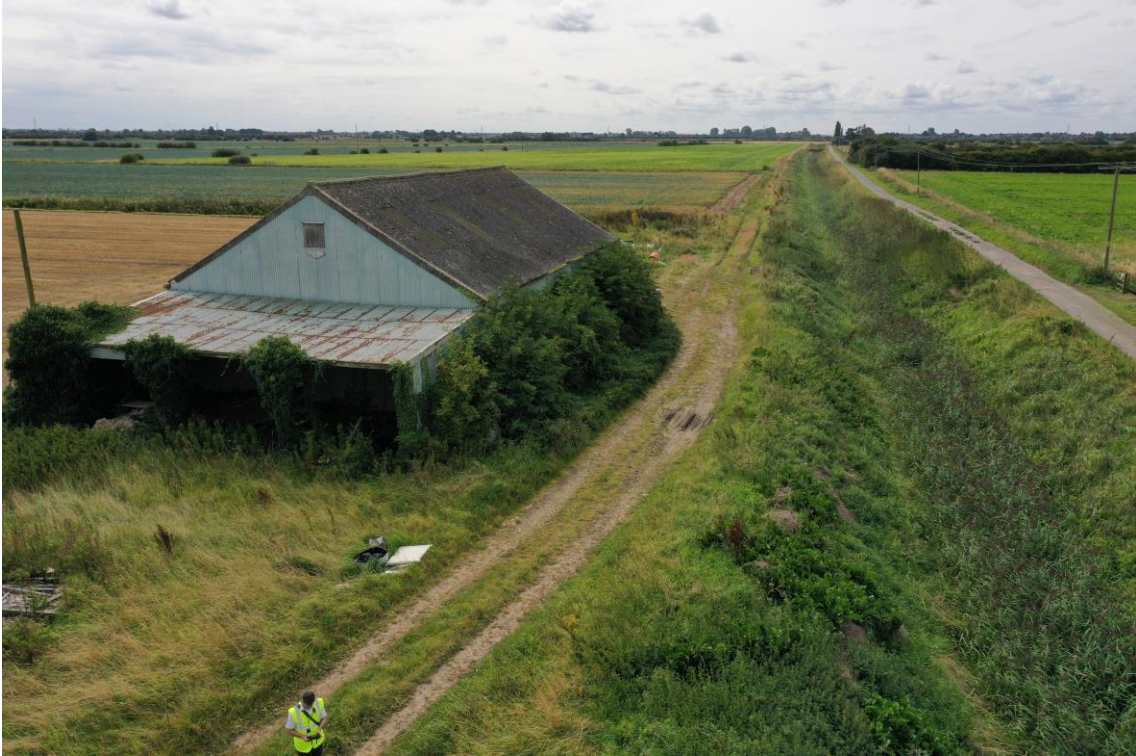
Ph. 1 View of barn from north-west showing the Moulton River on the right hand side.

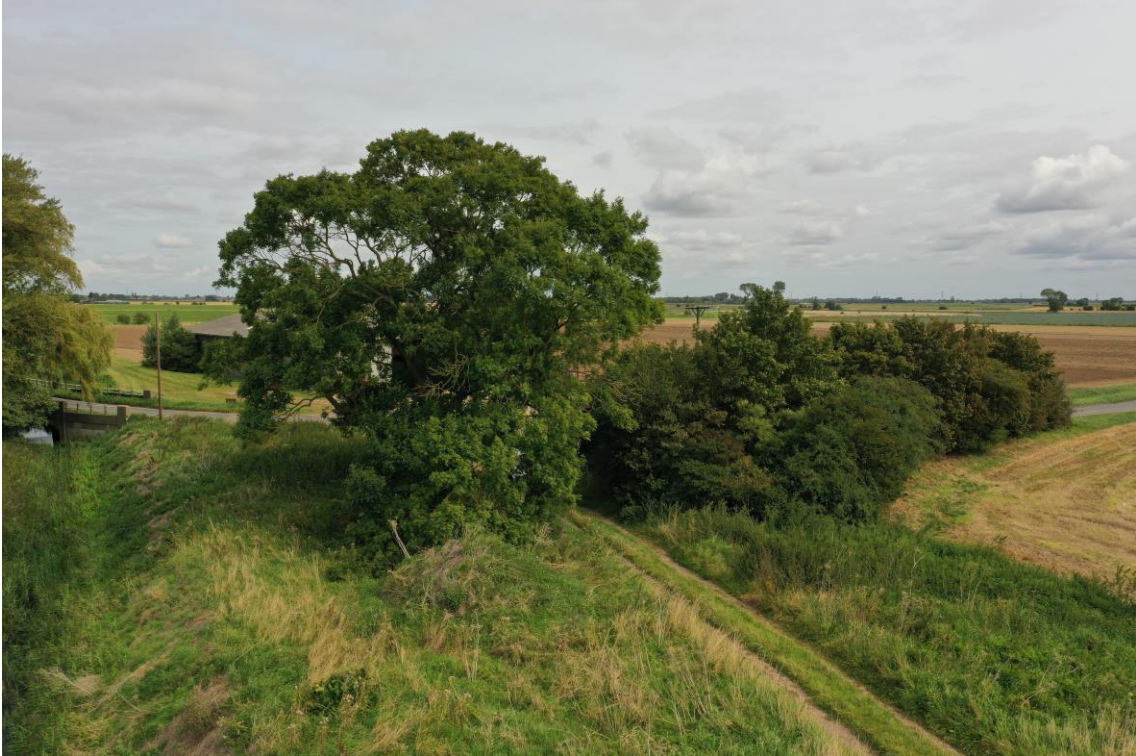
Have any waste disposal activities (including the burning of waste) been carried out onsite?	Yes <input type="checkbox"/>	No <input checked="" type="checkbox"/>
Have any waste disposal activities been carried out on surrounding land within 250 metres of the site?	Yes <input type="checkbox"/>	No <input checked="" type="checkbox"/>
Is there any evidence of demolition activities (e.g. rubble) onsite?	Yes <input checked="" type="checkbox"/>	No <input type="checkbox"/>
If 'Yes' to any of the above, please provide details.	Building rubble present from former cottage at north end of site.

Ph. 2 View of the north end of the site, the building rubble is the mound in front of the largest tree.

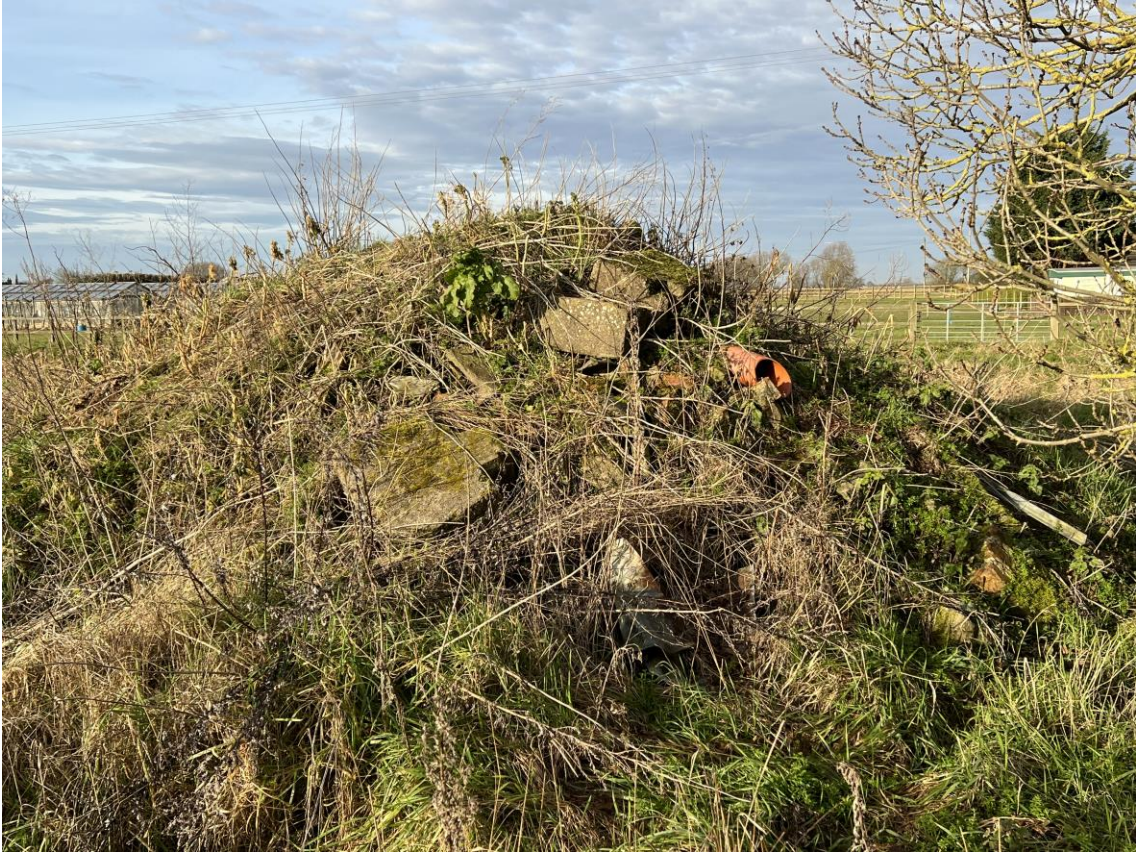
The site is generally surfaced with grass with a grass track running along the west side, giving access to the barn and field beyond. An historic map study has indicated that the site was developed prior to 1887. The map resource from 1887 indicates a barn with possibly stables or cow sheds in the vicinity of the current barn. There are no remnants of this earlier structure visible. The north end of the site accommodated a dwelling, the layout of which appears to have changed over the course of the 20th Century. There is a pile of building debris (brick etc) at the north end of the site which appears to be all that remains.

Ph. 3 Detailed view of the pile of building rubble at the north end of the site.

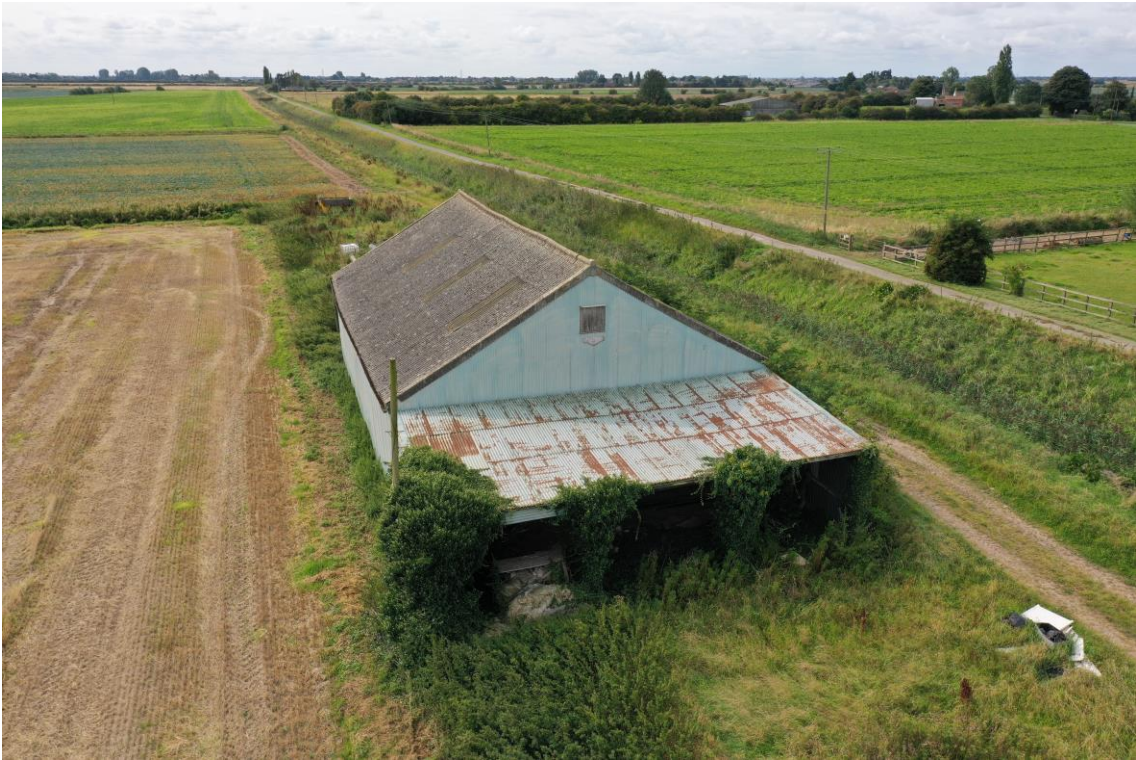
The building and claddings are generally in reasonable order.

Ph. 4 General view of the barn showing surrounding agricultural land.

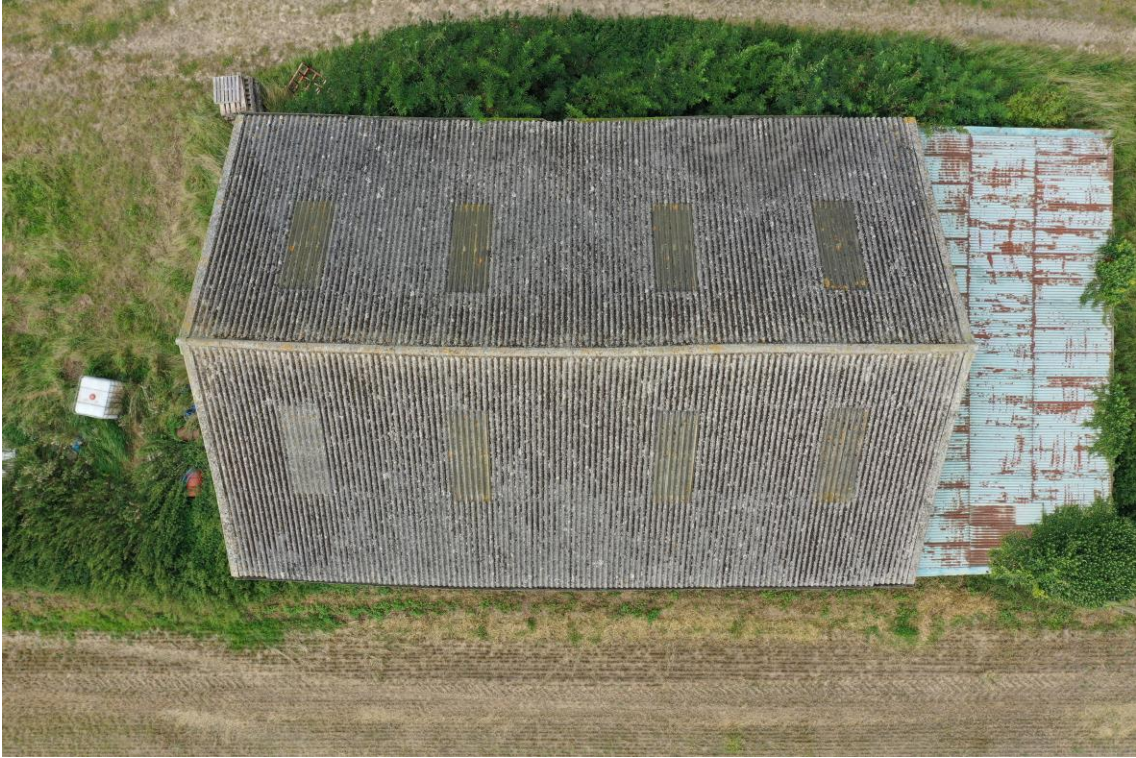
The site contains an agricultural shed comprising a main block, with a lean-to at the north end, which totals approximately 299m² in area. There is are no visible signs to indicate subsidence, nor made ground. The walls of the shed are finished in steel sheet cladding and the roof and rainwater goods appear to be of cement fibre construction (possibly containing asbestos).

Ph. 5 Aerial view of the barn showing suspected ACM to the roof.

Are any of these buildings constructed from suspected asbestos containing material? (including cement sheets, gutters, drainpipes, lagging and insulation)	Yes <input checked="" type="checkbox"/>	No <input type="checkbox"/>
If any buildings are constructed from suspected asbestos containing material, please state whether an asbestos survey has been carried out and whether the material will be removed as part of the development.	To date an asbestos survey has not been undertaken, though it is suspected that the roof coverings and rainwater goods will be found to contain Chrysotile. A survey will be undertaken before any of the material is disturbed. Any ACM will be removed appropriately.

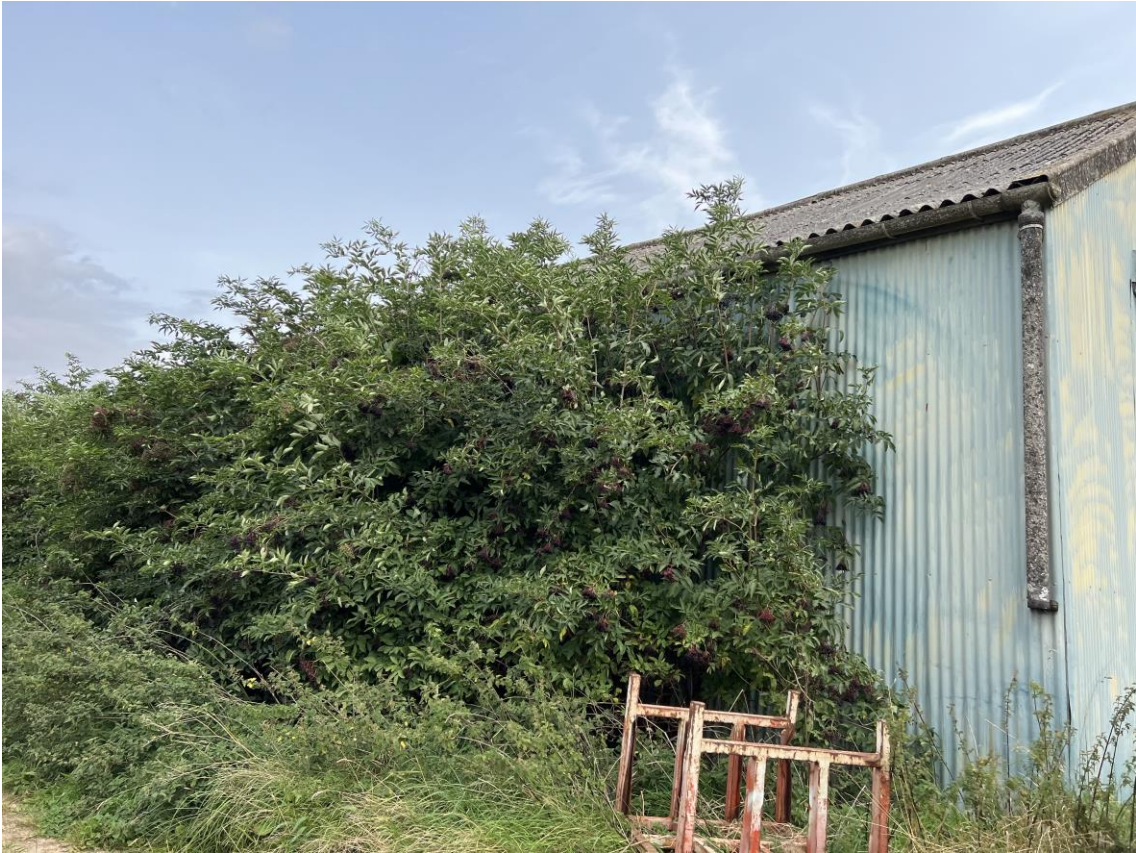
Ph. 6 Side view of the barn showing suspected ACM to the rainwater goods.

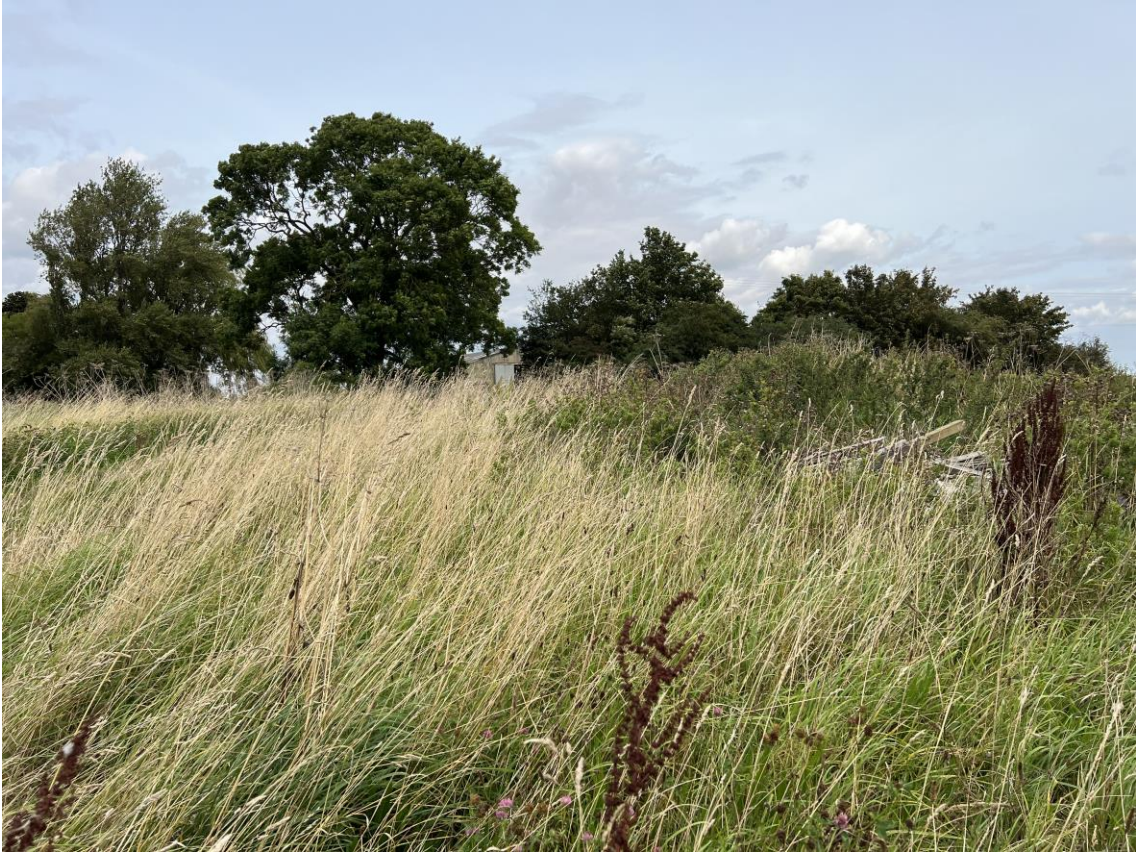
Ph. 7 General view of the site showing vegetation.

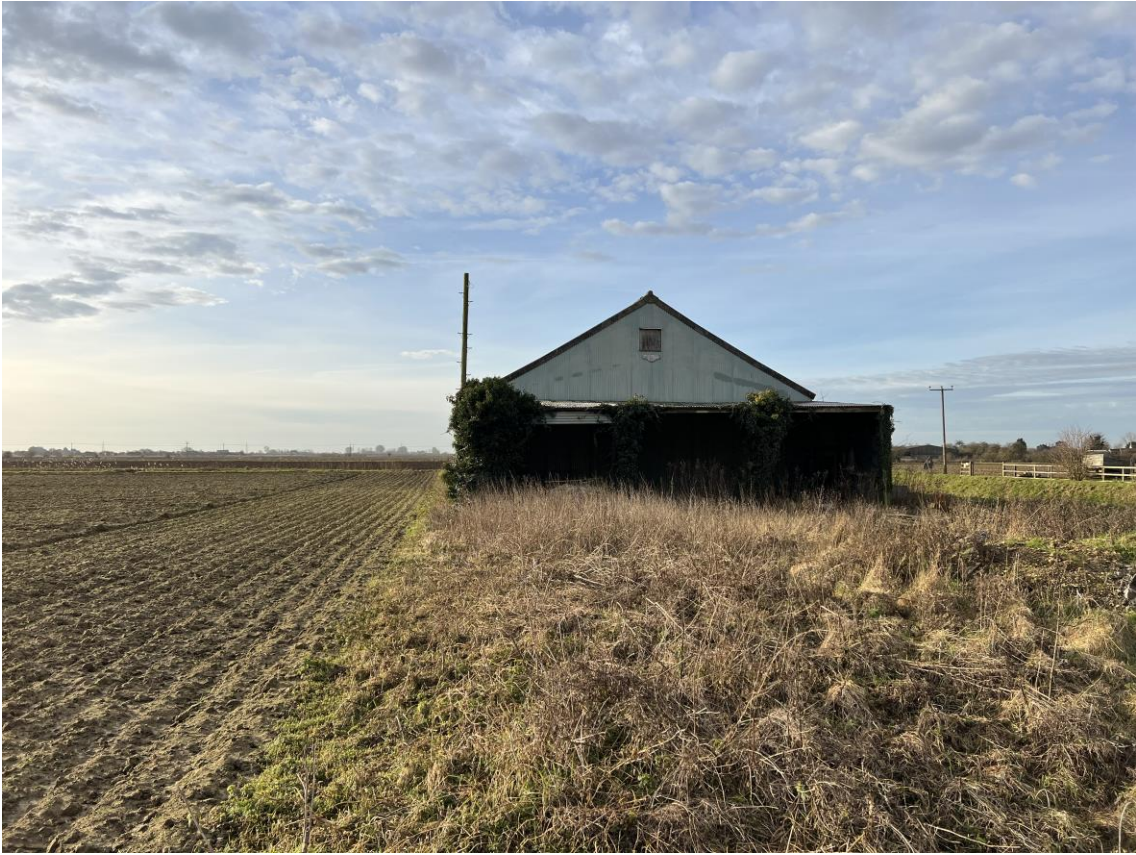
Ph. 8 General view of the site showing vegetation.
