## **HERITAGE IMPACT ASSESSMENT – WEST PINCHBECK PARISH CHURCH**

Site Address: The Parish Church of St Bartholomew,  
Six House Bank,  
West Pinchbeck,  
SPALDING  
Lincolnshire PE11 3UD

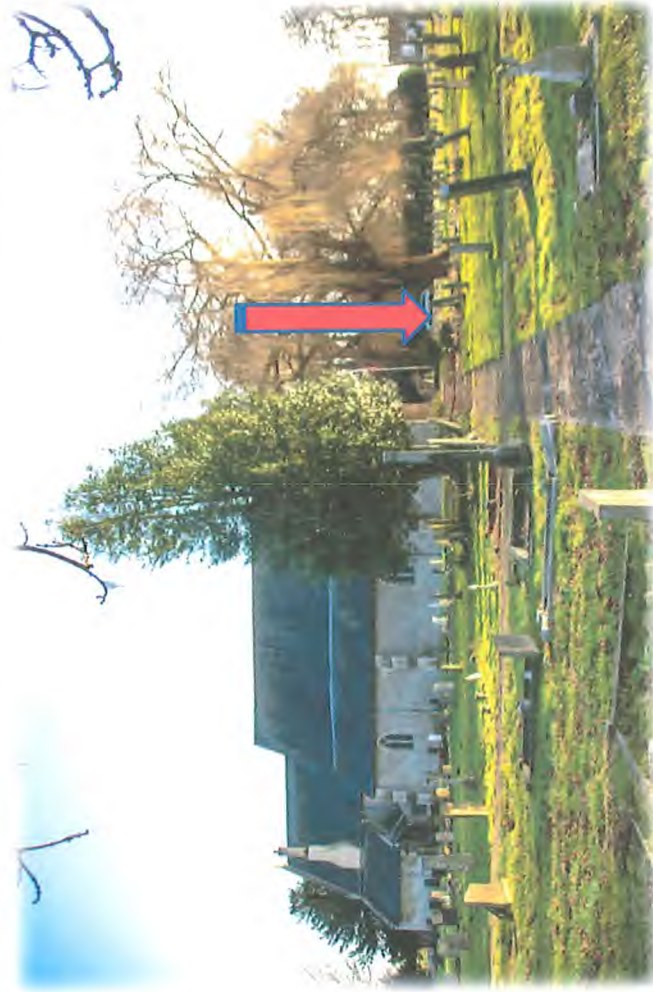
**Figure 1: View of Church grounds from the northern boundary.**

The position of the western cremated remains area is indicated by the arrow.

While a sight line exists, the cremated remains area is largely hidden by churchyard vegetation.

The monuments and path within the cremated remains area are at ground level making them difficult to see at distances beyond ten metres.

All works (pathways and flat memorial slabs) are to be situated at or below ground level and will have no impact on the appearance of the church building as viewed from the nearest public highway (Figure 5), the churchyard boundaries (Figures 1, 3 and 7) or indeed from the majority of the churchyard (Figures 1, 3, 5 and 7).

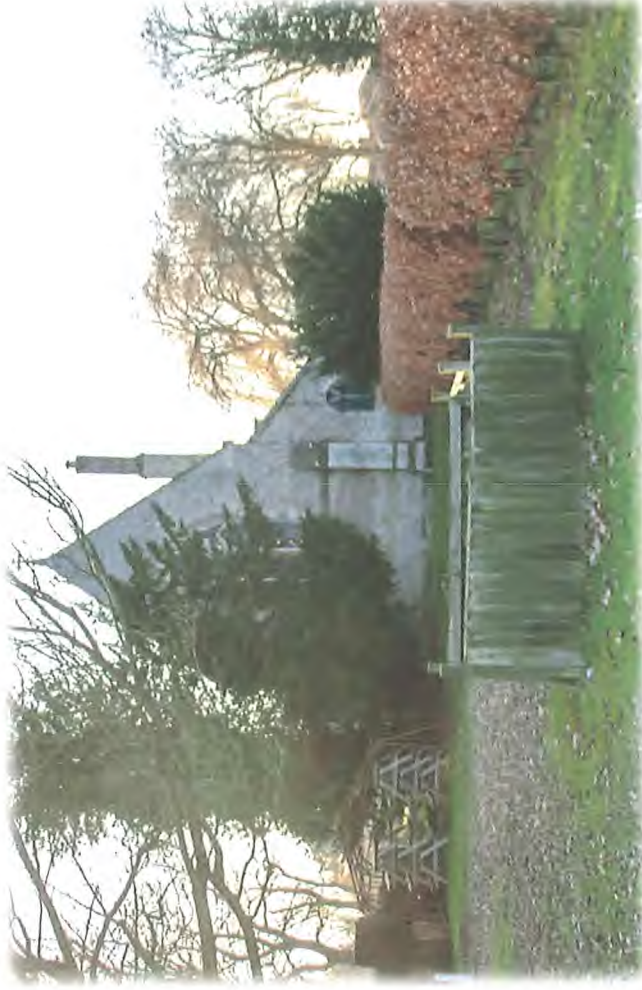
**Figure 4: View from the Churchyard boundary looking East.**

The land to the east of the Churchyard is open farmland, with a small copse providing wildlife habitat to the left.

Along the horizon houses and trees mark the course of the nearby River Glen.

The wooden enclosure is a service point for caravans, which occasionally pitch on the grassed area in Figure 4 below.

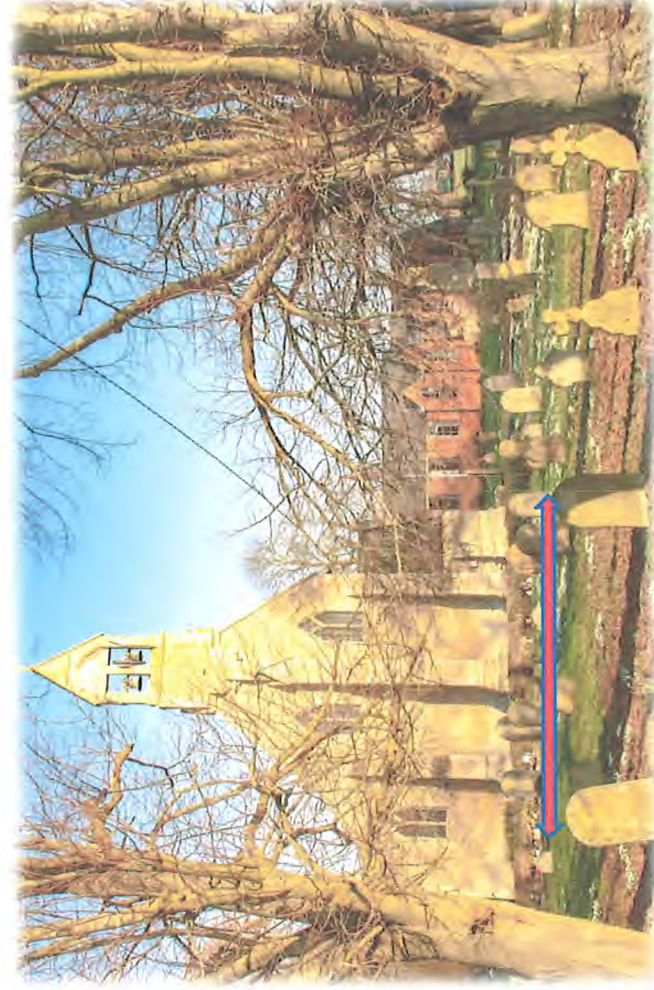
**Figure 5: View of Church grounds from the Eastern boundary.**

This photograph is taken from the public highway, Six House Bank, looking towards the Church building. The Village Hall (former Schoolhouse) can be seen to the immediate right of the Church building, though at a greater distance.

The western Cremated Remains Area (indicated in red) runs along the foot of a low retaining wall to the immediate west of the Church building.

The pathways and monuments constituting the cremated remains area, being flush with the ground, are not readily visible even from the western church boundary.

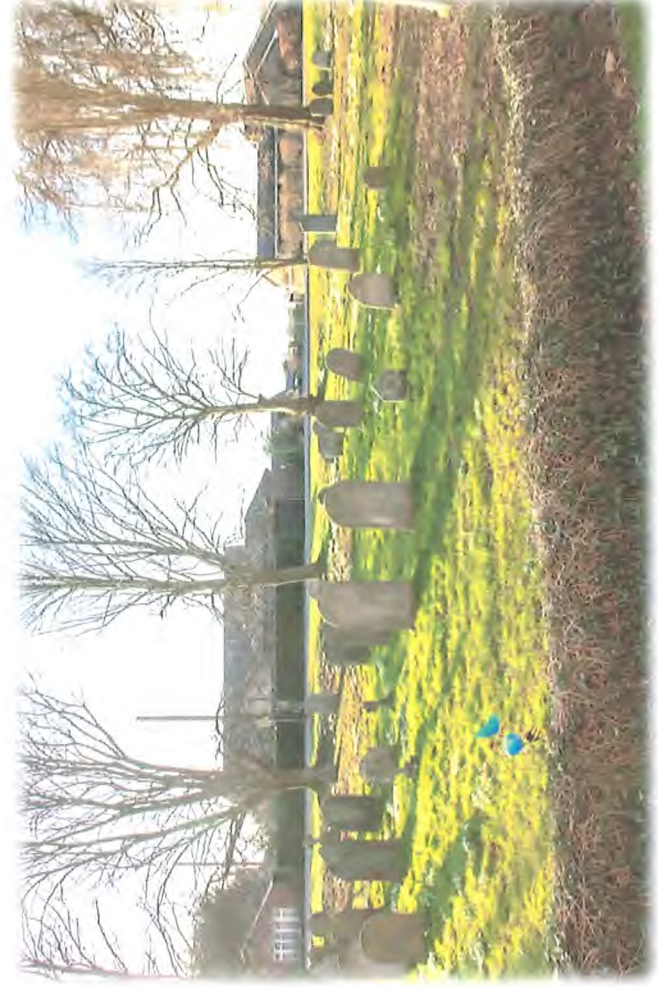
**Figure 6: View of Church grounds from the Eastern boundary.**

The Eastern boundary of the Churchyard is a public highway – "Six House Bank". Residential buildings line the western boundary of the public highway.

The low retaining wall in the foreground masks the western Cremated Remains Area.

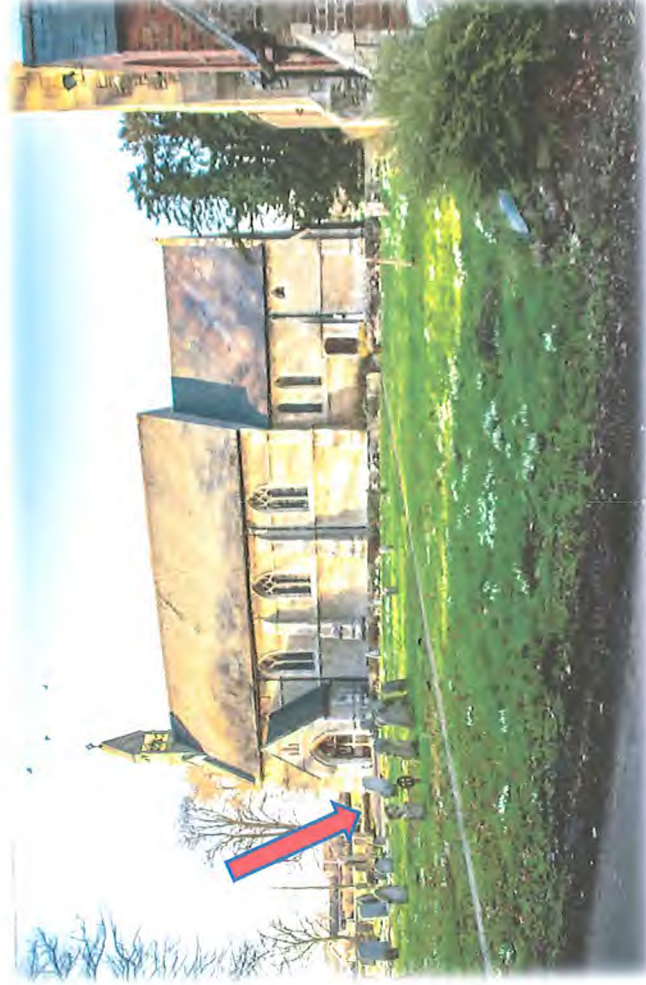
**Figure 7: View of the Church building from the eastern Churchyard boundary.**

The Church building and, at the right edge of the frame, the end of the former Schoolhouse (now Village Hall).

The arrow indicates the location of the proposed extension to the Cremated Remains area.

Due to the low retaining wall at the west end of the church building, there is no direct line of sight from this part of the Churchyard.

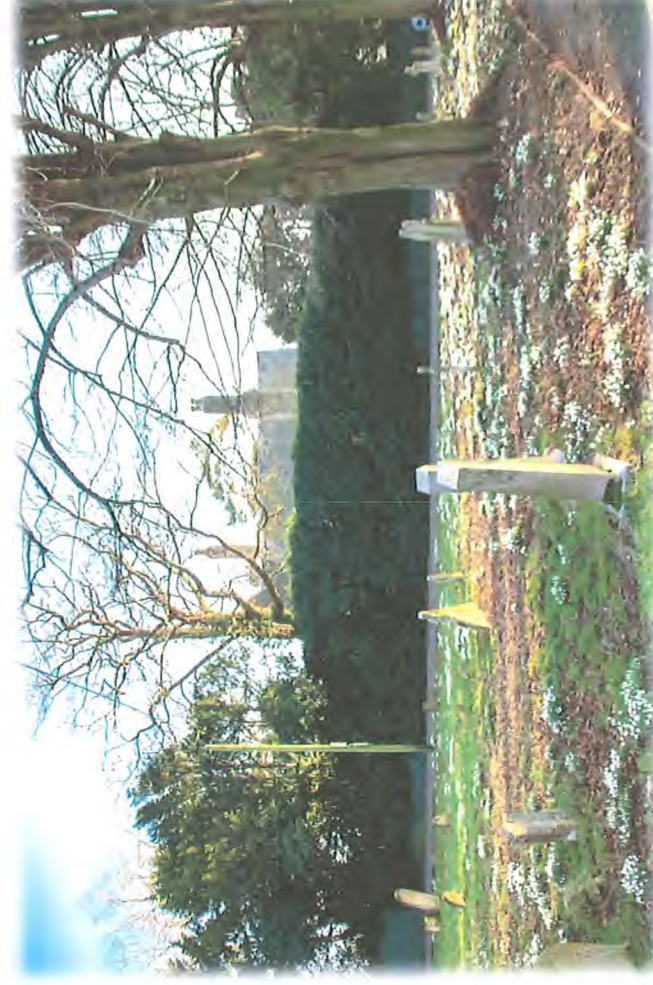
**Figure 8: View of Church grounds from the Eastern boundary.**

An asphalt driveway runs from left to right along the base of the hedge. Behind the hedge, and now a private residence, stands the former Vicarage, Butterfield House.

This part of the Churchyard contains the earliest recorded graves, dating from 1852.

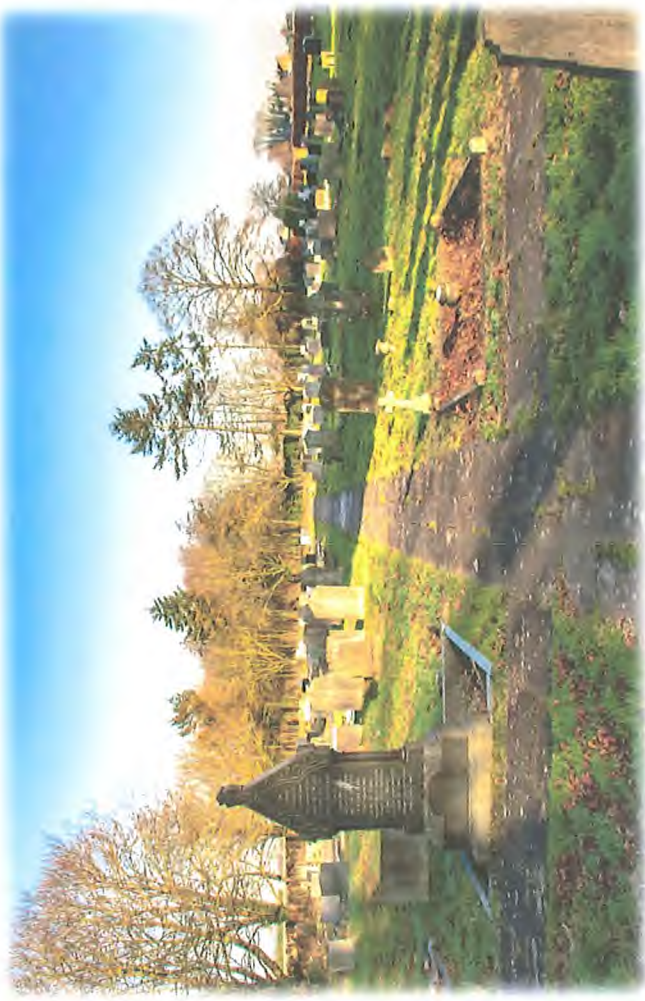
**Figure 9: General view of primary Churchyard paths.**

These are of a slabbed construction laid directly into soil, giving good and level access by foot and by mobility scooter or wheelchair.

The majority of Churchyard paths are of this type.

The proposed path for the new Cremated Remains Area employs the same type of slabs with the intention of preserving the character and proportion of the churchyard as a whole.

The proposed path materials (slabs laid on a pea shingle bed) are in keeping with existing pathways across the site (Figures 9, 10 and 14).

All other churchyard pathways are of slabbed construction, laid directly into compacted soil (Figures 9 and 10 below).

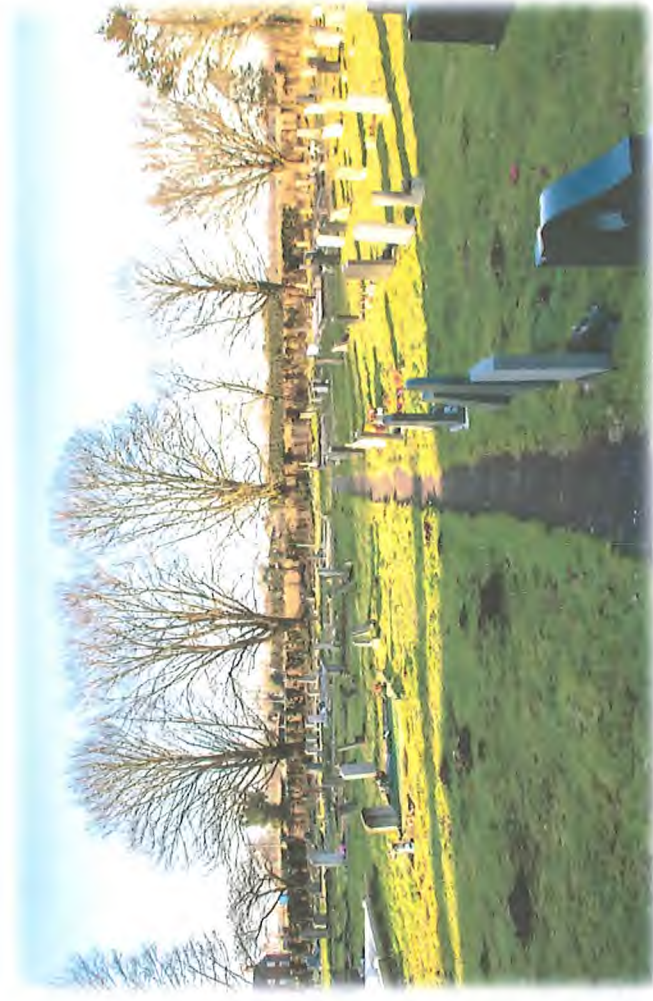
**Figure 10: General view of secondary Churchyard paths.**

These are narrow (single slab width) and give adequate access by foot, though not by wheelchair whenever the ground is wet.

This has, on occasion, precluded access for some wheelchair users attending churchyard burials.

The Parochial Church Council wishes to avoid this limitation in respect of the western Cremated Remains area, by widening and extending the path to form a looped route to ease wheelchair access.

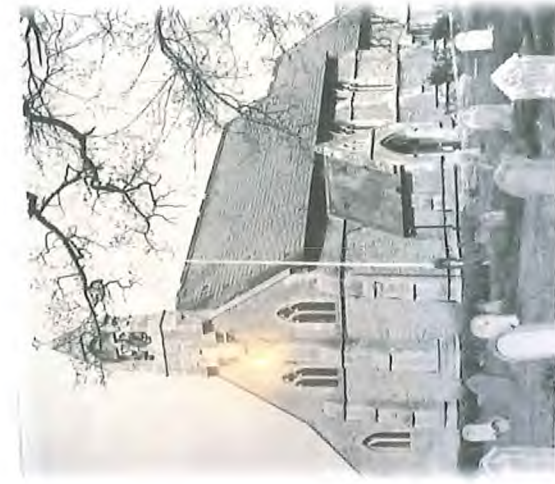
**Figure 11: Historical photograph: St Bartholomew's Church (1960s).**

This photograph, believed to date from the 1960s, predates the construction of the cremated remains areas currently found along the southern and western walls of the Church building.

The character of the church building and the churchyard as a whole has changed only a little over the last six decades.

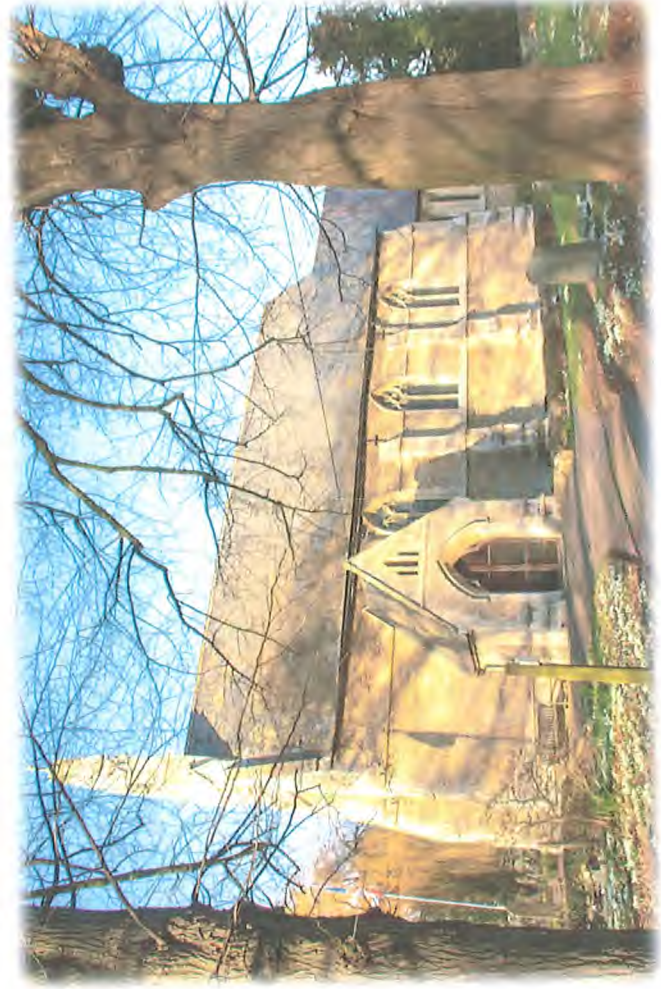
**Figure 12: Modern photograph of St Bartholomew's Church.**

This 2023 photograph postdates the creation of both the Southern and Western Cremated Remains Areas shown in Figures 13 and 14

The churchyard path, linking the carpark drive and the church door, is of asphalt.

A short asphalt spur extends from the church door around the west end of the building.

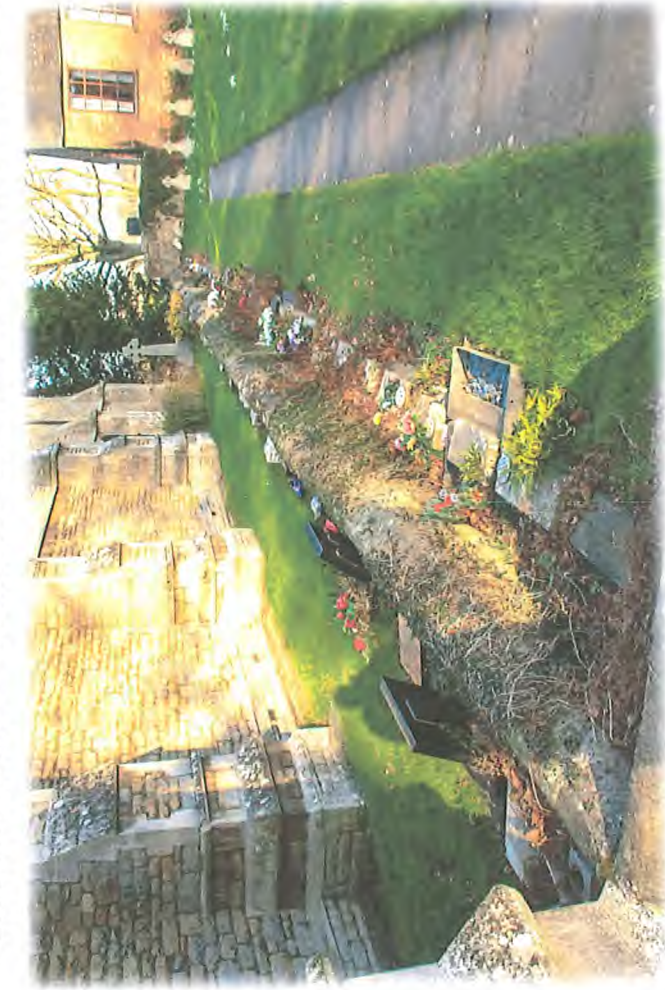
**Figure 13: Southern Cremated Remains Area**

This is the earliest Cremated Remains area at St Bartholomew's Church.

The low retaining wall running parallel to the path permits two rows of interments - one on either side of the wall.

These are memorialised in a wide variety of monument styles; most are flat tablets but some stand above ground level.

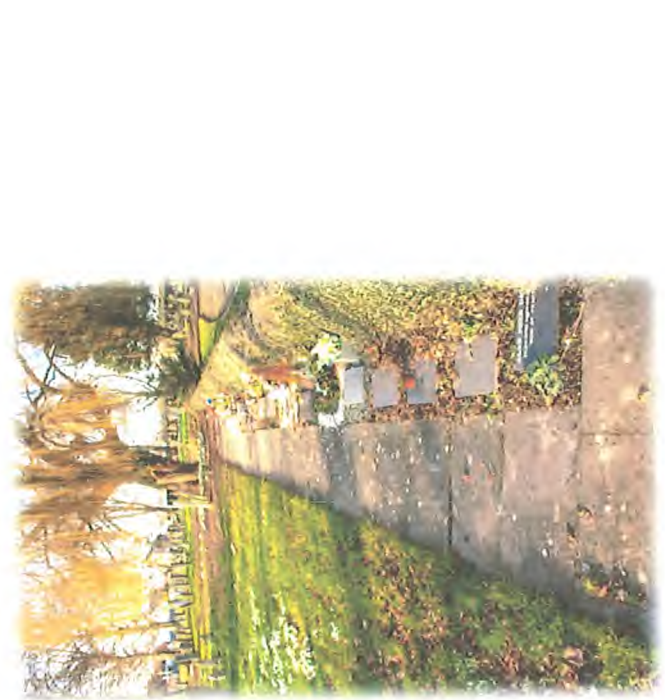
**Figure 14: Western Cremated Remains Area**

This is the second Cremated Remains area at St Bartholomew's. All memorials in this area are standardised flat stone tablets laid flush with the ground for ease of maintenance.

The planned extension is on the grassed area to the immediate left of the slabbed path. There are no recorded burials in this area.

As part of the proposed scheme, the path is to be widened to better meet the current guidelines for access by wheelchair users.

The proposed area already contains interments of cremated remains and associated memorial tablets (Figure 14) and the introduction of new interments and memorial slabs will not change its character. No existing memorials will be altered in any way.
