**Site Investigation Report**  
**for the Proposed Development**  
**on land adjacent to**  
**40 Knight St, Pinchbeck, Lincolnshire**

Date: November 2017  
Report: 1059/4364/P

**SITE INVESTIGATION REPORT FOR**  
**LAND ADJACENT TO 40 KNIGHT STREET, PINCHBECK**

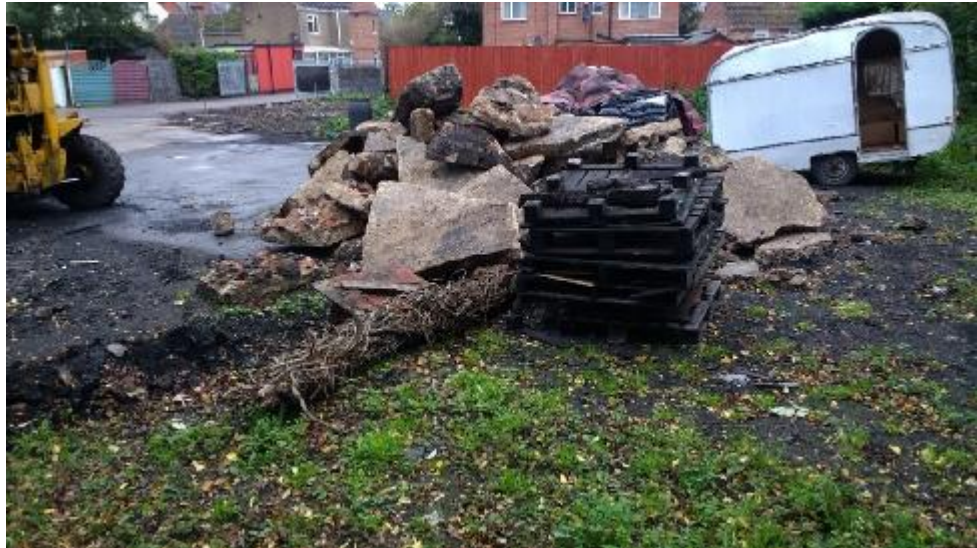
**Area of BH3 and BH4**

The site has evidently been in commercial use as a coal depot. There is much coal dust scattered on the bare earth around the southeast corner of the site.
