Phase 2 (geo-environmental ground investigation) report

Keston Nursery, Pinchbeck

Produced for D. Brown Building Contractors Ltd

| <b>Report number:</b> | 1197/5171/P/P2 |

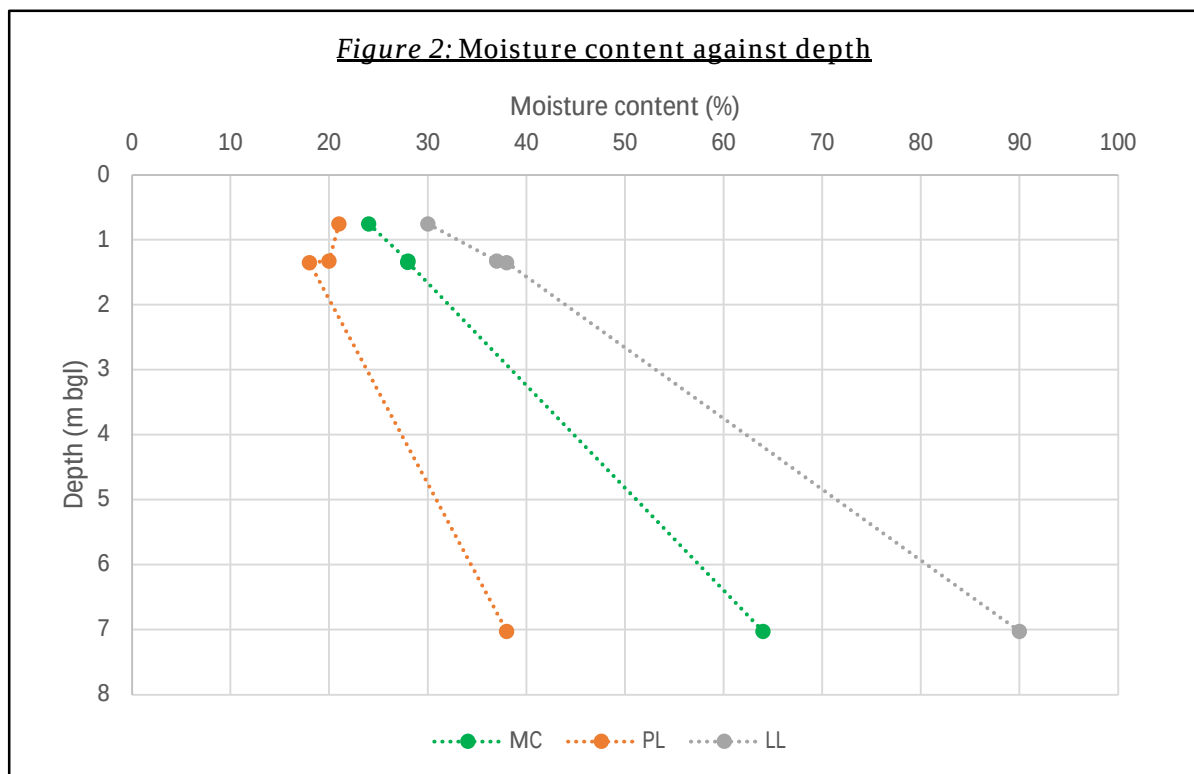
The moisture content of the TFD clay samples appears to increase with depth, as shown below (in Figure 2). The moisture content is between 24% and 28% at depths less than 1.7m bgl. However, it increases to 64% at about 8m bgl. Perhaps the slightly organic silts/clays at greater depth have higher water contents.

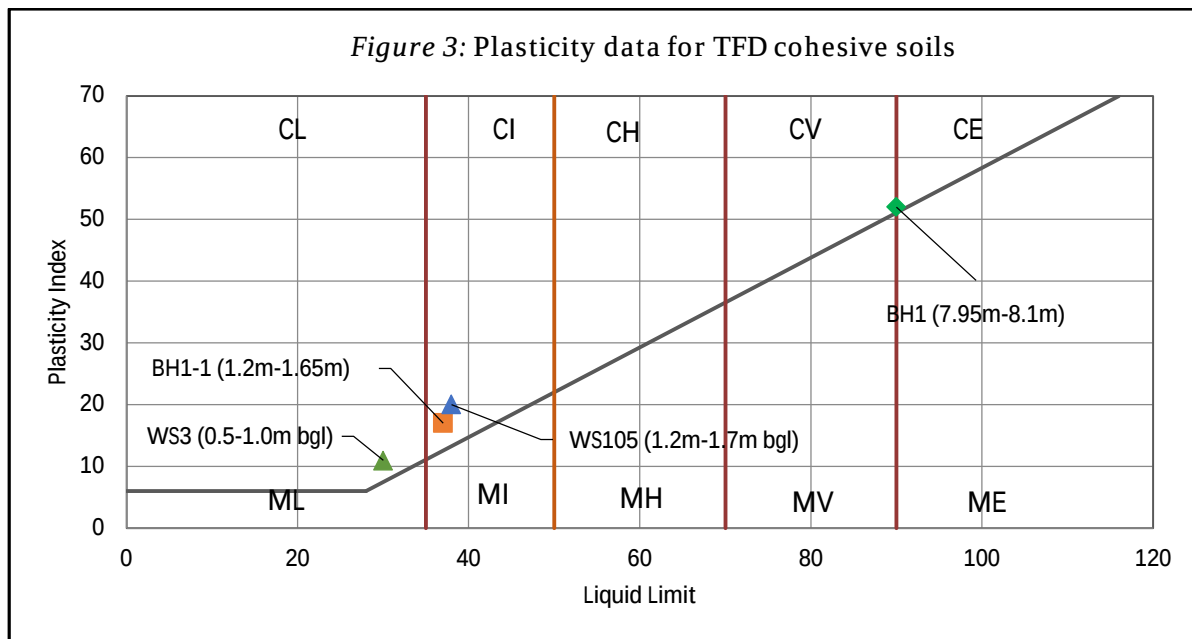
The liquid limit and plasticity index of the deeper (very soft) slightly organic clay appears to be much greater than in the shallow (soft / firm) TFD clays. The plasticity index at shallow depth is generally between 11% and 20%. However, the sample of deeper peaty clays at about 8m bgl was found to have a plasticity index of about 52%. The plasticity chart below (in Figure 3) shows that the shallow samples of TFD silts/clays would be classed as low to intermediate plasticity (silty) clay while the deeper peaty sample would be classed as very to extremely high plasticity silt/clay. However, it is normal for deeper, softer (more organic) clays to have much higher moisture contents and plasticity indices.

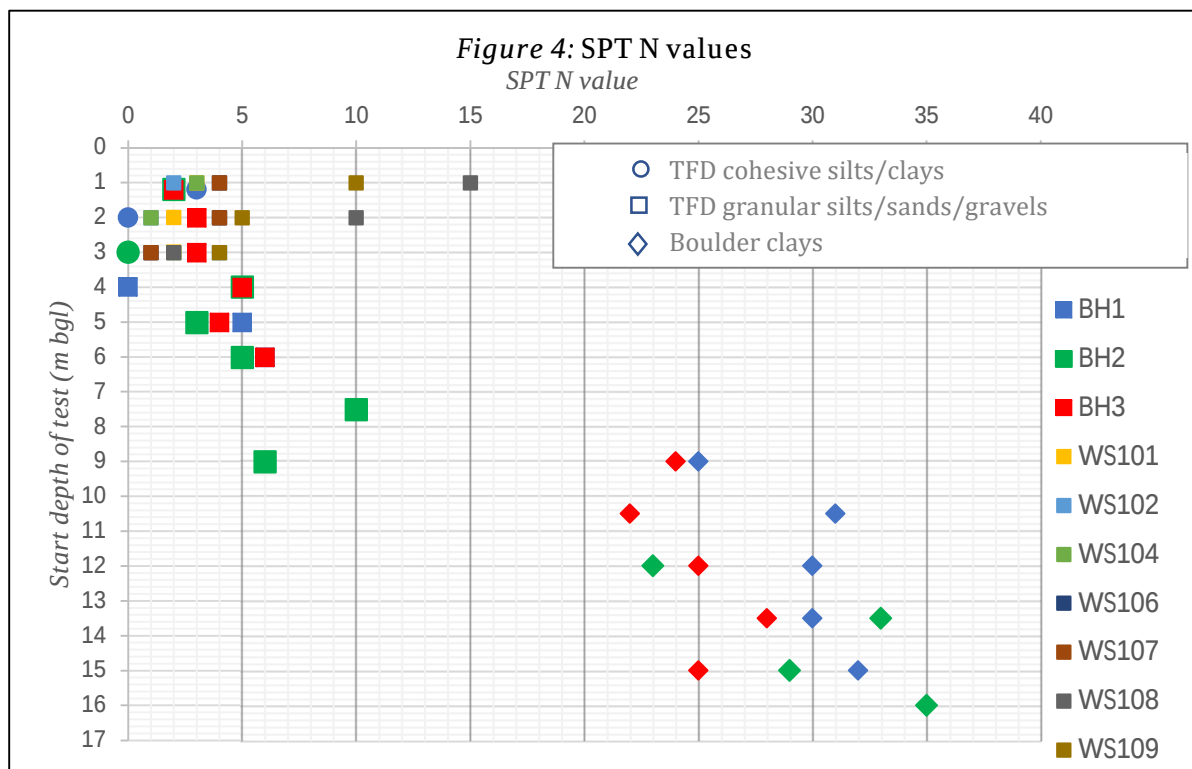
Some of the SPTs were mainly carried out in the TFD granular silts, sands and gravels, but some mostly tested the cohesive silts/clays of the TFD, as shown below (in Figure 4). SPT N values mainly in the silty clays ranged between 0 and 3 (blows per 300mm penetration).

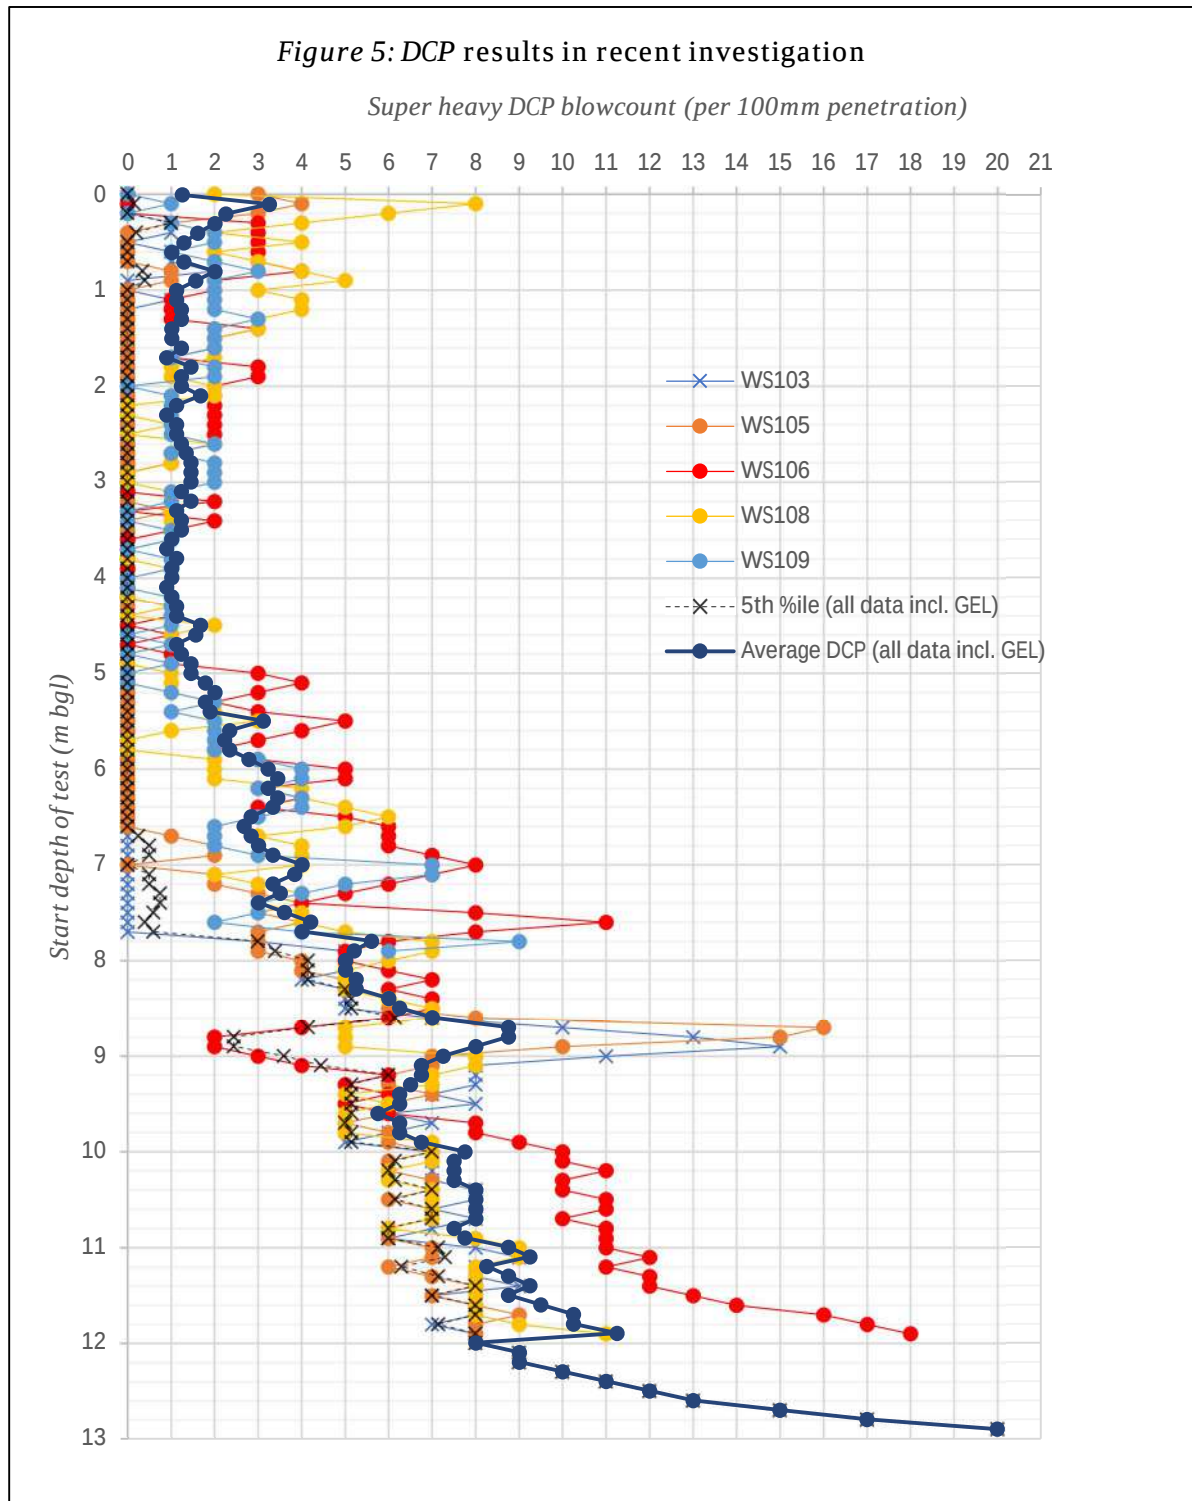
The DCP results indicate that the TFD soils have very little resistance to penetration between depths of about 2m and 5m bgl, as shown below (in Figure 5). There is a blowcount of mostly between 0 and 3 (blows / 100mm) to a depth of about 2m bgl. The 5<sup>th</sup> percentile of the combined data (including previous DCP results from the GEL investigation) show a possible characteristic DCP blowcount of about zero blows/100mm between ground surface and about 7m bgl.

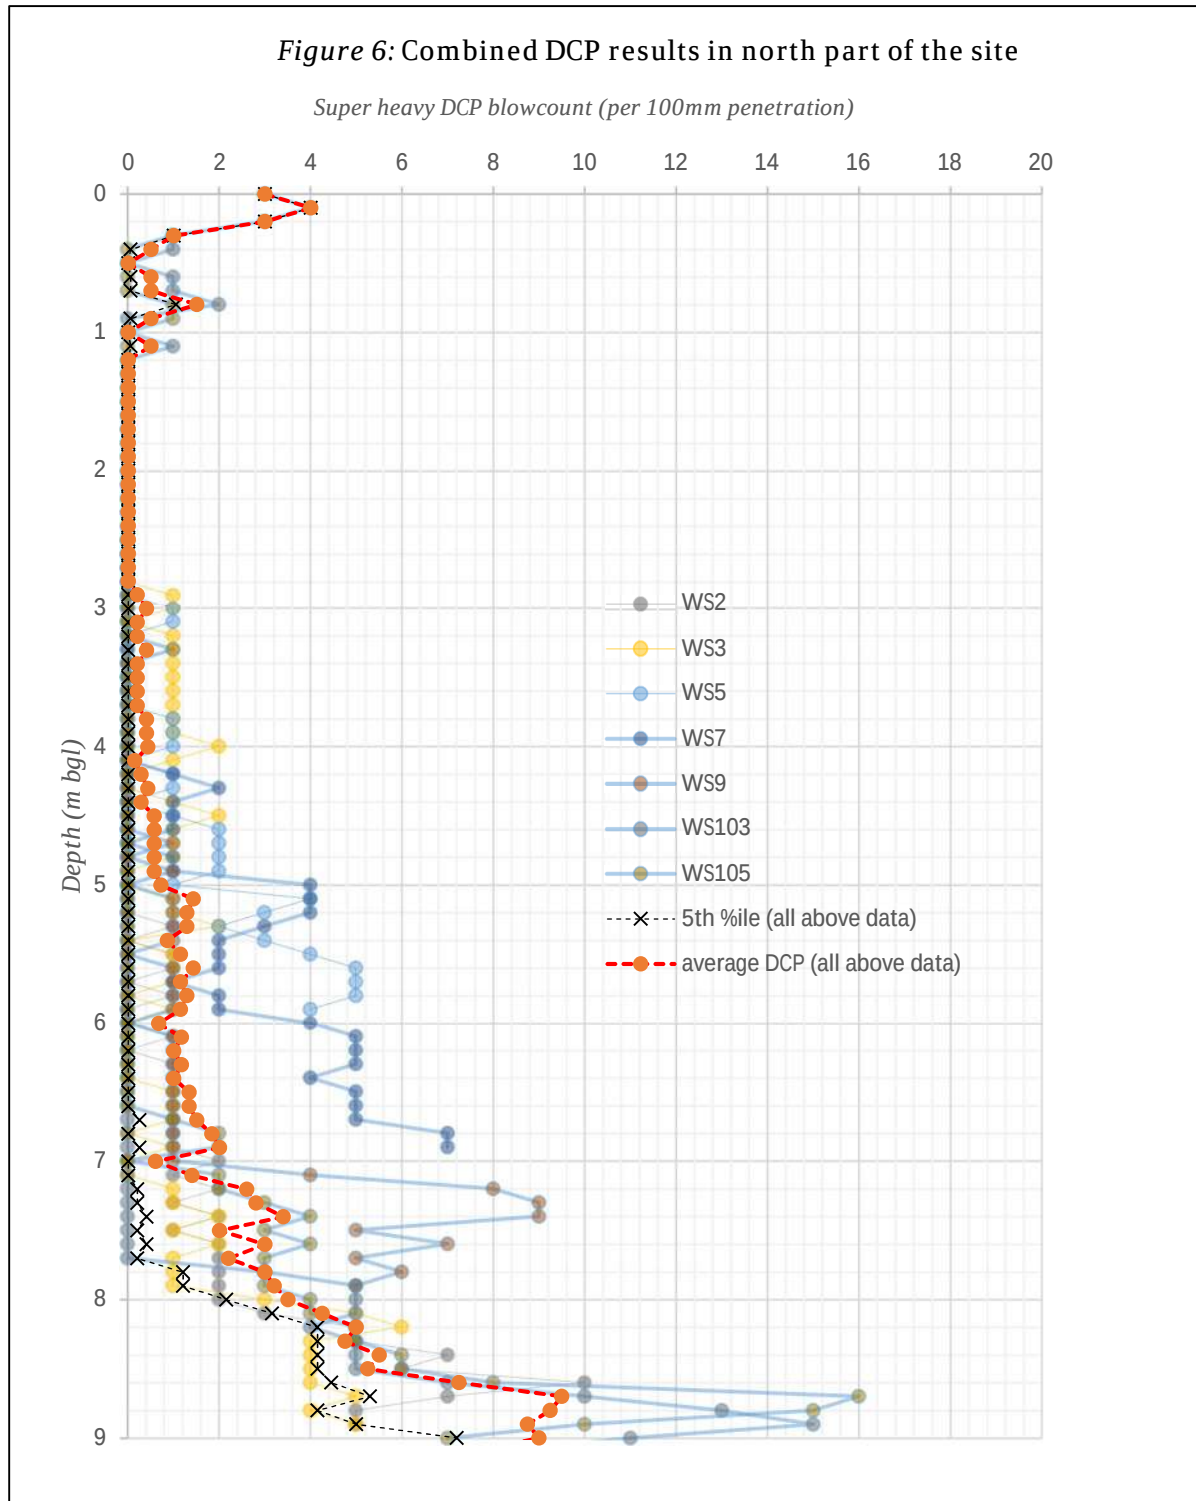
The undrained shear strength of the TFD cohesive soils can also be roughly determined using the results of DCP testing. The boreholes where the ground conditions were mainly of cohesive silts and clays tended to be in the north area of the site. Thus, the results of DCP testing in the north part of the site (in WS103, WS105, WS2, WS3, WS5, WS7, WS9) show that the average blowcount is 0 to 4 between 1m and 1.3m bgl and zero from 1.3m to 7m bgl, as shown later (in Figure 6). This suggests the undrained shear strength was

probably low to a depth of about 1.3m bgl and then extremely/very low (e.g. <15kPa) at greater depth.

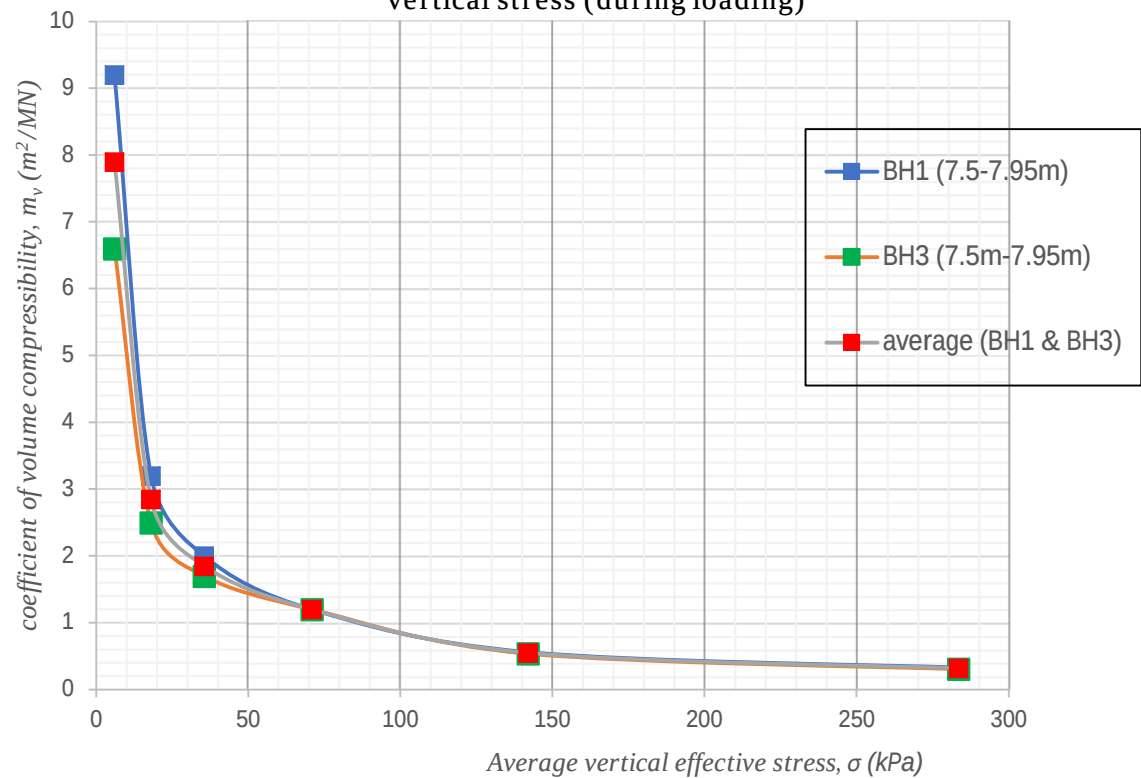
Figure 7: Deep TFD very soft peaty silt/clay -  $m_v$  values against vertical stress (during loading)

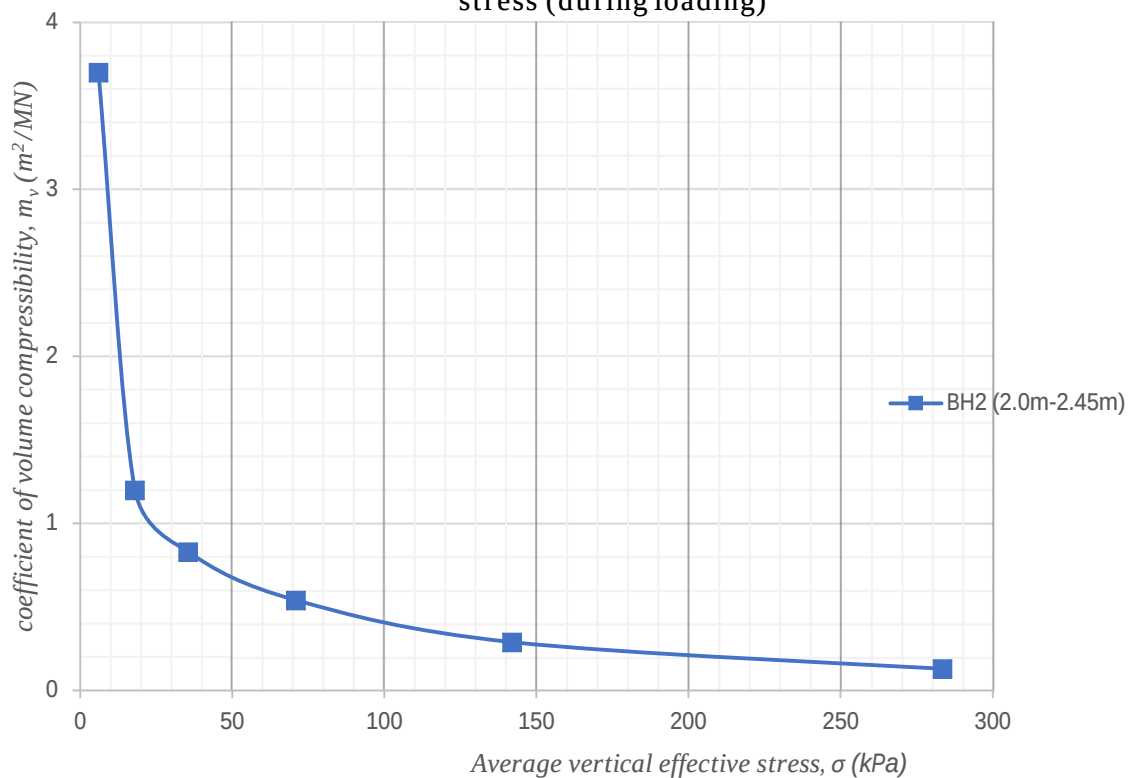
Figure 8: Shallow very soft TFD silt/clay -  $m_v$  values against vertical stress (during loading)

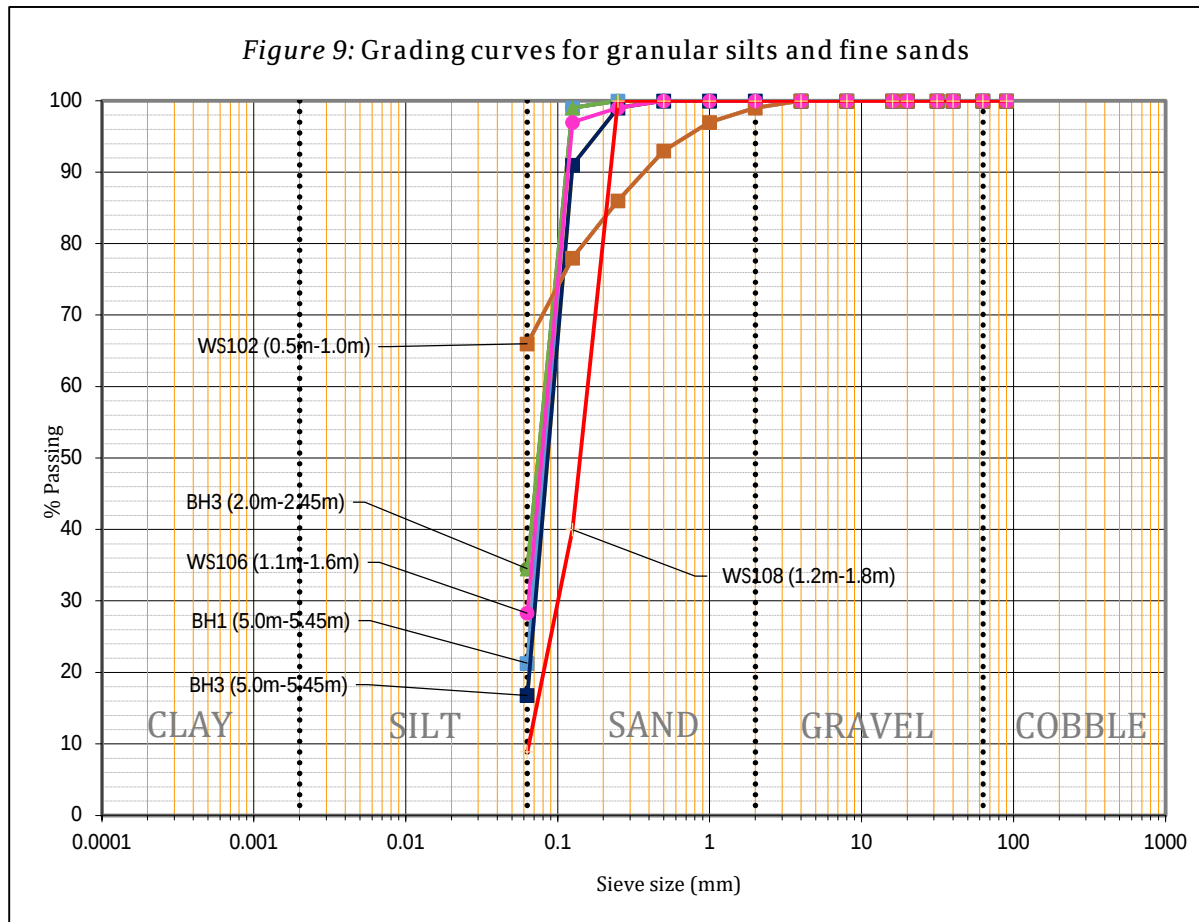
The gradings indicate all the test samples are granular in nature except for the sample from WS102 (from the north part of the site). This confirms the findings of the previous GEL investigation (see Table 7 above) which found the shallow TFD soils in the south half of the site are comprised entirely of granular (non-shrinkable) soil.

The findings of the grading curves suggest the TFD silts and sands have a narrow spread of particle size. The soils are mostly very closely- or poorly-graded.

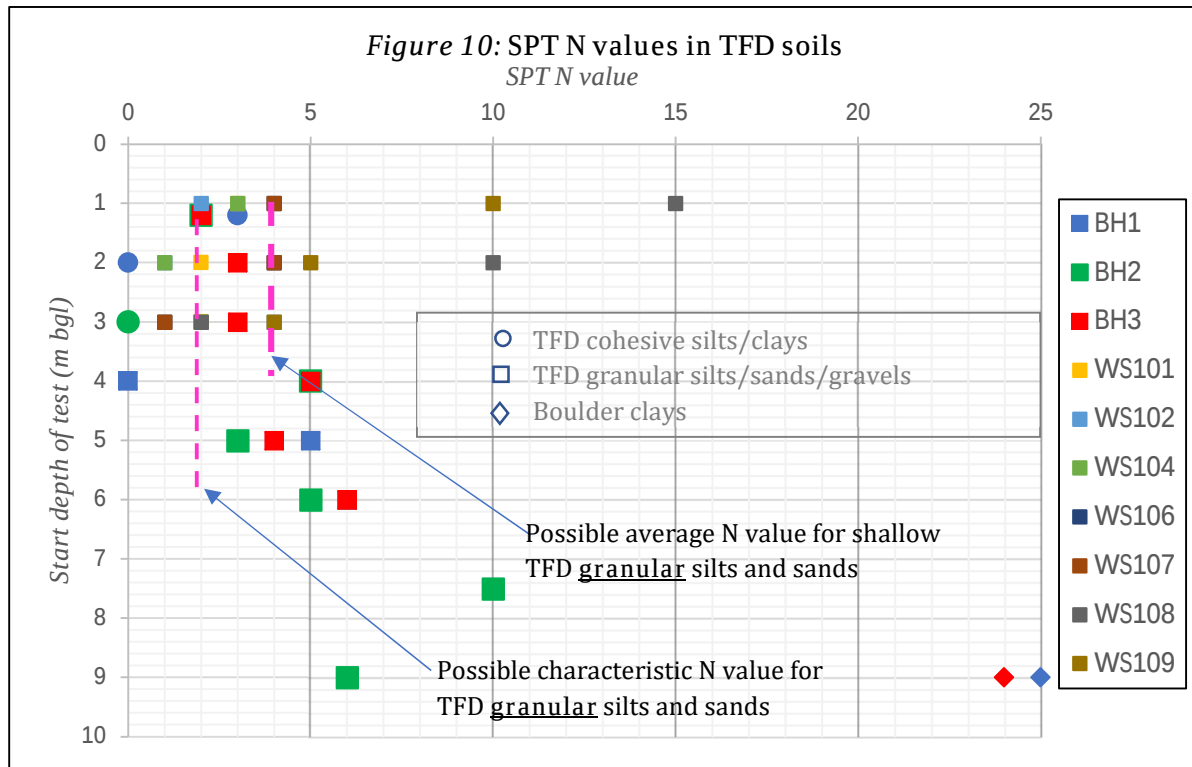
There appears to be some variation in recorded SPT N values with depth in the TFD granular soils, as shown below (in Figure 10). However, a generally suitable characteristic (i.e. cautious value for) N value could be 2 (blows / 300mm) while an average SPT N value is about 4 (blows/300mm) at shallow depth.

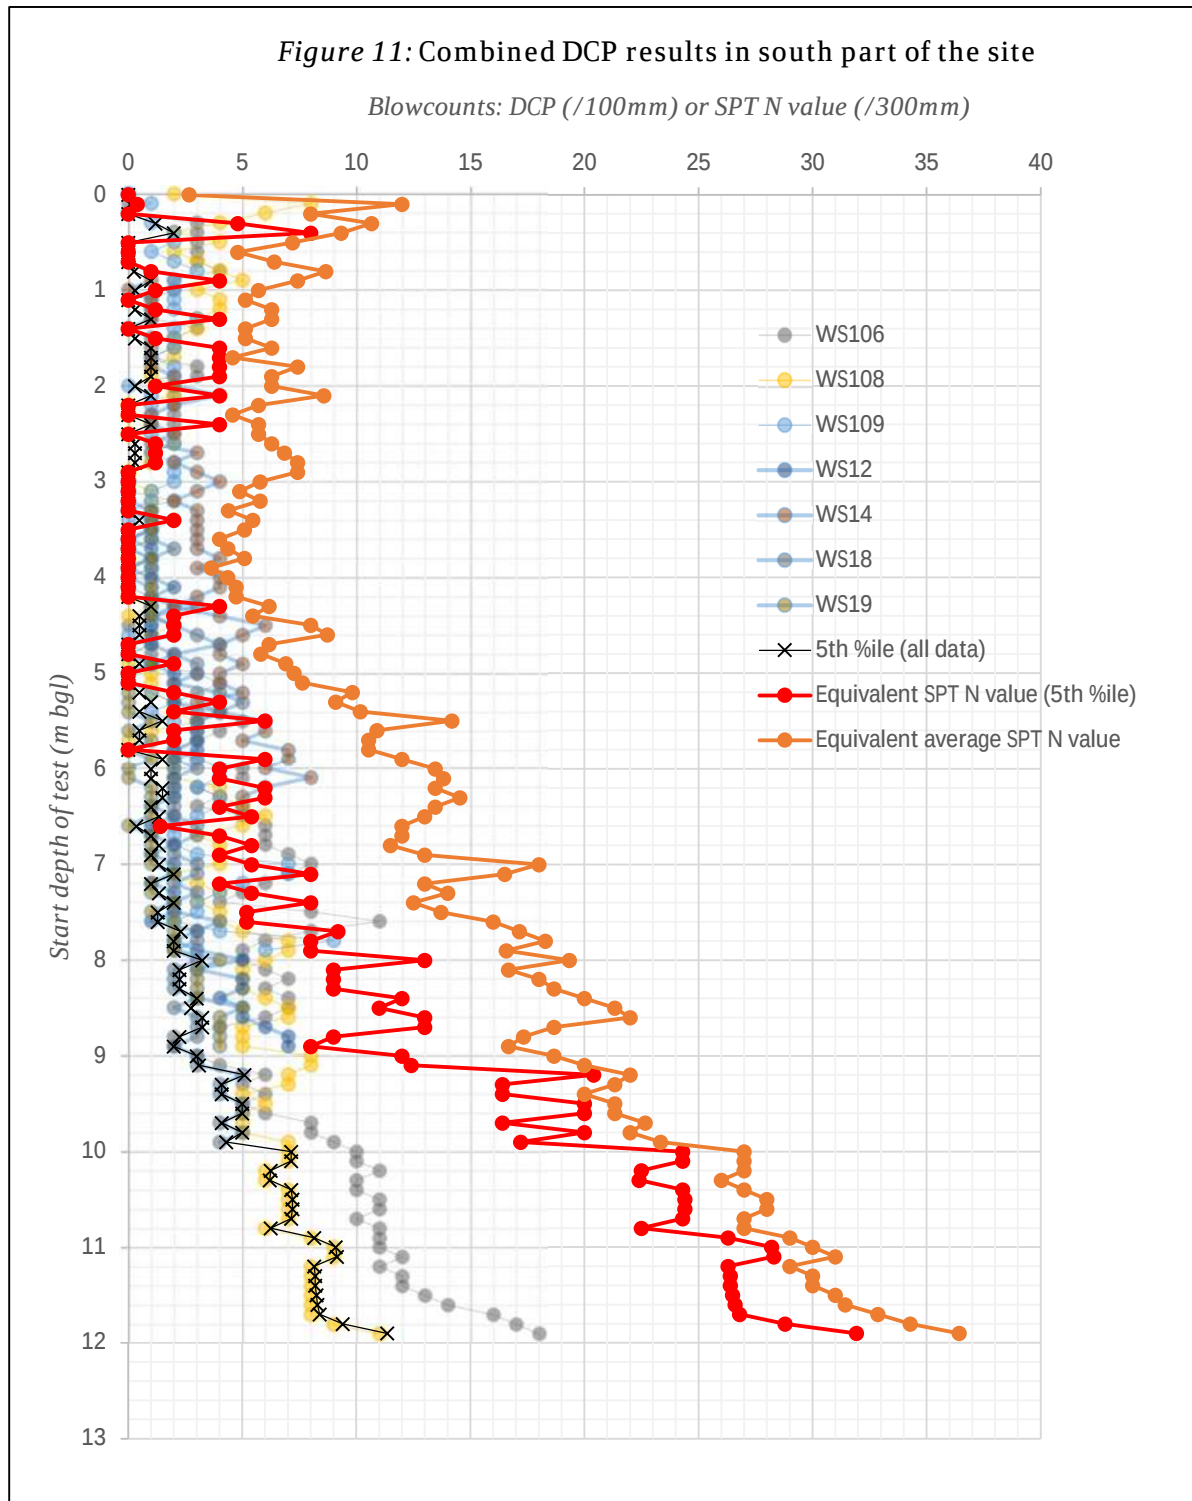
The relative density of the TFD granular soils can also be evaluated from the results of DCP probe testing. The combined DCP test results from the south part of the site – where granular silt and sand ground conditions were found to predominate – indicate that the blowcount ranged between 0 and 8 (per 100mm) between ground level and about 7.5m bgl, as shown below (in Figure 11).

At depths greater than about 7.5m bgl, the DCP blowcounts tended to increase. This suggests the TFD soils were becoming more resistant to penetration or the material was starting to change into a different stratum (e.g. Glacial Till).

Figure 11 (below) also shows equivalent SPT N values (using the findings of Cearns and McKenzie, 1988) for the 5<sup>th</sup> percentile DCP blowcounts. This shows that the minimum relative density could occur between 3m and 4m bgl, where the equivalent (5<sup>th</sup> percentile) SPT N value is about zero. Nevertheless, an approximate overall suitable characteristic equivalent SPT N value between 1m and 7m bgl could be 1 blow per 300mm. Similarly, an average SPT N value overall in the TFD granular silts/sands could be about 6 (blows/300mm).

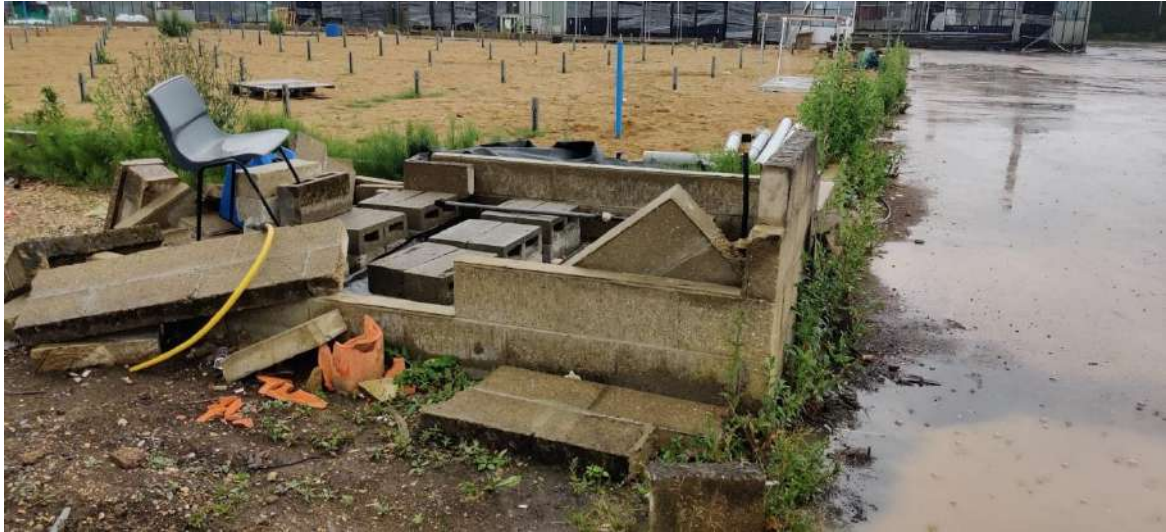
*Photo: 5*      *Date: 17 June 2020*  
*Photo direction: West*  
*Description: Location of suspected previous above-ground fuel tank*

Some tanks are noted within the site itself. This includes a tank in the northwest part of the site (e.g. in mapping dated 1984-1988). An above ground fuel tank has also been identified in the north part of the site. There are also existing above ground water tanks.

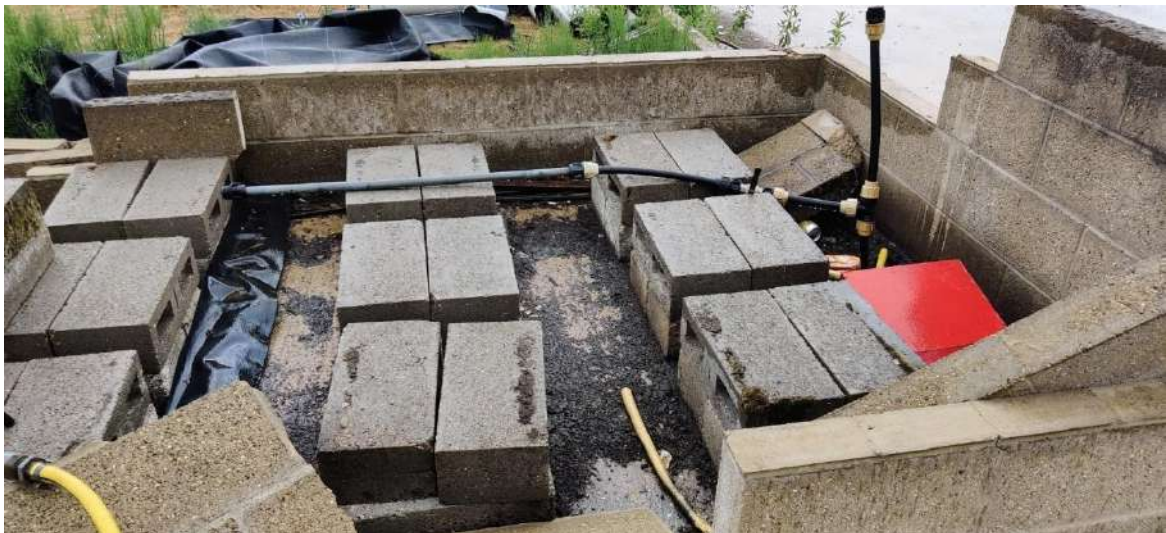
*Photo: 6*      *Date: 17 June 2020*  
*Photo direction: West*

*Description:* Location of suspected previous above-ground fuel tank
