Yews Farm
Pinchbeck

**Combined Phase I Desk Study and
Phase II Exploratory Investigation
For
Ashwood Homes**

Project No: D39032		Date: 20 th January 2021	
Issue/revision	Prepared by	Checked By	Approved By
	Paul Kershaw BSc (Hons) PGDip CGeol FGS Director	Daniel Brunt BSc (Hons) MSc CGeol FGS Associate	Paul Kershaw BSc (Hons) PGDip CGeol FGS Director

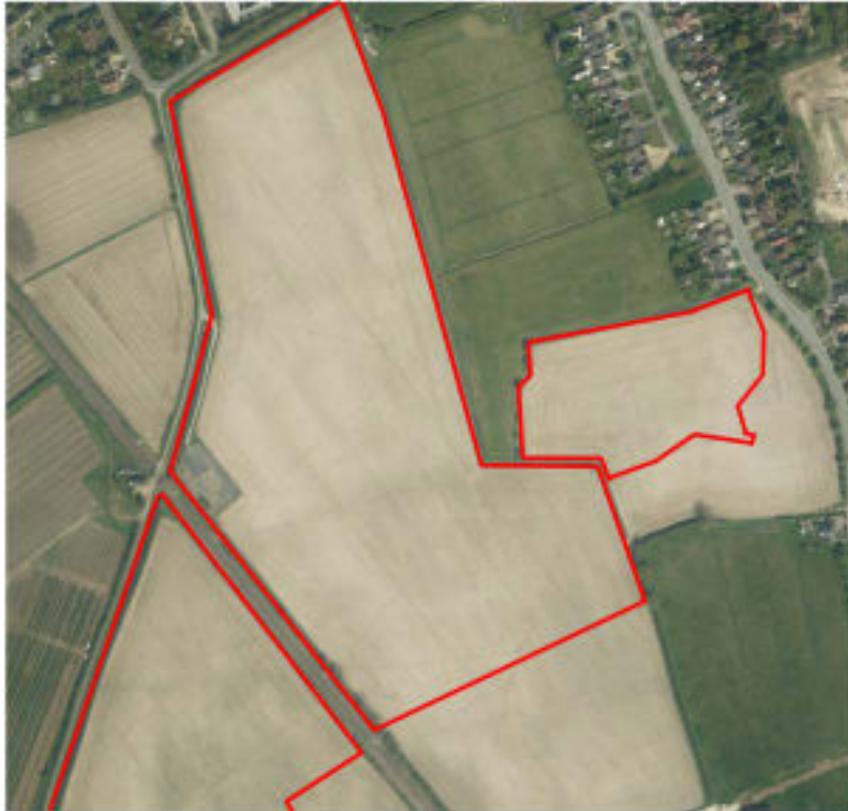
Figure 1: Aerial photograph of the site (2020 image)

An aerial photograph of the site, obtained from the Landmark Analysis tool commissioned as part of our works, is presented in Figure 1 on the following page, with the current OS mapping plan for the site and surrounding area presented in Figure 2. It should be noted that Figures 1 and 2 do not show the far south western corner of the site due to the size limits of the mapping tool.

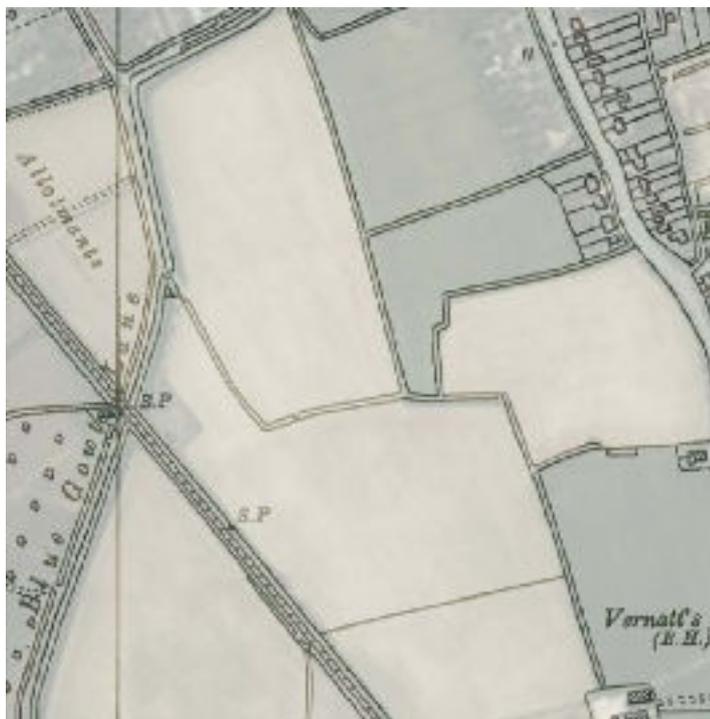
Figure 3: Current Aerial Imagery Overlain with 1956 Historical Map Data.

The former drain running through the site is visible, together with the railway line through the site. The allotment gardens are shown to the north west of the site.

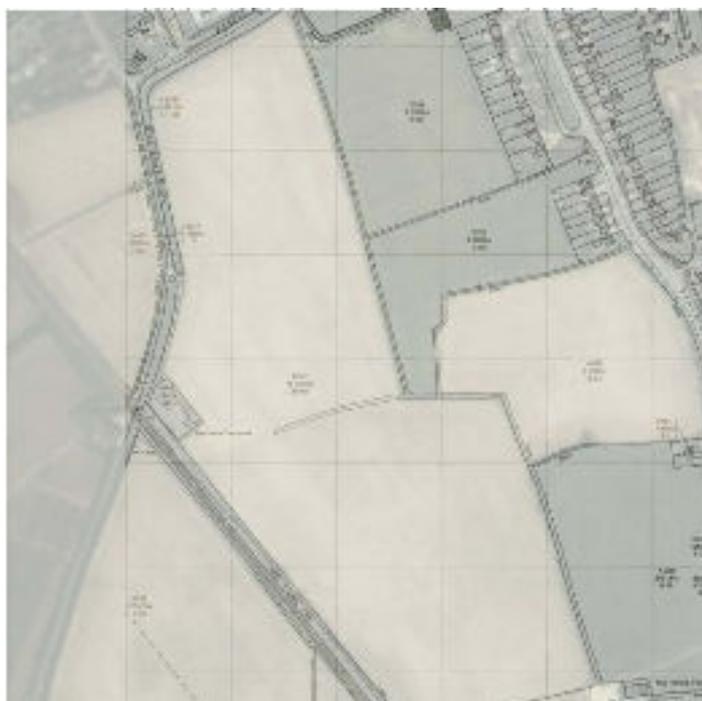
Figure 4: Current Aerial Imagery Overlain with 1980 Historical Map Data.

The former drain running through the site appears to now be partially infilled. The allotment gardens are no longer present to the north west.

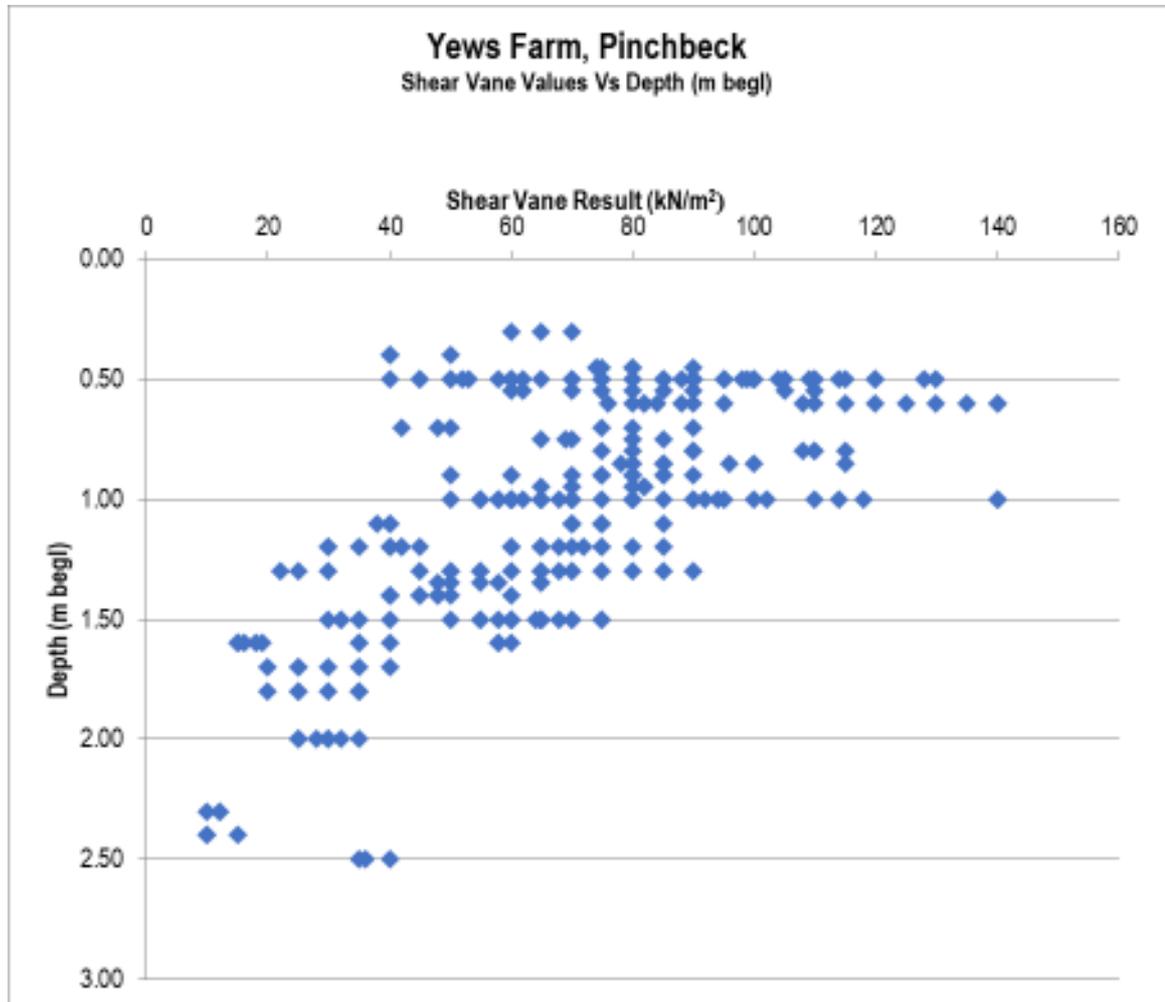
A Chart showing the shear vane values in relation to depth recorded in the trial pits is provided below for information. Table 8 shows a summary on the shear vane values between specific depth ranges. Individual shear vane results are provided on the exploratory hole logs included in Appendix IX of this report.

TABLE 8 – SUMMARY OF SHEAR VANE RESULTS			
Depth (m begl)	Minimum SV Reading (kN/m ²)	Maximum SV Reading (kN/m ²)	Average SV Reading (kN/m ²)
0.00 – 0.50	40	130	68
0.50 – 1.00	42	140	82
1.00 – 1.50	22	90	57
1.50 – 2.00	15	60	30
2.00 – 2.50	10	40	20

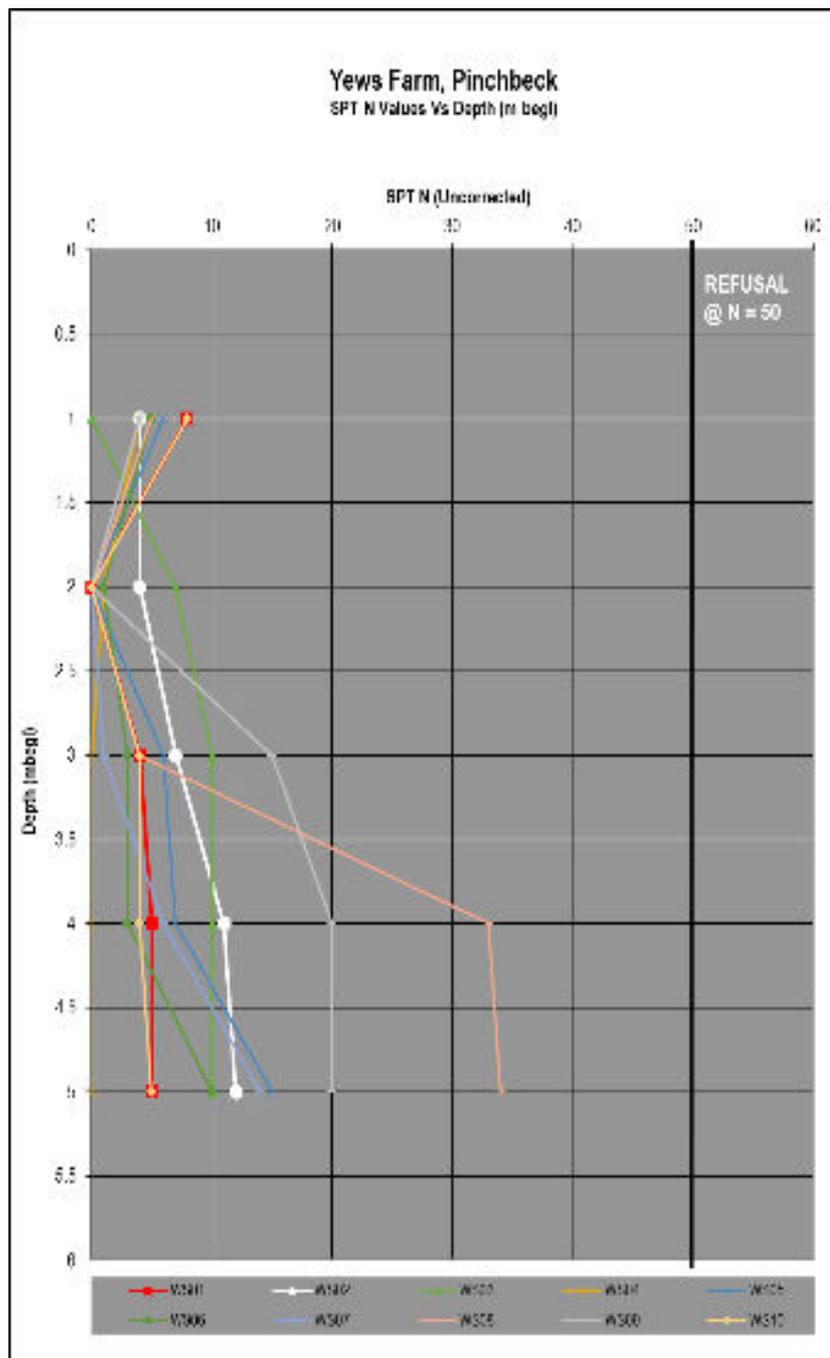
An SPT Vs Depth Chart of the data obtained from the boreholes advanced at the site is shown on the chart below.

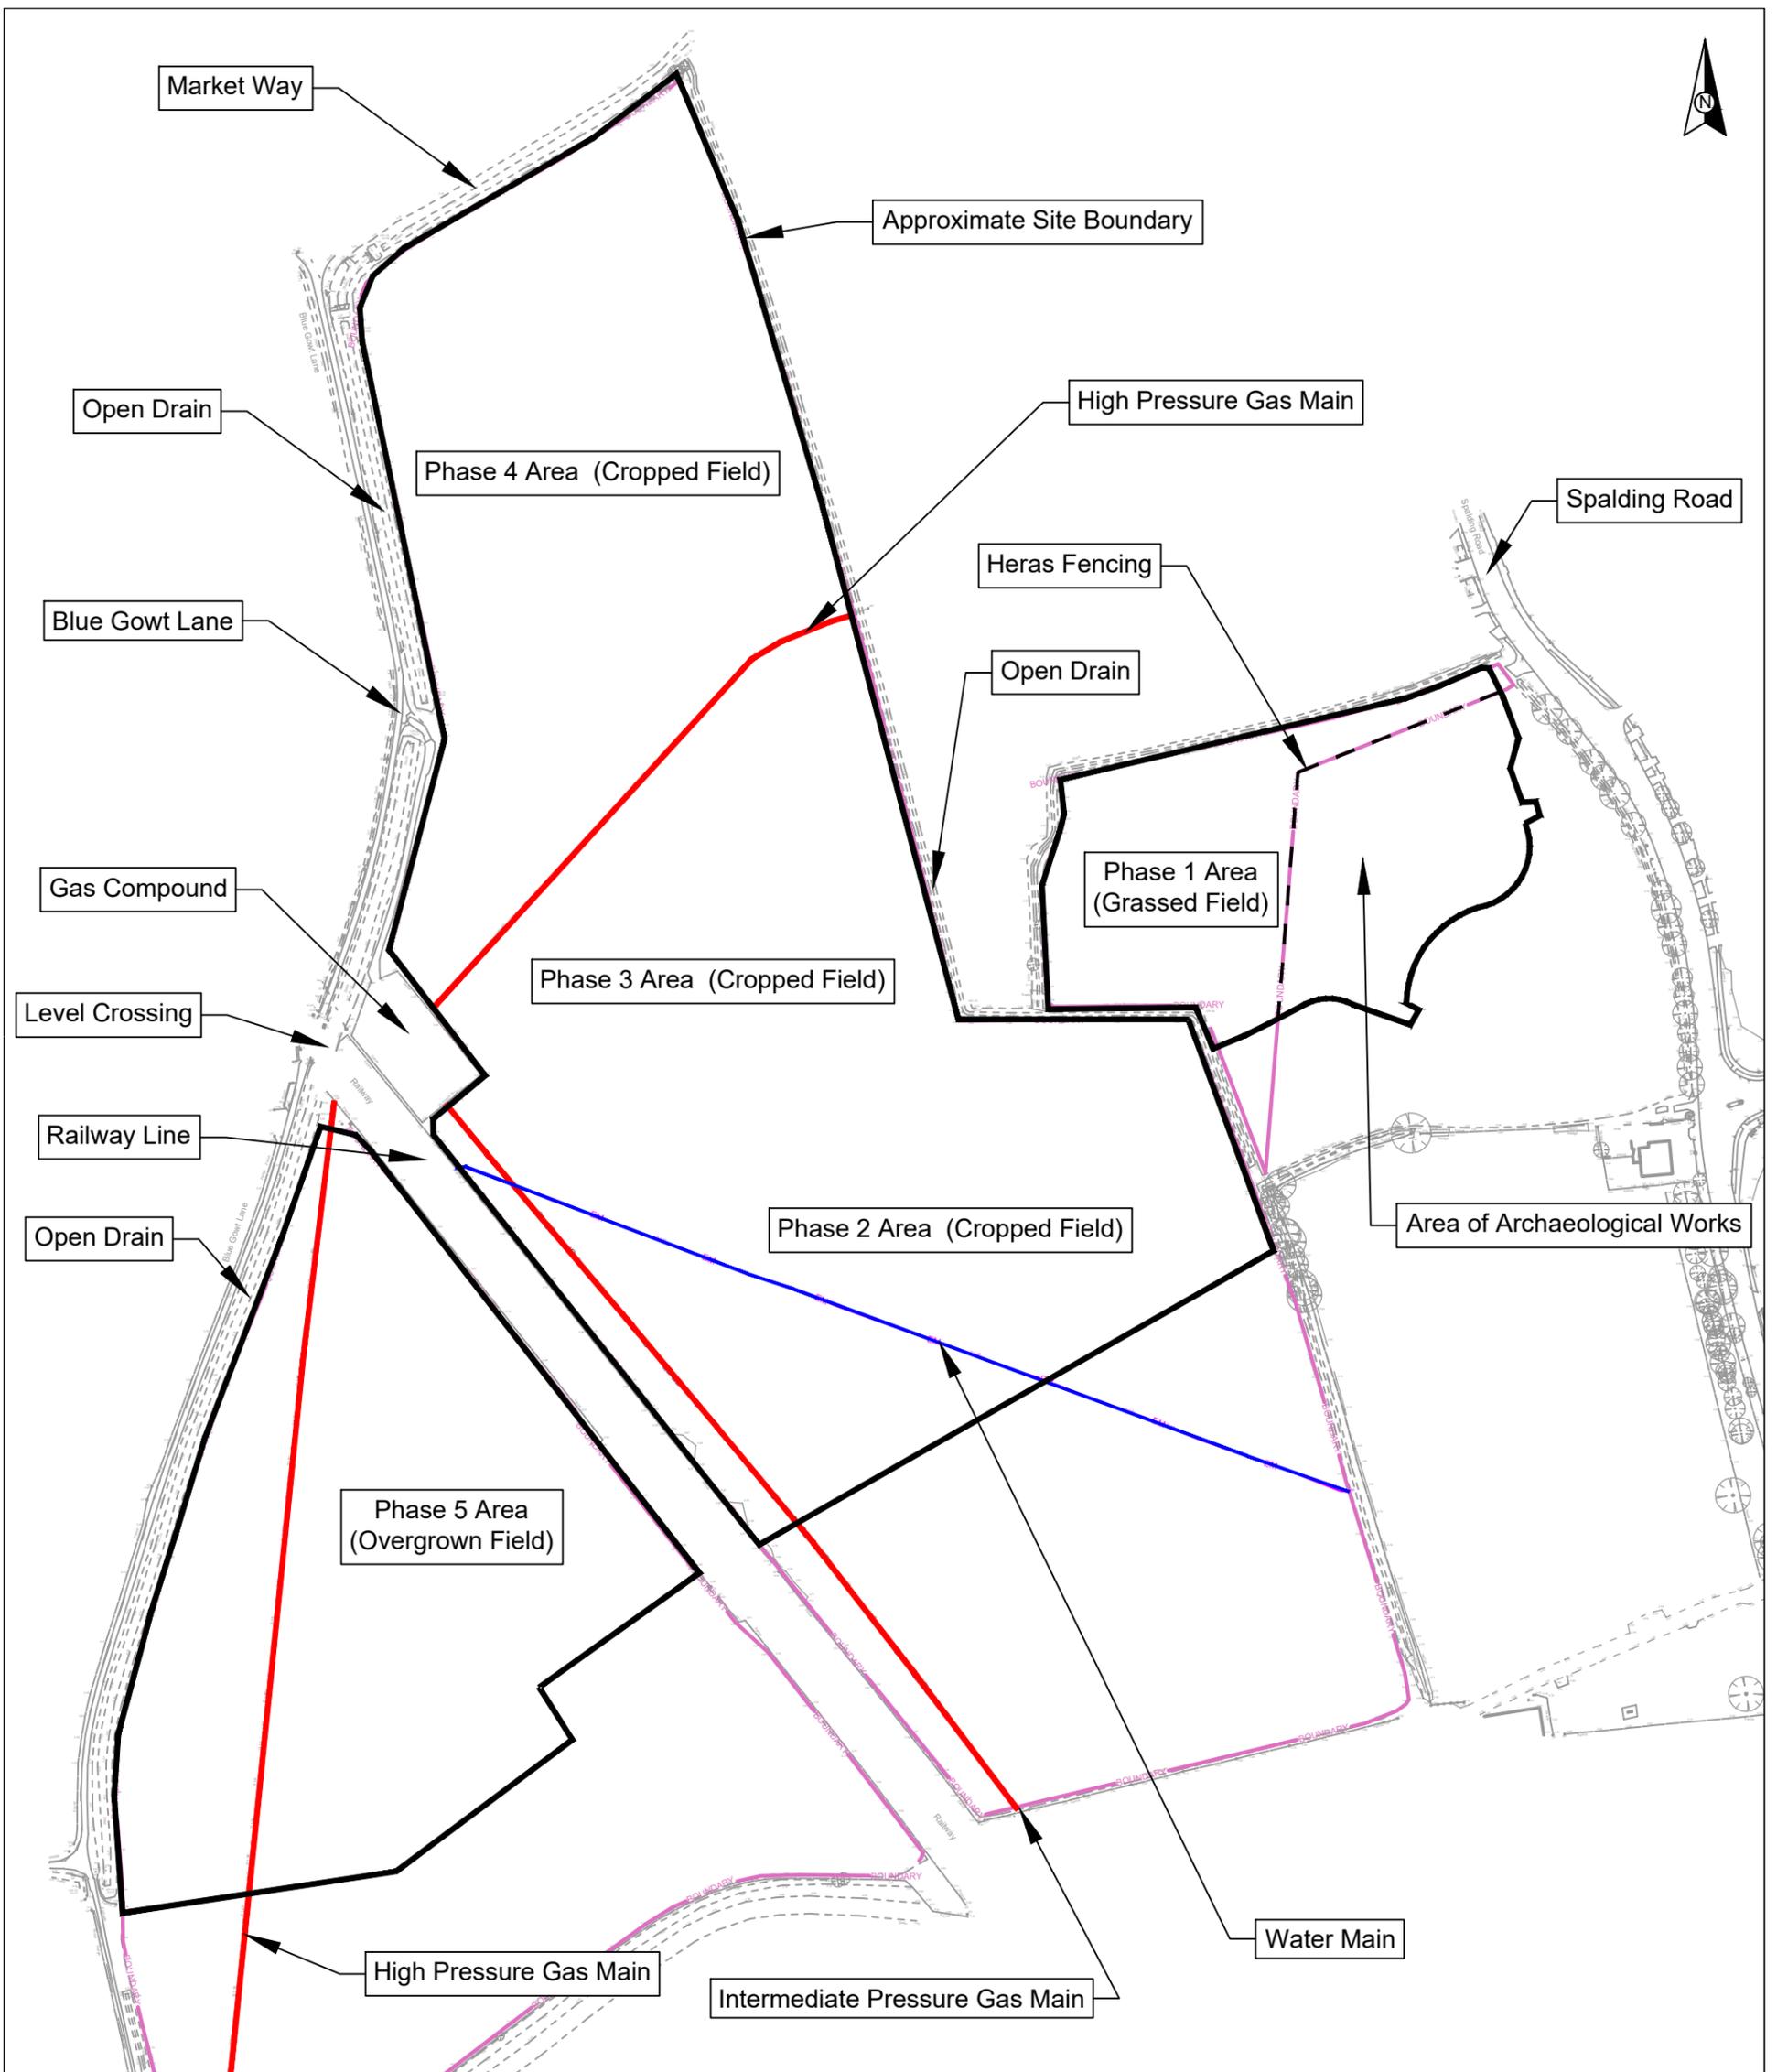
APPENDIX III
Annotated Site Plan
(Figure No. D39032/02)

Drawing based on Utility Survey Report by Mantra Drawing No. 1036-100 Dated: 23/07/20. Used, edited and reproduced with permission of the Client.

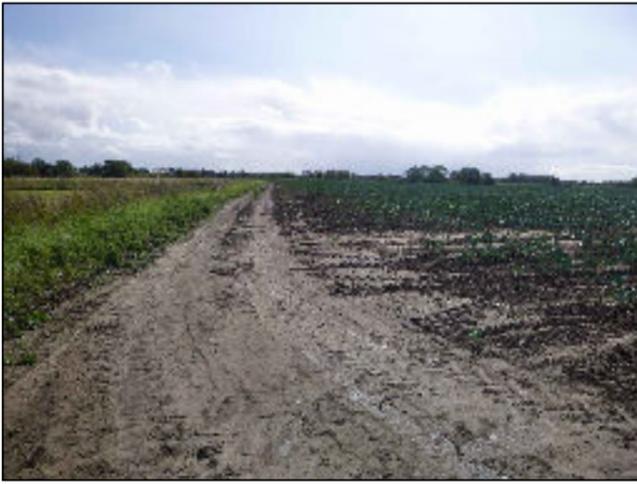
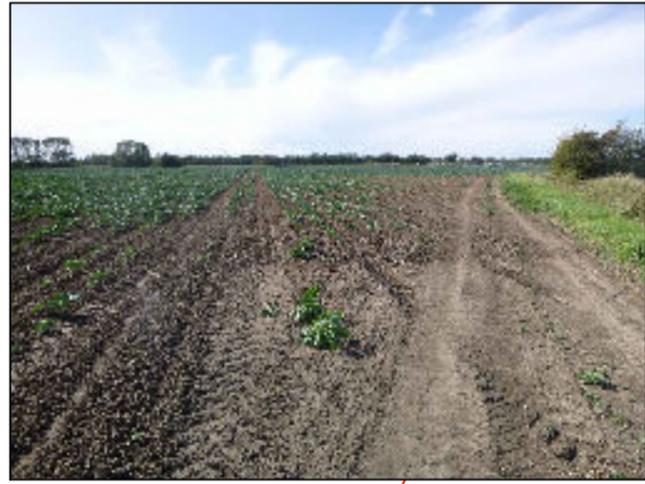
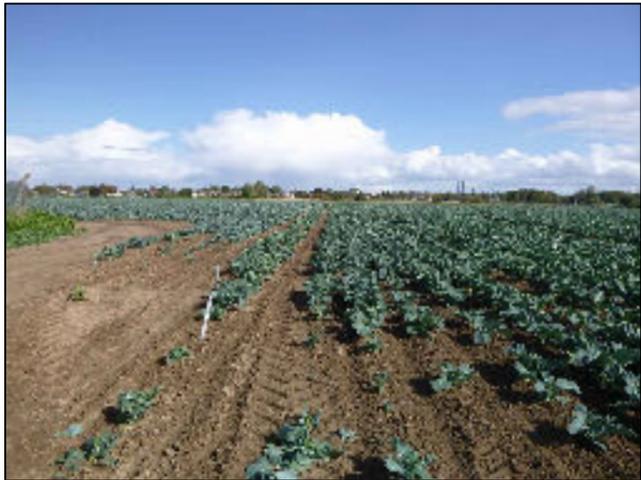
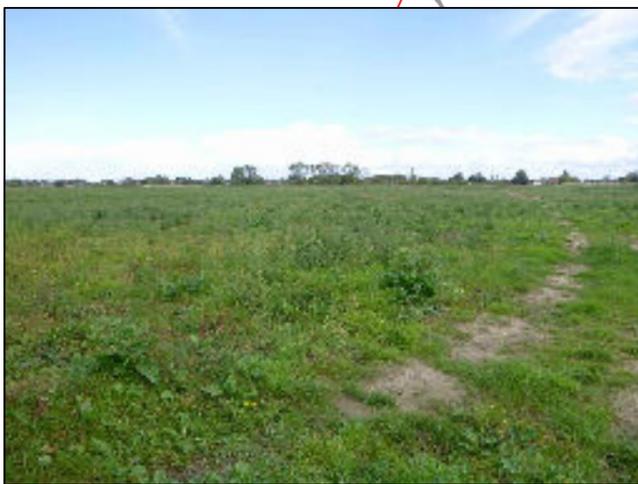
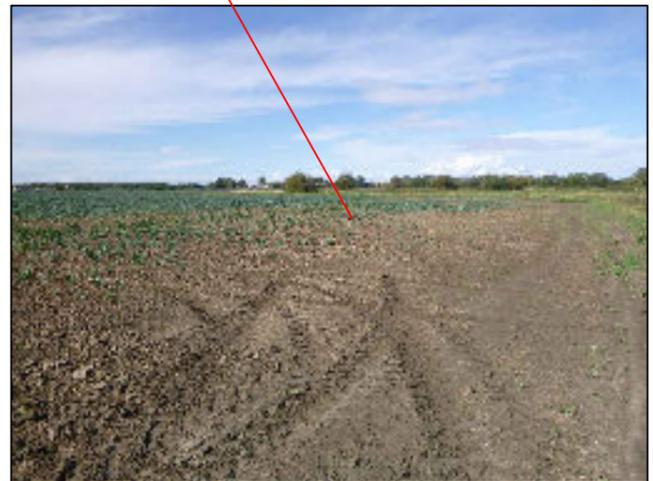
**Site Plan Showing General Site Views
(Figure No. D39032/03)**

Project No.	D39032	Drawn By	GH
Client	Ashwood Homes	Checked By	PK
		Approved By	PK
Project	Yews Farm, Pinchbeck	Scale	NTS
		Date Drawn	05/01/2021
Title	Site Plan Showing General Site Views	Revision	
		Figure No.	D39032/03
