**HISTORIC BUILDING RECORDING  
THE COTTAGE  
COWBIT DROVE  
WEST PINCHBECK  
LINCOLNSHIRE  
WPCD18**

Work Undertaken For  
**East Midlands Design Associates**

November 2018

APS Report No. **66/18**

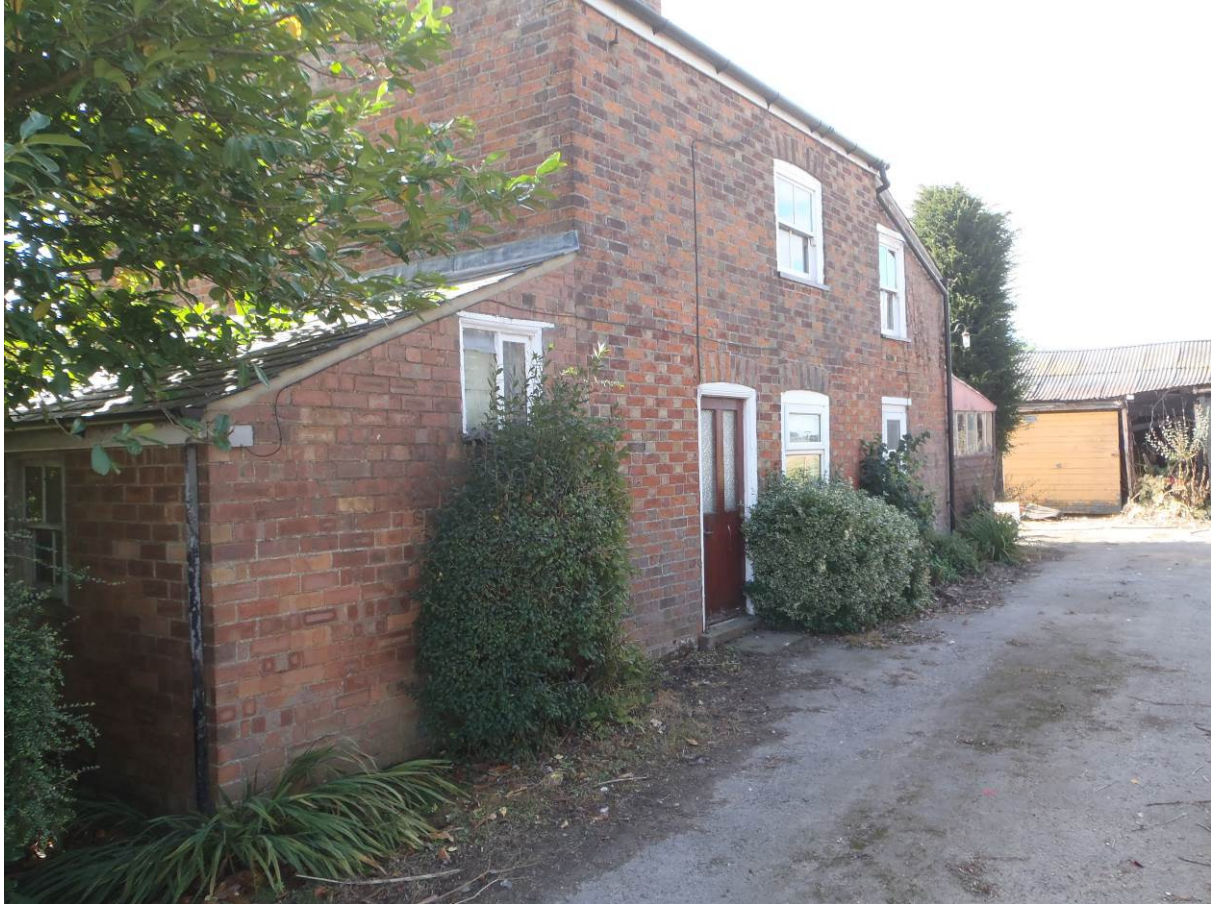
**Plate 1.** General oblique view of the northern elevation of The Cottage

The north elevation is the main façade of the building and fronts onto an open area that appears to have been the main route between the farmhouse and the farm buildings.

The main unit of the building is the central two up – two down building which is set slightly forward from the outshut on the west and the extension on the east.

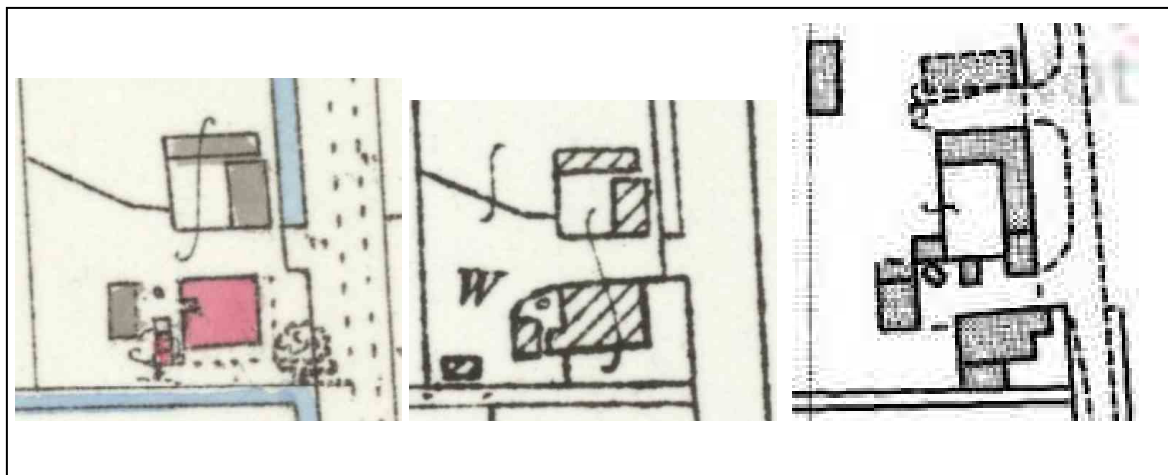
**Fig.1** Extract from the Ordnance Survey 25" inch Map of 1888 (left) 1904 centre and 1968 right.

The farmhouse and outbuildings lie between drains to the south and east on the eastern side of Cowbit Drove. The earliest available map of 1888 shows the farmhouse and its outbuildings in a slightly different form from how they now appear. The main farm building (The Cottage) in pink has two separate outshuts on the western side as seen in plan. Next to this is an outbuilding that is also present in the subsequent map of 1904. The farm buildings to the north (shaded grey) lie within a small plot and are two separate entities. There is a further farm building to the west also shaded in grey.

By 1904, the double outshut has been joined to form a single unit in plan and what may be a privy has been added to the southwest corner, possibly replacing the detached pink building in the previous map, which is no longer present by this edition. Similarly, the farm building to the west has been repositioned. There is no change to the layout of the farm buildings to the north.

It is suggested from a date carved on site that further alterations were undertaken on the farm in 1930. By the time of the 1968 map, at the south side of The Cottage, a new structure has been added: local knowledge relates that this was utilised for the processing and bagging of potatoes. The two modern extensions have also been added to the east and west elevations of the building. The farm buildings have undergone considerable alterations, with the building to the west of The Cottage having been replaced by one situated further to the north. Further buildings have been added but a notable change is to the main farm buildings to the north that have been extended southwards and joined to form one unit with two ranges. It may be that at this time, previous brick structures were replaced with the timber walled structures seen today.

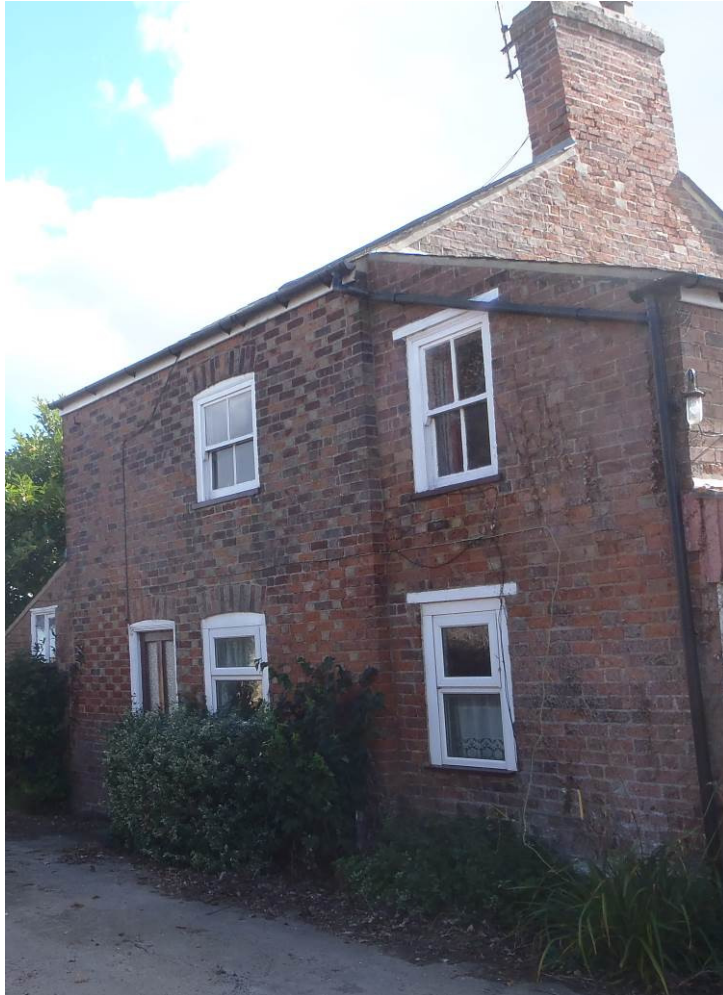
**Plate 2** (left). Oblique view of the north elevation of The Cottage, looking southeast. A change in colour in the bricks between the windows on the right of the picture shows where the outshut has been raised.

The bricks are laid in Flemish bond in the central unit and in the western outshut as a decorative feature for the main facade. There is a slight change in the quality and colour of brickwork indicating where the outshut has been raised to add an extra storey (Plate 2).

The apertures for the windows and door in the main part of The Cottage are topped with segmental arches of bricks laid as soldiers. The ground floor window is a UPVC replacement

but the upper floor is a wooden sash window. The wooden door is modern. The pattern of windows is repeated in the two storey western unit. The raised level of the outshut has a wooden sash while the ground floor window is a modern replacement. There are no arches above either window. The rainwater goods are modern plastic.

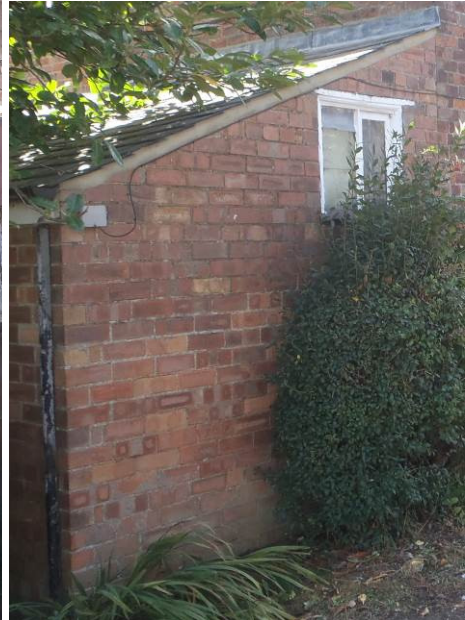
**Plate 3** (below). The 20<sup>th</sup> century extension to the east side of the building.

The eastern extension is mid-20<sup>th</sup> century and abuts the east elevation. The brickwork is stretcher bond with a small window aperture with a wooden framed window that opens on its western side.

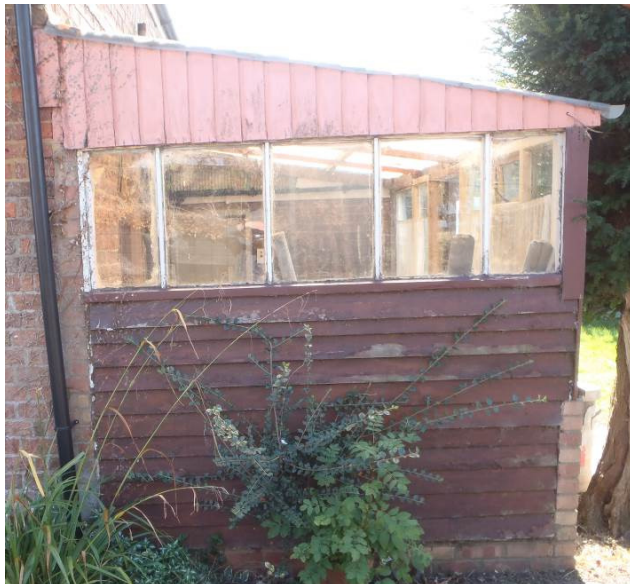
**Plate 4.** The north wall of the modern western extension

At the west end of the elevation, the north wall of the modern western extension is constructed from overlapping wooden panels on a brick footing. Above this, a window divided into five panes sits under vertical wooden boarding under a shallow pitched roof. This covers the original external wall.

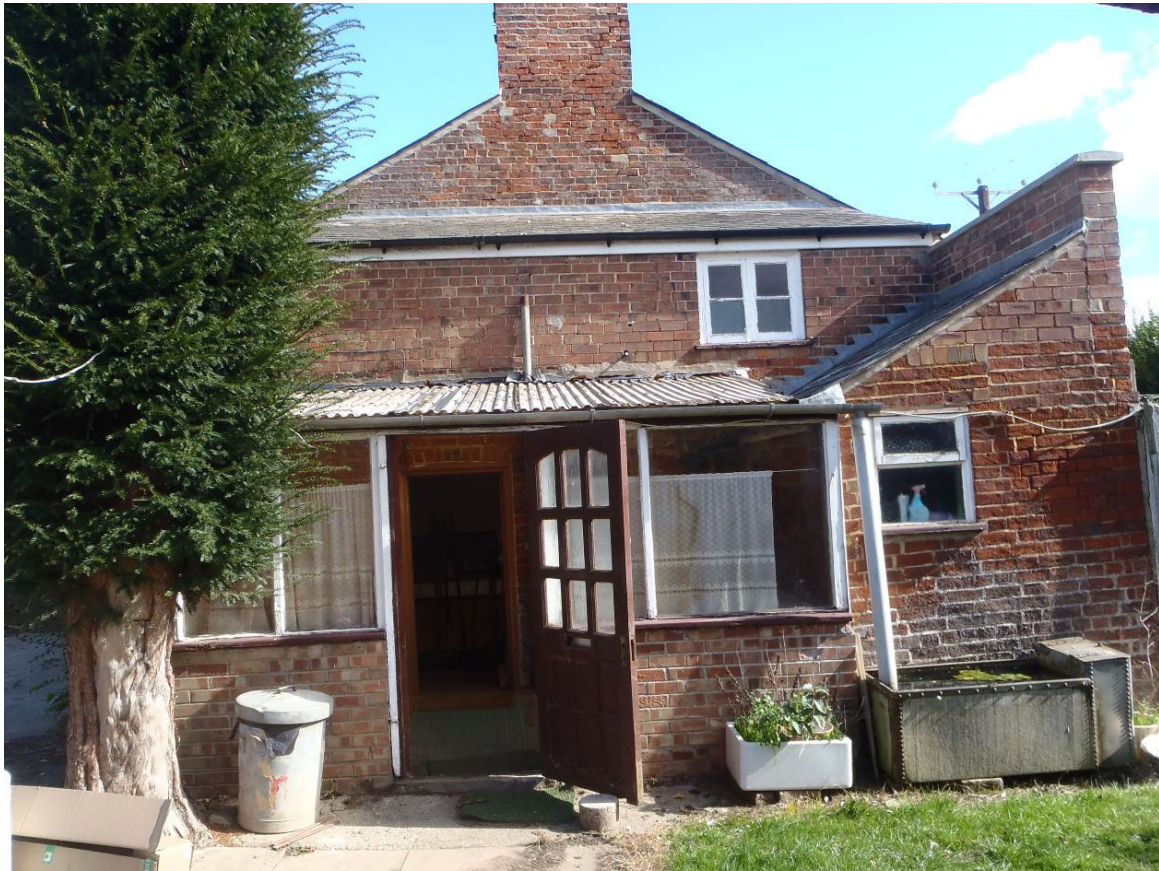
**Plate 5**

The west elevation shows several phases of the building which are demonstrated by conspicuous changes in the brickwork.

The western elevation showing the several phases of alteration to The Cottage

Topped with large glass windows and divided by a central door, the modern extension has bricks laid to 0.85m in height. These are laid in a stretcher bond and are 20<sup>th</sup> century machine made bricks.

The possible privy on the south end of the elevation did not appear on the map of 1888 but was present in 1904 and the bricks, laid in English Garden Wall bond, are in keeping with the early phases of the house. This privy was raised at roof level, probably when the southern extension and area of hardstanding was added. The bricks are laid in stretcher bond and abut a raised wall level that can be seen on the southern elevation.

The raised level of the outshut to form a second storey appears to have occurred as part of the same process. The bricks are of the same type appearing to date from the early to mid-part of the 20<sup>th</sup> century, and are also laid in stretcher bond.

The bricks of the gable end of the central unit are part of the original phase of the building and are laid mostly in English Garden Wall bond apart from where they form the downward line of the chimney stack.

The windows are framed in wood, the ground floor privy window appears to be a later insert while the outshut window is contemporary with the construction of the upper storey.

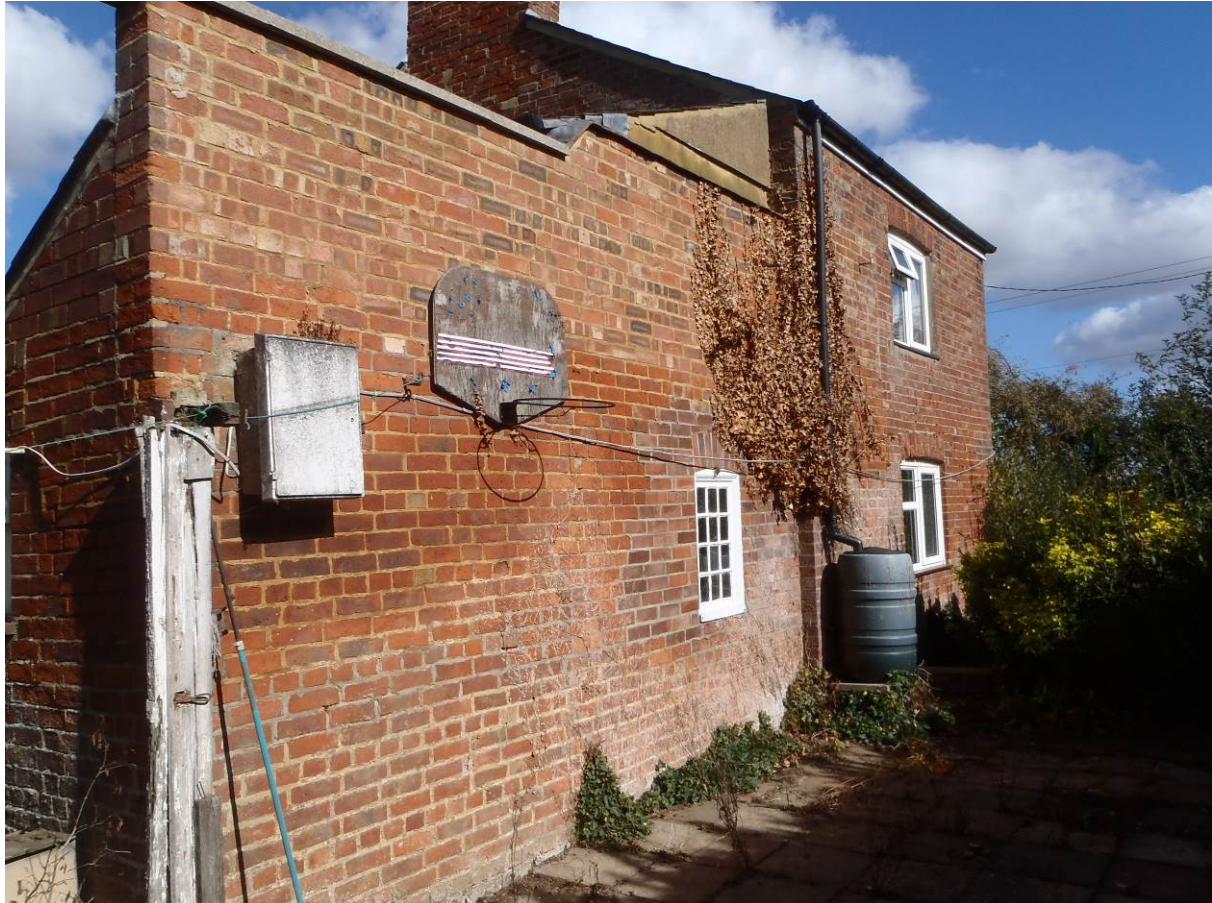
**Plate 6**

Oblique view of the west end of the south elevation with an inserted window and raised levels of brickwork forming new roof line

A flagged area has been added to the ground to the south of the privy at the southwest corner of The Cottage. This is slightly raised (approximately 0.3m) from the main body of the building. This formed the floor of a glasshouse/conservatory area that has since been demolished. This leant against the south elevation.

The lower part of the wall is of broadly contemporary brickwork to that of the main unit, being the slightly later addition of the privy. Where the lower level of the outshut, to which the privy is attached joins the building, an area of brick has been removed and a 12 light casement window inserted. This is topped with a soldier course segmental arch and the surrounding bricks are contemporary with those above that have been used to raise the height of the privy and add the second storey to the outshut. Most recently, this area was used for sorting potato crops.

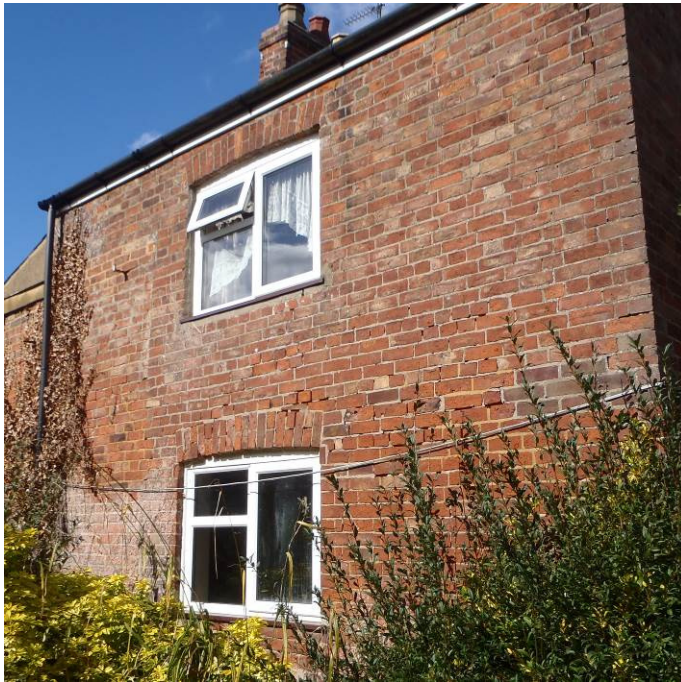
**Plate 7** (left) The southern elevation of the main unit of The Cottage

The main unit of The Cottage is relatively plain. The bricks, laid in English Garden Wall bond have a centralised window aperture for each floor with shallow segmental arches constructed from bricks laid as soldiers and rowlocks. Both windows are UPVC.

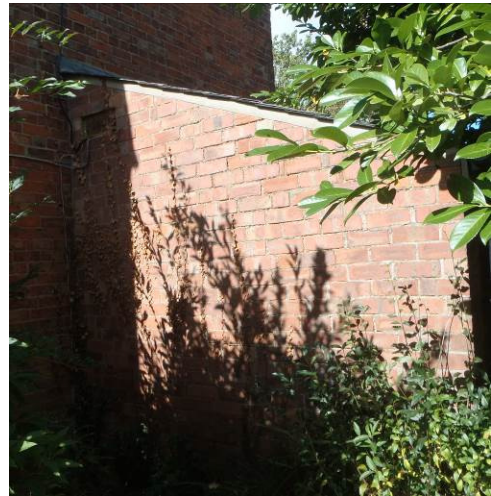
**Plate 8** (Below) Southern elevation of the eastern extension

There are no details or apertures on the south side of the eastern extension.

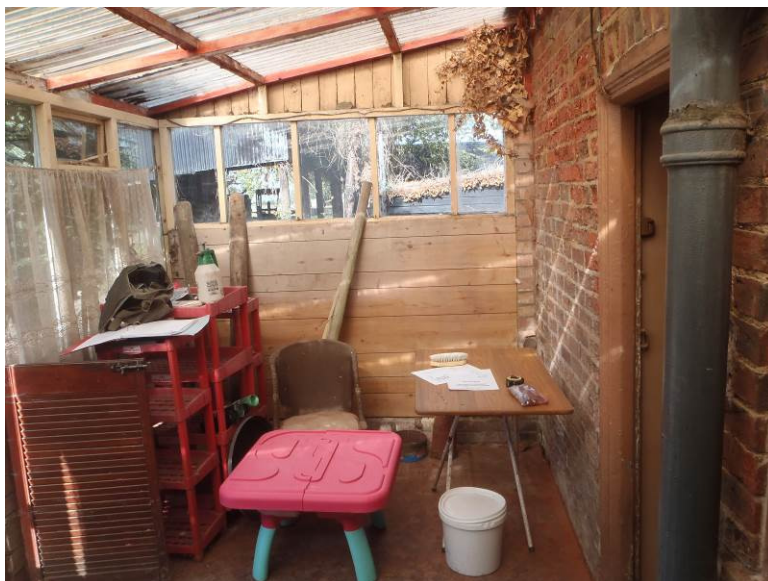
**Plate 9.** Room G1 at the west of The Cottage, looking north

Comprising a single skin of half height bricks that forms the western wall, the rest of room G1 is a wooden structure that encloses the area between the outshut that formed the original outer west elevation and the privy on the south side. The floor is concrete and the roof is Perspex. The room serves as a lean-to structure apparently used for storage.

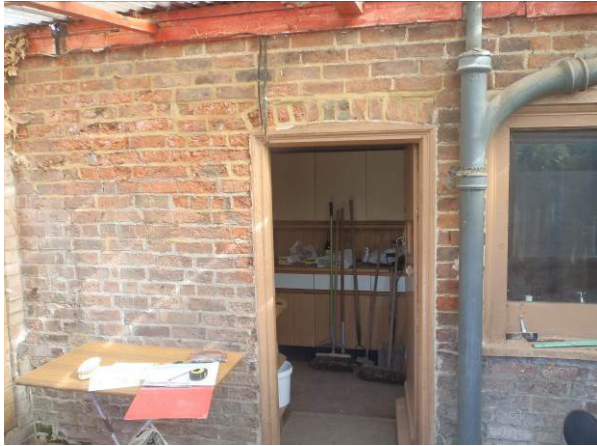
**Plate 10.** The original outer wall in Room G1

Enclosed within Room G1 is the original outer wall of the outshut. The door aperture may occupy an original position although it appears to have been altered and a window inserted to the south during the construction of the additional upper floor. The later brickwork above and between the door and the window can be seen to extend upwards externally. Original iron rainwater goods are present. The entrance to the privy is also contained within this room, the door to which may be contemporary with the line of bricks indicating where this was also raised.

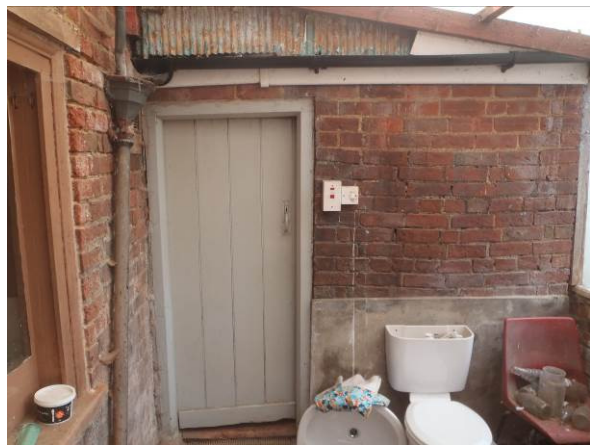
**Plate 11.** The enclosed wall of the outdoor privy

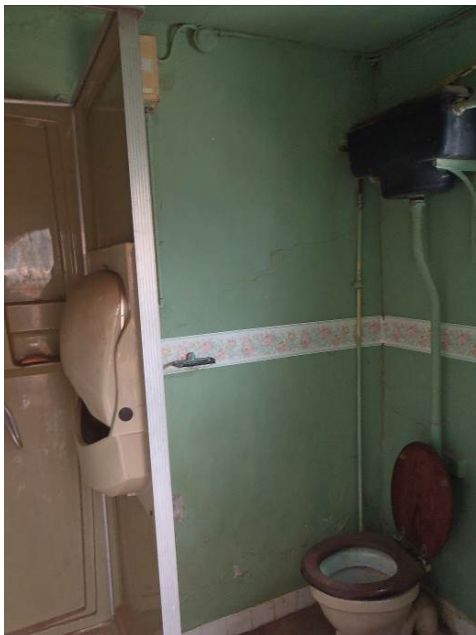
**Plate 12.** Room G2 in use as a downstairs bathroom

This room occupies what was probably originally an outdoor privy, and is in use as the same function but with an added shower.

Aside from the plumbing, the room is plain and is probably little altered from its original form.

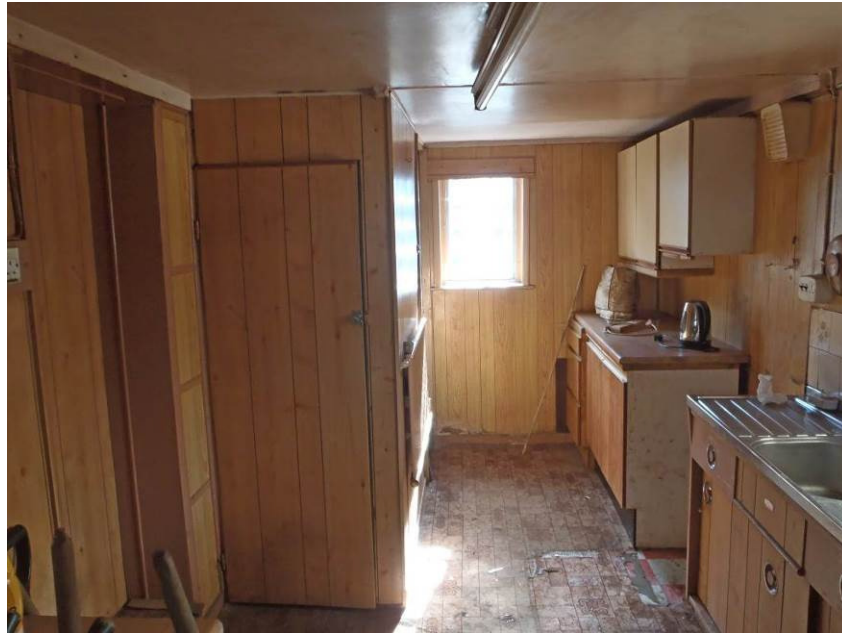
**Plate 13**  
Room G3 looking south

Occupying the original ground floor outshut, Room G3 contains the kitchen and panelled-in staircase. The door giving access is to the north of centre in the west wall. The floor is concrete with two visible phases of linoleum over the top. Each wall is panelled, including the space below the stairs at the south end of the room. This is not the original stair to the first floor. The north and south walls of the room have a window as does the west, now looking into Room G1. The kitchen units and sink are along the west wall. To the north of the stairs, a

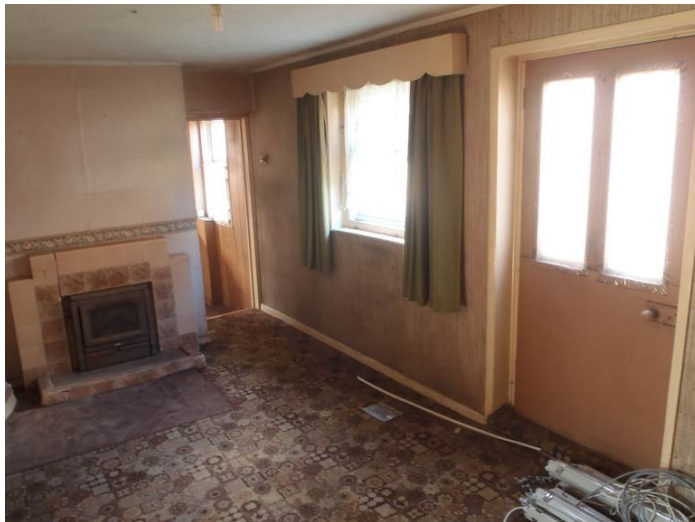
**Plate 14** (above left). Room G4  
looking northwest

Access to Room G4 is adjacent to the chimney breast and fireplace on the west wall. Sitting on a carpeted concrete floor, the hearth contains an enclosed metal burner and ashtray with a mid-20<sup>th</sup> century tiled fire surround.

In the north wall the main front door sits to the east of the window. In the east wall at the northeast corner of the room is a doorway leading to Room G5, inserted when Room G5 was constructed.

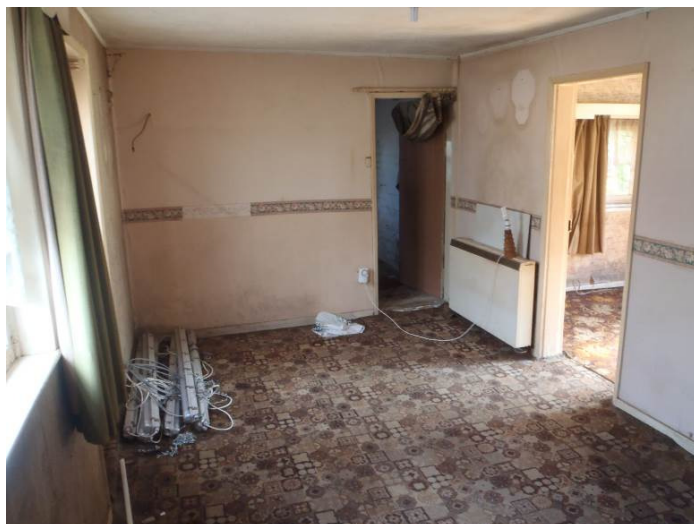
**Plate 15** (left). Room G4 looking  
roughly east

On the south wall a door leads into room G6. The ceiling is now covered by board and plaster but originally the staircase to the first floor was at the east end of this room. The current partitioning wall is at least in part a later replacement.

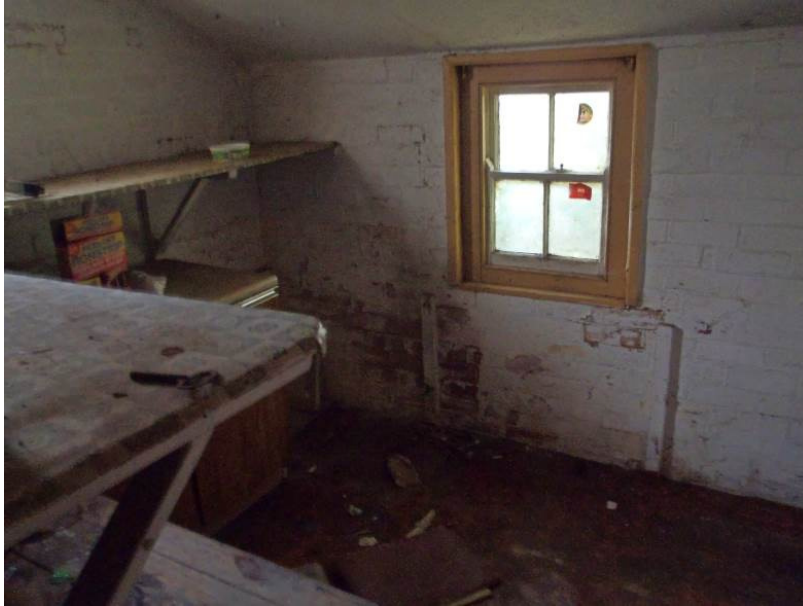
**Plate 16.** Room G5, a pantry, looking roughly east

Occupying the eastern extension that butts the east elevation of The Cottage, Room G5 has a concrete floor and bare painted brick walls with small windows in the north and east walls.

Wooden shelving and a storage unit are present indicating that the room was used as a pantry/store room.

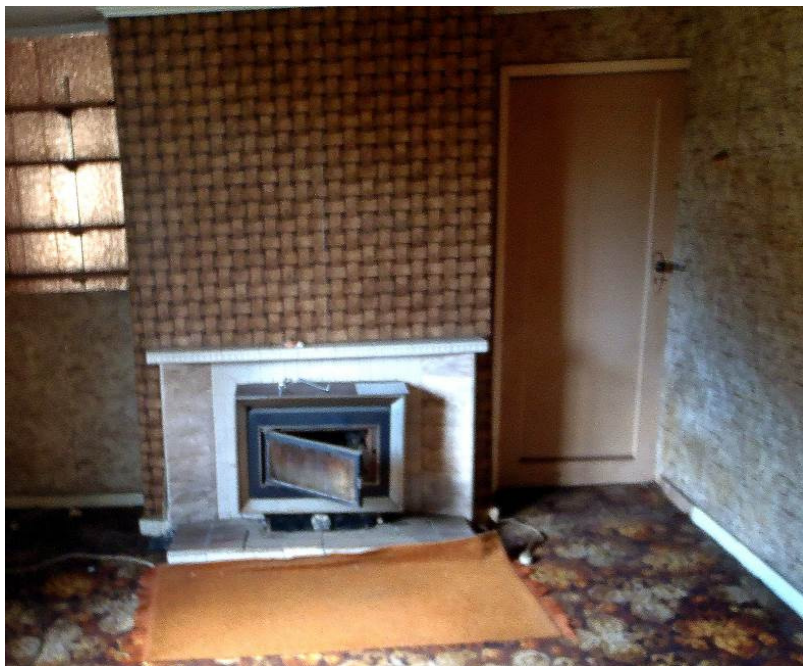
**Plate 17.** Room G6, one of the two main living spaces, looking south

A door in the south wall from the kitchen, adjacent to the hearth and chimney breast, provides one of the two access points to this room. As with room G4, the carpet sits on a concrete floor and the hearth has been enclosed with a metal burner and a mid-20<sup>th</sup> century tile surround. A large window occupies the south wall and the ceiling has been boarded and plastered.

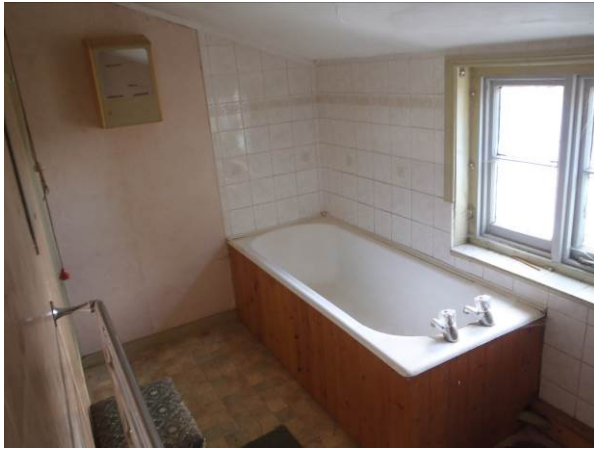
**Plate 18.** Room F1, looking southwest

The wooden floorboards in the bathroom are covered with linoleum. The west wall is tiled, as are part of the north and south walls where the bathroom furniture is situated. The window is central to the west wall of this room as it is partitioned. The positioning of the window apertures suggests that the partition is contemporary to the raising of the height of the outshot. The ceiling slopes with the roof pitch to the west and is boarded over.

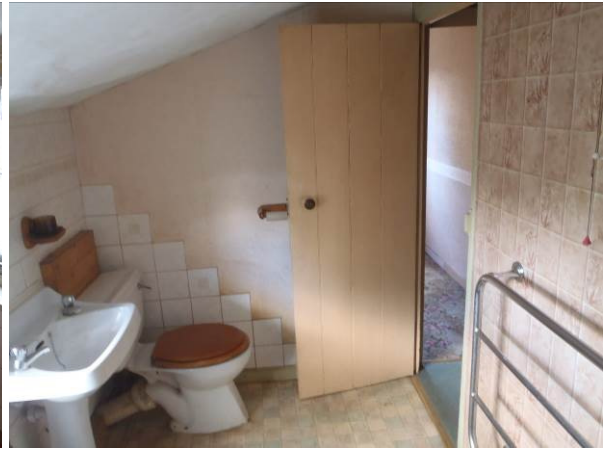
**Plate 19.** Room F, looking north

Within the partitioning wall and over the stairs, an area has been enclosed as a small cupboard that houses an immersion heater.

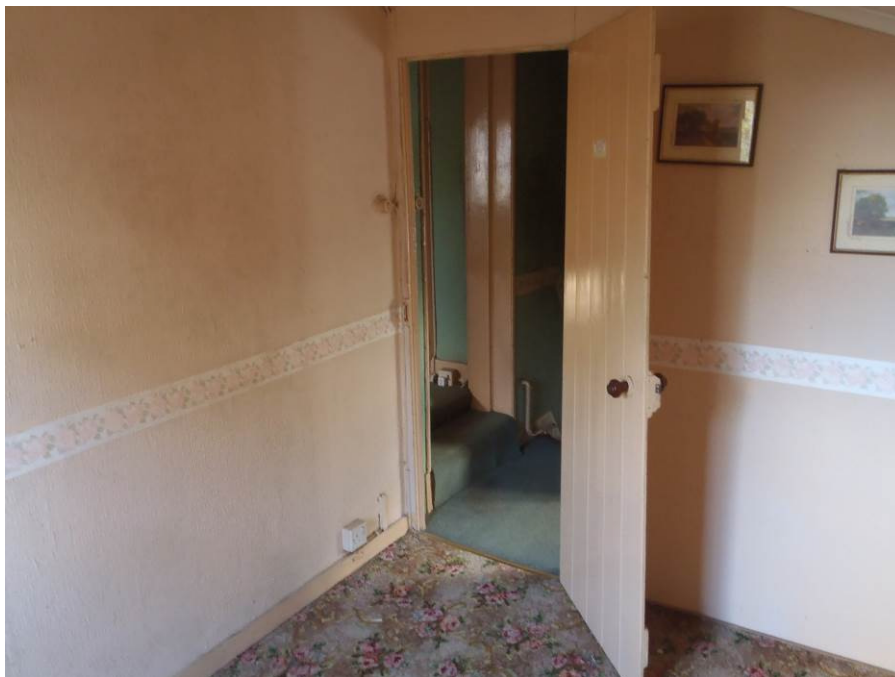
**Plate 20.** Room F2, looking southeast

Room F2, at the north end of the raised portion of the outshot is accessed from the landing. A small box room, it has carpet over the wooden floor. The partition wall between Room F1 is lath and plaster and also wallpapered. The eastern wall is brick and forms the back of the chimney breast for Room F3. There is a single window in the north wall.

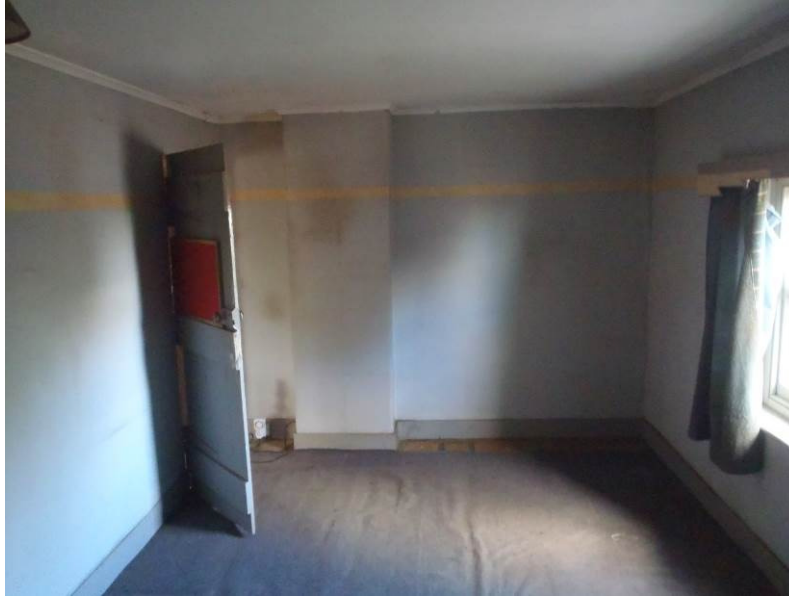
This room is the northern and smaller of the two upper rooms in the main range of the building. Two stairs lead to small circulation area and the room is accessed by a door in its southwest corner. The partitioning wall is not original, having been set further north when the new stair was constructed. A change in the floorboards at the eastern end of the room indicates where the original stair would have ascended in the main range of the building.

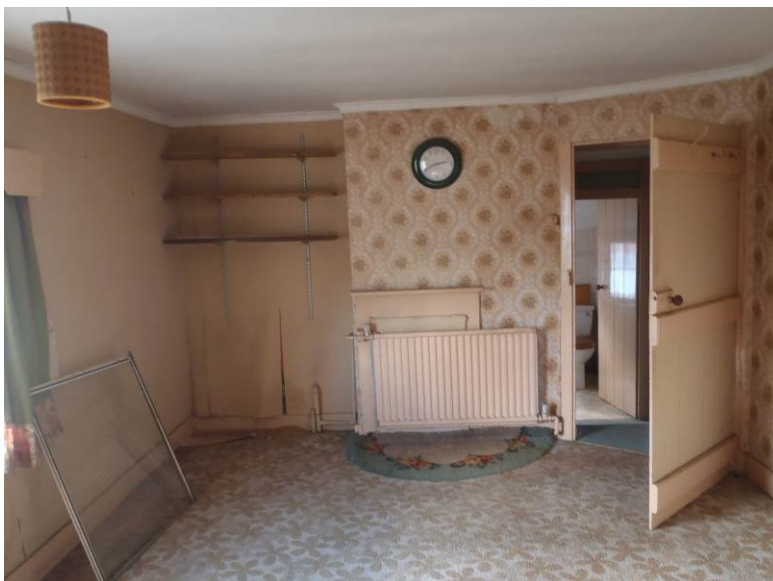
**Plate 23.** Room F4, looking west

Accessed by a corner door from the landing adjacent to the chimney breast, the larger of the two rooms as currently partitioned contains a blocked hearth covered by a radiator. The boarded floor appears to be uniform under the carpet. The window in the south wall sits over the ground floor window. There is no access to the roof space.

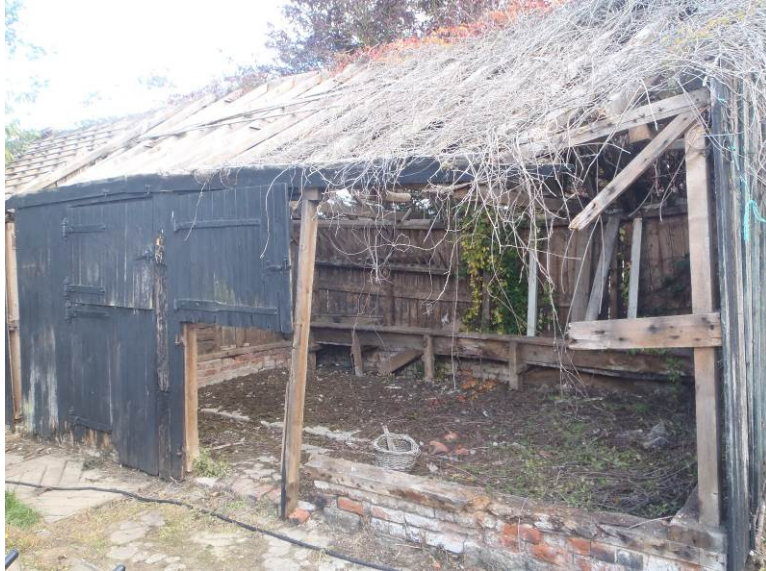
Much of the timber from the western wall is missing, along with the pantiles from the roof. The timber frame of the building is heavily rotted.

The base of the walls comprise five courses of brick that appear to be contemporary with the brick used in the first phase of the house.

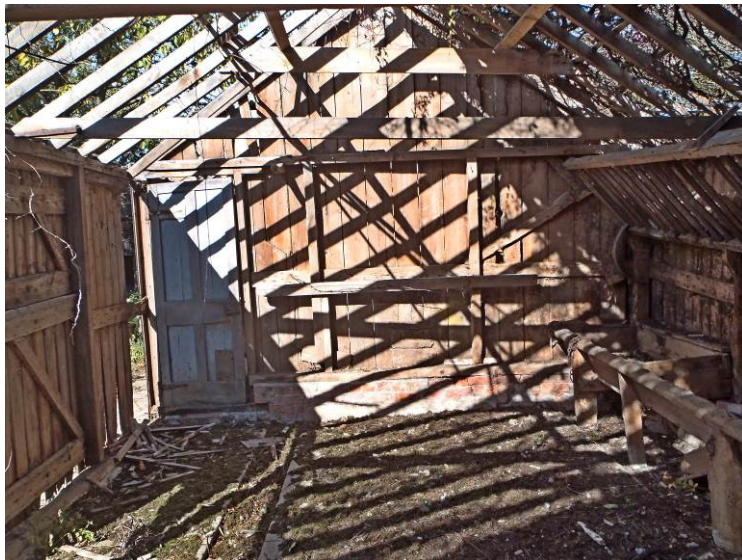
**Plate 25 (left).** Stables, internal, looking north

Internally there is a brick floor with a manure passage on the western side of the stable which runs to an outlet on the south end. Above this, the date 1930 is set in concrete suggesting a date for the alteration of the outbuildings. Along the east wall is a wooden manger with a hay rack above. None of the other internal divisions are present so it is unclear how many horses would have been stabled.

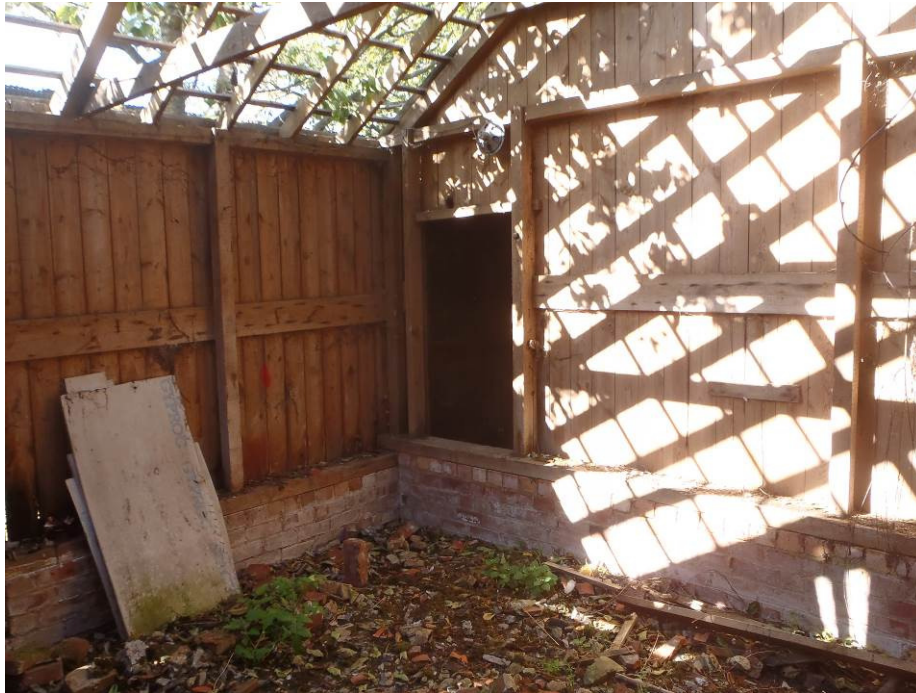
**Plate 27**

The brickwork of the internal dividing walls in this room is more likely to date from the 1930 alterations, or later and is several courses higher than those in the previous room, particularly on the north side where it is separated from the milking shed. The floor is also brick and the

**HISTORIC BUILDING RECORDING: THE COTTAGE, COWBIT DROVE, WEST PINCHBECK, LINCOLNSHIRE**  
timber walls are plain. As with the stable, the tiles are missing from the roof. The function of this room is uncertain but it may have served either as a loose box or a tack/store room for the stable.

The store room or loose box, looking northwest

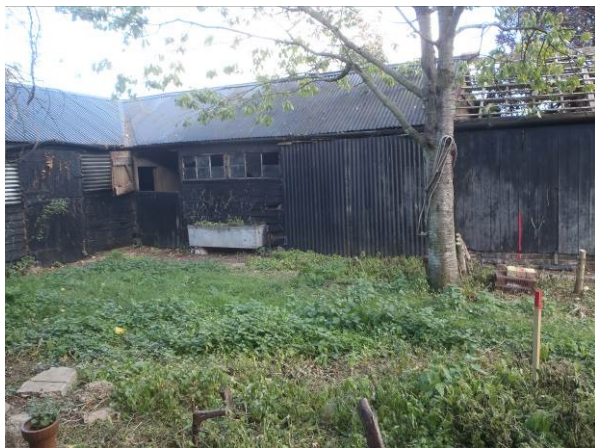
Enclosing the crew yard on the east and north sides, the remaining buildings are associated with milking.

**Plate 28.** The milking sheds, looking northeast

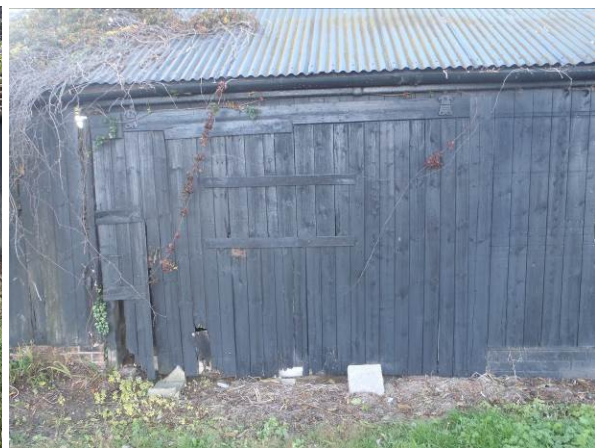
**Plate 29.** Sliding door, east elevation of milking shed

The shed in the north – south range has a sliding door that opens out towards Cowbit Drove in the east wall. The floor at this point is at general ground level. Internally, to the north of the door the floor is raised forming a milking platform. The remaining milking shed occupies the entirety of the east – west range of sheds at the north of the farm buildings where the entire floor is given over to milking. This is accessed from the enclosed yard by three doors and from the west end by a single large door below the covered machinery shed.

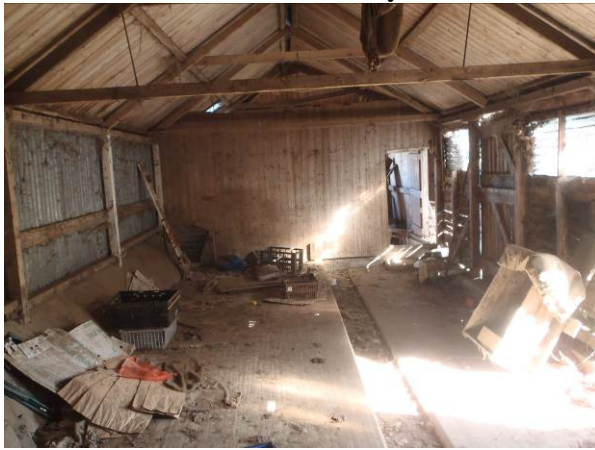
The roof timbers over both the north – south and the east – west range are a single contemporary construction and cover another small room in the northeast corner, the purpose

**Plate 30.** The milking shed in the east – west range, looking east

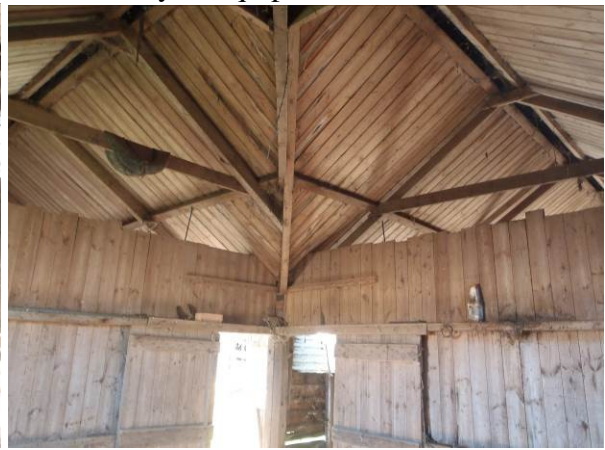
**Plate 31.** The roof structure where the building ranges join

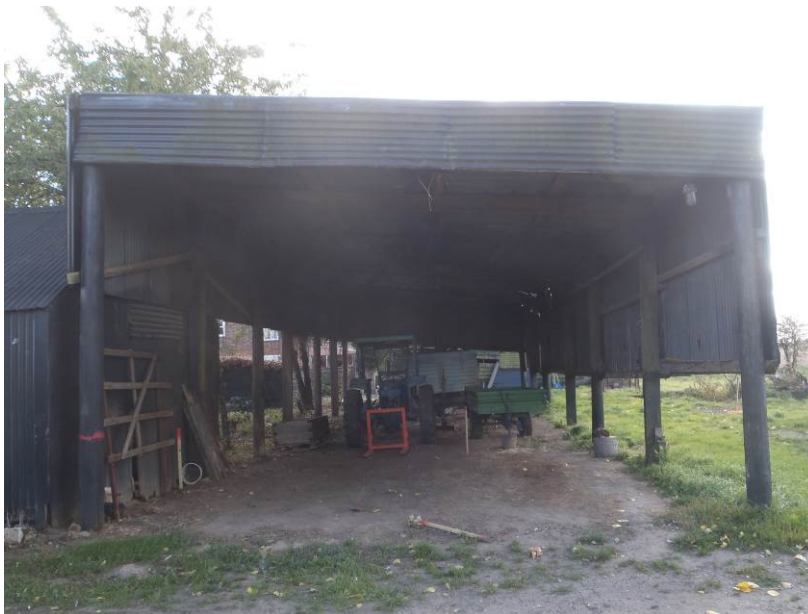
**Plate 32.** The covered machinery shed

The remainder of the main range of farm buildings is taken up, on the east side, by a large open sided covered shed with post built sides and clad in corrugated metal. This serves as a storage area for agricultural equipment.

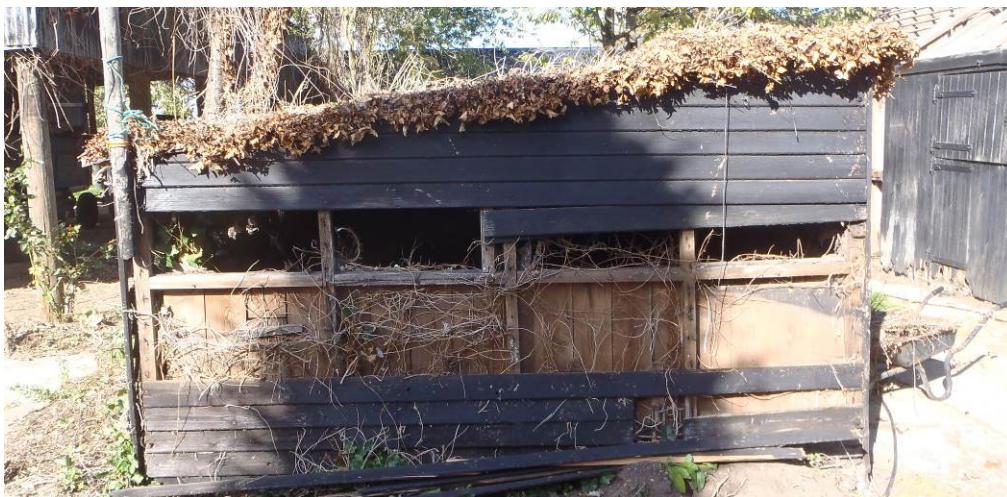
**Plate 33.**  
Pig or  
poultry shed

At the southern end of the farmyard there is a small timber built structure with a mono-pitched roof. Recently used to store coal, it may once have served as a pig or poultry shed. There is no internal evidence to suggest a definitive function.

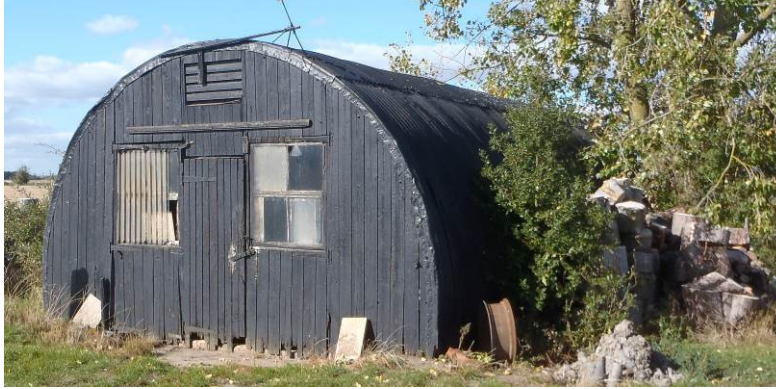
**Plate 34.** The Nissen storage hut

Of the remaining buildings that make up the overall farm, there are three isolated buildings that were constructed in the 20<sup>th</sup> century. Used for storage and built over a concrete floor is a timber and corrugated metal Nissen hut that lies to the west of the open sided shed.

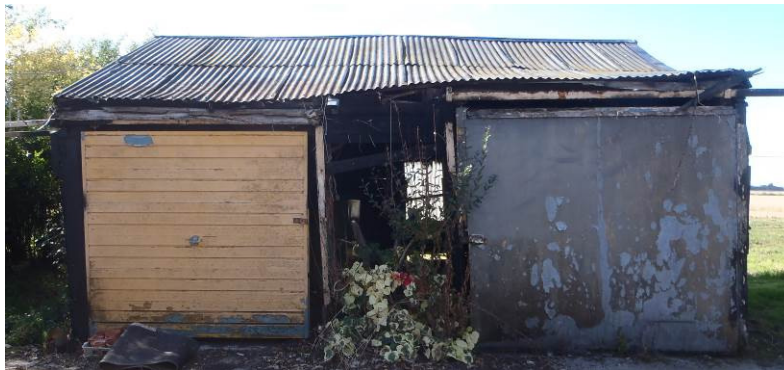
**Plate 35.** Modern double garage

To the south of this there is a timber and corrugated metal double garage which is in a poor state of repair and currently unused. It is of 20<sup>th</sup> century construction.

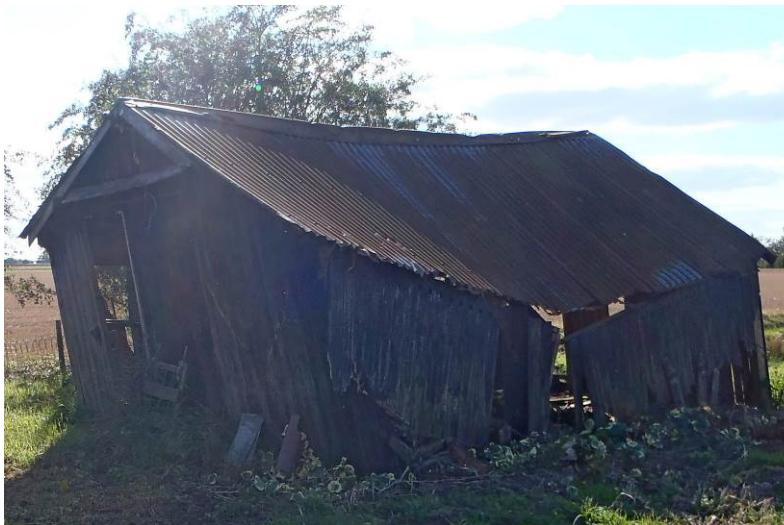
**Plate 36.** Dilapidated shed

Towards the western edge of the site, the final remaining farm building is a small dilapidated corrugated metal shed on a timber frame. The original use is uncertain, as is the date of construction, but it was built in the 20<sup>th</sup> century.
