**HISTORIC BUILDING RECORDING  
THE COTTAGE  
COWBIT DROVE  
WEST PINCHBECK  
LINCOLNSHIRE  
WPCD18**

Work Undertaken For  
**East Midlands Design Associates**

November 2018

APS Report No. **66/18**

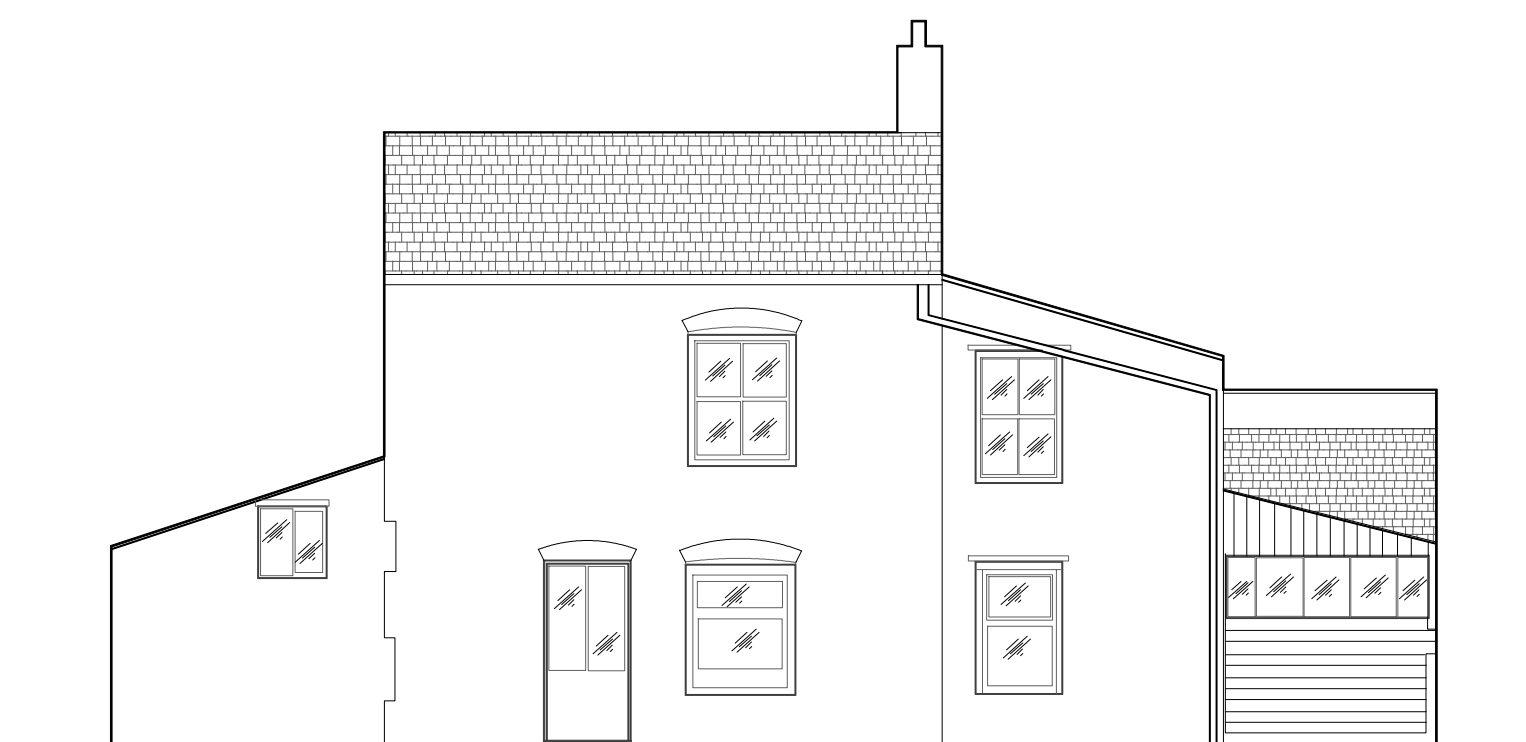
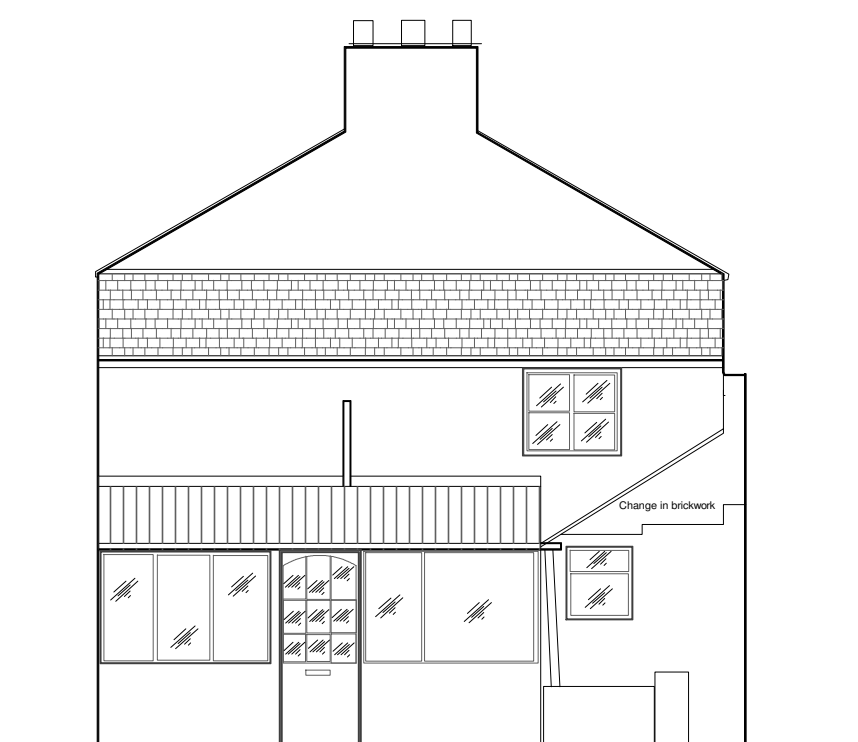
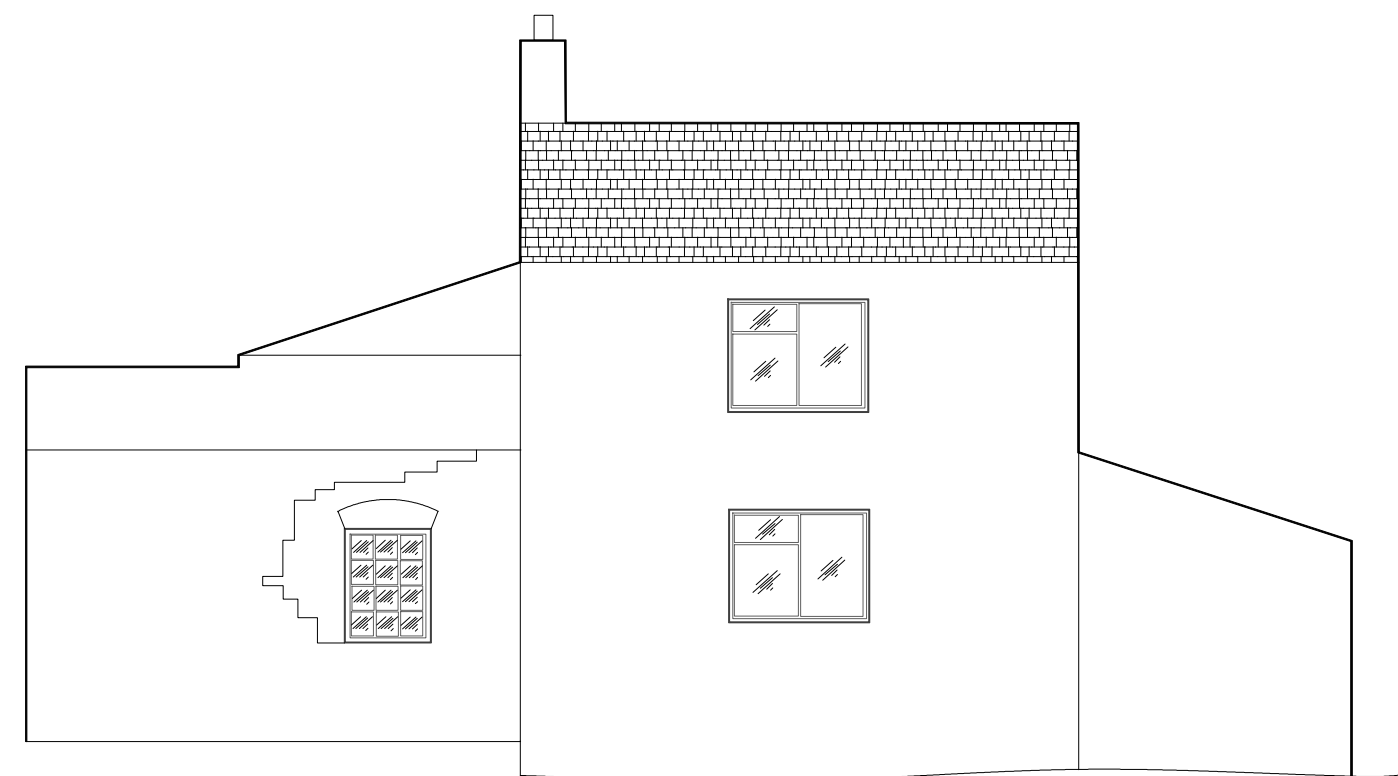
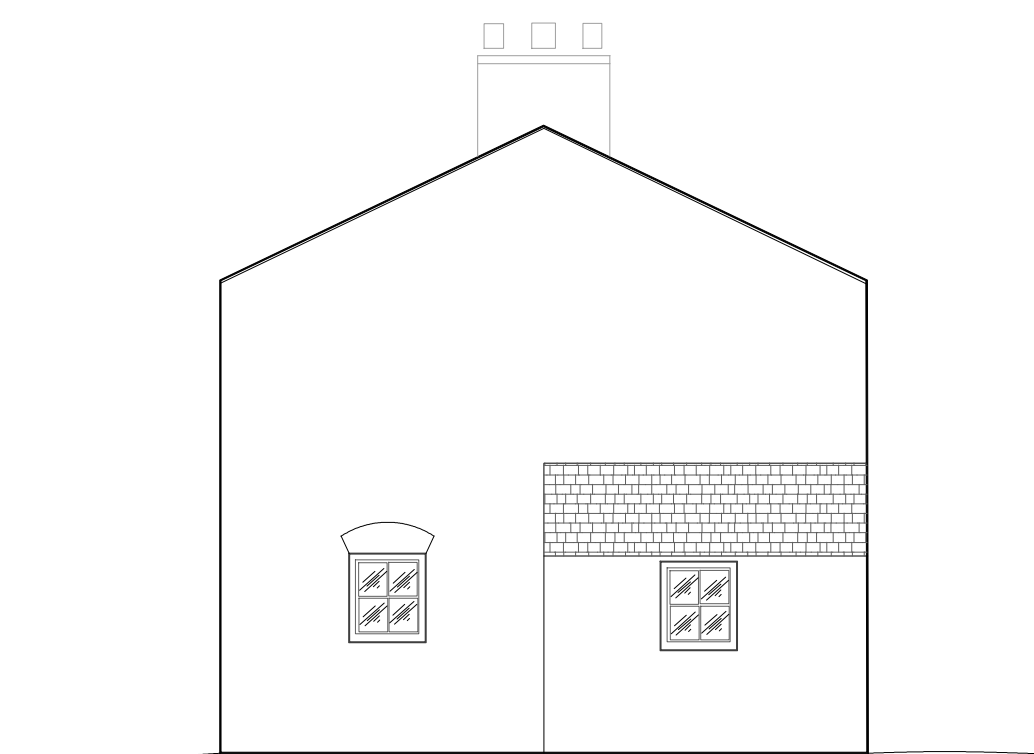
Figure 4. The Cottage Elevations

North Elevation

West Elevation

South Elevation

East Elevation

### **6.1 Exterior description (Fig. 4)**
