## **Stage One Environmental Desk Study of**

**Dovehirne Farm, Bourne Road**

**West Pinchbeck, Spalding, PE11 3NQ**

**REPORT NUMBER 17-08-01**

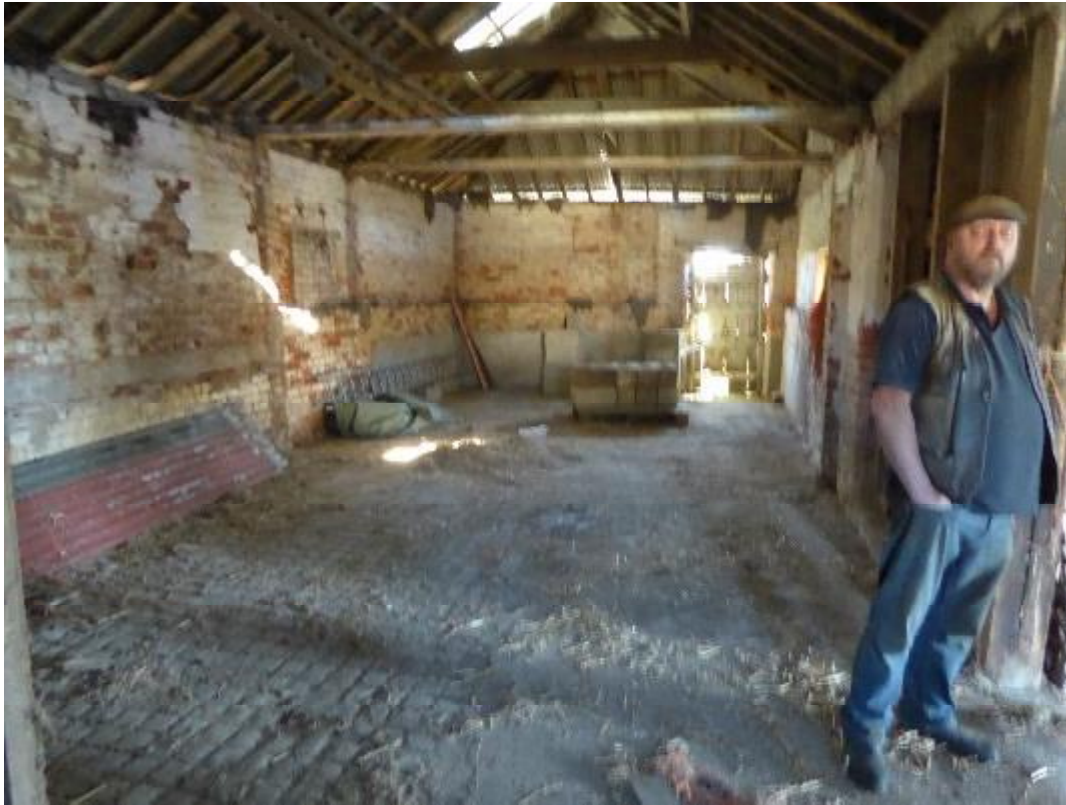
3.3 Michael pointed to the area of the barn in the northeast corner that is part of this development where a small diesel tank used to be located (photo 1). The tank was installed for use in an emergency and was hardly ever used. It was a square tank with a capacity of less than 1,000 litres and was emptied about 20 years ago and removed. The concrete on which the tank was located was at least 50 years old and was very clean with no trace of oily residues (photo 2).

Photo 1 Northern barn, location of diesel tank to far left corner

5.3 The diesel tank in the barn to the rear right corner of the site was a very small tank and was used only a very few times. It was removed about 25 years ago and the concrete under it is very clean with no oily stains. The heating oil tank at the west of the farmhouse is some way from the development and if small amounts of oil were spilled, it is unlikely that it would have migrated to this part of the site as the house and hard standing are between the source and the receptor. The risk of harm to the occupiers of the site is not significant and the risk is acceptable.

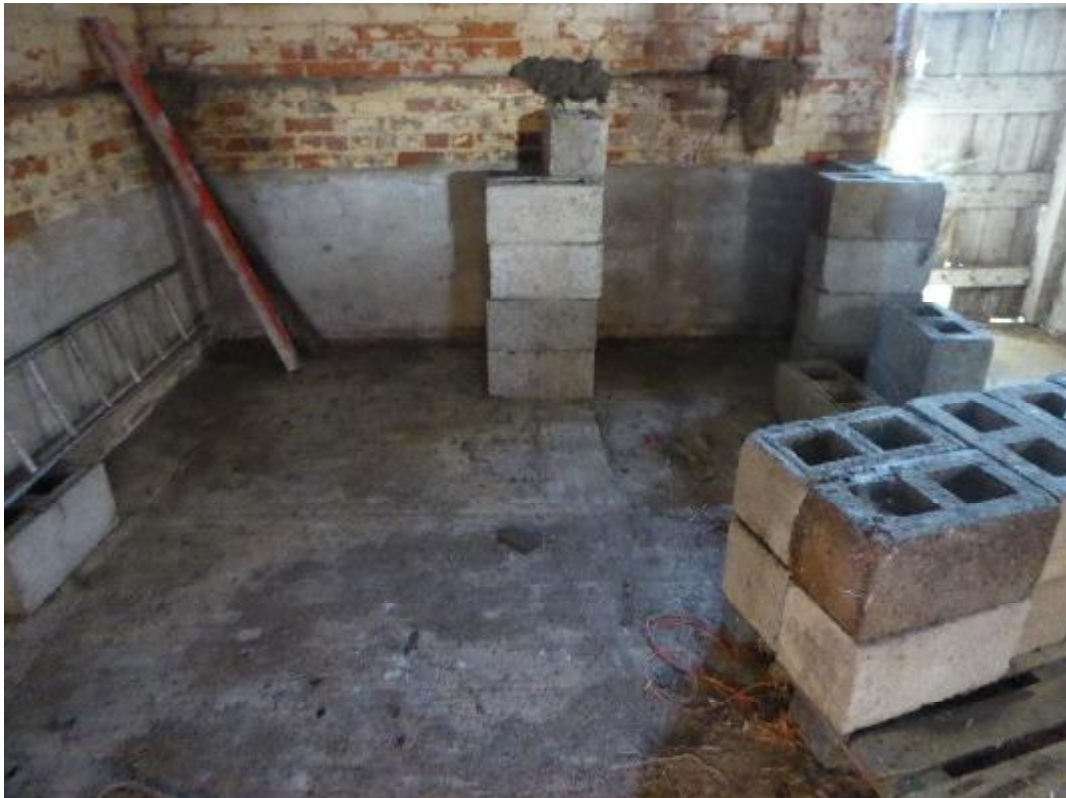
Photo 2 Very clean concrete with no evidence of oil staining from diesel tank

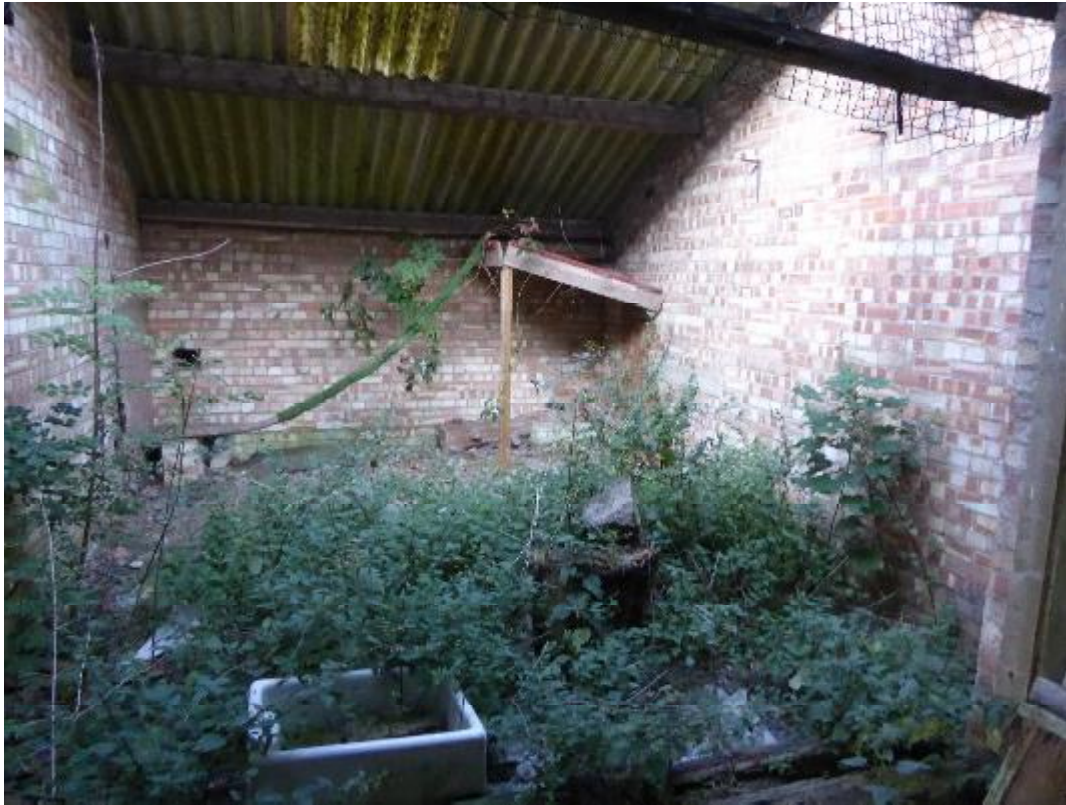
Photo 5 Enclosure in western barn that held birds of prey

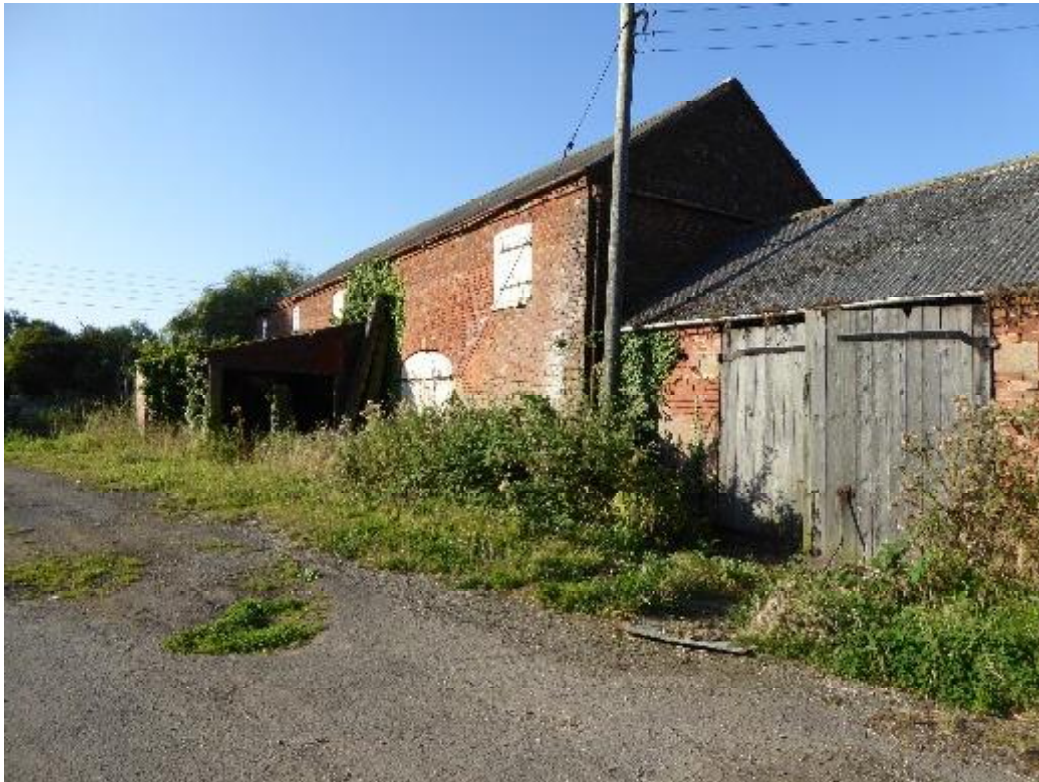
3.5 The entrance to the site on the eastern side is also that for the buildings and land that Michael is going to retain (photo 6). However, the access road may be moved to the field boundary to the east to allow the barn conversion to have some garden area. If this is done then the present access road and hard standing will have to be removed and soil of appropriate quality placed in this area.

Photo 6 Access to buildings and land that is to be retained by owner

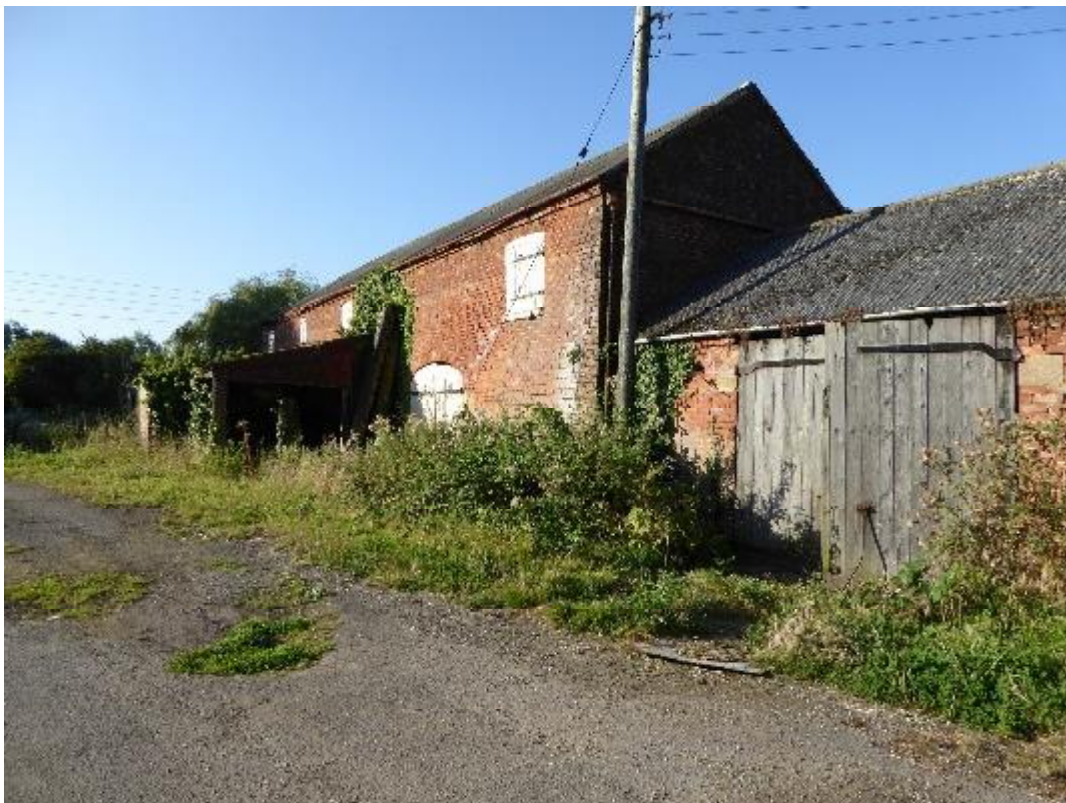
Photo 8 Eastern side of development with potential asbestos fibre sheeting

5.2 The potential cement stabilized asbestos fibres present a significant risk of harm to the occupiers of the developed site and analysis of samples of the sheeting should be undertaken

prior to removing it from the roof. The sheeting on the adjoining buildings should be considered to be a potential source of contamination and removed if found to contain asbestos fibres.

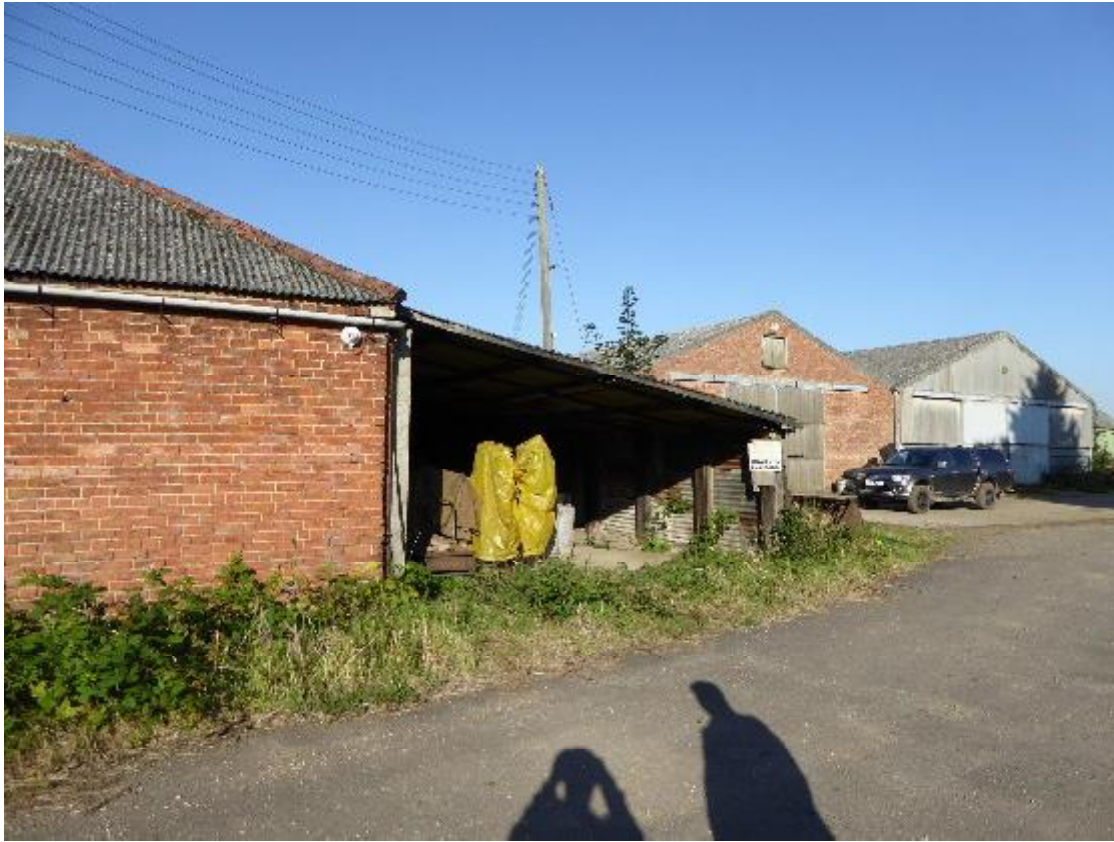
3.6 The tank marked on the Google satellite image was a fertilizer mixing tank of huge capacity ( $>20\text{ m}^3$ ), but the base and bund were very clean with no evidence of any hydrocarbons (photo 7). The single storey barns to the north of the site and the buildings adjoining these barns had what appeared to be cement stabilised asbestos sheeting to the roofs (photos 8 & 9). The land to the north of the site had no evidence for potential sources of contamination (photo 10) and the cement stabilised sheeting on the large barn (photo 9 to the far right) was in good condition with no damage evident.

Photo 9 Building attached to northern barn with potential asbestos fibre sheeting
