**Environmental Site Investigation of  
Cuckoo Bridge Farm, North Drove  
Spalding, Lincolnshire, PE11 3JY**

**REPORT NUMBER 20-04-01/2**

## **Environmental Risk Assessment of Cuckoo Bridge Farm**

**Planning Application No. H14-0187-20**

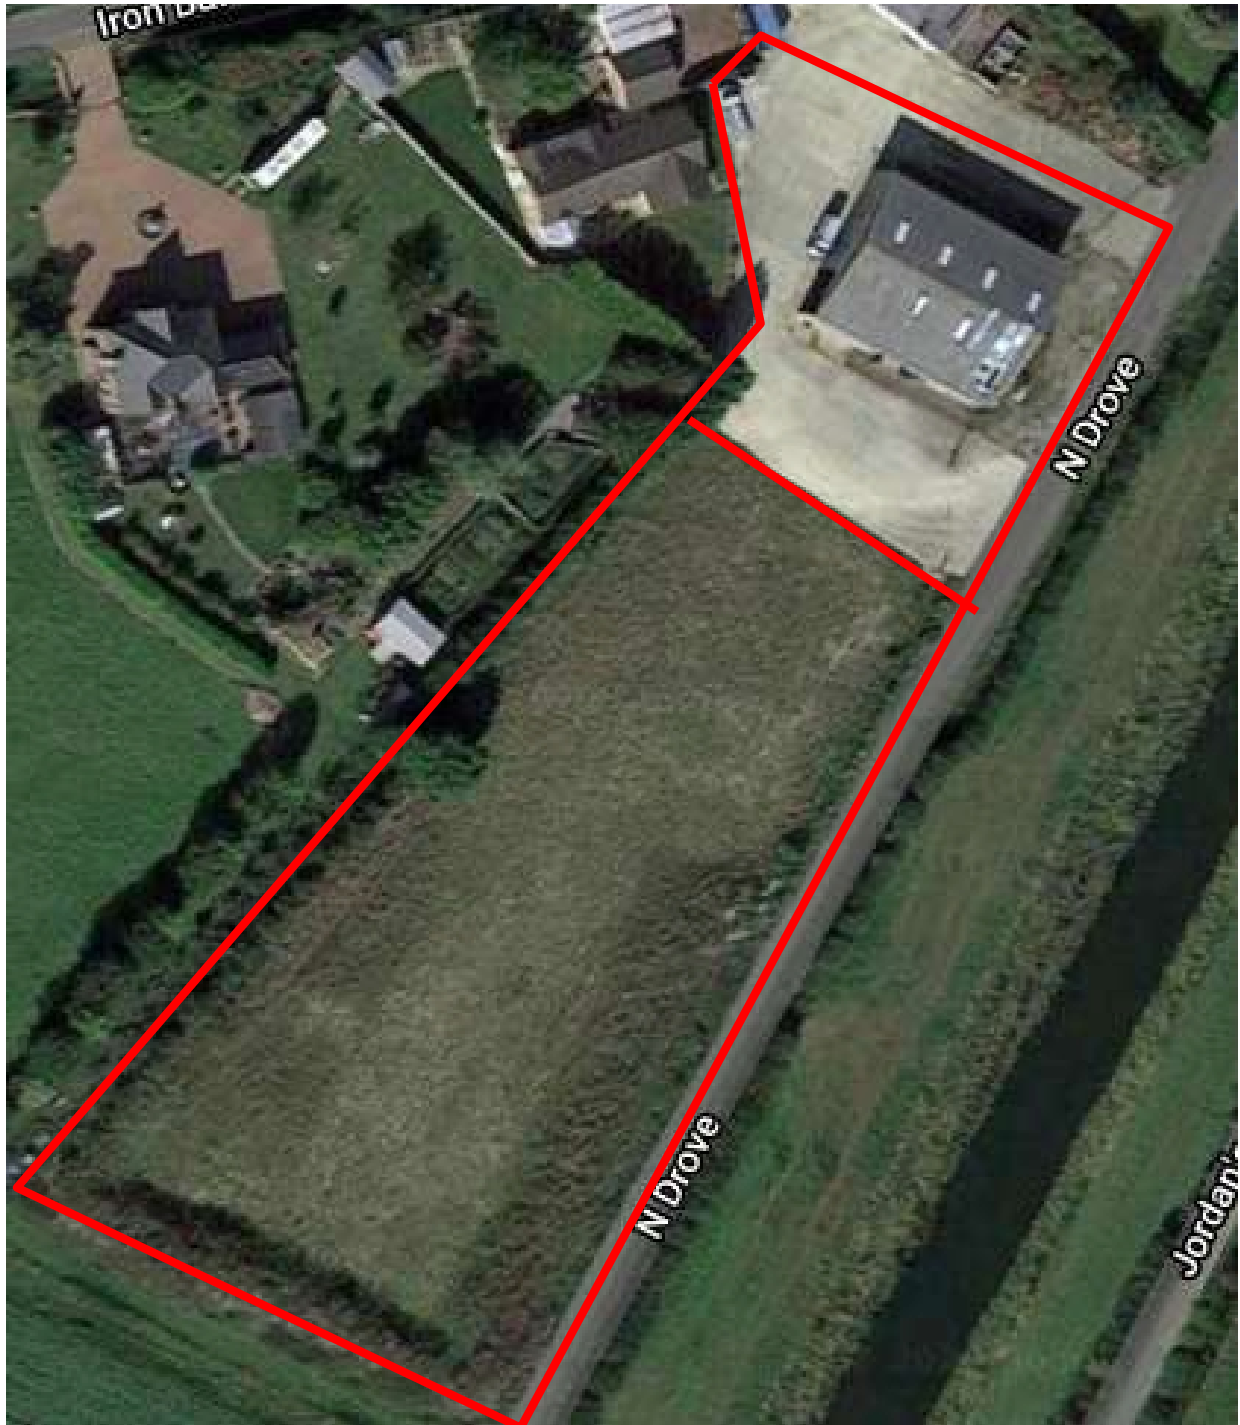
Figure 1 Google aerial image of 2020 showing paddock area and concrete covered area

2.2 The Google aerial image in the Sitecheck Data report shows that site is in a rural area with a few houses near the site. The Google image photographed in 2020 in Figure 1 shows the area that appears to be grassed and the area that is covered in concrete.

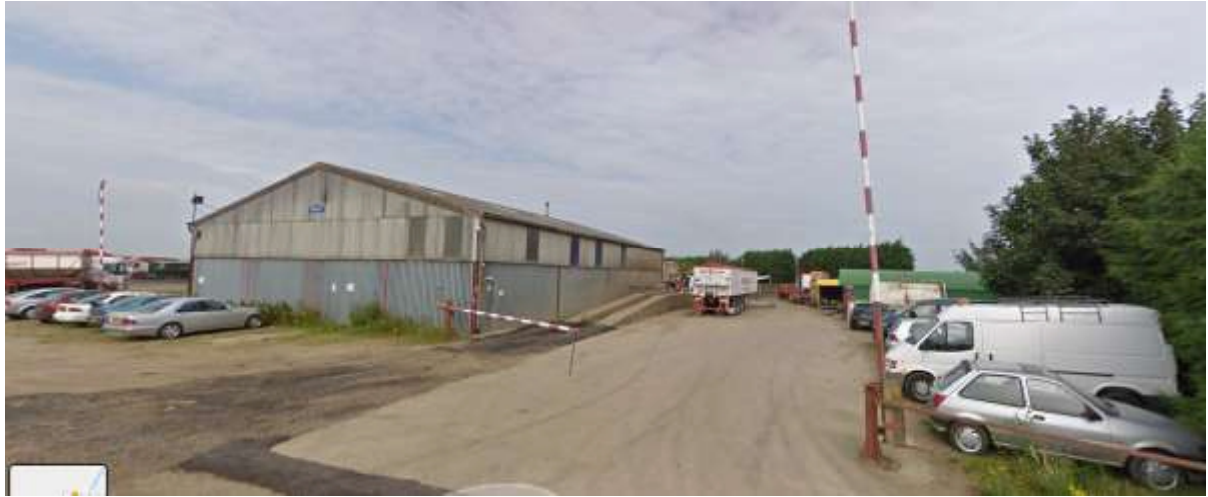
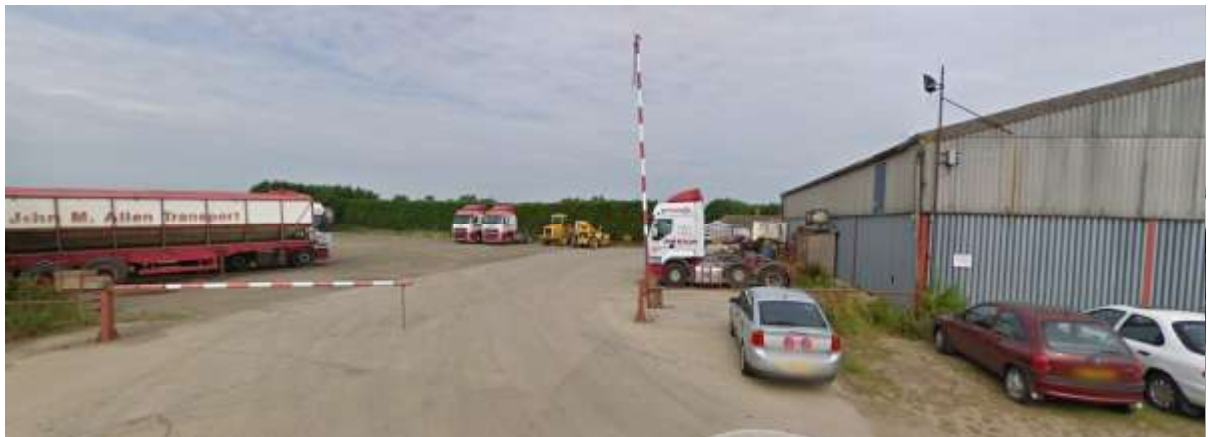
Figure 2 Google street level photograph taken in July 2009

2.4 Under current land use for the surrounding area, two sewage discharge consents are marked at about 40 m to the north and 200 to the northwest and an inactive road haulage services is marked at about 40 m to the northeast. The actual business operated from the main part of this site, as seen in the Google street level photos of 2009 (figures 2 and 3)

3.4 The large shed has potential cement stabilised asbestos sheeting at height with steel sheeting from ground level up to about 3 m high (figure 2 and 3, photo 6 and 8), the only exception seems to be where a large door for access to the shed has new sheeting (photo 9). However, the sheeting appears to be quite recent and may not contain asbestos fibres. The interior of the large shed is extremely clean with no trace of oily deposits or fuel on the concrete (photo 10). A paint spray booth is located in the top right hand corner of photo 10, but bore little sign of use. Jeff Robinson explained that it was cheaper to use a specialist paint shop than to prepare the paint and the spray booth for use, so it has not been used for some time.

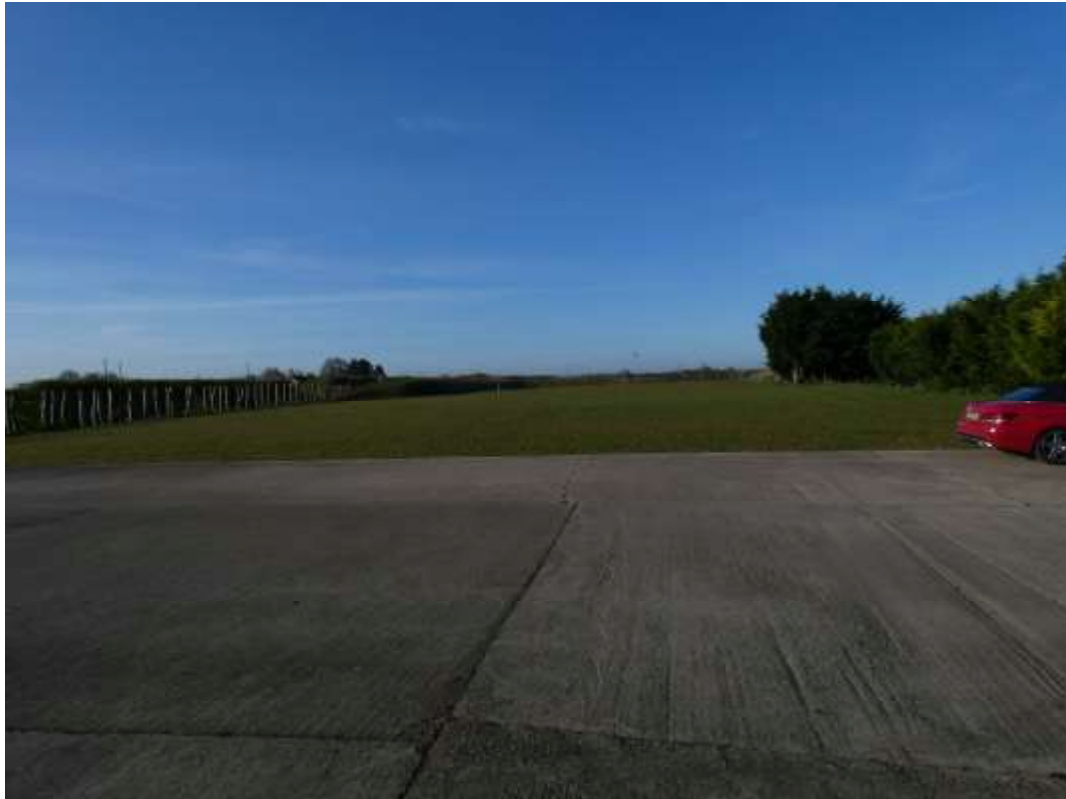
Photo 1 Concrete area with paddock to the southwest

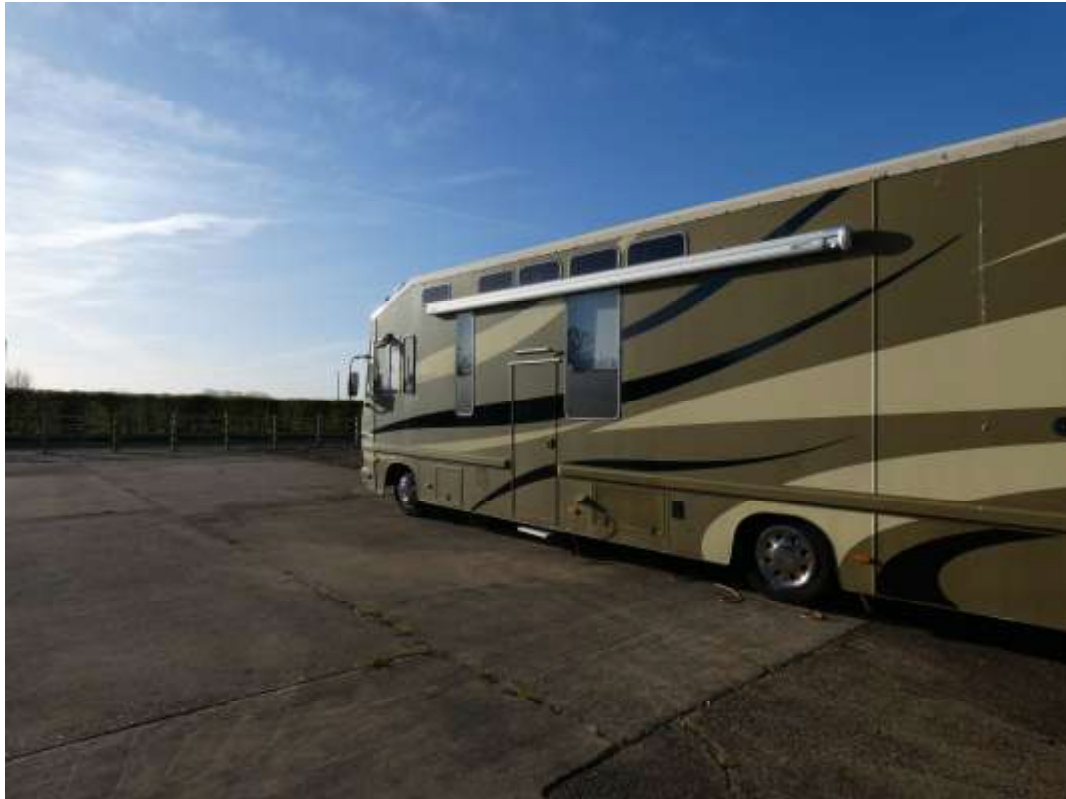
Photo 3 Concrete area to north eastern side of large shed looking toward road

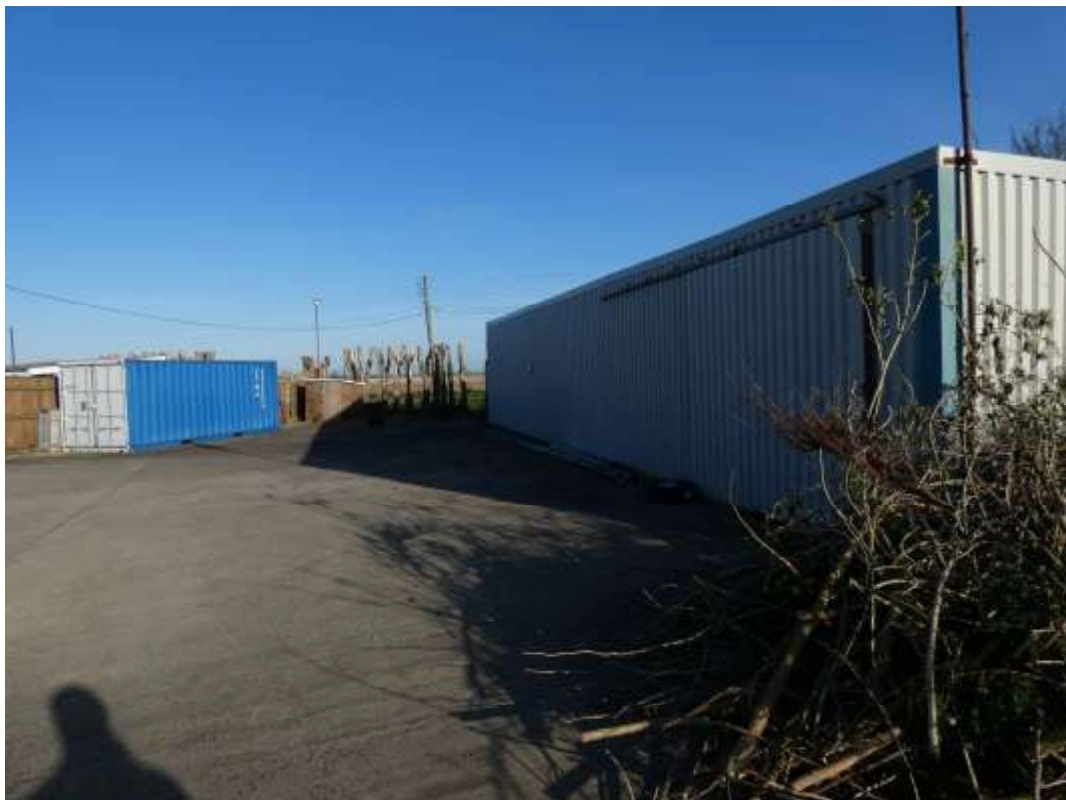
Photo 4 Concrete area near small shed looking toward northwest

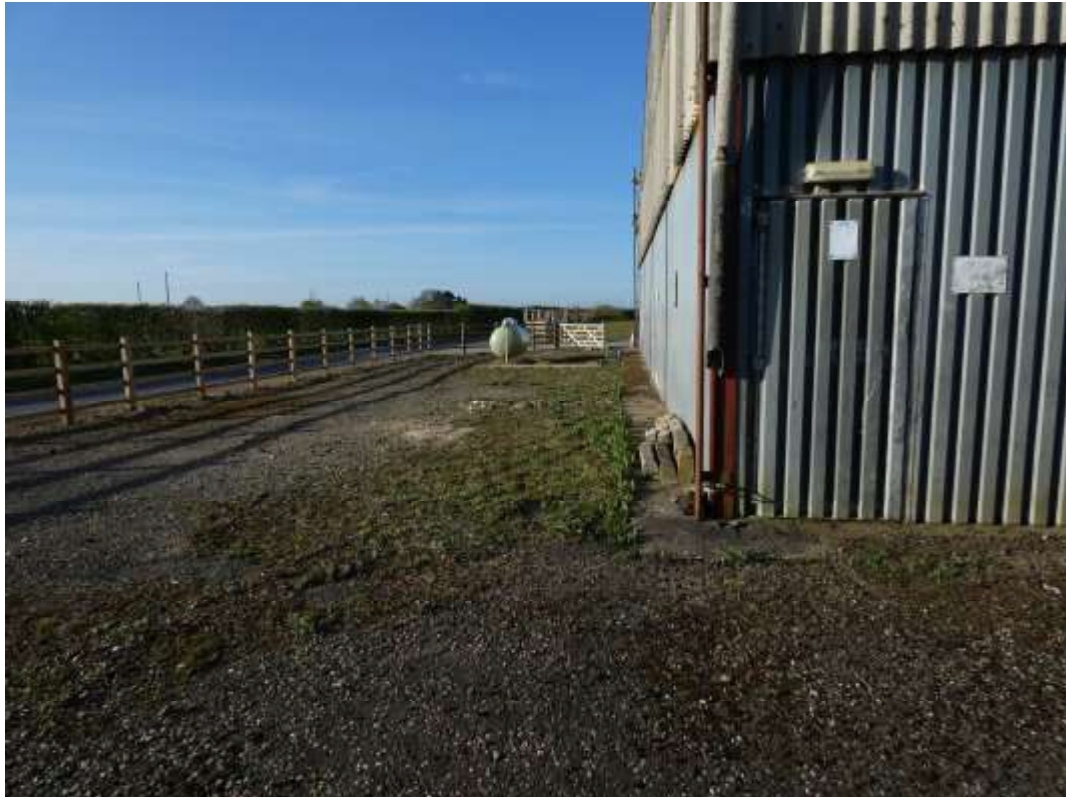
Photo 5 Compacted gravel between large shed and road

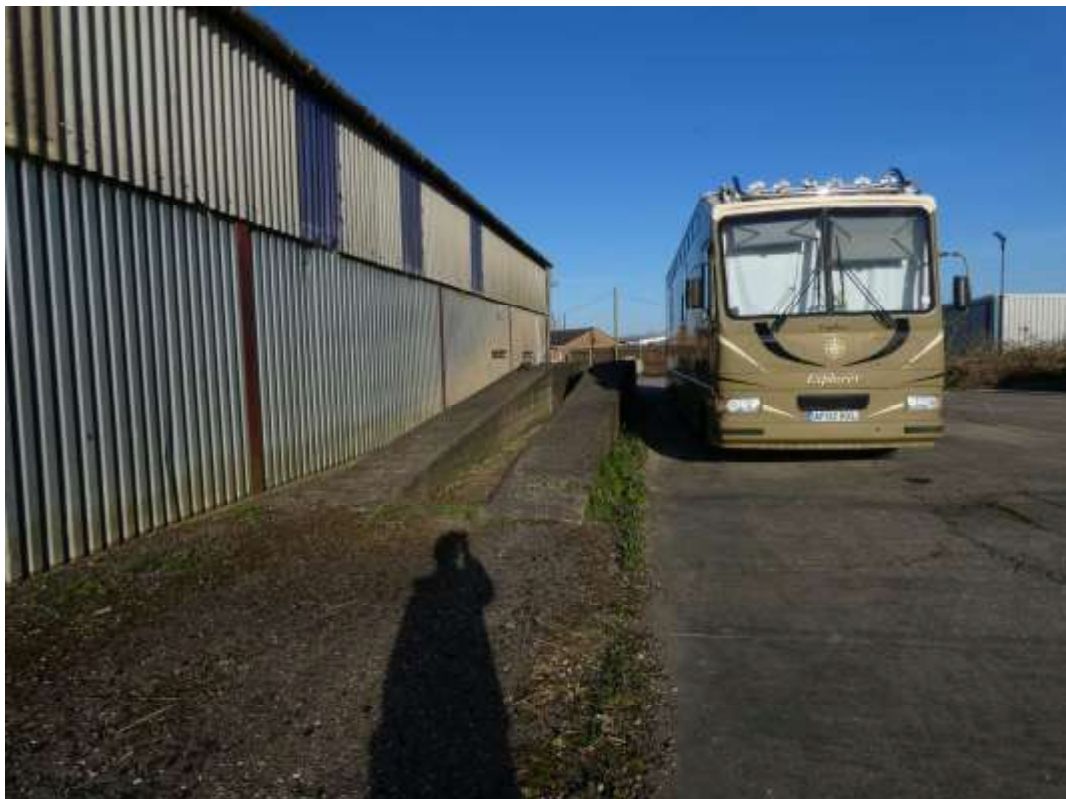
3.3 A road haulage business is potentially contaminating, but that depends on the careful operation of the business. Jeff indicated that a small fuel tank was located on the corner of the large shed (photo 8) but there was little evidence for that, except that the concrete appeared to have remnants of a structure on that could have been a small bund that has subsequently been removed. The bund near the small shed (photo 7) did not show any signs of oily contamination on the walls and vegetation was growing inside it, suggesting that little or no hydrocarbon contamination was present inside the bund. The gravel around the bund was also very clean. A very close inspection of the concrete did not find any discoloration associated with hydrocarbon contamination (photos 1, 2, 3 and 4). All the joins in the concrete sections were very clean as was the gravel under the ramp and the ramp itself (photo 6).

Photo 6 Compacted gravel along north eastern side of large shed and concrete ramp

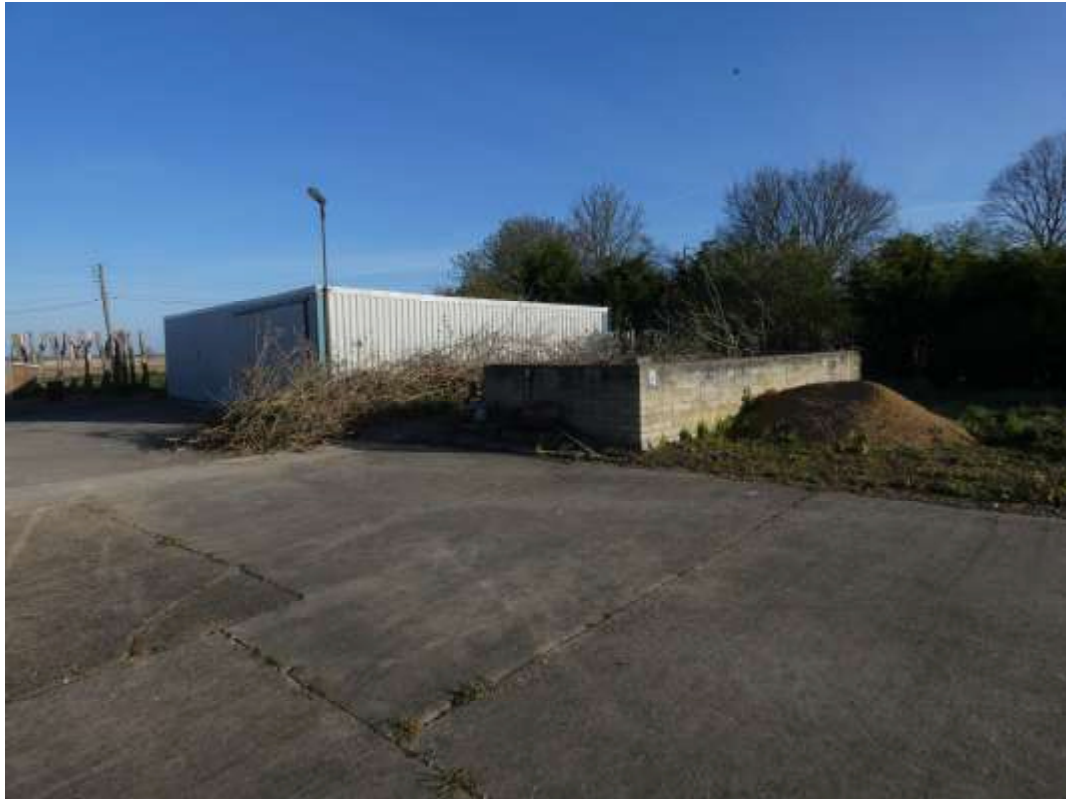
Photo 7 Small shed with gravel area to south eastern side and bund for fuel tank

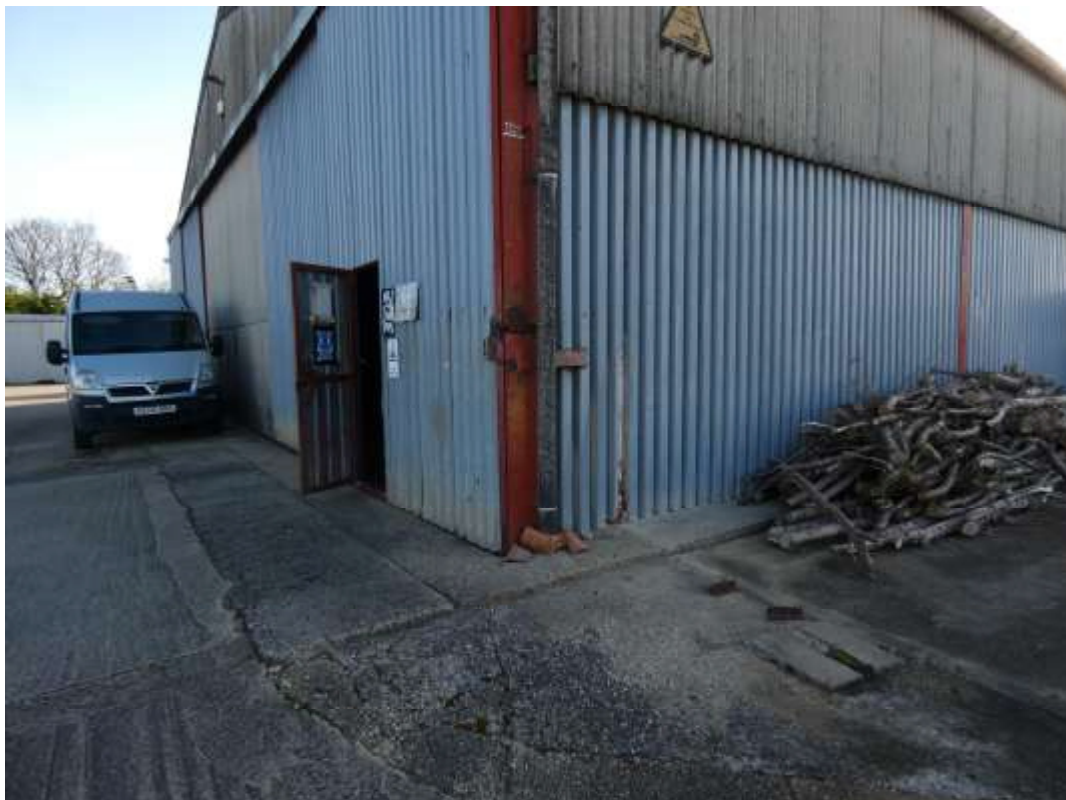
5.1 The cement stabilised sheeting with potential asbestos fibres is in very good condition and will not present a significant risk of harm to the occupiers of the site unless the sheeting is damaged or altered. This is very unlikely as there are no large vehicles on site that can damage the sheeting. It is now, and remains, the responsibility of the site owner to use competent contractors if alterations to the sheeting are carried out. The risk of harm to the occupiers of the site from asbestos fibres is not significant and the risk is acceptable.

Photo 8 Western corner of large shed showing potential asbestos containing cladding

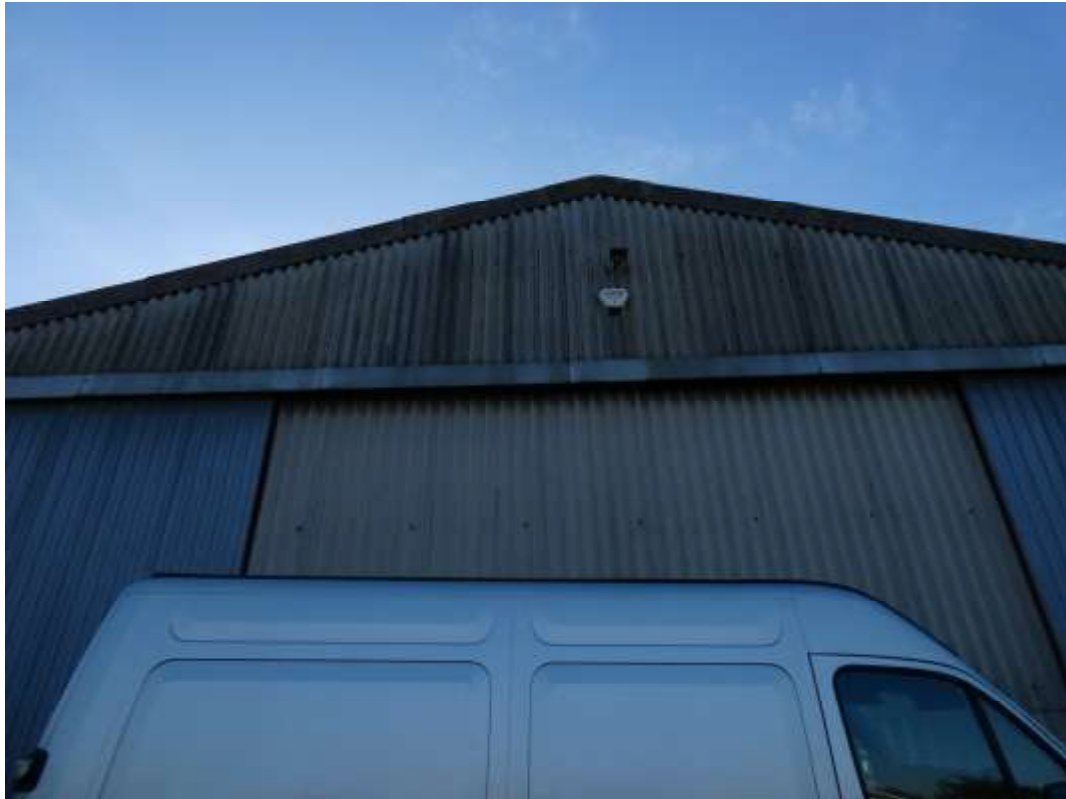
Photo 9 New section of sheeting on door between steel sheeting.

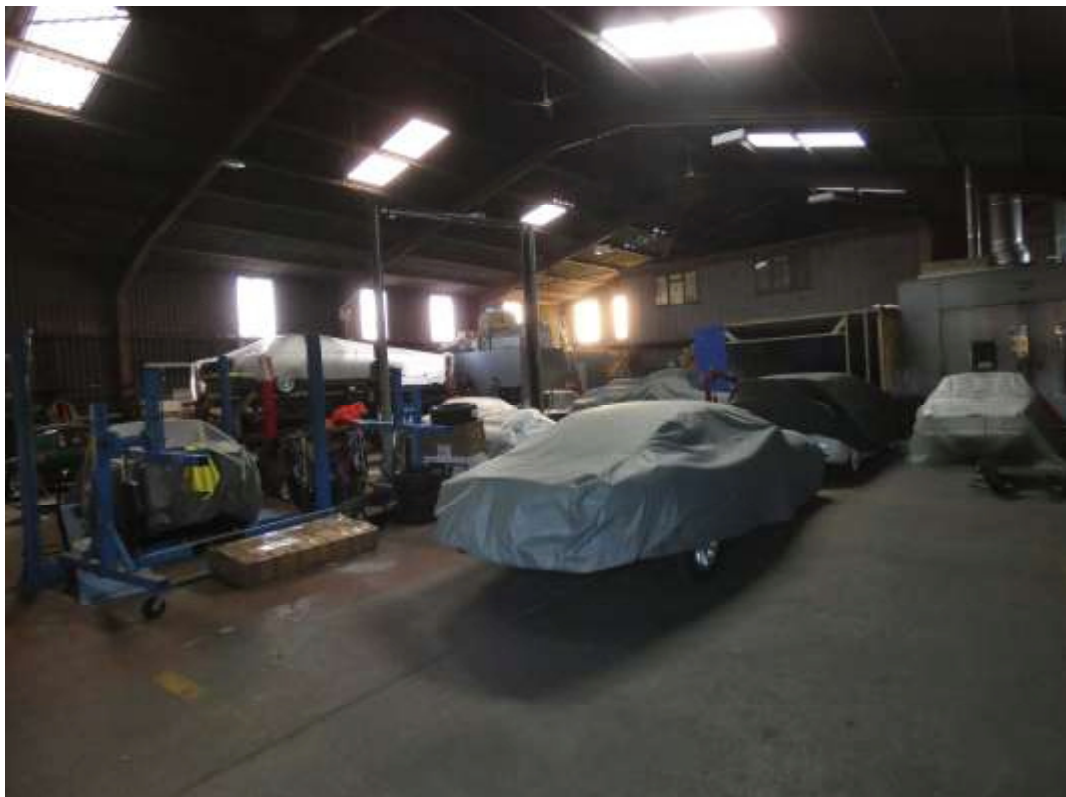
Photo 10 Interior of large shed with paint spray booth in right corner

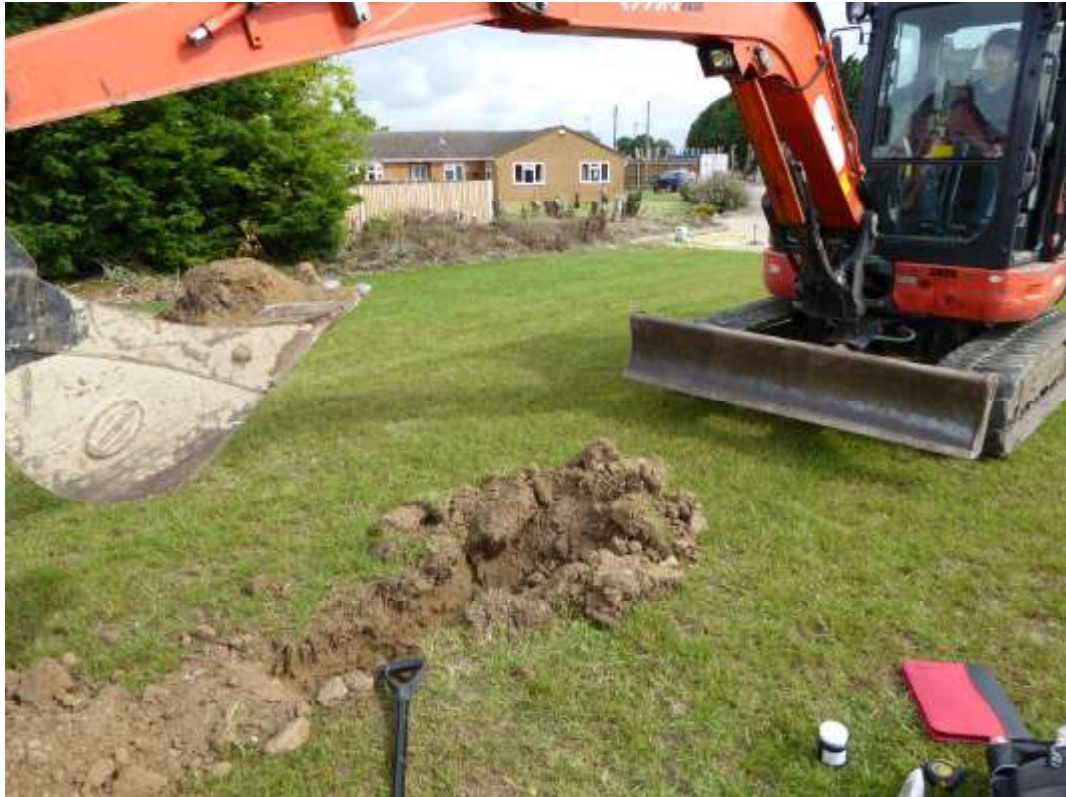
Photo 11 TP1 near north eastern corner of plot

TP1 near north eastern end of site (photo 11)

| Sample Depth | Description of sample/ground |
|---|---|
| 0.1 – 0.2 m | Light brown slightly clayey sand |
| 0.5 – 0.6 m | Light brown slightly clayey sand |

TP1 0.5 – 0.6 m reported total aliphatic and aromatic at 268 mg/kg of which about 210 mg/kg were in the non-volatile aromatic C<sub>21</sub>-C<sub>40</sub> fraction

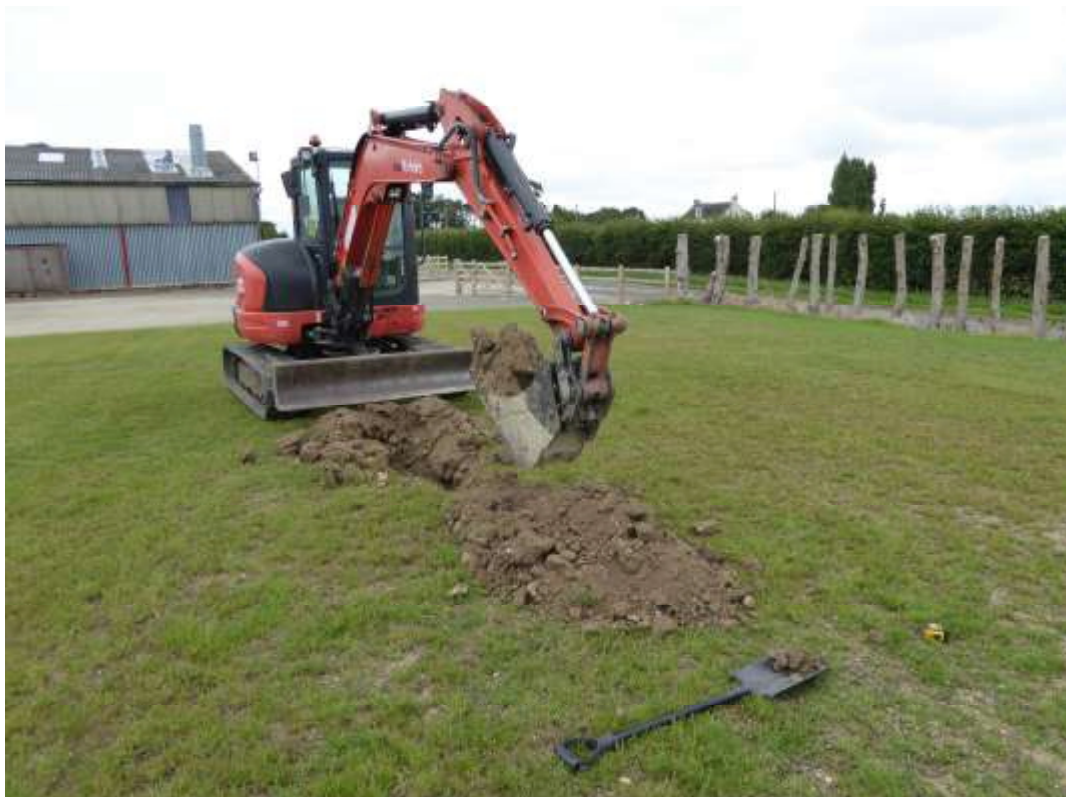
Photo 12 TP2 near north western corner of plot

TP2 near north western end of site (photo 12)

| Sample Depth | Description of sample/ground |
|---|---|
| 0.3 – 0.4 m | Light brown slightly clayey sand |
| 0.6 – 0.7 m | Mainly stiff dark brown clay |

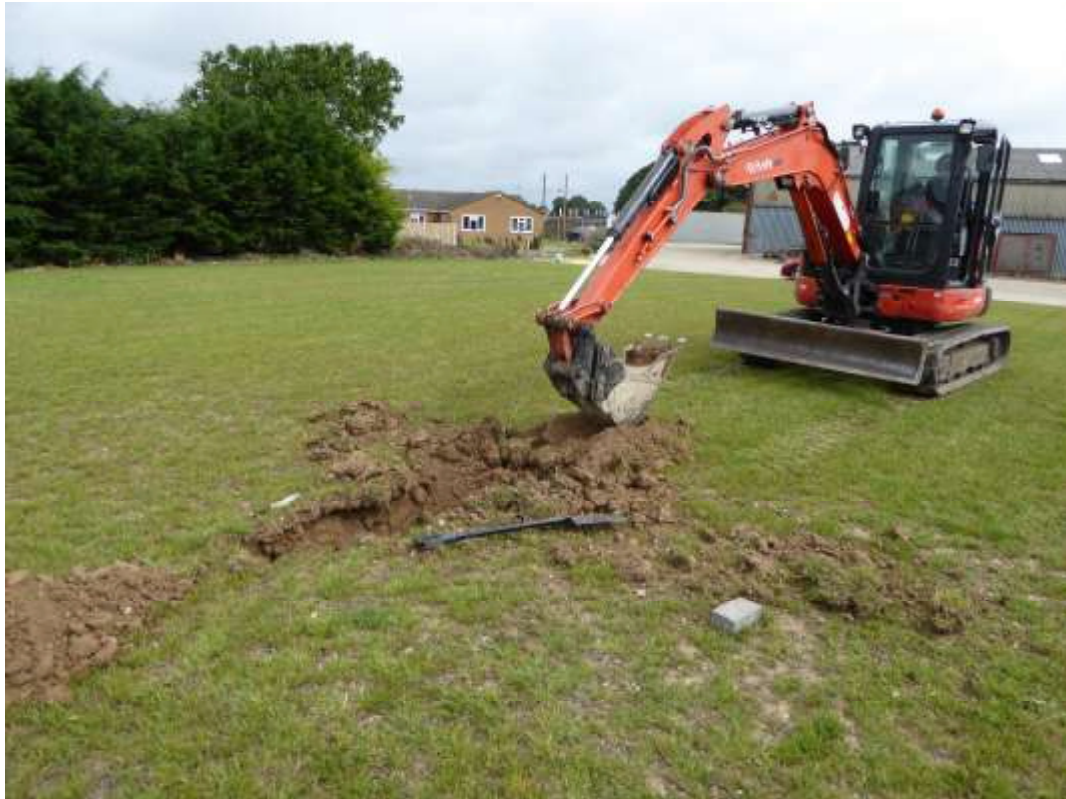
Photo 13 TP3 north eastern end in middle

TP3 north eastern end in middle (photo 13)

| Sample Depth | Description of sample/ground |
|---|---|
| 0.1 – 0.2 m | Light brown slightly clayey sand |
| 0.4 – 0.5 m | Light brown slightly clayey sand |

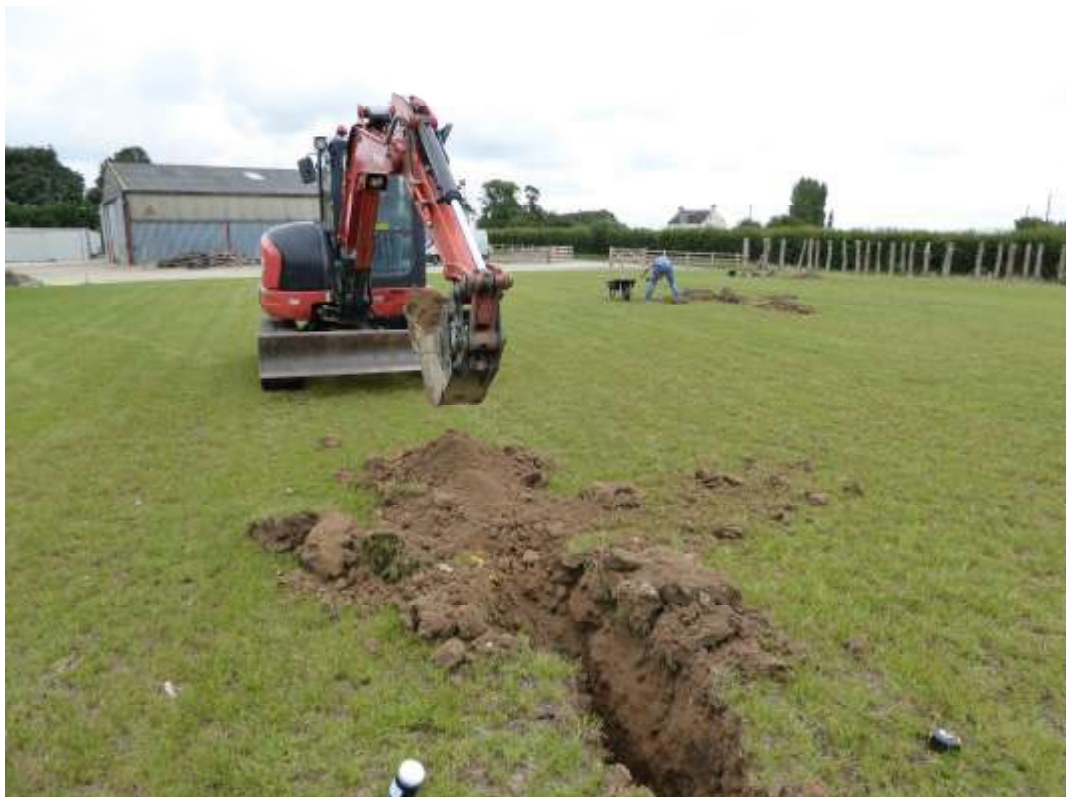
Photo 14 TP4 north eastern end middle eastern side

TP4 north eastern end middle eastern side (photo 14)

| Sample Depth | Description of sample/ground |
|---|---|
| 0.2 – 0.3 m | Light brown slightly clayey sand, but more clay |
| 0.6 – 0.7 m | Light brown slightly clayey sand, but more clay |

TP4 0.6 – 0.7 m reported total aliphatic and aromatic at 317 mg/kg of which about 270 mg/kg were in the non-volatile aromatic C<sub>21</sub>-C<sub>40</sub> fraction

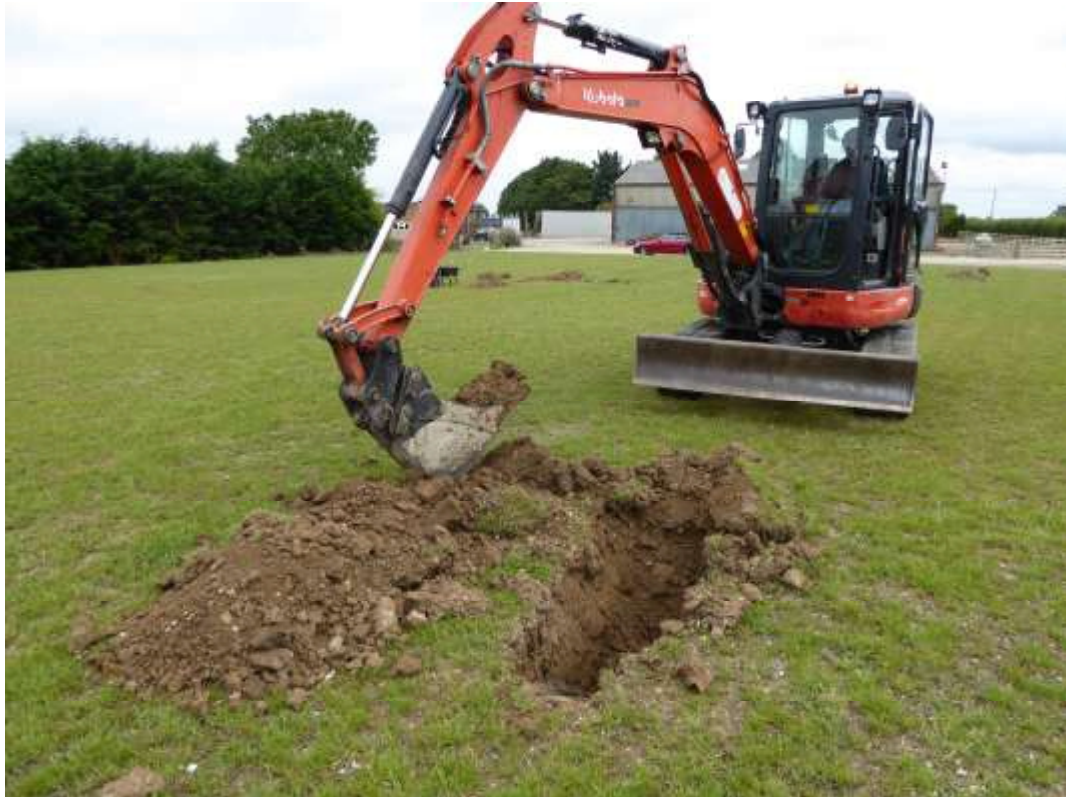
Photo 15 TP5 north eastern end middle western side

TP5 north eastern end middle western side (photo 15)

| Sample Depth | Description of sample/ground |
|---|---|
| 0.3 – 0.4 m | Light brown slightly clayey sand, but more clay |
| 0.6 – 0.7 m | Light brown slightly clayey sand |

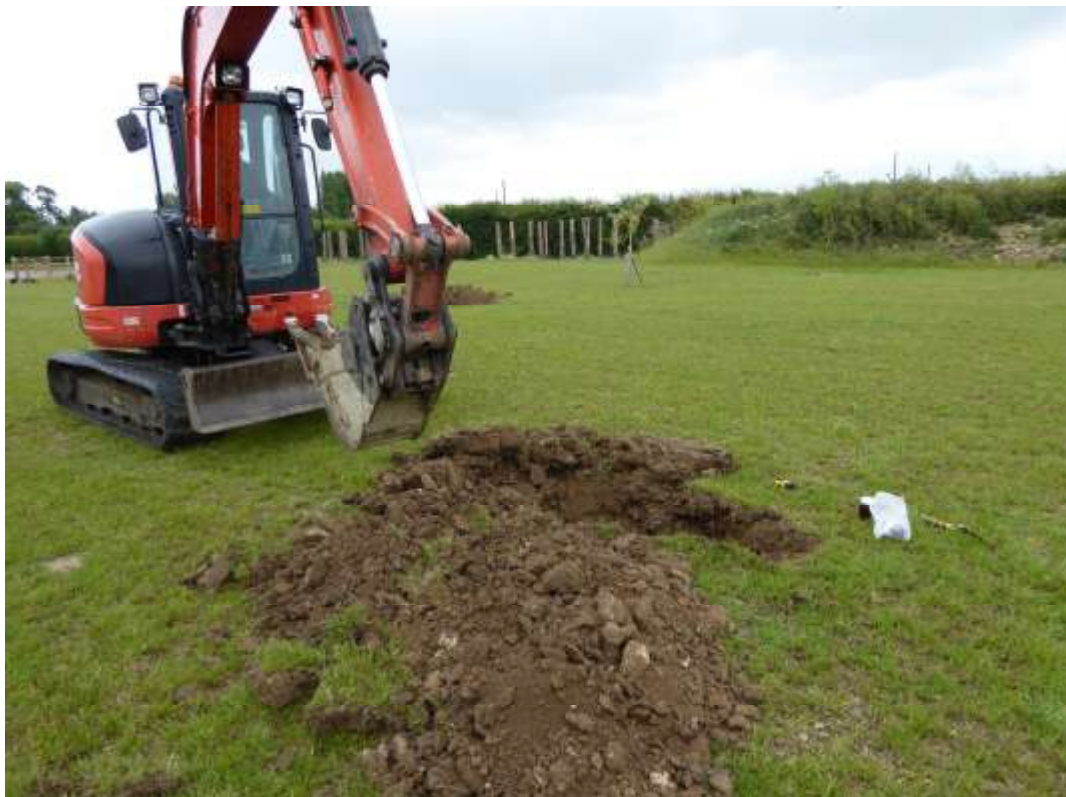
Photo 16 TP6 south eastern end middle of site

TP6 south eastern end middle of site (photo 16)

| Sample Depth | Description of sample/ground |
|---|---|
| 0.2 – 0.3 m | Light brown slightly clayey sand, but with a little extra clay |
| 0.4 – 0.5 m | Light brown slightly clayey sand |

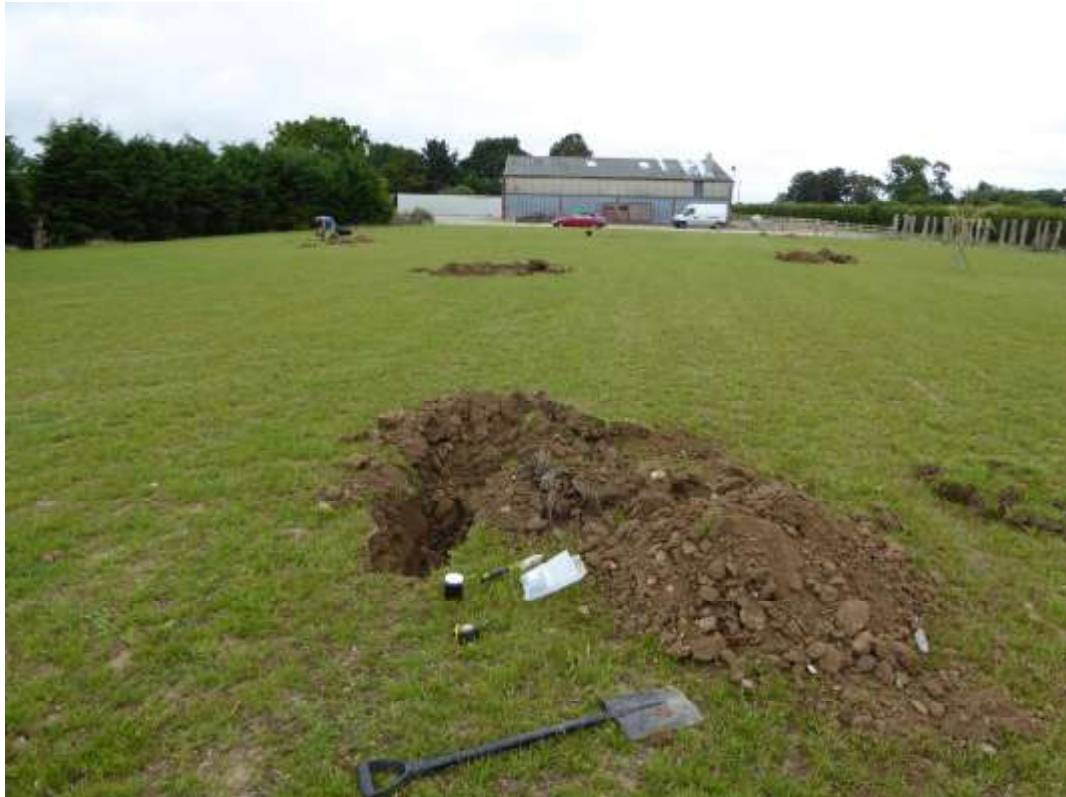
Photo 17 TP7 south eastern end middle to south of site

TP7 south eastern end middle to south of TP6 (photo 17)

| Sample Depth | Description of sample/ground |
|---|---|
| 0.1 - 0.2 m | Light brown slightly clayey sand |
| 0.5 – 0.6m | Light brown slightly clayey sand |

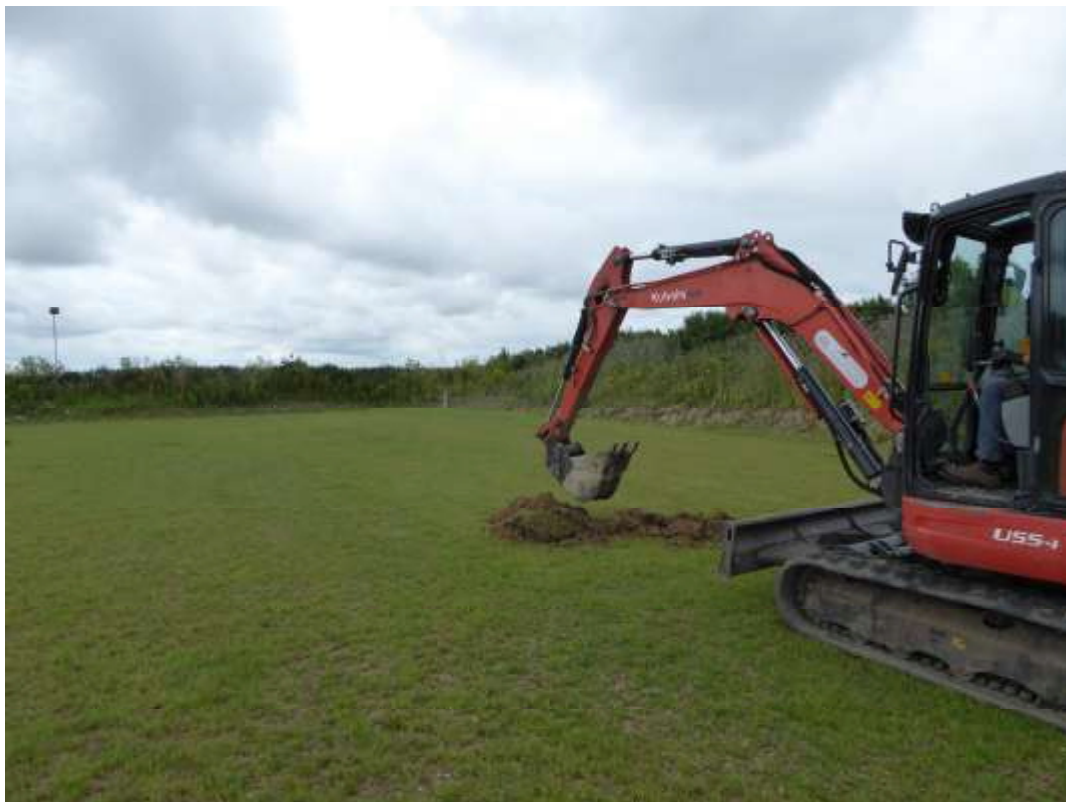
Photo 18 TP8 south eastern end to eastern side of site

TP8 south eastern end to eastern side of site (photo 18)

| Sample Depth | Description of sample/ground |
|---|---|
| 0.3 – 0.4 m | Light brown slightly clayey sand |
| 0.6 – 0.7 m | Light brown slightly clayey sand |

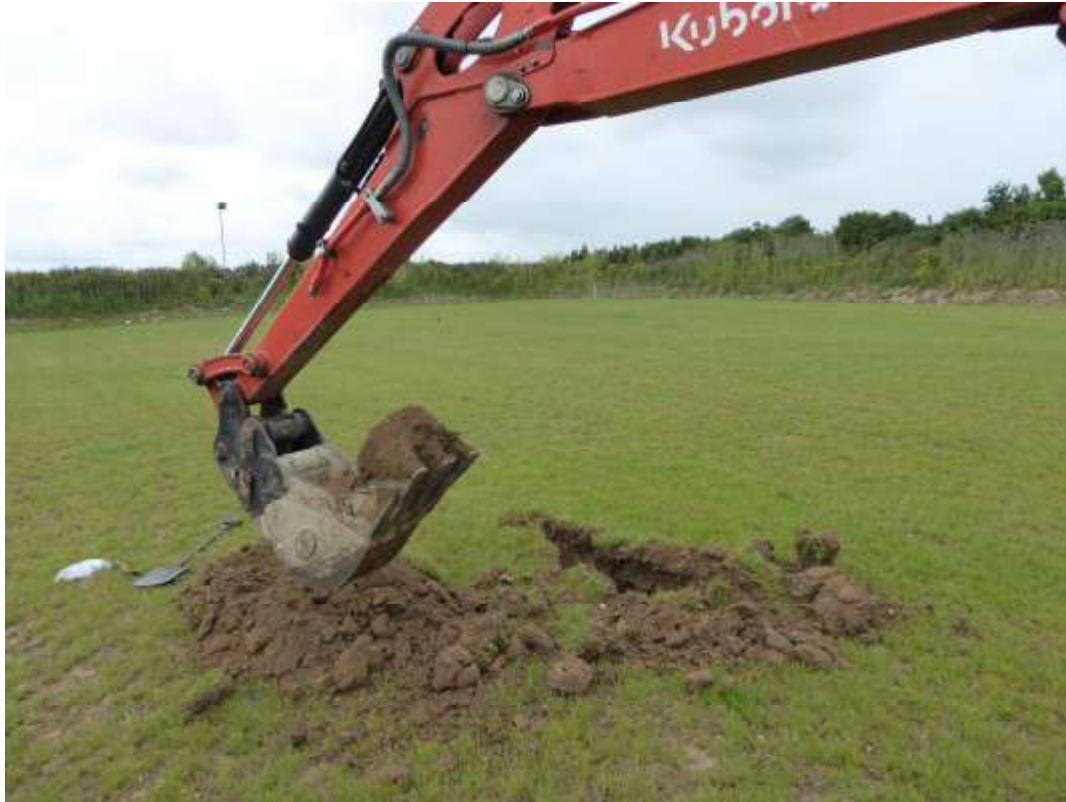
Photo 19 south eastern end to western side of site

TP9 south eastern end to western side of site (photo 19)

| Sample Depth | Description of sample/ground |
|---|---|
| 0.2 – 0.3 m | Light brown slightly clayey sand |
| 0.5 - 0.6 m | Light brown slightly clayey sand |

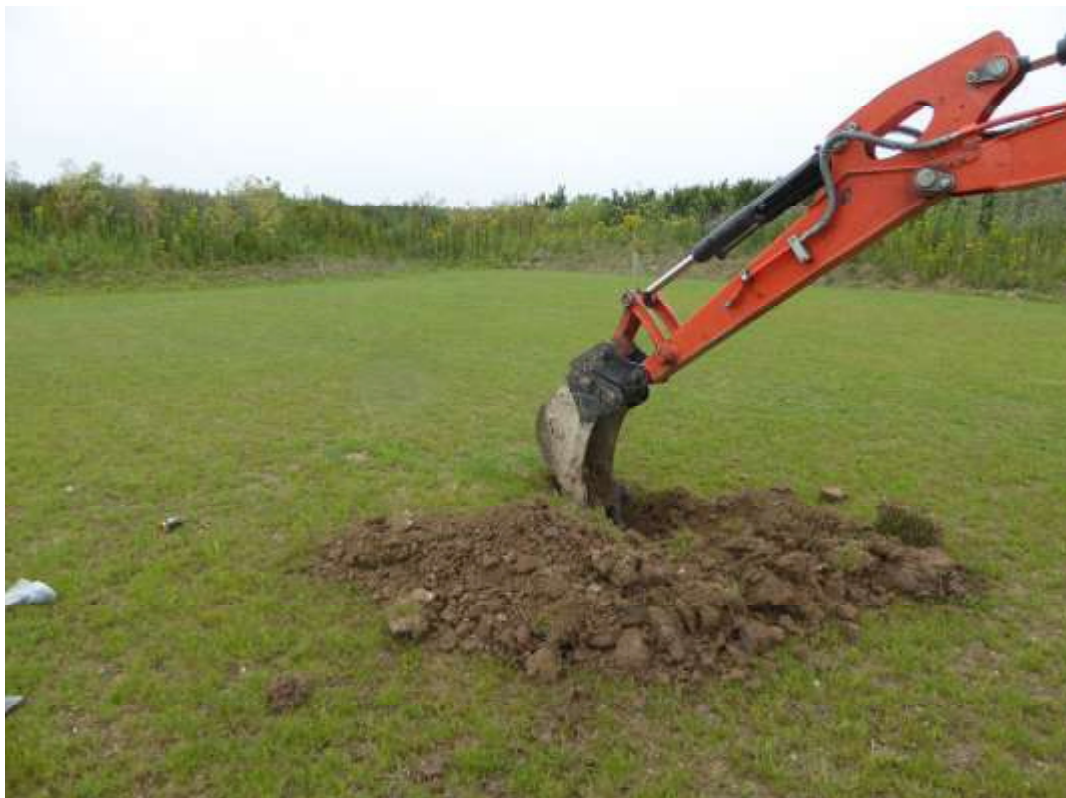
Photo 20 south eastern end middle at south of site

TP10 south eastern end middle to south of site (photo 20)

| Sample Depth | Description of sample/ground |
|---|---|
| 0.1 – 0.2 m | Light brown slightly clayey sand |
| 0.4 – 0.5 m | Light brown slightly clayey sand |
