AN ARCHAEOLOGICAL DESK BASED ASSESSMENT STUDY  
OF LAND AT AND TO THE REAR OF THE FORMER BELL INN PUBLIC HOUSE,  
33, CHURCH STREET,  
PINCHBECK, LINCOLNSHIRE.

**[Site Centred at National Grid Reference: TF 2418 2574]  
Planning Reference: H14-0219-22**

PREPARED FOR MR. GUY DIXON OF DIXON DAWSON, CHARTERED ARCHITECTS, ON  
BEHALF OF HIS CLIENTS - VENTURE BUSINESS SPACE LTD.

April 2025

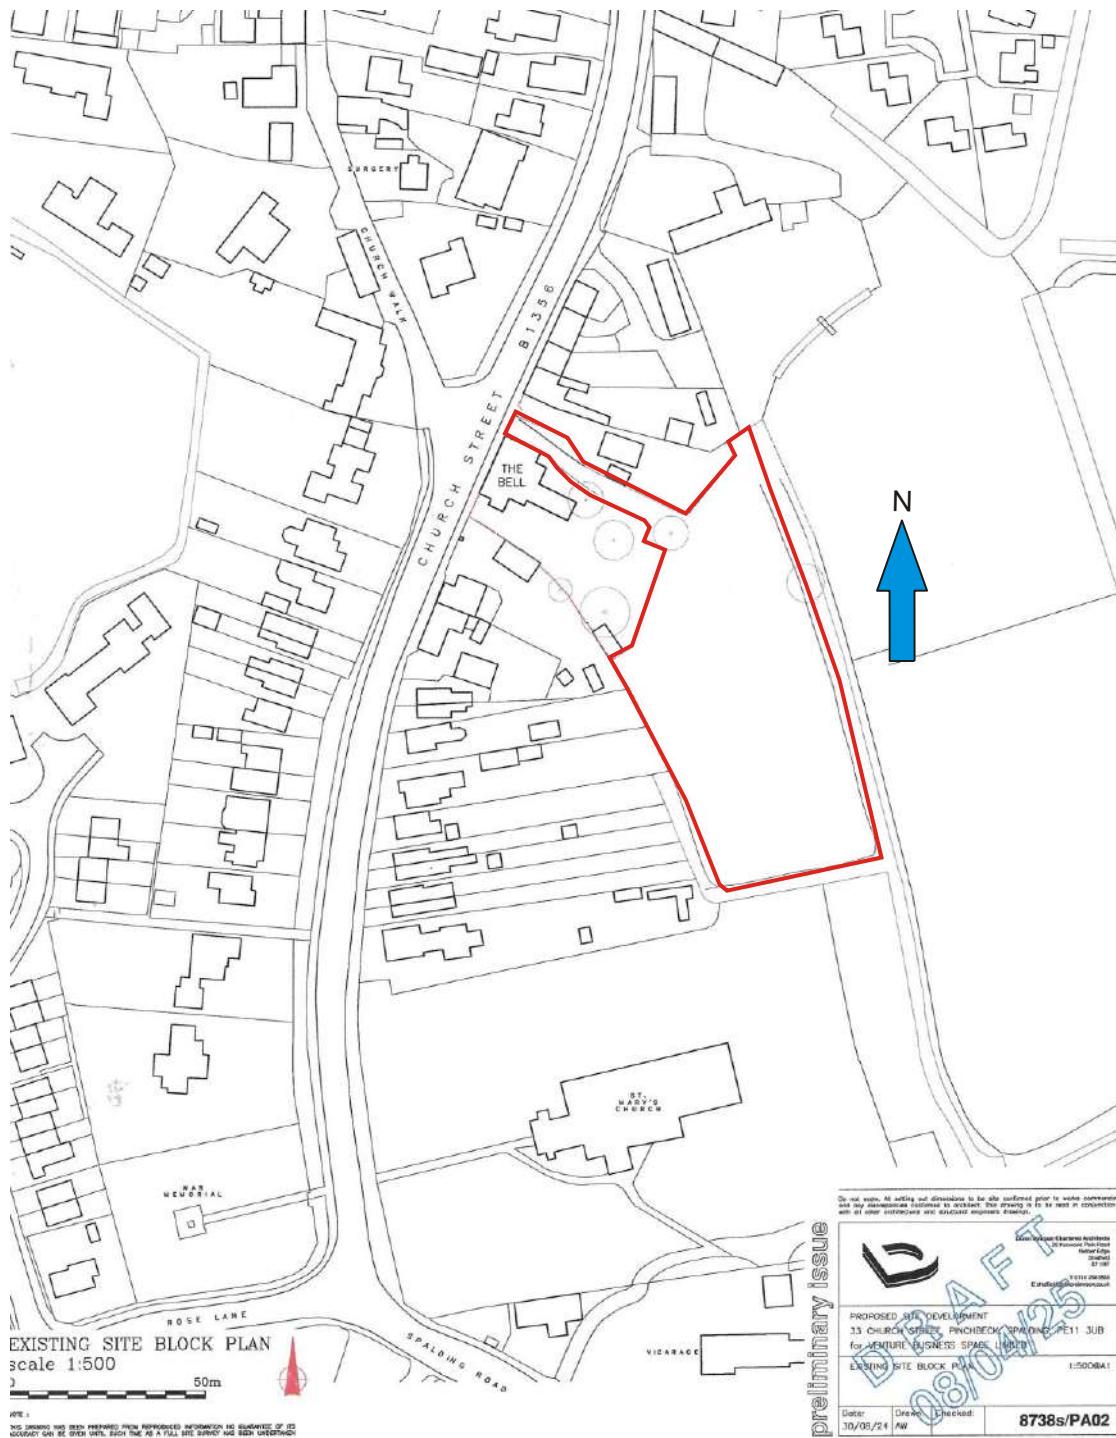
**Figure 2:** Site location at an original scale of 1:500 at A1, (extract from Architects plan). The assessment site is shown outlined in red.

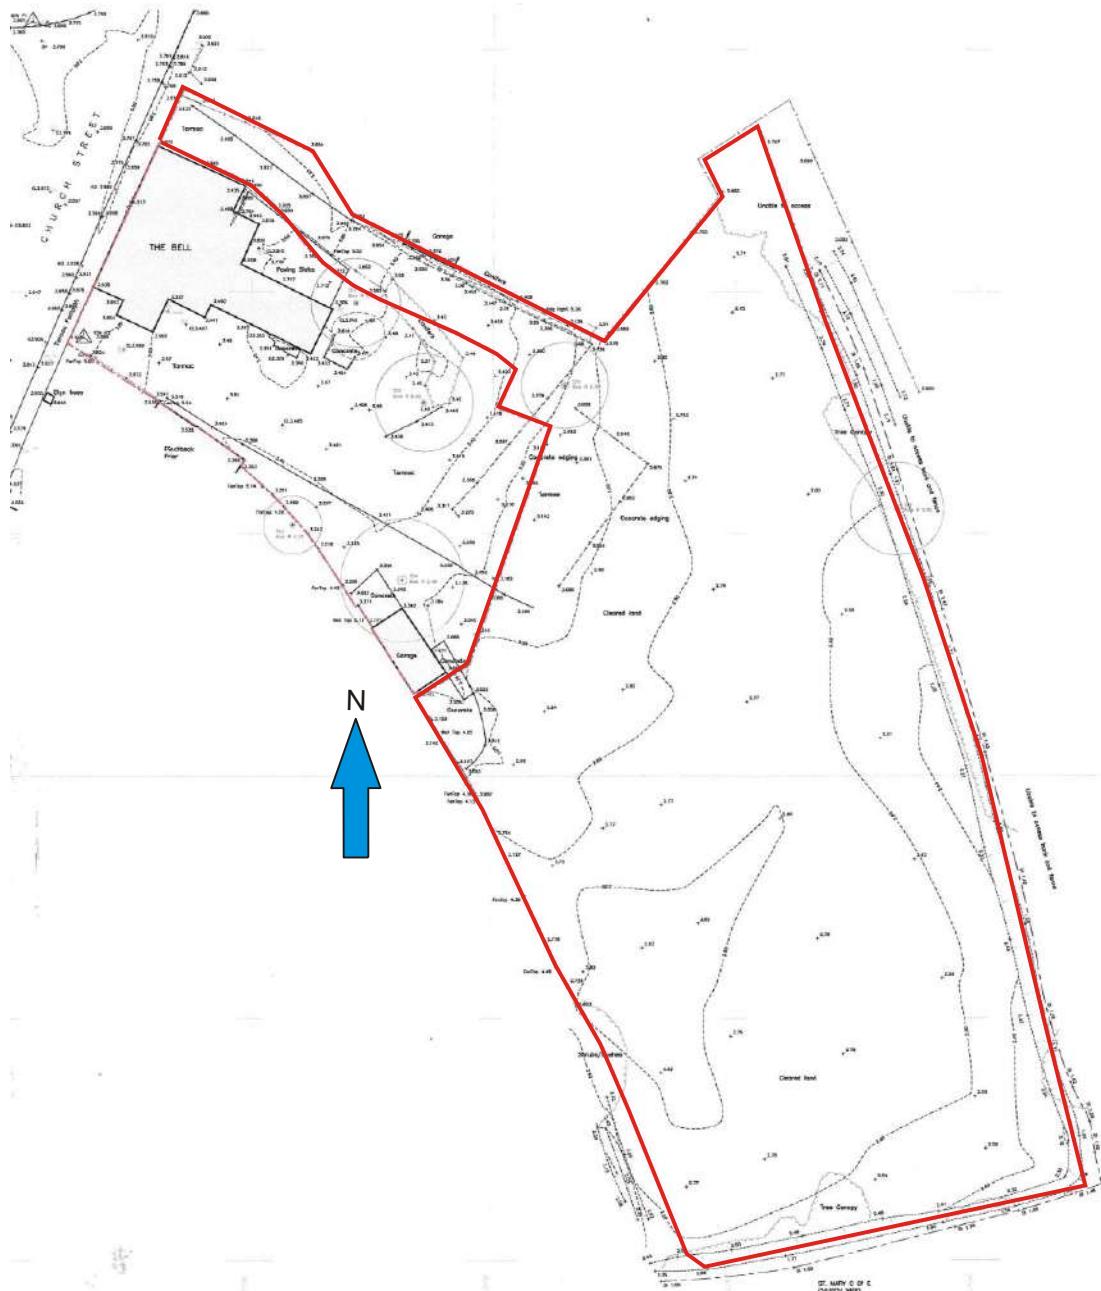
**Figure 3:** Plan showing the existing layout of the assessment site at an original scale of 1:200 at A1, (extract from Architects plan).

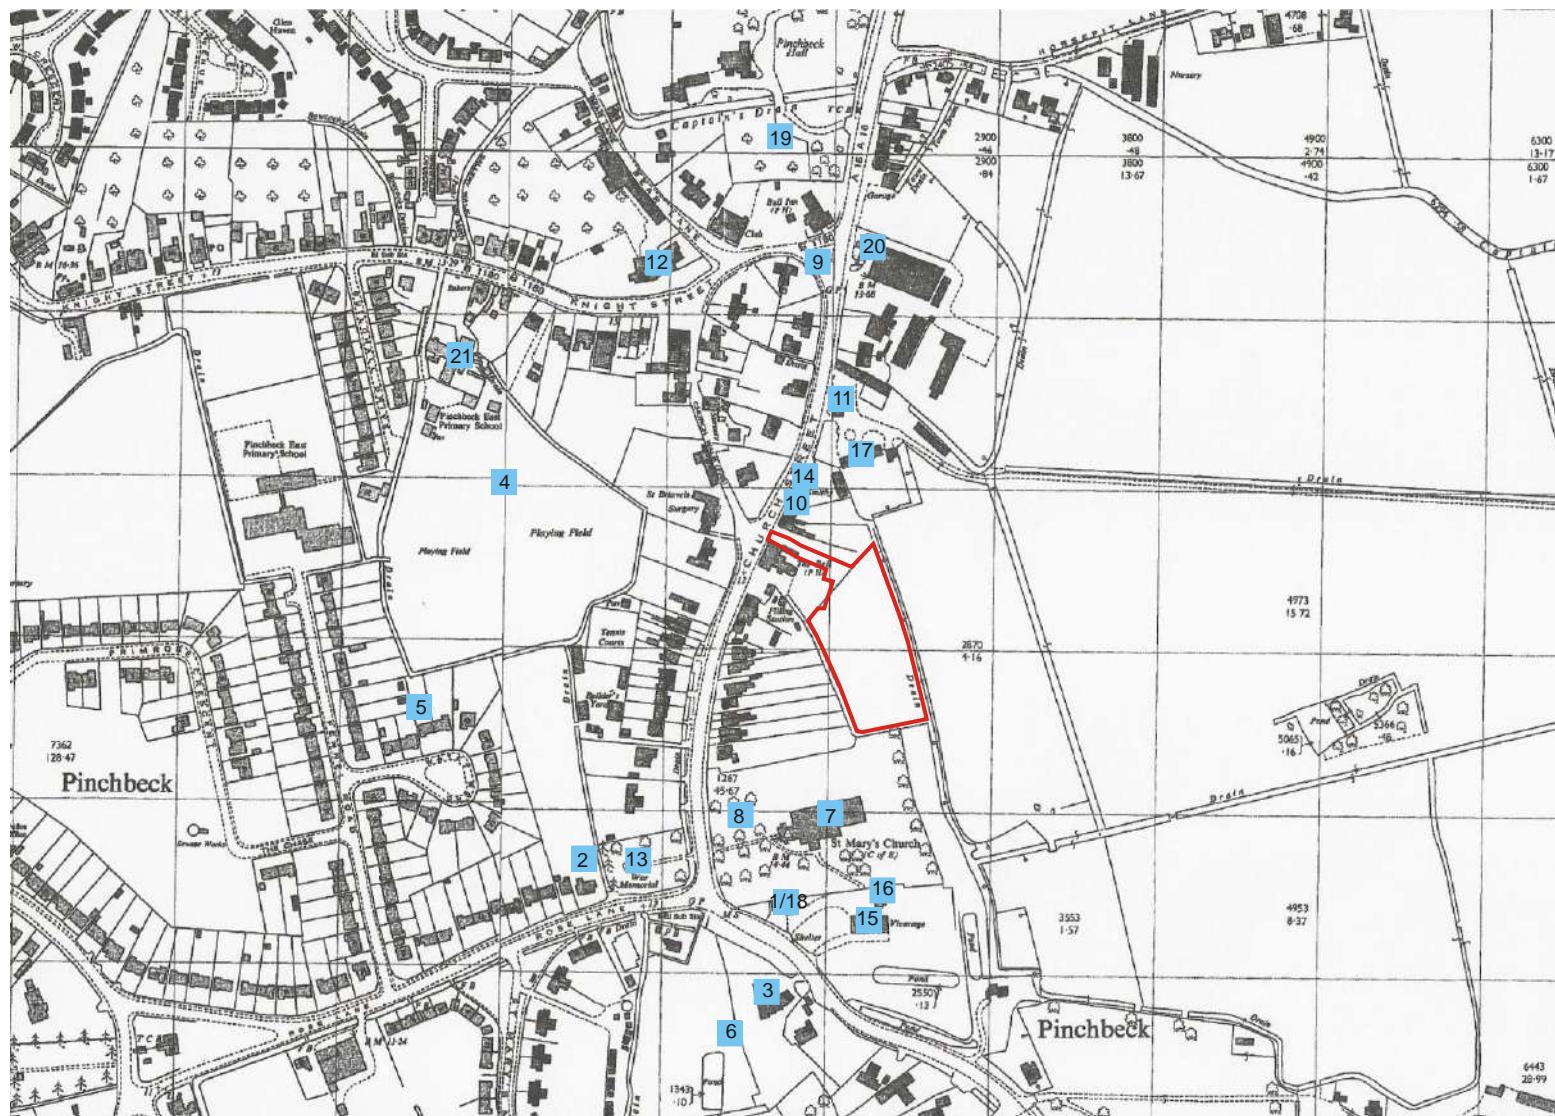
**Figure 4:** Cultural heritage sites within a 0.25km radius of the assessment site at an original scale of 1:2,500. The assessment site is shown outlined in red.

- 4.5.1 In 2009, an historic building appraisal was carried out prior to the repair and reuse of the former coach house at the Old Vicarage, Church Street (**Site No. 1**, HER ELI12219). The building is of two storeys and is constructed of brick with a pantile roof and dates from the 18th century. The building has 19th and 20th century additions. The stables and traphouse at the Vicarage (now stores and a garage) are Grade II listed and date from the late 18th century (**Site No. 18**, HER MLI94631, NHL 1359313). The building was extended in the 19th century and has 20th century alterations.

- 4.5.10 A bronze key of post-medieval date was found in 1963 during the excavations for a new house at Wayet Road (**Site No. 5**, HER 22422).
- 4.5.11 It is clear also that this assessment site lies within the area of the post-medieval settlement with several listed buildings from this period situated to the immediate north. So it is considered that there will be a **high** potential for archaeological activity and finds from this post-medieval period to be made on this assessment site.

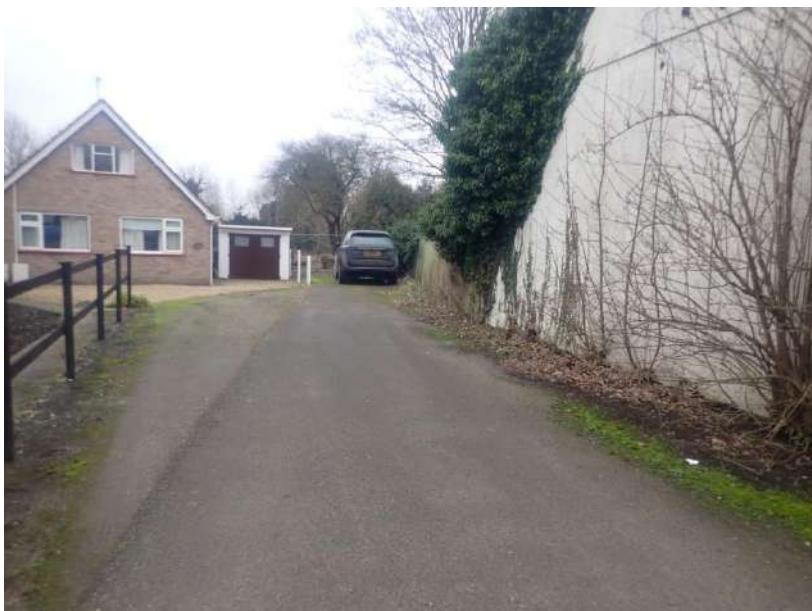
Plate 6: View of the current northerly access into the assessment site off the south-eastern frontage of Church Street, from the west

5.1.3 **Plate 6** features the present northerly modern access into the interior of the assessment site off the south-eastern frontage of Church Street. This image shows the north-western portion of the line of the proposed new site access road, which will extend into the area of the proposed new residential development within the interior of this assessment site to the south. The north elevation of the adjacent former Bell Inn public house is also shown to the right (south).

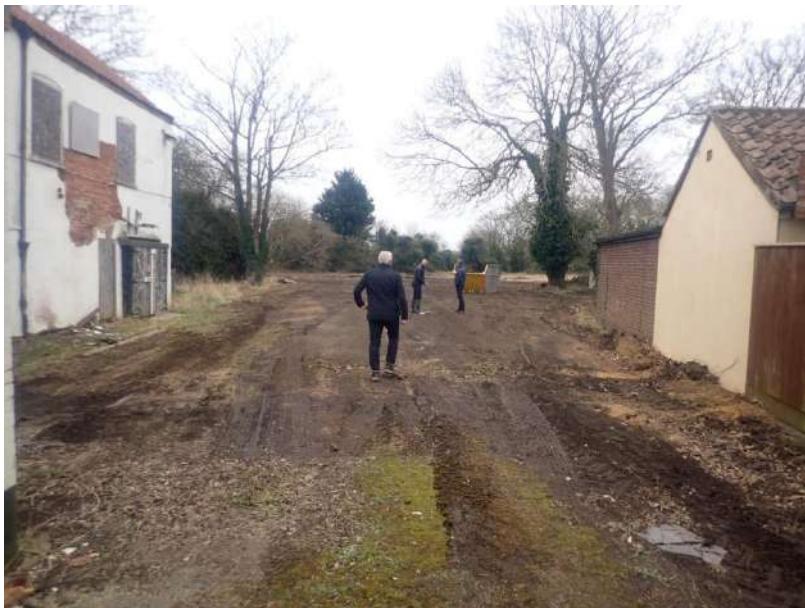
5.1.4 **Plate 7** shows the current second and southerly access into the interior of the assessment site off the south-eastern frontage of Church Street. The assessment site interior is shown in the background to the south-east and south. The south elevation of a modern rear extension to the former Bell Inn public house is shown to the left (north) along with modern development to the immediate south (right) at the south-eastern frontage of Church Street.

Plate 7: View of the current southerly access into the assessment site off the south-eastern frontage of Church Street, from the west

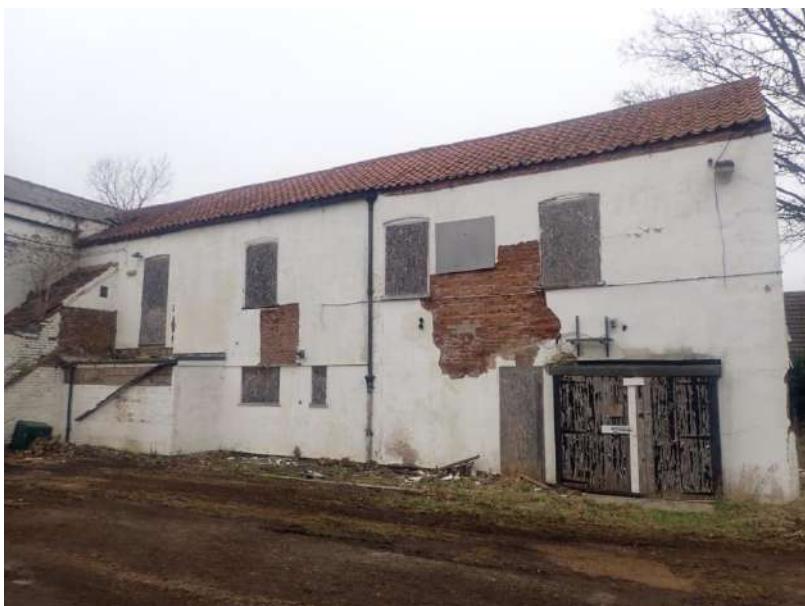
Plate 8: View of the former Bell Inn public house, from the south-west

5.1.5 **Plates 8-11** furnish further views from several different vantage points of the rear of the former Bell Inn public house and in particular featuring its modern 20th century rear extension. **Plates 10 and 11** also provide further views of the current southerly modern access off the south-eastern frontage of Church Street into the interior of the assessment site from several different postions.

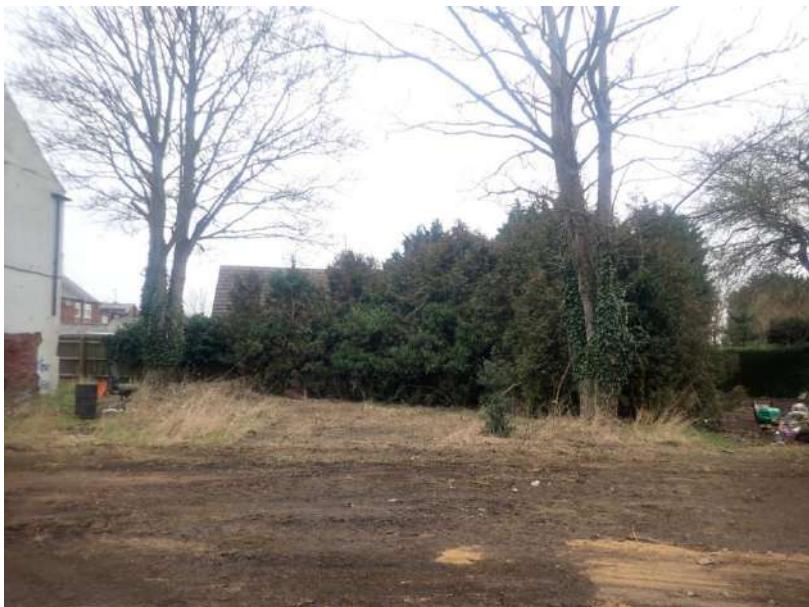
**Plate 12: View of the assessment site, from the south-west**

5.1.7 **Plate 12-16** feature various views of the site interior, which were all taken from the north-west. **Plate 12** features a portion of the line of the proposed new site access road into the area of the proposed new residential development at the rear of the former Bell Inn public house, which is located to the left (west). Featured in the background is a portion of the north-eastern assessment site boundary with its screen of tree and hedgerow cover, along with modern residential development beyond this to the north and along the eastern frontage of Church Street. **Plates 13 and 14** show the interior of the assessment site along with the eastern site boundary with its dense and mature screen of tree and hedgerow cover. **Plate 15** also shows the interior of the assessment site with a portion of the eastern site boundary along with the southern site boundary with their dense screens of mature tree and hedgerow cover in the background. **Plate 16** features a portion of the southern site boundary with the Grade I listed medieval parish church of St. Mary in the background (**Site No. 7**). Also shown in this image is the western site boundary with the modern residential development beyond this to the right (west) along the eastern frontage of Church Street.

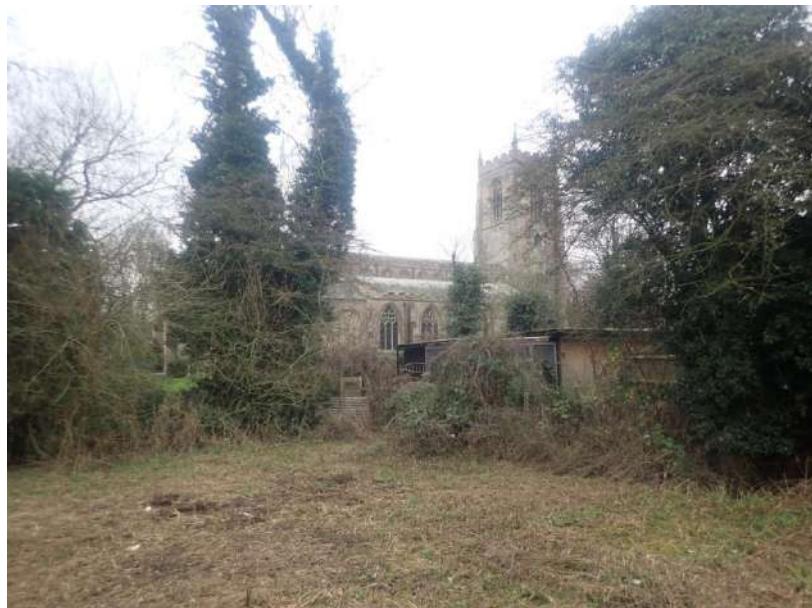
5.1.8 **Plates 17-19** were taken at the southern end of the assessment site. **Plate 17** features the southern end of the western site boundary along with a portion of the southern site boundary. To the right (west), the western site boundary is composed of tree cover and fencing along with rear outbuildings of the modern residential dwellings that are situated along the eastern frontage of Church Street to the west. To the left (south), is the western portion of the southern site boundary with its dense screen of mature tree and hedgerow cover. In the background is the Grade I listed parish church of St Mary (**Site No. 7**) and its attendant parish churchyard. **Plate 18** shows the same southern site boundary with the parish church and churchyard in the background. **Plate 19** features the remainder of the southern site boundary with its dense screen of mature tree and hedgerow cover.

**Plate 17: View of the assessment site, from the north**

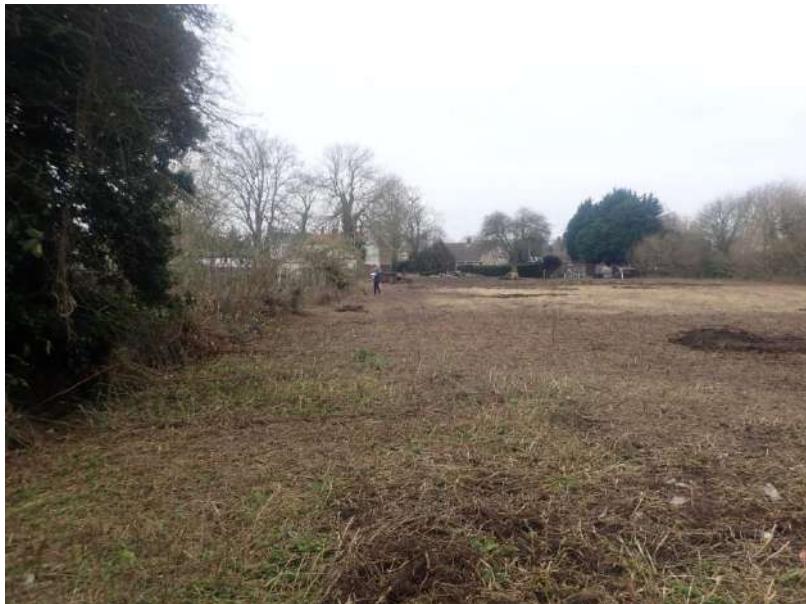
**Plate 20: View of the assessment site, from the south**

5.1.9 **Plates 20-22** were taken from the south-western corner of the assessment site and provide images of the assessment site interior with its 100% grassed ground cover in the foregrounds. **Plate 20** shows the western site boundary with its scattered tree and hedgerow cover with fencing. In the background are the north-eastern and part of the eastern site boundaries with their dense and mature tree and hedgerow cover. **Plate 21** also shows the eastern site boundary in the background. **Plate 22** also features the southern portion of the eastern site boundary in the background along with the southern site boundary to the right (south) with its dense screen of mature tree and hedgerow cover.

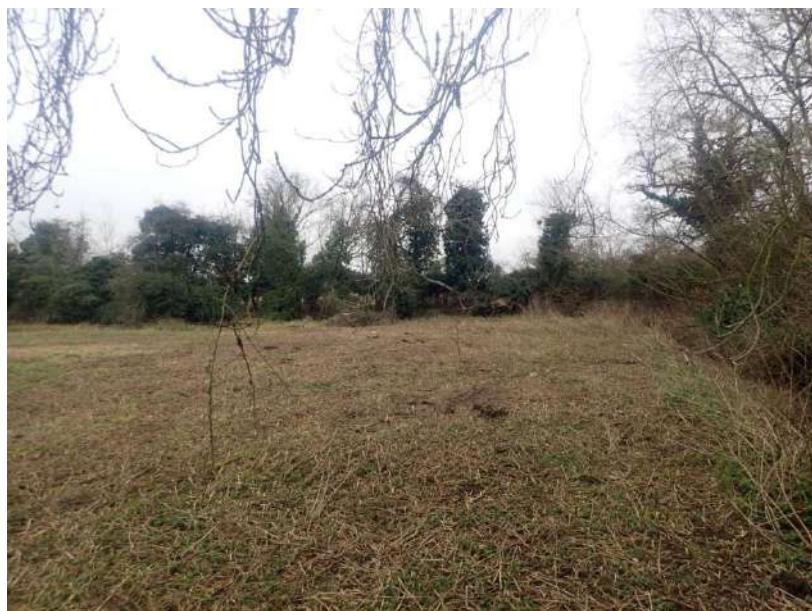
**Plate 23: View of the assessment site, from the west**

5.1.10 **Plates 23-26** were taken from the southern boundary of the assessment site and show the 100% grassed ground cover of the site in the foreground. **Plate 23** shows the eastern portion of the southern site boundary along with the southern portion of the eastern site boundary with their dense screens of mature tree and hedgerow cover. **Plate 24** features the remainder of the eastern site boundary in the background. **Plate 25** shows the northern end of the assessment site in the background with the former Bell Inn public house, the north-eastern and eastern site boundaries with their dense screens of mature tree and hedgerow cover and the western site boundary to the left (west) with the rear of the modern dwelling properties that are situated along the eastern frontage of Church Street to the west.

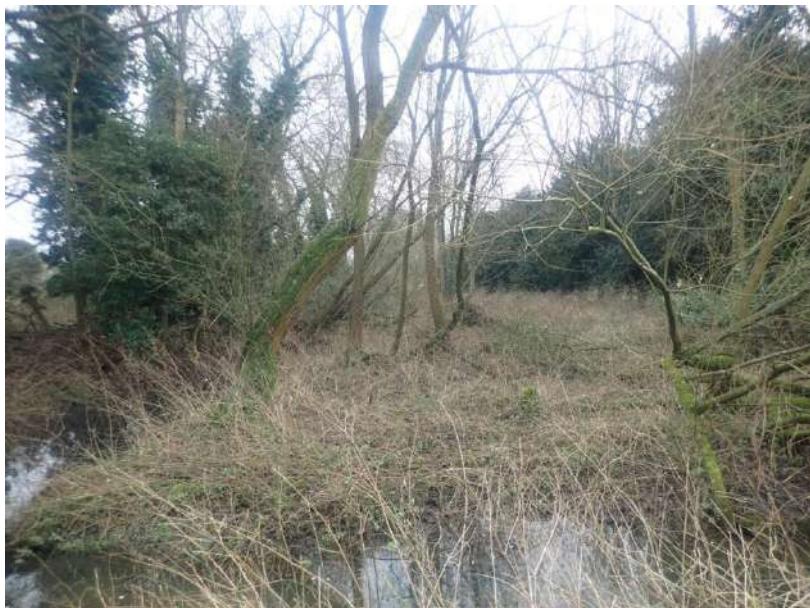
5.1.11 **Plates 27-29** provide views of the southern boundary of the assessment site with its dense screen of mature tree and hedgerow cover. The actual boundary is denoted by a water filled drainage ditch with views of the adjacent parish churchyard beyond this boundary to the south.

**Plate 27: View of the southern boundary of the assessment site, from the north**

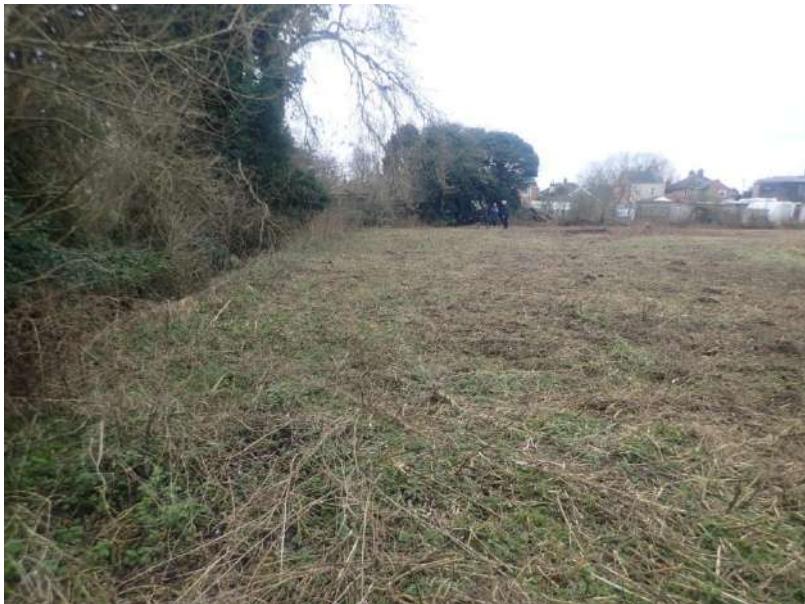
**Plate 30: View of the assessment site, from the east**

5.1.12 **Plates 30-32** were taken from the south-eastern corner of the assessment site and show the 100% grassed ground cover in the foregrounds. **Plate 30** features the southern site boundary with its dense screen of mature tree and hedgerow cover with the southern portion of the western site boundary in the background. Beyond this boundary and to the west are shown the modern residential dwellings that extend along the eastern frontage of Church Street, further to the west. **Plate 31** shows the north-eastern site boundary and the former Bell Inn public house in the background to the north-west along with the northern portion of the western site boundary in the background. **Plate 32** features the eastern site boundary with its dense screen of mature tree and hedgerow cover along with the north-eastern site boundary and the former Bell Inn public house in the background.

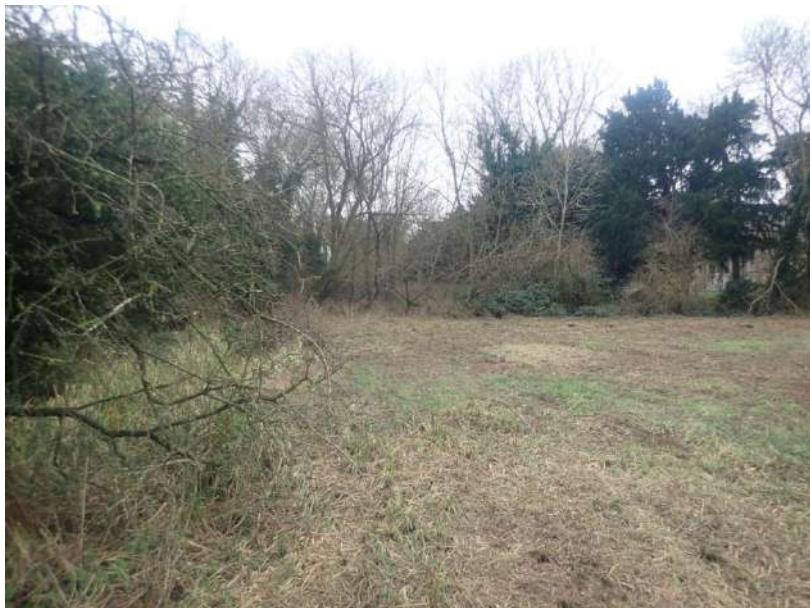
**Plate 33: View of the assessment site, from the north**

5.1.13 **Plates 33-37** were taken from the eastern site boundary and feature the 100% grassed ground cover in the foregrounds. **Plate 33** shows the southern portion of the eastern site boundary along with the eastern part of the southern site boundary with their dense screens of mature tree and hedgerow cover. **Plate 34** features the remainder of the southern site boundary and the southern portion of the western site boundary in the background. Also featured is the Grade I listed parish church of St Mary (**Site No. 7**), further in the background to the south. **Plate 35** shows the western site boundary in the background along with the modern residential dwellings beyond this, further to the west. **Plate 36** features the northern end of the site with the former Bell Inn public house and the north-eastern site boundary in the background. **Plate 37** provides a further view of the eastern site boundary to the right (east).

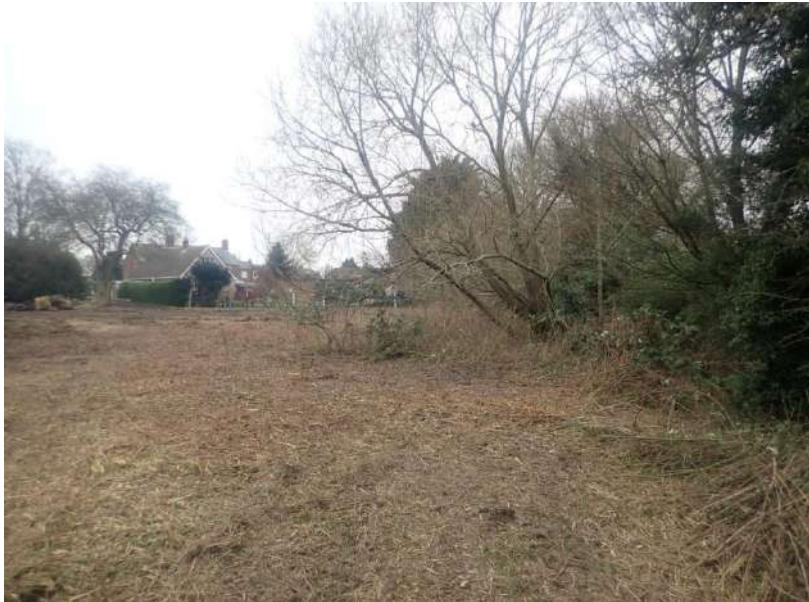
Plate 38: View of the assessment site, from the south

5.1.14 **Plates 38-43** were similarly taken from the eastern site boundary and feature the 100% grassed ground cover of the site on the foregrounds. **Plate 38** shows the northern portion of the eastern site boundary with its dense screen of mature tree and hedgerow cover along with the north-eastern site boundary in the background. **Plate 39** shows the northern end of the assessment site with the former Bell Inn public house and the north-eastern site boundary in the background. **Plate 40** features the western site boundary in the background with the modern residential dwellings beyond this further to the west. **Plate 41** shows the southern portion of the western site boundary and the western part of the southern site boundary with the medieval parish church of St Mary (**Site No. 7**) in the background further to the south. **Plate 42** features the remainder of the southern site boundary with its dense screen of mature tree and hedgerow cover along with a further view of the parish church of St Mary in the background. **Plate 43** shows the remainder of the southern site boundary along with the southern portion of the eastern site boundary.

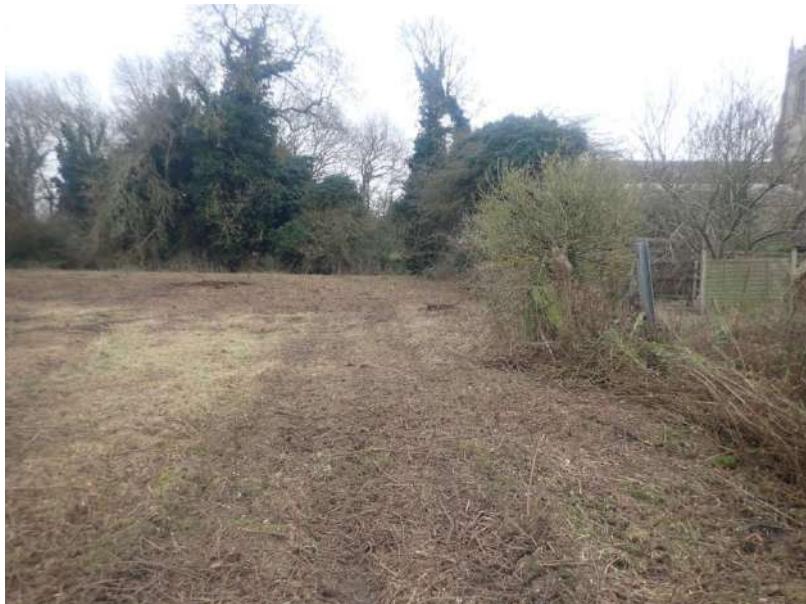
**Plate 84: View of the assessment site, from the north-west**

5.1.24 **Plates 84-88** were taken from the western site boundary and show the 100% grassed ground cover over much of the area of the site. **Plate 84** provides a detailed view of much of the western site boundary with its combination of tree and hedgerow cover and modern fencing. The western portion of the southern site boundary is also shown in the background. **Plate 85** features the remainder of the southern site boundary along with the southern portion of the eastern site boundary in the background. **Plates 86 and 87** show the remainder of the eastern site boundary in the background along with a portion of the north-eastern site boundary. **Plate 88** shows the north-western end of the assessment site, with the north-eastern site boundary and the rear of the former Bell Inn public house, in the background. The remainder of the western site boundary is also featured in detail to the left (west). **Plates 87 and 88** also show the areas of exposed ground in the background where the 100% grassed ground cover was absent.

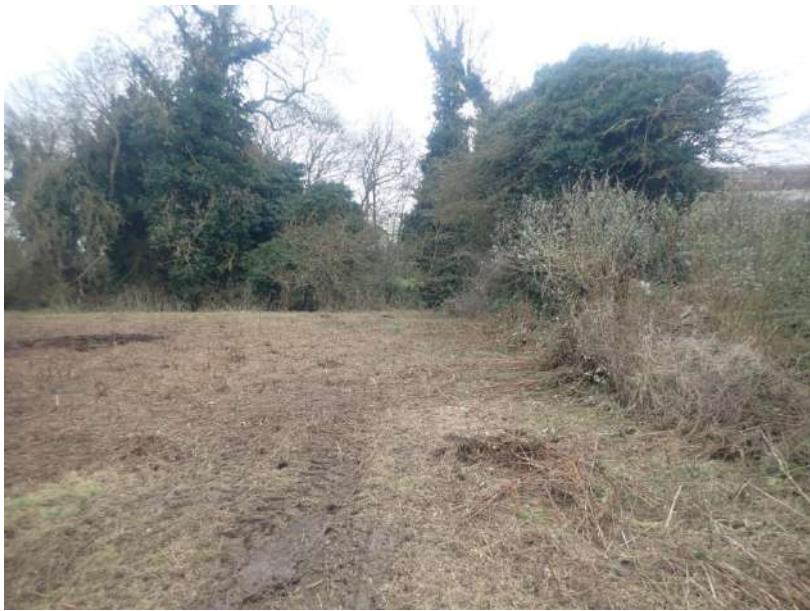
**Plate 89: View of the assessment site, from the north-west**

5.1.25 **Plates 89-93** were similarly all taken from the western site boundary and show the 100% grassed ground cover over much of the area of the site. **Plate 89** features the southern portion of the western site boundary in detail with its screen here of dense hedgerow and tree cover. The western portion of the southern site boundary is also shown in the background. **Plate 90** shows the remainder of the southern site boundary along with the southern end of the eastern site boundary in the background. **Plates 91 and 92** show the remainder of the eastern site boundary in the background. **Plate 92** also features a portion of the north-eastern site boundary. **Plate 93** shows the remainder of the western site boundary to the left (west) along with the northern end of the assessment site with the rear of the former Bell Inn public house and the north-eastern site boundary featured in the background.

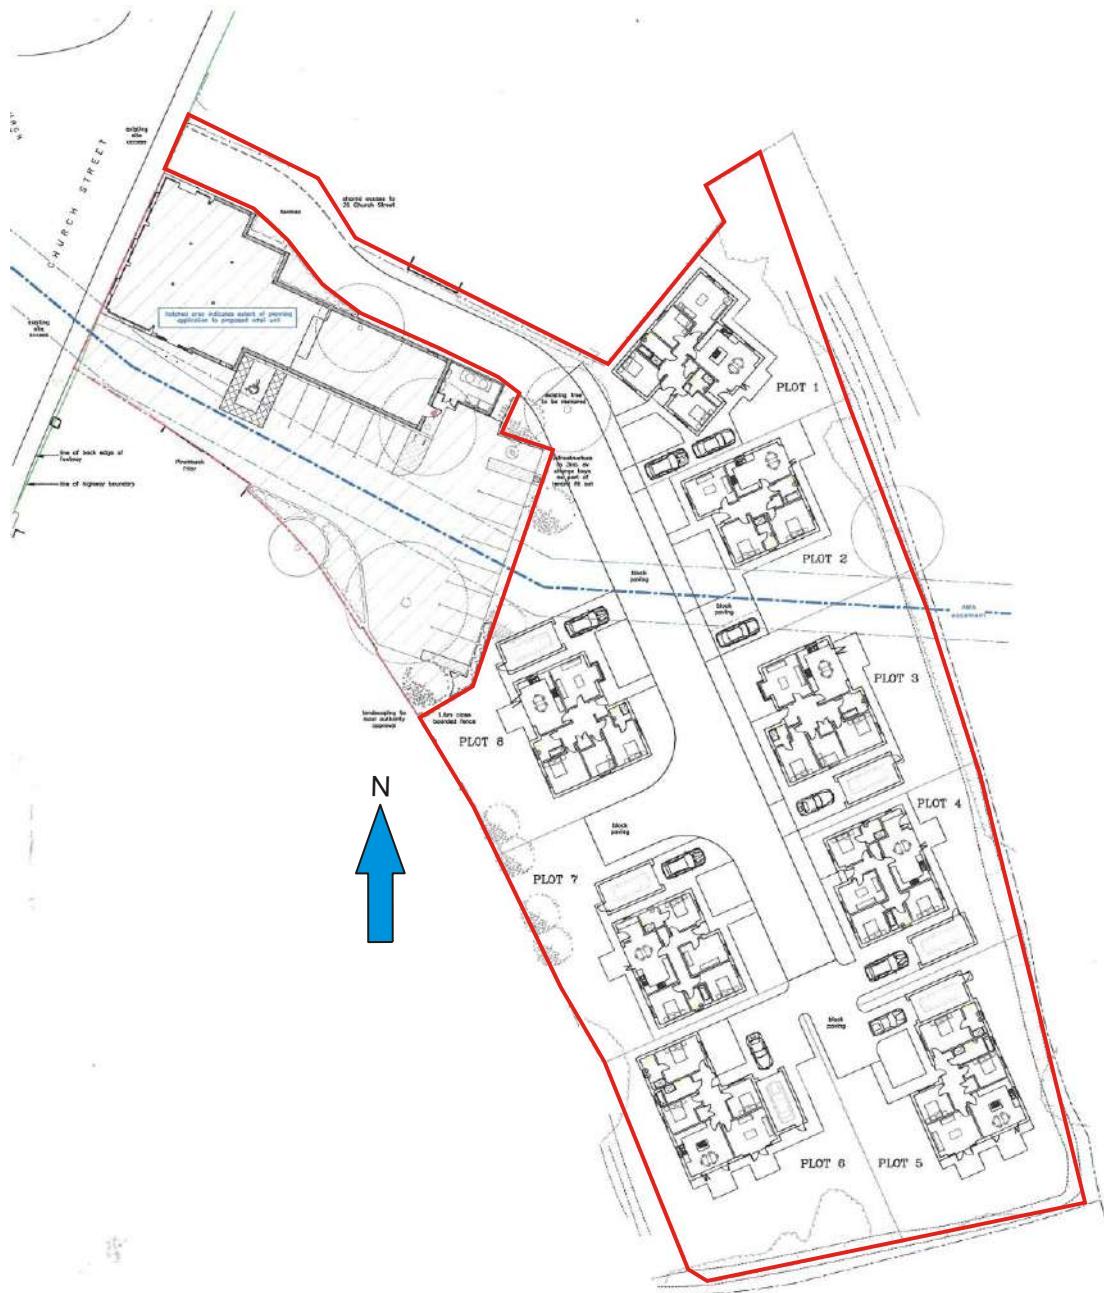
**Figure 5:** Plan showing the proposed layout of the development site at an original scale of 1:200 at A1, (extract from Architects plan).

- 5.2.2 The groundworks, which will be required for this proposed development, will comprise the excavation of new foundations and services for the eight proposed new residential dwellings and garaging (Plots 1-8) along with ground reduction to facilitate the construction of the new access road into this residential development off the south-eastern frontage of Church Street.

- 5.2.4 The potential impact on any underlying archaeological resource will come from the nature of the intended groundworks for this proposed new residential development and in particular from the excavation of the foundations and services for the new residential dwellings and garaging and the ground reduction for the new access roadway. Should as yet unrecorded archaeological remains be present within the area of the proposed new residential development site, they could well be removed by the proposed groundworks.

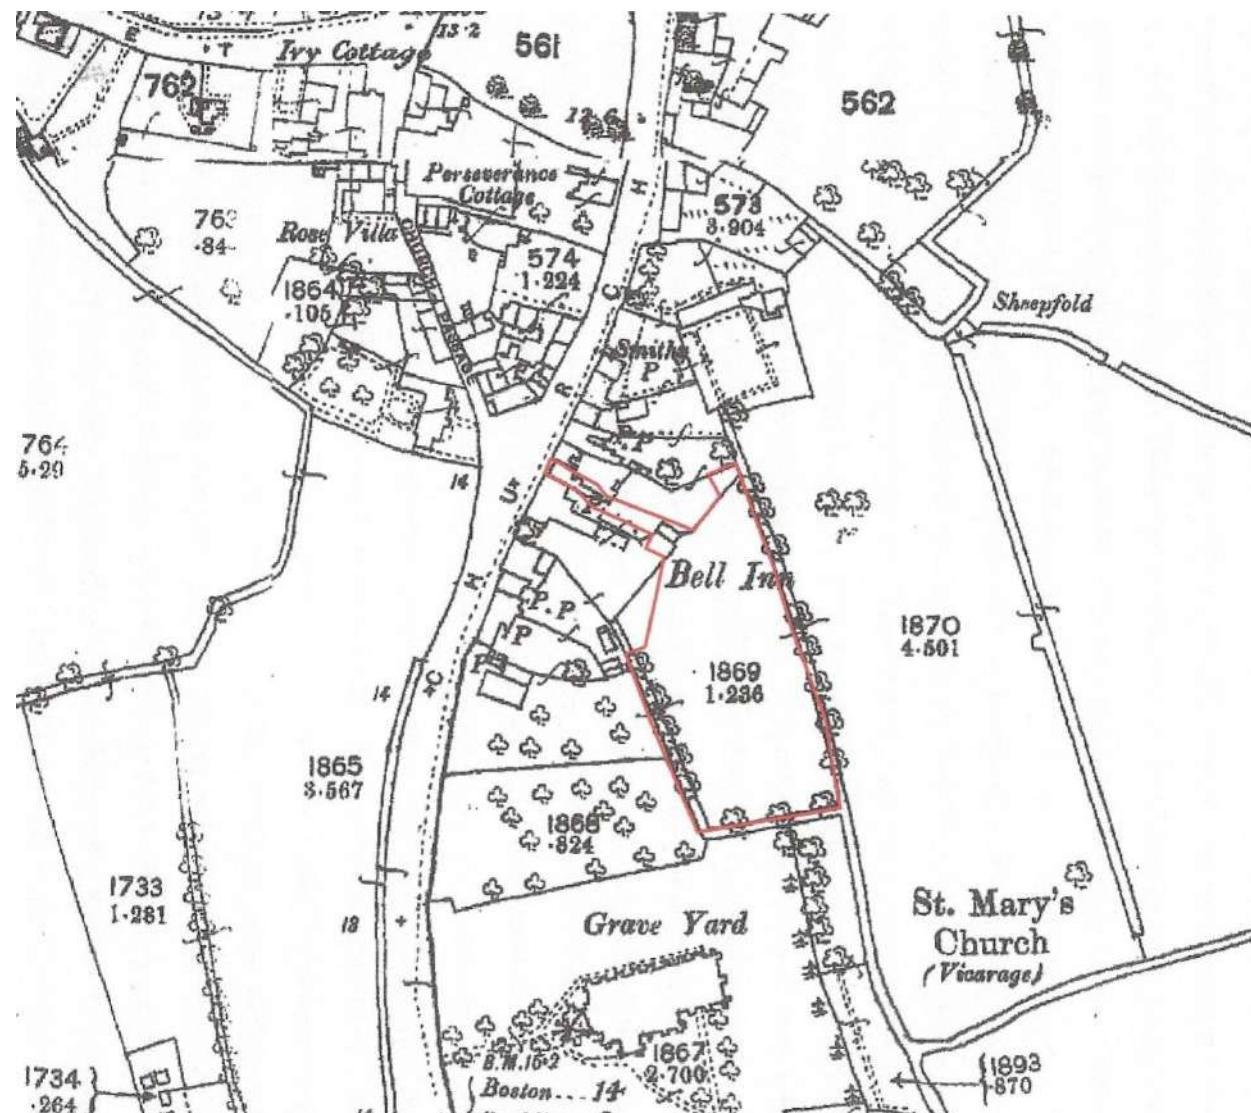
**Figure 6:** Extract from the First Edition 25 inch to one mile scale Ordnance Survey (O.S.) map of 1888, map sheet no. Lincolnshire 134.10. The approximate boundaries of the assessment site are shown outlined in red.

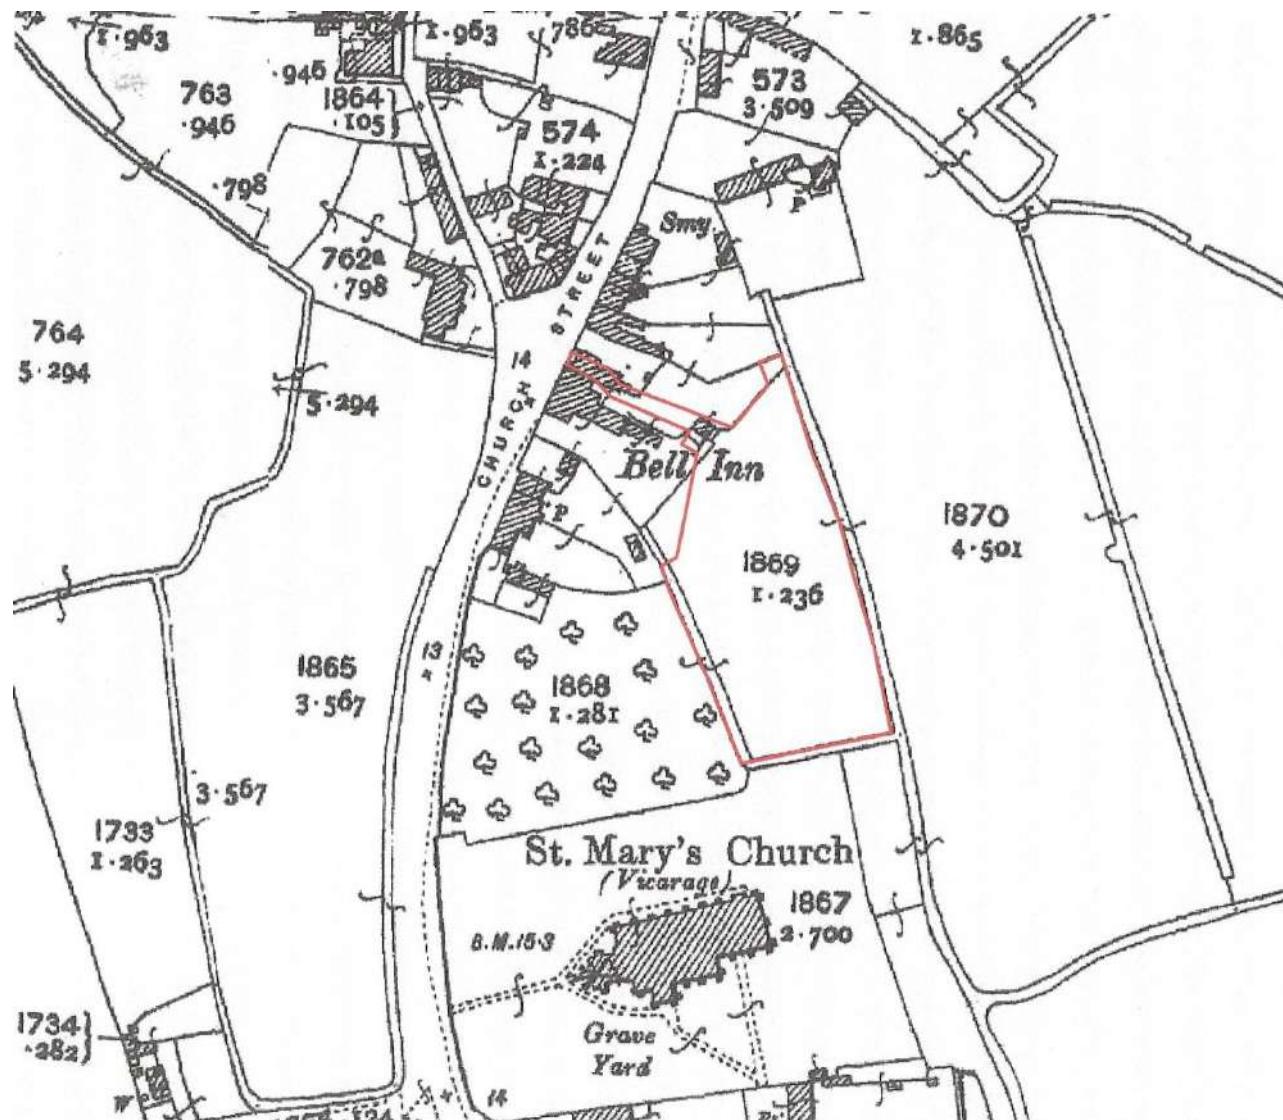
**Figure 7:** Extract from the Second Edition 25 inch to one mile scale Ordnance Survey (O.S.) map of 1904, map sheet no. Lincolnshire 134.10. The approximate boundaries of the assessment site are shown outlined in red.

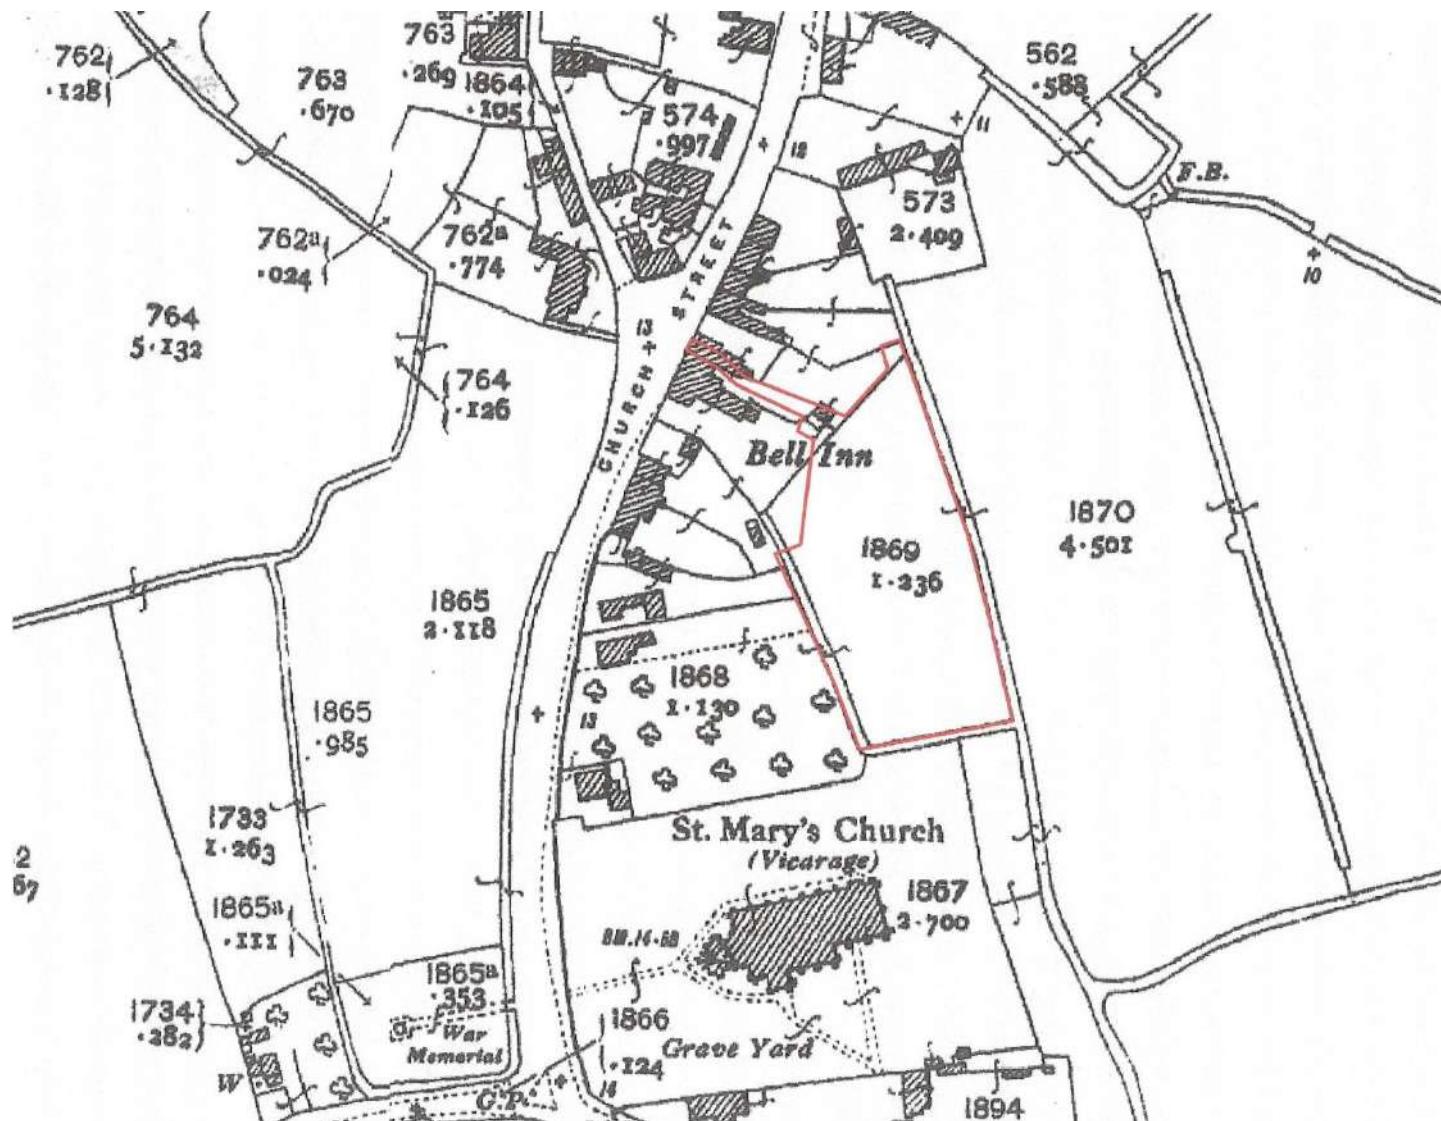
**Figure 8:** Extract from the 1932 Edition 25 inch to one mile scale Ordnance Survey (O.S.) map, map sheet no. Lincolnshire 134.10. The approximate boundaries of the assessment site are shown outlined in red.

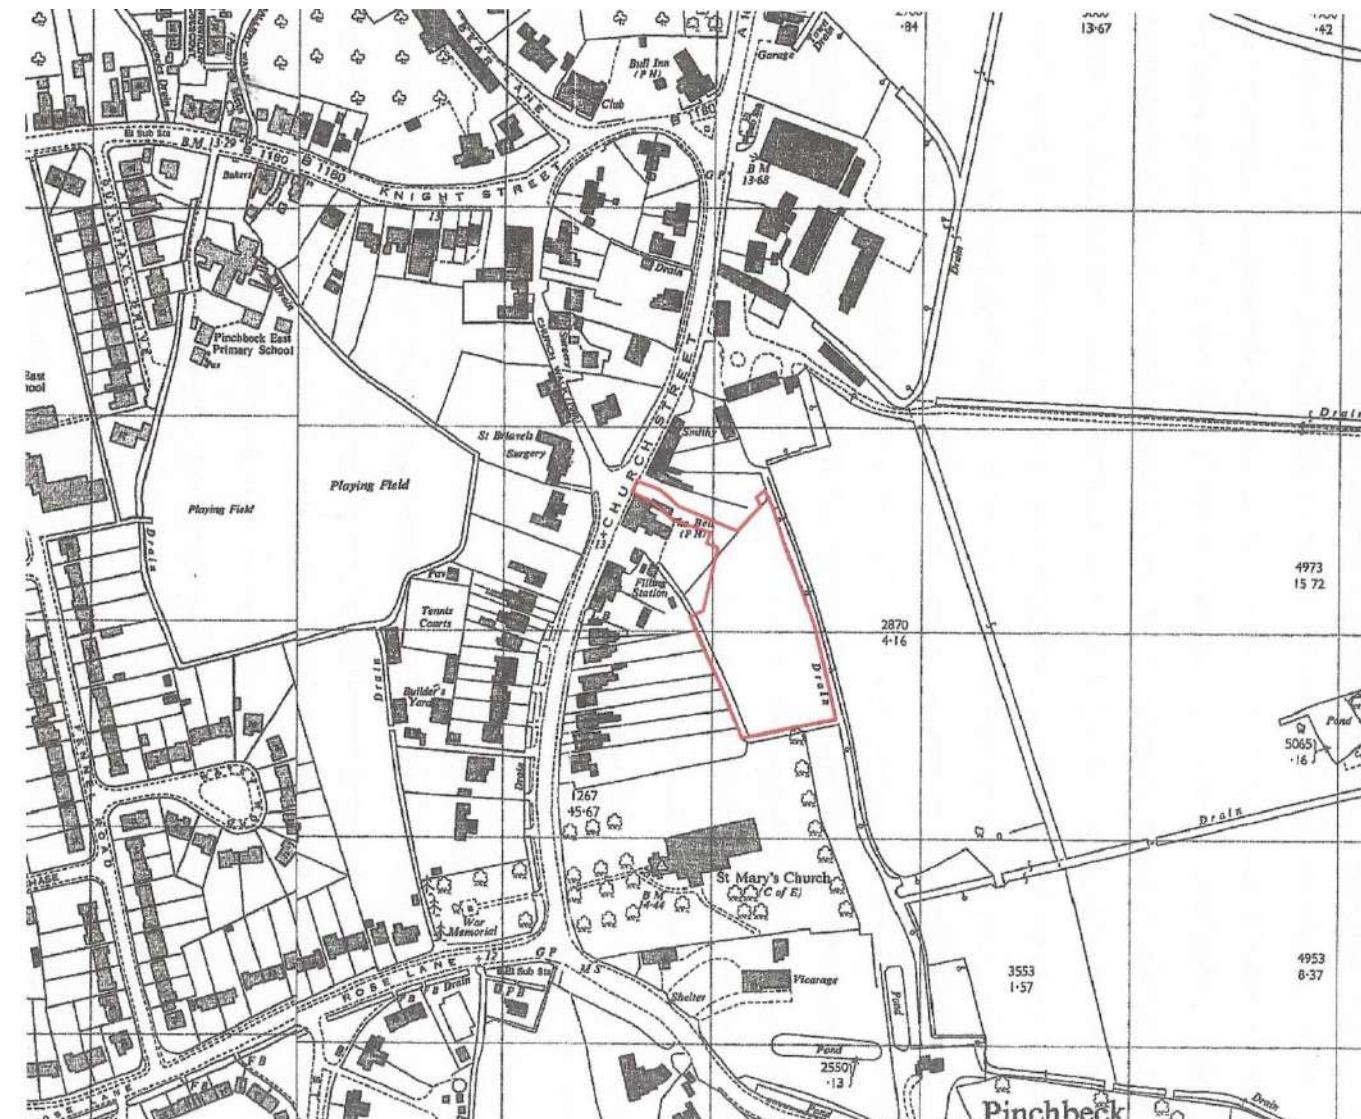
**Figure 9:** Extract from the 1:2,500 scale O.S. map of 1968. The approximate boundaries of the assessment site are shown outlined in red.
