AN ARCHAEOLOGICAL DESK BASED ASSESSMENT STUDY  
OF LAND AT AND TO THE REAR OF THE FORMER BELL INN PUBLIC HOUSE,  
33, CHURCH STREET,  
PINCHBECK, LINCOLNSHIRE.

**[Site Centred at National Grid Reference: TF 2418 2574]  
Planning Reference: H14-0219-22**

PREPARED FOR MR. GUY DIXON OF DIXON DAWSON, CHARTERED ARCHITECTS, ON  
BEHALF OF HIS CLIENTS - VENTURE BUSINESS SPACE LTD.

April 2025

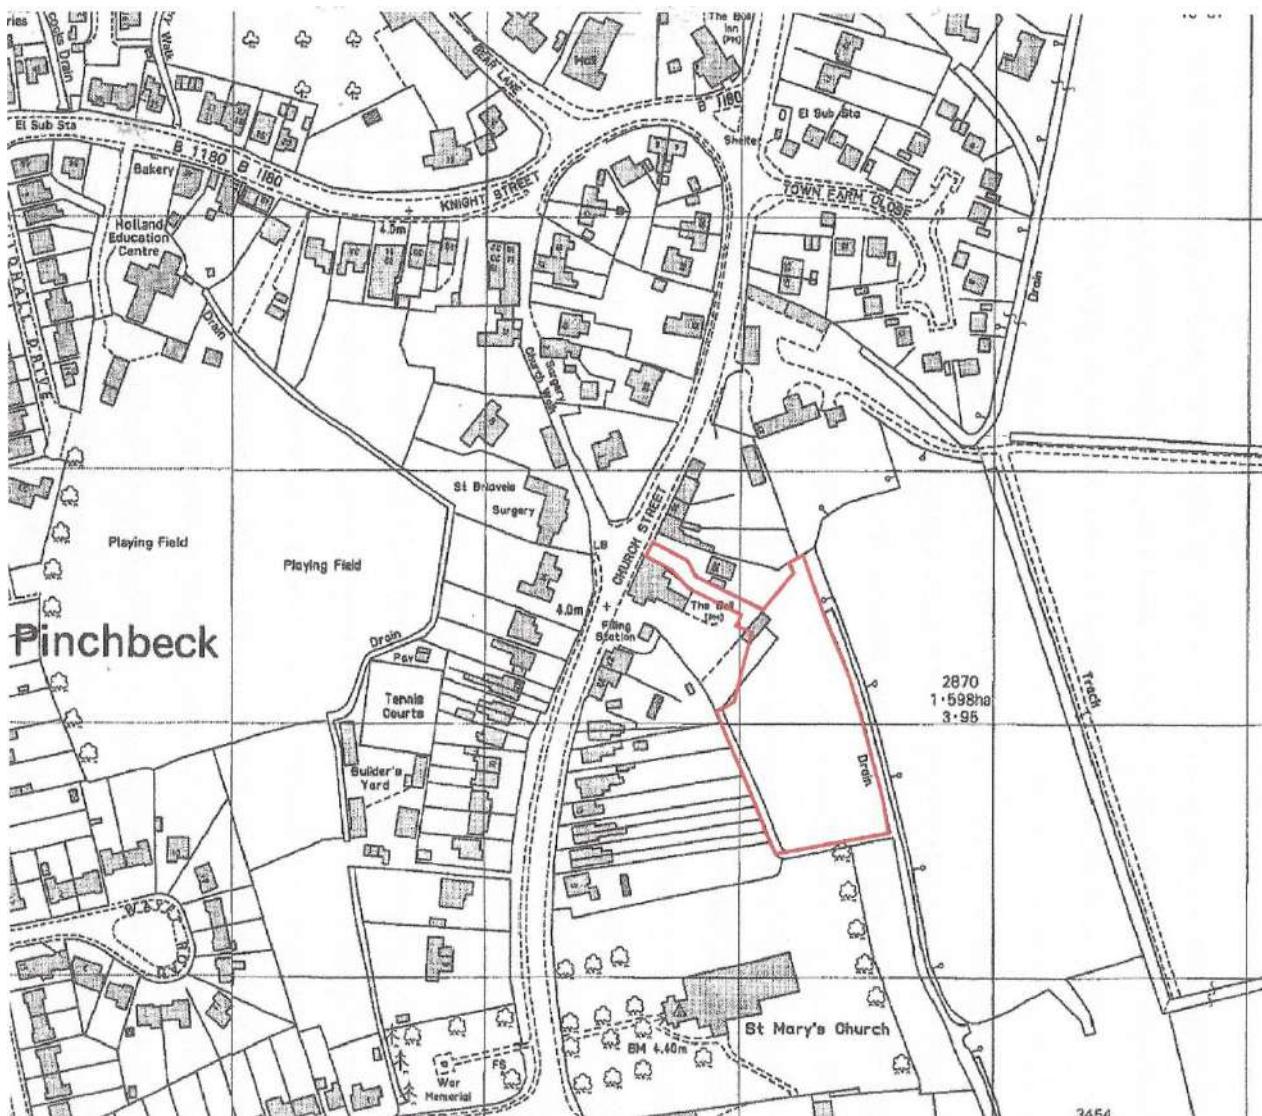
**Figure 10:** Extract from the 1:2,500 scale O.S. map of 1988. The approximate boundaries of the assessment site are shown outlined in red.
