# WINDOW SCHEDULE

The Grange, Northgate, Pinchbeck, Lincs, PE11 3SE

On behalf of Paul & Sam Jeffery

Dragonfly Building Conservation

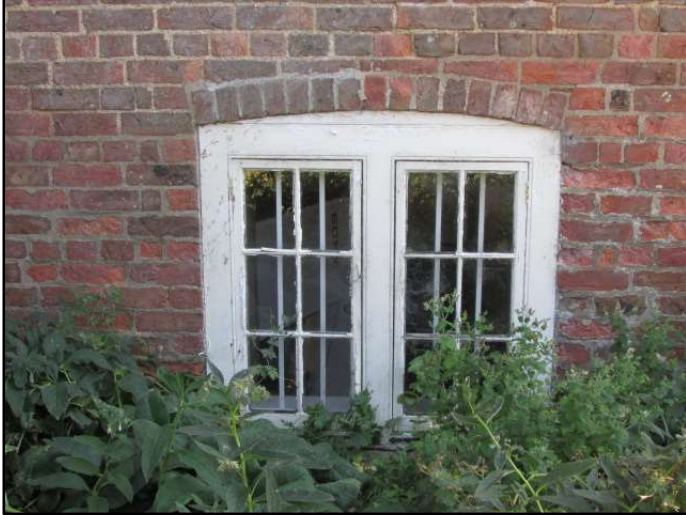
George Barnsdale Ref: W1.

Location: Cellar, north elevation.

Description: Flush casement.

Condition/ Defects: deep rot to cill, bottom rails, lower jambs, glazing bars; single glazed.

Proposal: Replace with matching timber flush heritage-DG casement window.

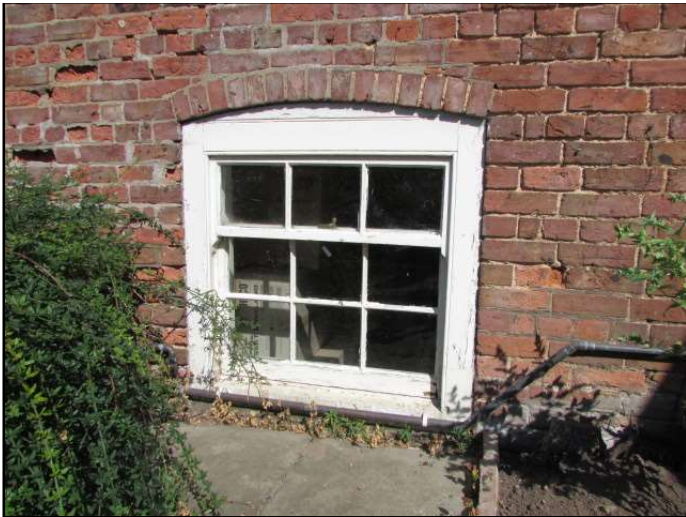
George Barnsdale Ref: W2.

Location: Cellar, west elevation.

Description: '3 over 6' sash window plus horns.

Condition/ Defects: deep rot to cill, bottom rail, lower jambs, glazing bars; single glazed.

Proposal: Replace with matching box sash window c.w. horns.

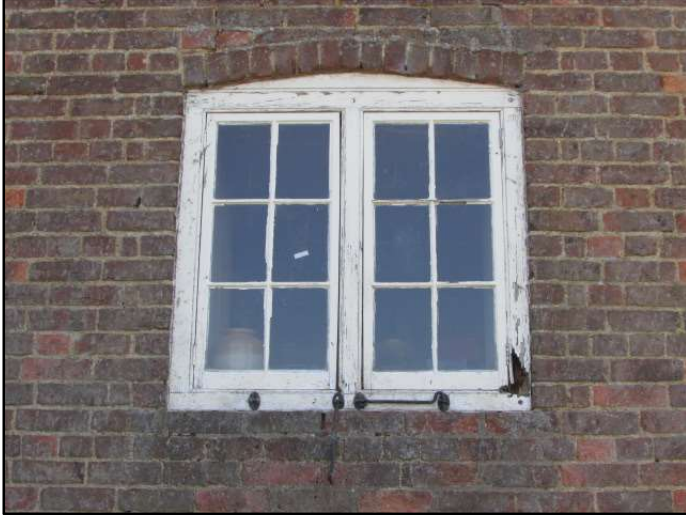
George Barnsdale Ref: W3.

Location: Ground floor pantry, north elevation.

Description: Flush casement.

Condition/ Defects: Wet rot to frame and bottom rails, lower jambs, glazing bars; single glazed.

Proposal: Replace with matching timber flush casement window.

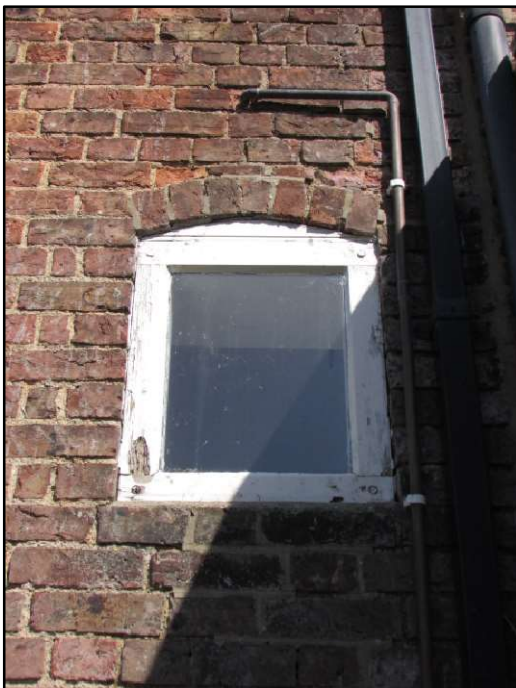
George Barnsdale Ref: W4.

Location: Pantry hallway, GF, west elevation.

Description: Small single light, C20 pegged frame.

Condition/ Defects: deep rot to lower frame, water ingress; single glazed.

Proposal: Replace with matching double-glazed window.

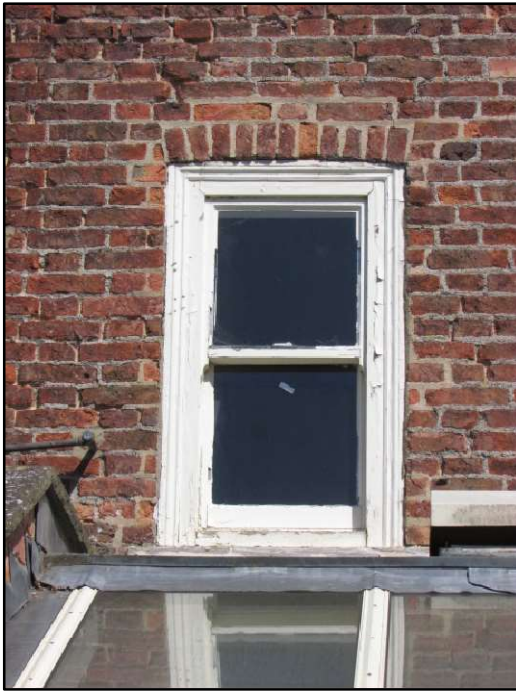
George Barnsdale Ref: W5.

Location: First floor landing.

Description: '1 over 1' horned sash window.

Condition/ Defects: Deep rot to cill, bottom rails, lower jambs, lower sash bars top and bottom, weather ingress; single glazed.

Proposal: Replace with matching box sash window c.w. horns.

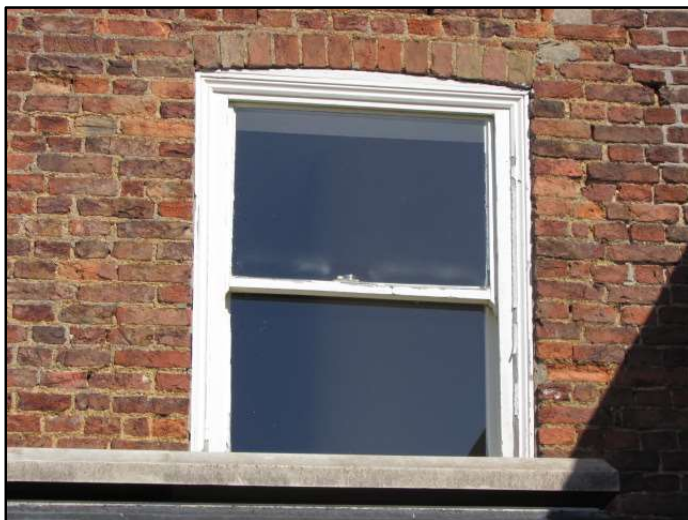
George Barnsdale Ref: W6.

Location: First floor landing.

Description: C20th '1 over 1' horned sash window.

Condition/ Defects: deep rot to cill, bottom rails, lower jambs, lower sash rails, weather ingress; single glazed.

Proposal: Replace with matching box sash window c.w. horns.

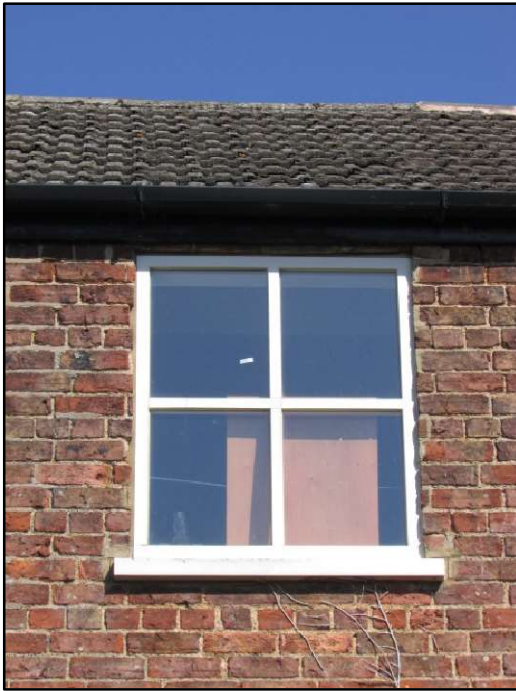
George Barnsdale Ref: W8.

Location: First floor office (formerly Bedroom 3).

Description: 4 light fixed window.

Condition/ Defects: Crude modern replacement.

Proposal: Reinstate flush casement to match others on nearby elevations.

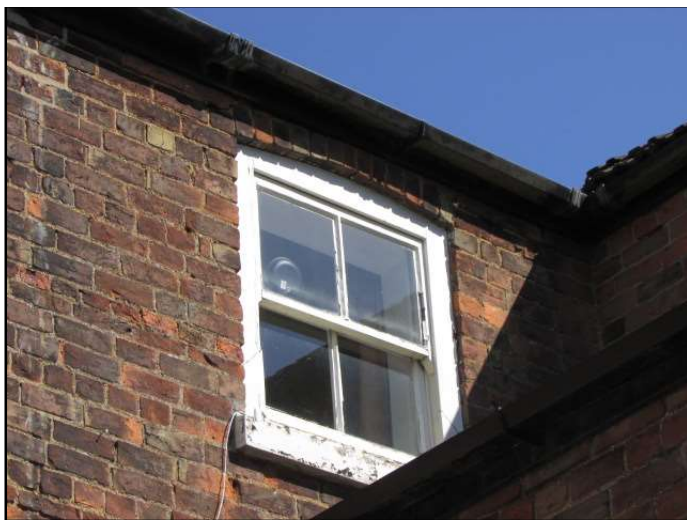
George Barnsdale Ref: W9.

Location: Study/sitting area, 2<sup>nd</sup> floor.

Description: '2 over 2' horned box sash window.

Condition/ Defects: Profound structural rot in most elements, weather ingress; single glazed.

Proposal: '2 over 2' box sash window in matching style.

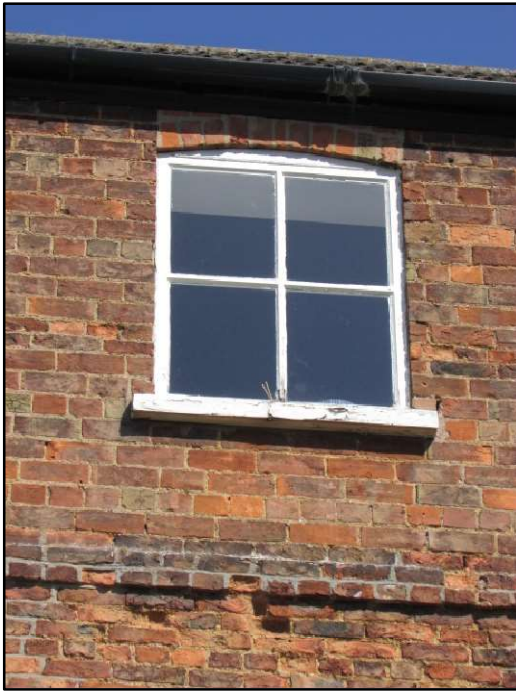
George Barnsdale Ref: W10.

Location: Study/sitting area, 2<sup>nd</sup> floor.

Description: Fixed 4 light window.

Condition/ Defects: Crude modern replacement; single glazed.

Proposal: Reinstate '2 over 2' horned box sash window to match adjacent windows.

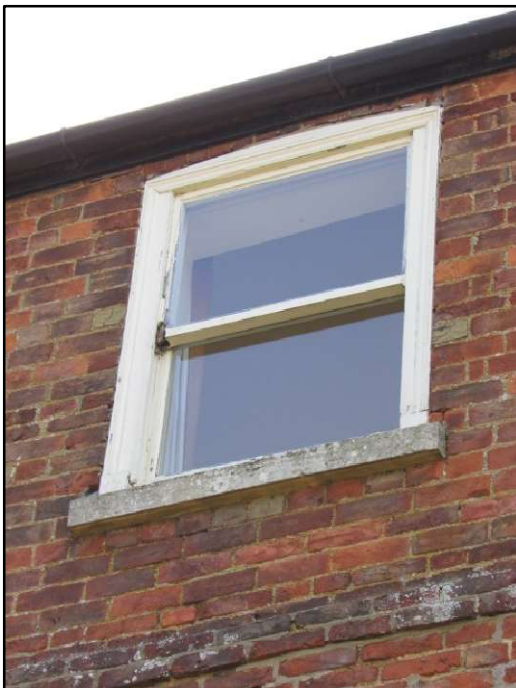
George Barnsdale Ref: W11.

Location: Study/sitting area, 2<sup>nd</sup> floor.

Description: '1 over 1' sliding sash window.

Condition/ Defects: Deep wet rot in most elements, top sash coming apart weather ingress; single glazed.

Proposal: Matching '2 over 2' horned box sash window.

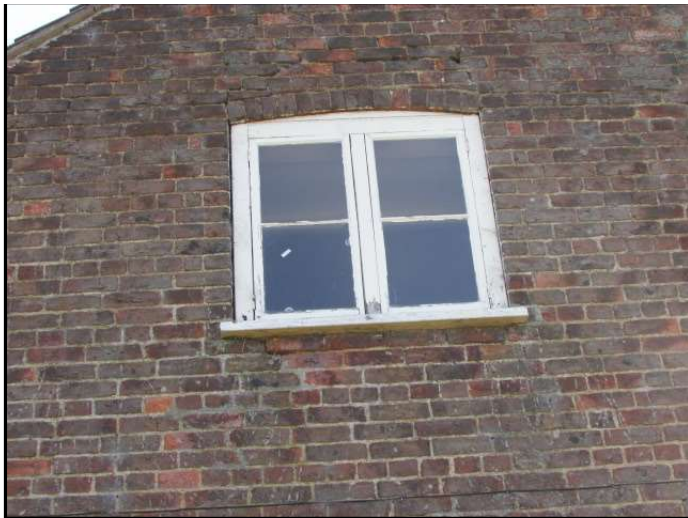
George Barnsdale Ref: W12.

Location: First floor office (formerly Bedroom 3), North aspect.

Description: Flush casement.

Condition/ Defects: Deep wet rot to cill, whole frame, lower rails and glazing bars; considerable weather ingress; single glazed.

Proposal: 4 light flush casement window.
