GROUND CONTAMINATION INVESTIGATION AND ASSESSMENT

PHASE 1 DESK STUDY

**Houghton Produce Ltd,
Fengate Road,
Pinchbeck
PE11 3PU**

Phase 1 Desk Study

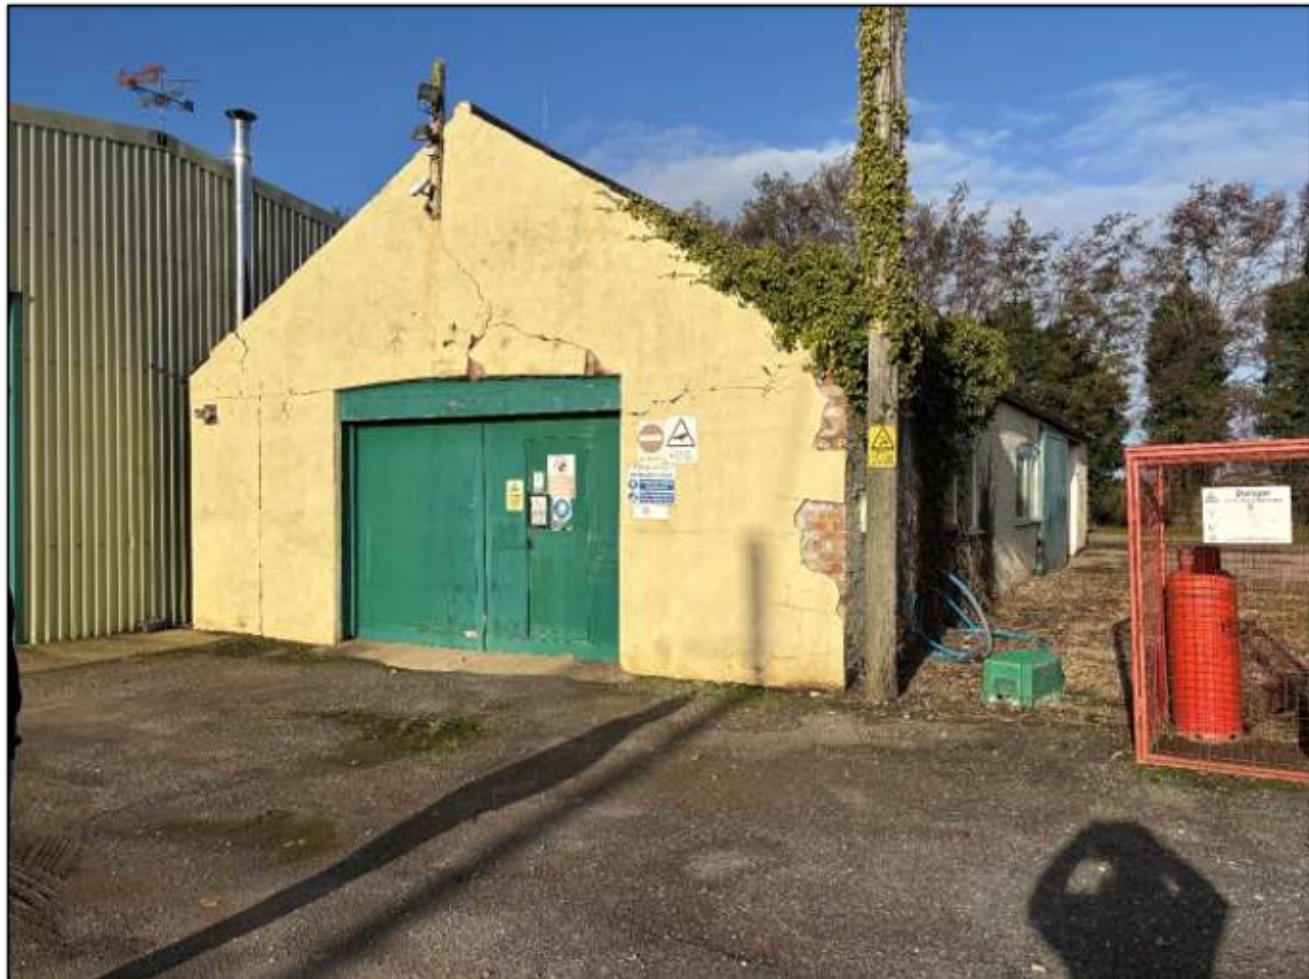
Fig 5 – packing shed

Both the packing shed and cold store have solid concrete floors.

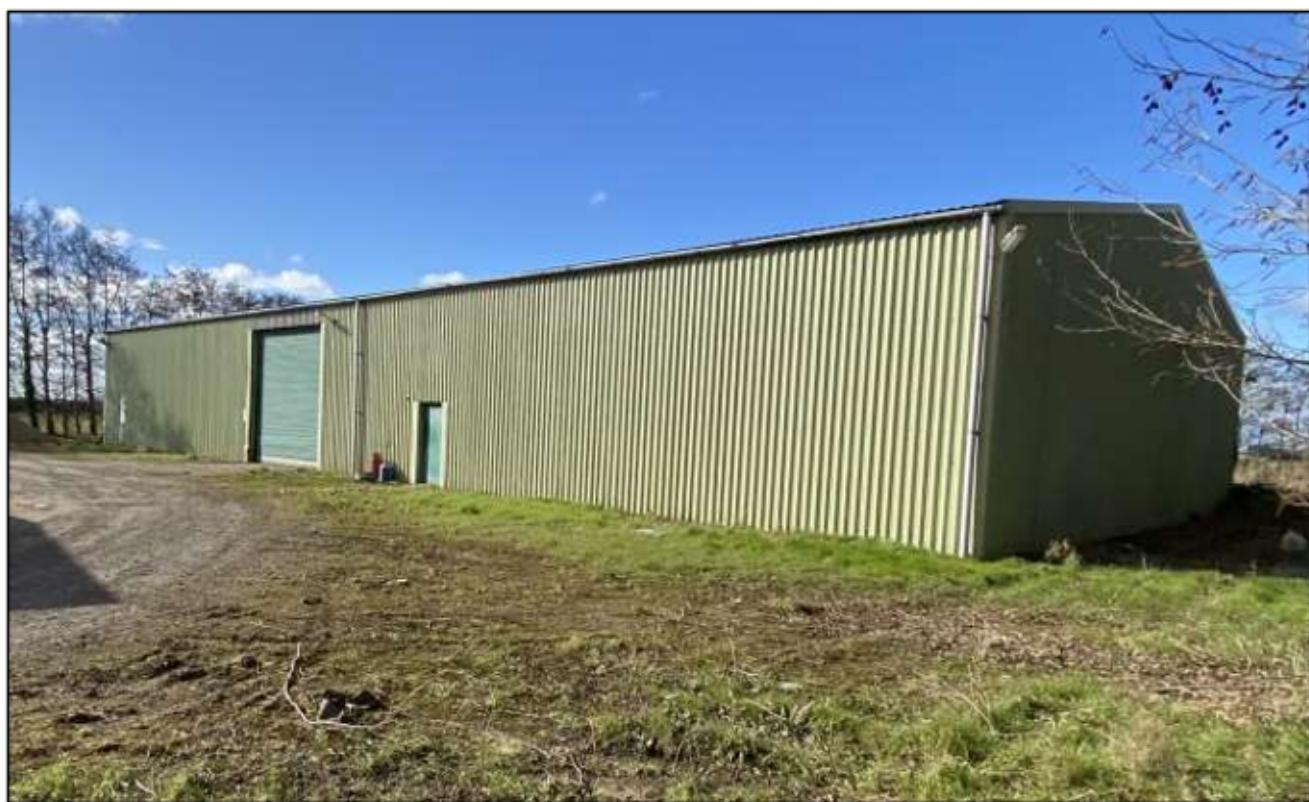
Fig 6 – the former warehouse, removed in 2024

The development site is flat and features the remains of the solid concrete floor of the former warehouse that had been dismantled and removed in 2024.

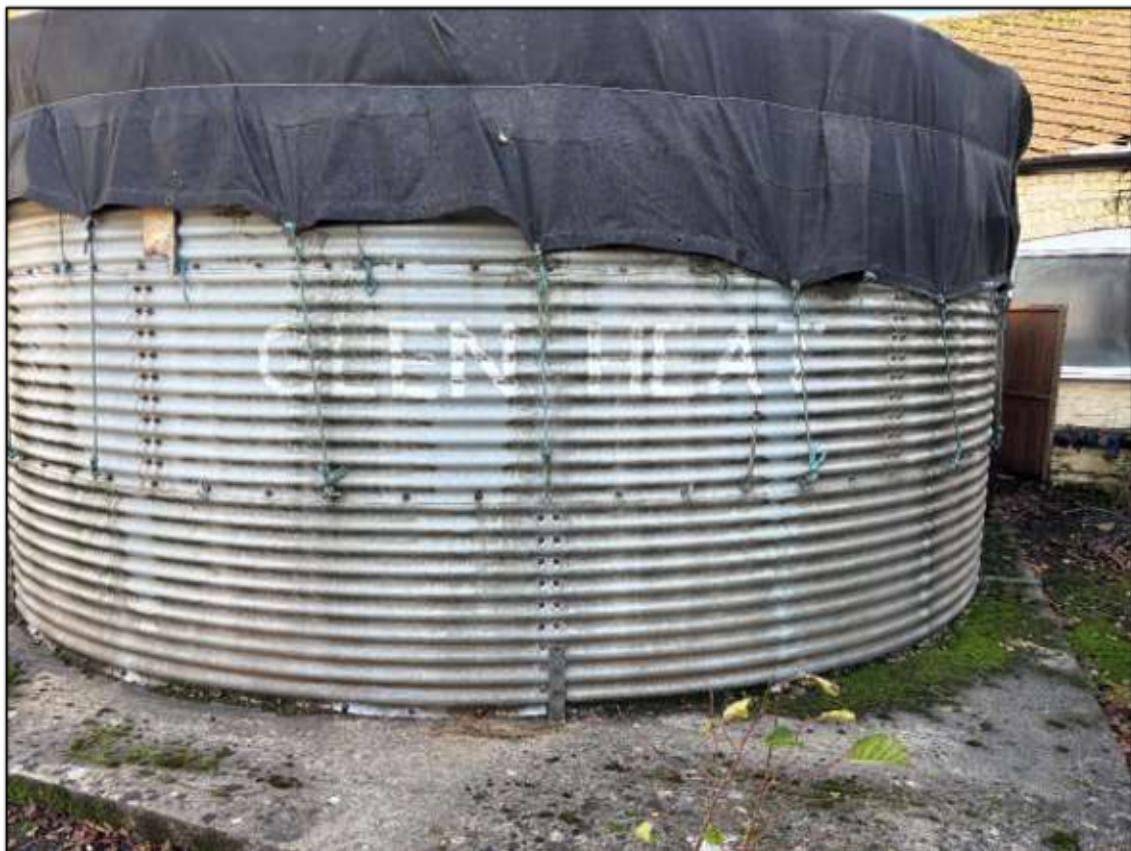
Fig 7 – washing water AST

The AST was for water used to wash the vegetables, with the washings drained directly to the nearby dykes.
