## **Phase 2 (Ground Investigation) Report**

### **Land adjacent to 62 Water Gate, Quadring, Spalding**

Produced for Mrs J Kane

| <i>Report number:</i> | 1251/5048/P/P2 |

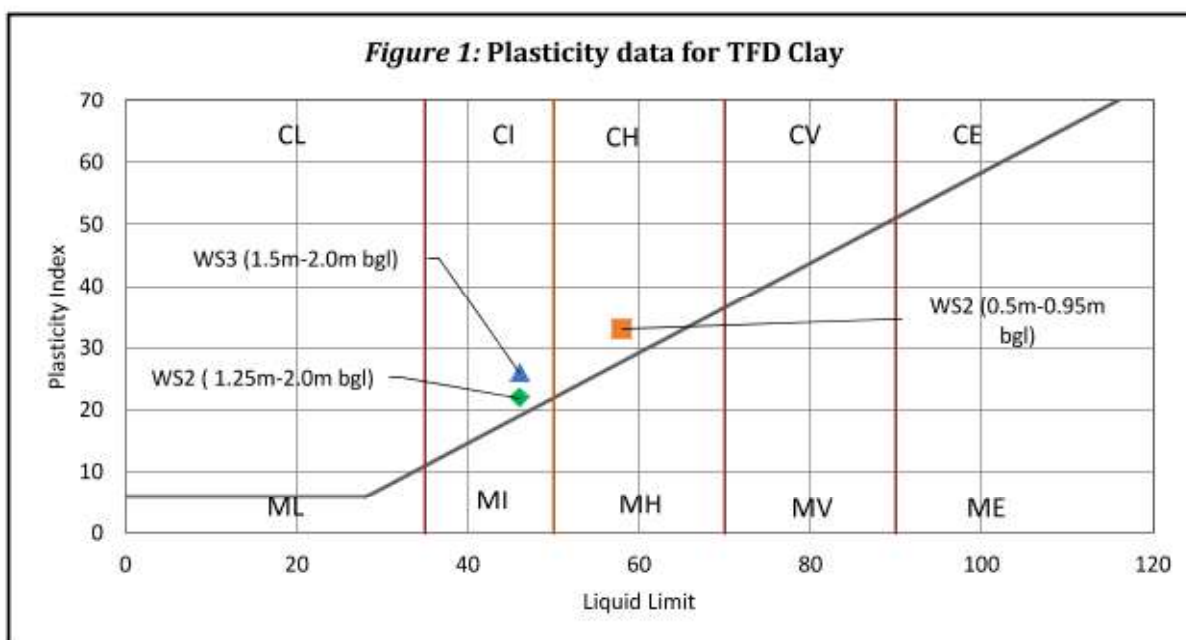
The calculated modified plasticity index (i.e. the plasticity index multiplied by the fraction of sample passing a 425µm sieve) of the TFD clay samples is between 22% and 33%. The three samples are shrinkable based on NHBC Standards (2018) and would be categorised as being of *medium volume change potential*.

The results of plasticity index and moisture content tests on samples of the tidal flat deposit silty clays are shown below (in Table 6). The natural moisture contents generally ranged between 32% and 43%. The plastic limits were between 20% and 25% and the liquid limits between 46% and 58%. The plasticity chart below (Figure 1) shows the fine-grained material (<0.425mm in diameter) within the TFD clay samples could be classified as intermediate to high plasticity clay.

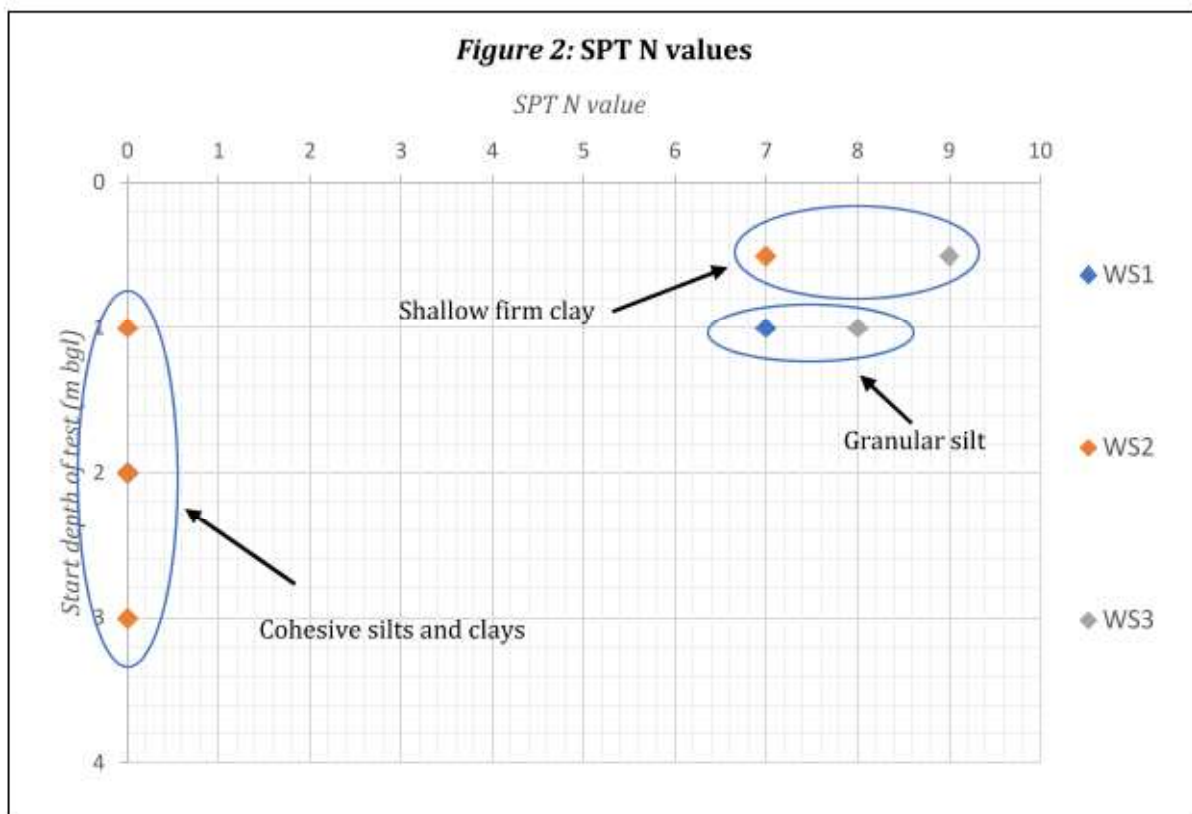
SPT N values in the TFD clay appear to decrease with depth, as shown below (in Figure 2). At a starting depth of 0.5m bgl, the SPT N values vary between 7 and 9 (blows/300mm penetration). However, at starting depths of 1.0m or greater, N values of zero were measured.

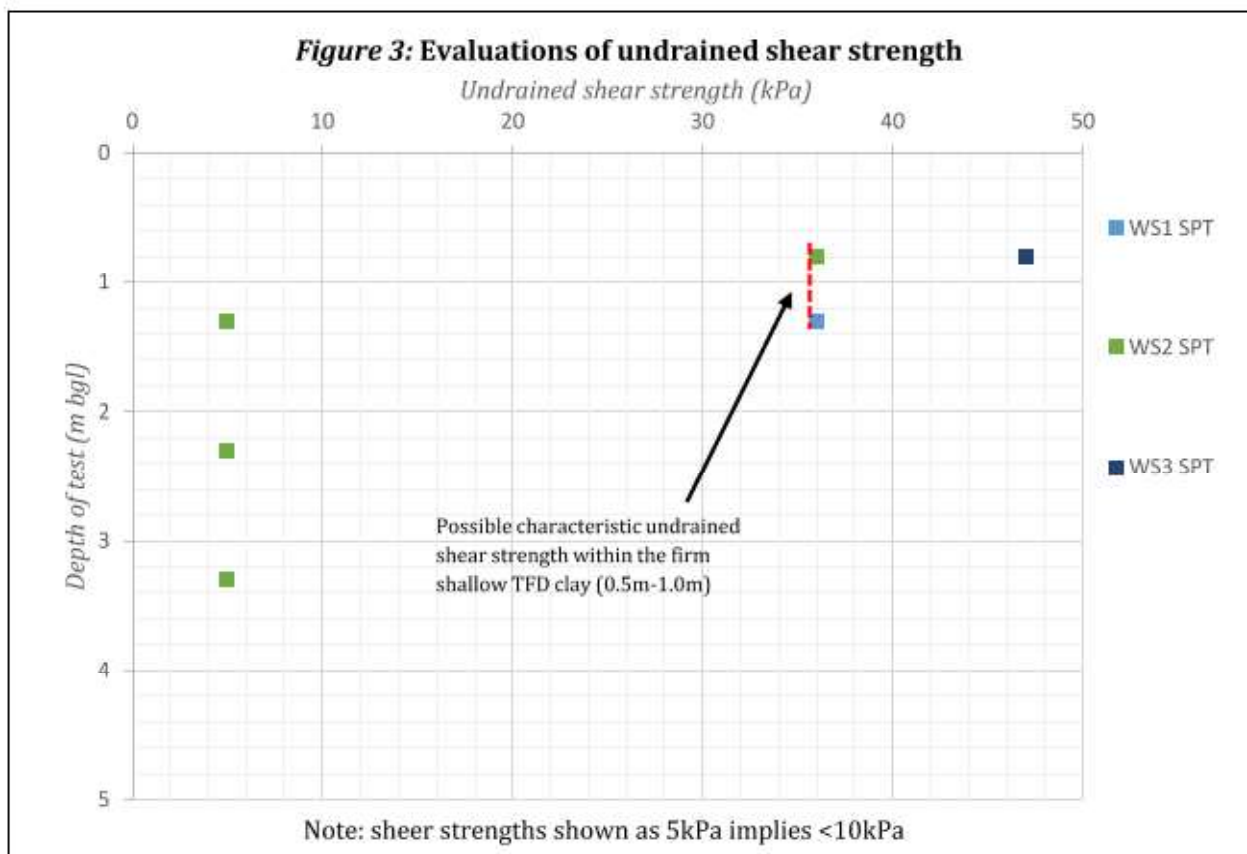
Overall, evaluations of the undrained shear strength of the shallow TFD clay suggest it is around 35kPa within the firm shallow TFD clays (in figure 3). However, below around 1m bgl this may not be the case as the ground conditions change becoming sandy silts which may not offer suitable bearing strata.

The undrained shear strengths of the underlying TFD clay can be roughly correlated from SPT N values (e.g. using Stroud, 1976), as shown below (in Table 7). The shallower SPT N values between 0.5m and 1m bgl from all three boreholes were found to be higher than the deeper SPT N values.

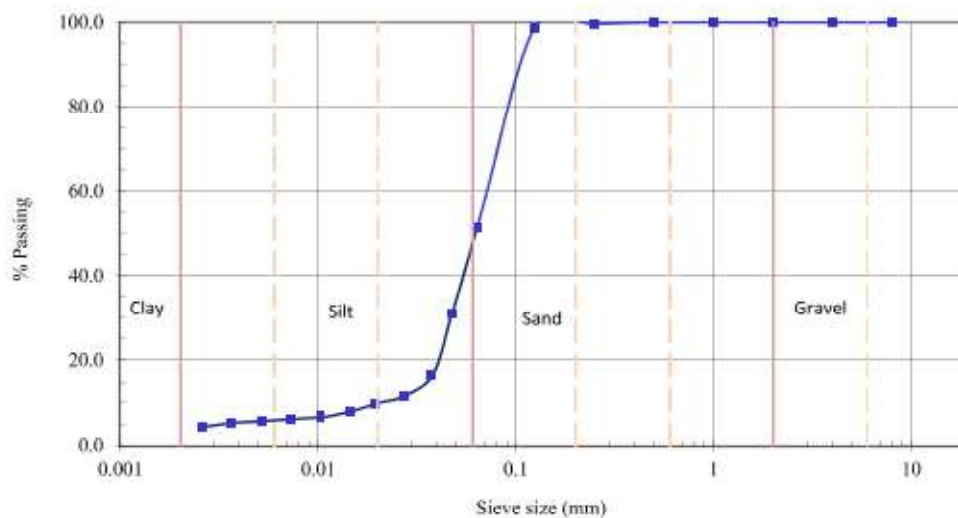
### Determination of Particle size distribution - Sedimentation method

Test method BS 1377 Part 2 1990

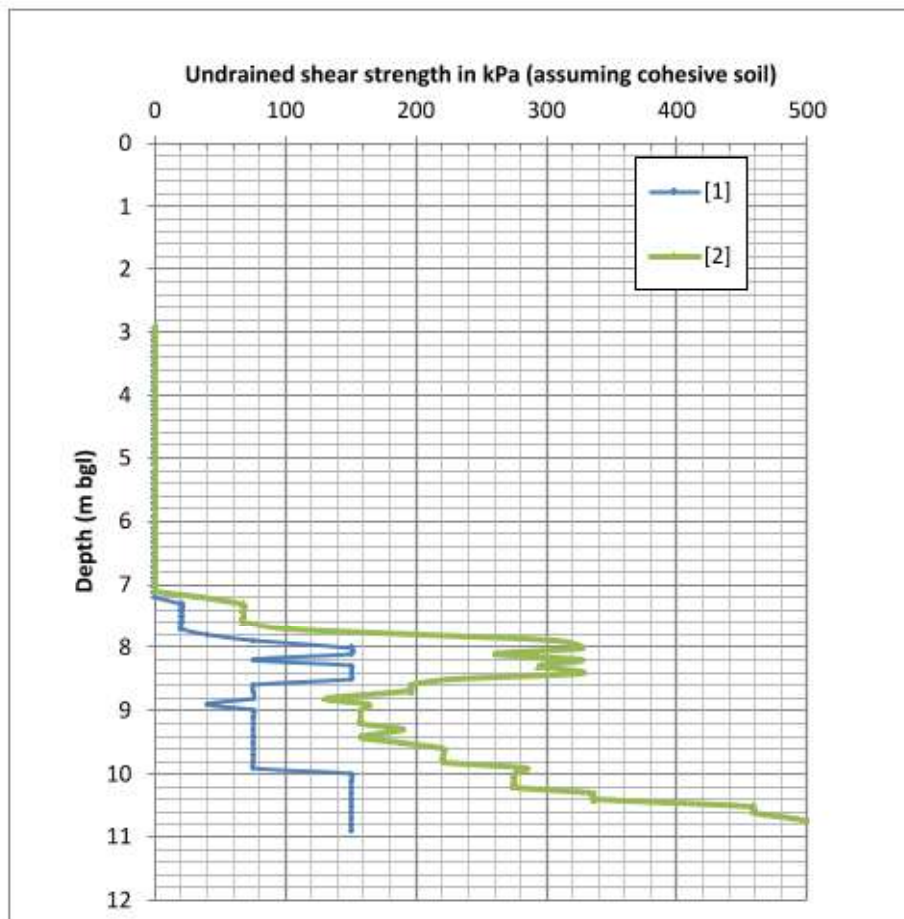
Minimum  $c_u$  (based on Huntley\*, 1990): [1]

Stiff clay (based on Butcher, 1996): [2]

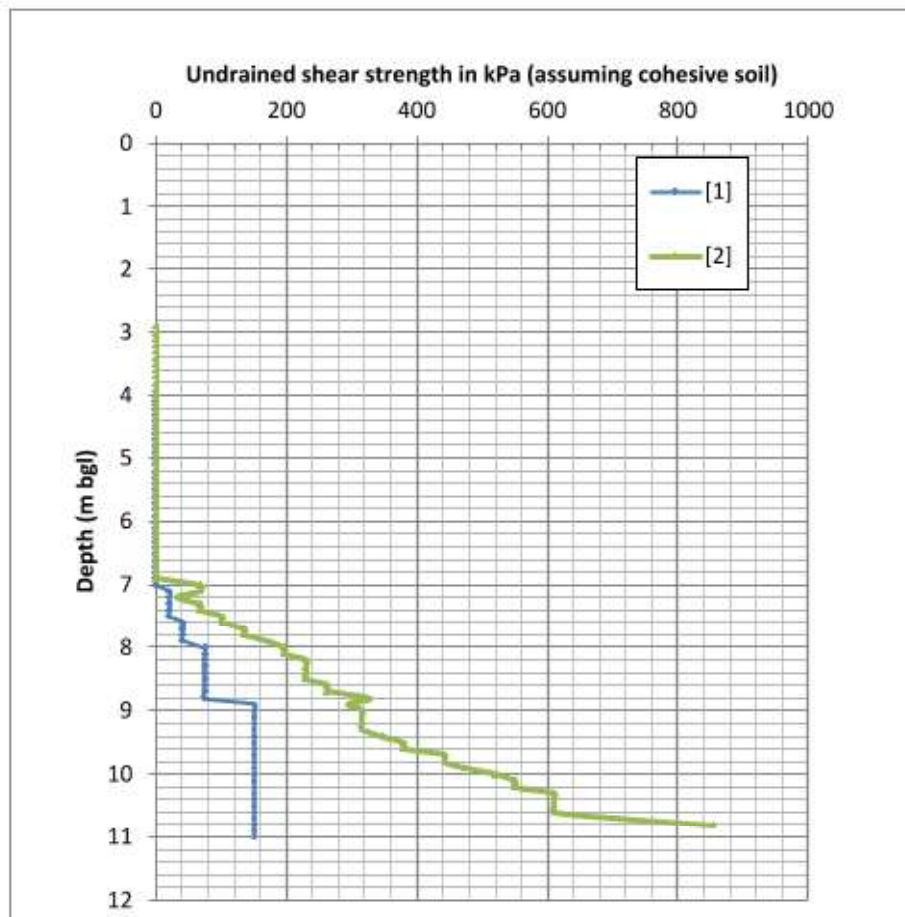
Minimum  $c_u$  (based on Huntley\*, 1990): [1]

Stiff clay (based on Butcher, 1996): [2]
