# GROUND CONTAMINATION INVESTIGATION AND ASSESSMENT PHASE 1 DESK STUDY

for the  
**Barn Conversion**  
at  
**The Laurels,  
Wood Lane,  
Quadring Eaudyke  
PE11 4SS**

Tier 1 Preliminary Risk Assessment -  
Desk Study

The Laurels, Wood Lane, Quadring  
Eaudyke PE11 4SS

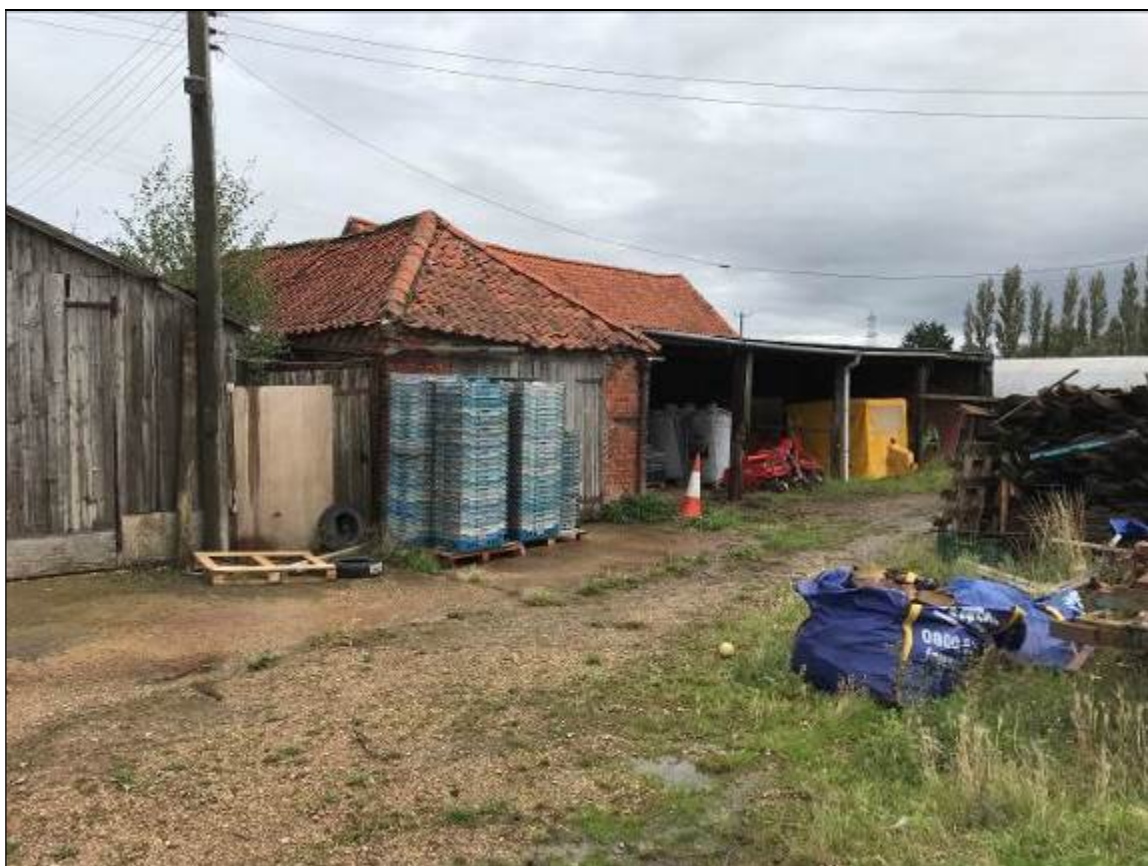
Fig 5 – view to northeast along south boundary

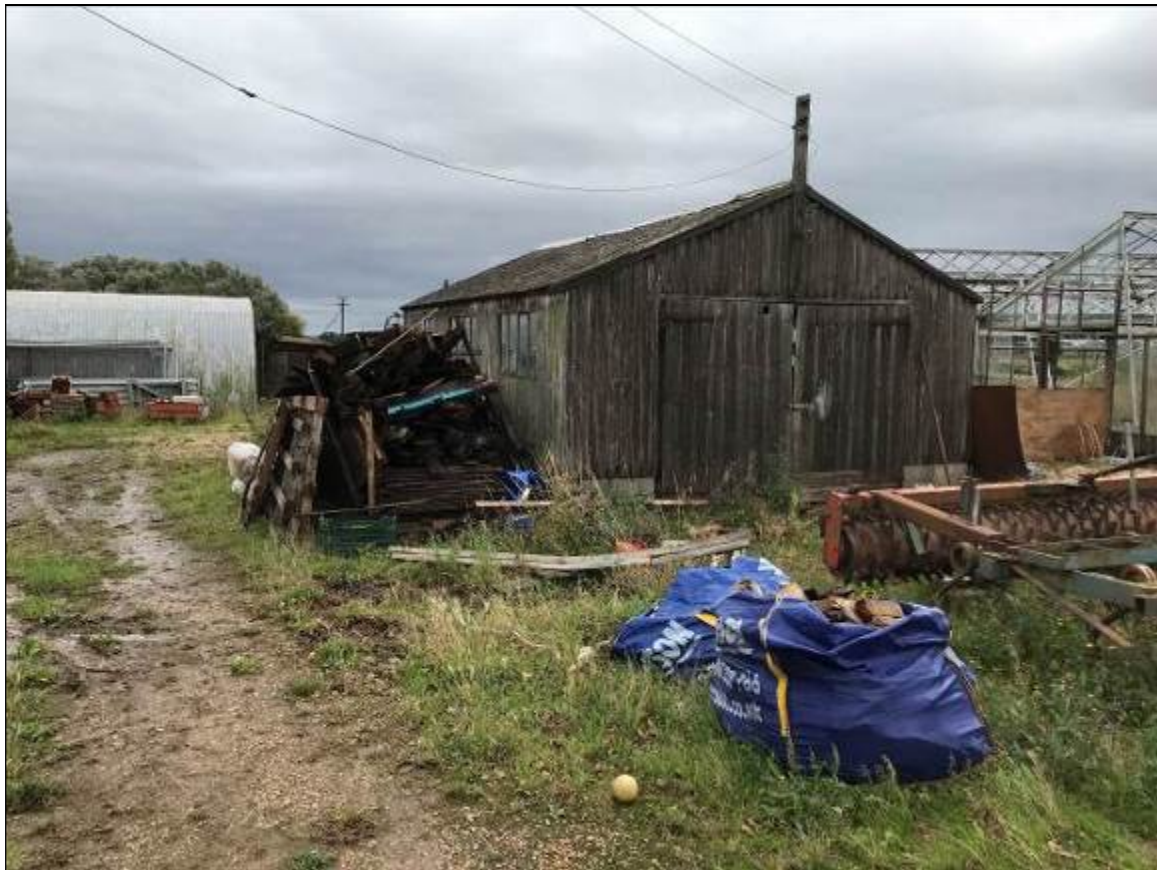
There is a small wooden shed beyond the south boundary that has a corrugated CBA roof and 30 m to the west is a large steel-framed warehouse, clad and roofed with CBA panels.

In all cases the CBA panels and roofing are in good condition, with no cracks or frayed edges.

Fig 6 – view to east along south boundary with wooden shed with CBA roof beyond

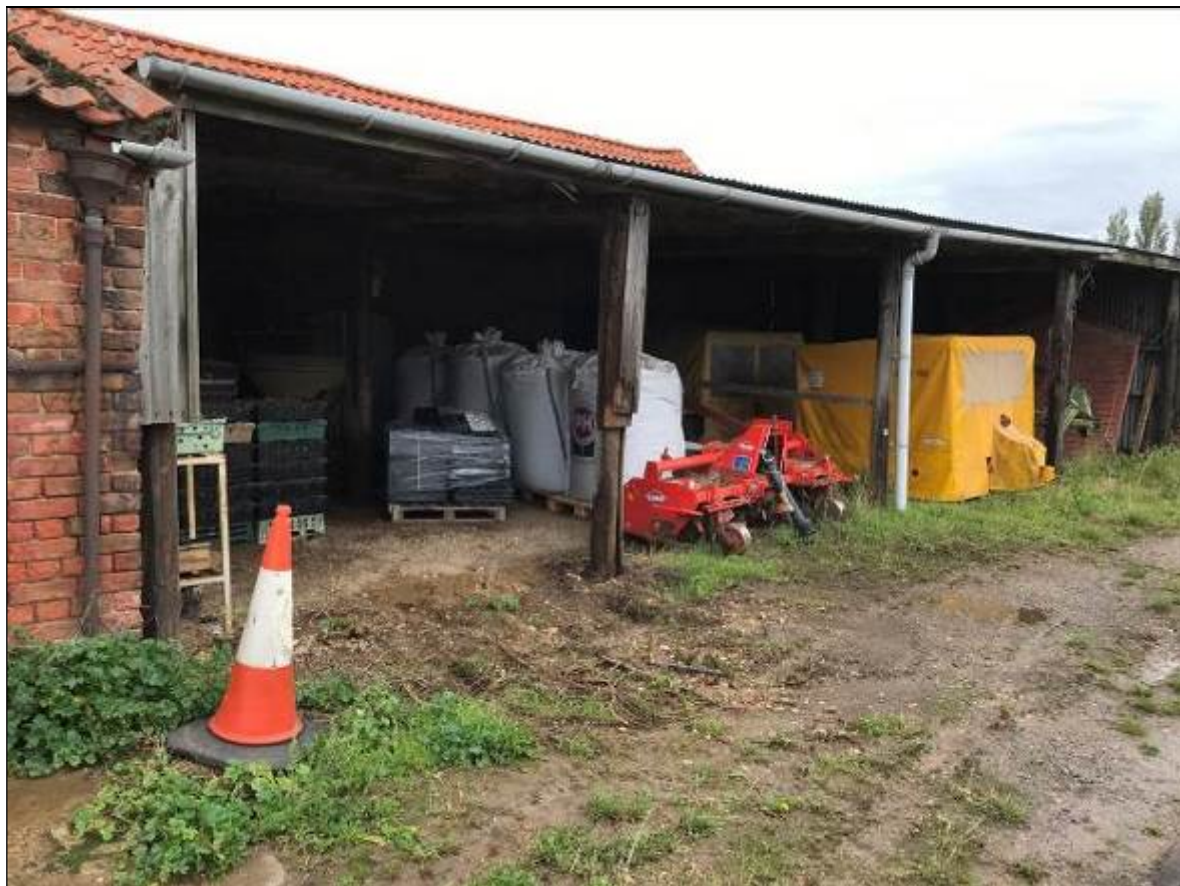
The sheds and buildings are in poor condition.

Fig 7 – view to north east of open-sided barn

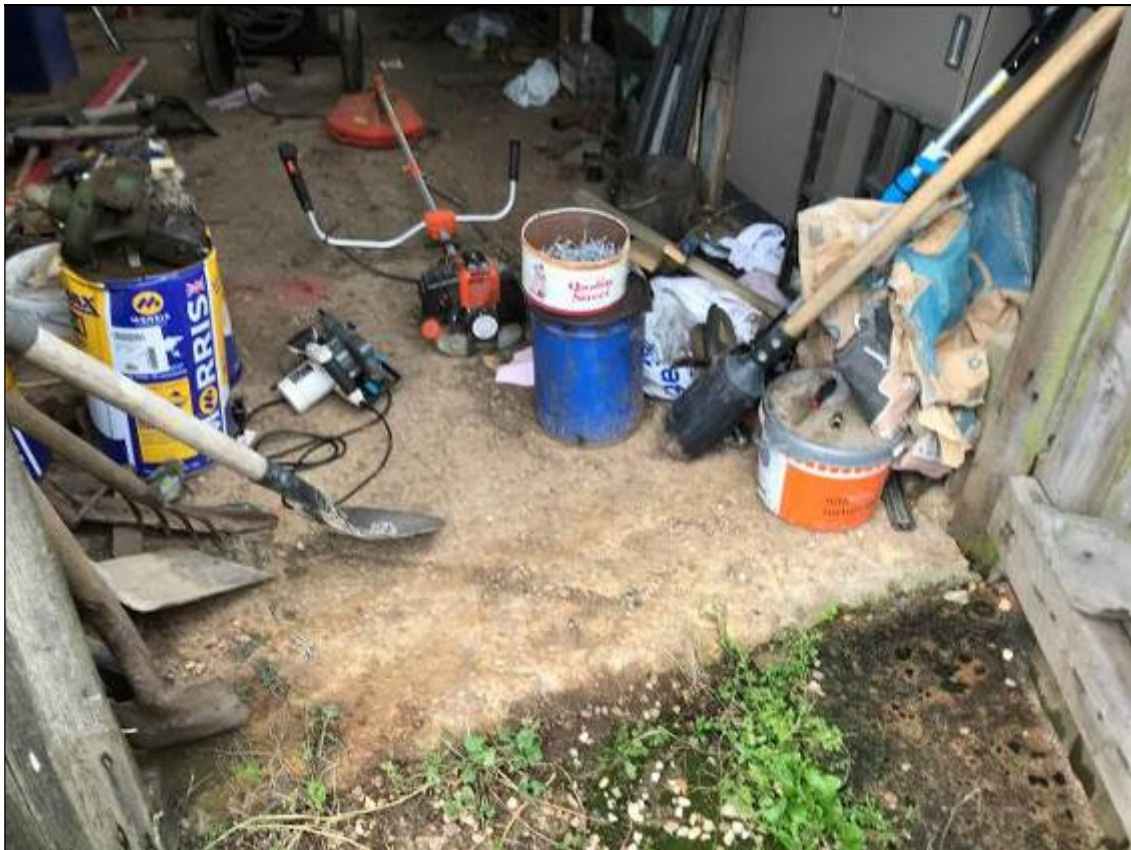
The floors of all of the on-site buildings are covered with concrete and no discolouration from oil or chemical spills were observed.

Fig 8 – concrete floor common in all sheds and barns

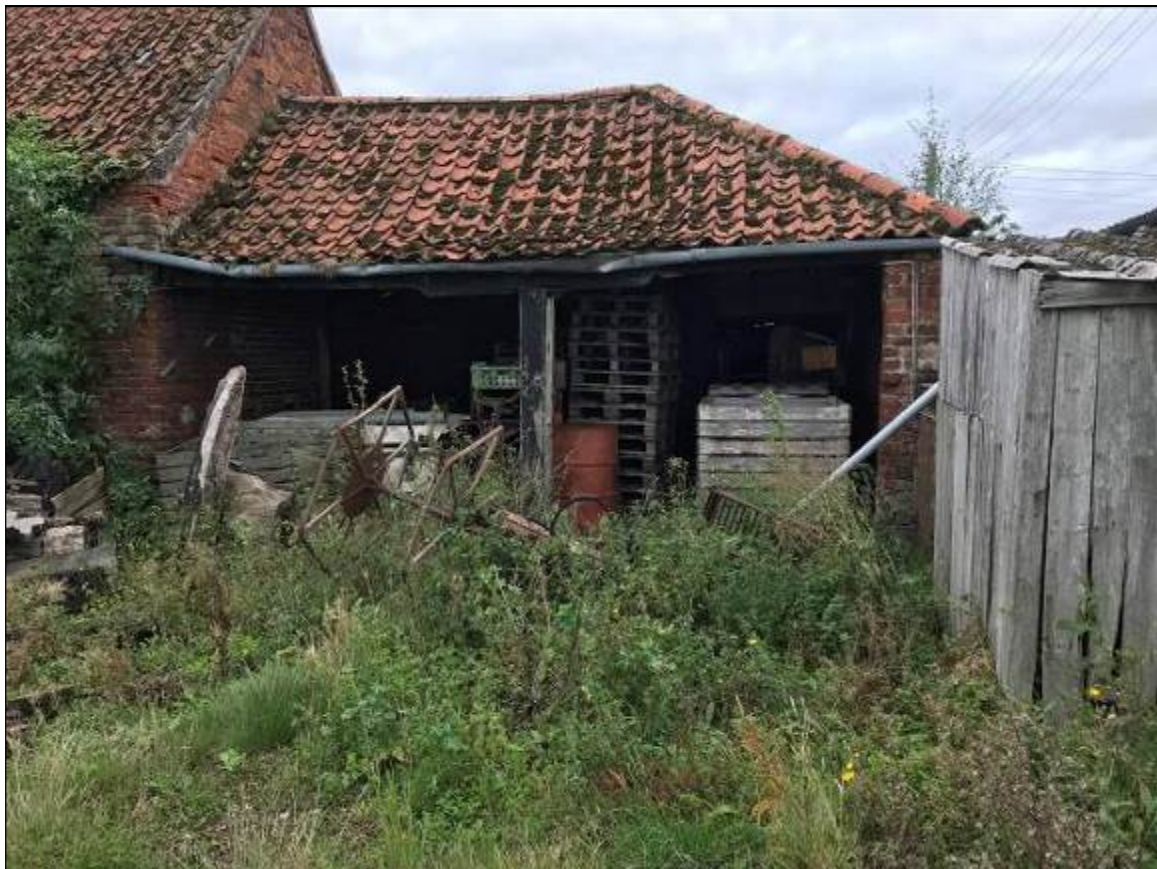
Fig 9 – view to south of north elevation

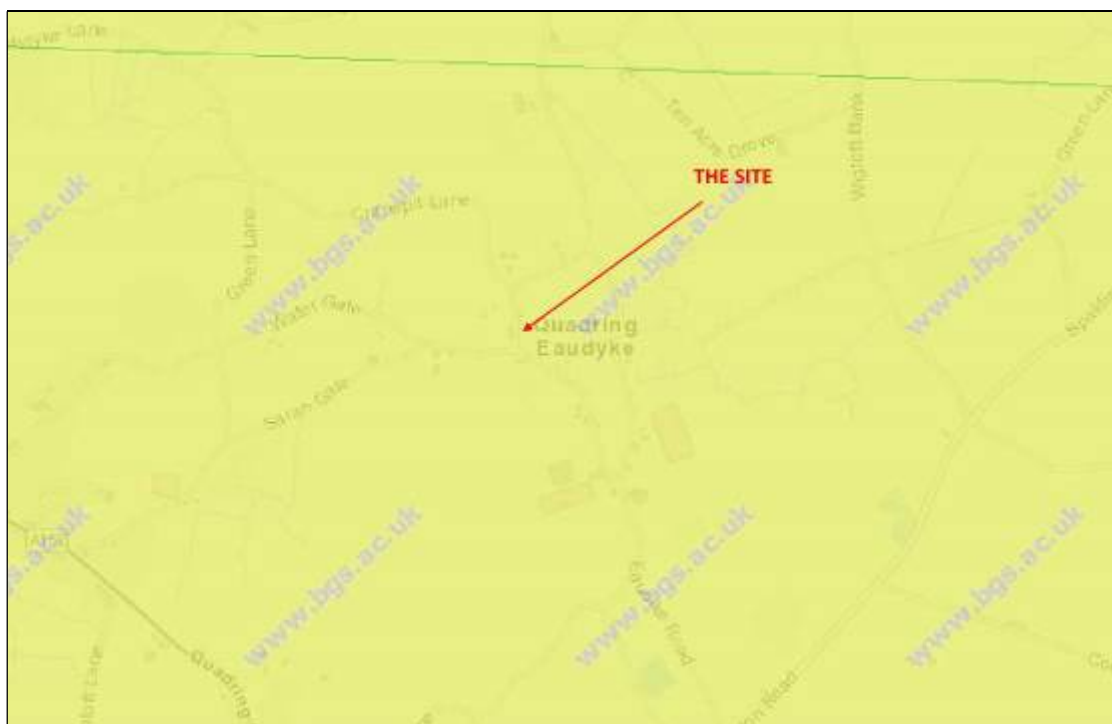
Fig 8 - Geology of the site

The 1:50 000 BGS map shows the solid geology to comprise the bedrock Jurassic Oxford Clay overlain by Quaternary Glacial Till and capped with the Recent Tidal Flat Deposits.
