| <b>Report type</b> | Phase 1 Preliminary Risk Assessment |
| <b>Site address</b> | Judy Cross Barn, Water Gate, Quadring, Spalding, PE11 4PY |

The client's proposed project involves the conversion of a barn into residential dwelling and associated works at Judy Cross Barn, Water Gate, Quadring, Spalding, PE11 4PY. A desk-top study has been requested by South Holland District Council, through attachment of conditions on planning application H15-0100-21. Oakshire Environmental have carried out a Phase 1 Preliminary Risk Assessment, as described below.

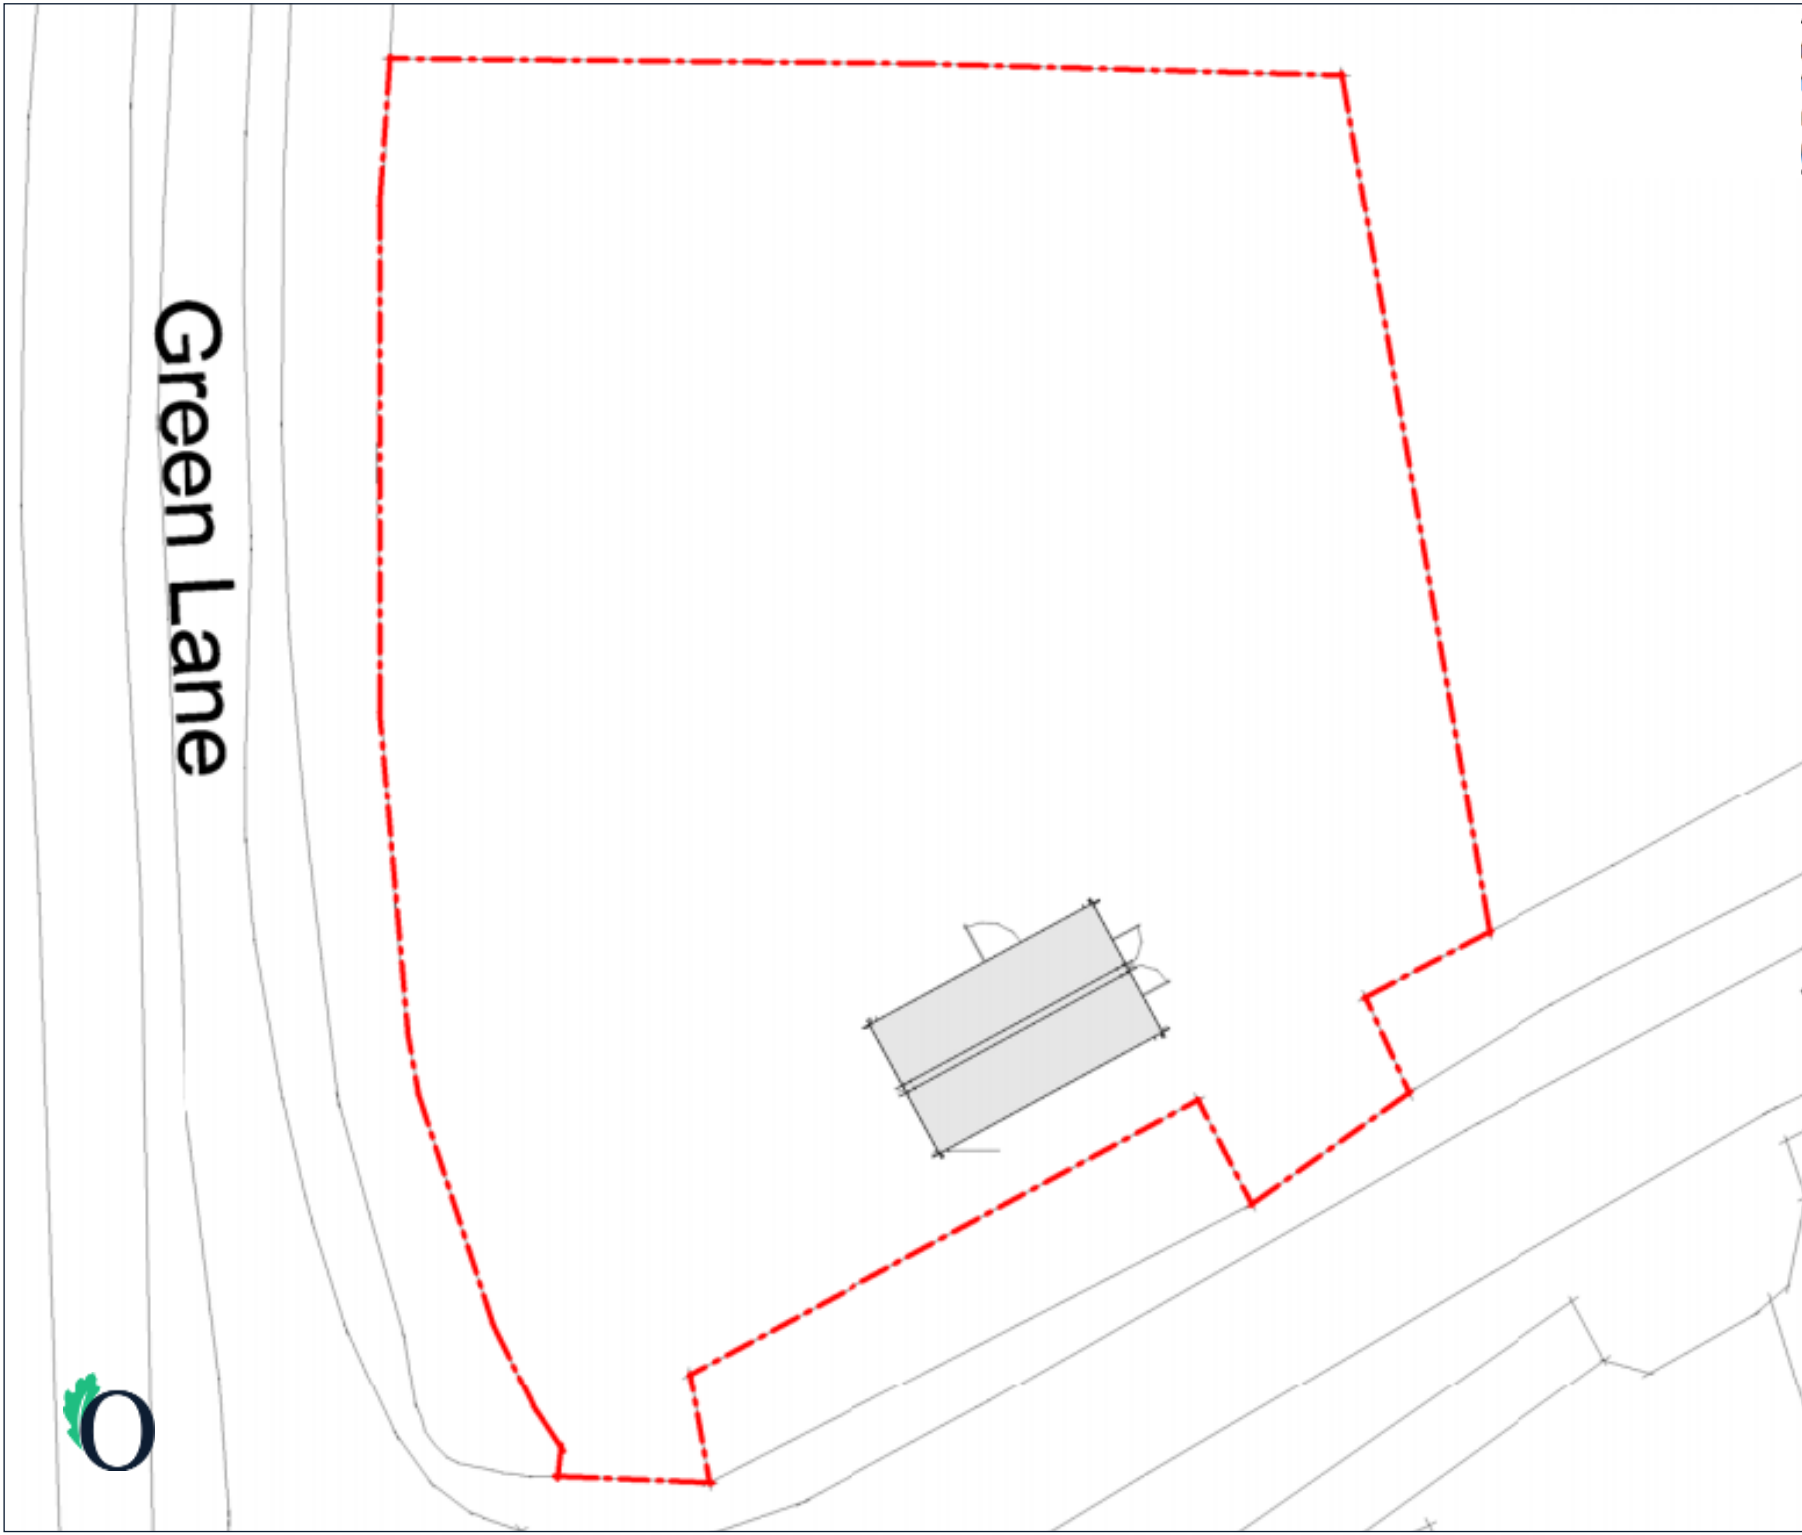
| Appendix A - Site Maps & Plans | |
|---|---|
| Name | Figure 1 |

| Appendix A - Site Maps & Plans | |
|---|---|
| Existing block plan | |

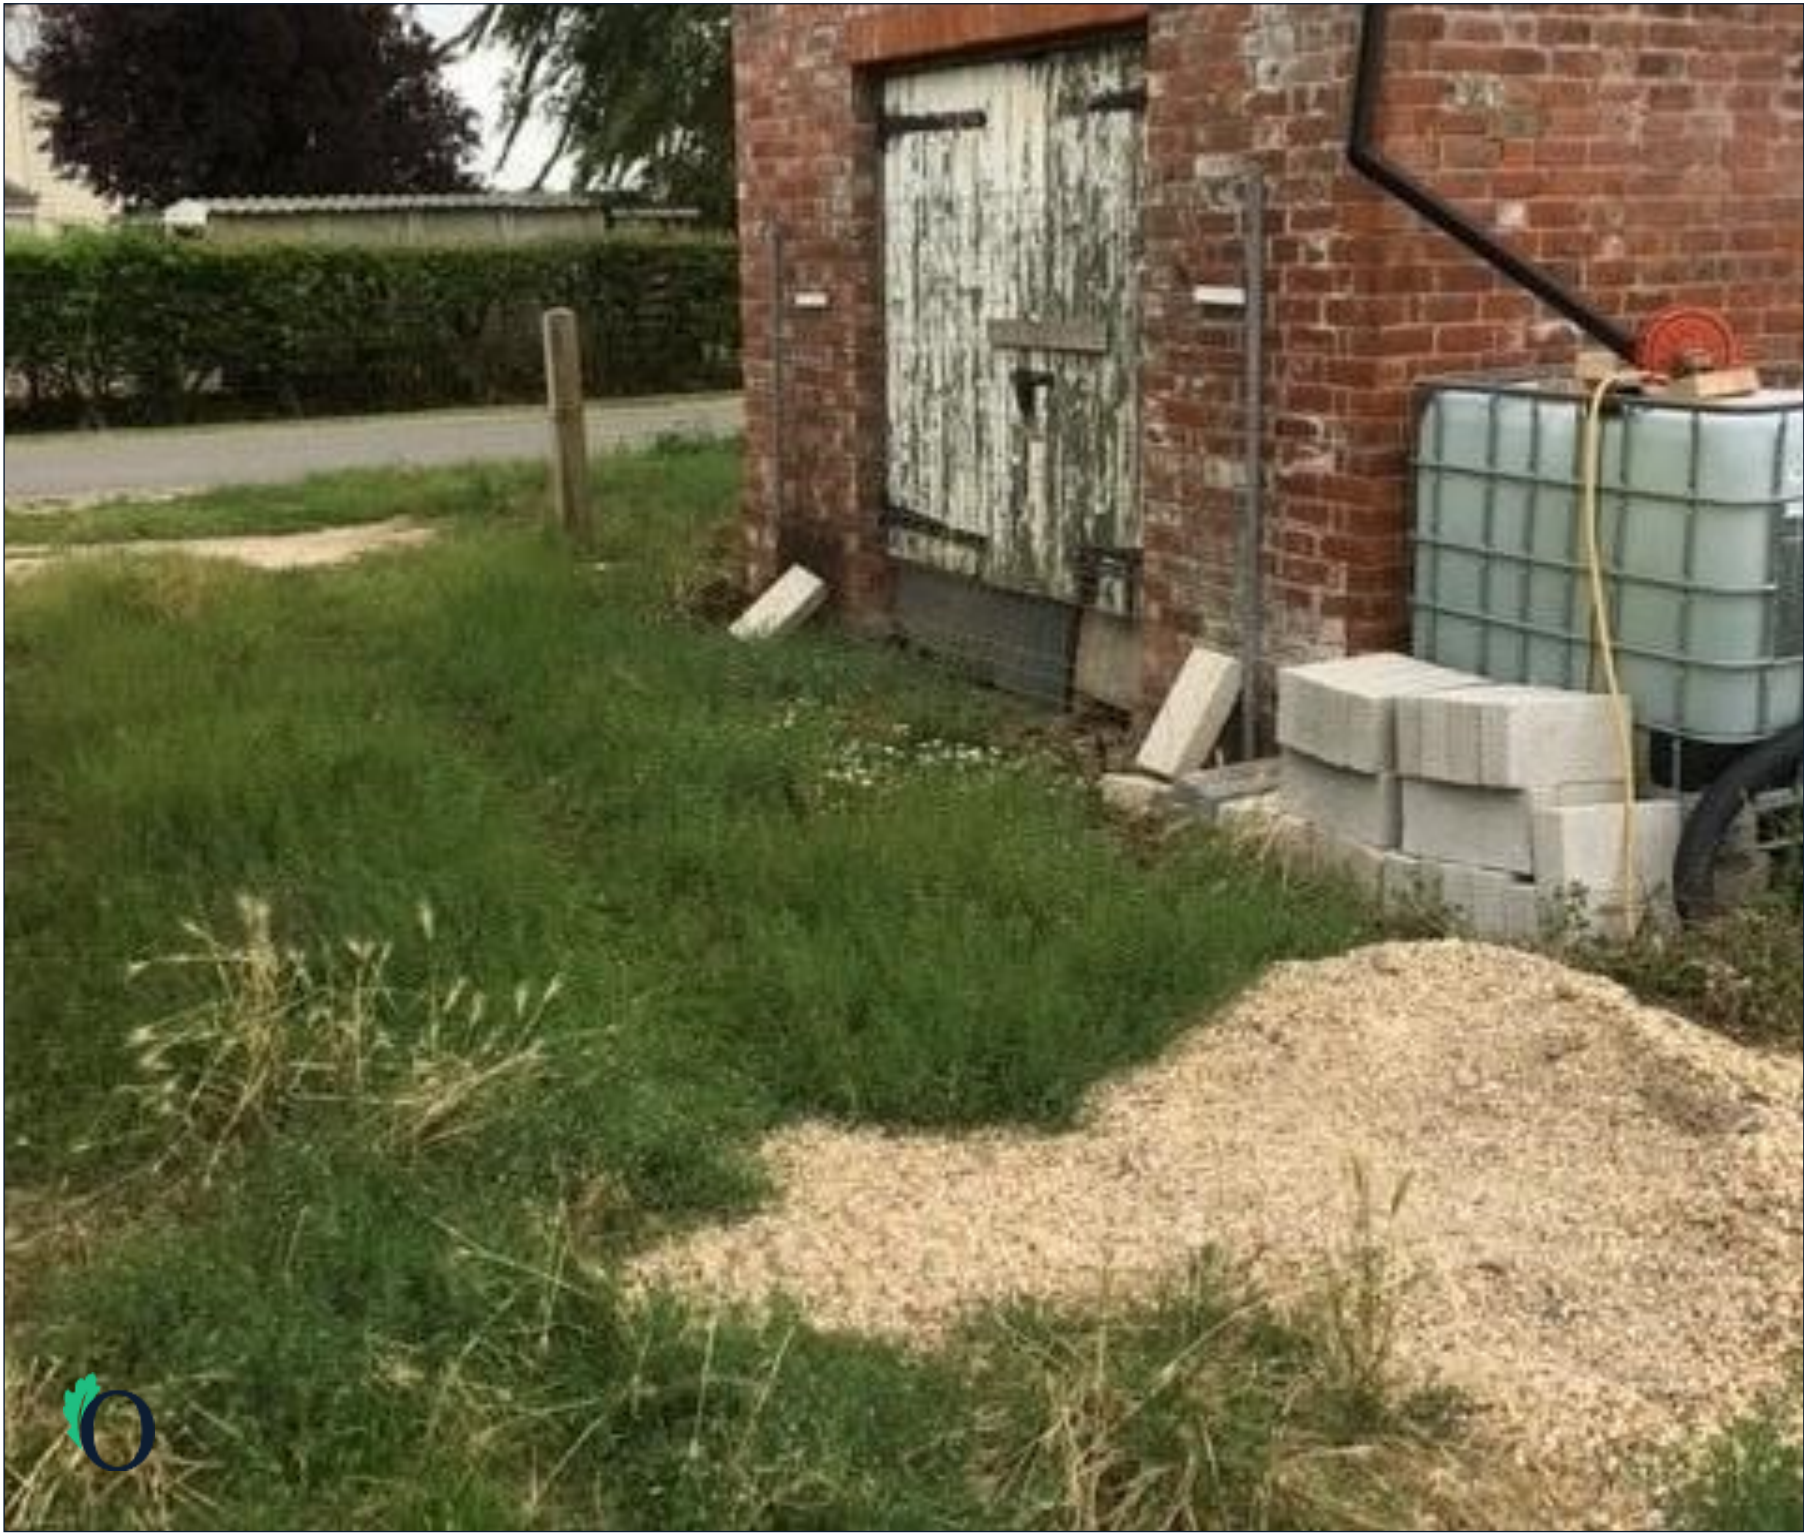
| Appendix B - Site Photos | | |
|---|--|---|
| Name | | Figure 3 |

| Appendix B - Site Photos | | |
|---|--|---|
| Photo of disused barn building and tank at the south of the site, facing south | | |

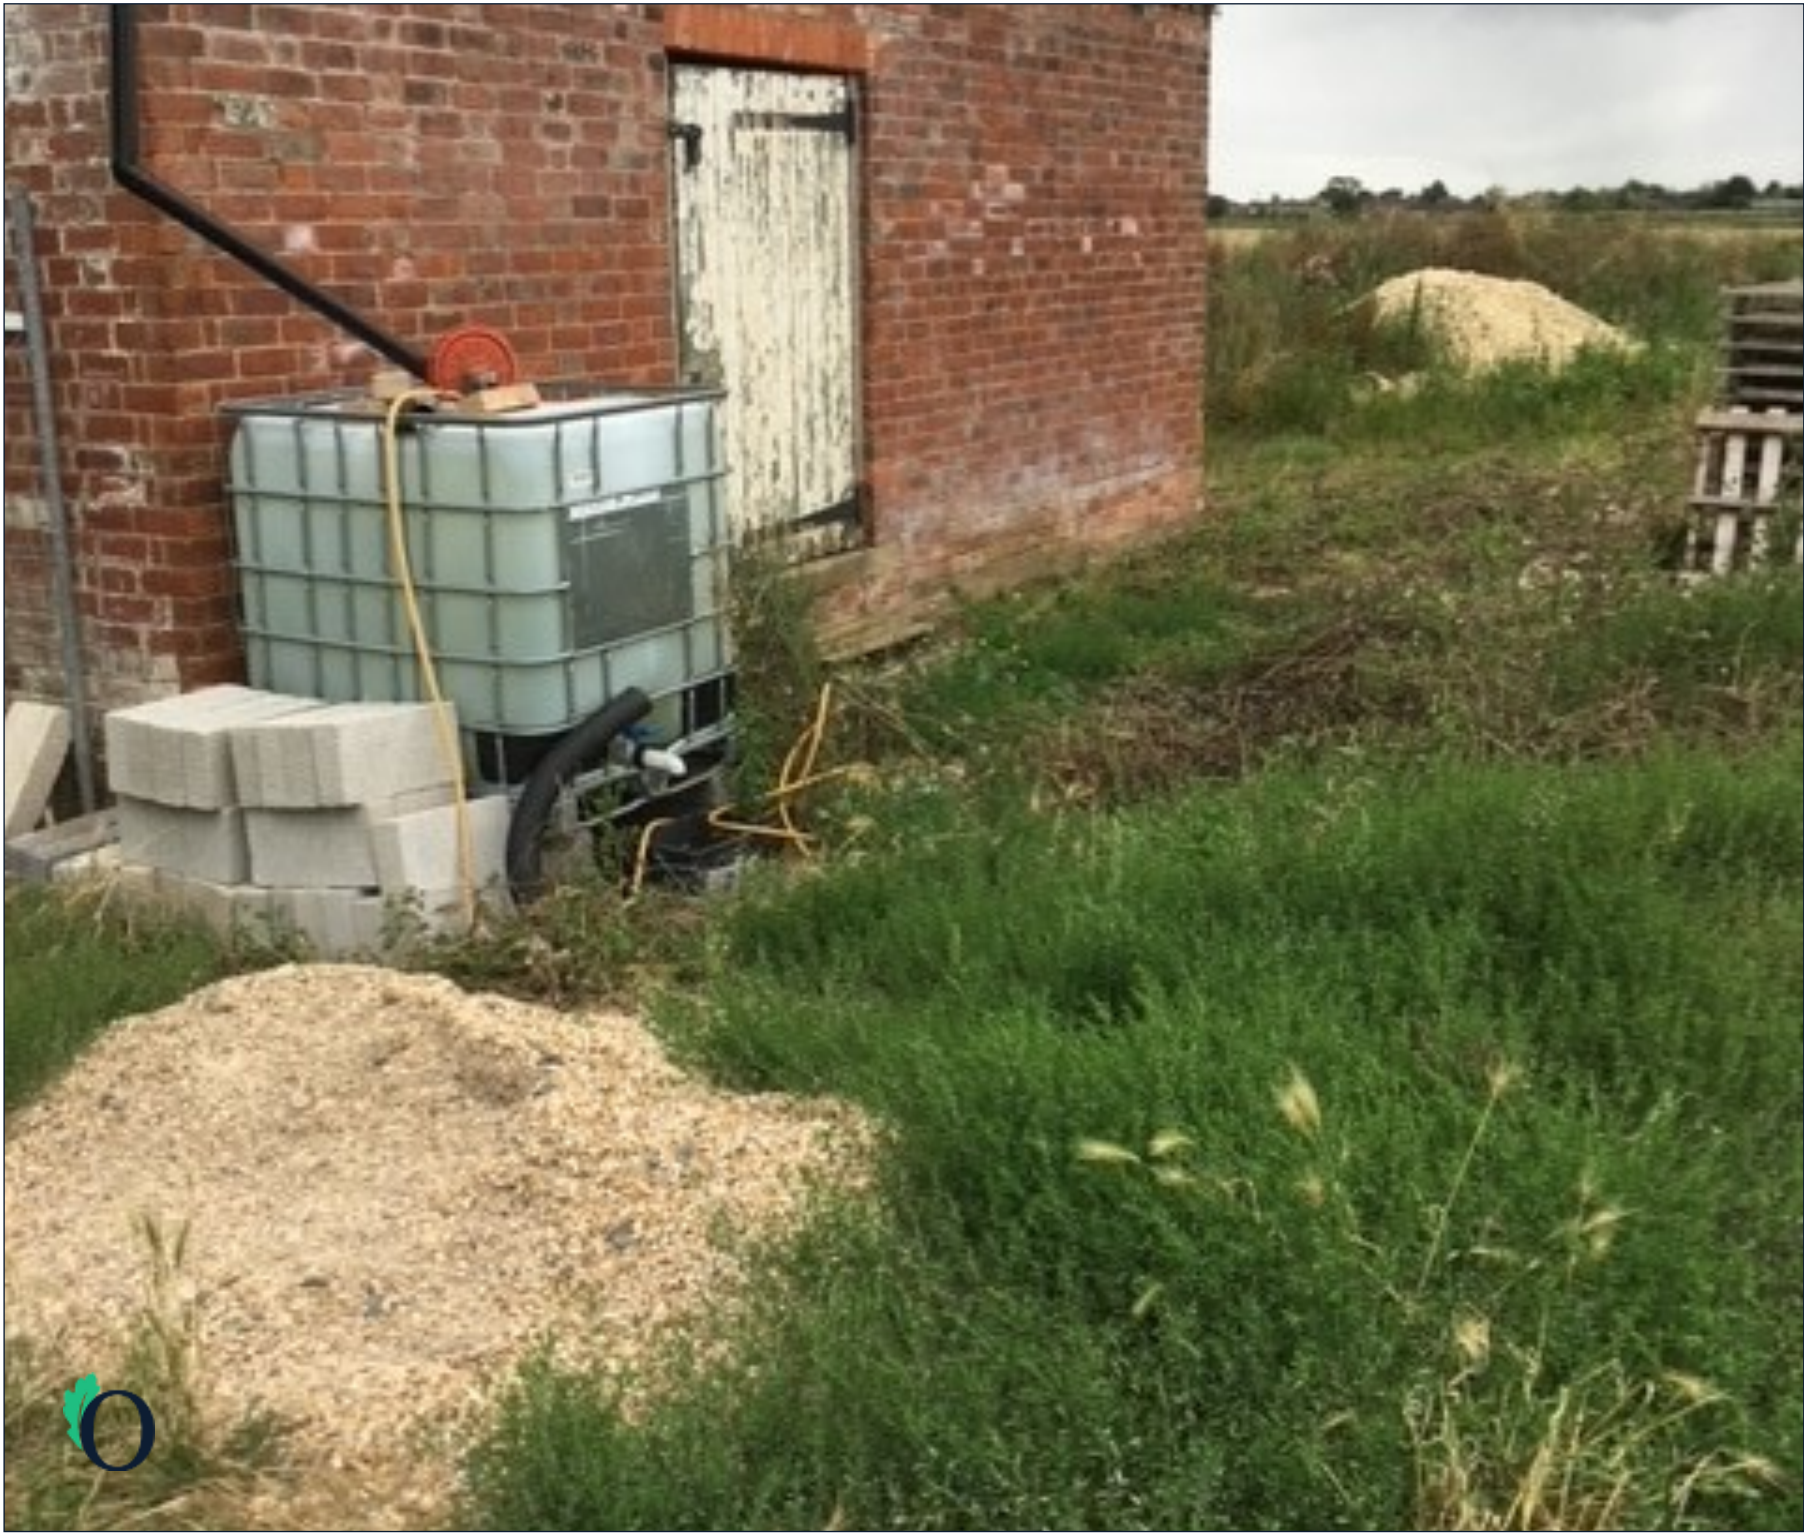
Figure 4

Photo of disused barn building and tank at the south of the site, facing south west

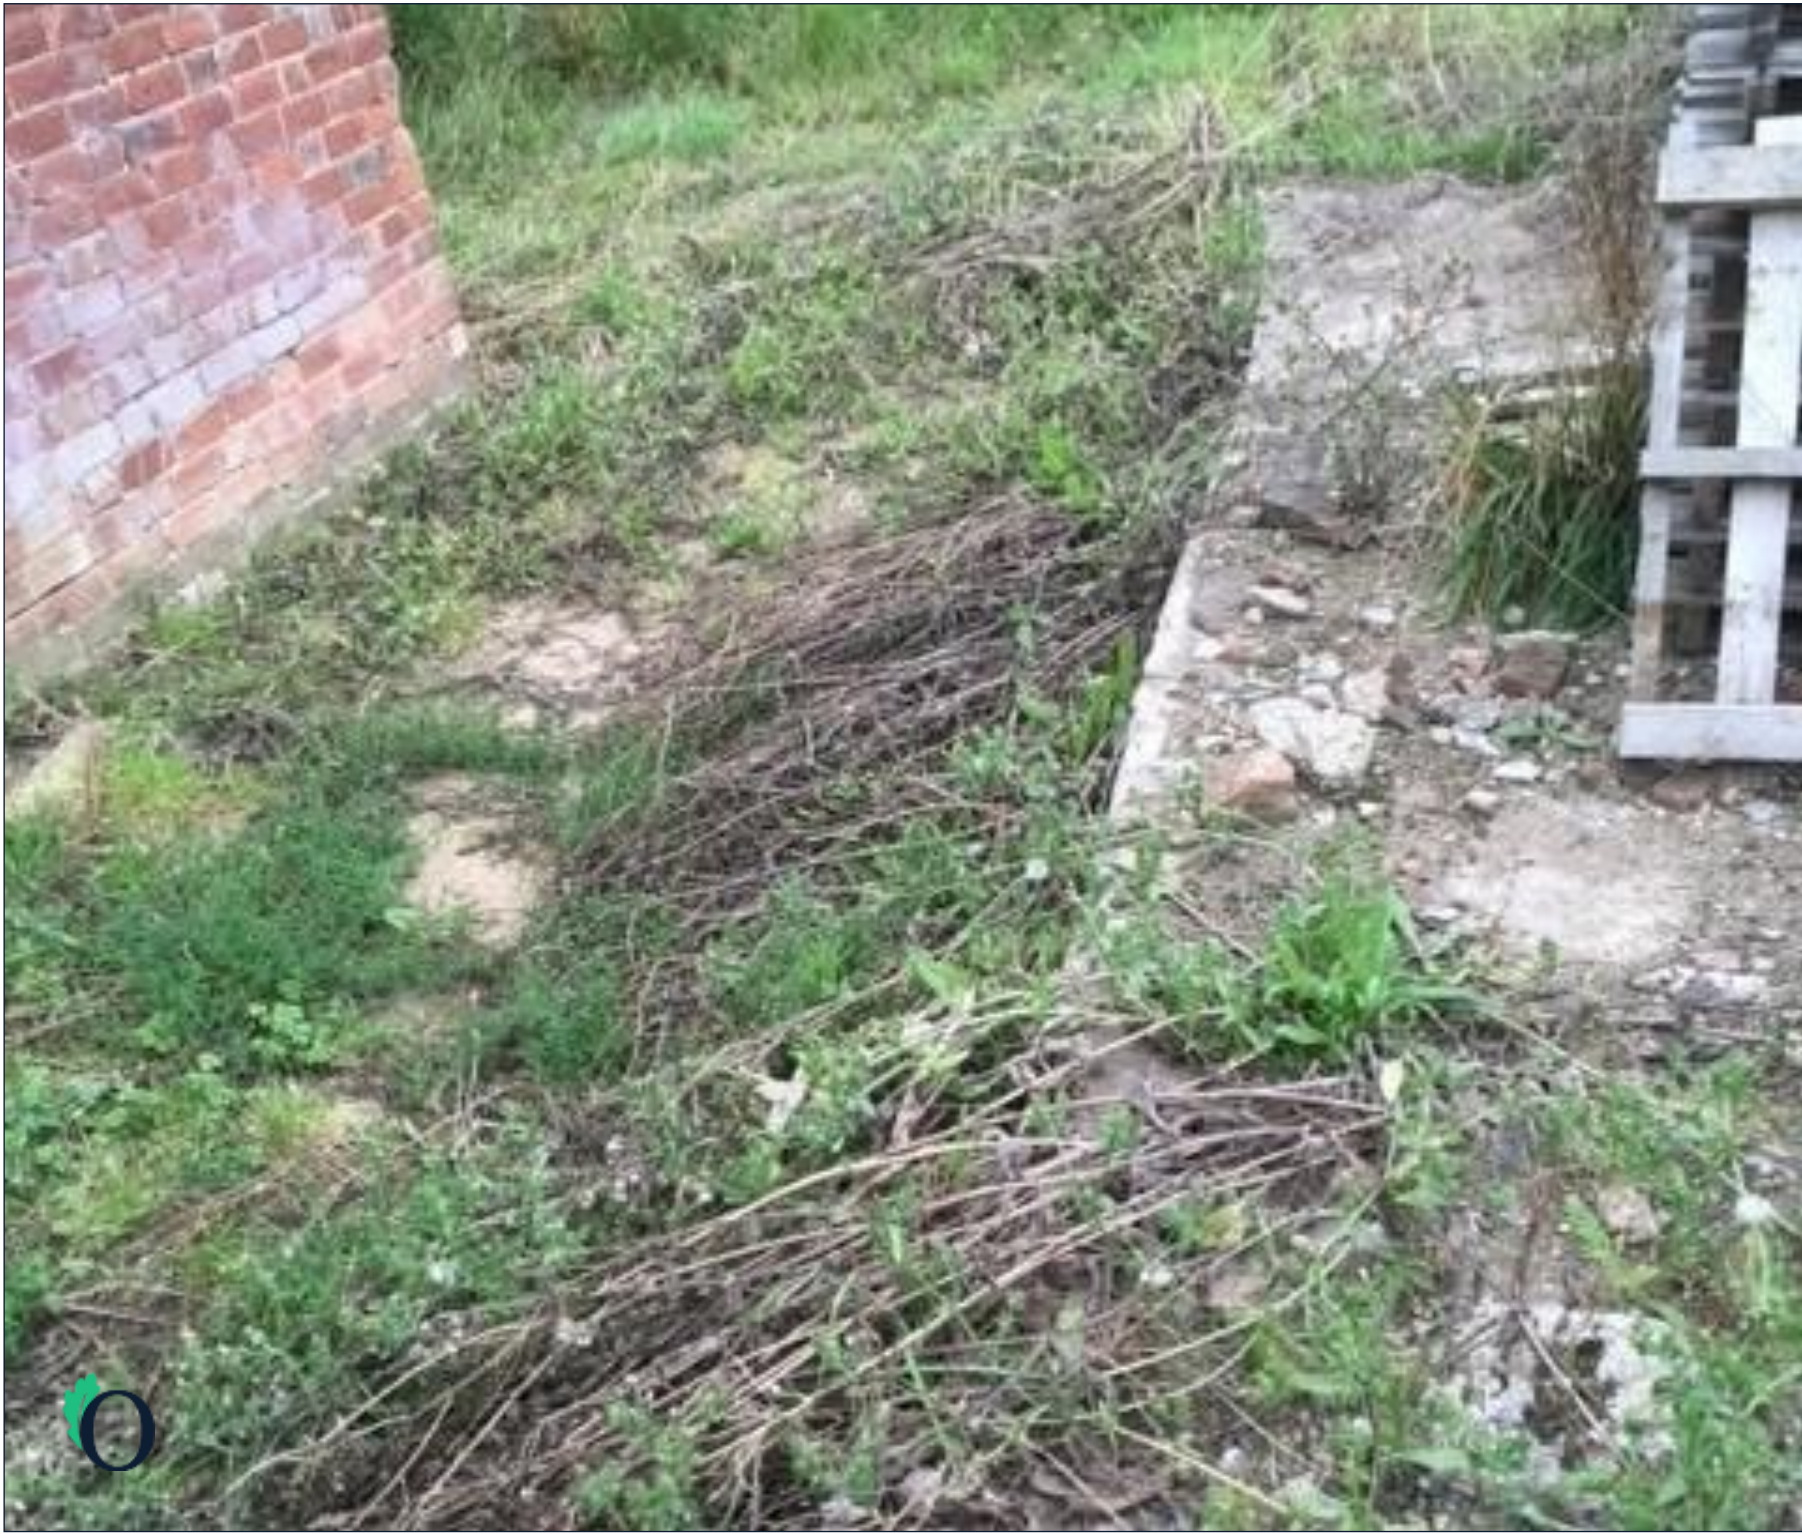
Figure 5

Photo of showing concrete base to the north of the disused barn building

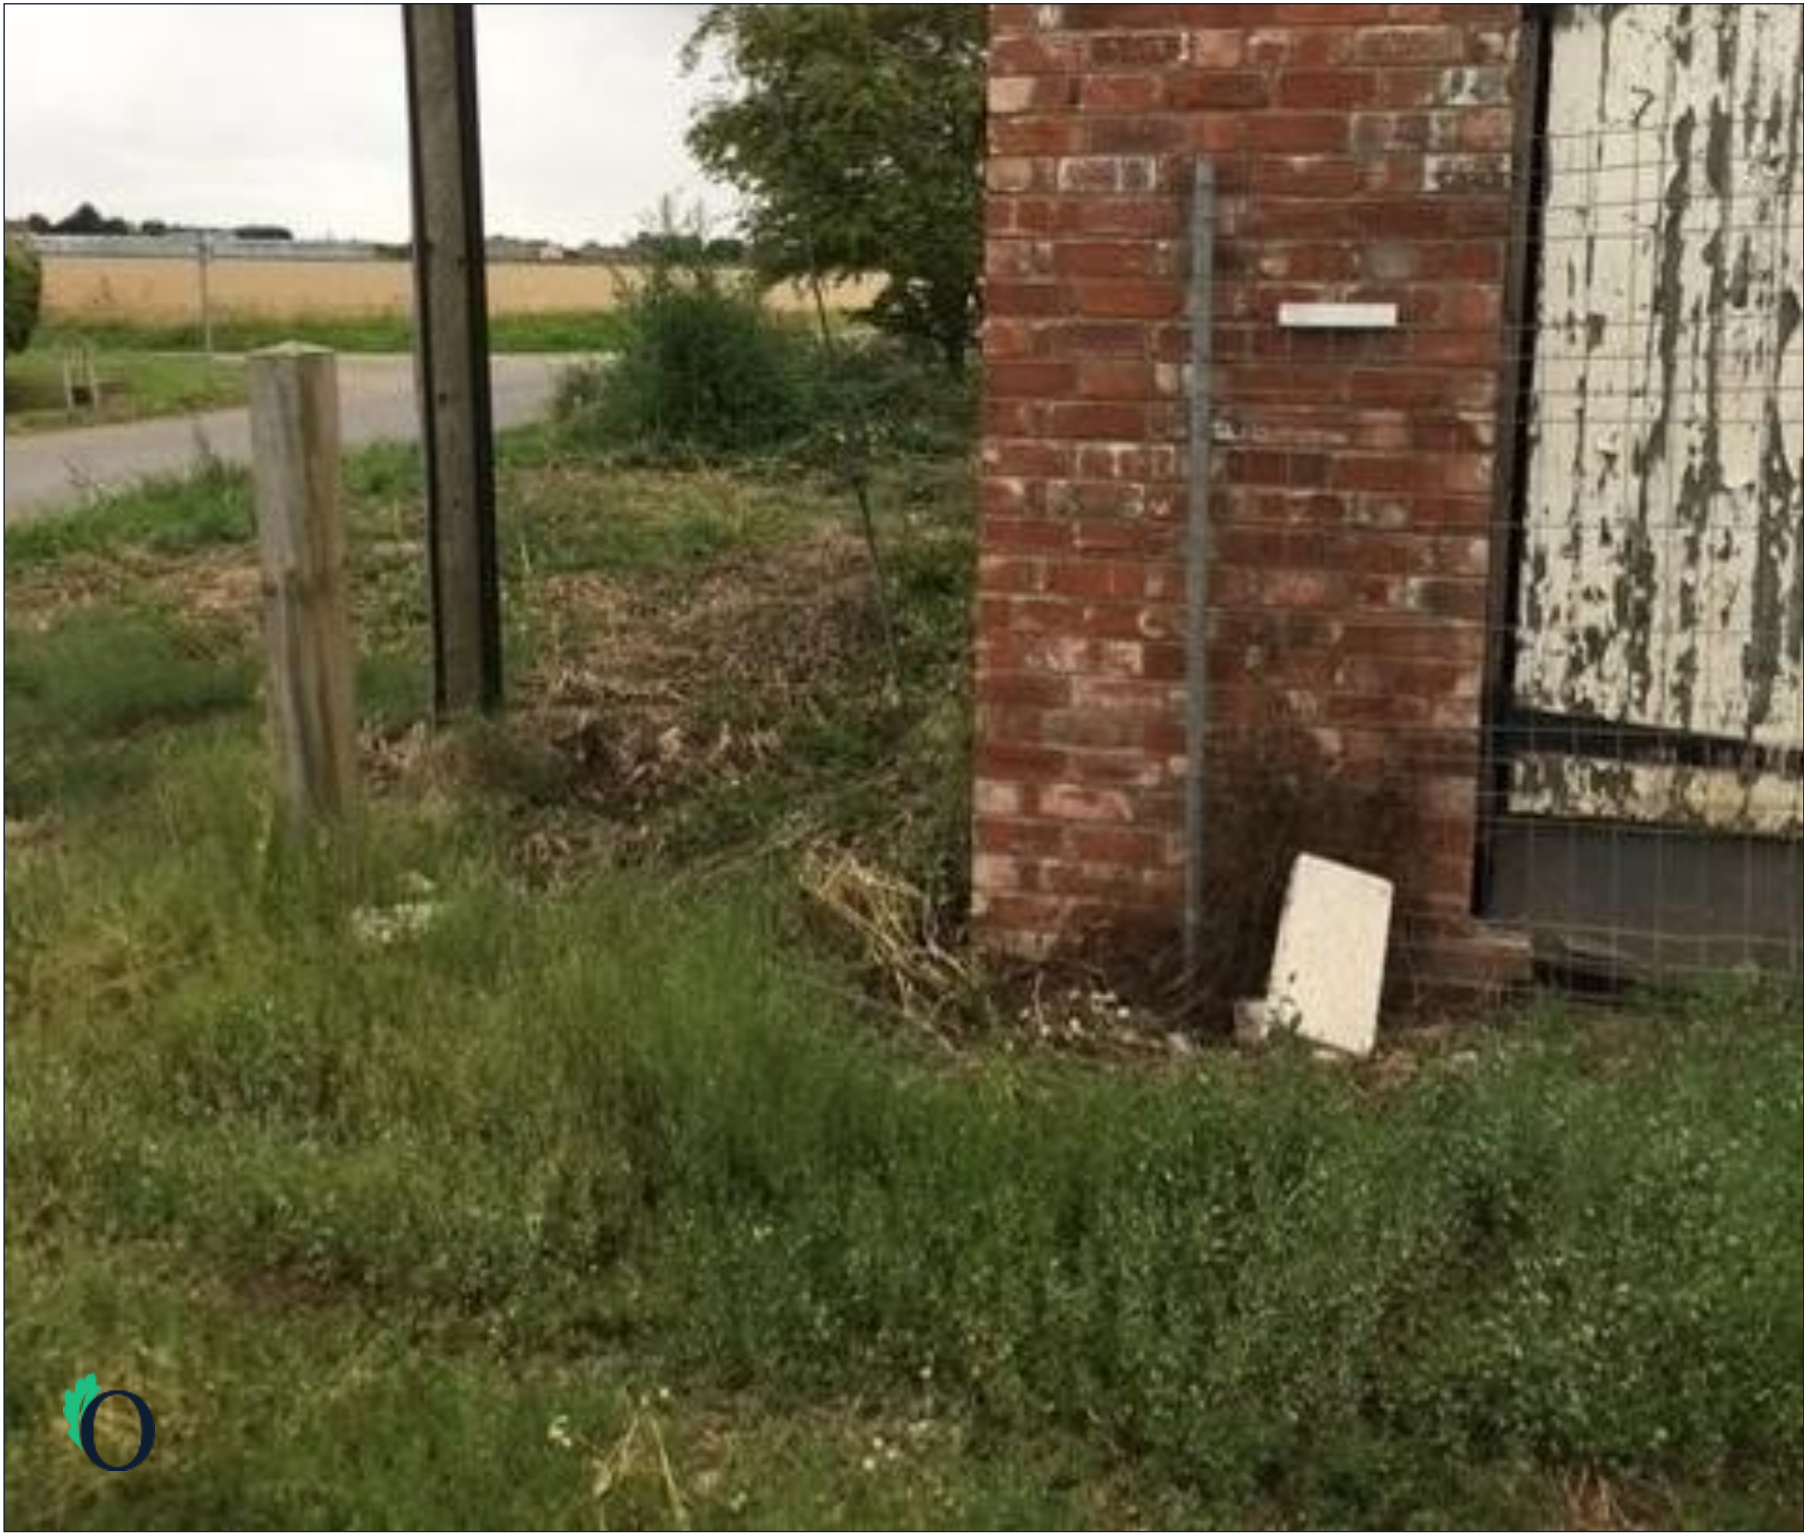
Figure 6

Photo of south boundary of the site, facing west

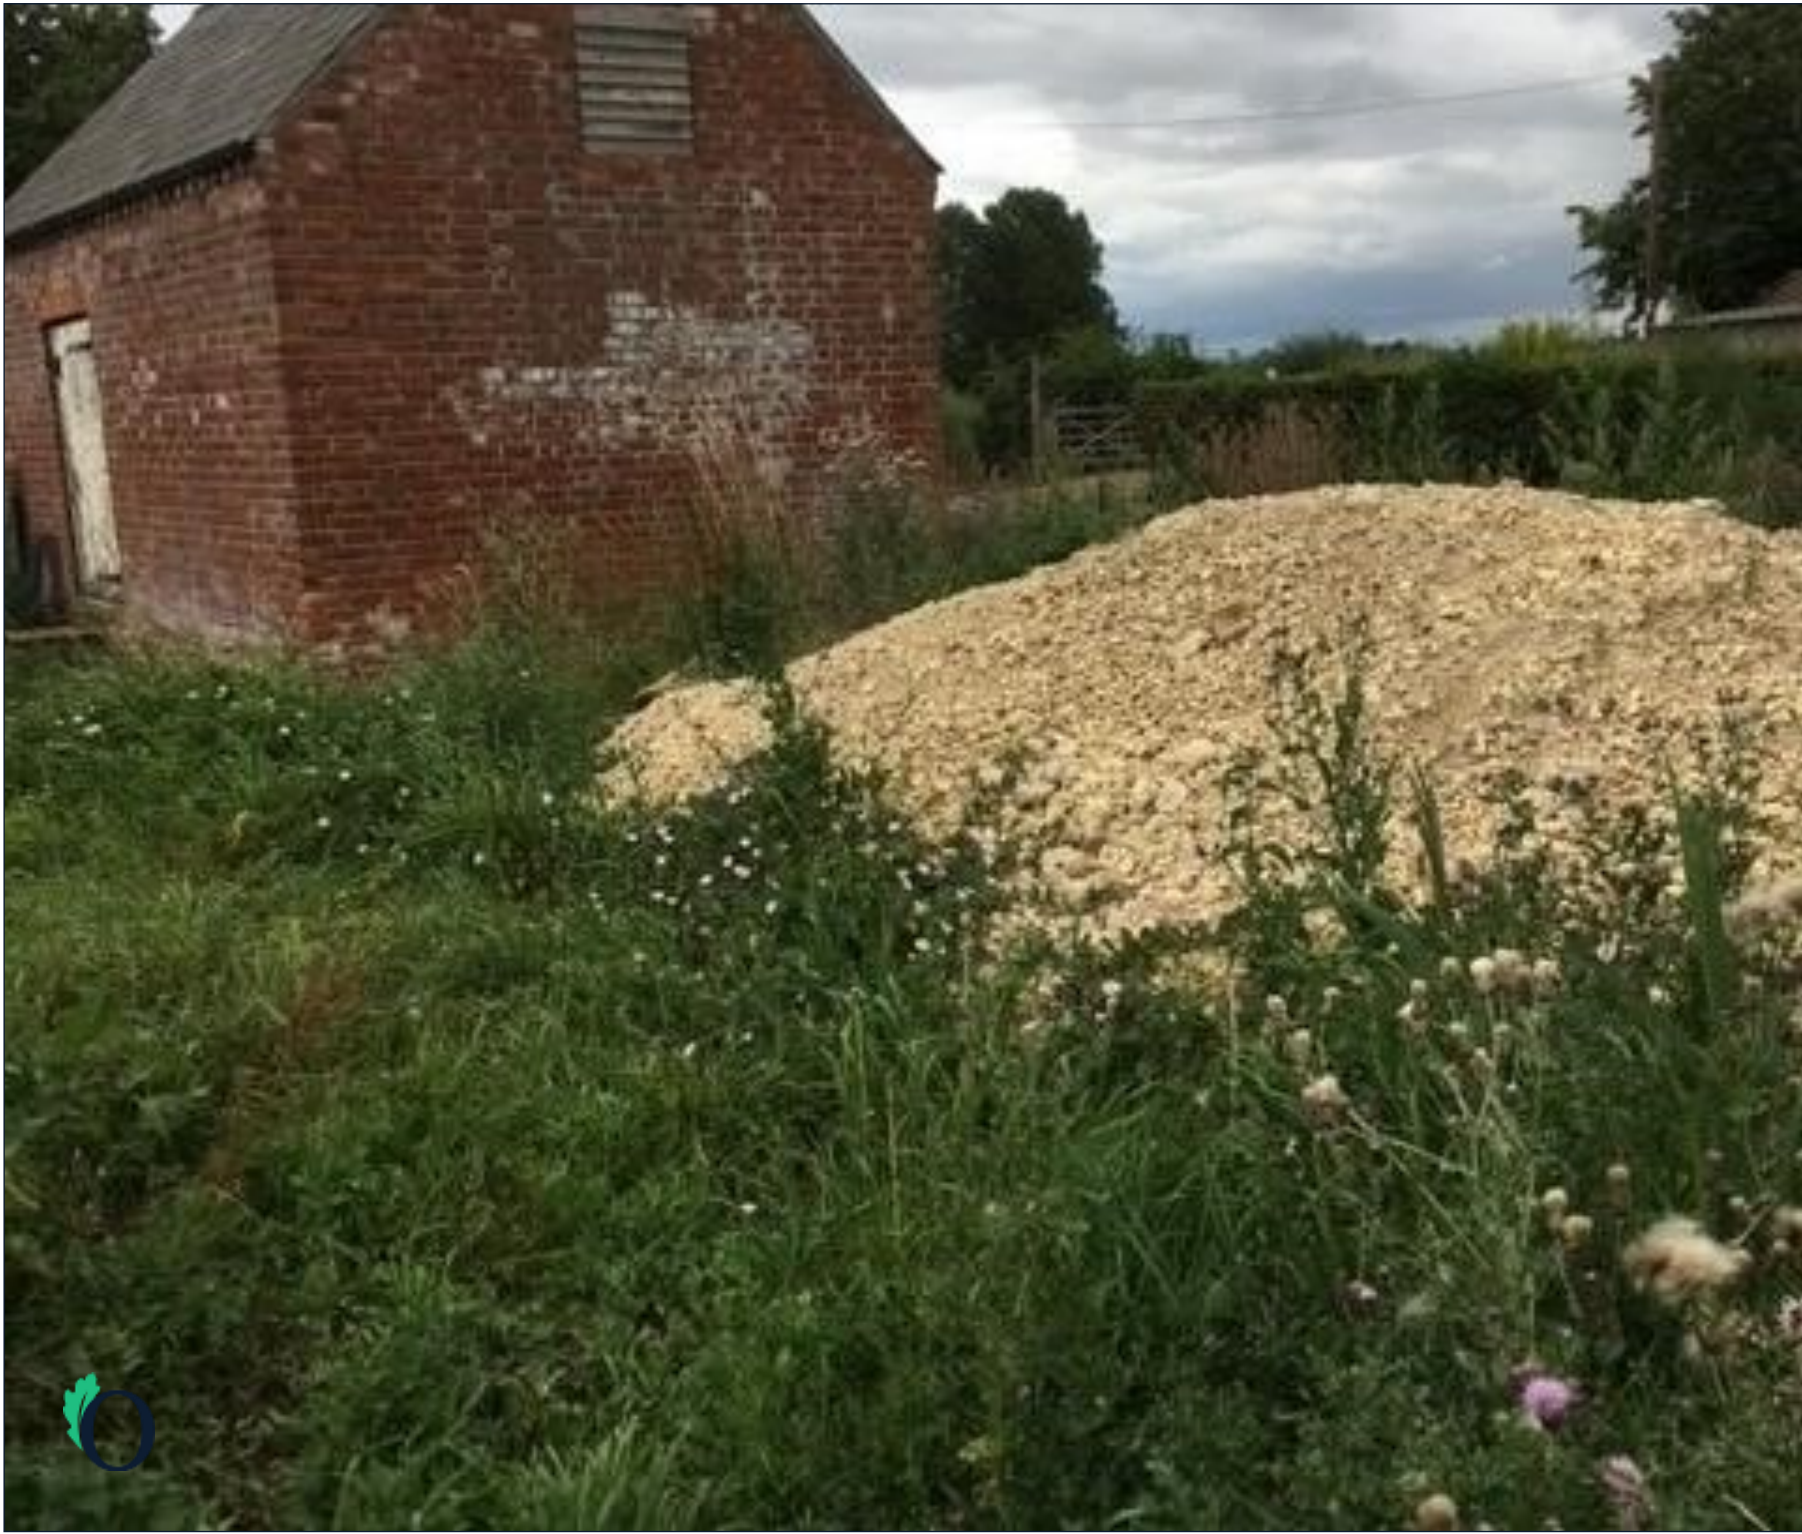
| Appendix B - Site Photos | | |
|---|--|---|
| Name | | Figure 7 |

| Appendix B - Site Photos | | |
|---|--|---|
| Photo of crushed limestone at the south west of the site, facing east | | |

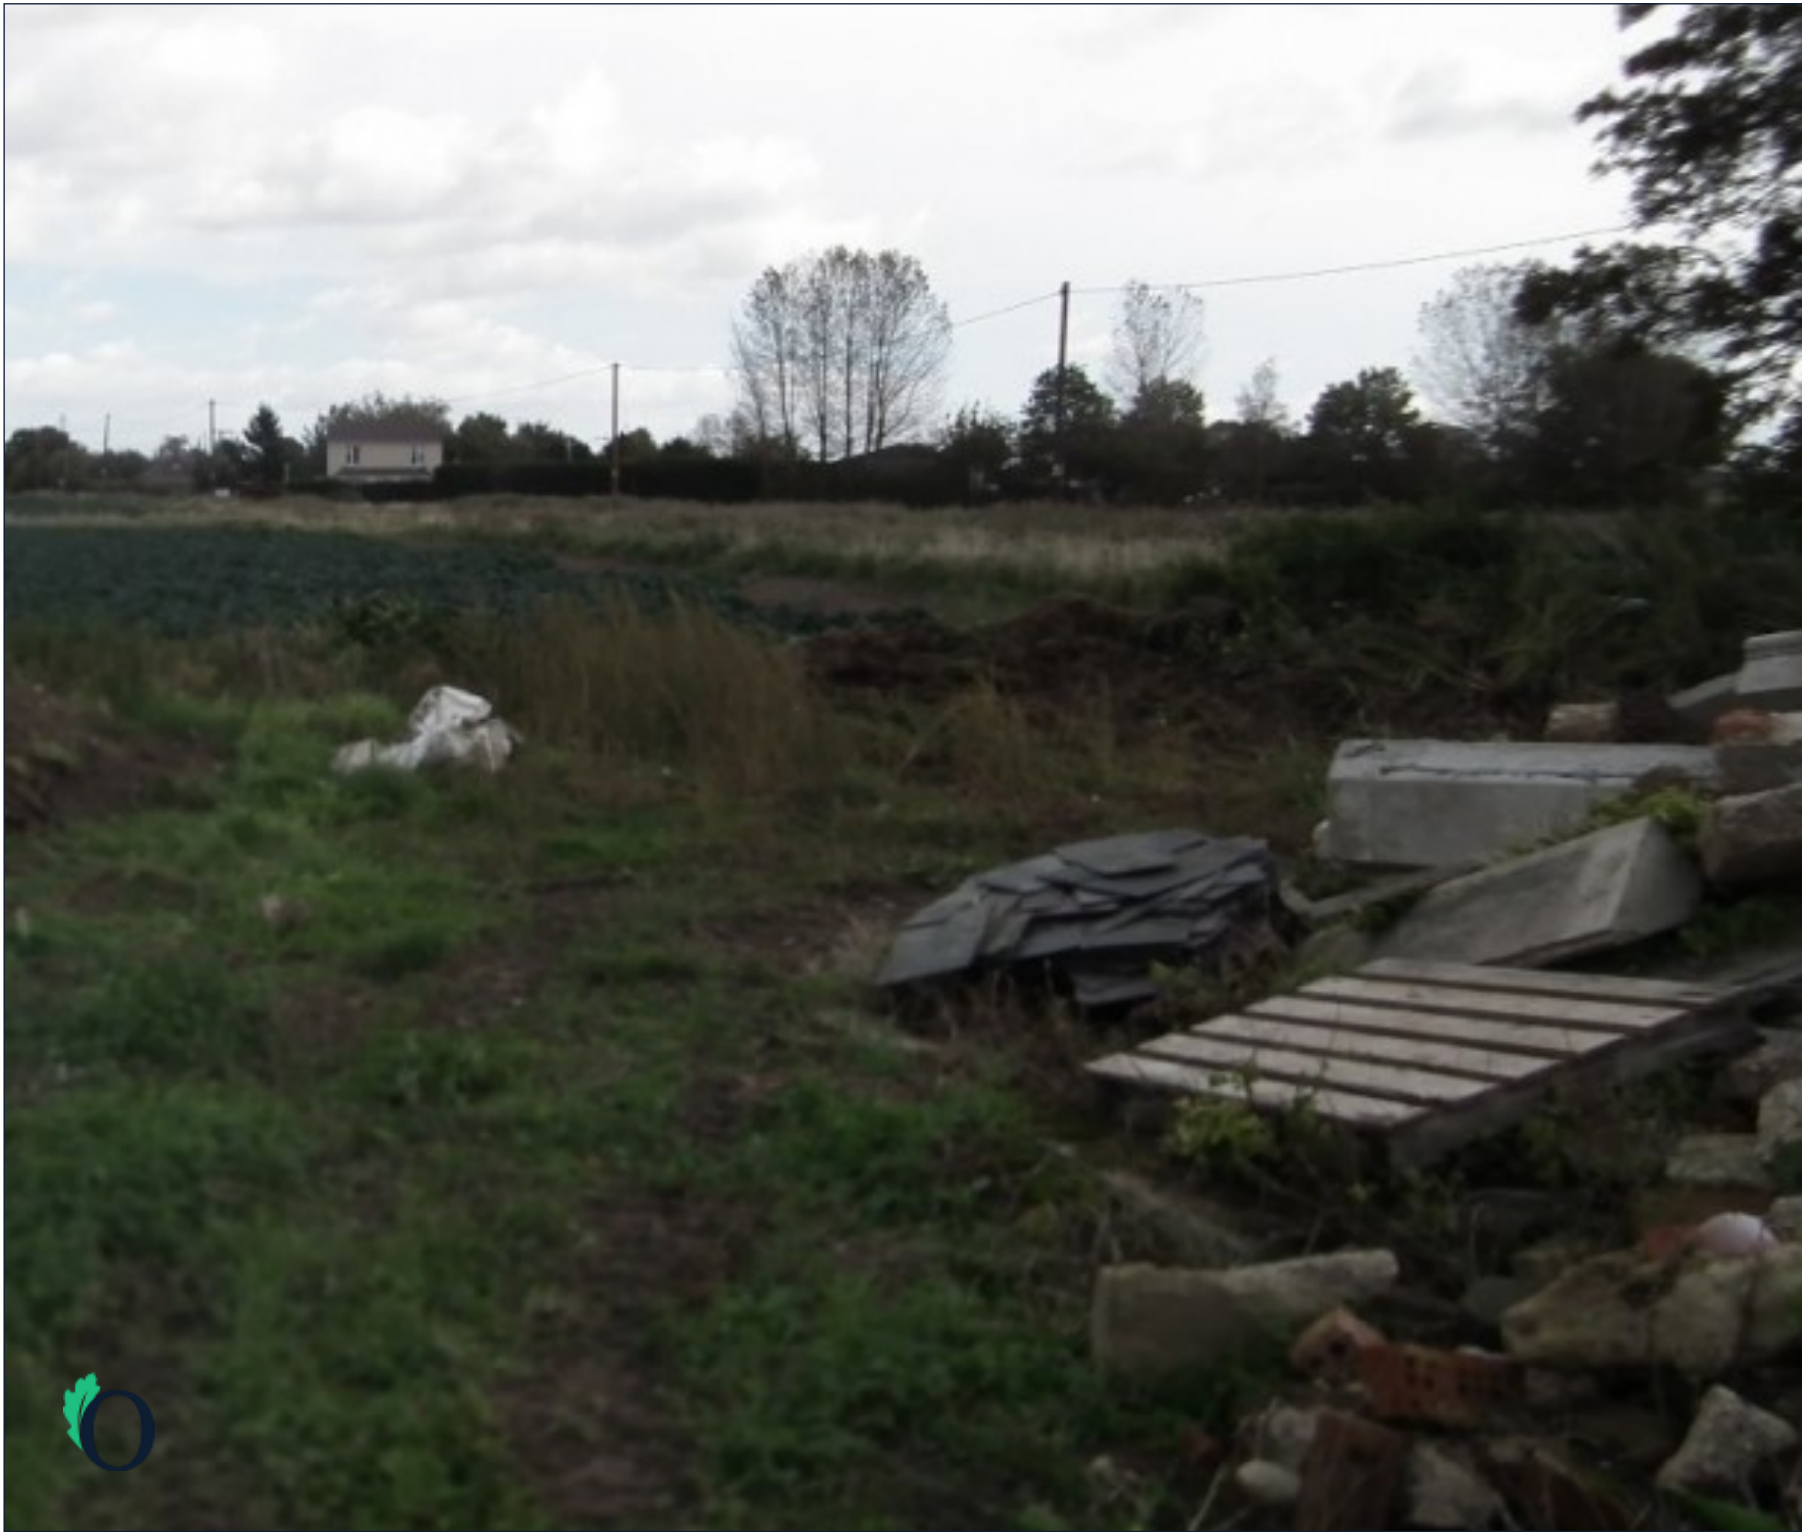
Figure 8

Made ground is also likely to be present and this may contain demolition rubble from previous developments on the site. Made ground deposits often contain elevated concentrations of contaminants such as heavy metals and hydrocarbons.

Photo of demolition rubble in the centre of the site, facing east

Based on the above conclusions, further investigation is recommended in the form of a Phase 2 Intrusive Site Investigation. This should include sampling of shallow soil at the site to be tested for a suite of contaminants including heavy metals and hydrocarbons.

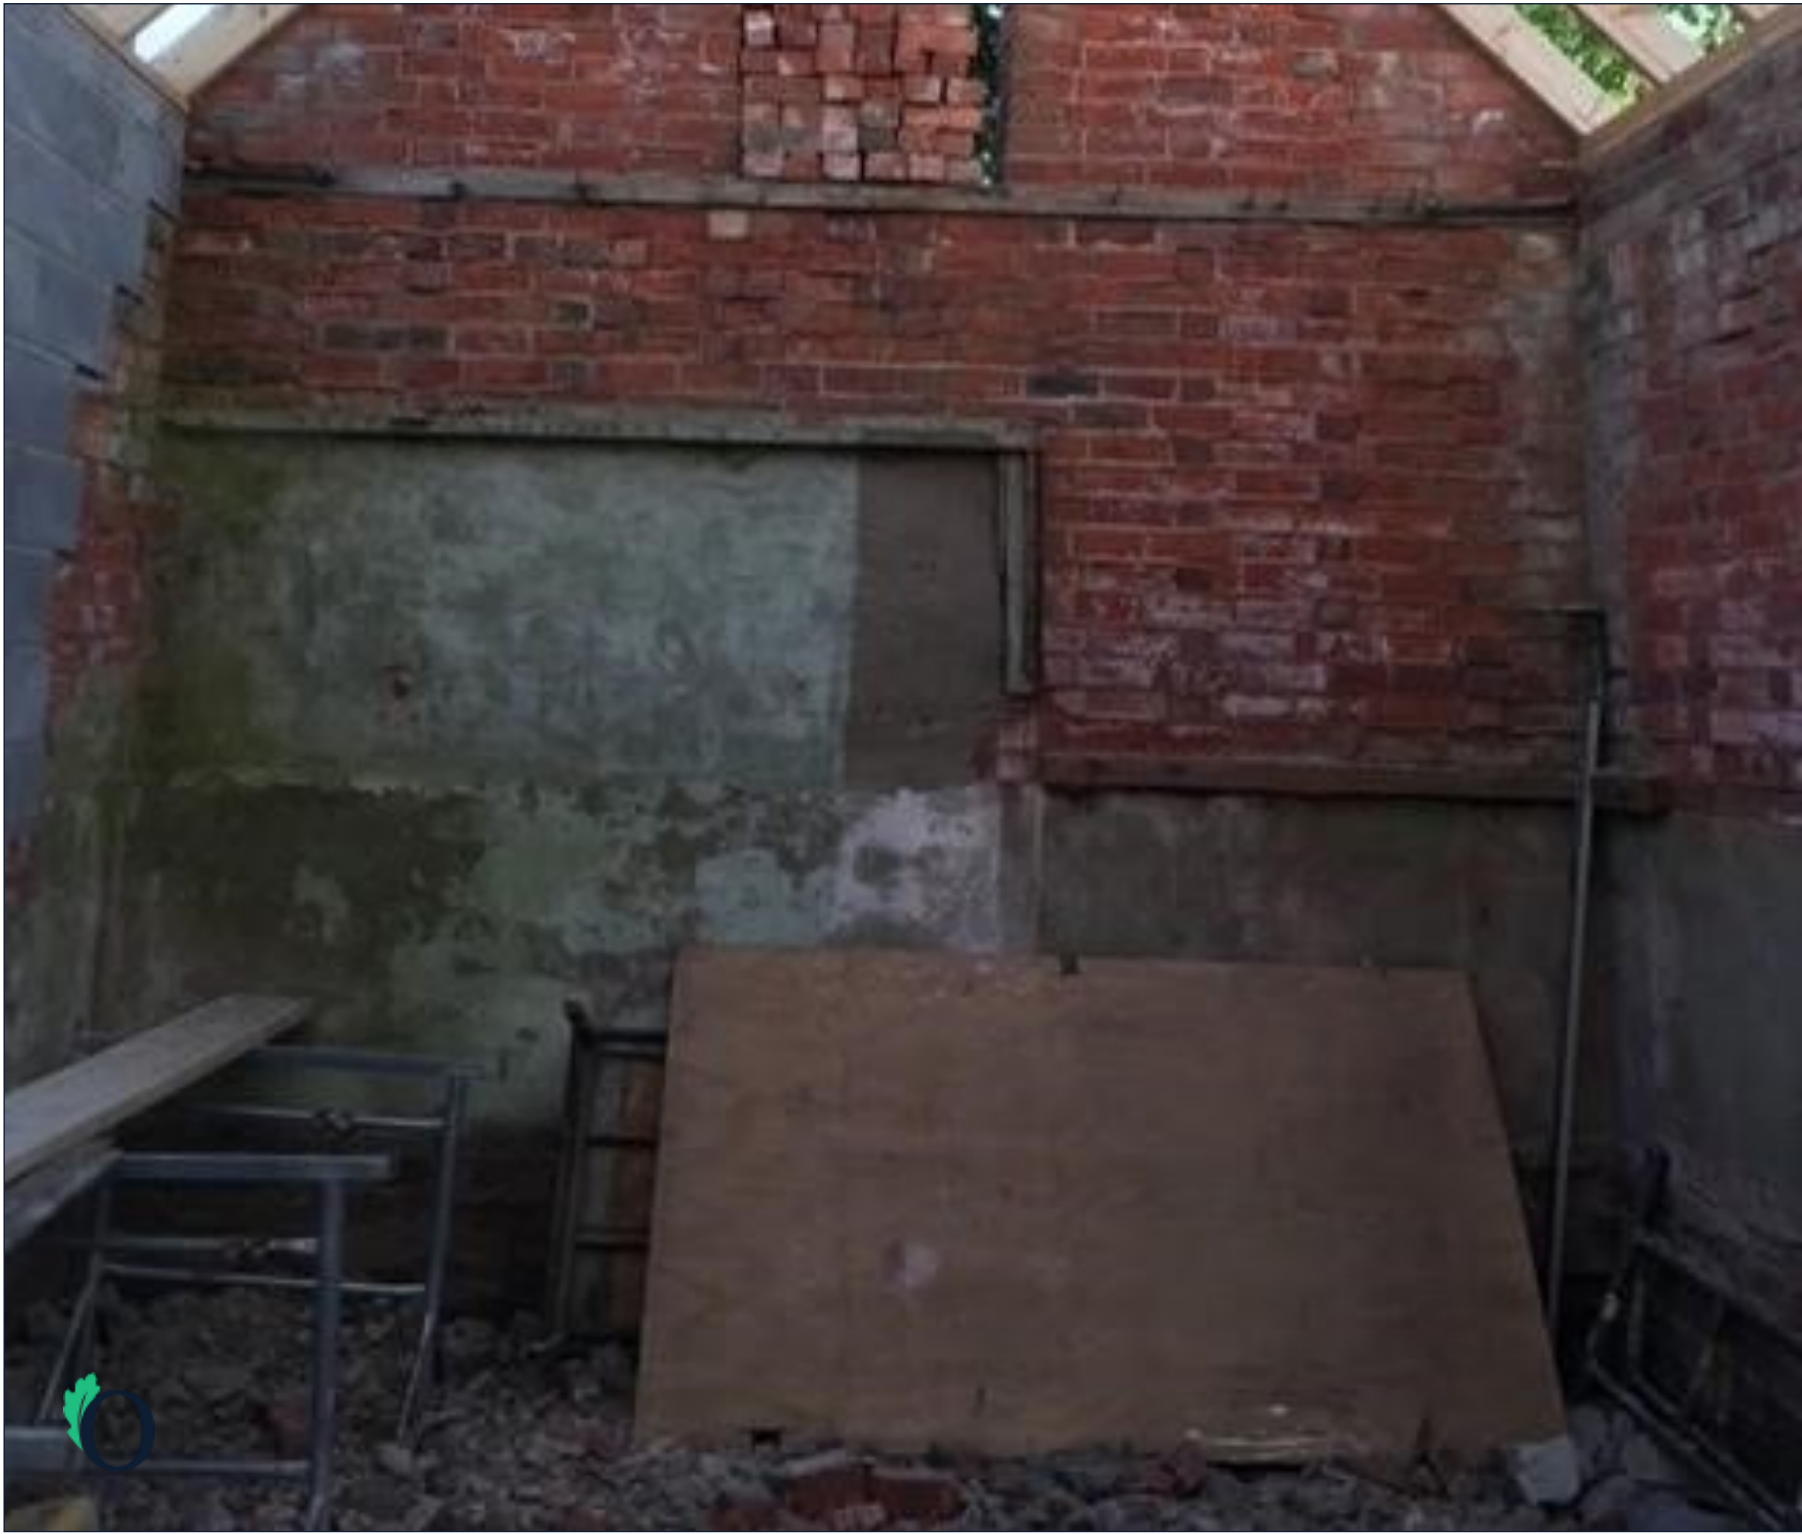
Figure 11

Photo of interior of the barn building at the south of the site, prior to repair work
