| <b>Report type</b> | Phase 1 Preliminary Risk Assessment |
| <b>Site address</b> | Judy Cross Barn, Water Gate, Quadring, Spalding, PE11 4PY |

The client's proposed project involves the conversion of a barn into residential dwelling and associated works at Judy Cross Barn, Water Gate, Quadring, Spalding, PE11 4PY. A desk-top study has been requested by South Holland District Council, through attachment of conditions on planning application H15-0100-21. Oakshire Environmental have carried out a Phase 1 Preliminary Risk Assessment, as described below.

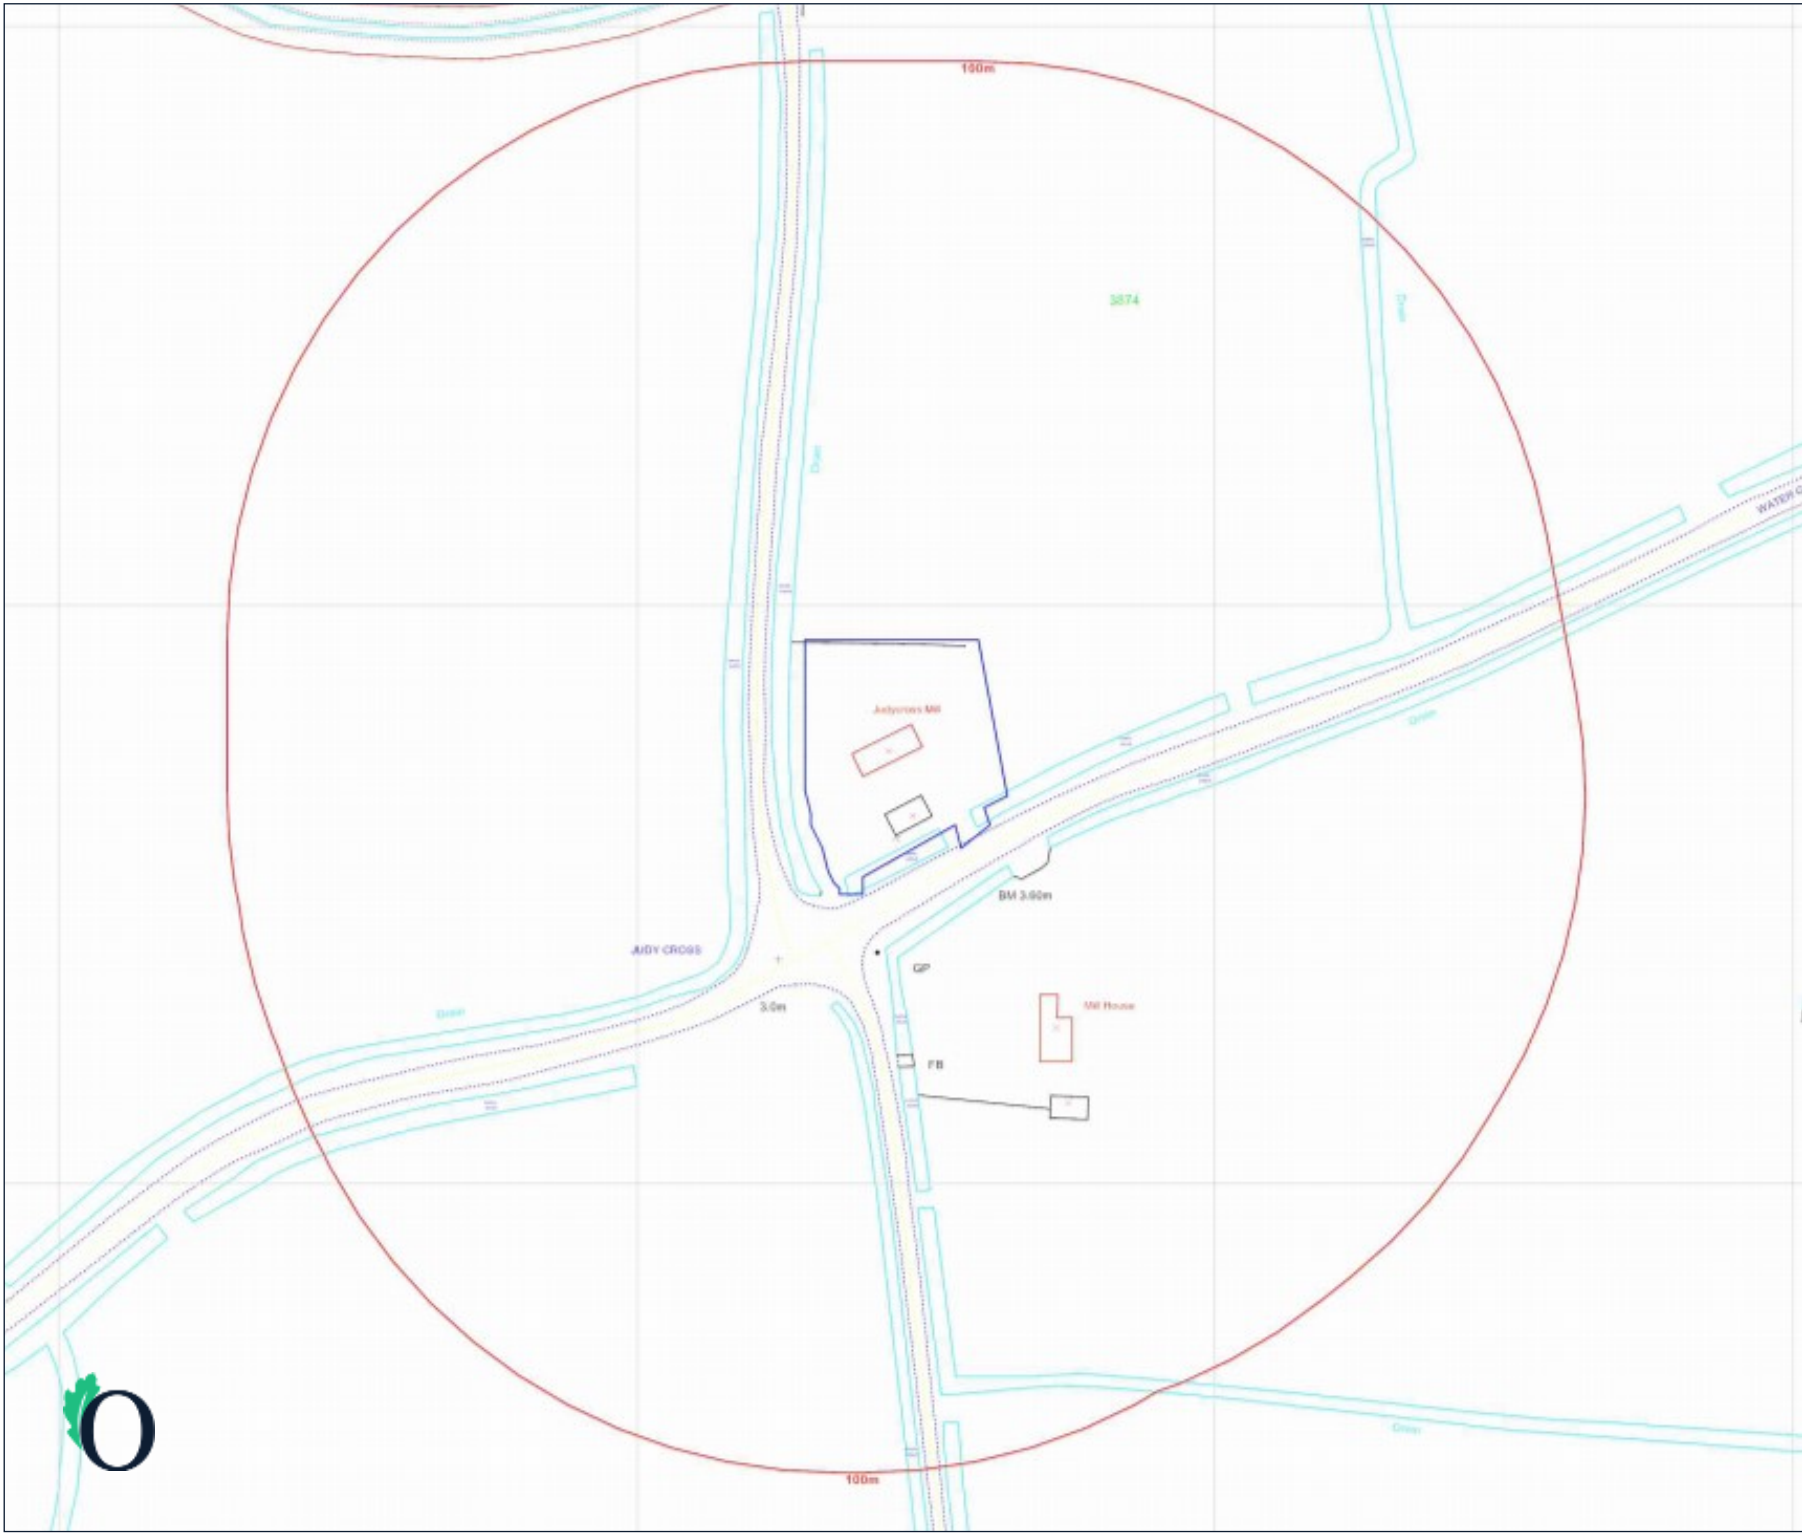
Figure 16

| Year | Site Description | Surrounding Area |
|---|---|---|
| 2003 | Unchanged | Unchanged |

Historical map dated 2003

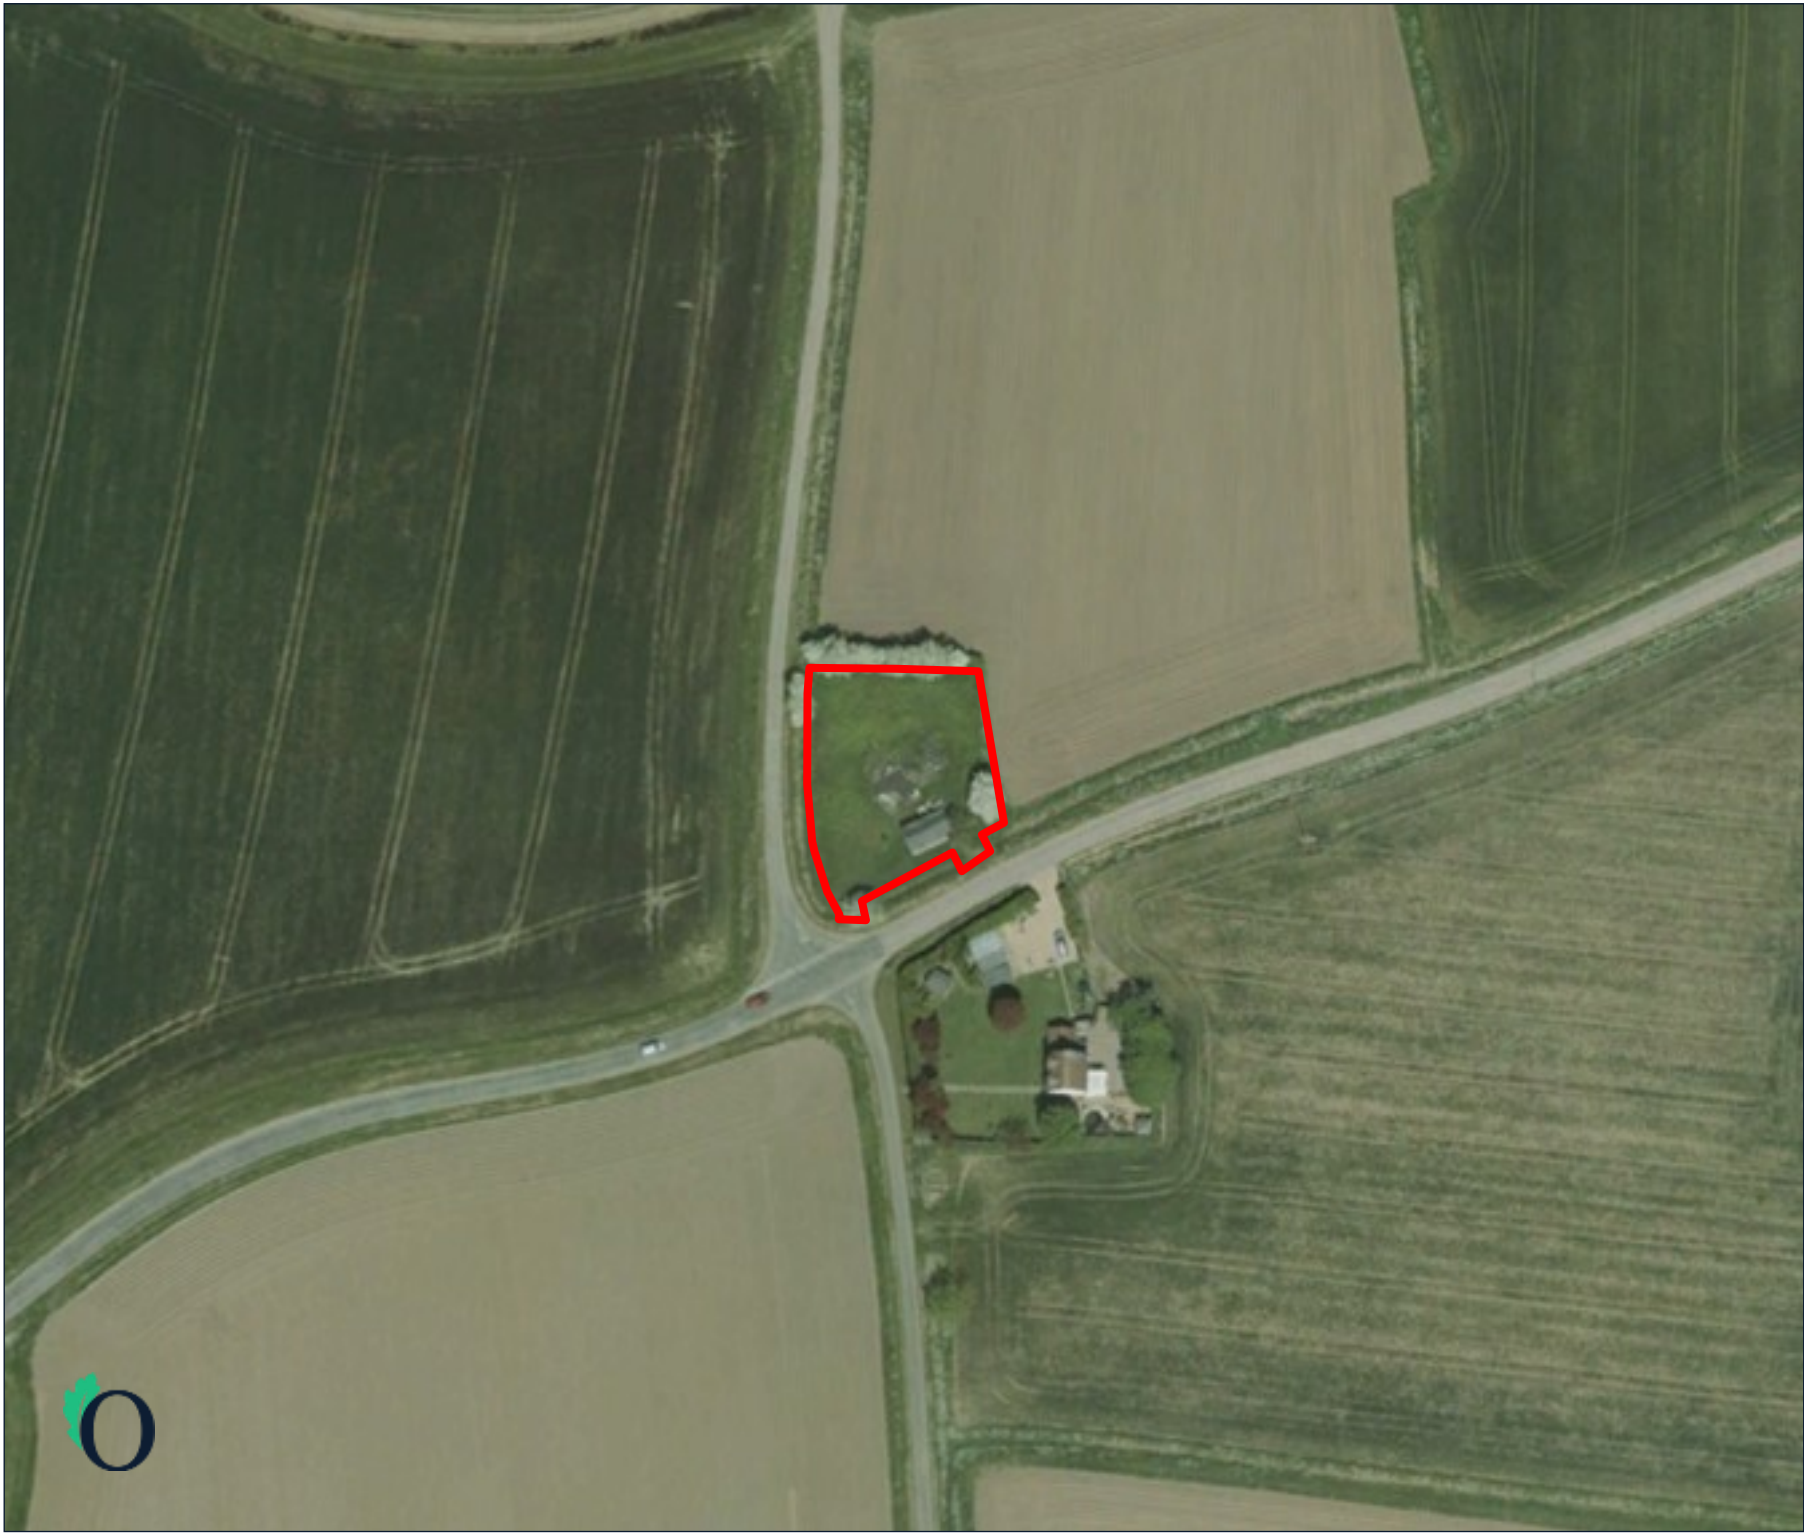
Figure 17

| Year | Site Description | Surrounding Area |
|---|---|---|
| 2010 | Rectangular building in the centre of the site has been demolished and there are some remnants of the base | Unchanged |

Aerial photograph dated 2010

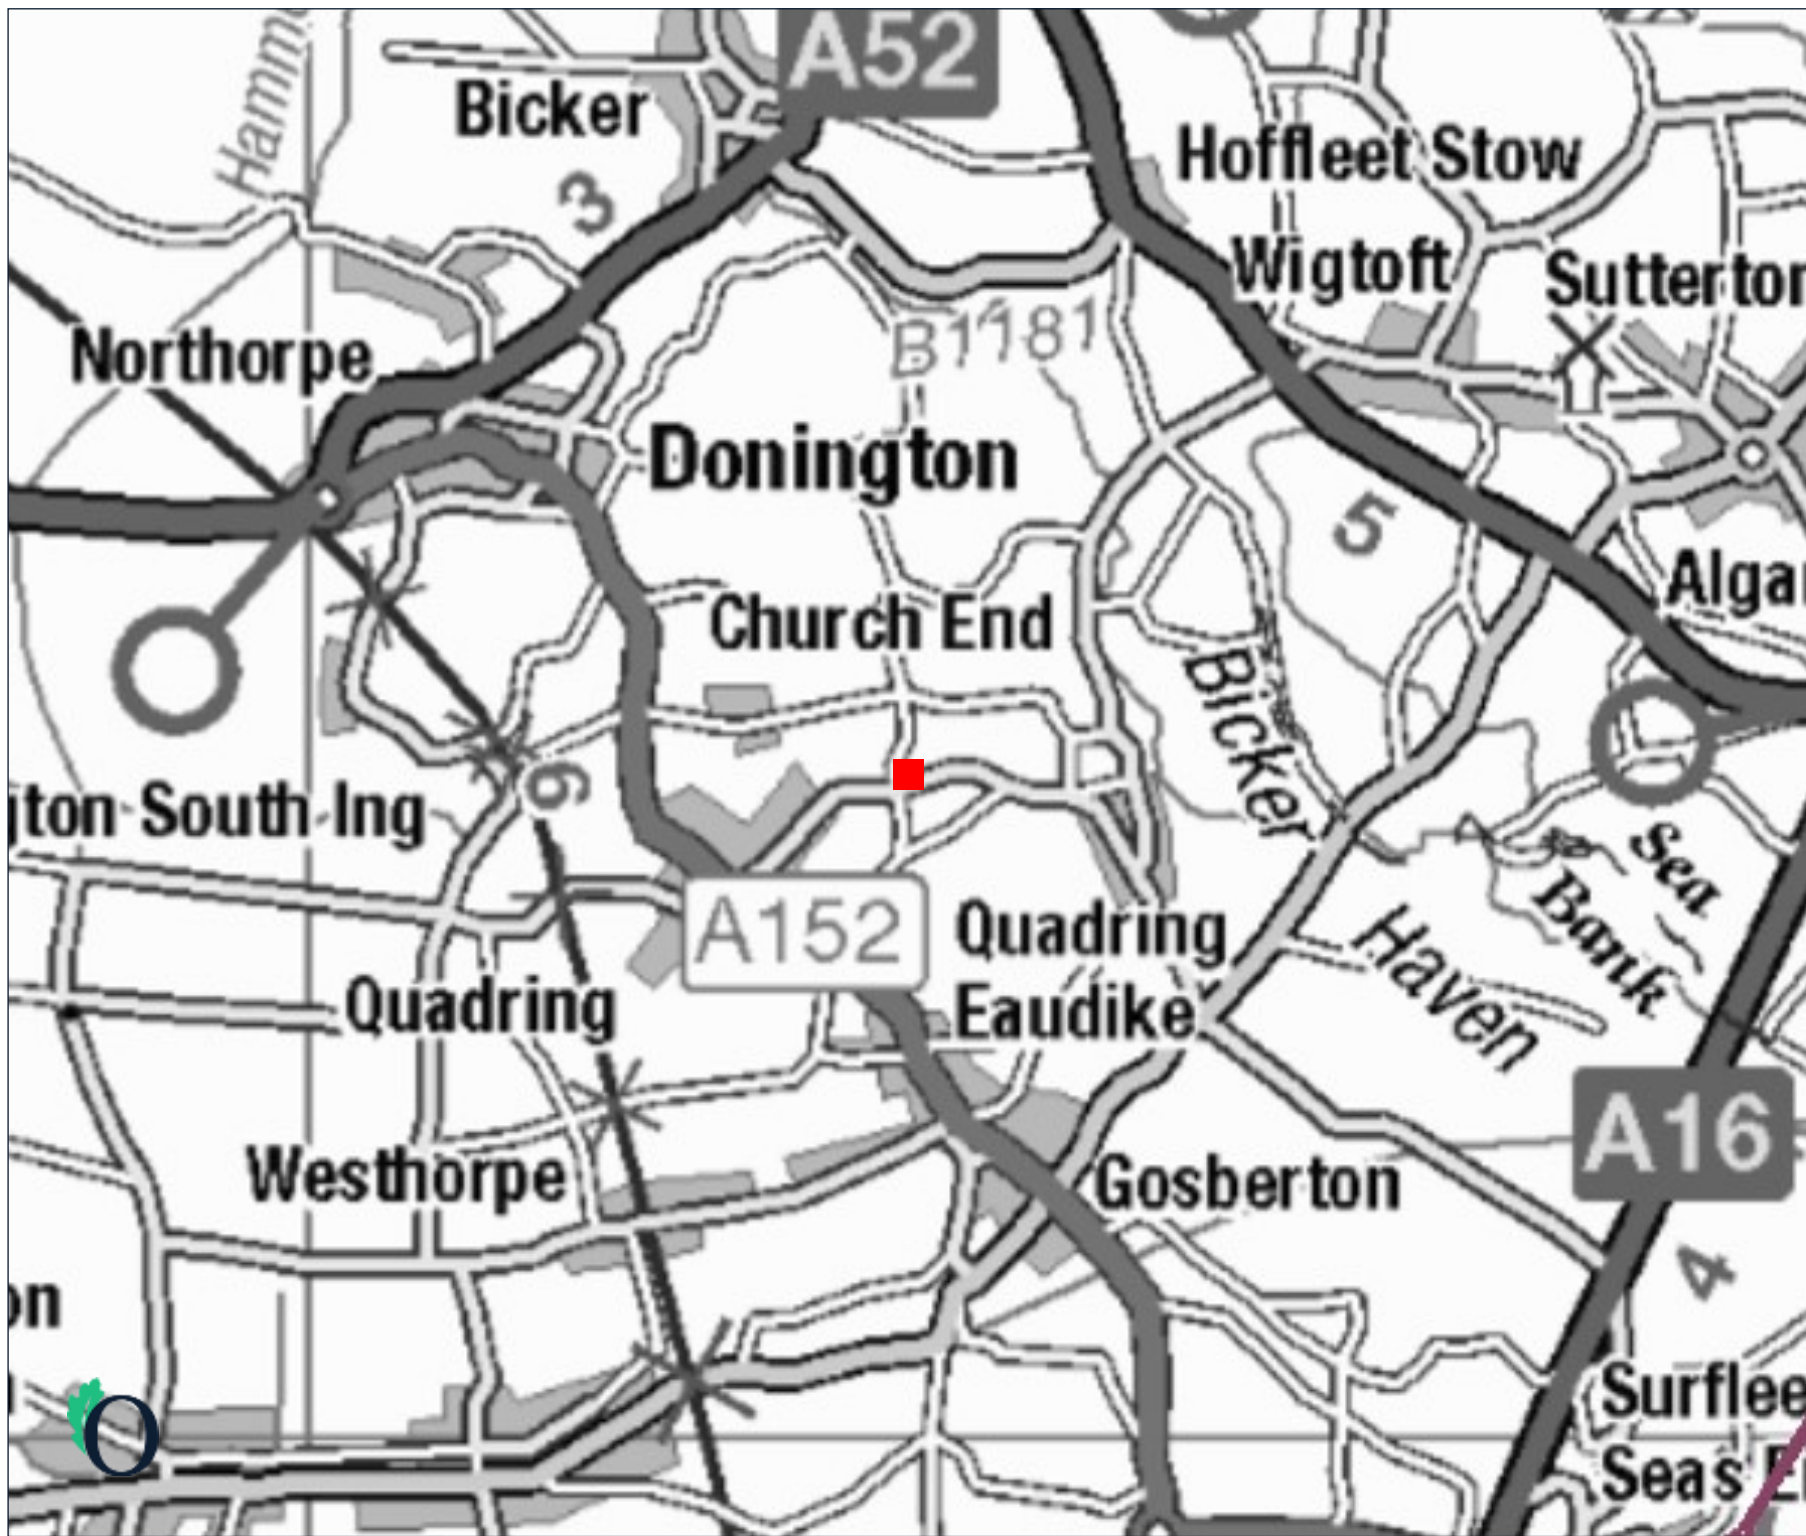
| Description | |
|---|---|
| Name | Figure 18 |

| Environmental Factor | | Details | |
|---|---|---|---|
| Hydrogeology | Aquifer Designation | Superficial | Unproductive |

| Description | |
|---|---|
| BGS map showing superficial hydrogeology on site | |

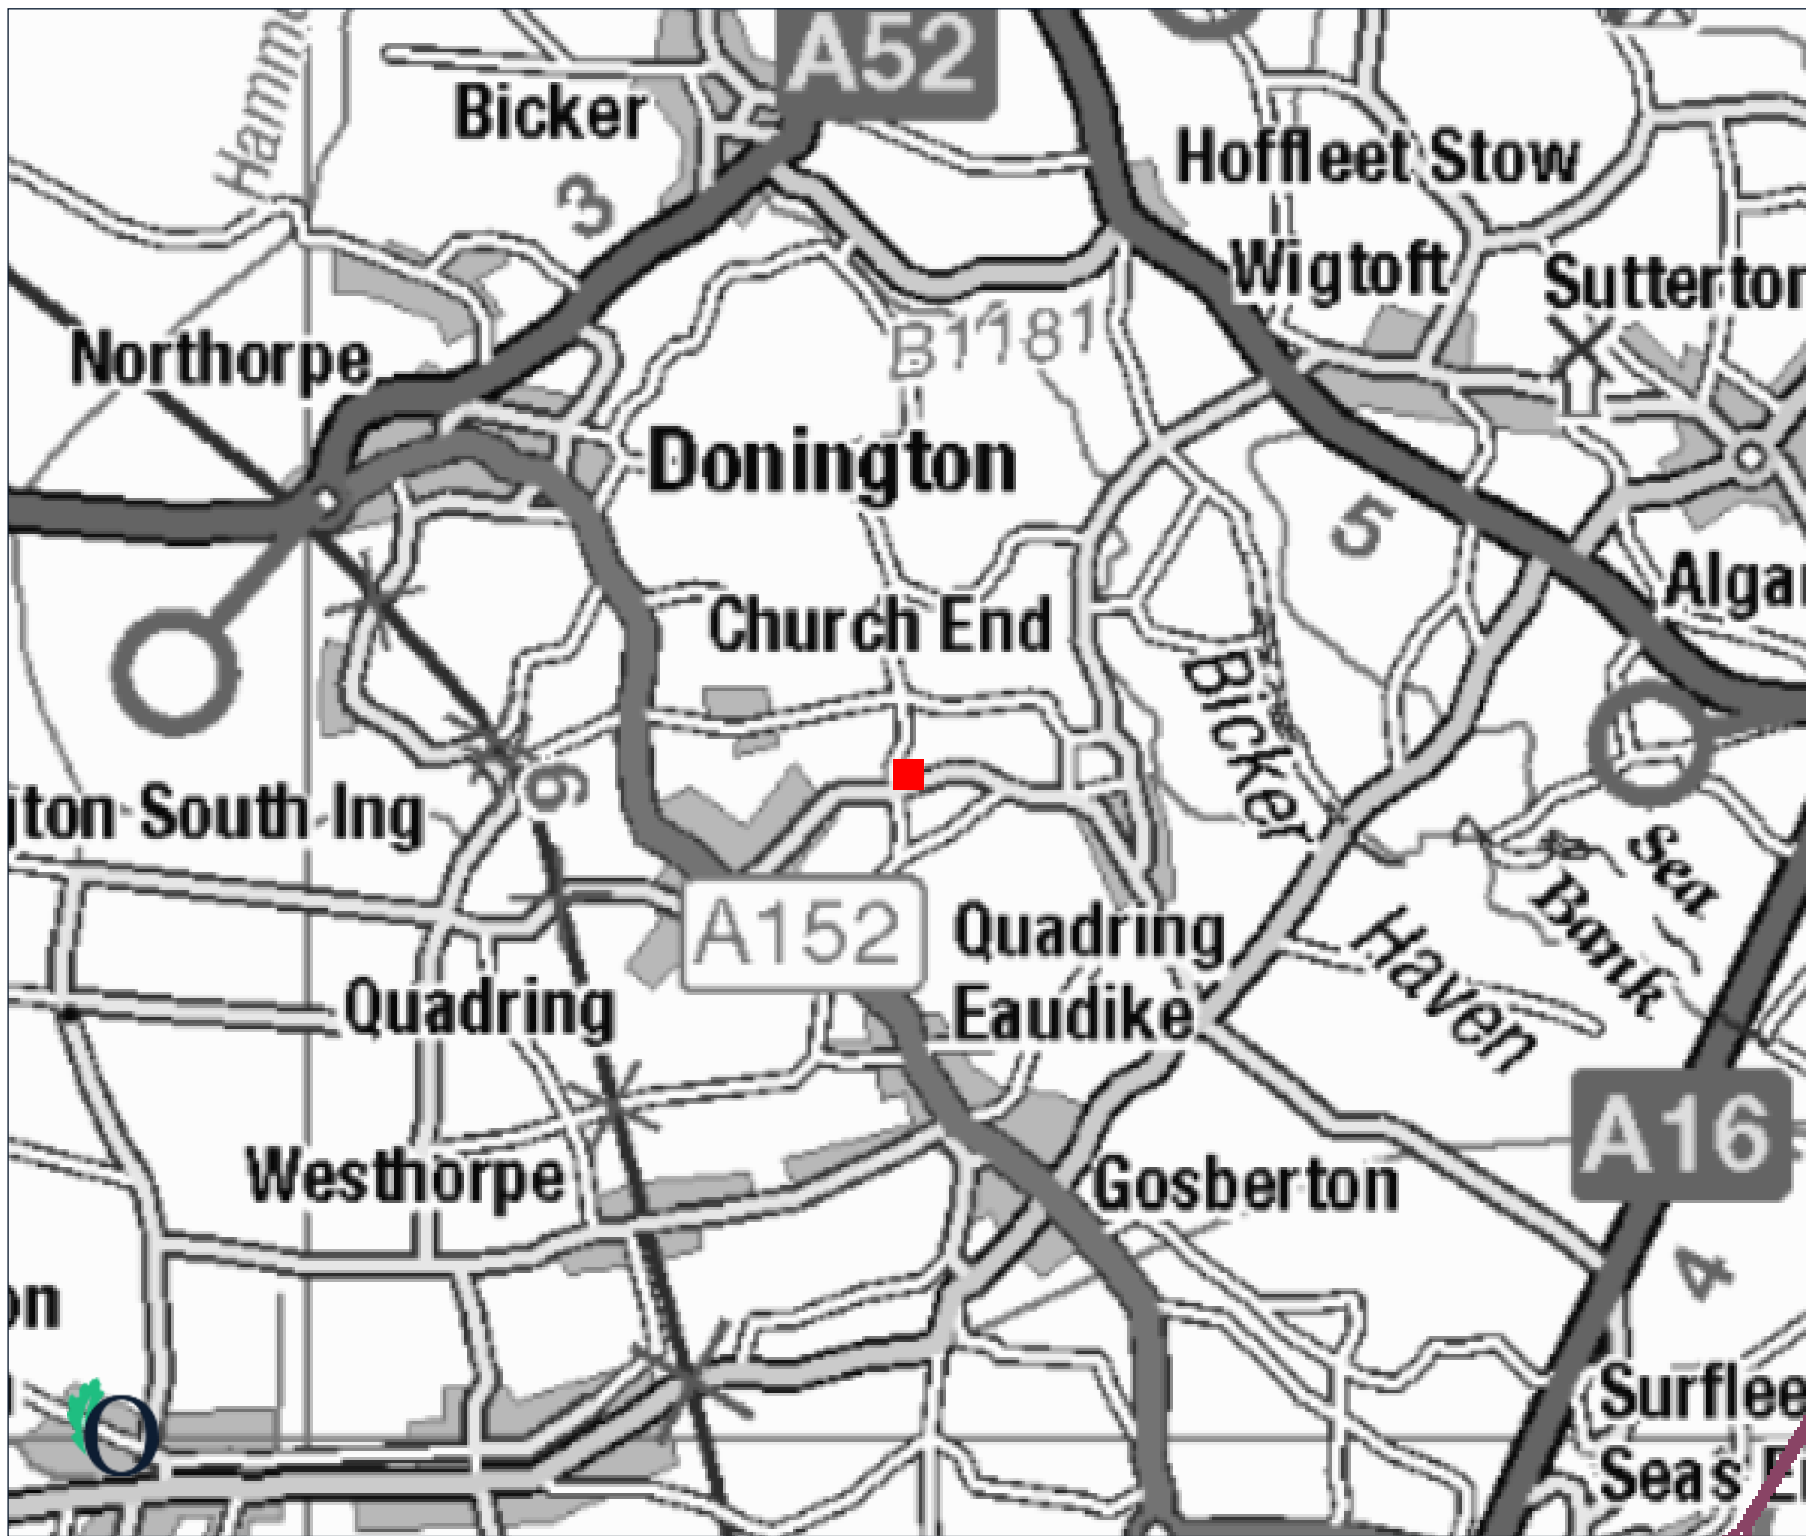
Figure 19

| Environmental Factor | | Details | |
|---|---|---|---|
| | | Bedrock | Unproductive |

BGS map showing bedrock hydrogeology on site

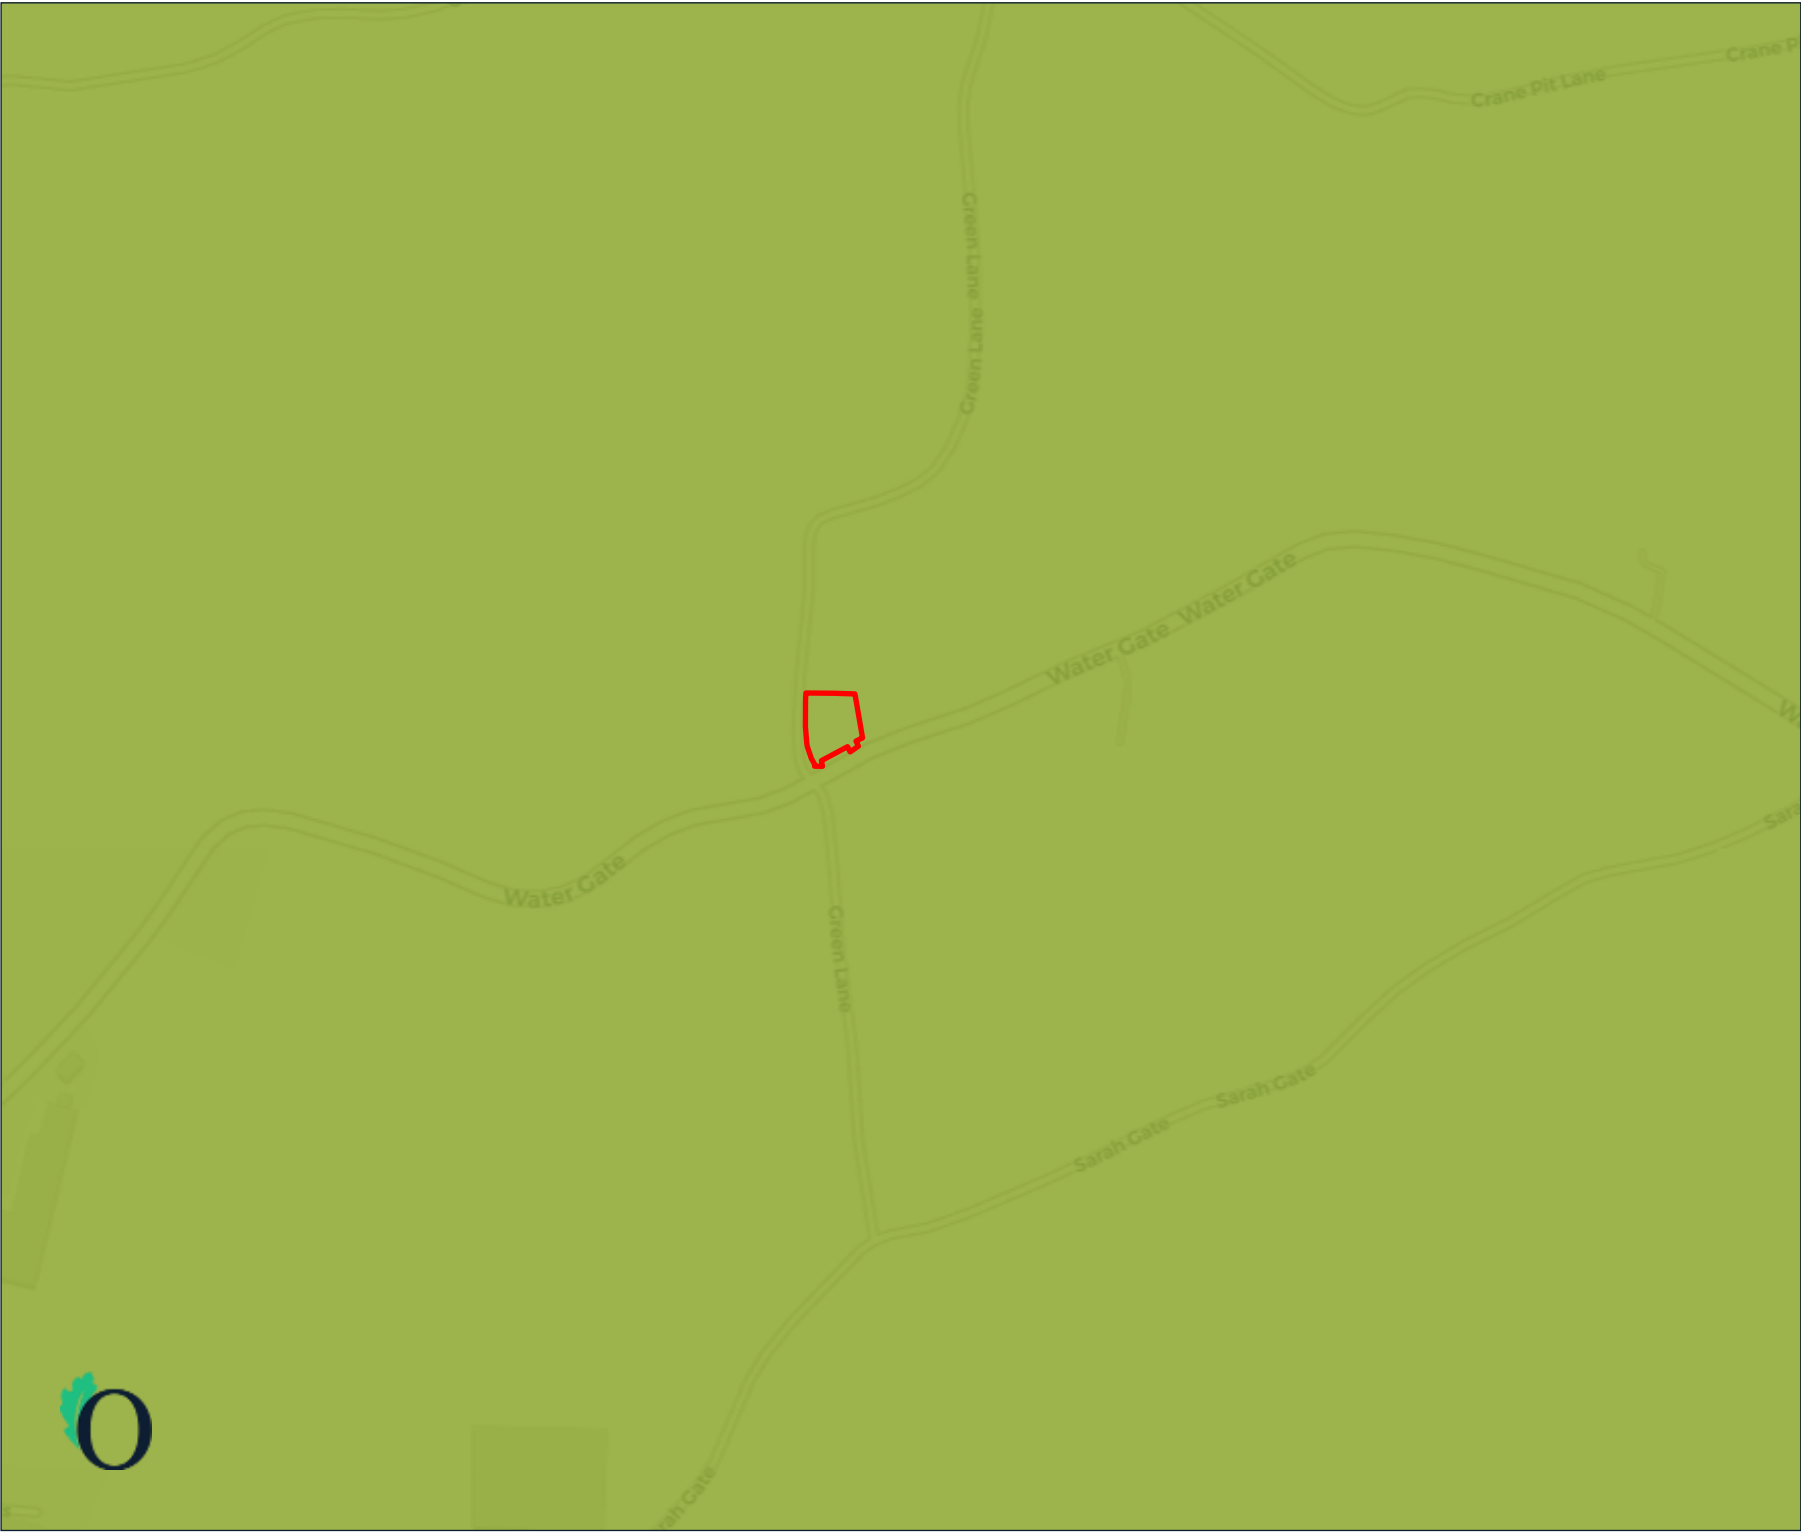
| Appendix D - Geological Maps | |
|---|---|
| Name | Figure 21 |

| Environmental Factor | | Details | |
|---|---|---|---|
| | Bedrock Geology | | Oxford Clay Formation - Mudstone |

| Appendix D - Geological Maps | |
|---|---|
| BGS map showing bedrock geology on site | |
