# Level 2 Historic Building Survey

38 Spring Gardens,  
Spalding, PE11 2XL.

**Type of Intervention:** Historic Building Survey

**Report No:** MAS/654/23

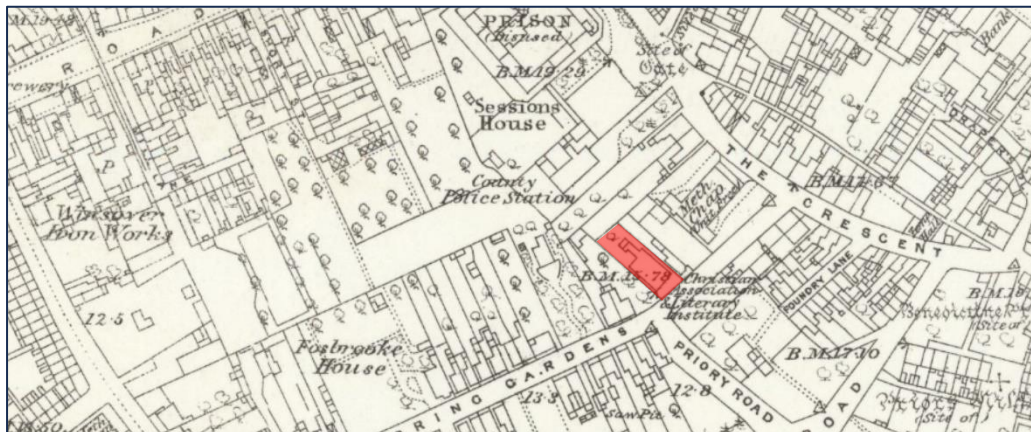
**Fig.8: 1887 Ordnance Survey showing site.**

It shows the site lying just southwest of the Methodist Chapel, the latter since demolished. It also shows a small linear structure and open space between the site and the methodist Chapel. This small building may represent the caretaker's accommodation (fig.8).

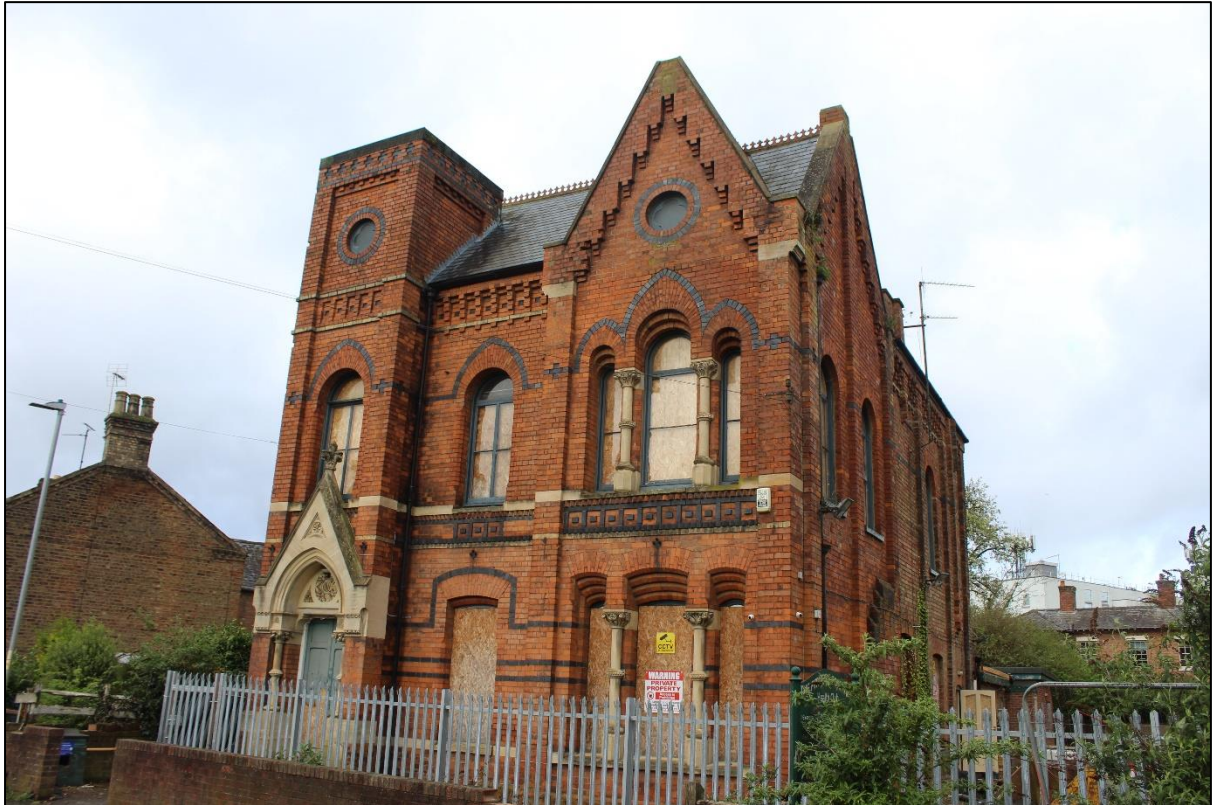
**Plate 1:** Southeast elevation looking northwest.

This elevation has a three-stage brick tower with an elaborate entrance at ground level. The entrance door is timber, of six-panels with chamfered edges. The entrance to the tower is under a kneelered limestone gable with stone copings and a fleur-de-lis finial on top. Set within the gable there is a carved floral motif and set within the gable is a pointed arch on stone columns, carved with ornate Corinthian capitals and amulets. Set within the arch is a date stone of 1871.

At first and third floor level, the tower element displays a recessed central panel, the second level has a four-pane window with wooden glazing bars under a semicircular arch of red brick with a pointed arch of vitrified brick. The third storey of the tower contains a blind oculus with a double circular surround of brick headers (figs. 3, 4, 7, plates 1-3).

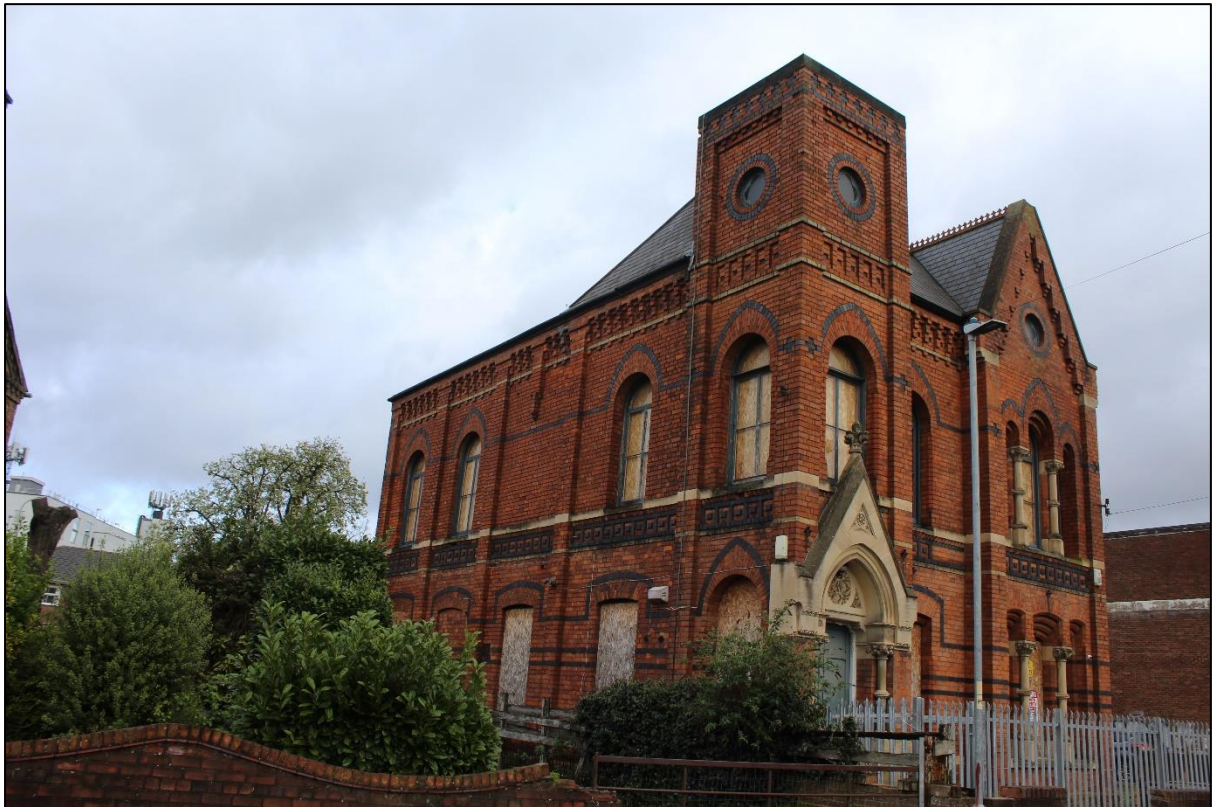
**Plate 3:** Southwest elevation looking north.

This elevation is of five bays, each separated by a brick pier. The first bay at ground level has at some point been bricked up and had a small rectangular window inserted. The next bay along is bricked up, the next two bays having one-over-one pane horned sashes.

This floor has four, four-light windows, with vitrified brick arches above each window except for the central bay which is plane brick. The fifth bay is that containing the tower, this is much the same as the front elevation, apart from the ground floor which has a semicircular arched window (figs. 4, 7, plate 3).

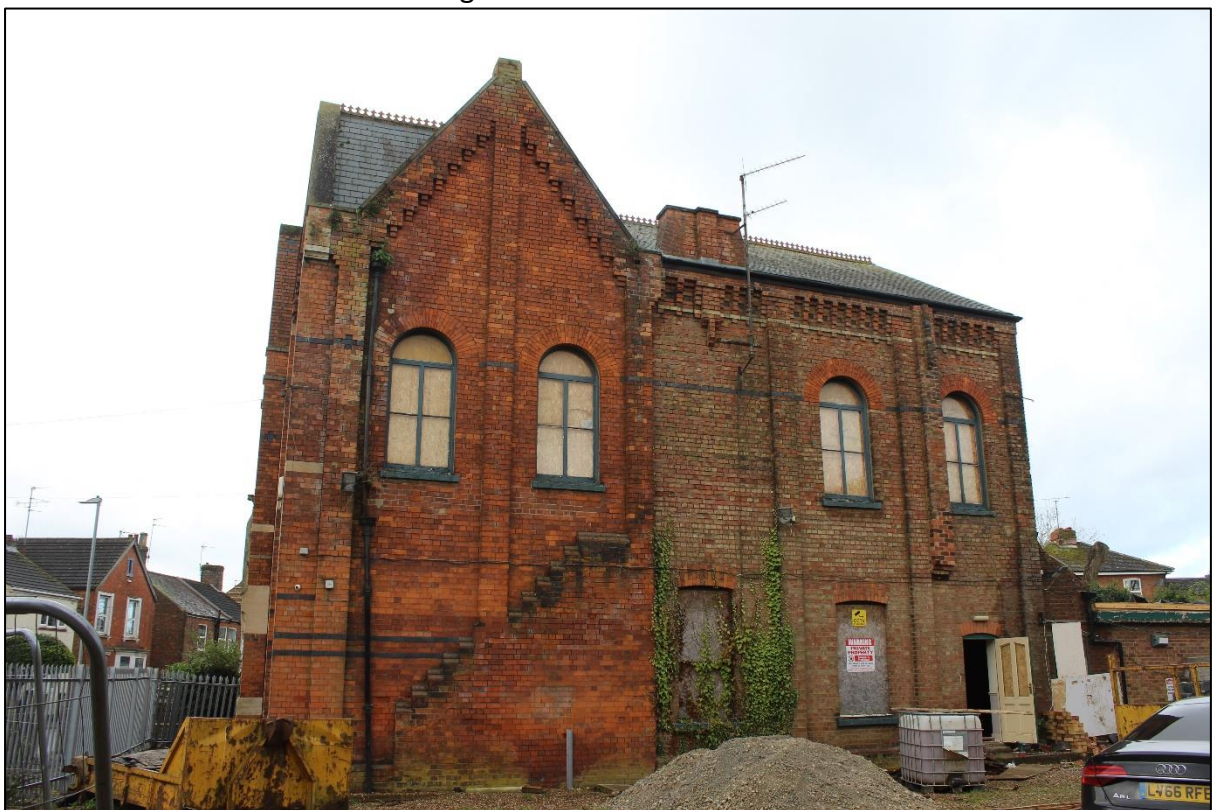
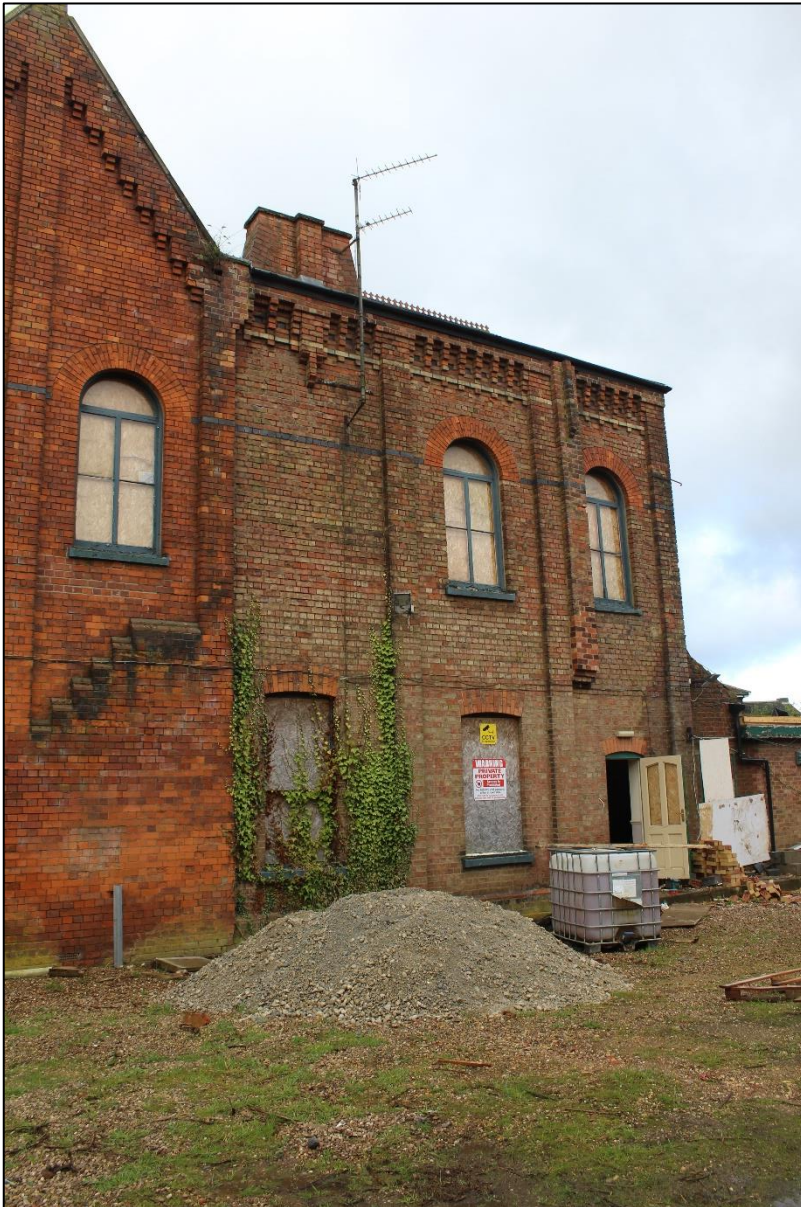
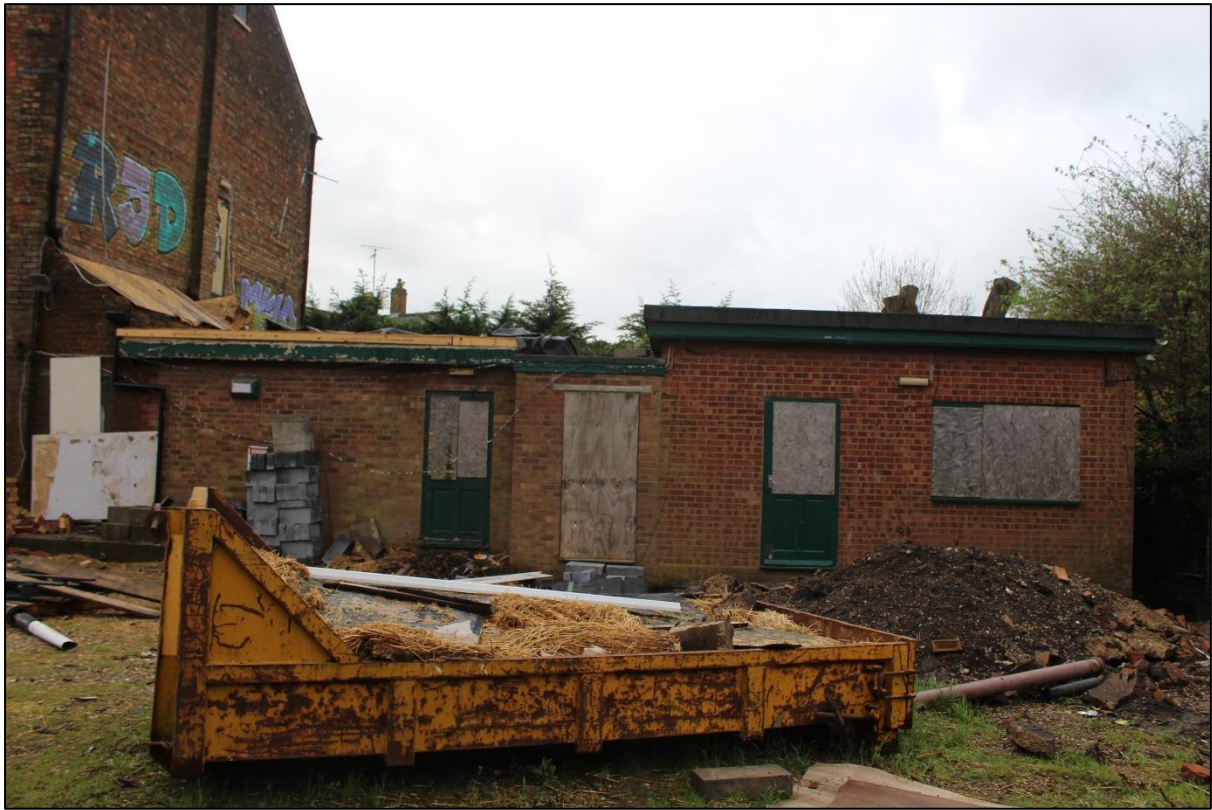
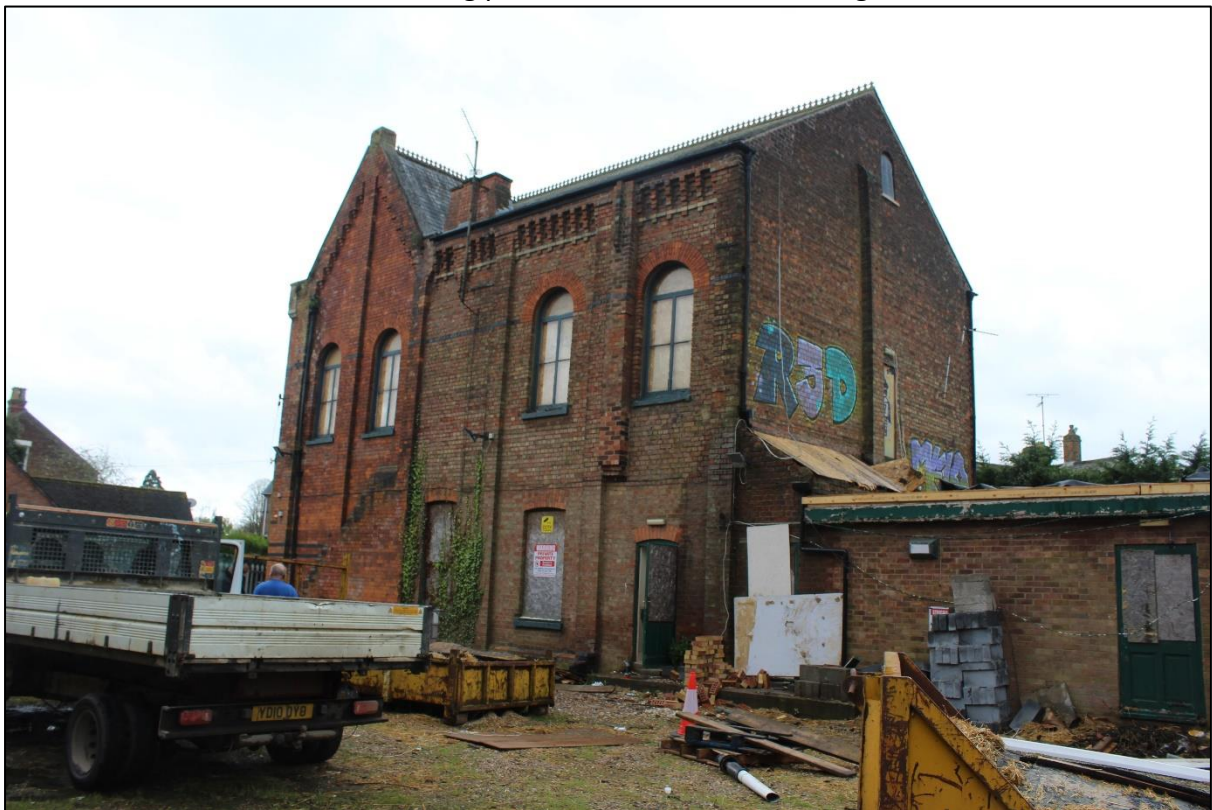
At this level, the position of the internal staircase is demarcated by a line of diagonal brickwork which spans across two bays demarcated by two brick piers. To the right of this are a pair of sash windows and an entrance opening, this part of the elevation being divided into three-bays, the brick used is of an inferior quality and presumably as it would have not been visible when first built due to its proximity to the caretaker's accommodation (figs. 4, 7, plates 4-7).

To the right is the post-war single storey extension, this is of brick in stretcher bond with a flat felted roof and comprises of five entrance doors and a single three-light rectangular window (figs. 4, 7, plates 4-7).

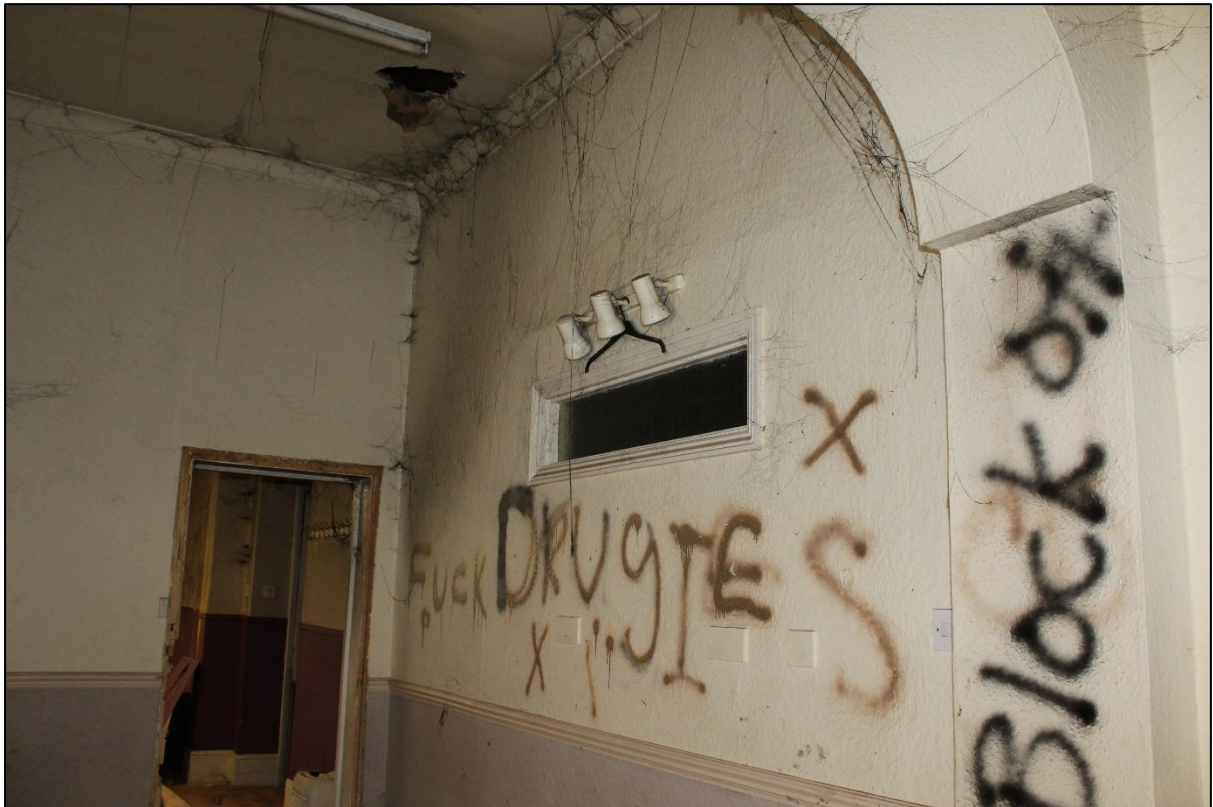
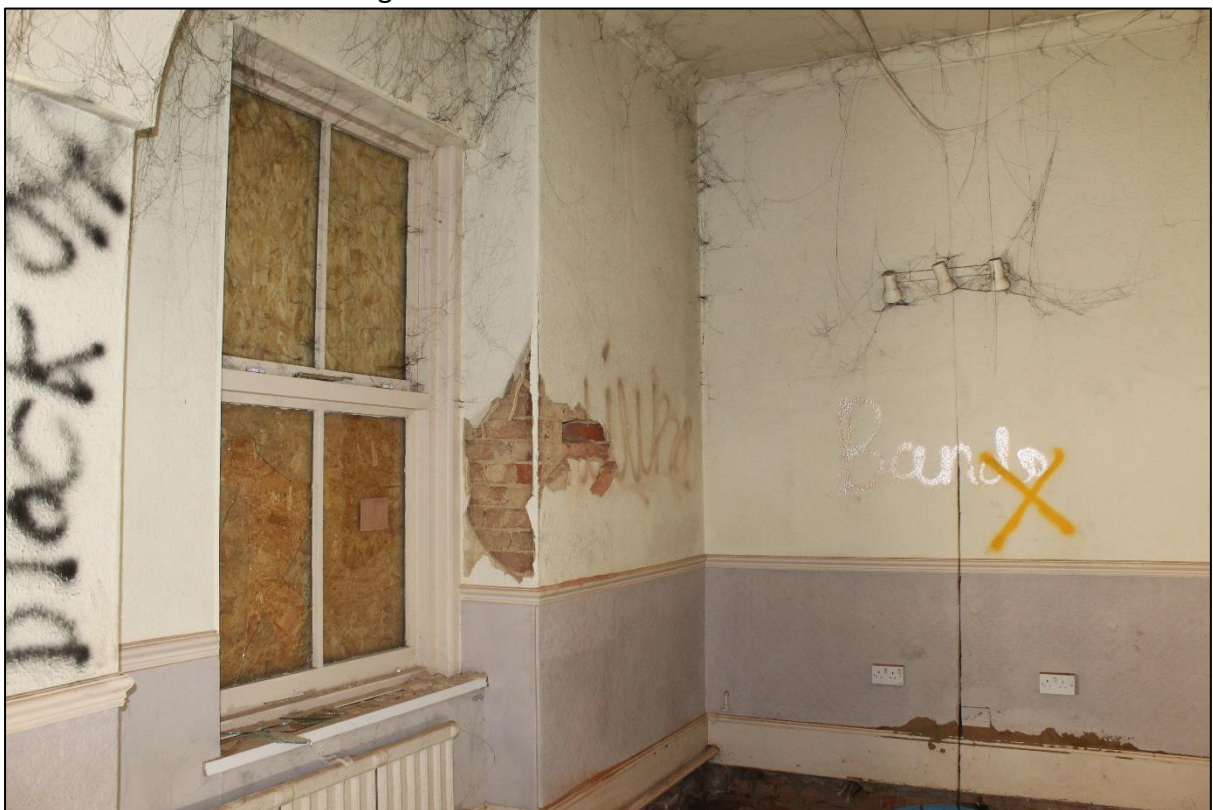
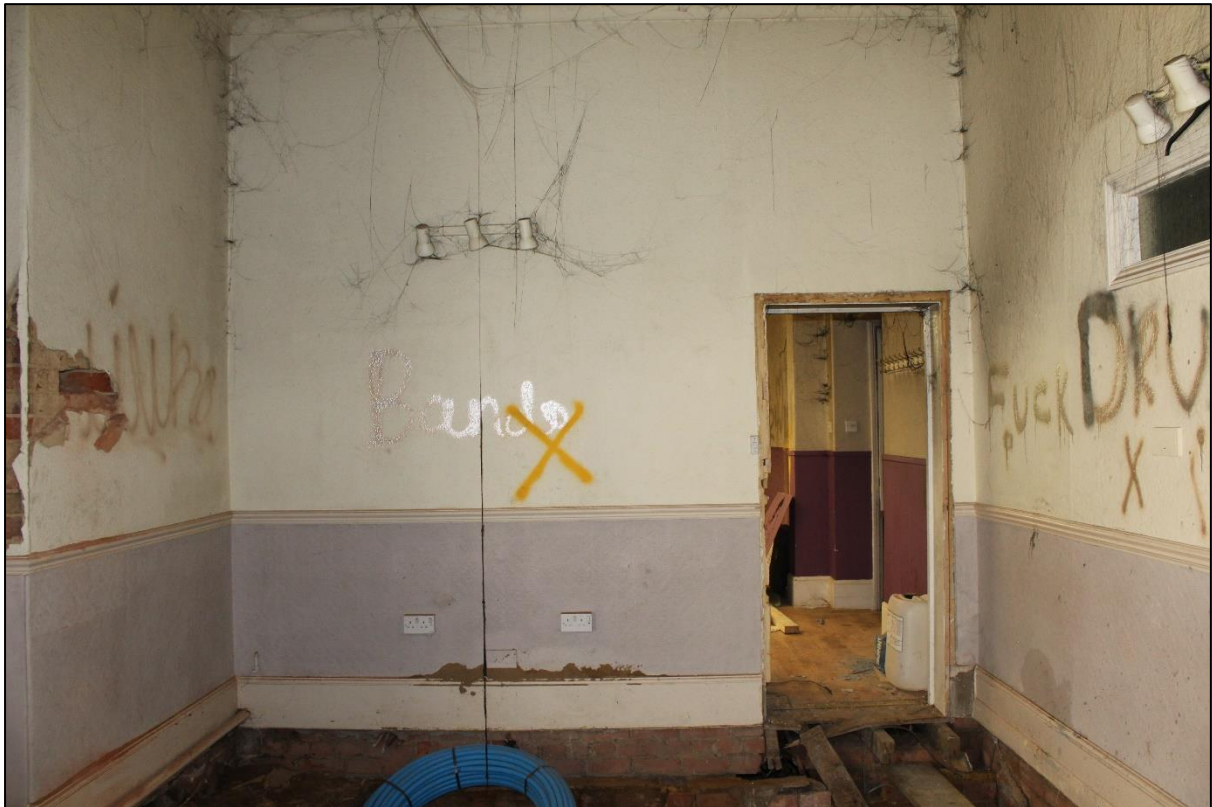
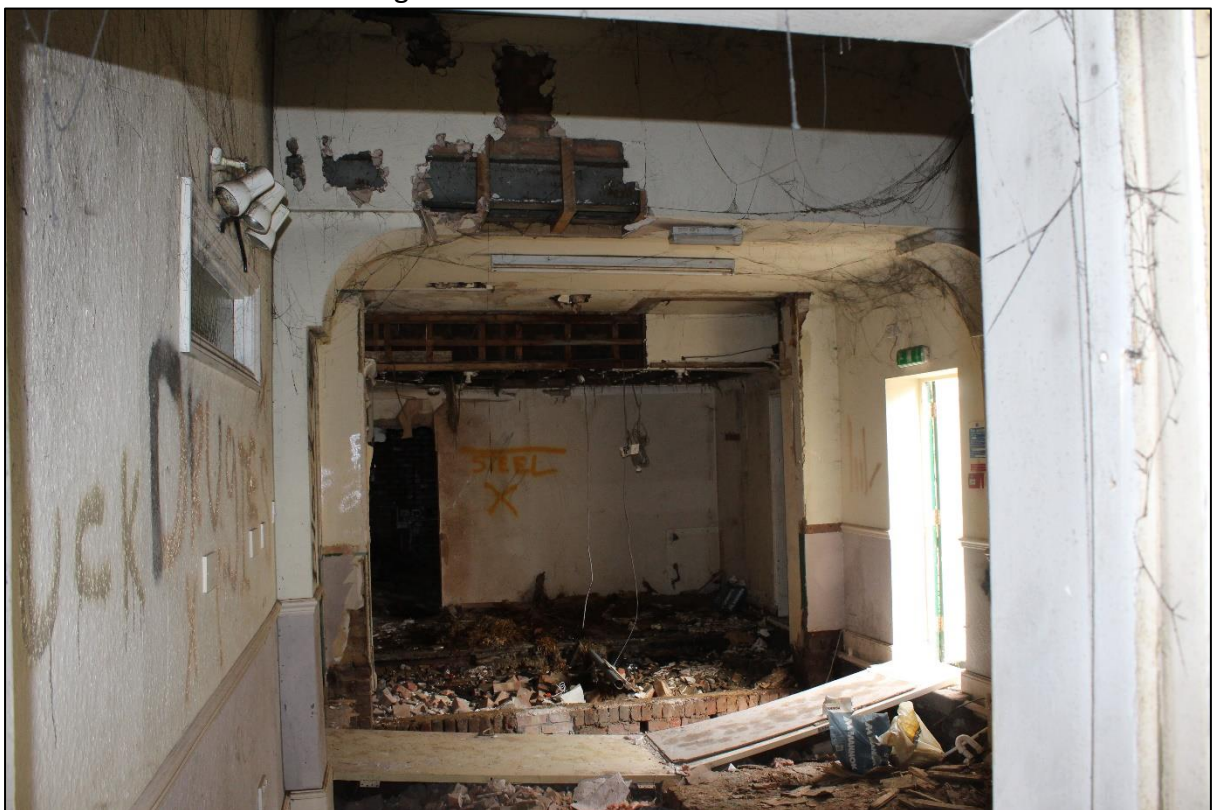
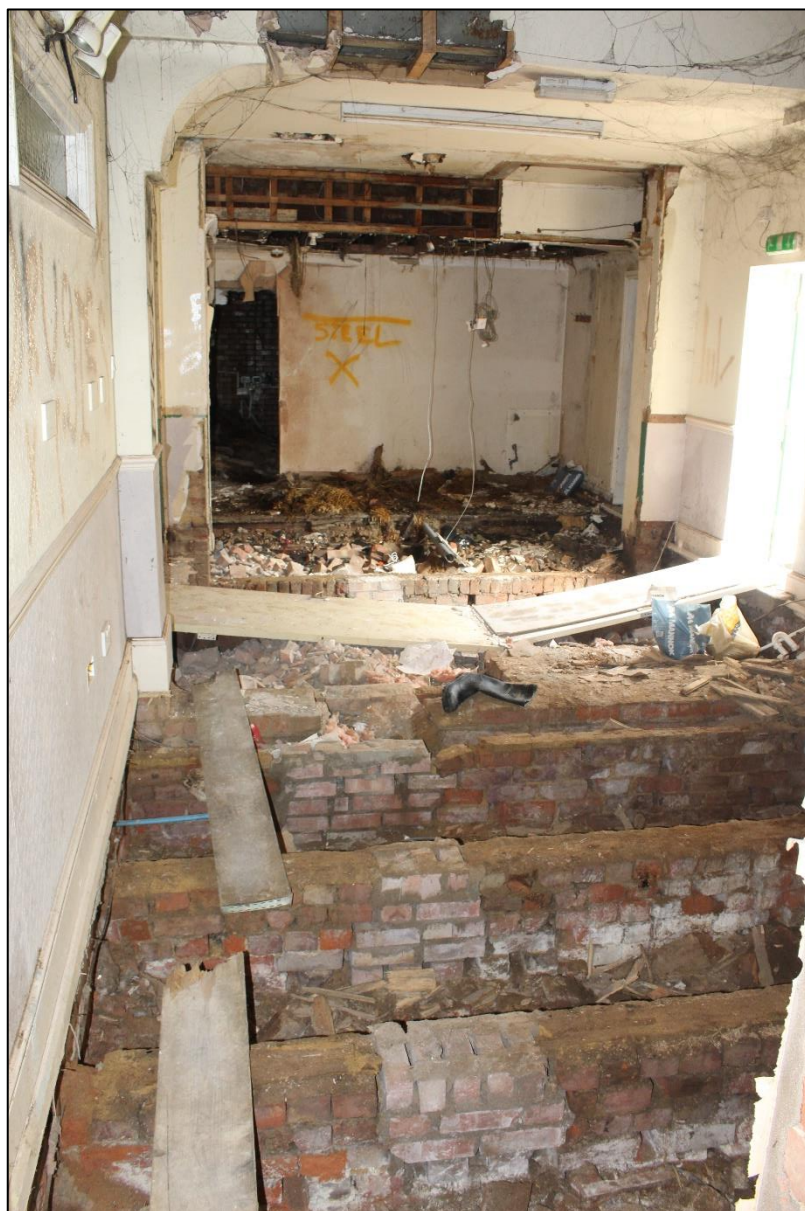
Rectangular in plan 'floor missing', walls are painted lime plaster and in some areas gypsum plaster, with occasional wood chip wall paper. There is a modern dado rail running throughout the room, as well as contemporary plaster coving. Skirtings survive, whilst the door frames throughout the room are missing, as are the doors. Sash windows are present.

The wall between this room and that of the 'Office' to the northwest has been removed, turning this area into one large space (figs. 4, 6, 8, plates 8-12).

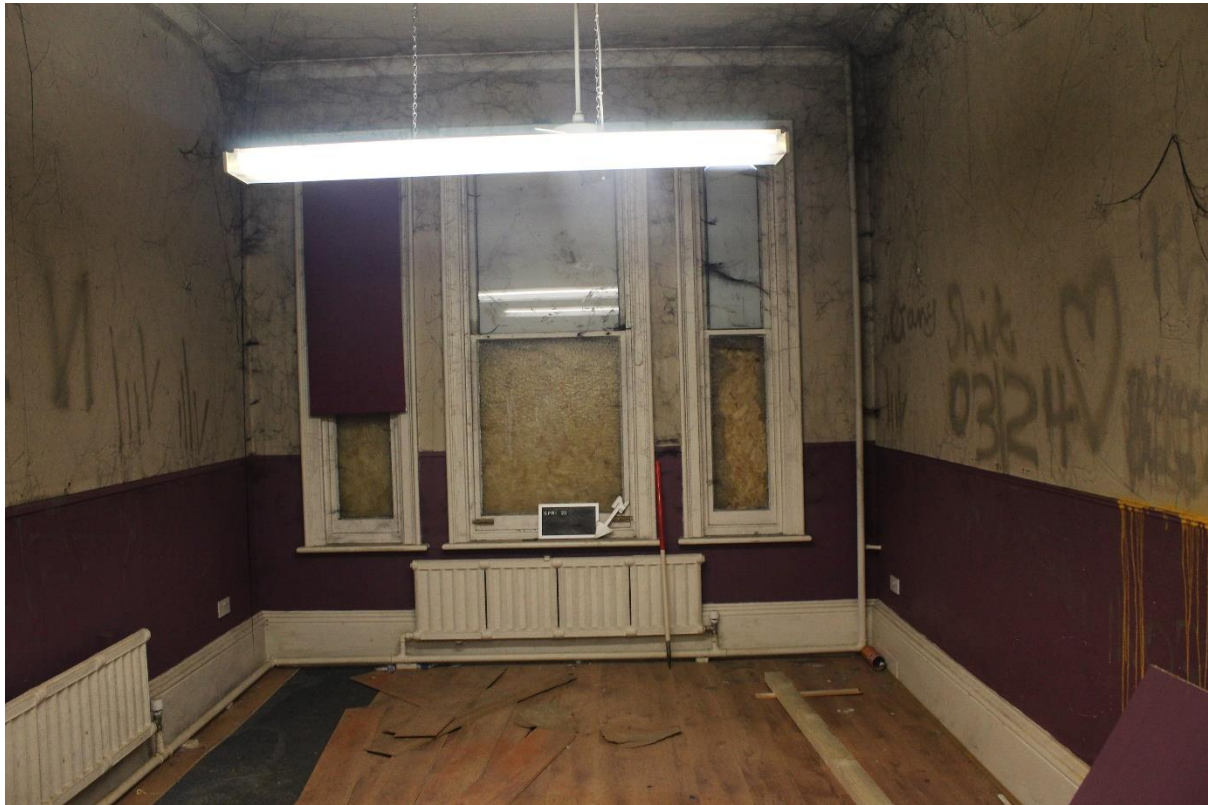
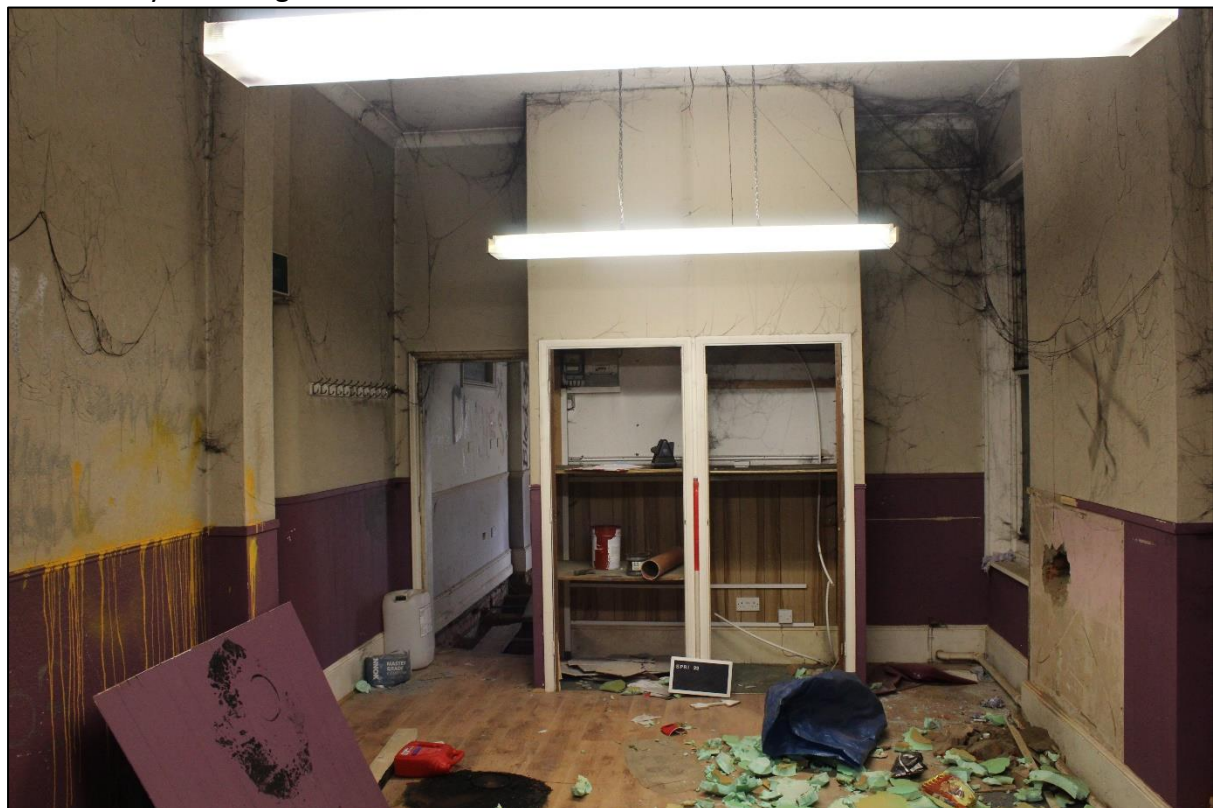
Rectangular in plan with a modern engineered laminate floor covering. The walls are of painted lime and gypsum plaster. Against the dividing wall with the exercise room is a tall double and fitted cupboard. At the southwest end of the room are three tall timber sash windows. There are some original skirtings throughout, while a modern dado rail runs throughout the room, along with some modern ceiling covings (figs. 3, 5, 7, plates 13, 14).

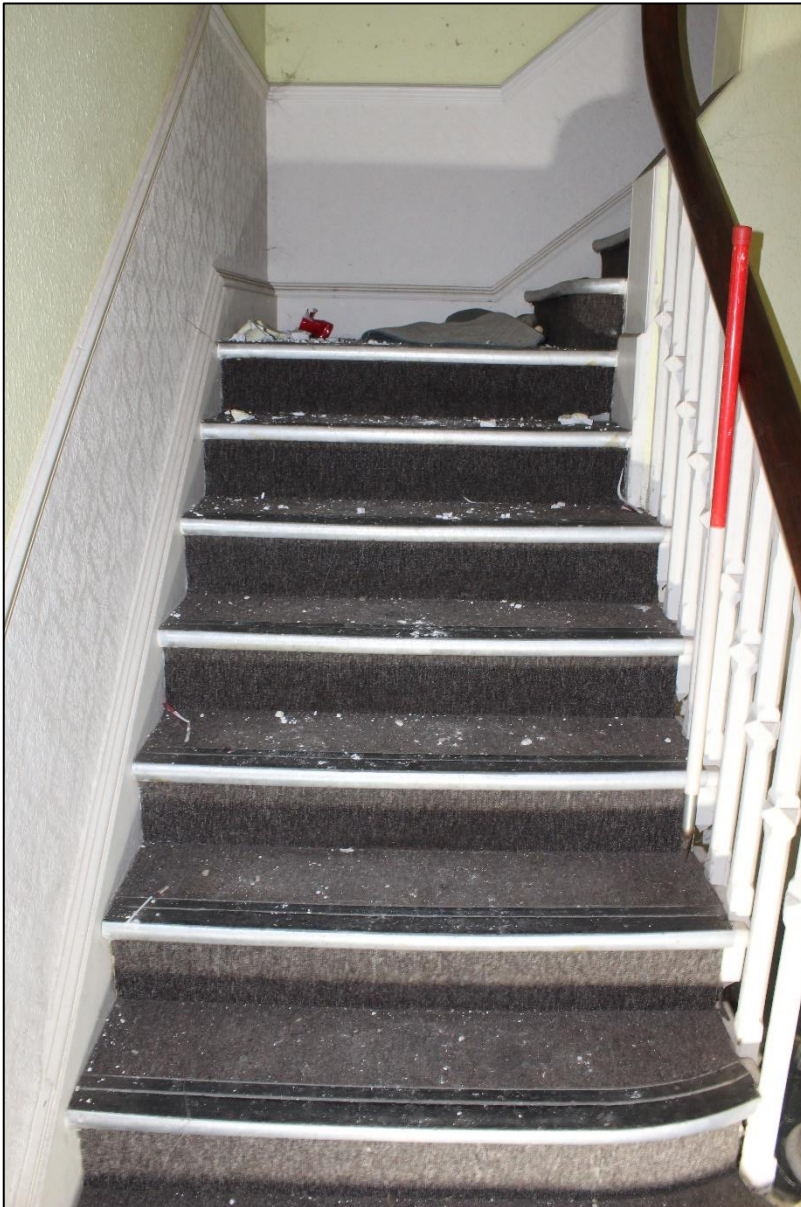
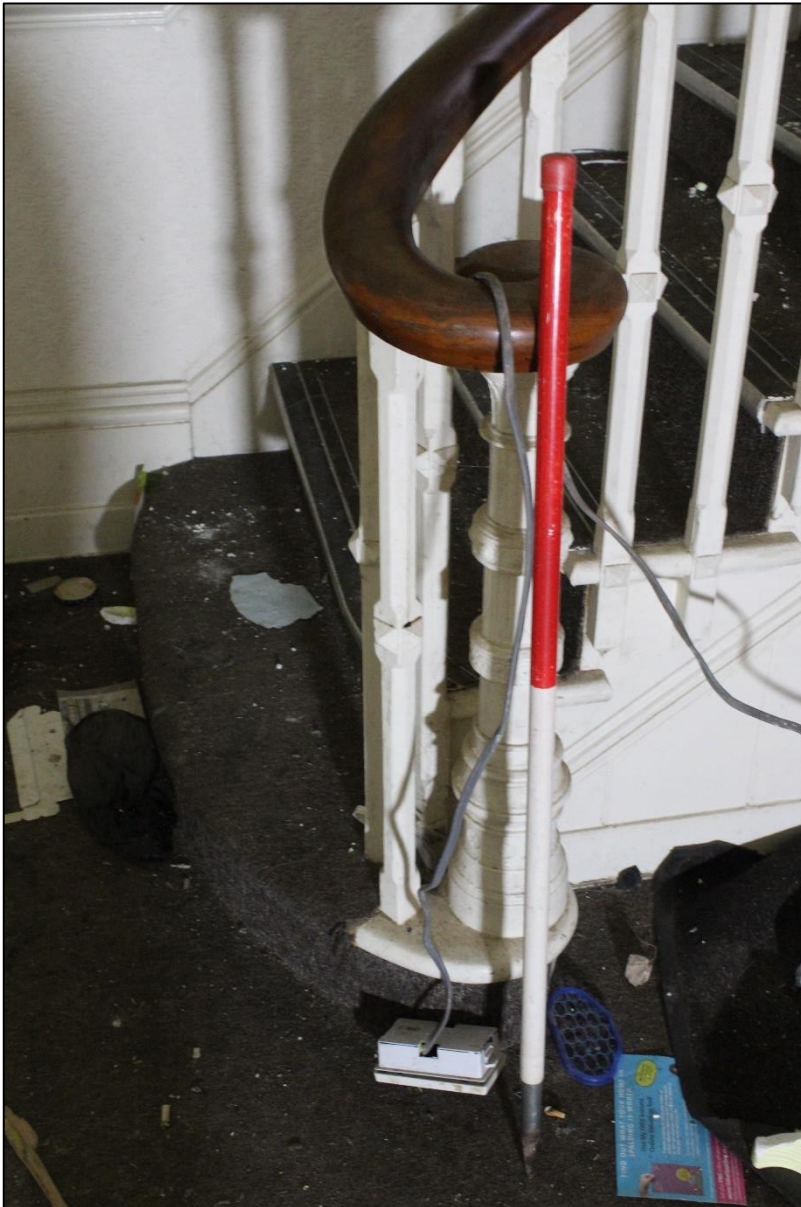
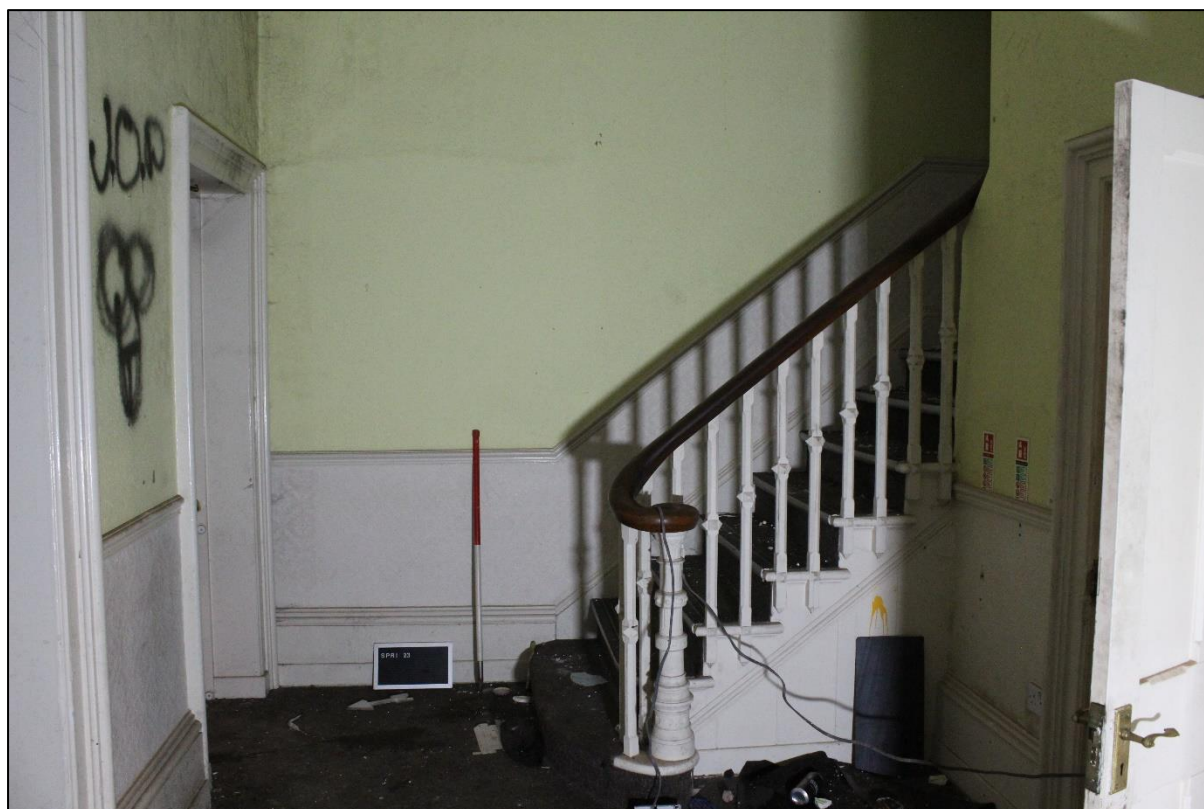
Rectangular in plan with a carpeted floor, painted plaster walls and ceiling, plaster covings, tall skirting boards and a dado rail running throughout the room. The door frames are intact, so too are the original four panel doors. Within the east corner of the room are set of timber stairs leading up to the exercise hall. The stairs are carpeted, the stairwell of painted plaster with skirtings, dado rail and covings to match those of

the entrance hall. There is also a decorative wooden balustrade and newel post present (figs. 3, 5, 7, plate 15-17).

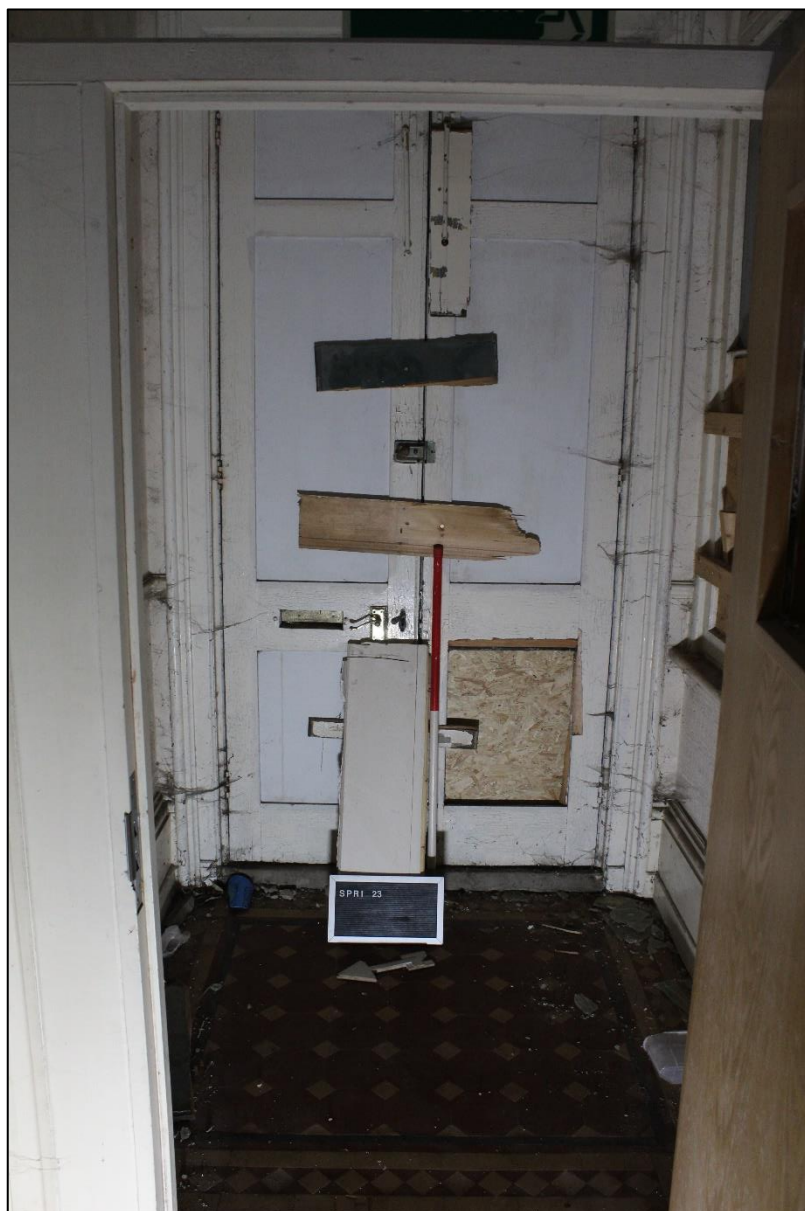
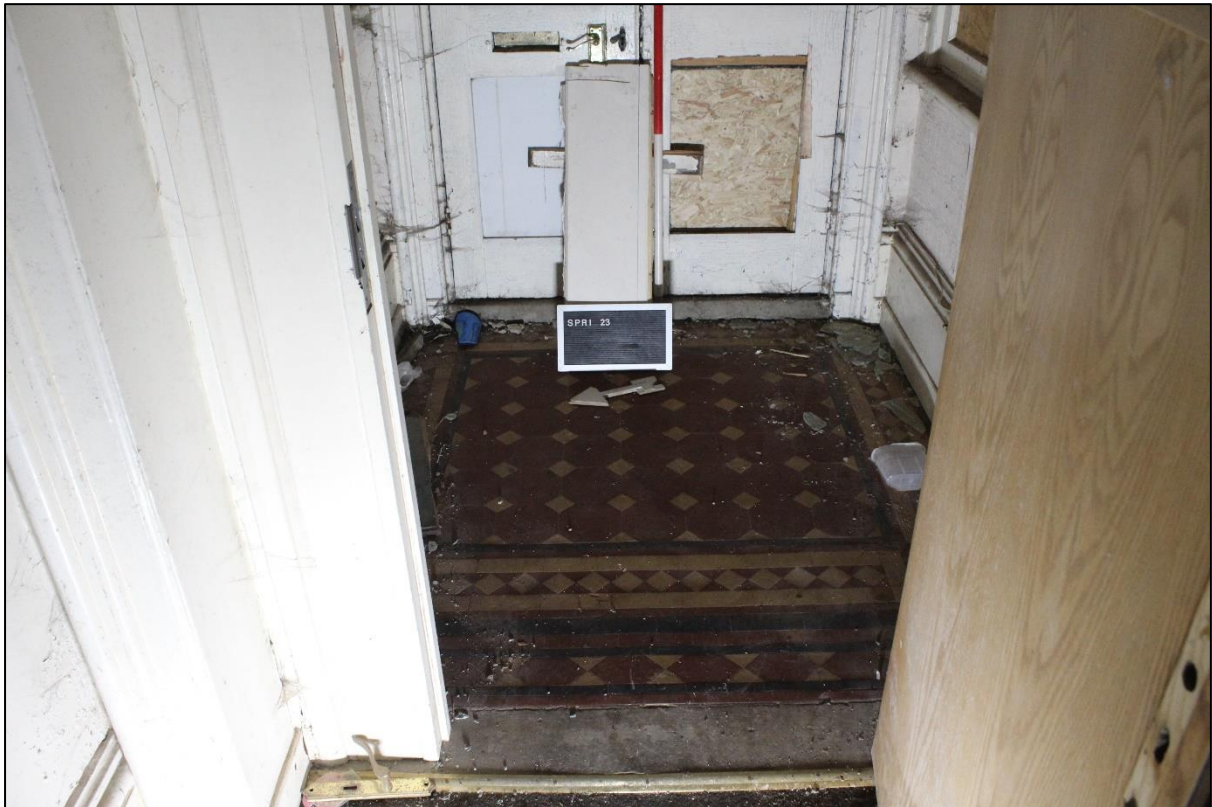
Square in plan, with painted plaster walls and ceiling, modern four panel door present, while the exterior four panel door appears original to the building. There is a decorative geometric pattern tiled floor and a timber sash window which is probably an original fixture located to the right of the area (figs. 3, 5, 7, plates 18, 19).

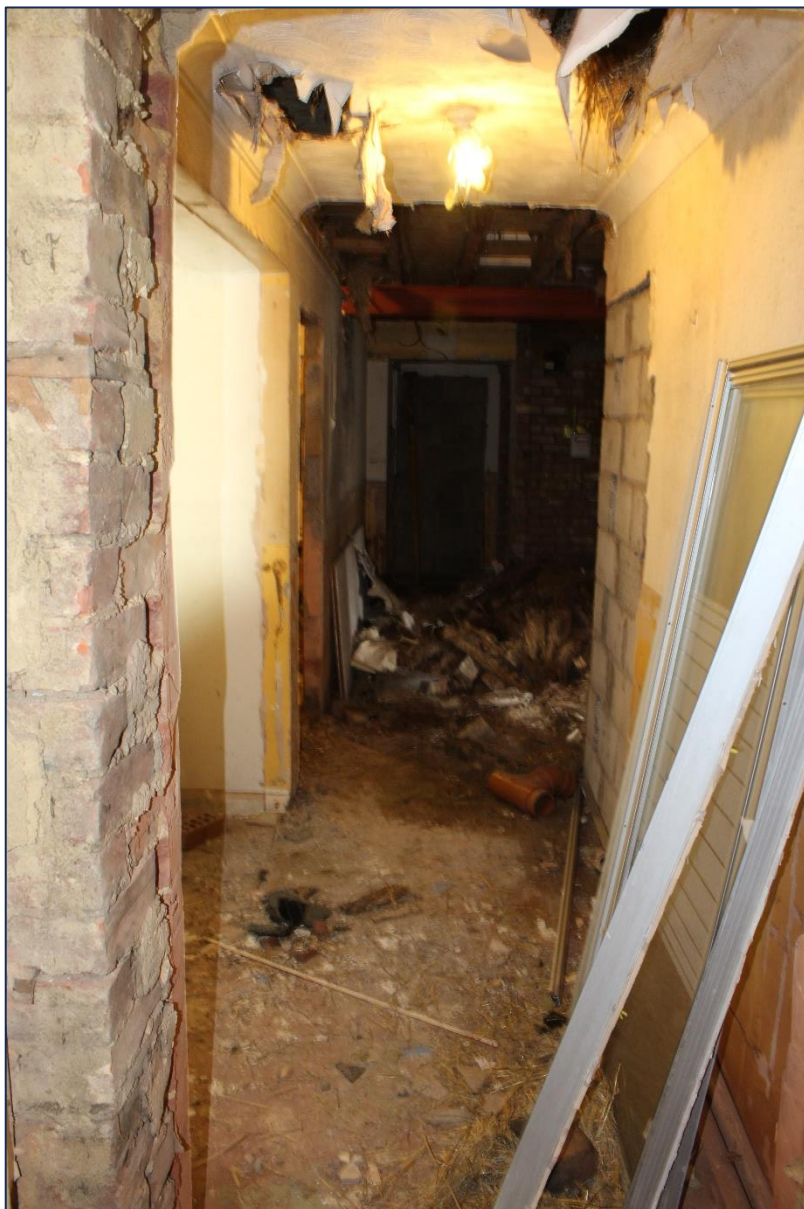
**Plate 24:** Hallway looking northwest.

Rectangular in plan with a dirt floor, painted plaster walls and ceiling, whilst there are areas of exposed brickwork, and the ceiling is in a state of partial collapse. This hallway connects the reception area to exercise room, office, female WC, stores (A,B,C), male WC boiler room and post-war extension to the rear of the building (figs. 3, 5, 7, plate 24).

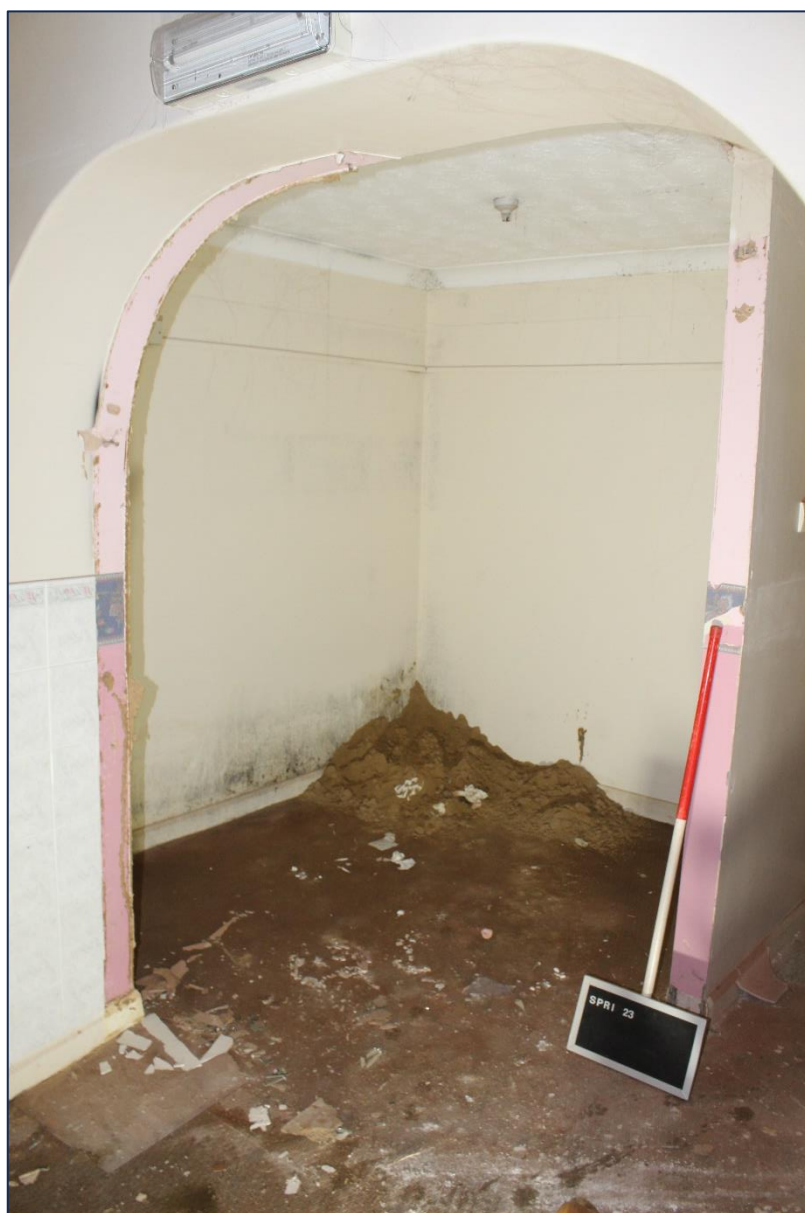
**Plate 25:** Entrance between Female WC and store A.

Square in plan with papered walls and a painted plaster ceiling. The floor is obscured by soil (figs. 3, 5, 7, plate 25).

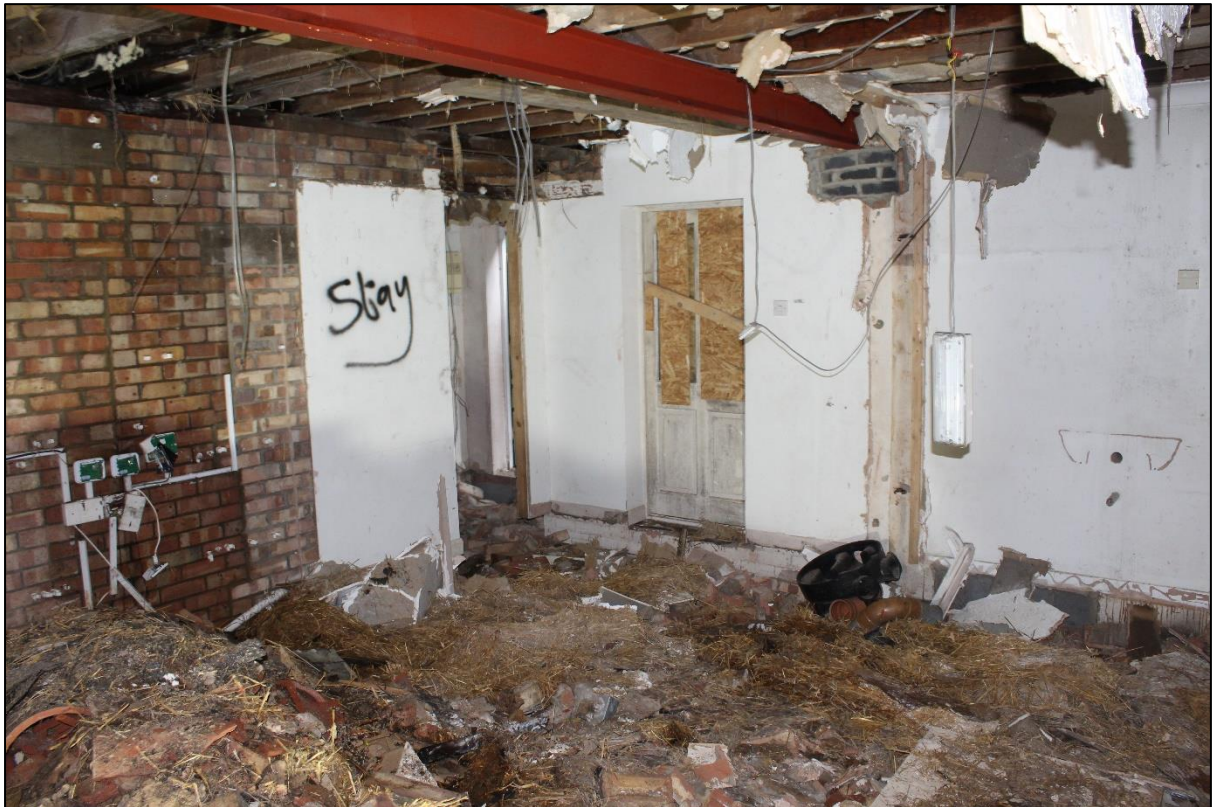
**Plate 26:** Store B, store C and boiler room looking north.

Rectangular in plan, with some painted plastered walls, with some exposed brickwork. The ceiling is missing with only the timber joists remaining and a modern RSJ supporting. The floor is obscured with debris and rubble. There is an exterior door of four panel design within the northwest-southeast wall (figs. 3, 5, 7, plate 26).
