# Level 2 Historic Building Survey

38 Spring Gardens,  
Spalding, PE11 2XL.

**Type of Intervention:** Historic Building Survey

**Report No:** MAS/654/23

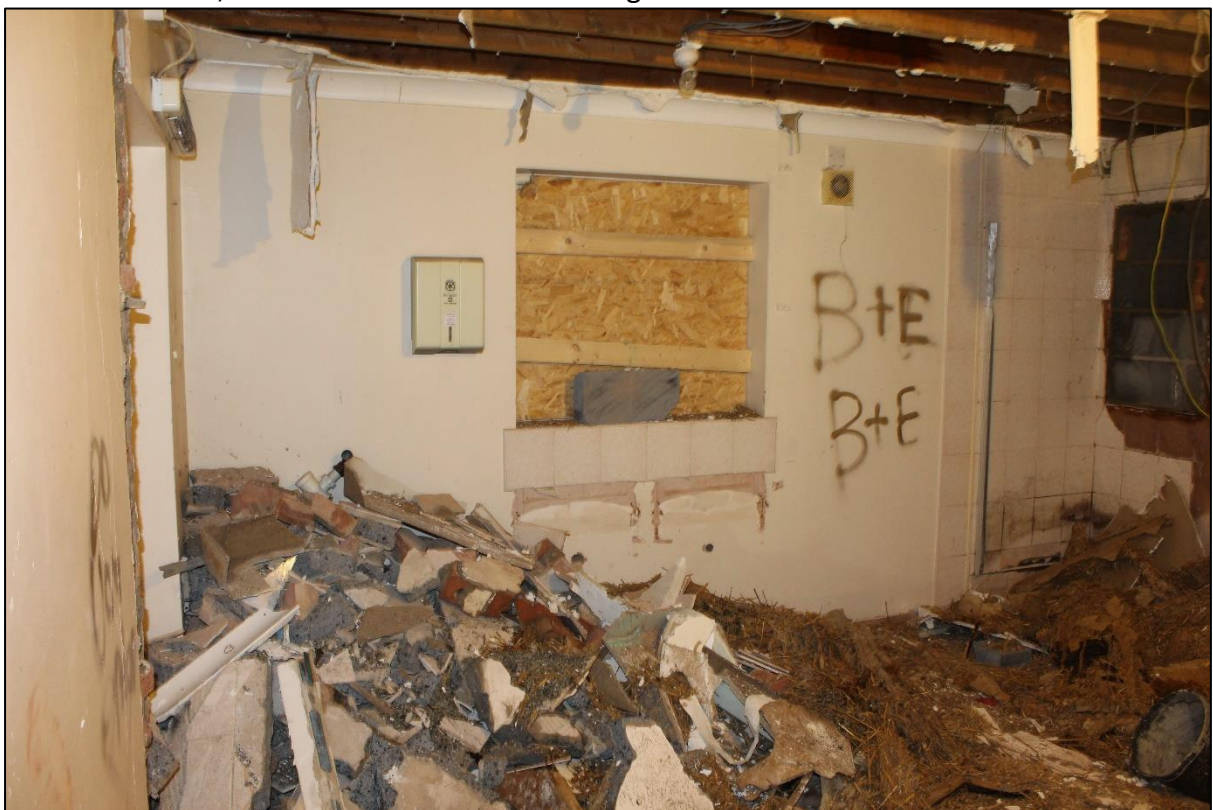
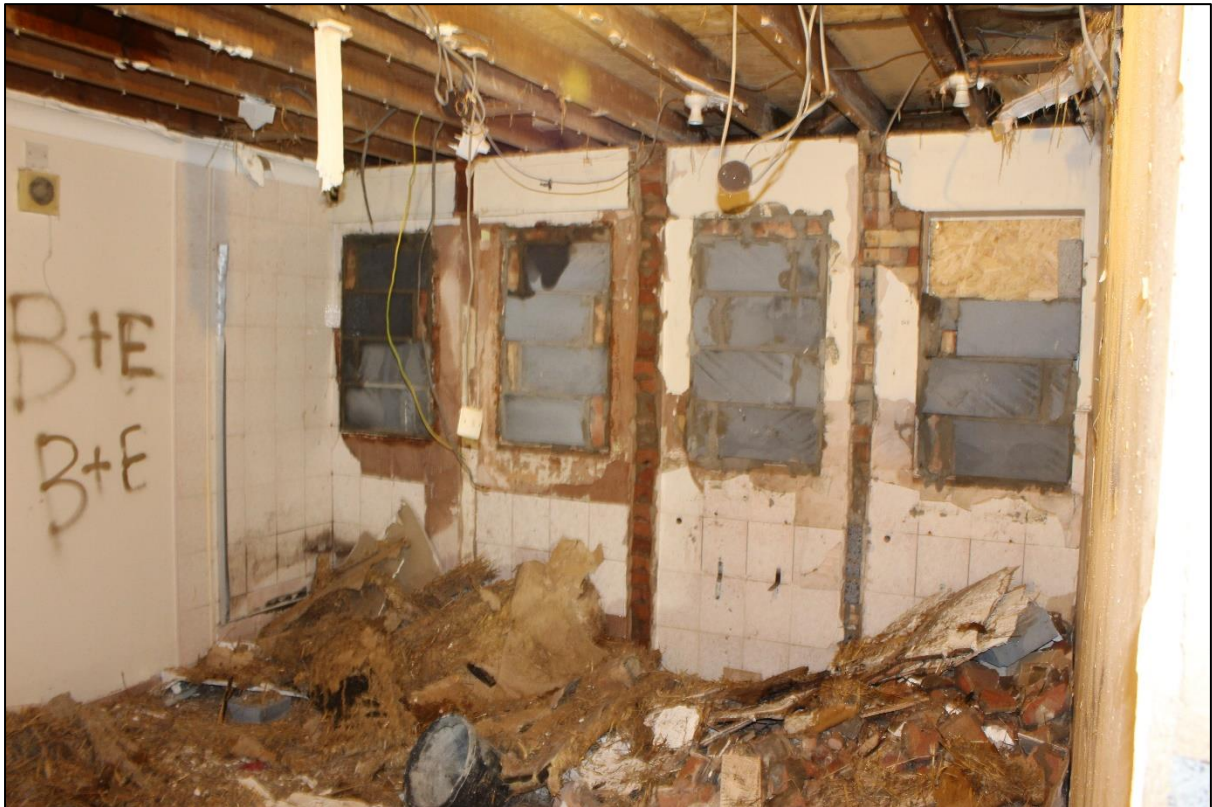
Rectangular in plan with painted plaster walls, in some parts they are tiled. The ceiling is missing, leaving the rafters visible, whilst the floors are obscured by rubble and debris. There are four blocked up window openings along the northeast-southwest wall (figs. 3, 5, 7, plates 27, 28).

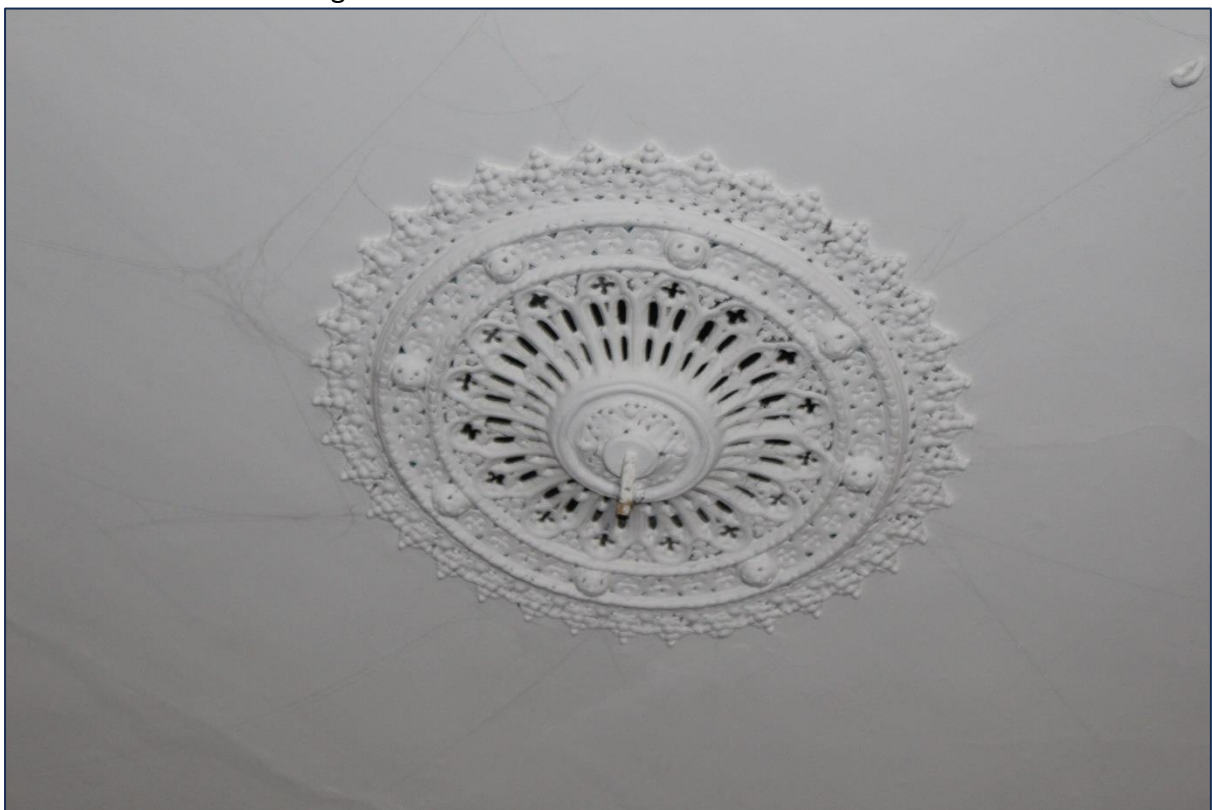
**Plate 29:** Decorative ceiling rose in exercise hall.

The building holds Grade II listed building status (**1464585**) and represents the former Christian Association and Literary Institute, which was constructed in 1871 (plate 29). An entry in Kelly's Lincolnshire Directory of the period describes the building as '*a building of red brick, in the French Gothic Style, and contains a lecture hall, reading and classrooms, with a library of 1,351 volumes, and residence for the caretaker*'.

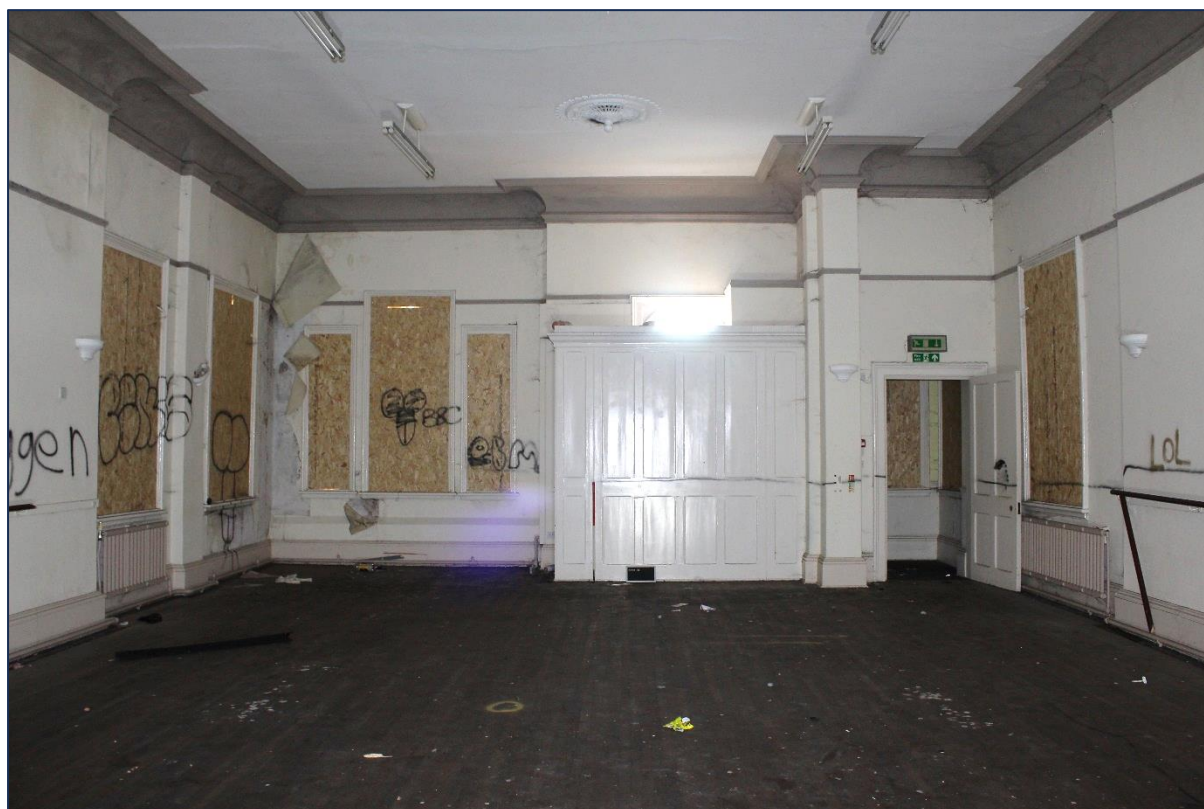
**Plate 30:** Exercise hall looking southeast.

southwest-northeast and southwest-southeast walls are heavy sash windows. Centre to the rear northwest elevation is a blocked access to the roof area (plate 31), while opposite to this is a panelled enclosed stairwell area (figs. 3, 5, 7, plates 30, 32, 33).

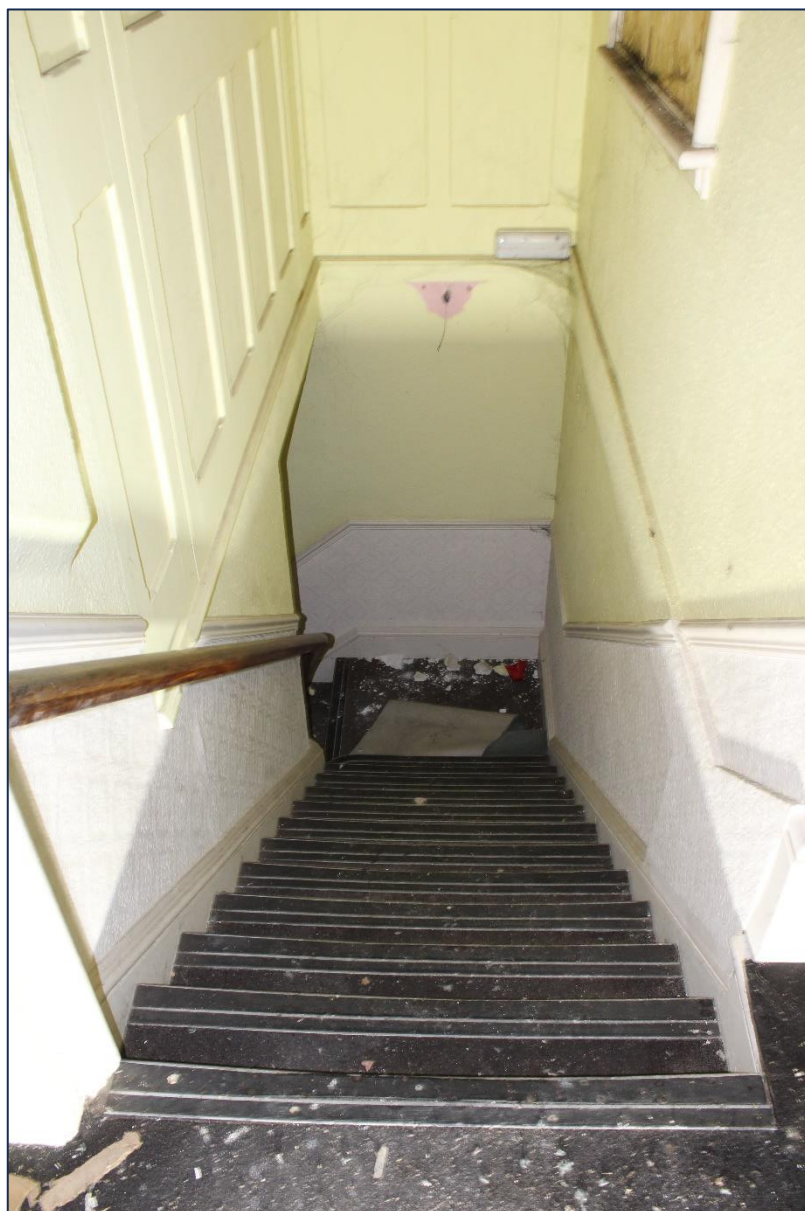
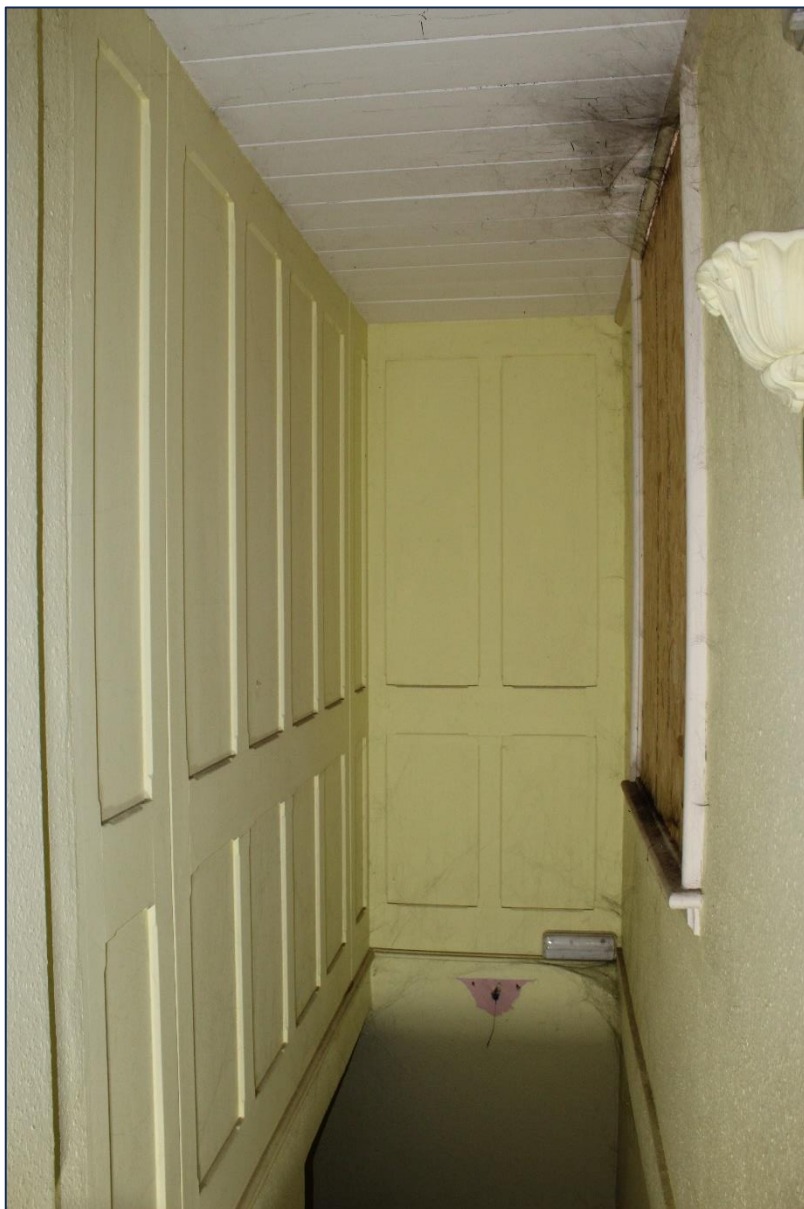
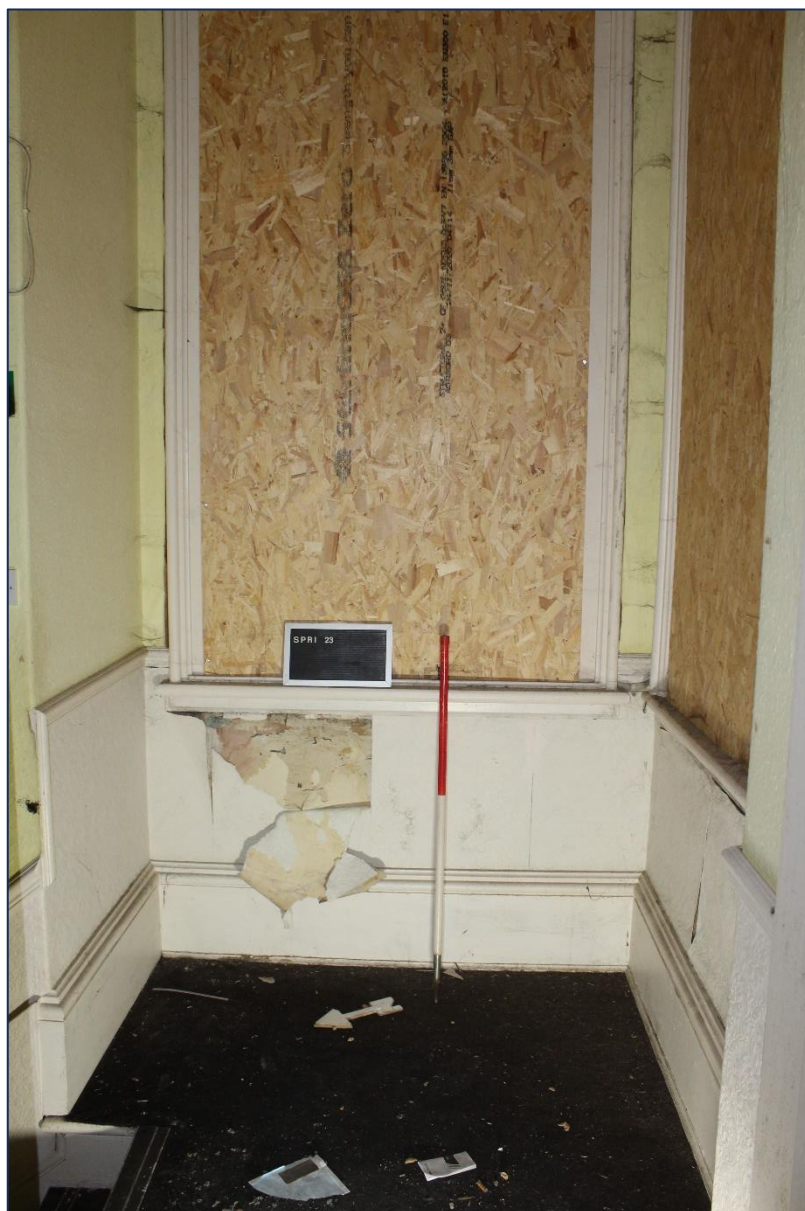
The rear area at ground floor level of the building housing (*fire escape access, lobby, kitchenette, shower room and treatment rooms*) was not surveyed due to dangerous site conditions, collapsed walls, ceilings, and floors (figs. 3, 5, 7, plates 32-34).

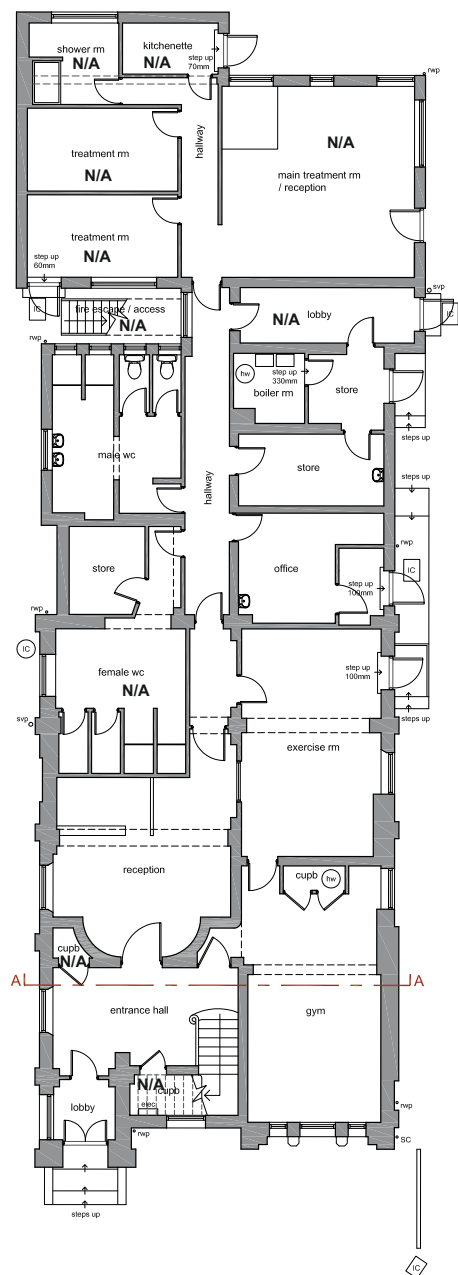
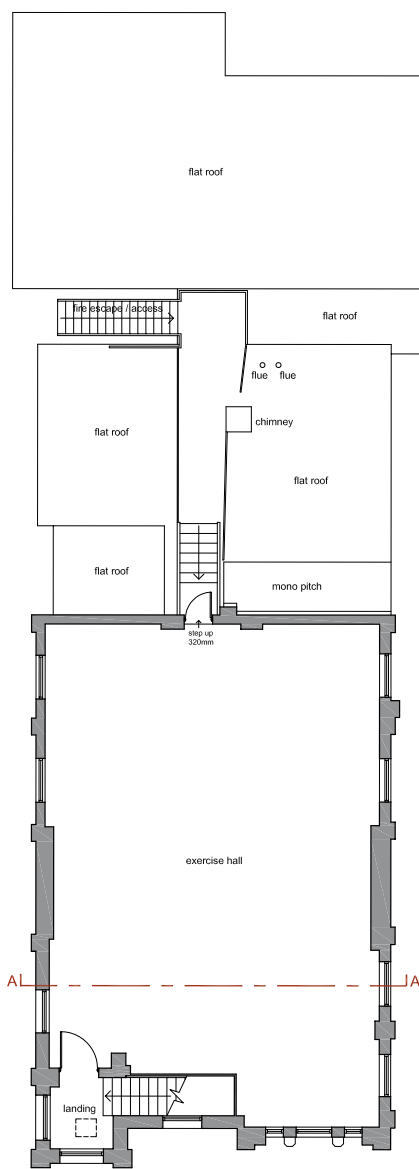
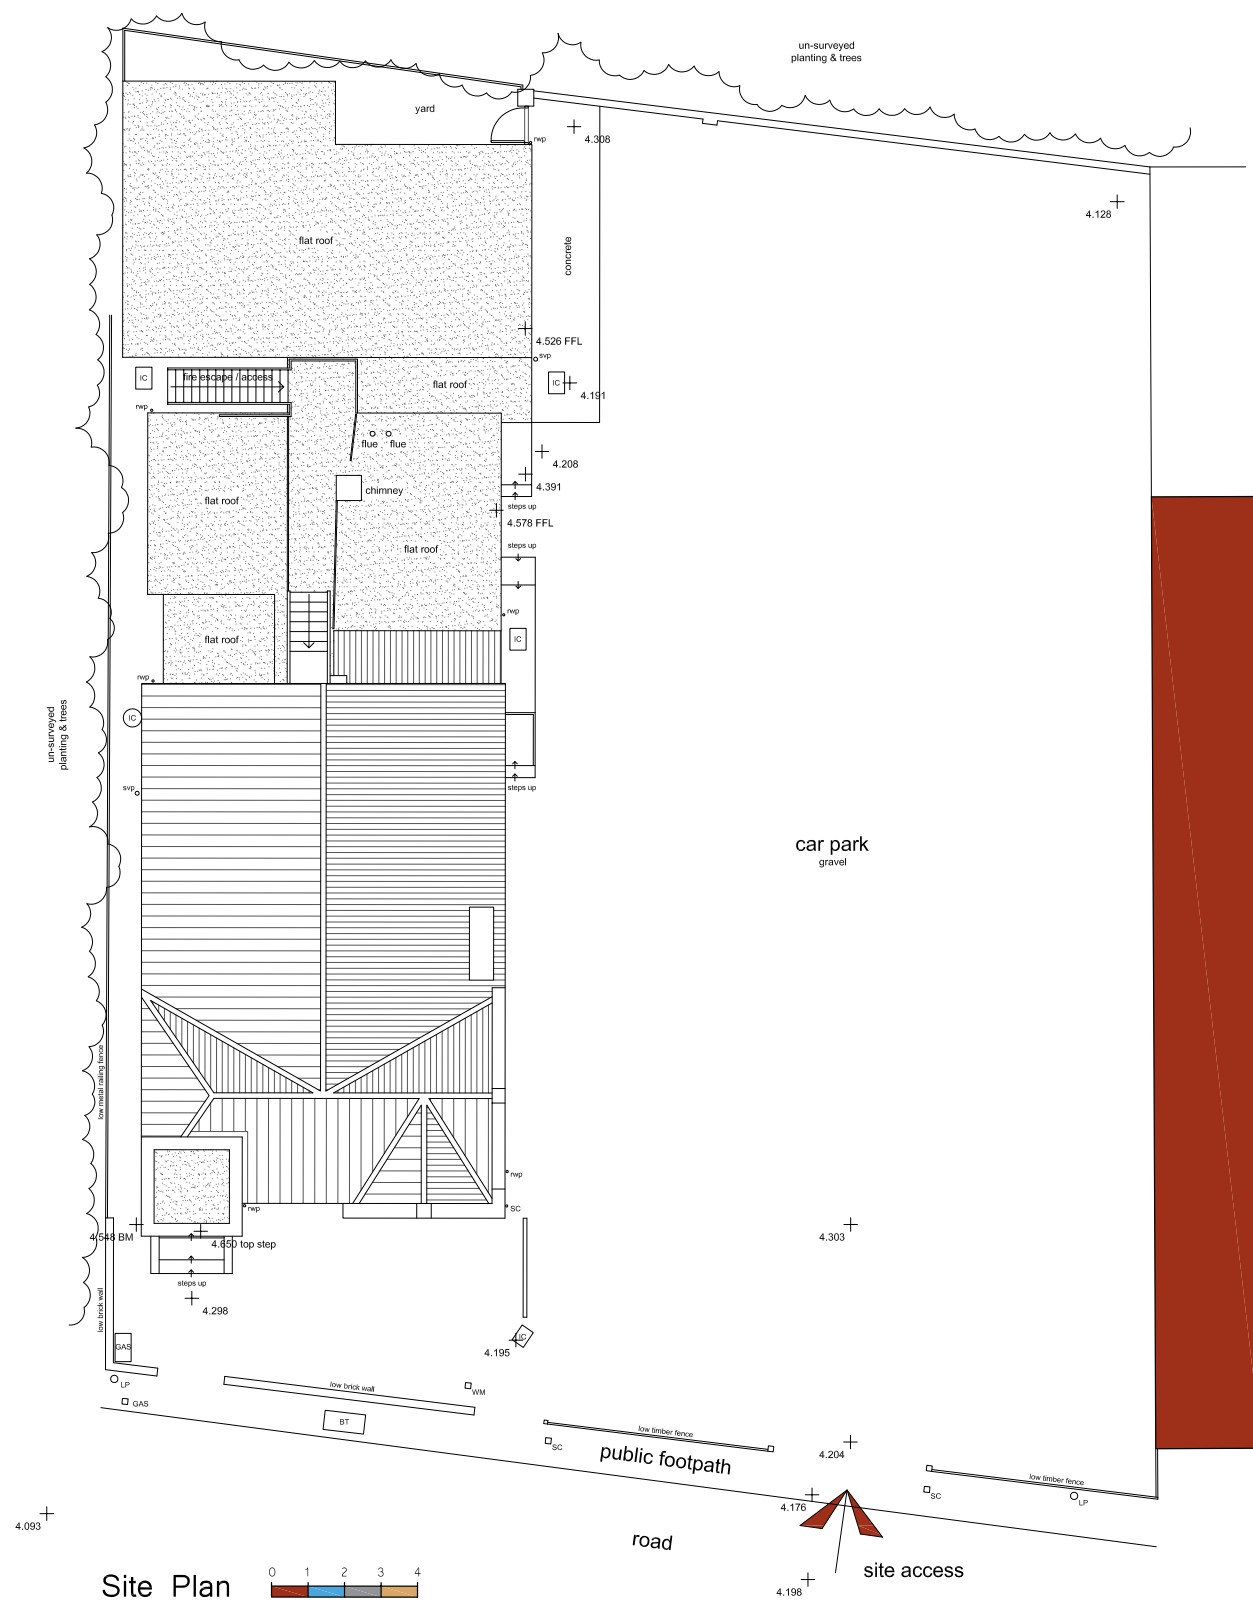
Fig.3

The photographic record was undertaken in high resolution digital photography. It included shots of the exterior and interior, as well as significant constructional elements, along with general photography, placing the building in its existing landscape setting. Rooms have been labelled using their contemporary names and which have been used on the architects' plans (figs. 3-7).

The drawn record was based upon the drawings supplied by the client and assumed correct at the time of the survey. These were checked for dimensional accuracy and amended to record architectural and constructional details, as necessary. These details were further described in accordance with standard architectural and constructional terminology.

The building was inspected internally and externally where safe access was possible, much of the building was in a dangerous state of collapse, in some instances entire floors were missing. Areas not possible to survey are marked N/A on the accompanying plans. The survey was undertaken by the author on the 5<sup>th</sup> of April 2024, at the time conditions were clear and bright.

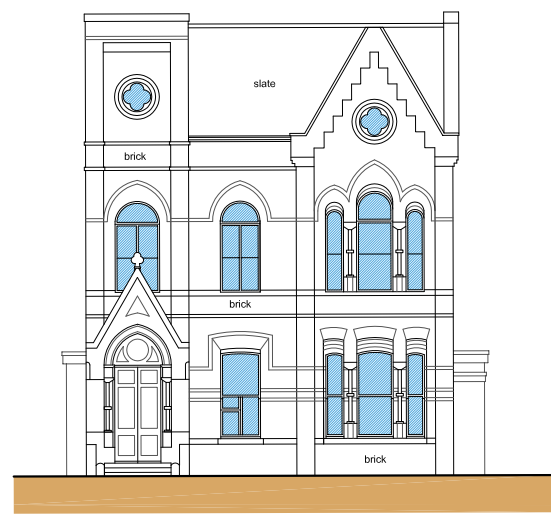
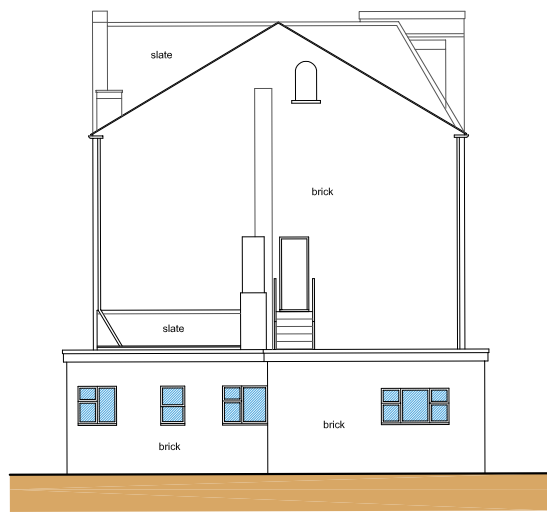
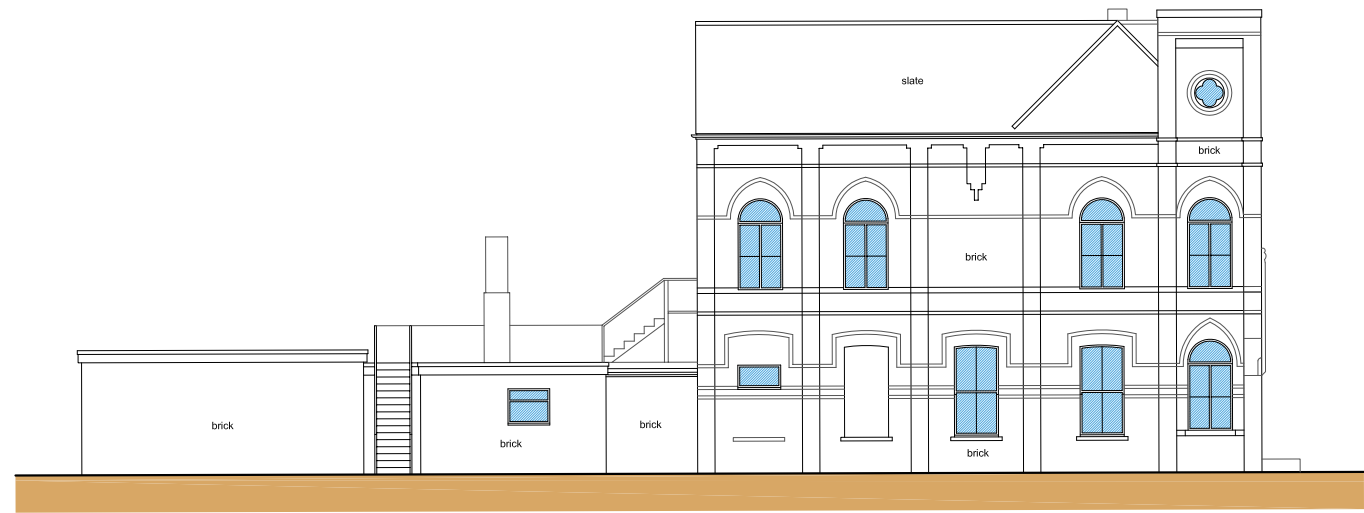
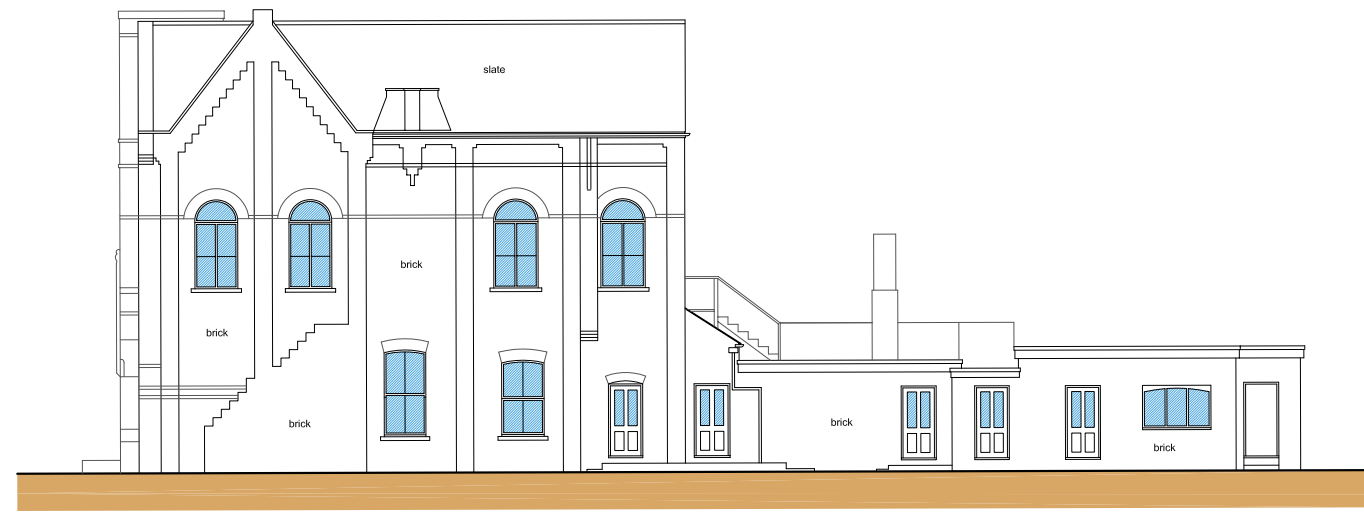
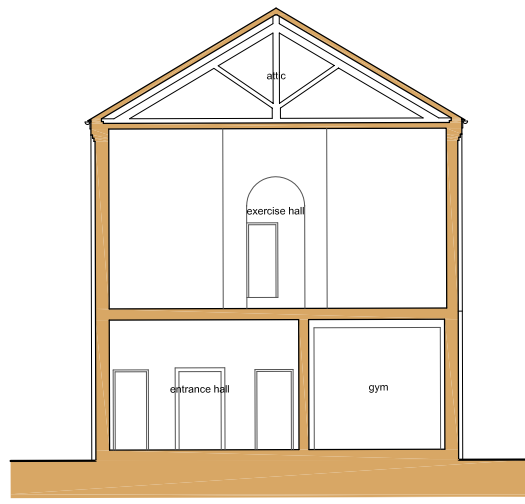
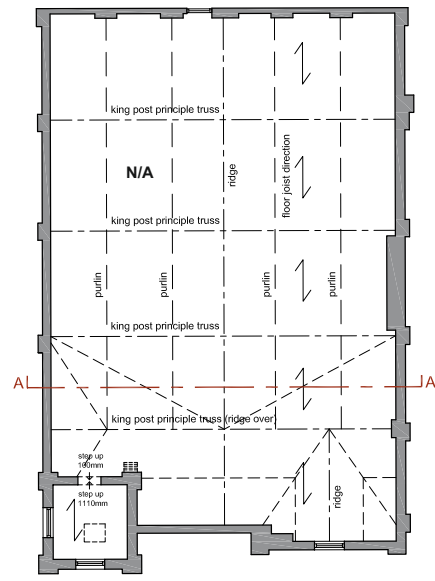
Fig.4

Difficult to see clearly due to access. At first storey height there is a small rectangular arched window offset to the right of the elevation (fig. 4).

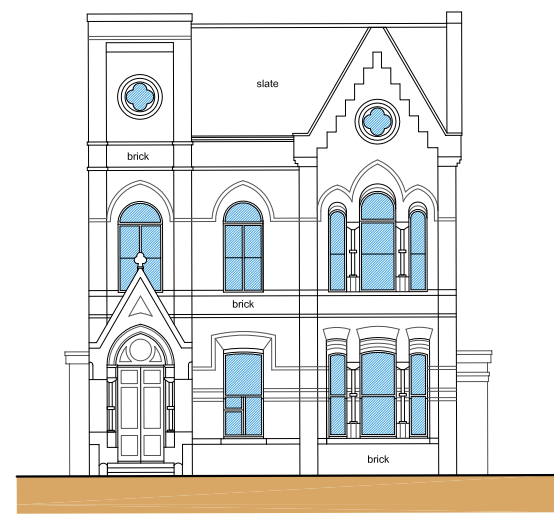
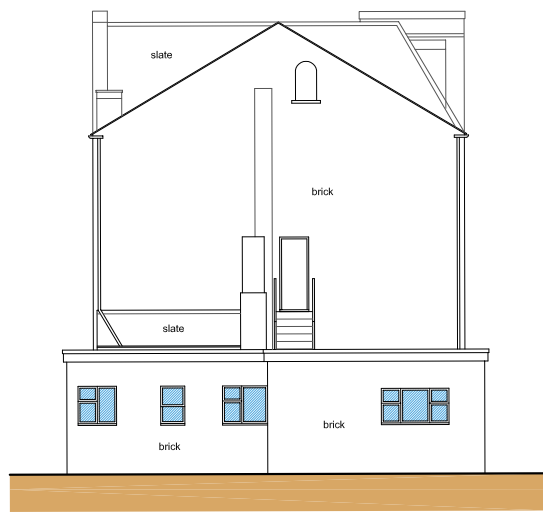
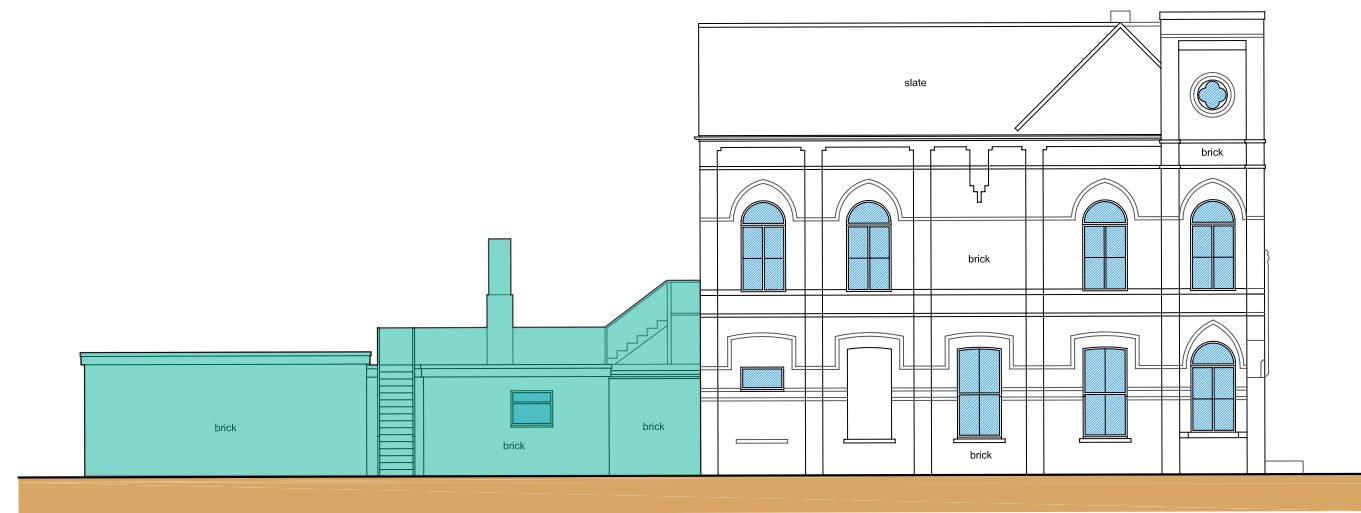
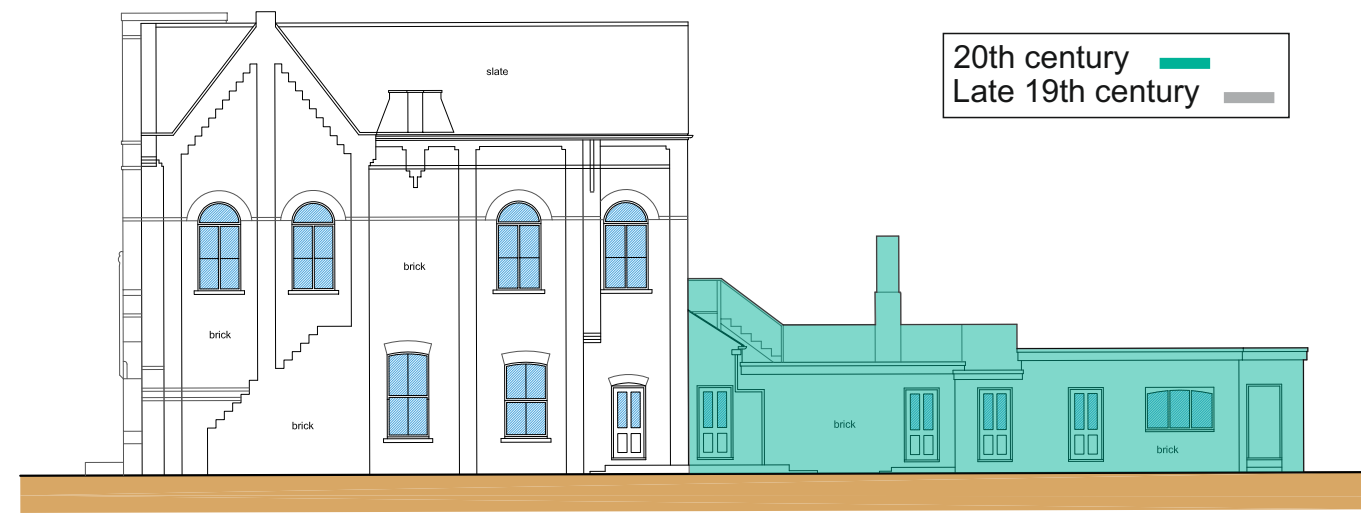
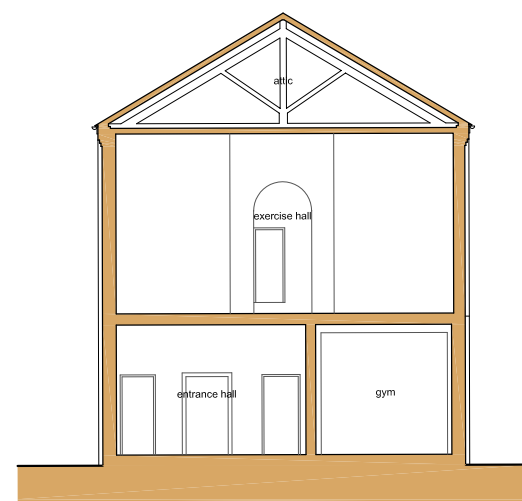
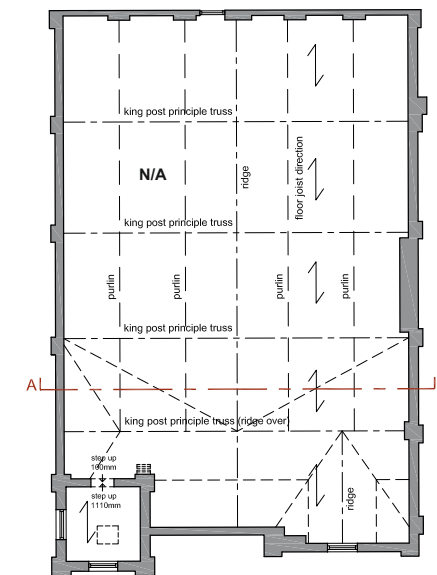
**Fig.5**

This floor has four, four-light windows, with vitrified brick arches above each window except for the central bay which is plane brick. The fifth bay is that containing the tower, this is much the same as the front elevation, apart from the ground floor which has a semicircular arched window (figs. 4, 7, plate 3).

At this level, the position of the internal staircase is demarcated by a line of diagonal brickwork which spans across two bays demarcated by two brick piers. To the right of this are a pair of sash windows and an entrance opening, this part of the elevation being divided into three-bays, the brick used is of an inferior quality and presumably as it would have not been visible when first built due to its proximity to the caretaker's accommodation (figs. 4, 7, plates 4-7).

To the right is the post-war single storey extension, this is of brick in stretcher bond with a flat felted roof and comprises of five entrance doors and a single three-light rectangular window (figs. 4, 7, plates 4-7).
