# Heritage Impact Assessment

Alterations to an existing opening through the boundary wall of Ayscoughfee Hall, Love Lane, Spalding, Lincolnshire

On behalf of South Holland District Council

A1572G – HIA rev P1

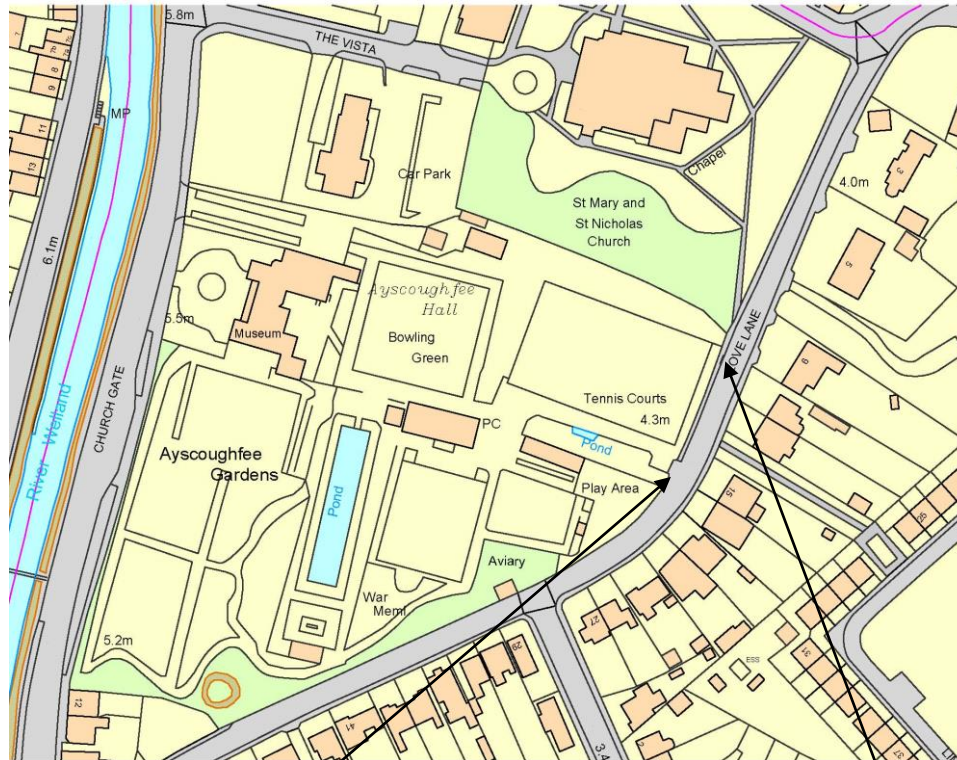
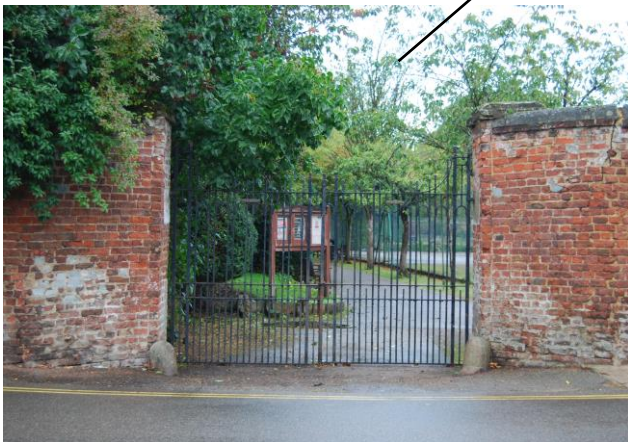
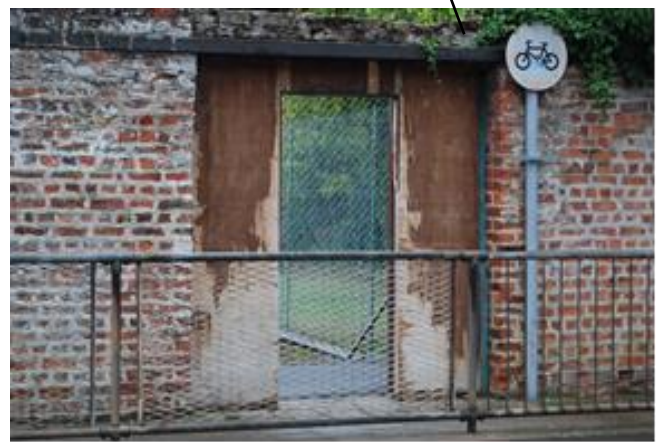
Fig.1 Gates A & B showing their positions in Love Lane

The gate to be replaced is shown as Gate A in the right hand photograph below, the pair of existing gates that are to remain unchanged is referenced as Gate B.

Gate B

Gate A

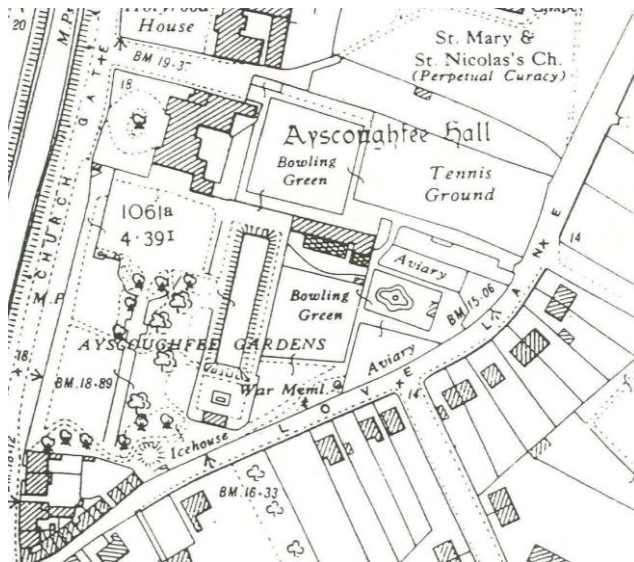
**Fig 4. OS map of 1929**

An OS map of 1929 (Fig 4) shows the tennis courts and it appears to show an opening in Love Lane to the left of the tennis courts

This map was revised in 1950 and published in a less detailed version in 1952 but the layout does not change.

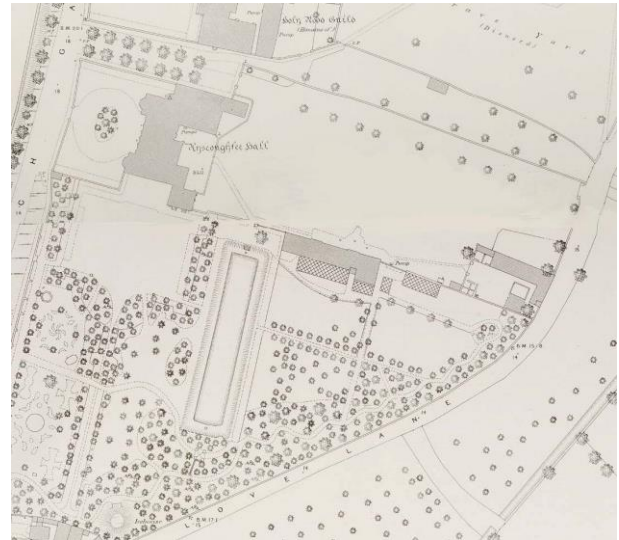
**Fig 5. Extract from the map produced by The Parish Church of St Mary and St Nicholas in conjunction with Ayscoughfee Hall**

- 4.7 The Parish Church of St Mary and St Nicholas in conjunction with Ayscoughfee Hall have produced a Learning Resource Pack. As part of this pack they have provided some maps. One map is labelled 1888 although in the margin of the map the roman numerals are unclear.

This map appears to show openings in the wall close to the site of gate A.

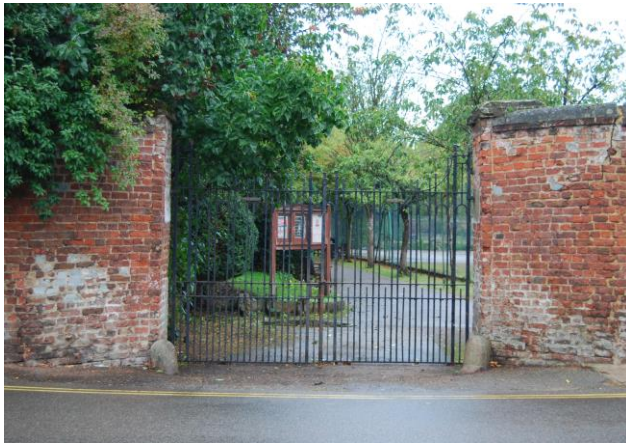
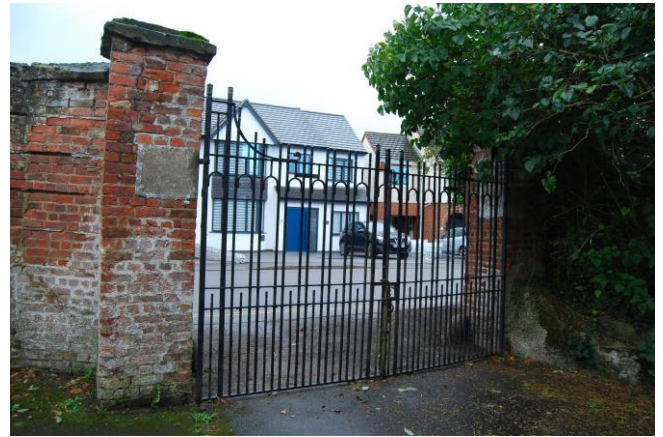
**Fig 8. Photographs of the existing opening and gates (Gate B)**

- 5.2.1 It is not known when the opening was made or the gates installed, the map of 1929 mentioned in 4.4 above shows the opening and may have been made to serve the tennis courts which had been resited in 1925 (see 4.3 above). The gates are in a style that relates to the 1920's and may date back to that time.
- 5.2.2 The opening is set back from the line of the main wall with short angled walls and 690mm square piers topped with lime stone cappings.
- 5.2.3 The gates are of wrought iron and are fixed into the ground and into stone blocks set in the brickwork.

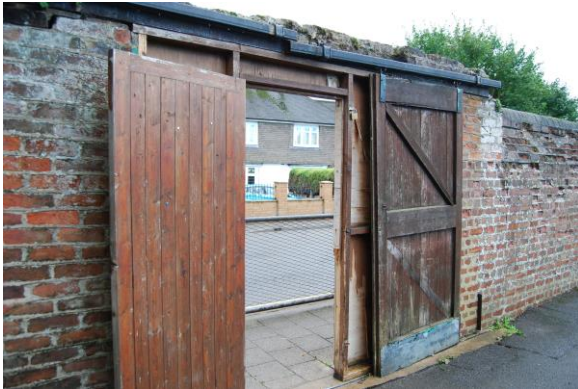
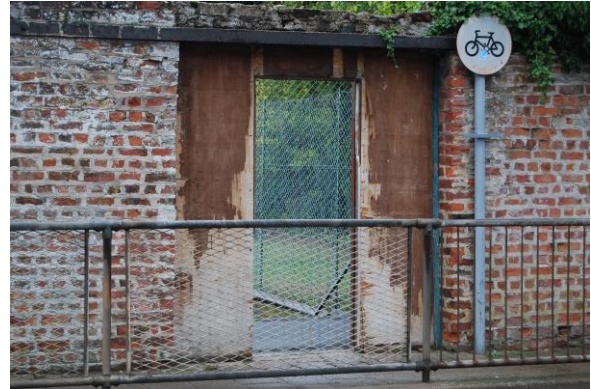
Fig 10. Photographs of the present day opening

- 5.3.1 It is unclear when the opening in the Love Lane, East Wall was formed but the gate was probably installed to allow direct access to the tennis courts.
- 5.3.2 As can be seen from Fig 9 the opening that was formed had raised sides and hipped capping. Little of the upper part of the brickwork survives although part of the capping that can be seen in Fig. 9 (March 2011), may be hidden in the vegetation growing over the wall.
- 5.3.3 The sliding mechanism with its ledge and braced softwood door is still in place but is no longer functional. A later softwood frame with plywood covering and a side hung door has been installed to allow the entrance to remain in use.
- 5.3.4 The inner leaf to the left of the opening for its full height and seven courses of stretcher bond brickwork to the right appear to be of a later date than the rest of the wall.

If the opening was made where there had been no opening previously, then the battered brickwork would have had to be removed and rebuilt to support the steelwork and sliding door gear that now spans the opening.

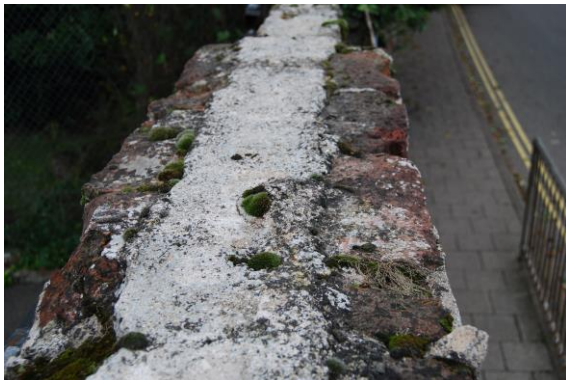
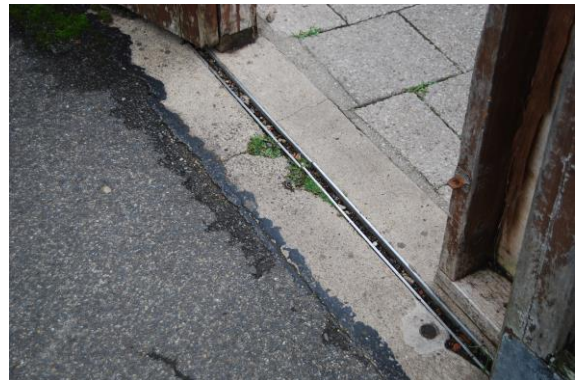
Fig 11. Photograph showing the obsolete brickwork at high level and the sliding door track

5.3.5 The brickwork encasing the steelwork above the opening and the steel runner set in the concrete at the entrance to guide the sliding door are now obsolete

**Demolitions**  
Carefully remove the existing C20 door, frame and ply covered softwood framing and dispose of.  
Carefully remove existing timber sliding gate complete with head gear and dispose of.  
Carefully remove steel base track and break out concrete strip across threshold of structural opening.  
Carefully remove remnant of concrete capping from top of wall.  
Remove remnants of damaged brickwork down to the level of the bottom of the steel angle lintels. Retain bricks where they are not significantly damaged and are suitable for reuse. Dispose of all other materials arising.  
Carefully remove the two 85mm steel angles that span across the opening and dispose of.  
Remove all residual mortar etc down to the level of the top of the brick course immediately beneath the base of the steel angles.

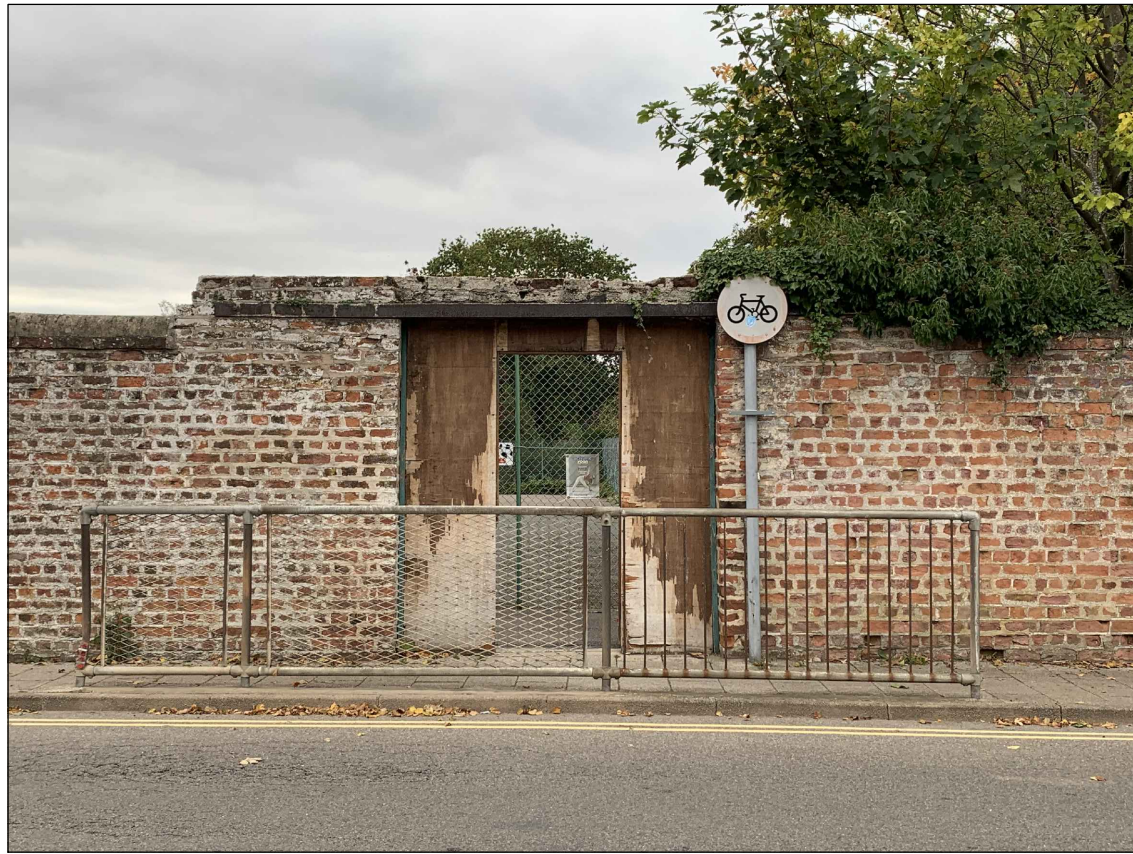
View of gate from east (Love Lane)

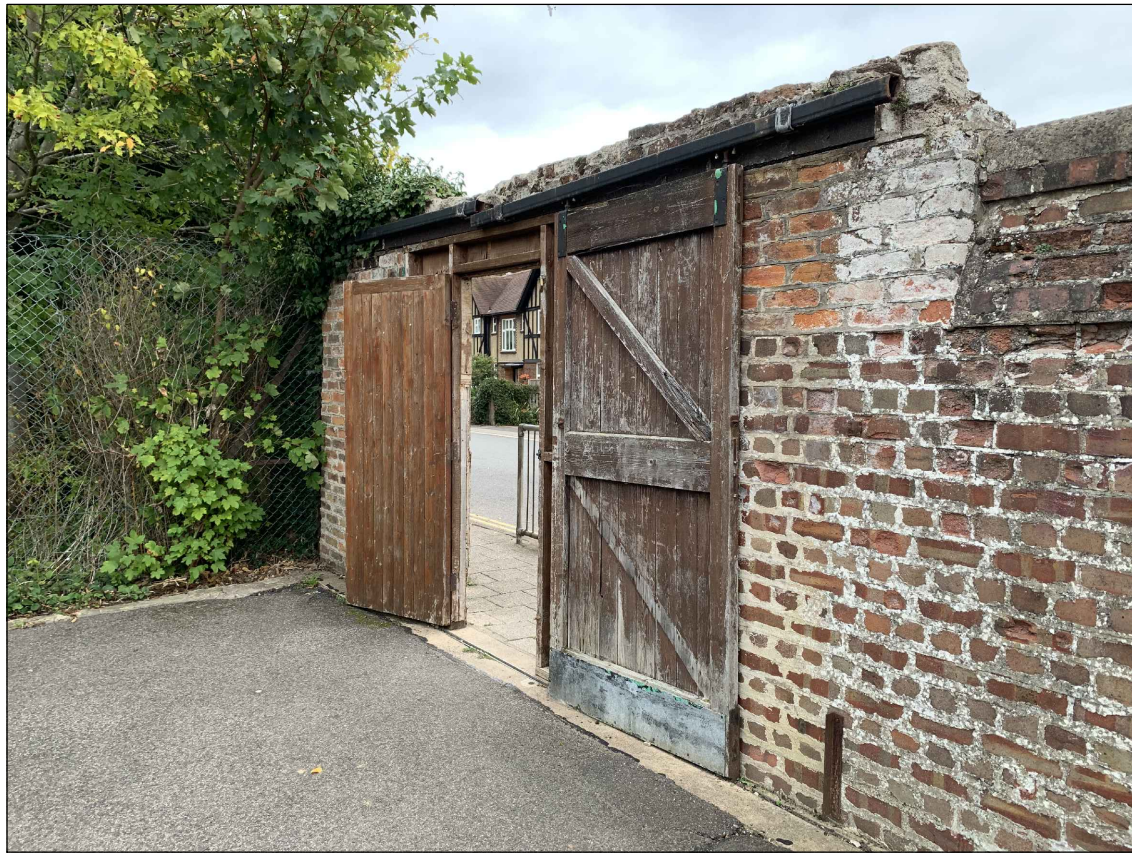
View of gate from west (Ayscoughfee Hall Gardens)
