Historic Building Assessment of  
**Holland House, 17 High Street, Spalding, PE11 1TW**

for  
**D&R Property Services Limited**

GLA-118  
April 2013

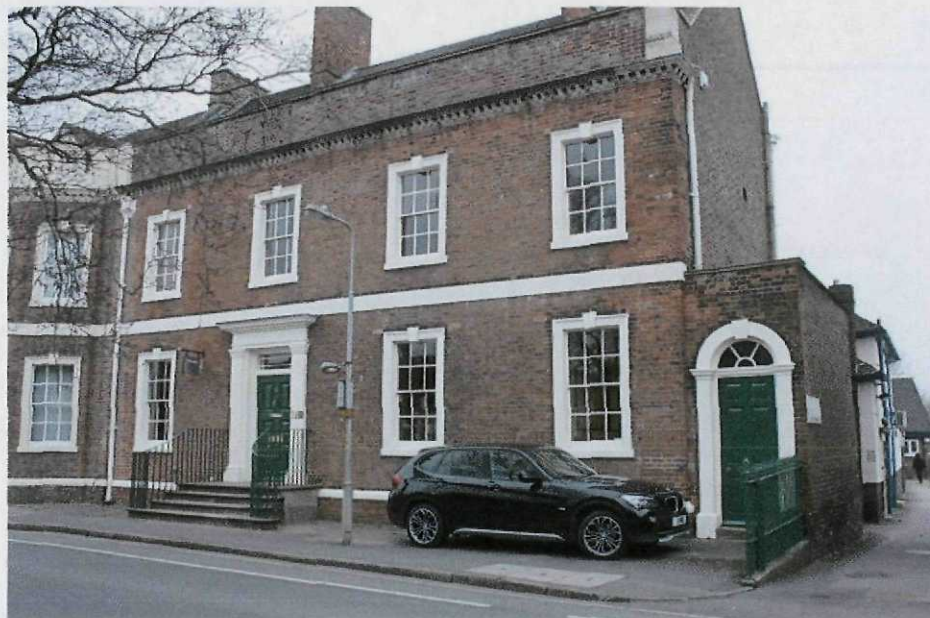
**Plate 3:** No.16 High Street, built as an extension to Holland House

- 2.2 To the immediate south-west is No.16 High Street, which was built as an addition to Holland House at some time in the mid nineteenth-century but is now separate (see Plate 3). This adjoining wing is a polite two-storey, four-bay red-brick, Georgian-style block with an imposing entrance door, reached by a short flight of steps.

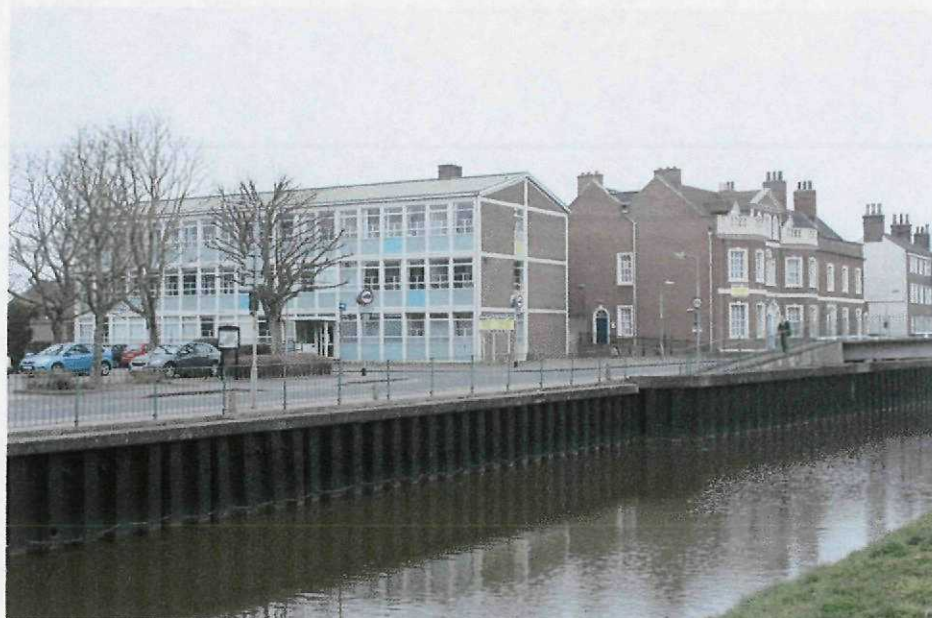
**Plate 5:** The Government Offices building built in 1960 and the car park to its north-east

- 2.4 To the immediate north-east is a large three-storey Government Offices building that was built within the original garden area of Holland House in 1960 (see Plate 5). This large and incongruous, framed building provides a highly inappropriate neighbour that degrades the setting of Holland House. The Government Offices building stands alongside Holland Road, which runs between High Street and Halmer Gate through what were the original grounds to Holland House (see section 4.0: Origins).

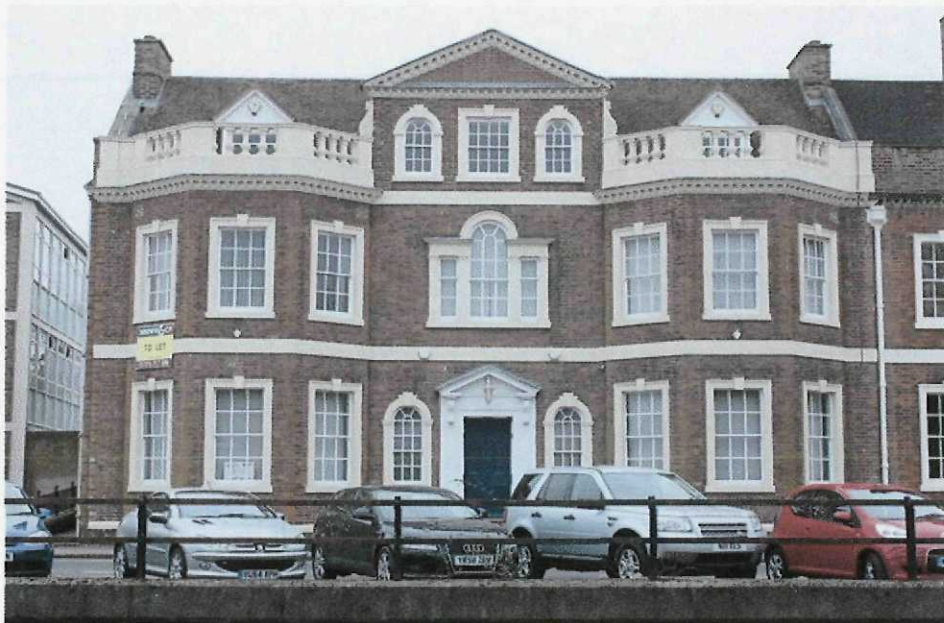
**Plate 8:** Holland House – the principal north-west-facing High Street facade

- 3.2 The building has a three-bay north-west facing principal façade, which addresses High Street and overlooks the River Welland (see Plates 8 and 9). The central bay has a panelled entrance door, reached by a flight of four steps, with an open-pediment canopy on scrolled brackets over, and a round-headed slender sash window to either side. Above, at first floor level, is a well-detailed Palladian window, and above that at second floor level is a square-headed sash window, with a similar round-headed window to either side. The central bay is surmounted by a pediment embellished with modillions.

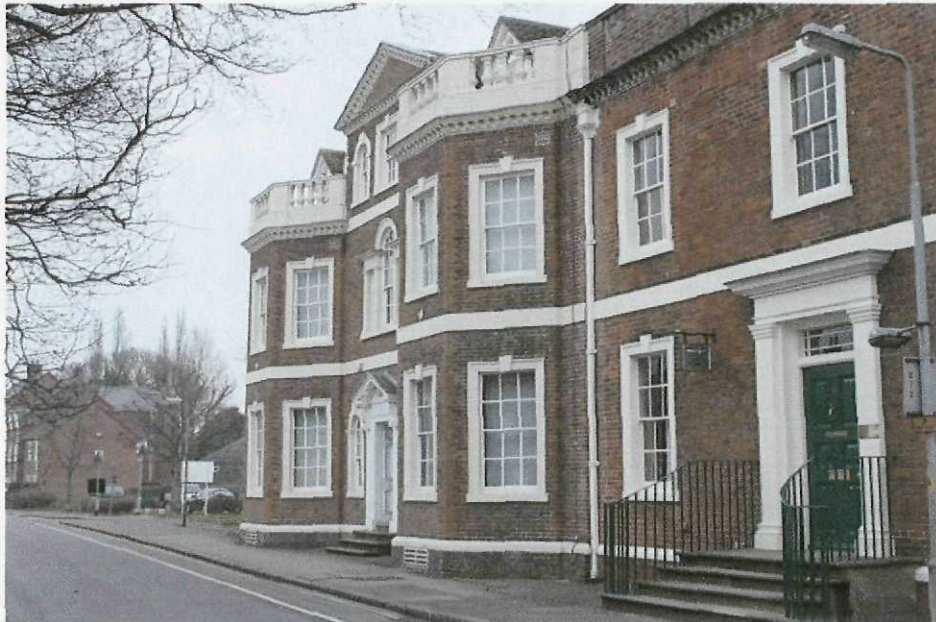
**Plate 9:** Oblique view of the principal High Street façade, together with the adjoining No.16 High Street, built as an addition to Holland House but now a separate property

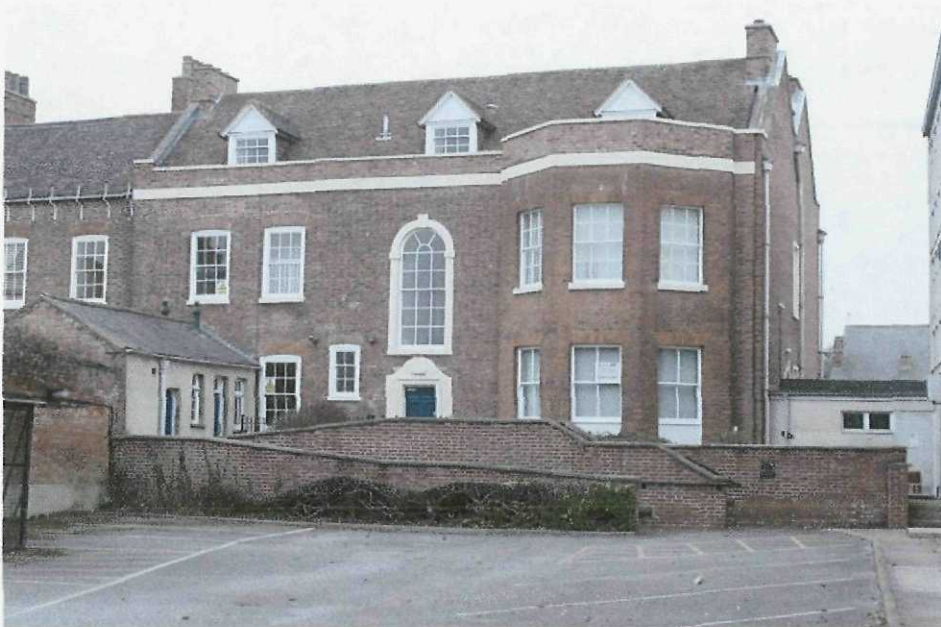
**Plate 10:** The south-east facing elevation of Holland House, which overlooks a car-park that has replaced the original garden

- 3.5 The south-east facing rear elevation, which now overlooks a car-park, is more informal in character (see Plate 10). The central bay has a modern panelled entrance door with bolection mouldings and an unusual rendered surround, which masks an earlier arrangement. Above the rear door is a tall round-headed, small-paned window that lights the stair well. The right-hand bay is dominated by a projecting, canted, two-storey brick bay, similar to those on the front, although the windows do not have stone surrounds and the parapet is plain brickwork. The left-hand bay incorporates a pair of six-over-six sash windows at first floor level. A rather poor quality rendered brick single-storey extension, with a double-pitched roof has been added to the left-hand bay at ground floor level. A single sash window squeezes against this unsightly

- 3.7 The appearance of the south-east facing rear or garden elevation is degraded by the presence of the Government office to the immediate east, the tarmaced car-park that was formerly a garden, and an unnecessarily heavy-looking disabled access ramp with angular solid brick side-walls immediately adjacent to the listed building (see Plate 10).

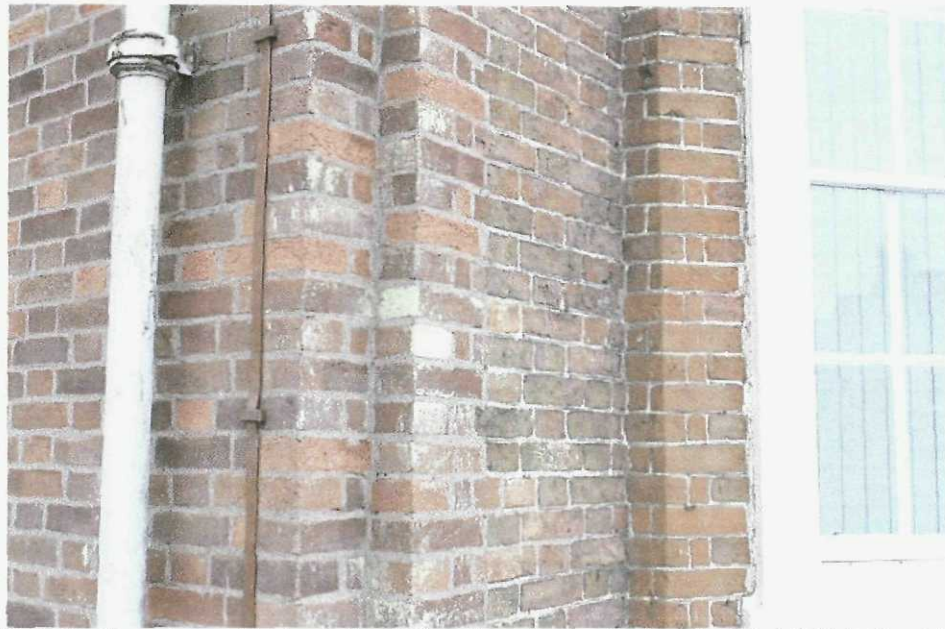
**Plate 11:** Three phases of brickwork: the c1960 north-east end wall to the left, original 1760s brickwork in the centre, and the later Georgian/early Victorian brickwork of the left-hand front facade canted bay

- 3.6 Close inspection of the brickwork shows that all three projecting, canted two-storey bays are later additions (see Plates 11 and 12). The brickwork is not bonded in and the bricks used in the construction of the bays are slightly larger.

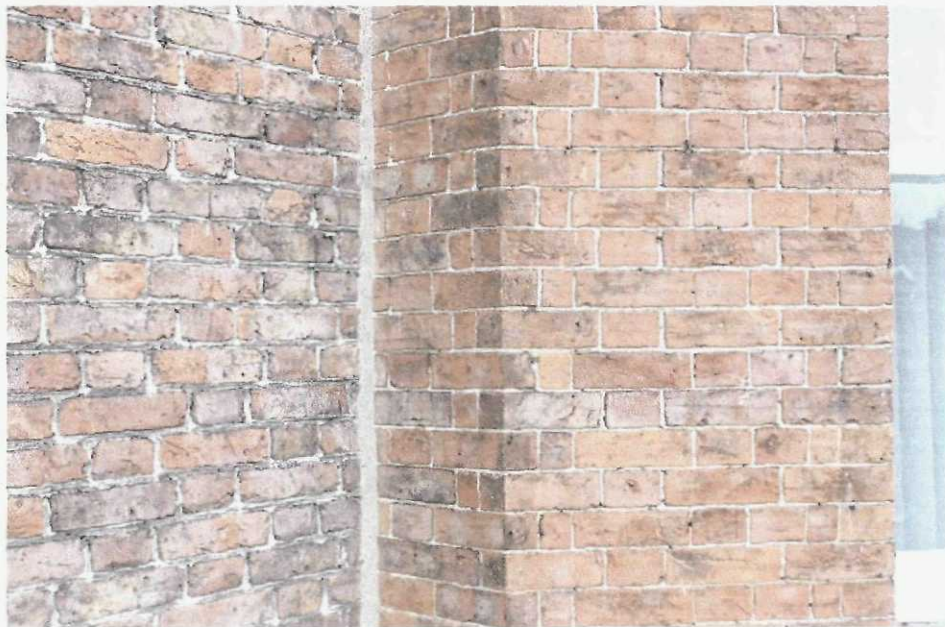
**Plate 12:** Original 1760s brickwork to the left and later Georgian/early Victorian brickwork of the rear facade canted bay to the right

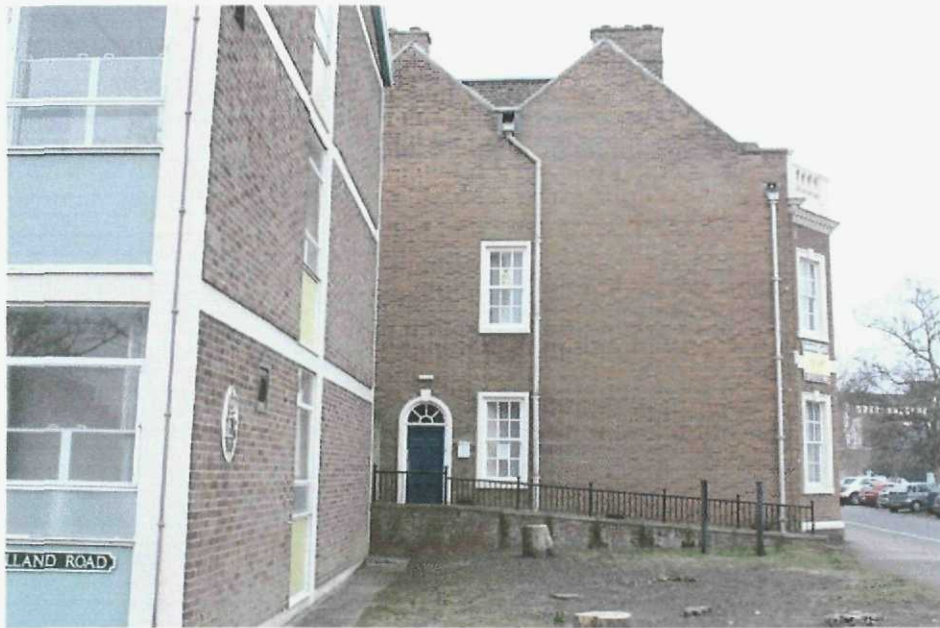
**Plate 13:** The north-west facing end, showing the double-pile form with central valley. The end wall, door and windows are modern, having been built since the removal of the adjoining coach-house and an addition to this end of the house c.1960, when the Government Offices building in the foreground was built.

- 3.8 The north-east facing end of the building has been refaced in brickwork and a door and two sash windows have been inserted (see Plate 13). These are modern features, as a coach-house and an addition to this end of the house existed until c.1960, when they were demolished to make way for the construction of the nearby Government Building.

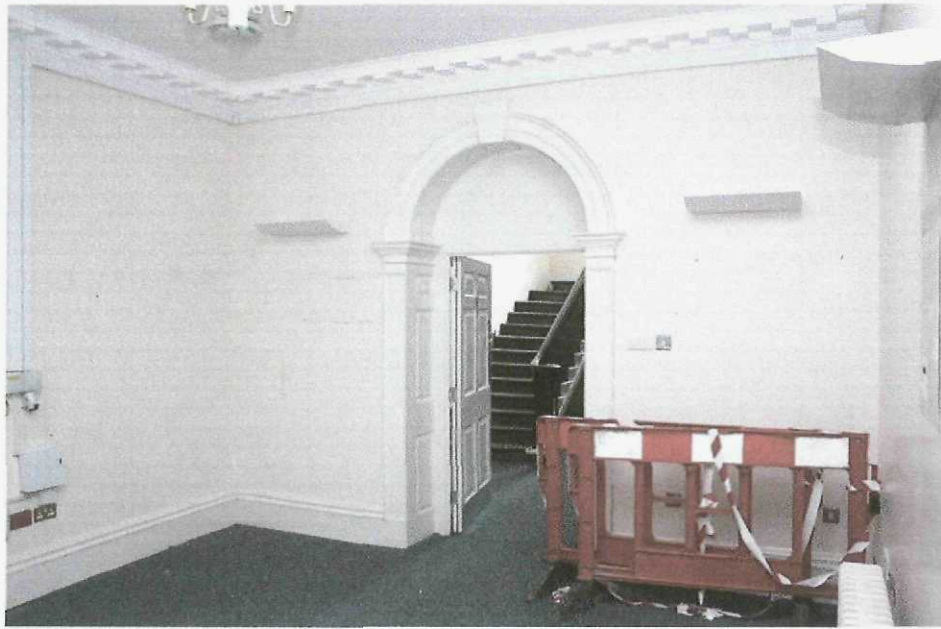
**Plate 14:** The entrance hall and arched opening with inappropriate infill

- 3.10 At ground floor level, the front entrance leads into a spacious hall in the front range, which connects to a cantilevered dog-leg, cut-string, timber staircase in the rear range (see Plates 14 and 16). The staircase is a fine feature of the house although it is heavily restored. Almost all the balusters are modern replacements. The stair is degraded by inappropriate nosings to the treads. The entrance hall retains a dentillated cornice with egg and dart enrichment (see Plate 15). The door separating the entrance hall from the staircase compartment, with an infill panel to the arch above, is an inappropriate modern insertion that disturbs the original panelled lining.

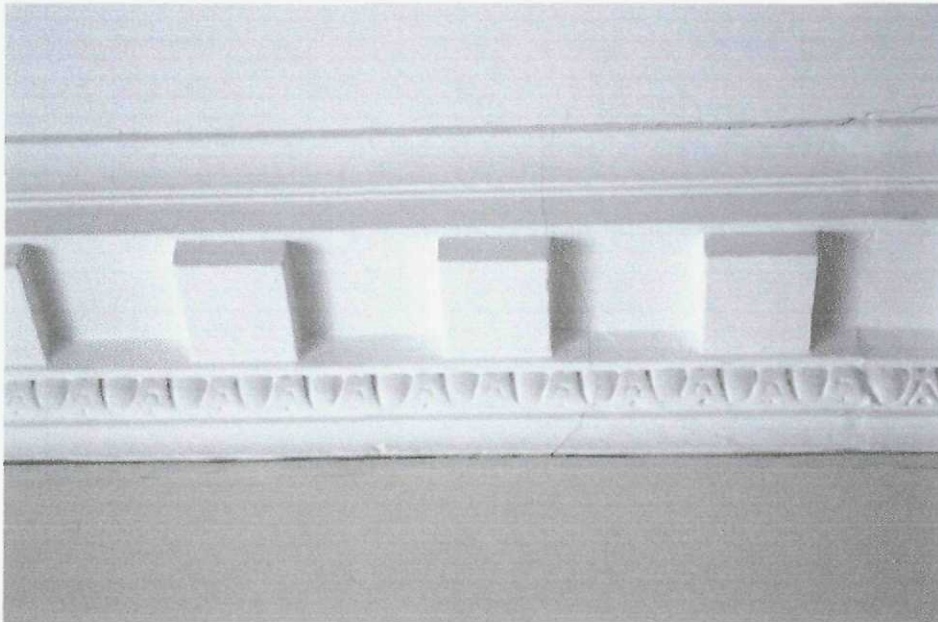
**Plate 15:** Dentillated cornice with egg and dart enrichment

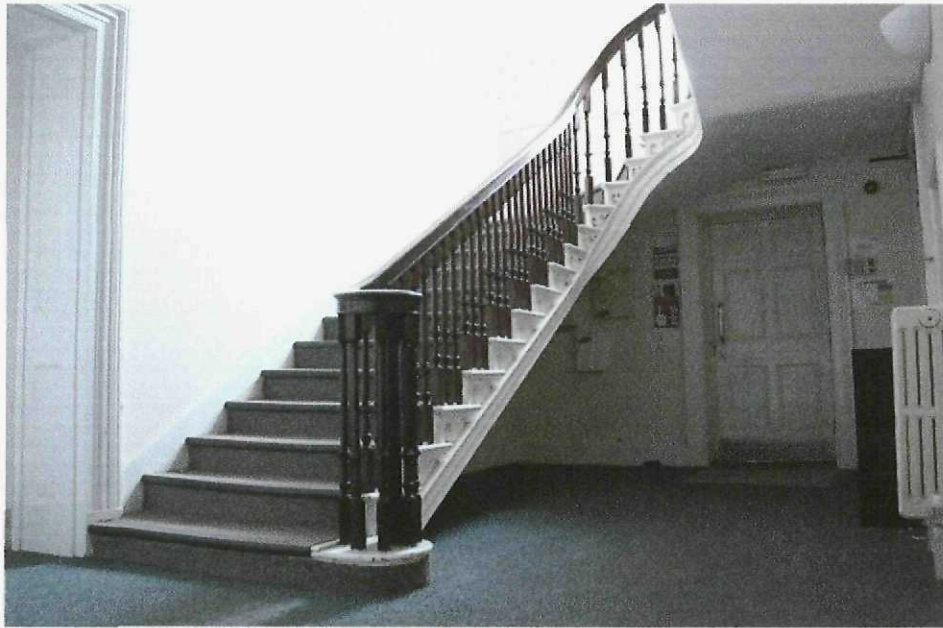
**Plate 16:** The restored cantilevered cut-string timber staircase

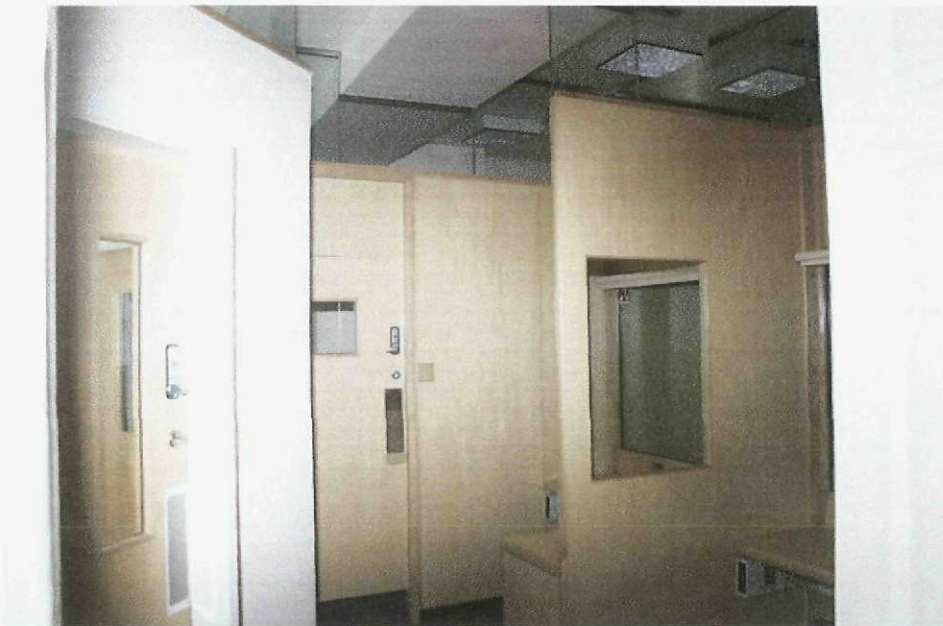
**Plate 17:** Modern partitions cluttering the front north-east ground-floor room

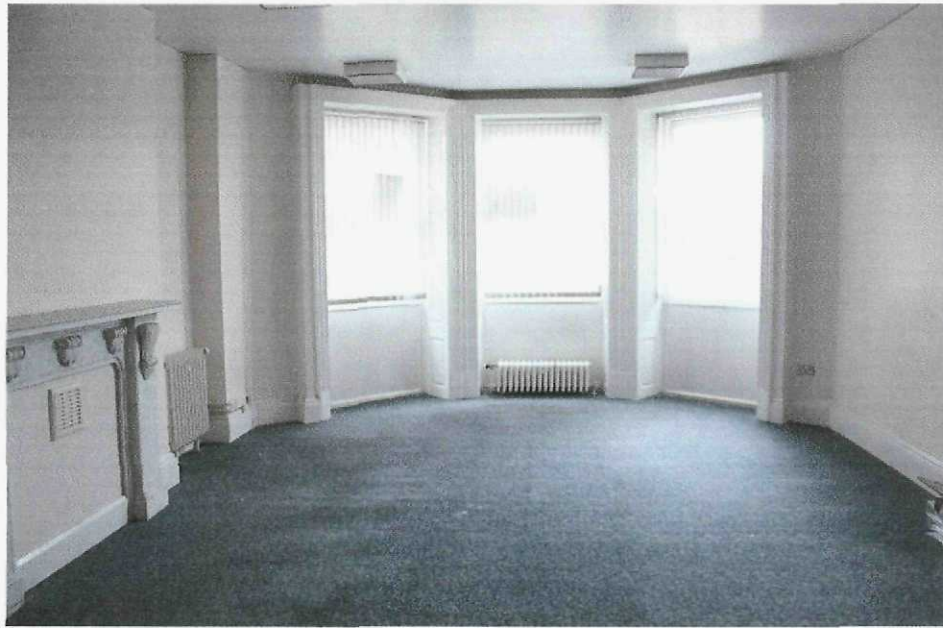
**Plate 18:** Rear north-east ground-floor room

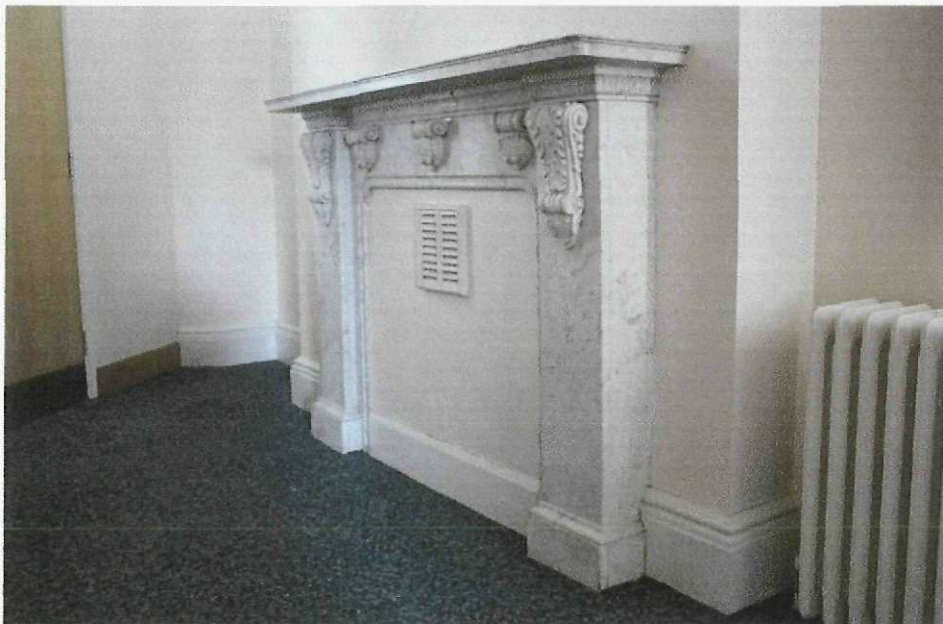
**Plate 19:** Marble fire-surround, front north-east ground-floor room

- 3.12 The two well-proportioned reception rooms on the north-east side, which have good quality matching marble historic fire surrounds (see Plate 19), are linked by an opening in the dividing wall. The timber linings to the opening are modern. It is unlikely that the opening is an original feature. The front room is cluttered with modern partitions to create interview spaces (see Plate 17). Both rooms are degraded by a modern ceiling with highly inappropriate light fittings. The original ceiling and possibly its cornice may survive above.

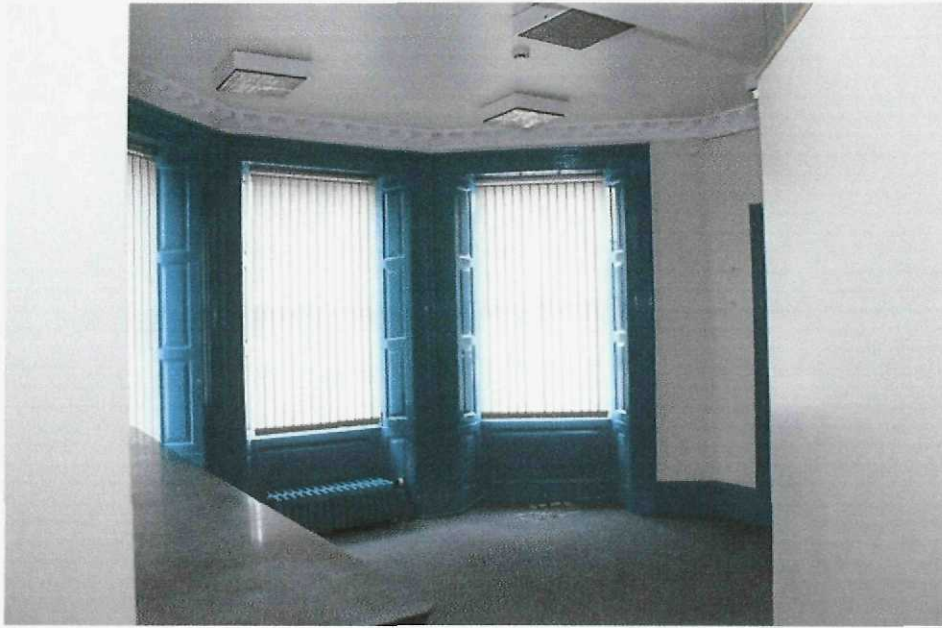
**Plate 20:** Front south-west room, with original panelling to the canted bay

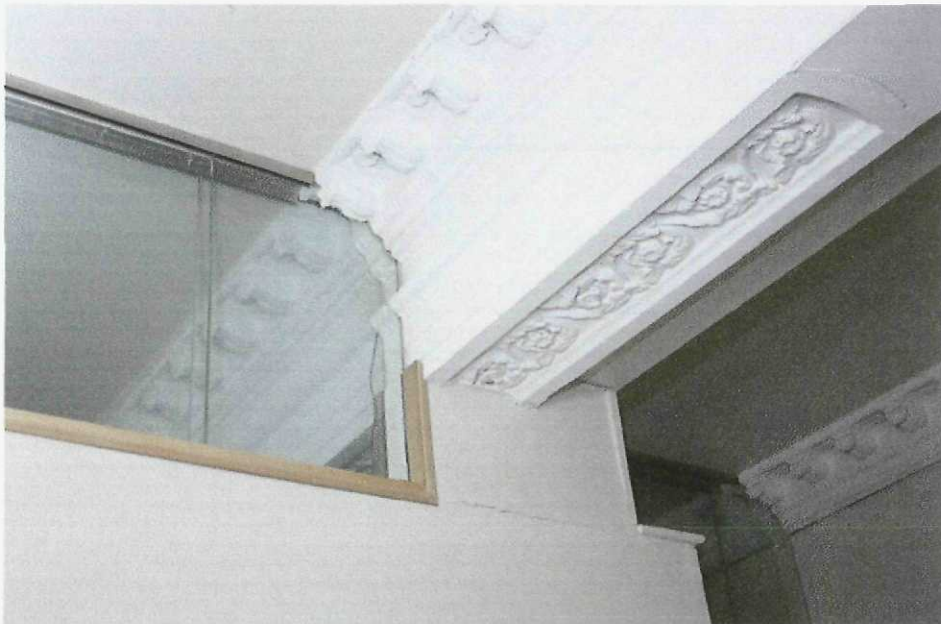
**Plate 21:** Front south-west room: modern partition needlessly cut into the cornice.

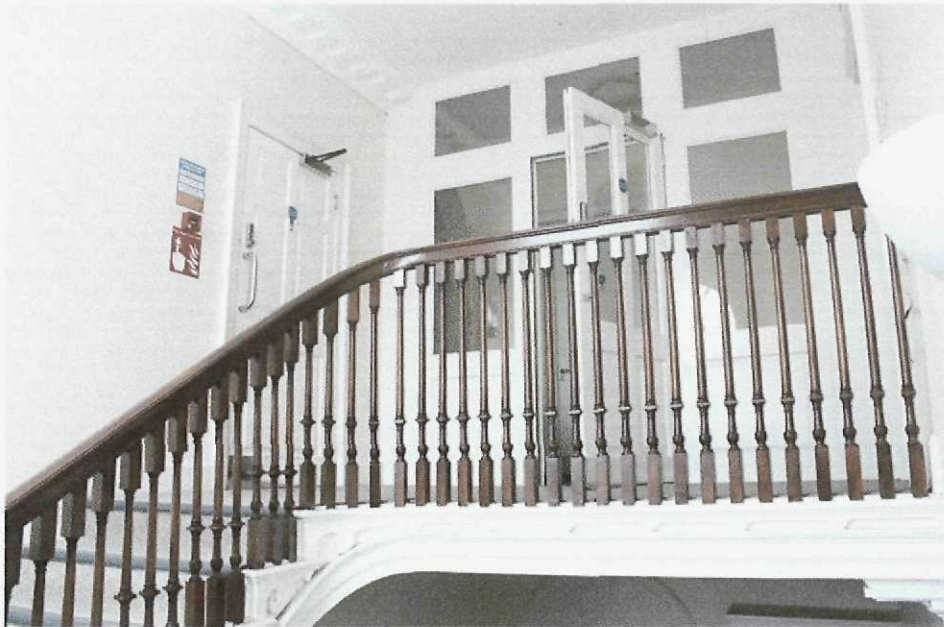
**Plate 22:** First floor landing with inserted modern screen

- 3.15 The main staircase leads onto a landing that has been bisected by a modern screen of no architectural quality, presumably for fire safety (see Plate 22). The landing/stairwell space retains its dentillated cornice, which matches that in the entrance hall. The door to the left at the top of the stairs has been re-fitted on the outer side of the lining, to open outwards, which degrades the architectural arrangement. The opposing door is in its correct inner position but has been fixed-up.

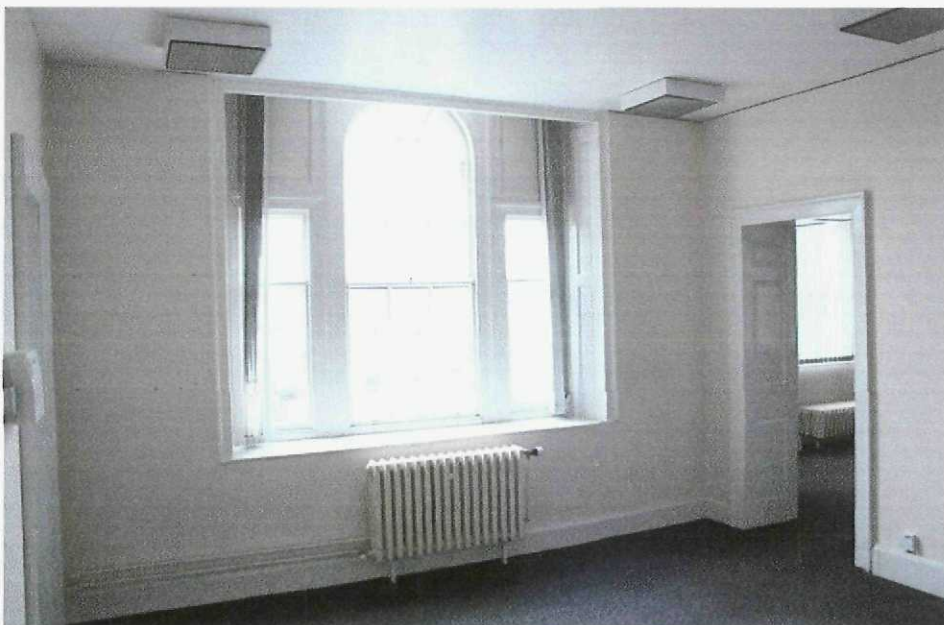
**Plate 23:** First floor central front room

- 3.16 The central front room appears to be designed as an ante-room giving access to principal bedrooms to either side. An inserted modern ceiling has an unfortunate relationship with the Palladian window (see Plate 23).

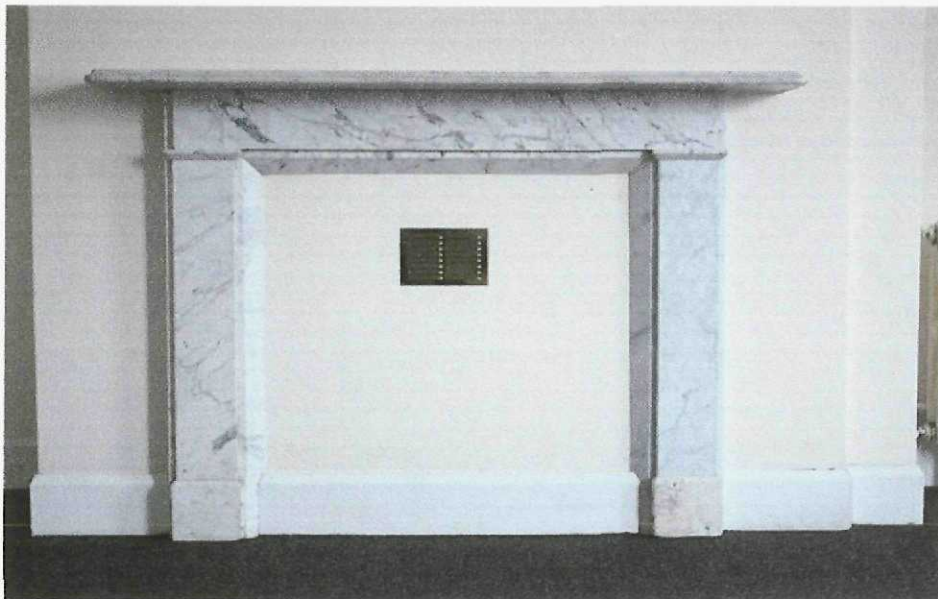
**Plate 25:** Fire-surround, first floor front bedroom, north-east side

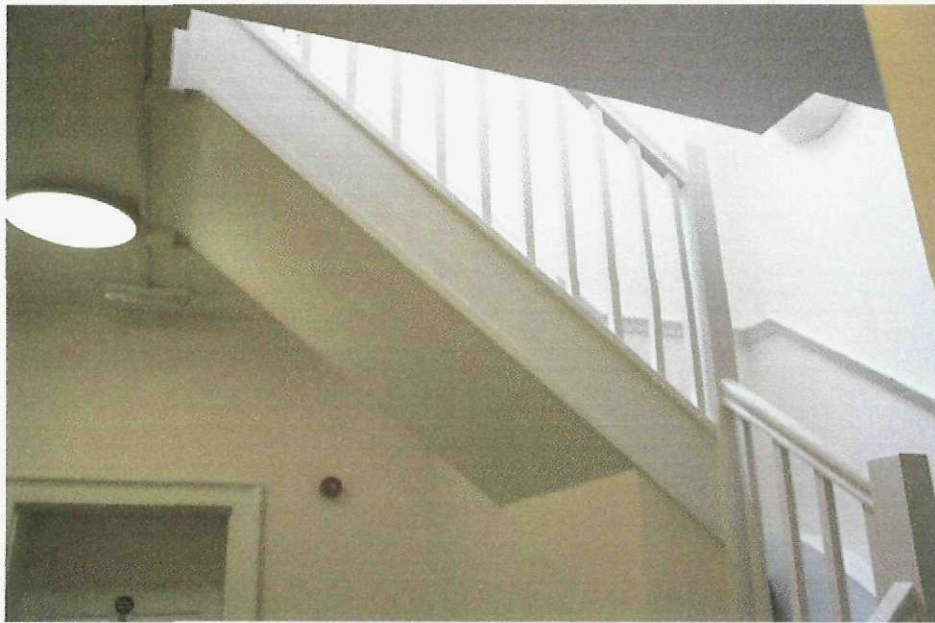
**Plate 26:** New secondary staircase from first to second floor

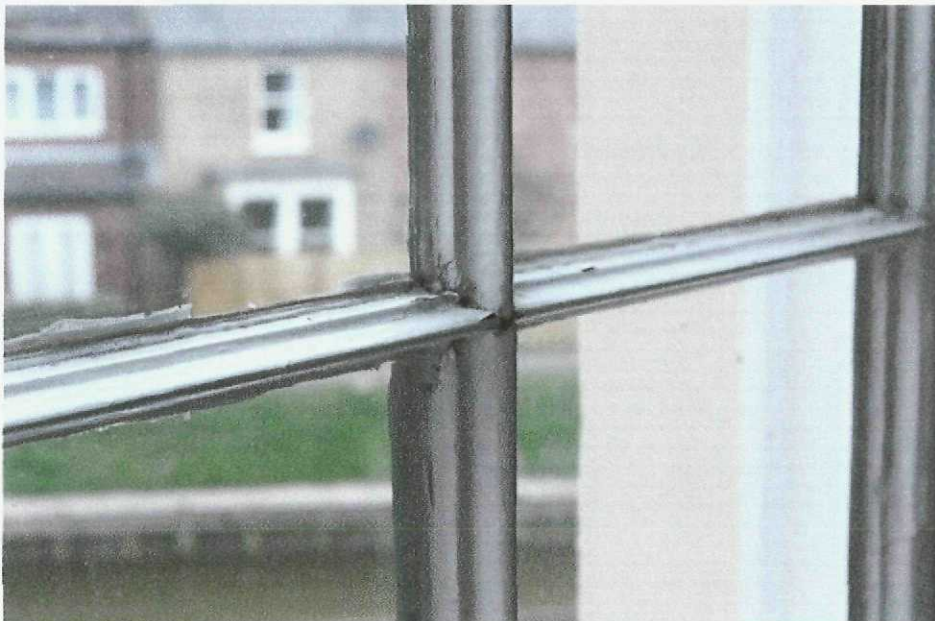
**Plate 27:** Original window joinery, with lamb's tongue glazing bar profile

- 3.21 Nevertheless, some historic fabric survives. The Palladian window joinery is original, and two of the original sash windows in the front canted bays survive (see Plates 28 and 29). All have matching lamb's tongue profile glazing bars (see Plate 27). The right-hand door at the top of the stairs looks to be original, as does the historic panelling to the south-west front and the rear canted bays.

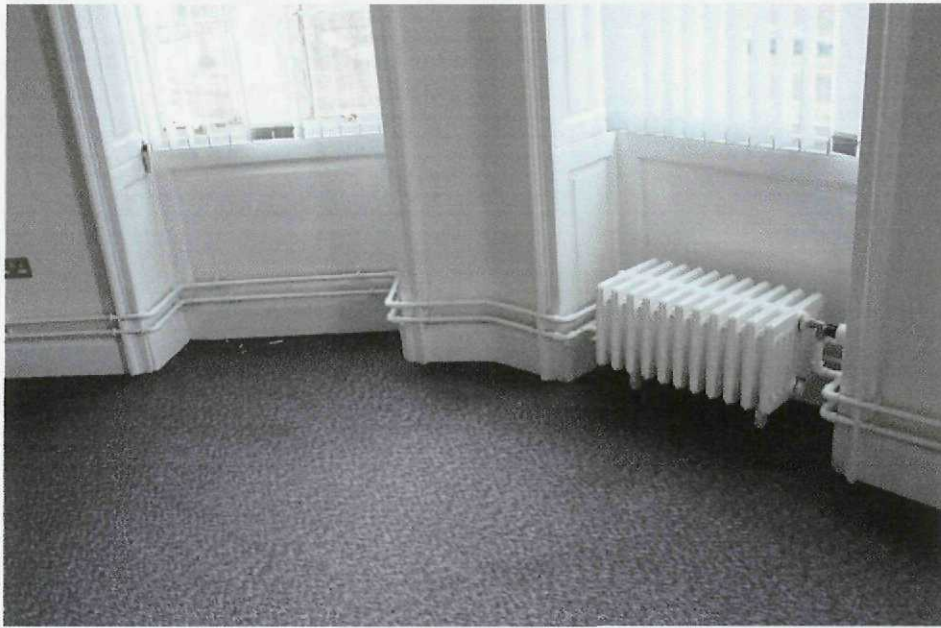
**Plate 28:** Original panelling to front, south-west first floor canted bay

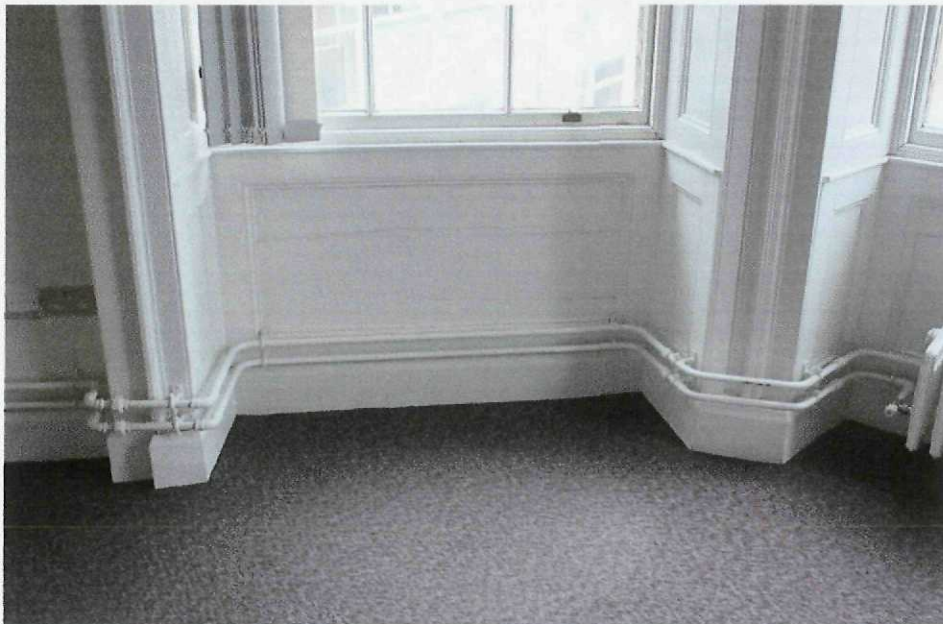
**Plate 29:** Original panelling to rear first floor canted bay

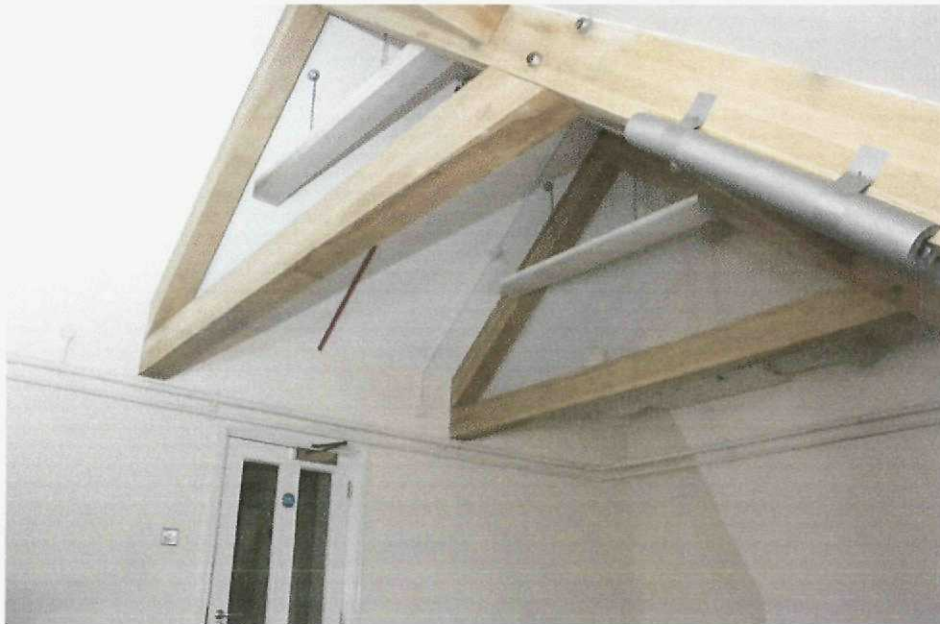
**Plate 30:** modern replacement laminated truss roof structure

- 3.23 The third or attic floor layout appears to survive in its original form, with six main spaces, but largely made up of modern fabric. Particularly noticeable are the modern laminated truss roof structure, which are partly exposed as a feature (see Plate 30). The laminated trusses are installed over the whole double-roof, with the exception of the central bay of the front-range, which is a modern softwood roof structure (see Plate 31). The new roof structure was constructed as part of the repair works following the 1993 fire.

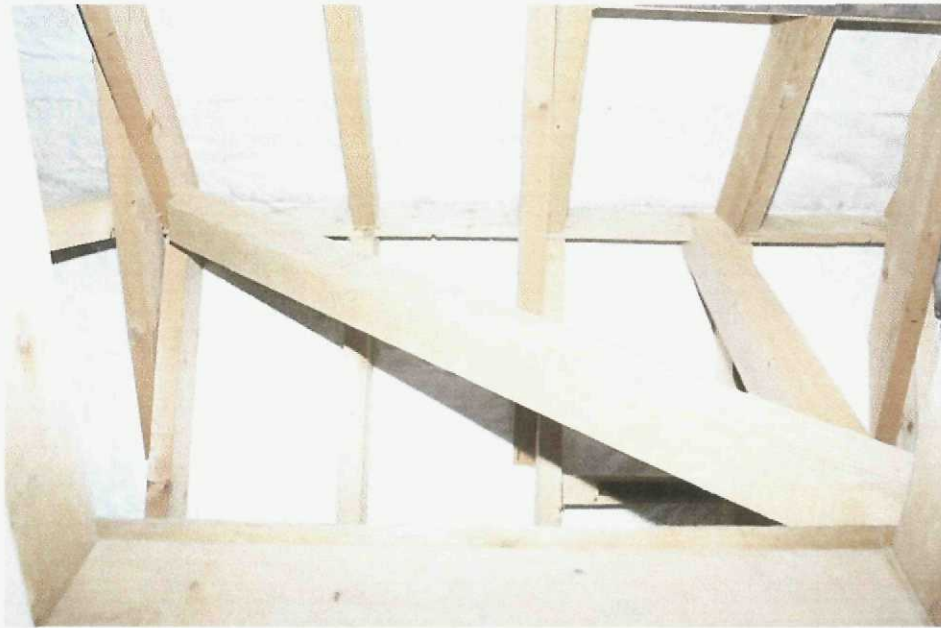
**Plate 31:** modern softwood roof structure over front, central bay

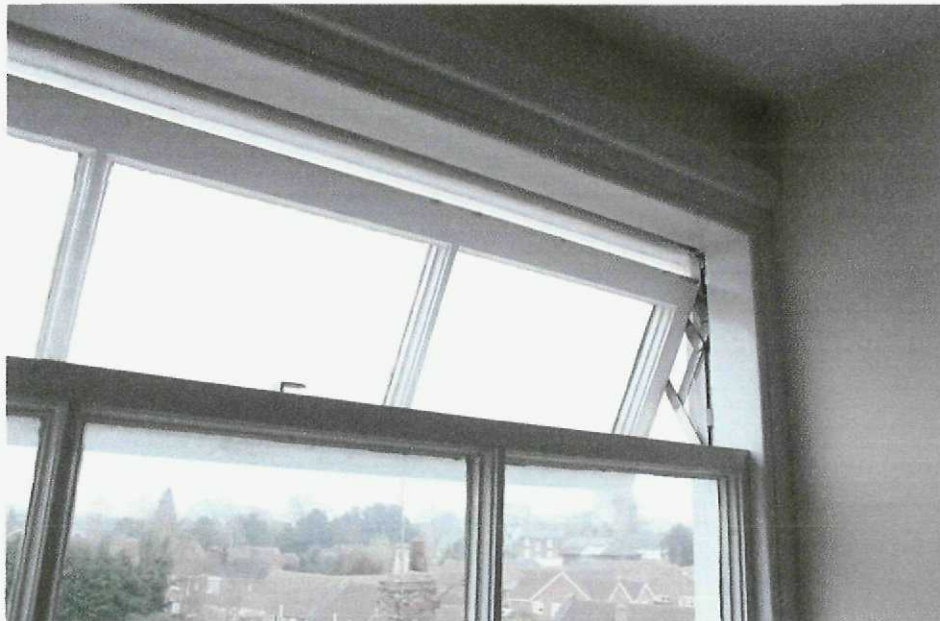
**Plate 32:** modern outward opening sash to second floor dormer

- 3.24 Internal partition walls appear to be largely made up of replacement masonry and all doors, which are half-glazed, are modern. The reconstruction work at second floor level includes window sashes that are actually outward opening (see Plate 32).

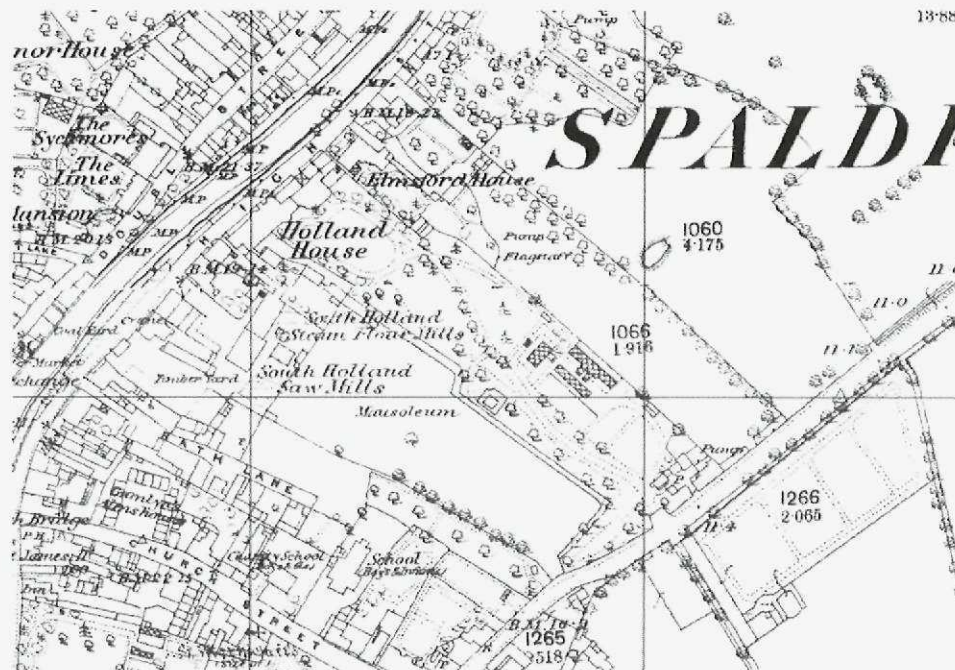
Figure 1: Extract from Ordnance Survey, published 1889 (original scale 1:2,500)

- 4.8 The first large scale edition of the Ordnance Survey shows the extent of the landscaped garden in the period prior to the sale, which extended south-eastwards from the house for a depth of 250 metres, as far as Halmer Gate (see Figure 1). The grounds contained winding paths, trees, beds, and a substantial group of glasshouses, as well as Theophilus Fairfax Johnson's mausoleum. Plate 33 is a historic photograph showing the view over the garden from Holland House and illustrates the parkland nature of the garden.

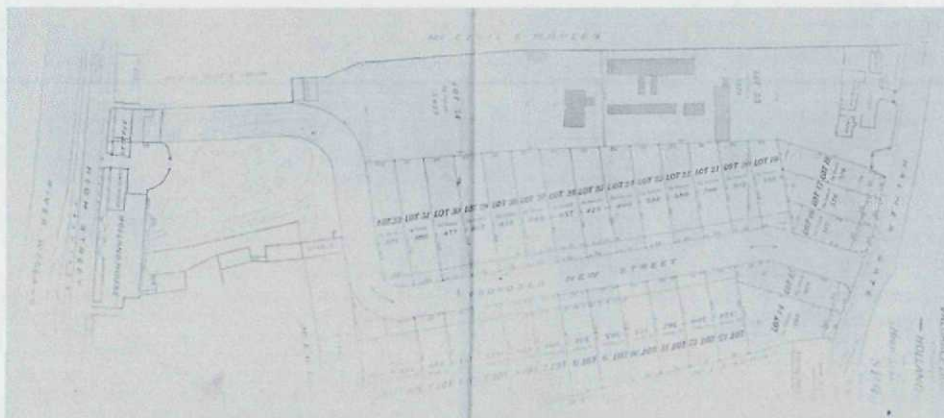
**Figure 2:** Proposed layout of Holland Road and building plots prepared for the 1909 sale of the greater part of the grounds of Holland House (source Leveritt, 1986)

- 4.12 In 1909, EW Gooch sold the greater part of the grounds for building purposes. Figure 2 is a copy of the plan showing the land offered for sale and the proposed new street, which necessitated the demolition of the stable block fronting High Street. Holland Road was subsequently formed in accordance with this plan, running from Halmer Gate to High Street, although the arrangement of building plots was modified. Much of the street was developed before the First World War but it was not fully developed until the later twentieth-century.

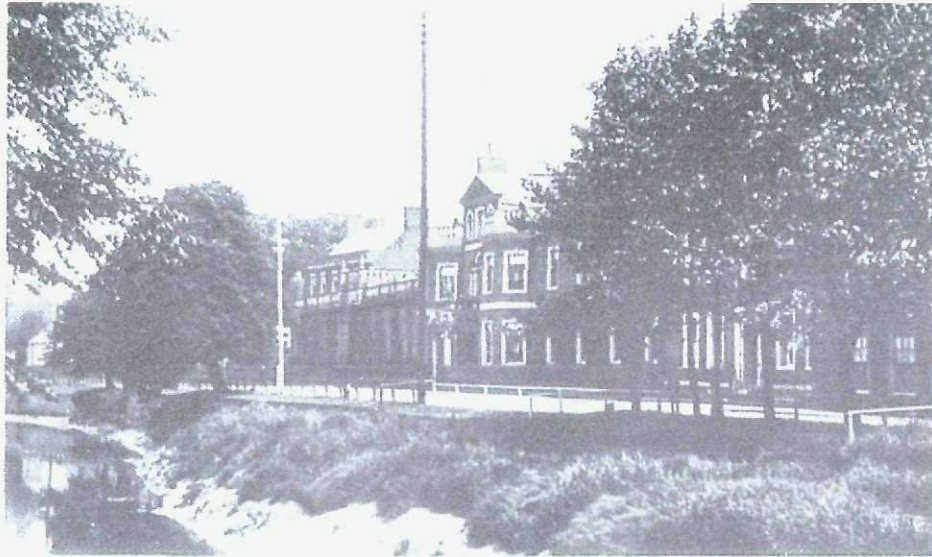
**Figure 34:** A historic view of the Holland House High Street façade, showing the now demolished single-storey coach-house, stables and arched entrance to the north, and Elmsford House beyond (source Leveritt, 1986)

- 4.5 According to Leveritt *ibid*, Theophilus Fairfax Johnson made considerable alterations to the house, including the addition of stables with a carriage entrance on High Street (see Plates 34 and 35) and construction of a lodge

- 4.17 Historic photographs (see Plates 34 and 35) indicate the appearance of the stable, coach-house and arched entrance added during the period 1830-53. They also show a rather incongruous portico, which must have been added in the nineteenth-century, and has since been removed. The historic photographs also show most of the windows with plate glass sashes with minimal glazing bars. Windows have now been restored to their assumed Georgian appearance, with small-paned sashes. Much of the restoration work was carried out after the 1993 fire.

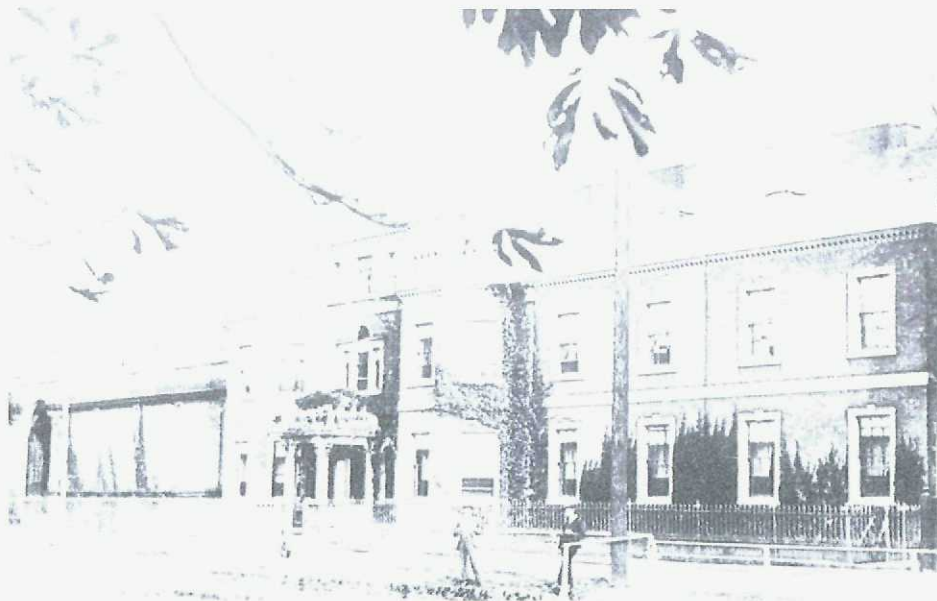
**Figure 35:** A historic view of the Holland House High Street façade, showing the now demolished single-storey coach-house, stables and arched entrance to the north, and Elmsford House beyond (source Leveritt, 1986)
