# Heritage Impact Assessment

Proposed restoration of the Temple of Remembrance

Spalding War Memorial within the gardens of Ayscoughfee Hall, Church Gate,  
Spalding, Lincolnshire

On behalf of South Holland District Council

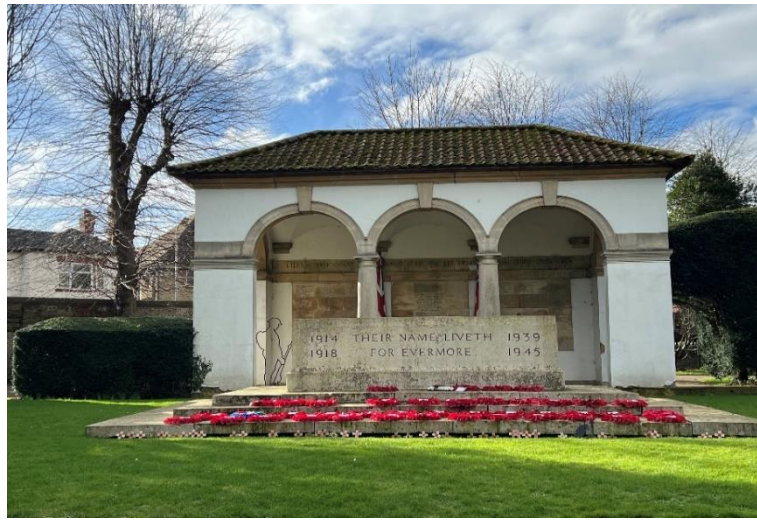
**Image 1: Front Elevation of the Temple of Remembrance with the War Stone in the foreground**

At the head of the memorial garden is the Temple of Remembrance, a brick pavilion with three Tuscan stone arches to the front and a single arch to each side; it has a solid rear wall. The roof is hipped, and clad in red pantiles. The floor has panels of red herringbone brickwork with stone surrounds. On the rear wall are two painted stone flags – the Union Flag (left) and White Ensign (right). The tops of the flagpoles are ornamented with pinnacles and encircled by laurel wreaths. The bases of the flagpoles are currently (2015) missing; these should rise from the shallow corbels set against the wall for that purpose. Three panels are set on the inner rear wall: the central one with the dedication and names added in 2015, the outer panels with the names of the fallen in the First World War.

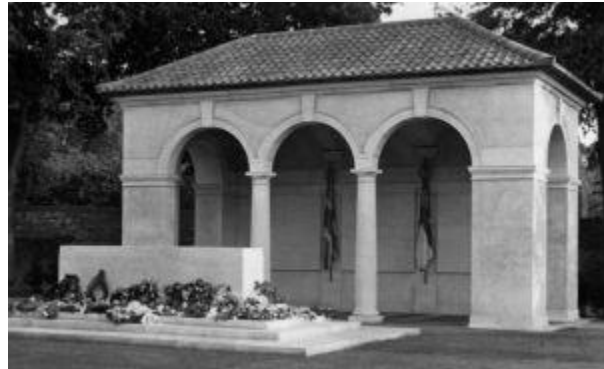
5.1.2 Figure 8 is a photograph which is believed to have been taken in the mid-1920s and shows the memorial shortly after its completion.

Image 8. View of the memorial believed to be from the mid 1920s (courtesy of South Holland Heritage).

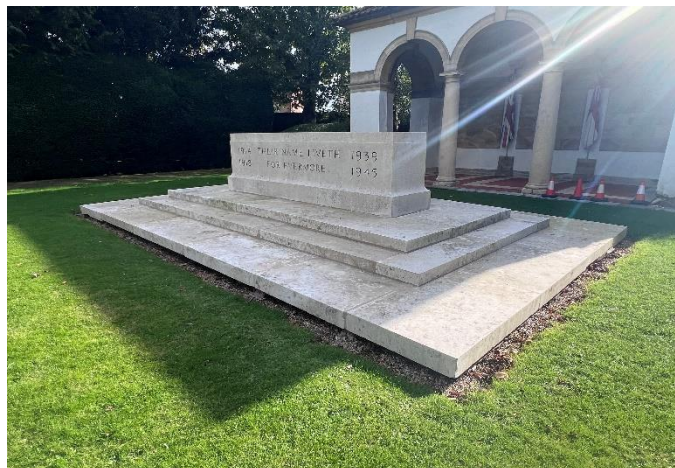
**Image 10. View showing the War Stone after the recent works mentioned at 1.7 above**

The Recommendations for these elements have been carried out separately as mentioned at 1.7 above.

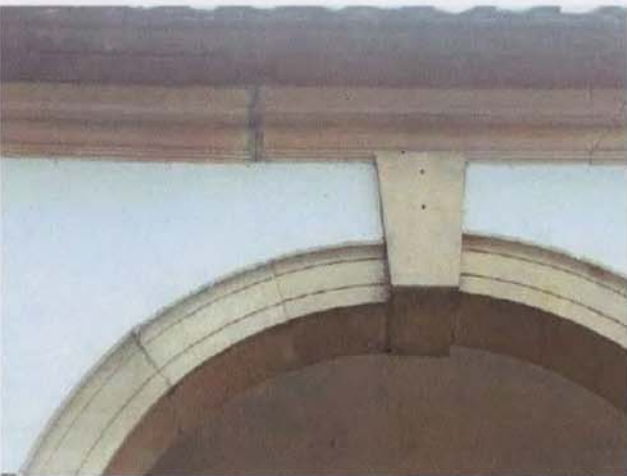
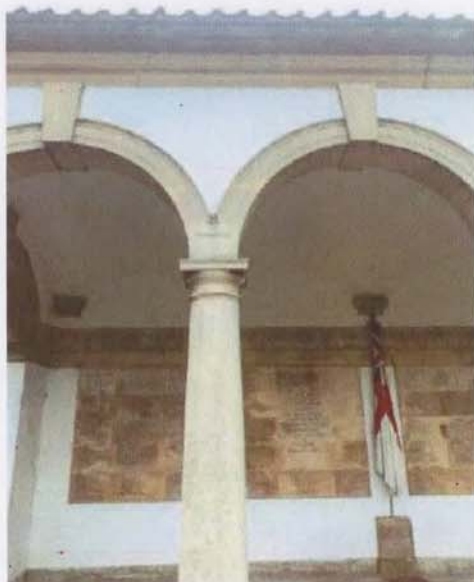
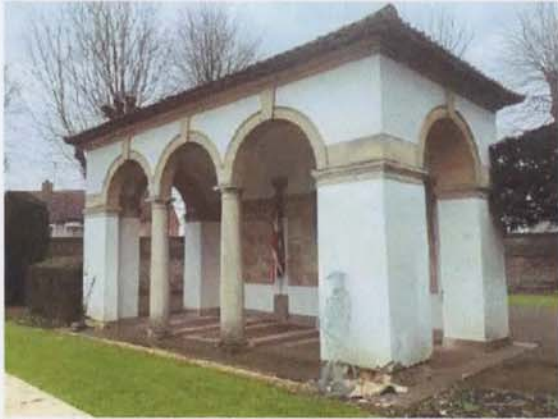
### 6.2.1 Scorer Hawkins report - 4.3.4 Arches (Photos 3, 5 & 7) noted:

In his report Edward Morton said, "You kindly showed me movement particularly obvious above arches which included some displacement or dropping of elements. I advised that this was certainly not of an extent to cause me any structural concern, and also indicated that I would not attempt to reset this, but leave it in its current position of equilibrium and just accepting that this is part of its history".

Fill cracks to east arch.

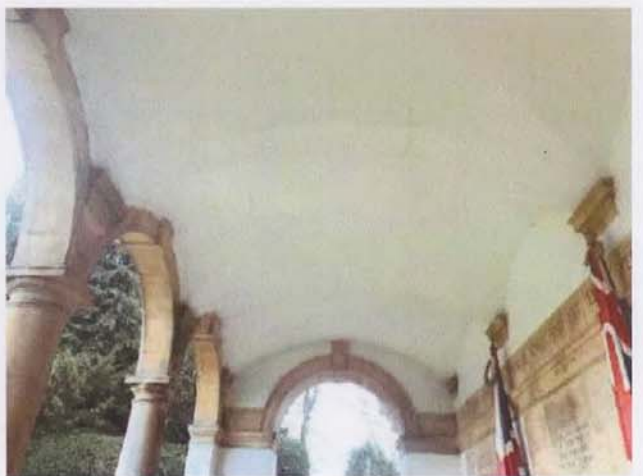
[4]

#### **4.2.2 Ceiling (Photo 4)**

There are a number of seemingly historic cracks evident but otherwise the ceiling appears to be in good order.

##### Recommendations:

- i) Rub-down, fill cracks and redecorate.

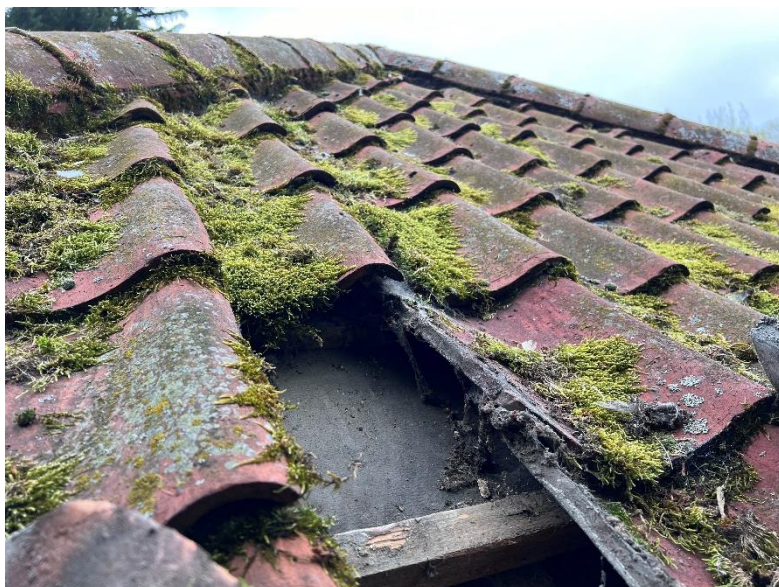
**Image 11** View of the middle section of the roof of the front elevation of the Temple of Remembrance showing the roof build up mentioned at 6.6. above

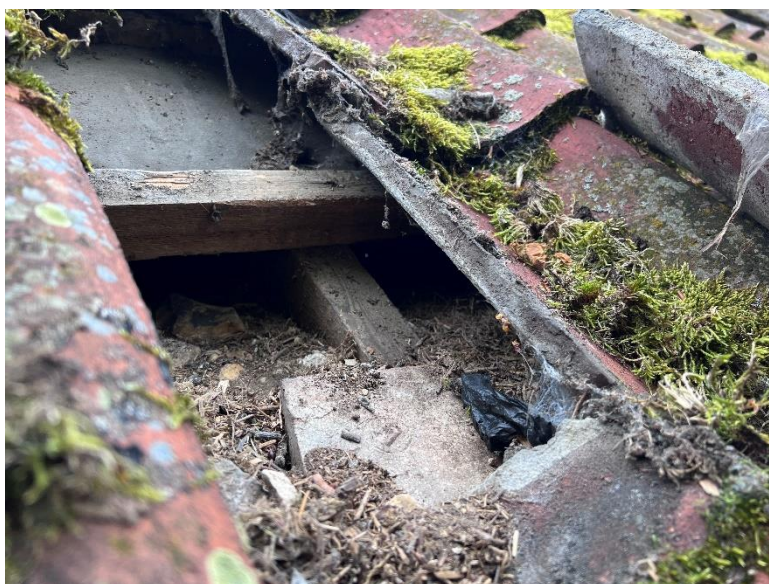
**Image 12** View of the lower section of the roof of the front elevation of the Temple of Remembrance showing the roof build up mentioned at 6.4 above
