## Mortar Analysis Report

**Project:** Ayscoughfee Hall War Memorial

**Sample Type:** Render

**Location:** External

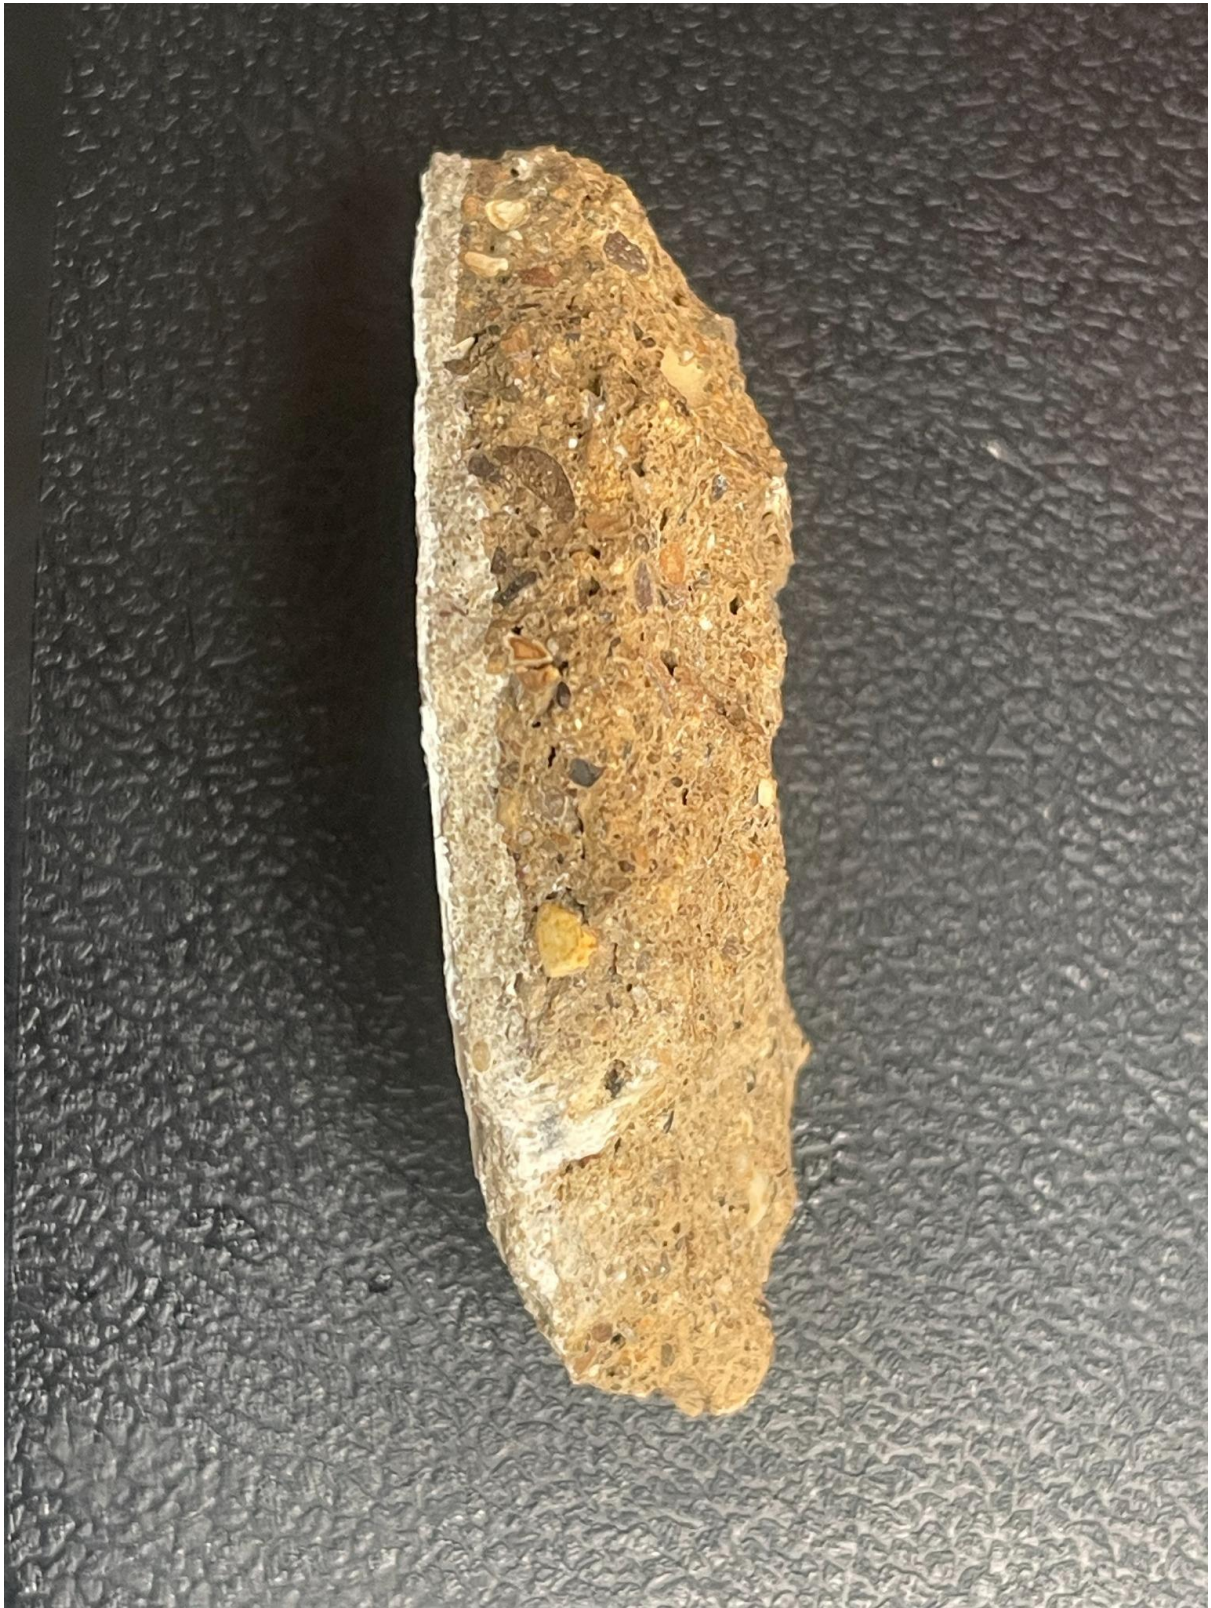
#### Visual analysis of whole sample

## Description of Each Layer:

### 1. Top Layer (Lighter Coloured Layer):

- **Texture:** The top layer has a finer, smoother texture compared to the underlying layer. The surface appears more homogenous and less coarse, indicating a more refined mixture with smaller aggregate sizes.
- **Particle Size:** The aggregates in this layer seem to be much finer and more uniformly distributed. There are no visible large particles, which suggests the use of a finely graded sand or filler material.
- **Colour and Composition:** This layer is lighter in colour, suggesting a different binder or a different mix ratio, possibly indicating a lime-based render. The lighter colour and smoother finish typically indicate it was intended as a finishing coat, designed to provide a smooth surface for painting or decorative work.

### 2. Bottom Layer (Darker Coloured Layer):

- **Texture:** The bottom layer appears rougher and more uneven. The texture is coarser, with larger, more angular aggregates visibly protruding from the surface.
- **Particle Size:** This layer contains a mix of aggregate sizes, including some larger, coarse particles. This varied particle size suggests it was designed for strength and structural integrity rather than for a fine finish.
- **Colour and Composition:** The darker colour and presence of larger aggregates indicate a different composition, possibly a more robust lime or cement-based mortar. This layer appears to be a base coat, providing a solid foundation for the finer topcoat.

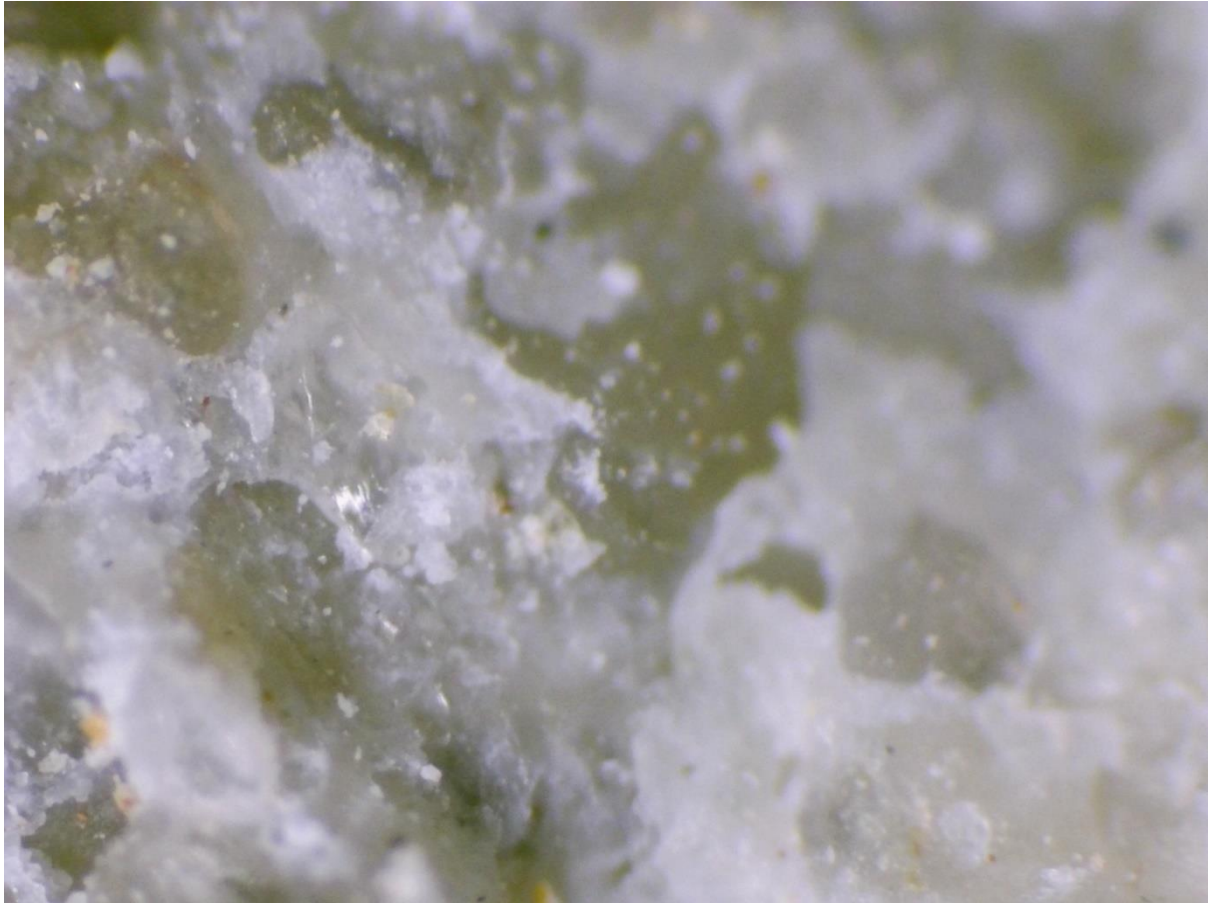
A 40x magnification of the top layer of the mortar sample, here are our observations:

- **Overall Texture:** The image reveals a relatively fine and compact texture with a smooth appearance, characteristic of a finishing layer in a mortar application. The surface seems to have a fairly uniform distribution of fine particles and binder, indicating that this layer was likely applied to provide a smooth, even finish.

- **Particle Size and Distribution:** The aggregates visible in the image appear to be small, mostly fine particles. There are no large, coarse aggregates, suggesting that the mortar mix for this top layer was well-sieved to exclude larger particles, resulting in a finer finish. The particles are well-embedded within the matrix, which contributes to the overall smooth texture.

- **Material Characteristics:** The light colour and relatively homogenous appearance suggest that the top layer may have a high content of lime or fine cement binders, possibly mixed with a very fine sand or filler material. The presence of these materials

- **Porosity:** There appear to be small, rounded voids or pores scattered throughout the matrix. These pores suggest that the mortar layer is somewhat porous, which is typical for mortars containing lime that need to allow moisture to pass through for breathability in historic buildings.
- **Inclusions:** There are tiny, irregularly shaped inclusions visible, possibly fine sand grains or other mineral particles. These inclusions are well-integrated into the binder matrix, indicating a good mix and suggesting that the top layer was applied carefully to achieve a uniform finish.
- **Surface Quality:** The surface under magnification does not show significant cracks or fissures, indicating that the top layer is relatively intact and has maintained its structural integrity.

The microscopic image of the top layer shows a fine, smooth mortar with small aggregate sizes and a homogenous appearance. The characteristics suggest this is a finishing layer, likely intended to provide a smooth, even surface that could be painted or otherwise finished. The fine distribution of the binder and the small, evenly mixed aggregates indicate a high-quality application, suitable for the final surface coat in historic masonry work. The presence of some porosity suggests breathability, which is essential for allowing moisture to escape and preventing damage in traditional building materials.

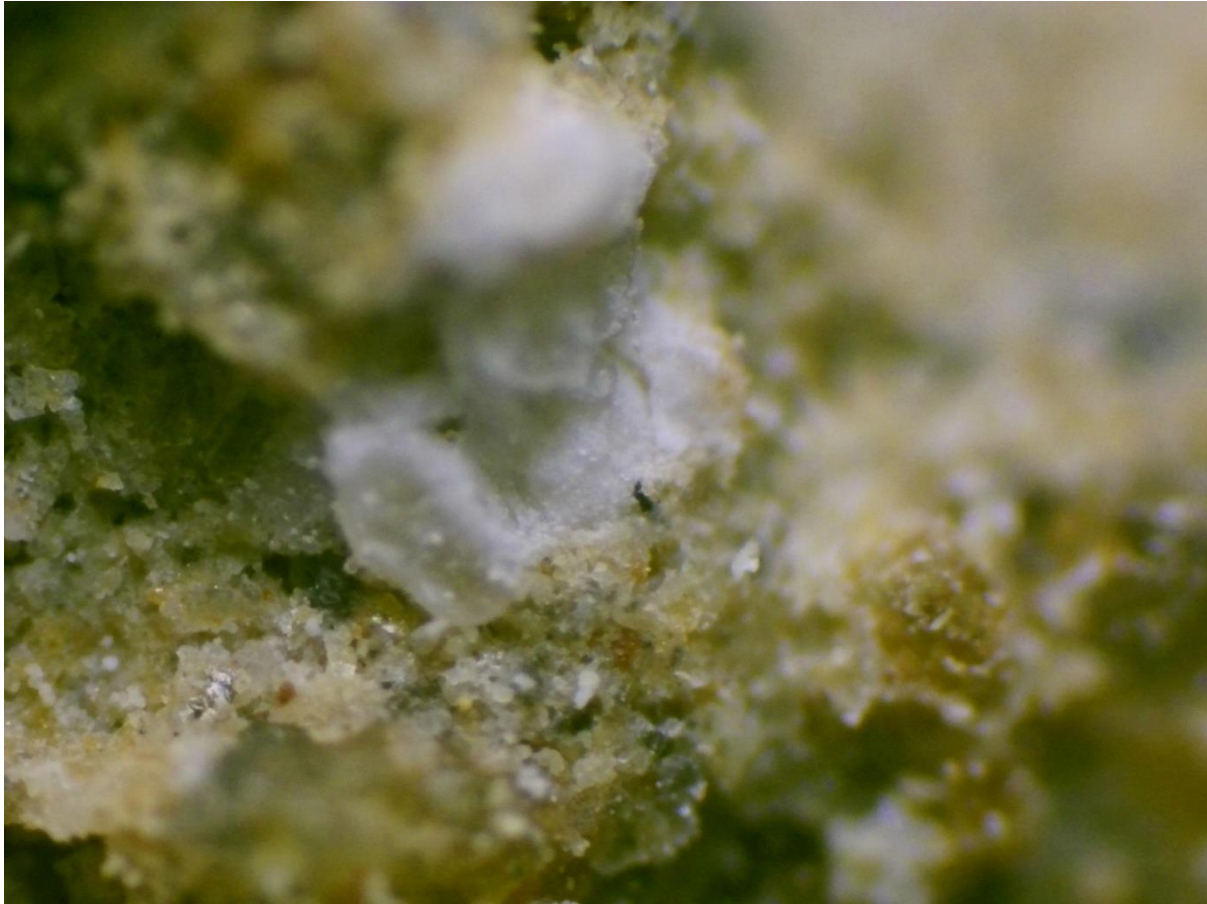
A 40x microscopic image of the bottom layer, here are our observations:

- **Overall Texture:** The bottom layer shows a much coarser and irregular texture compared to the top layer. The surface is uneven, with visible protrusions and recesses, indicating a rougher composition. This texture suggests that the bottom layer is a structural base coat designed for strength rather than a smooth finish.

- **Particle Size and Distribution:** The image reveals a mix of larger aggregates and finer particles. The aggregates are visibly more prominent and varied in size, ranging from medium to coarse. This suggests a less refined mixture, typical of a base coat meant to provide structural support and adherence rather than aesthetics.

- **Material Characteristics:** The colour in this layer is more varied, with a mixture of light and dark areas. This variation indicates distinct types of materials or minerals used in the aggregate mix. The darker areas could be denser materials or areas with more concentrated binder content, while lighter areas may represent different minerals or voids.

- **Inclusions:** The image shows a variety of inclusions, ranging from fine sand grains to larger, stone fragments and brick. These inclusions are embedded in the binder, which has varying degrees of density and distribution.
- **Porosity:** There seems to be a relatively higher level of porosity in this layer, with visible gaps and voids between the aggregates. This porosity indicates that the mortar mix allows for some permeability, which is crucial for the structural integrity of historic buildings as it permits moisture to move through the wall, reducing the risk of trapped moisture and associated damage.
- **Surface Quality:** The coarse and varied surface quality suggests that this layer has not been finished to a smooth texture and is likely intended to act as a base or intermediate layer that supports subsequent finer coats.

The bottom layer, as observed under the microscope, is characterized by a coarse, heterogeneous mixture of aggregates and binder. The varied particle sizes and rough texture indicate a robust structural layer, designed to provide strong adhesion to the substrate and support for the finer top layers. This layer's composition, with larger inclusions and visible voids, suggests a focus on mechanical strength and flexibility, rather than achieving a smooth finish. This kind of mortar is typical in historic construction, where a base coat needs to be both durable and compatible with the masonry substrate to accommodate movement and prevent cracking.

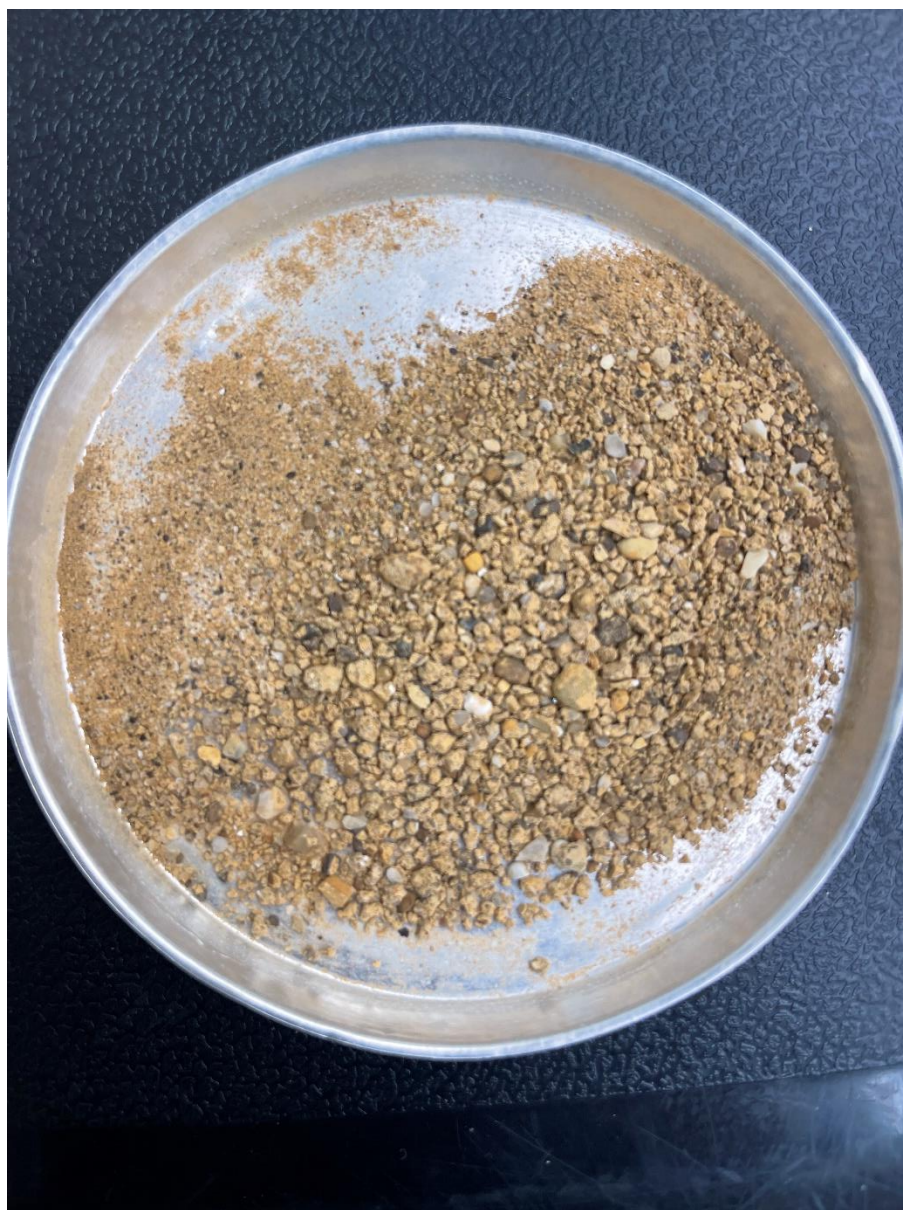
Bottom Layer

## Analysis of the Base Layer Sample After Acid Dissolution

- **Aggregate Size and Distribution:** The aggregates visible in the sample are primarily coarse, with a noticeable range of particle sizes. The particles vary from small to medium-sized grains, suggesting a heterogeneous mixture. Most of the particles appear to be angular, which is typical for crushed stone or sharp sand, and some are rounded, indicating natural weathering or river-sourced aggregates.
- **Colour and Material Composition:** The colour of the aggregates ranges from light tan to darker brown shades, which indicate different types of minerals or stones. This colour variation suggests a diverse source of materials, likely including quartz, feldspar, and other common sand and gravel minerals. The darker particles could be fragments of denser rock types or brick may contain iron oxide.

- **Effect of Acid Dissolution:** The acid dissolution process removes the binder material, typically lime or cement, leaving behind the aggregate. The absence of a finer, powdery residue in the sample suggests that the binder was fully dissolved, which is consistent with a well-reacted lime or cement-based mortar. This process allows for a clearer examination of the aggregate itself without interference from the binder.

- **Texture and Surface Quality:** The aggregates have a rough, gritty texture, typical of materials used for the base layer in mortar applications. This roughness aids in mechanical bonding within the mortar matrix, providing structural stability and durability. The angular nature of many particles indicates good interlocking potential, enhancing the mortar's overall strength.
- **Inclusions and Impurities:** There are visible impurities or inclusions among the aggregates, which could include small fragments of other materials or contaminants. These inclusions are normal in natural sand and gravel sources and generally do not affect the performance of the mortar unless present in excessive quantities.

- **Structural Role:** The coarse, varied aggregate composition suggests that this mortar was intended for use as a base or scratch coat, providing a robust foundation for subsequent layers. The range of particle sizes and the angularity of the aggregates are ideal for creating a strong, adhesive layer that binds well to masonry substrates.
- **Durability and Compatibility:** The diverse aggregate mix, with its good mechanical interlocking properties, would contribute to the mortar's durability, especially in an external application where exposure to weathering and moisture is a concern. The presence of natural, weather-resistant stone particles would further enhance the mortar's longevity and compatibility with historic masonry.

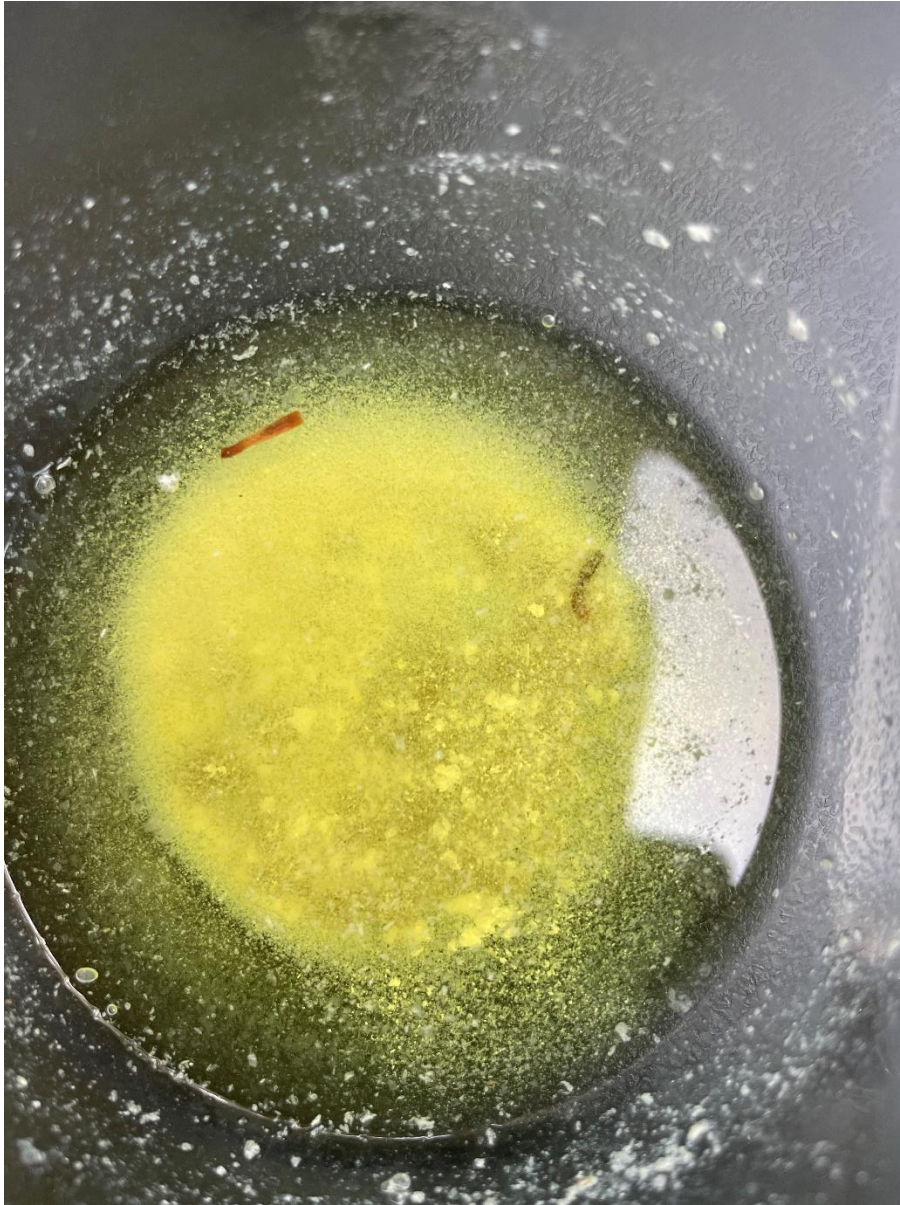
### **Observations of the Top Layer Mortar in Acid Solution:**

readily in acid, which could be indicative of silica sand or other non-reactive minerals commonly found in mortar.

- There is no visible vigorous bubbling or effervescence, which would typically be observed if a strong reaction were occurring between the acid and a carbonate material (like lime). This shows that the initial reaction has already taken place, and the solution has reached a more stable state, or that the top layer has a lower carbonate content compared to what would be expected in a lime-rich mortar.

The top layer mortar in the acid solution provides insight into the chemical composition and properties of the mortar. The yellow hue and fine precipitate suggest that the mortar includes components such as fine aggregates and possibly some metal oxides, which are less reactive with hydrochloric acid. The lack of vigorous effervescence indicates either a low carbonate content and that the reaction has reached a stable state, highlighting the possible use of cement-based materials and a low-lime formulation in the top layer mortar.

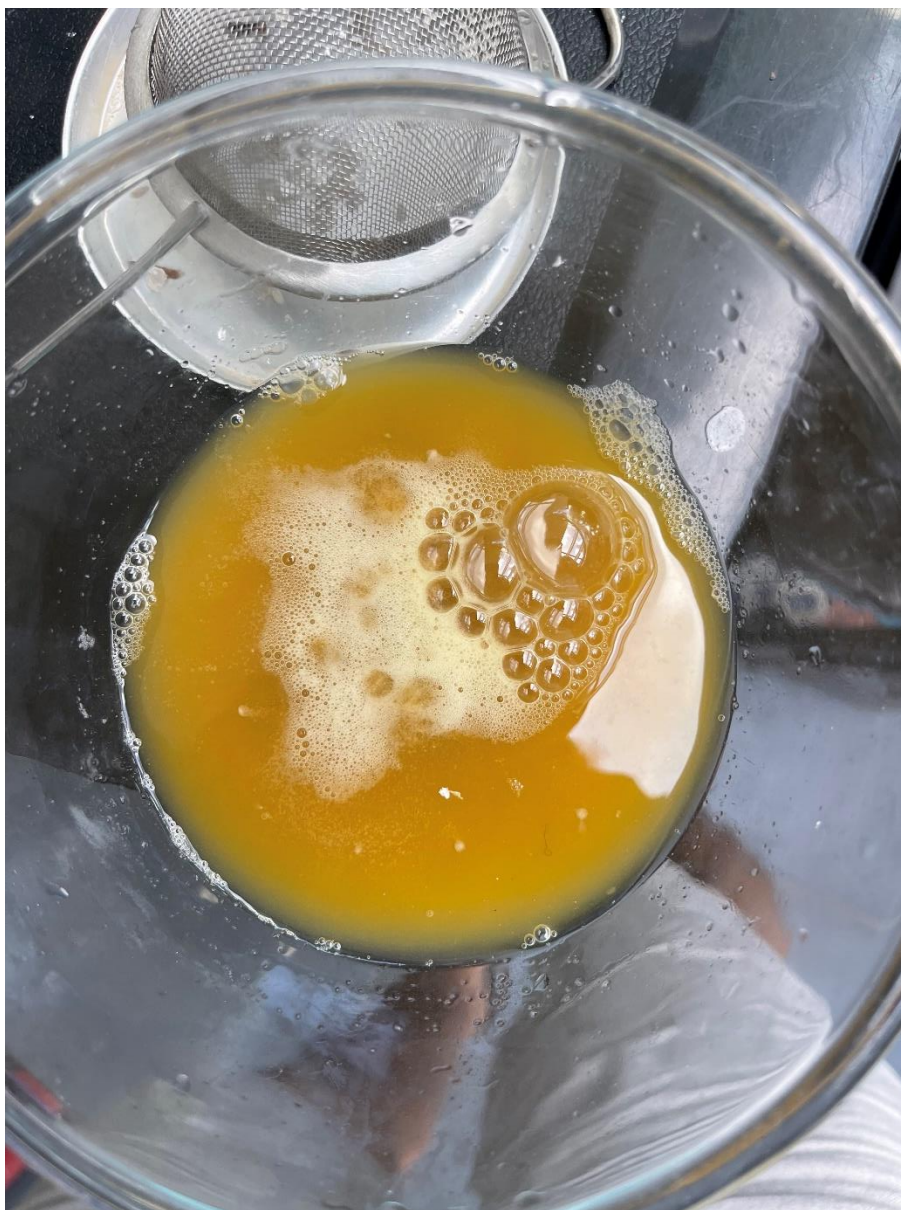
### **Observations of Whole Sample of Mortar in Hydrochloric Acid Solution:**

The observed reaction of the mortar samples with hydrochloric acid provides insights into the composition of the mortar layers. The vigorous effervescence and bubble formation confirm the presence of carbonate materials, such as lime, which are common in historic mortars. The yellow to orange-brown colour change indicates that iron compounds or organic materials may also be present, affecting the mortar's appearance and durability.

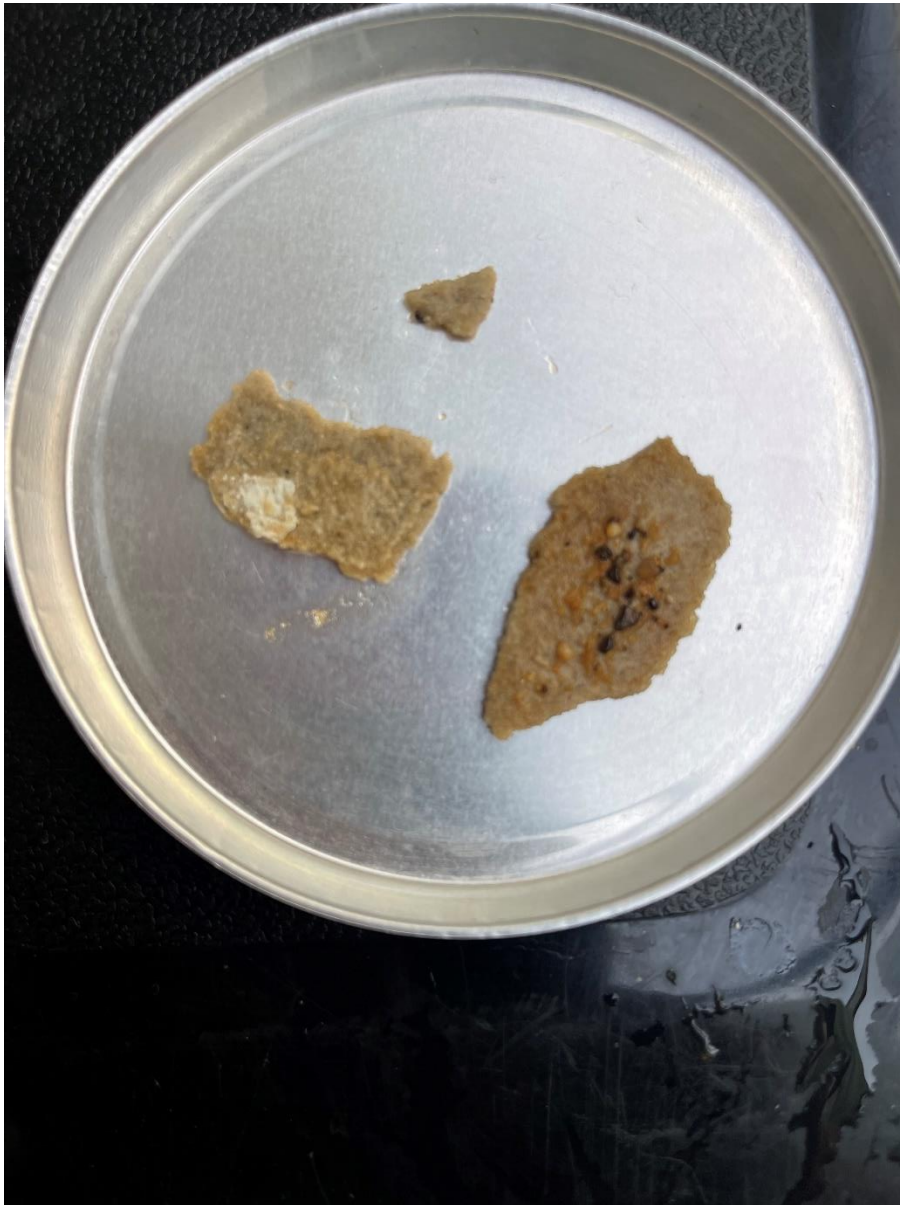
**Observations of the Mortar Sample Remnants from the Sample Above:**

**1. Visible Remnants and Layer Characteristics:**
