| Report type: | Phase II Site Appraisal |
| Site: | Kings Road, Spalding |
| Client: | Reliant Building Contractors Ltd. |

SITE APPRAISAL REPORT  
FOR  
RELIANT BUILDING CONTRACTORS

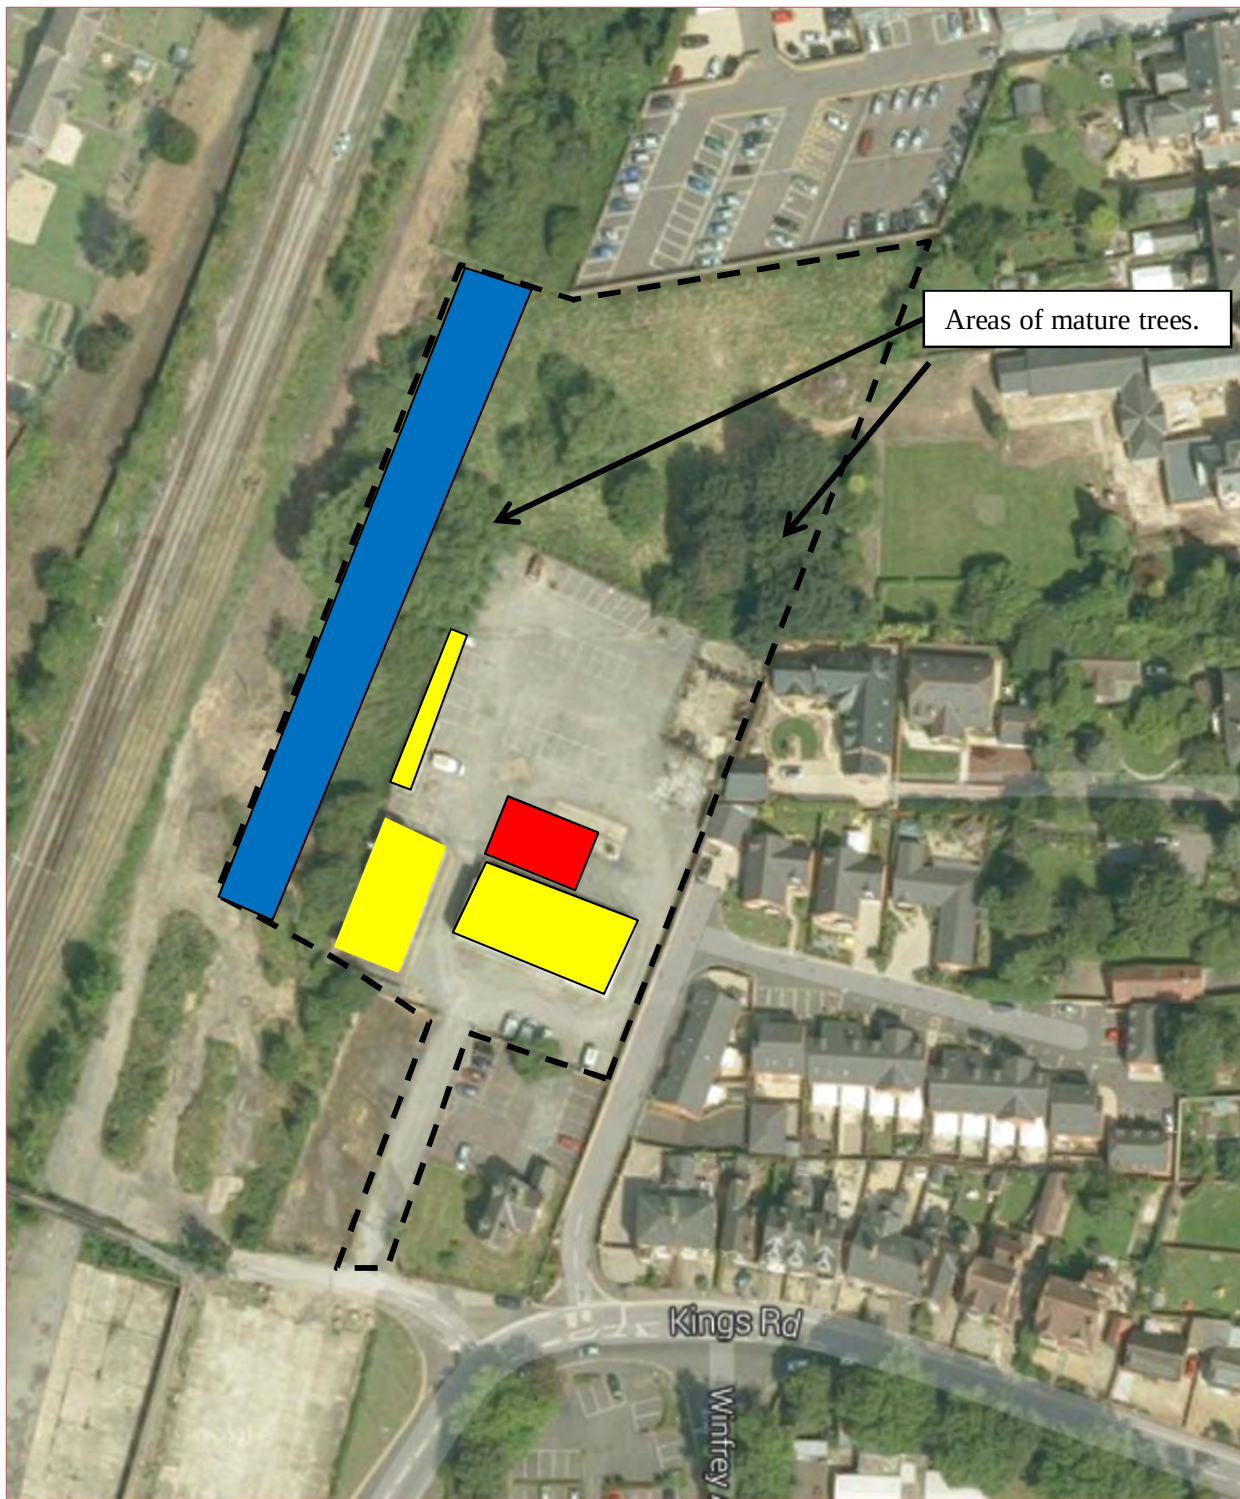
Indicated buried fuel tanks.

The Phase I Ground Hazard Diagram is presented in Appendix D.

The investigation has targeted particular sources as identified in the Phase I Ground Hazard Diagram, presented in Appendix D.
