# Heritage Impact Assessment

Demolition of greenhouse, erection of fencing, pergola and replacement of door within the Gardeners Area at Ayscoughfee Hall, Love Lane, Spalding, Lincolnshire

On behalf of South Holland District Council

A1572GA – HIA rev P1

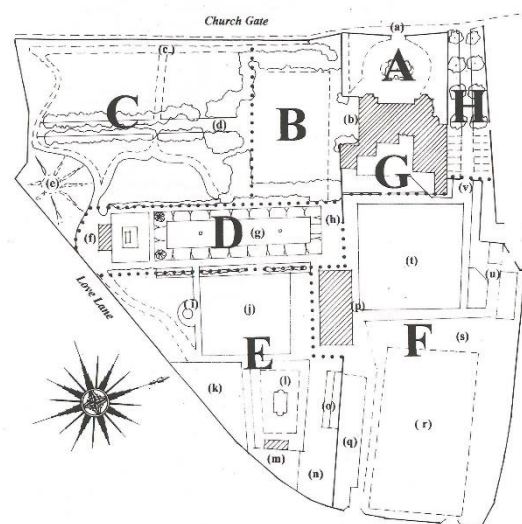
3.5.7 Gardeners Buildings These are relatively unobtrusive structures of little architectural merit tucked into a yard area on the north side off Area F.

**Fig. 2 Anderson and Glenn's Map given in their document: 'Ayscoughfee Hall, Spalding, Lincolnshire Conservation Plan July 2000' - the Glasshouses are marked a 'u' close to area F**

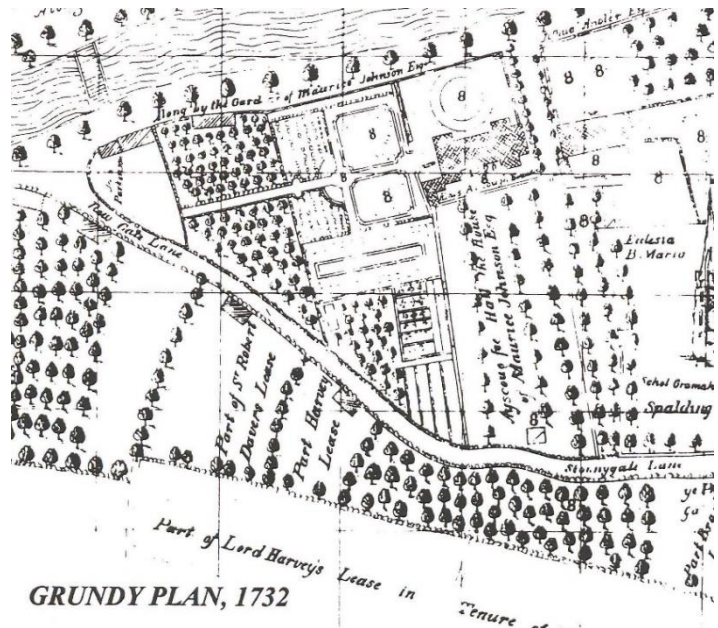
4.7 The earliest known plan of the gardens by John Grundy 1732 is provided in both of the Anderson and Glen's documents (extract of the map provided here at Fig 3), it shows orchards where the Gardeners Area is now sited. The report also shows a map by Armstrong of 1779 which again has the same building outline.

**Fig 3. Extract from the Grundy Plan of 1732**

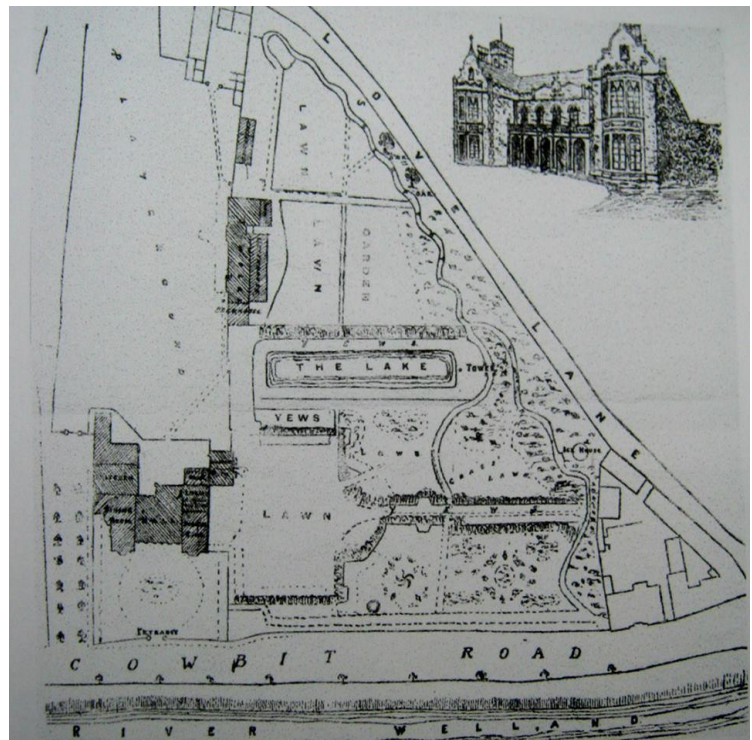
4.8 A guide to the Hall that was published around 1912 also shows the area without any structures

**Fig 4. Extract from a Guide to Ayscoughfee  
Hall published around 1912**

4.09 OS maps of 1887 and 1903, showed the same layout as the Fig.4 above.

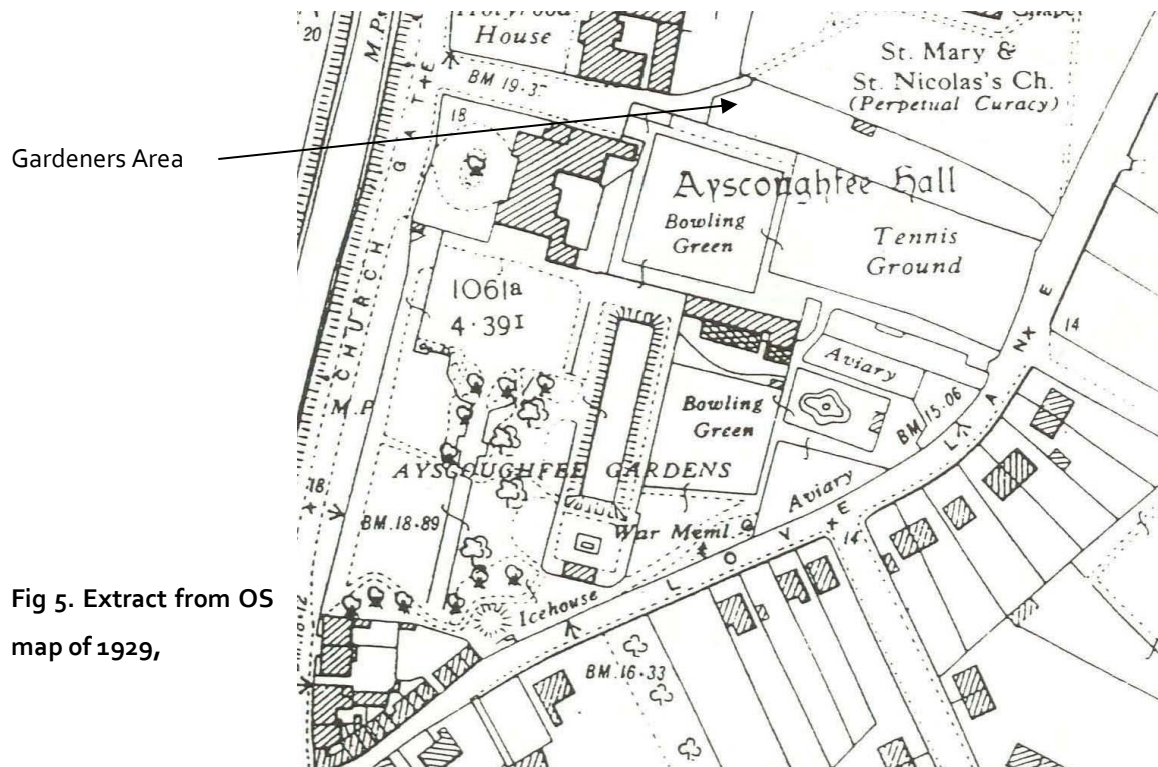
4.10 The OS map was revised in 1929 (see fig 5 below) but no structures are shown in the Gardeners Area

Fig 5. Extract from OS map of 1929,

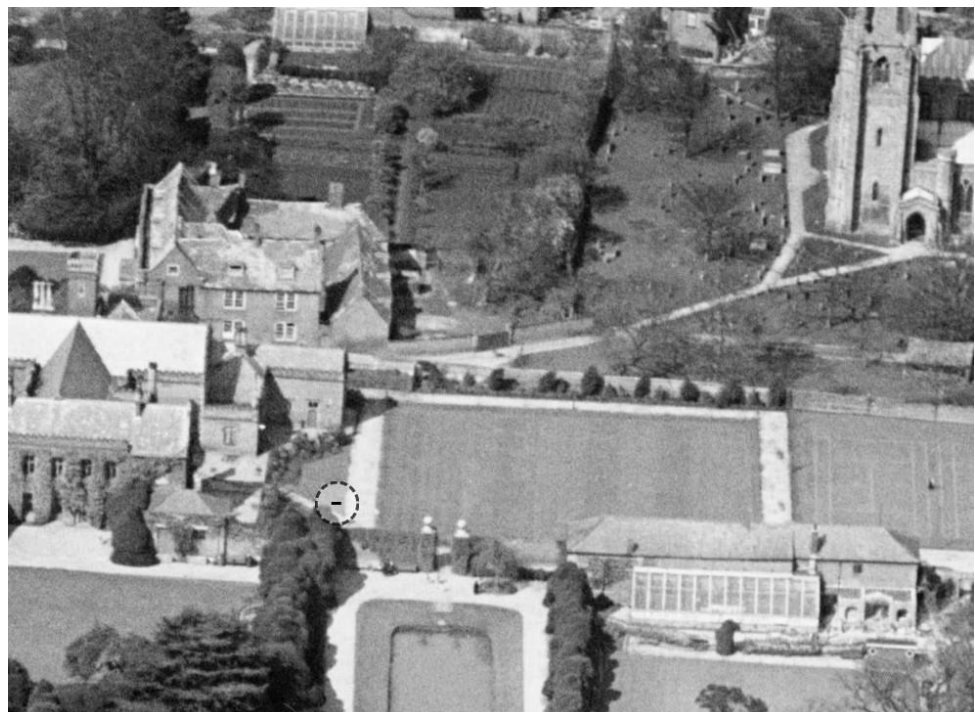
4.11 The aerial photograph (Fig 6) taken May 7th 1930 shows no buildings in the area under discussion

Fig 6. Extract from: Ayscoughfee Hall, the River Welland and the town centre, Spalding, 1930  
© Historic England. Aerofilms Collection

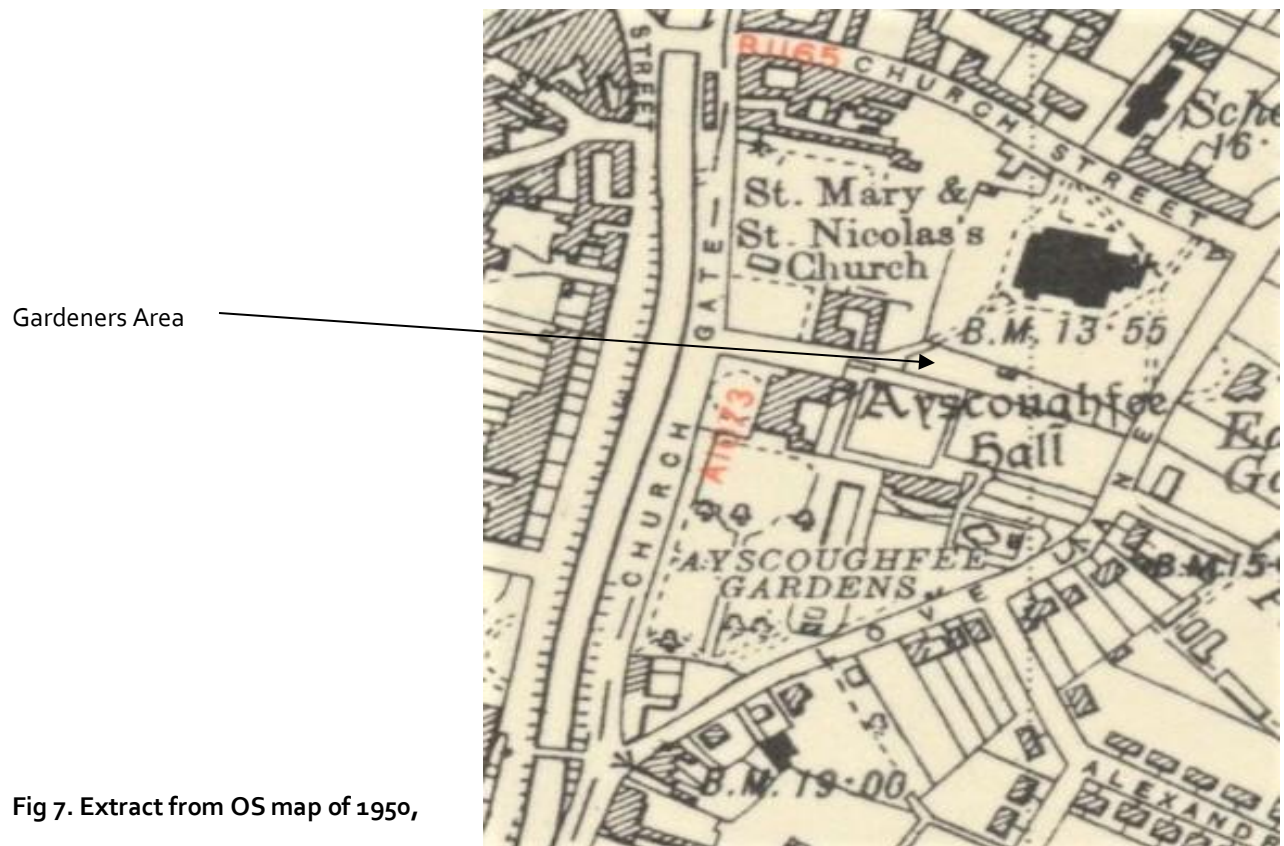
4.11 The OS map was revised again in 1950 (see fig 7 below) and then published in a less detailed version in 1952 but no structures are noted in the Gardeners Area on either of these maps.

**Fig 7. Extract from OS map of 1950,**

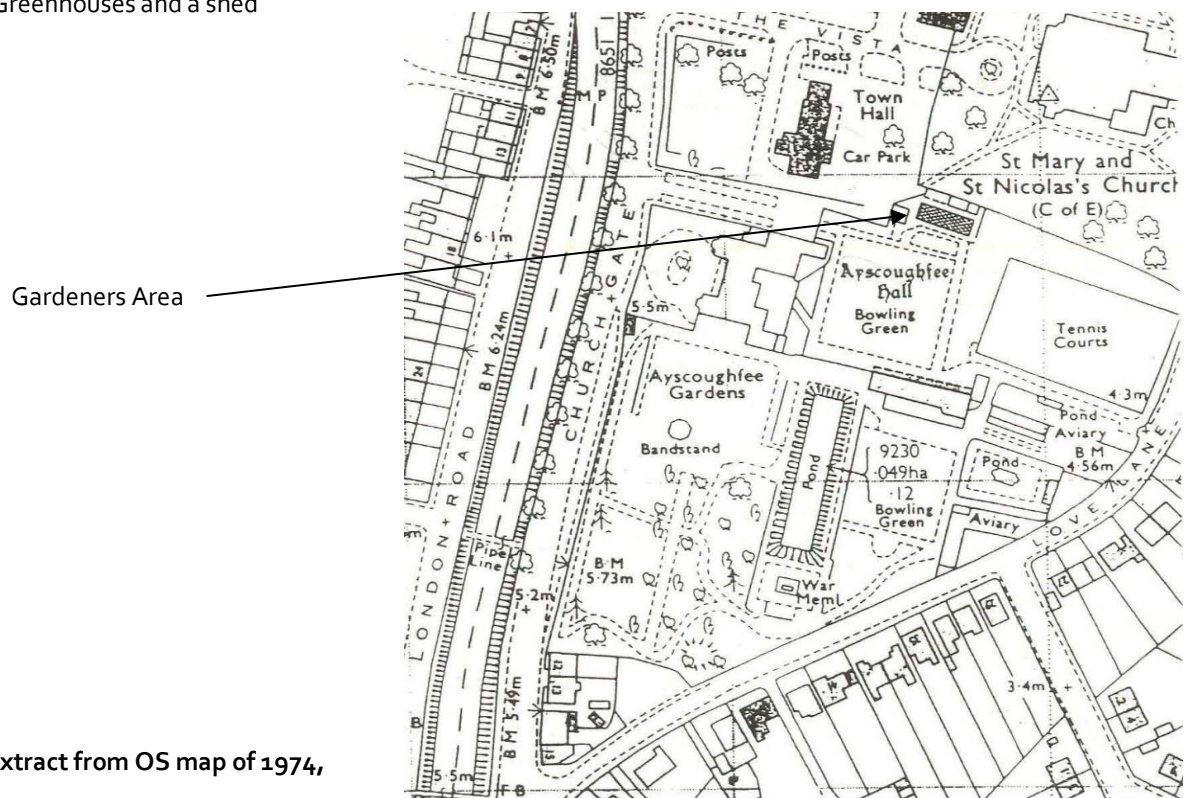
4.12 The OS map of 1974, (see fig 8) is the first to show structures in the Gardeners Area, these may be Greenhouses and a shed

**Fig 8. Extract from OS map of 1974,**

5.3.1 The first Ordnance Survey Map that shows any structures within the Gardeners Area is dated 1974

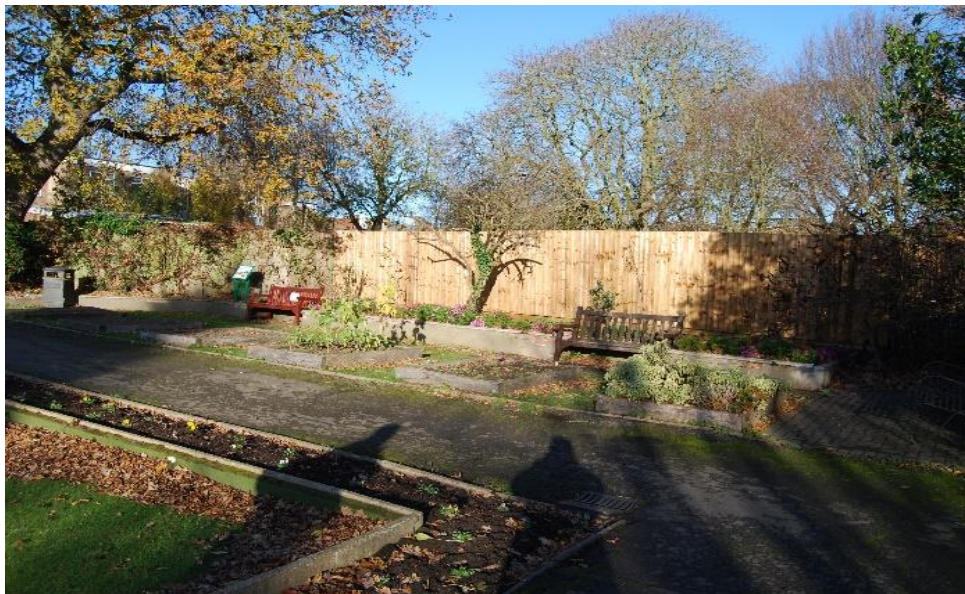
- 5.2.1 While it is not possible to tell from any of the maps or plans, it is clear that there were no fences between Ayscoughfee Gardens and St Mary & St Nicholas's church in 1930 (see fig 6 above).
- 5.2.2 The new fence is of the style and height as the existing and it now encloses the Gardeners Area making the area more secure and safer for the public.

**Fig 9. View of the fence viewed from the bowling green, showing the older section to the left and the new length erected on the same line, to the right**

- 6.3 The fencing that has been carried out better defines the area and uses traditional materials that have a limited lifetime and can be removed easily should it be required

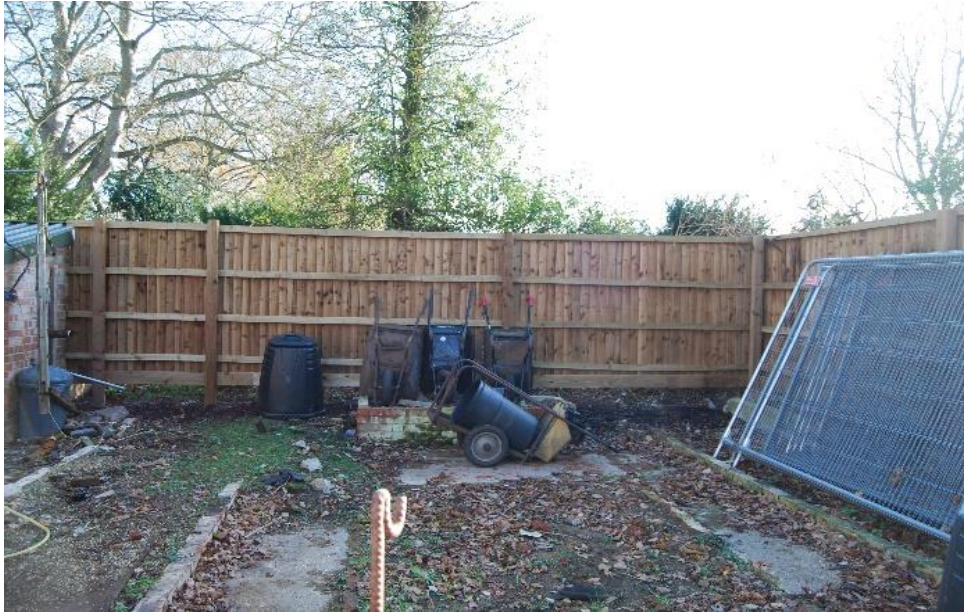
**Fig 10** View of fence enclosing the end of the Gardeners Area, viewed from within,

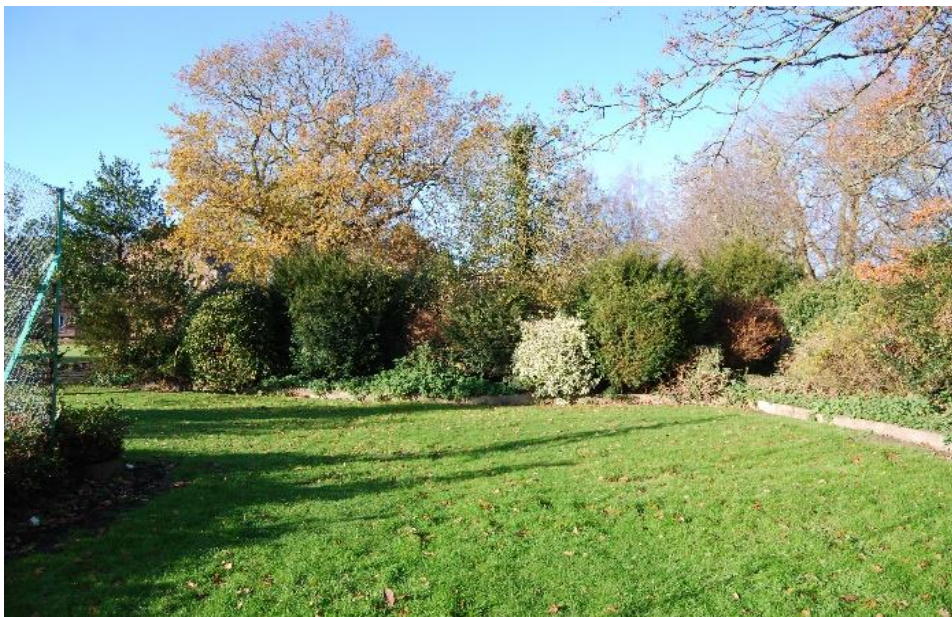
**Fig 11** View from the tennis courts of the end section of fence hidden by shrubbery.

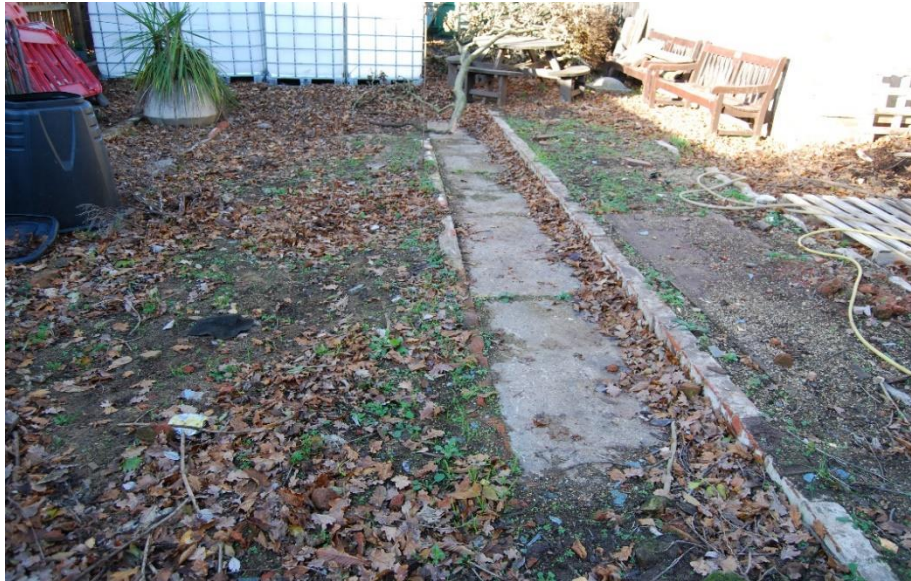
5.3.2 No record is available for the style or type of Greenhouse that were erected at that time

**Fig 12. Image showing the bases of the Greenhouses December 2021**

- 6.4 The Greenhouses that were removed had deteriorated and had no historic significance
- 6.5 The shelter that has been erected has used traditional materials and can be easily removed.

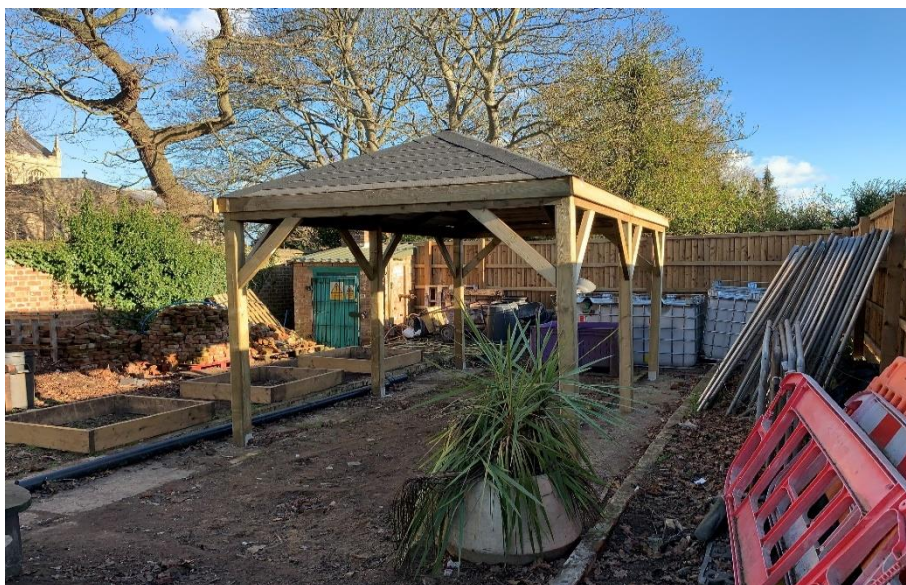
5.3.4 The shelter is built of materials that are in keeping with its surroundings. It is free standing, built of timber and is open sided with a lightweight felt tile roof

5.3.5 The construction is bolted down to the existing concrete so that it is easily reversible should a different use be needed for the area or a more historic reference is found.

**Fig 13 The free standing shelter April 2022**

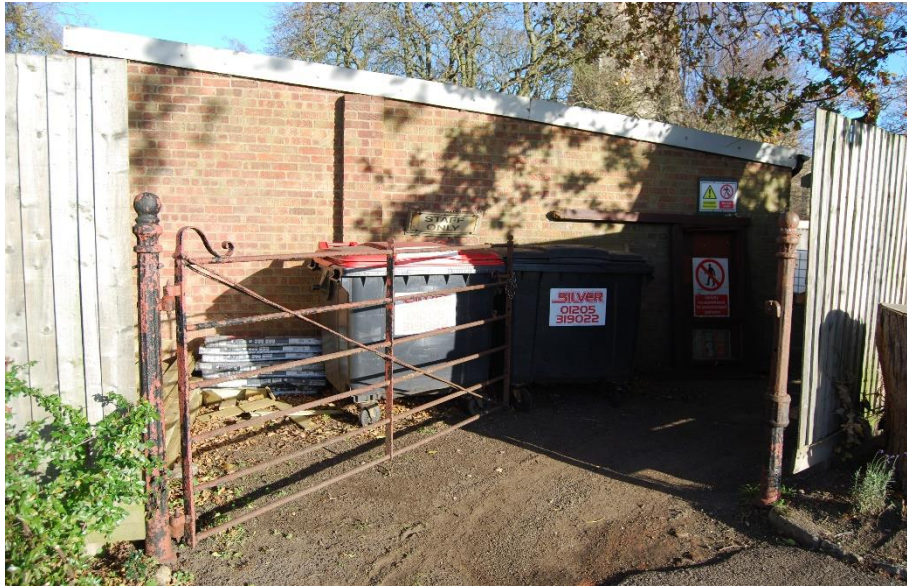
- 5.4.1 The store has a mono pitch roof and is built in a single skin of common brickwork with external pillars, its style and the materials used, dates it to the latter part of the 20<sup>th</sup> century.

**Fig 14** The entrance to the Gardeners Area showing the side elevation of the store.

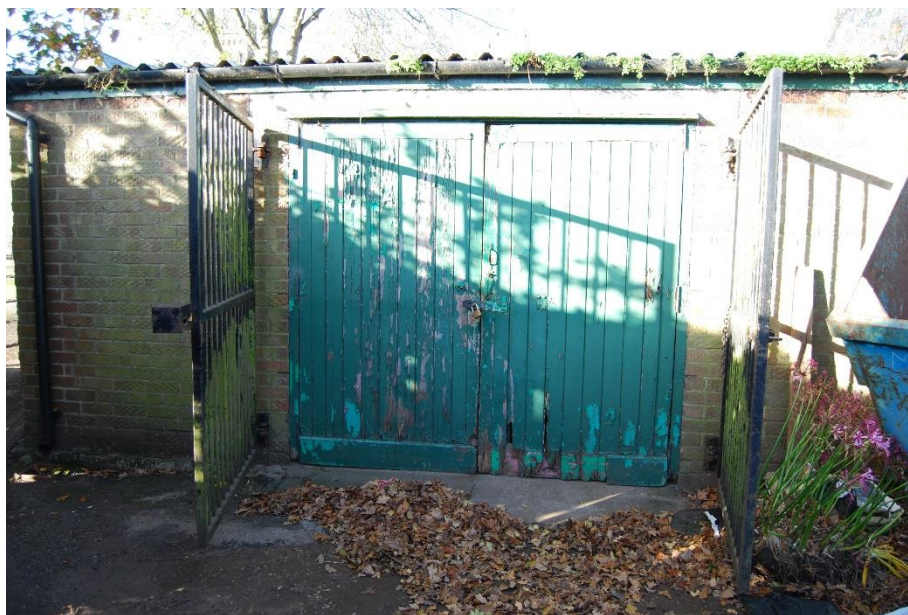
- 5.4.2 The timber doors to the store are softwood framed. Ledged and braced doors from the same period as the building. The doors have deteriorated over time and are beyond repair, they are both difficult to use and make the store vulnerable to theft. Steel gates have been fitted to protect the garden equipment kept in the store and these impede the movement of machinery. A metal roller shutter door would be more secure in itself and allow the removal of the steel gates should that be required.

**Fig 15** The doors to the Gardener's store which are to be removed and replaced with a roller shutter door

- 6.6 The removal of the timber doors and installation of a roller shutter door, finished in a suitable colour will make the store more secure and safer for the gardeners to access their machinery.

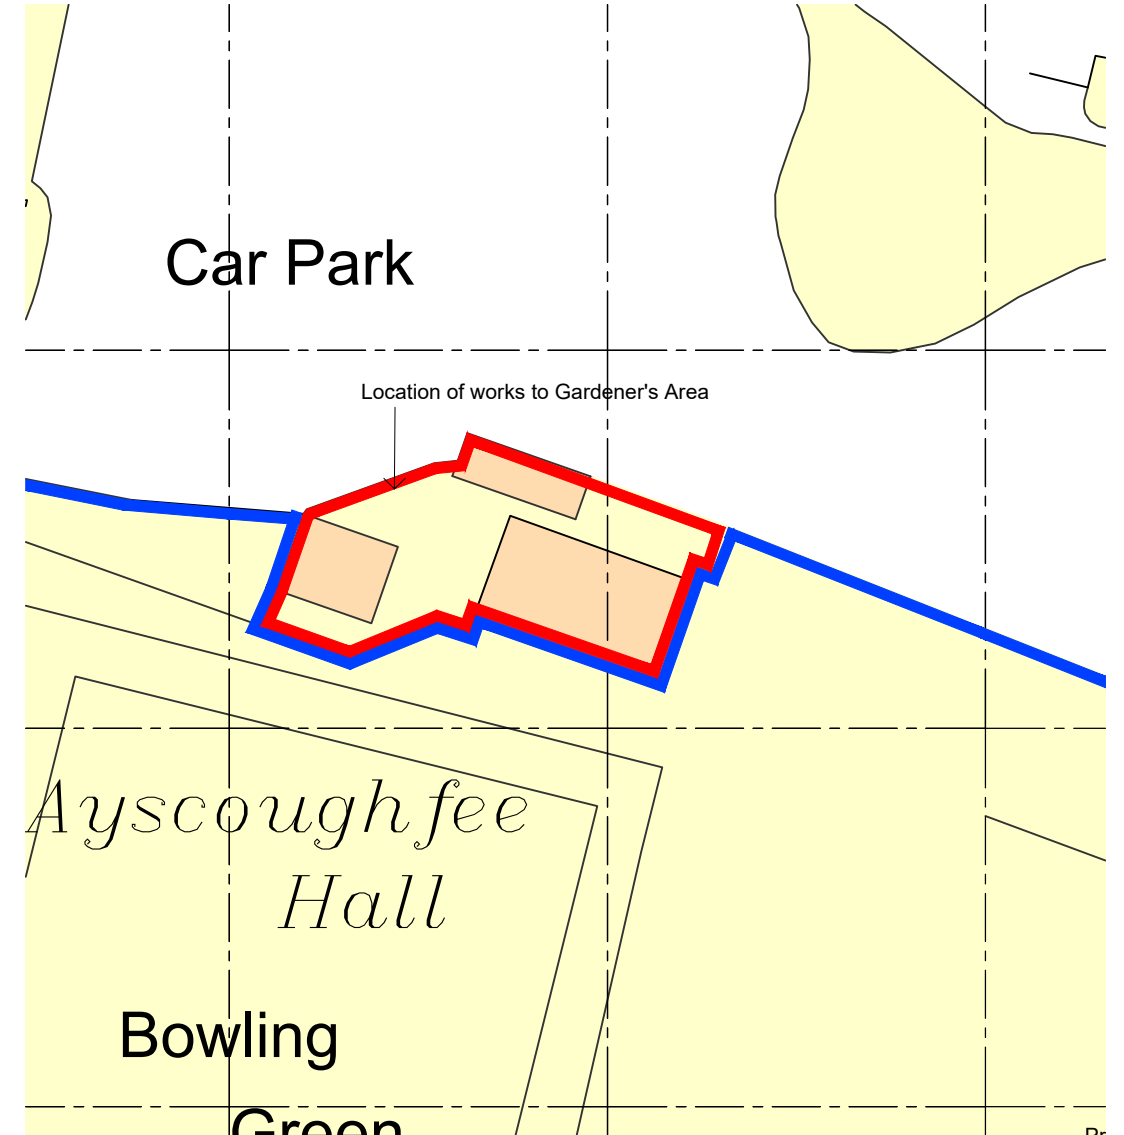
### Site Block Plan

Site of proposed works outlined in red

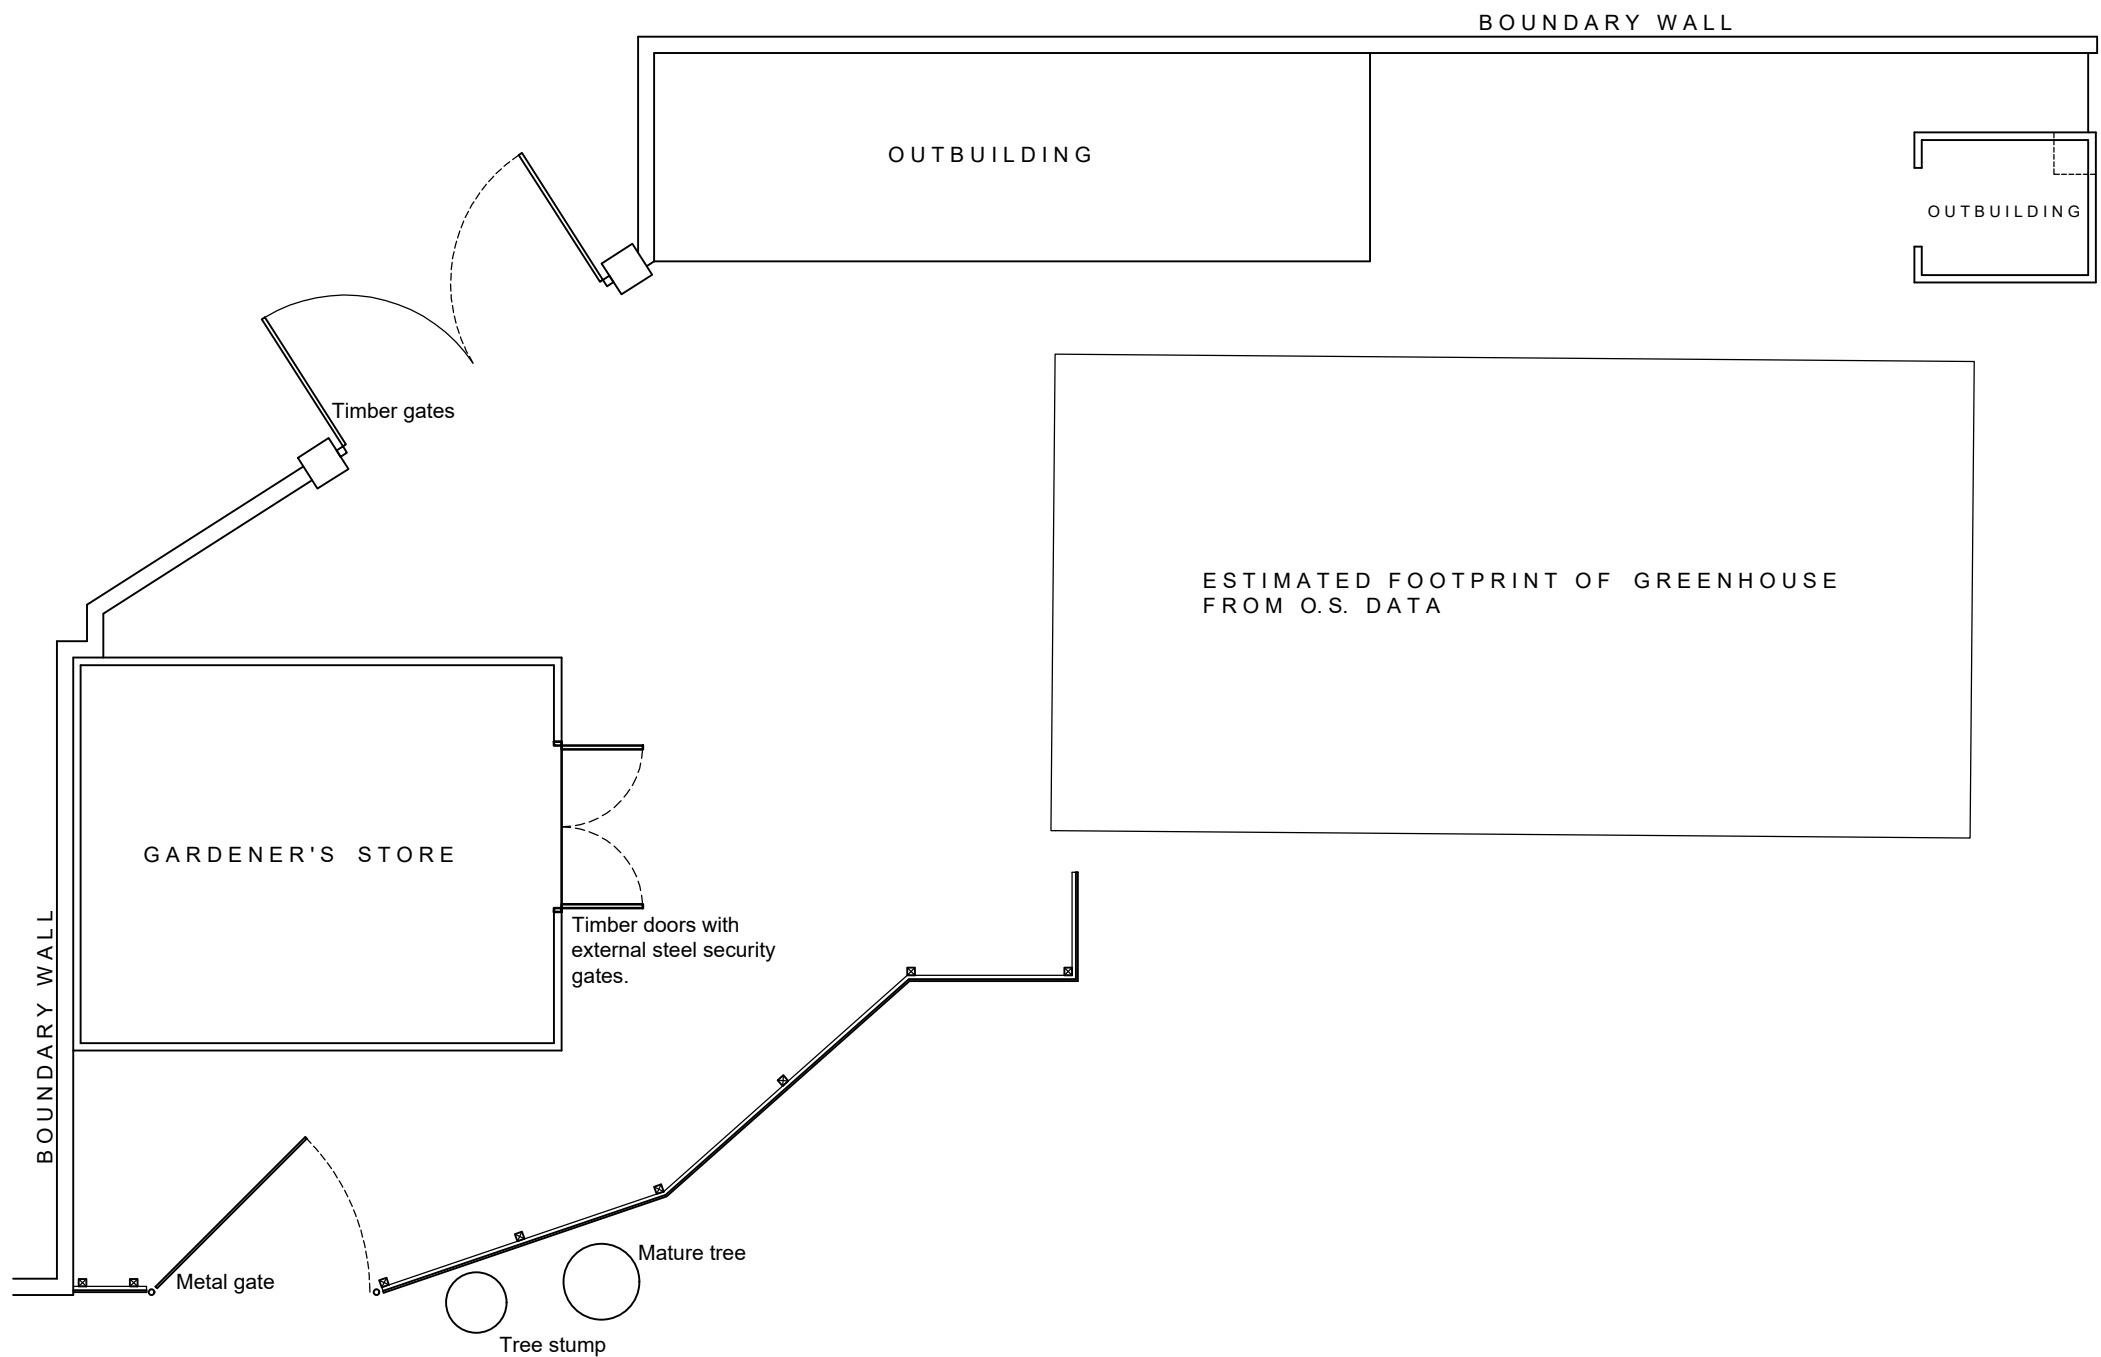
Plan of Gardener's Area prior to 2021 / 2022 works (estimated) - existing  
Scale 1:100  
SCALE 1 : 100  
SCALE 1 : 1

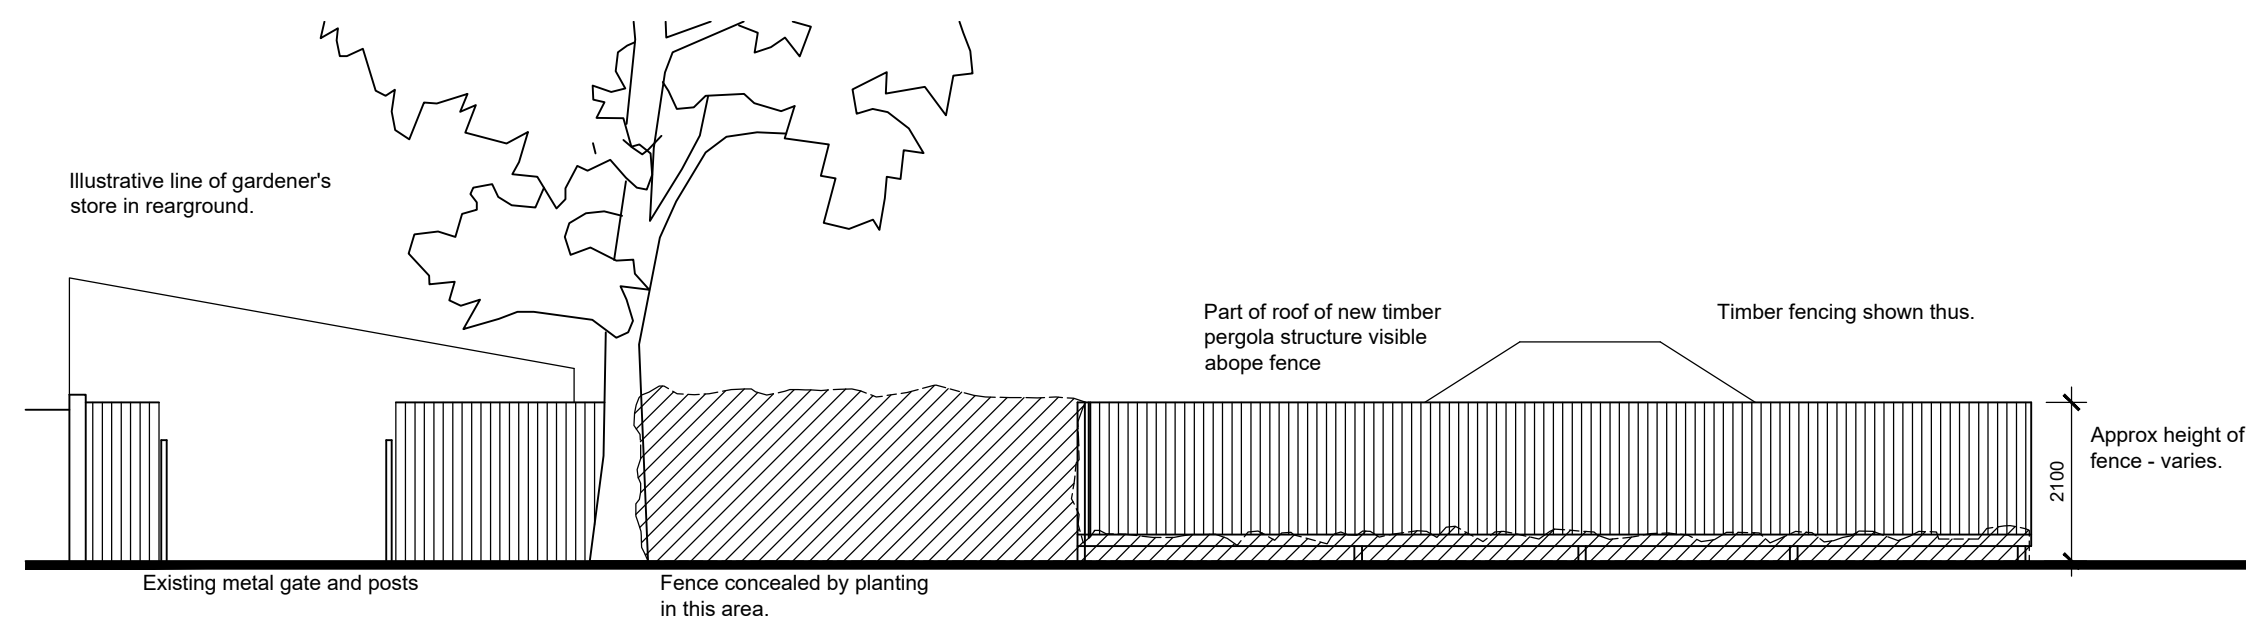
South elevation showing fence and pergola in rearground  
Scale 1:100  
SCALE 1 : 100  
SCALE 1 : 1

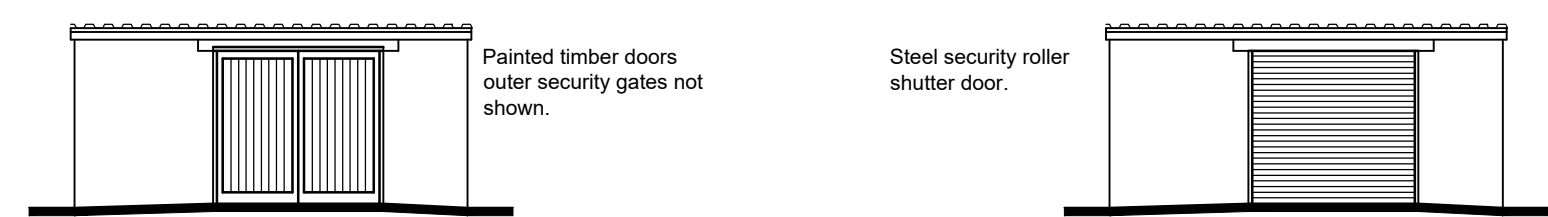
East elevation of Gardener's Store as existing  
Scale 1:100  
SCALE 1 : 100  
SCALE 1 : 1

East elevation of Gardener's Store as proposed  
Scale 1:100

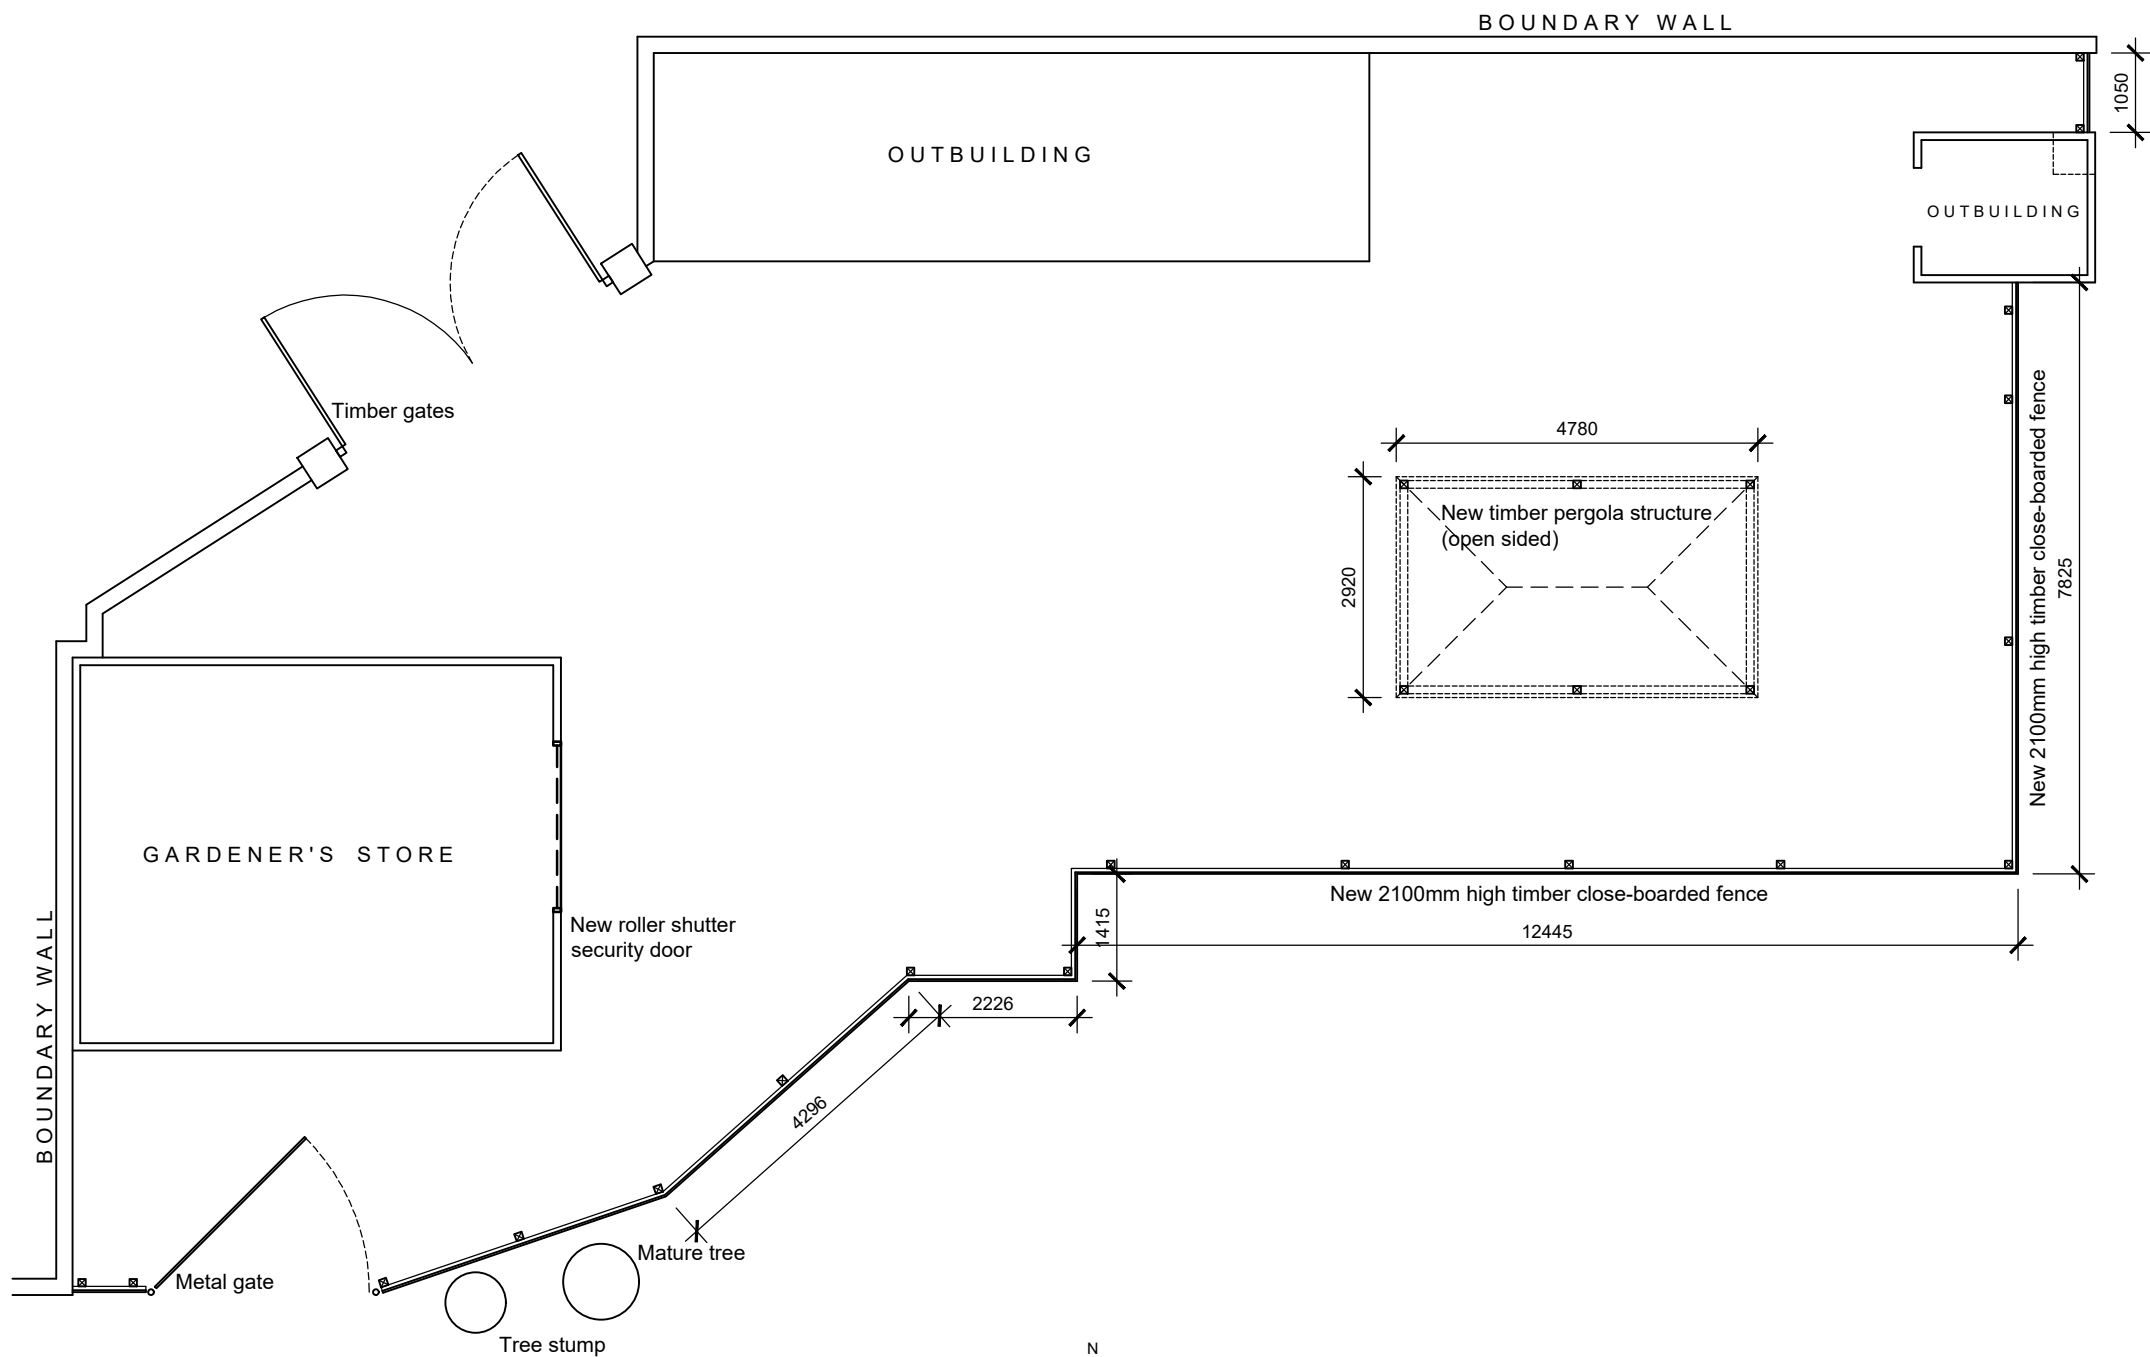
Plan of Gardener's Area after 2021 / 2022 works - proposed  
Scale 1:100

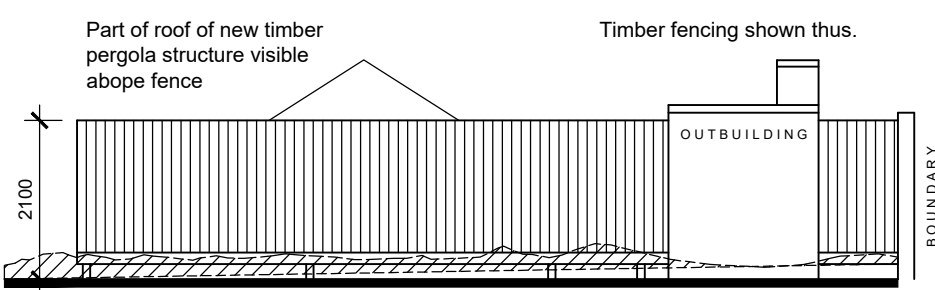
East elevation showing fence and pergola in rearground  
Scale 1:100

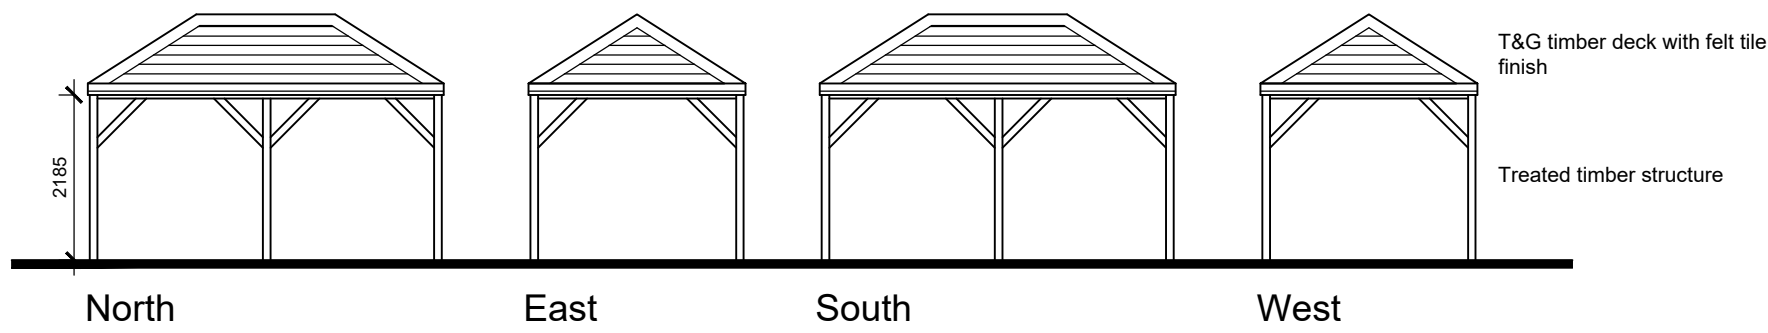
Indicative Elevations of timber pergola structure  
Scale 1:100

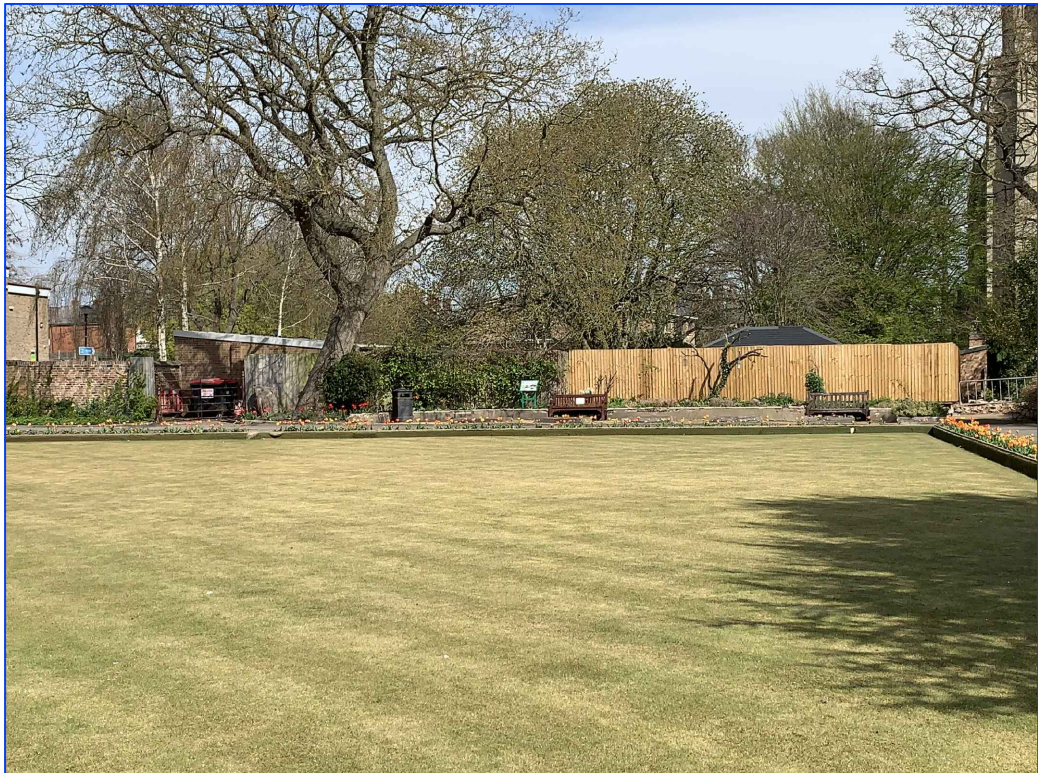
View from south, fence and pergola visible right of centre

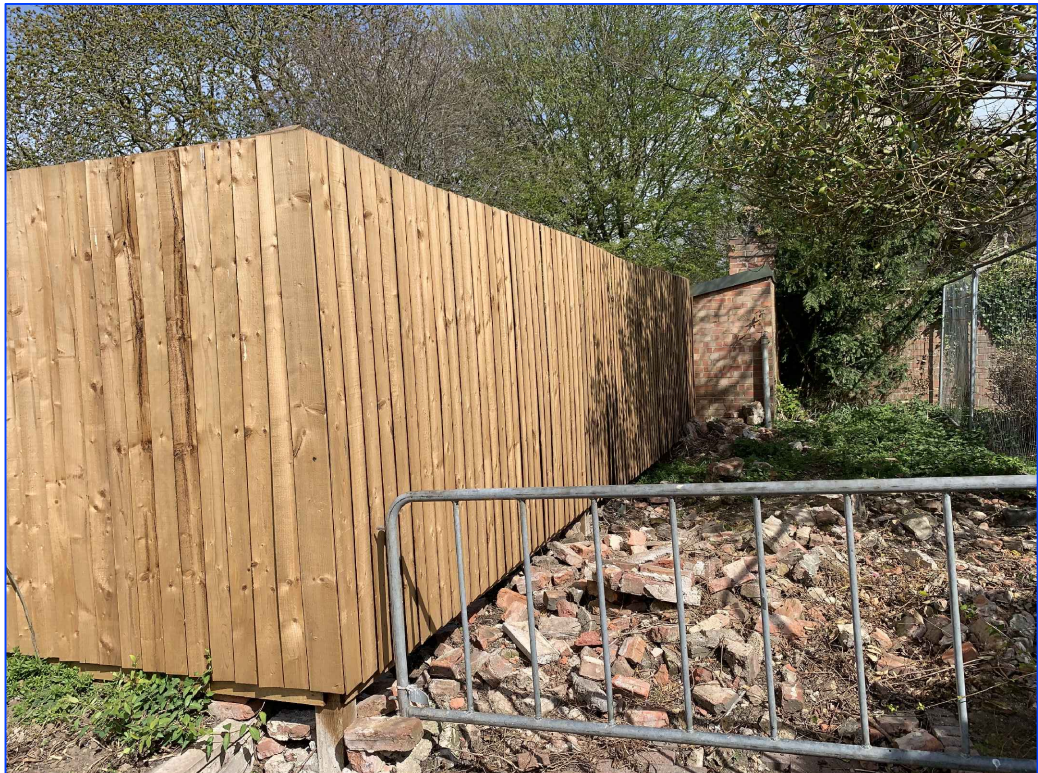
View from south showing new fencing.

- 1.2 Part of the assessment is retrospective and is in support of works carried out to items within the Gardeners Area namely:
  - 1.2.1 The replacement of close boarded fencing that had deteriorated over time and damaged by high winds

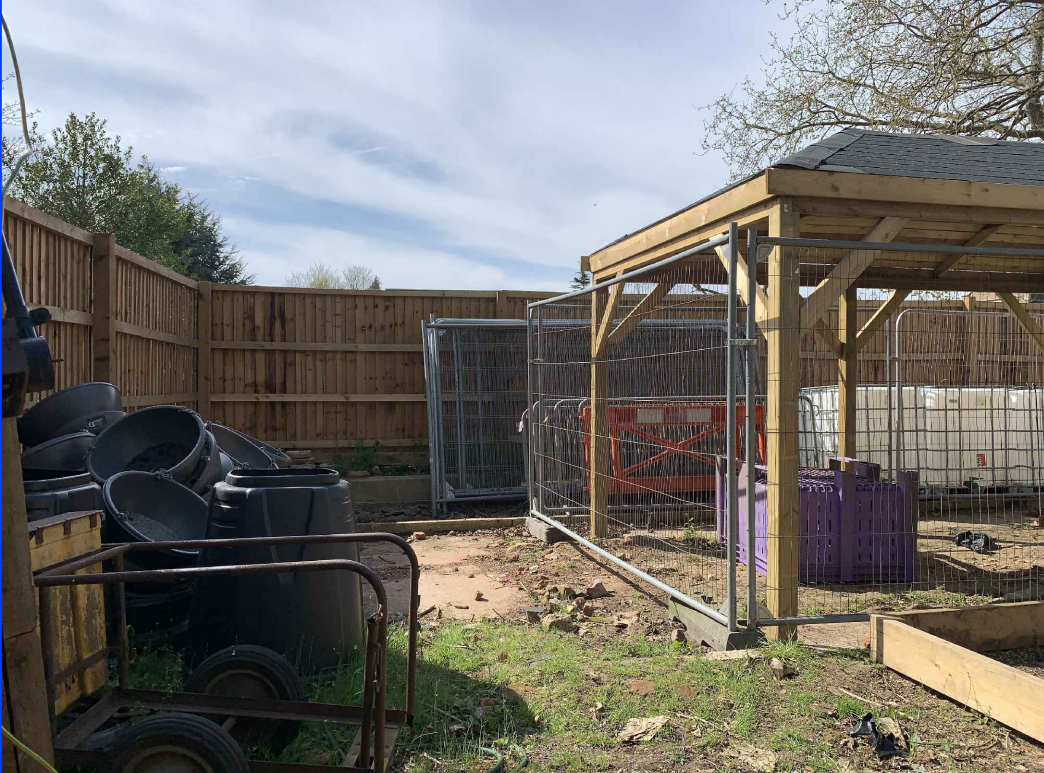
View of fencing from inside gardener's area
