# Heritage Impact Assessment

Demolition of greenhouse, erection of fencing, pergola and replacement of door within the Gardeners Area at Ayscoughfee Hall, Love Lane, Spalding, Lincolnshire

On behalf of South Holland District Council

A1572GA – HIA rev P1

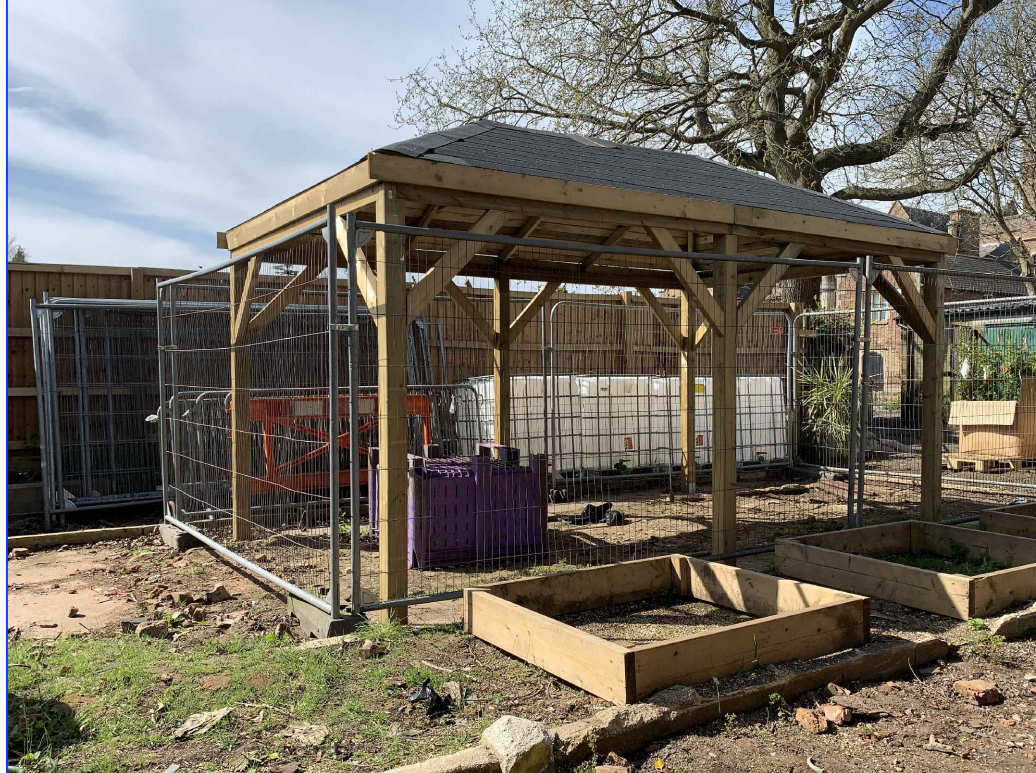
View of timber pergola

5.3.5 The construction is bolted down to the existing concrete so that it is easily reversible should a different use be needed for the area or a more historic reference is found.

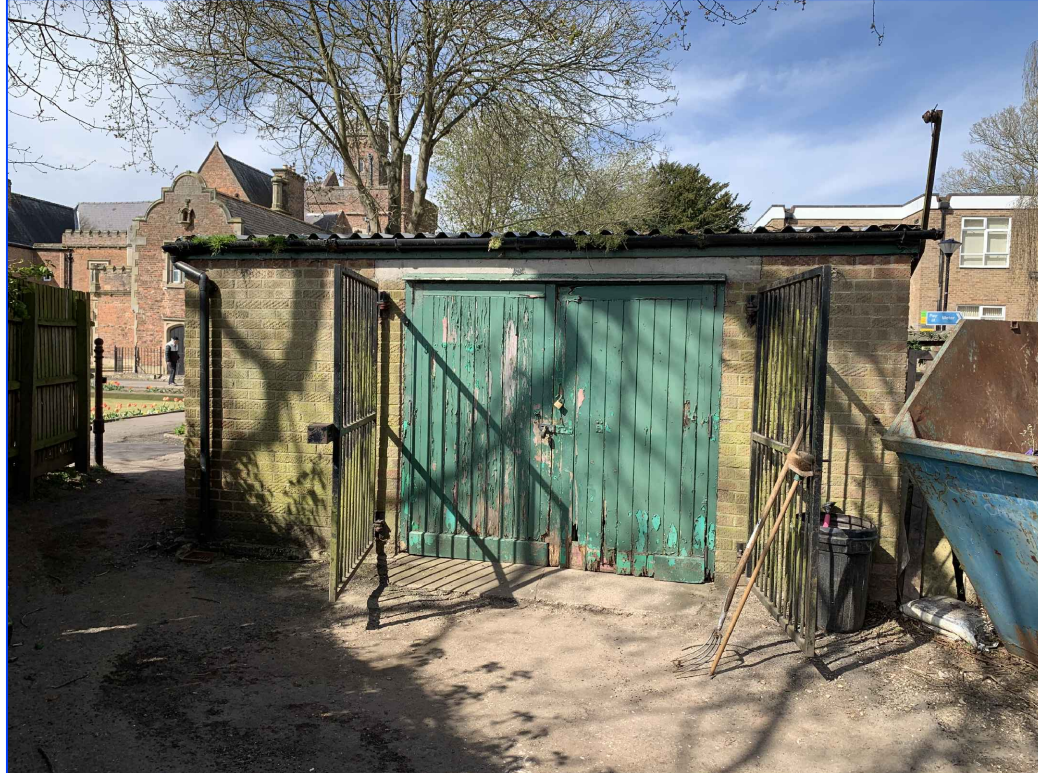
View of gardener's store door to be replaced

- 5.4.2 The timber doors to the store are softwood framed. Ledged and braced doors from the same period as the building. The doors have deteriorated over time and are beyond repair, they are both difficult to use and make the store vulnerable to theft. Steel gates have been fitted to protect the garden equipment kept in the store and these impede the movement of machinery. A metal roller shutter door would be more secure in itself and allow the removal of the steel gates should that be required.

**Fig 15** The doors to the Gardener's store which are to be removed and replaced with a roller shutter door
