Monks House Lane West
Spalding

**Combined Phase I Desk Study and
Phase II Exploratory Investigation
For
Seagate Homes**

Project No: D44118		Date: 14 th March 2025	
Issue/revision	Prepared by	Checked By	Approved By
	Thomas Archer BSc (Hons) FGS Senior Geo-environmental Engineer

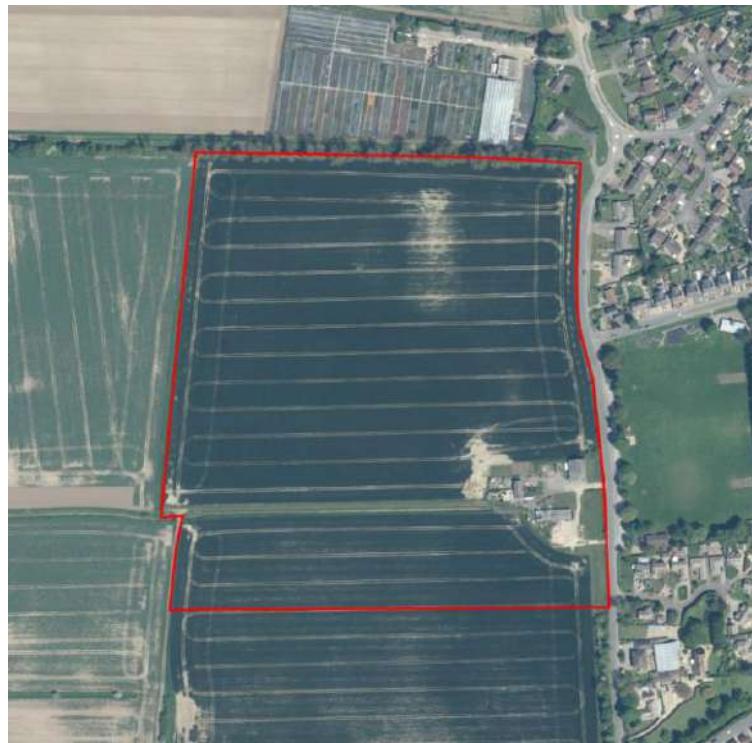
Figure 1: Aerial photograph of the site (2025 image).

An aerial photograph of the site, obtained from the Landmark Analysis tool commissioned as part of our works, is presented in Figure 1 on the next page, with the current OS mapping plan for the site and surrounding area presented in Figure 2. The site boundary is delineated in red.

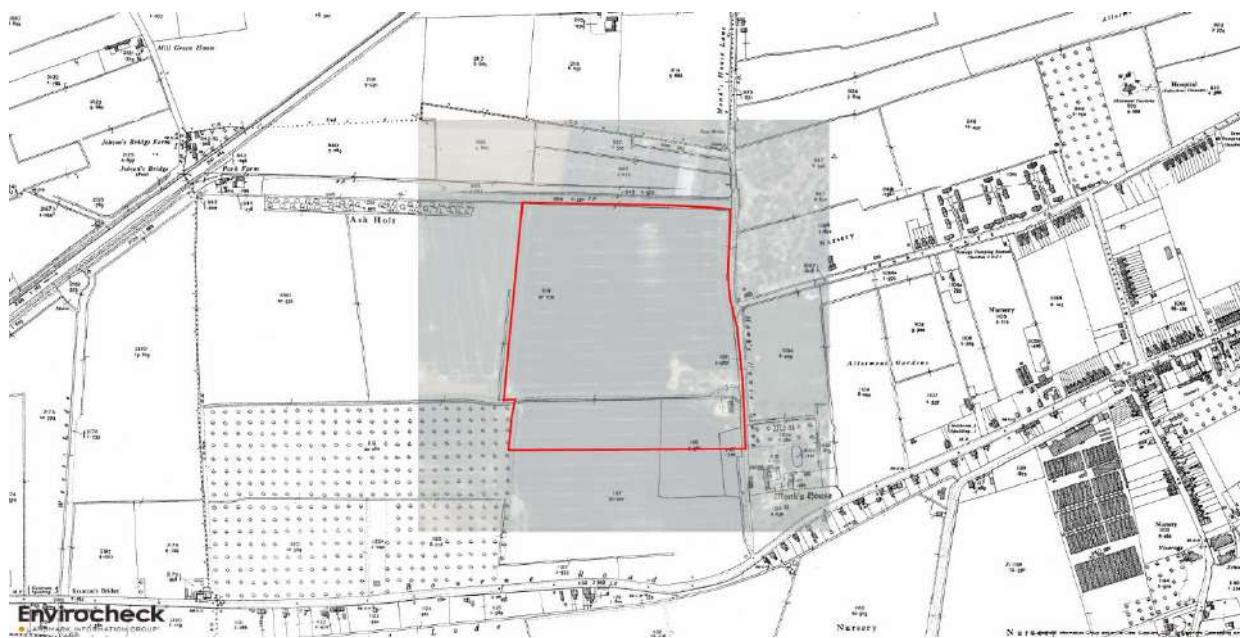
Figure 4: Current Aerial Imagery Overlain with 1931-1932 Historical Map Data.

A small rectangular building is present in the southeastern extent of the site. Several drainage ditches located in the northern, southwest and southeast parts of the site are no longer shown. A track is present running along the northern edge of the drainage ditch in the southern extent.

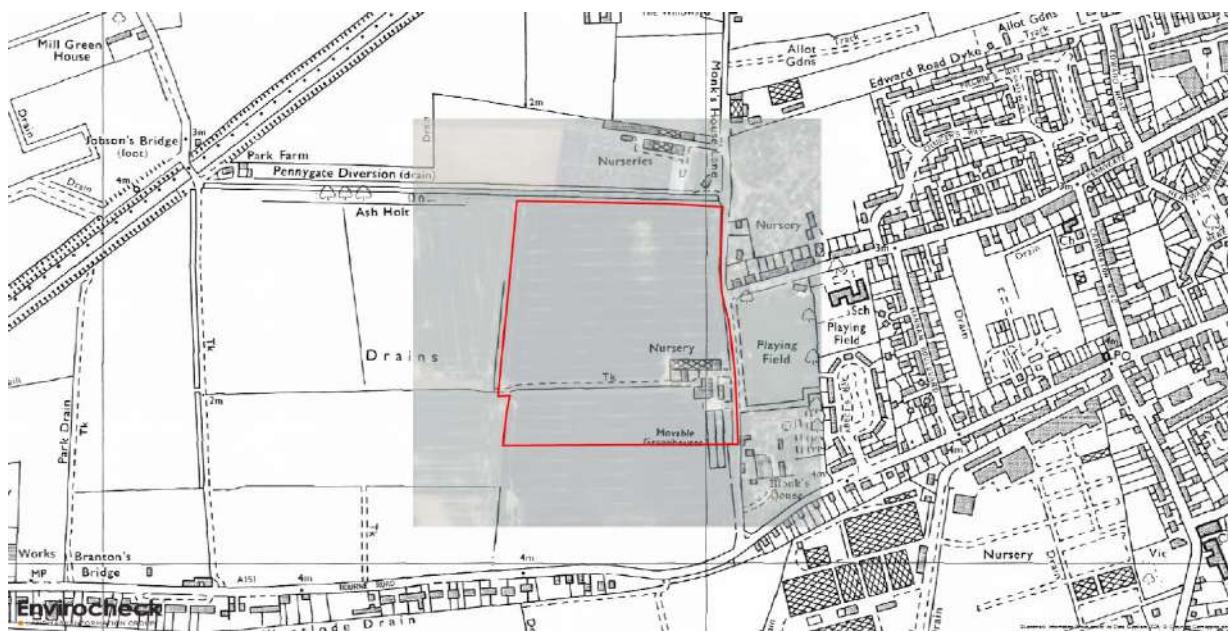
Figure 6: Current Aerial Imagery Overlain with 1982 Historical Map Data.

Two large rectangular moveable greenhouses have been constructed in the southeastern extent of the site extending beyond the sites south boundary.

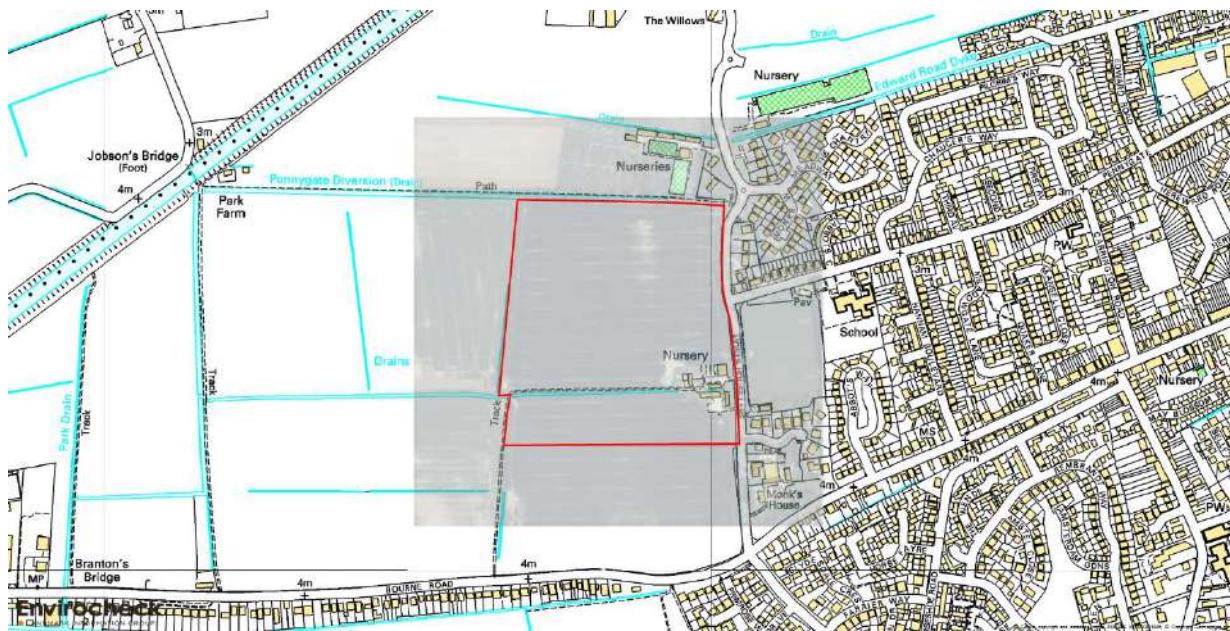
Figure 7: Current Aerial Imagery Overlain with 2006 10K Raster Map Data.

The moveable greenhouses and the nursey buildings are no longer present.
