Our ref: D40178/SS

**Re: Validation Sampling Report – Locksmill Farm, Spalding**

**Site Plan Showing General Site Views  
(Figure No. D40178/01B)**

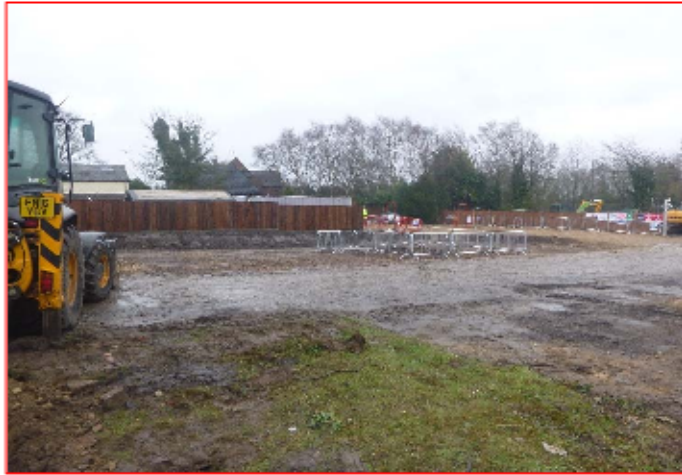
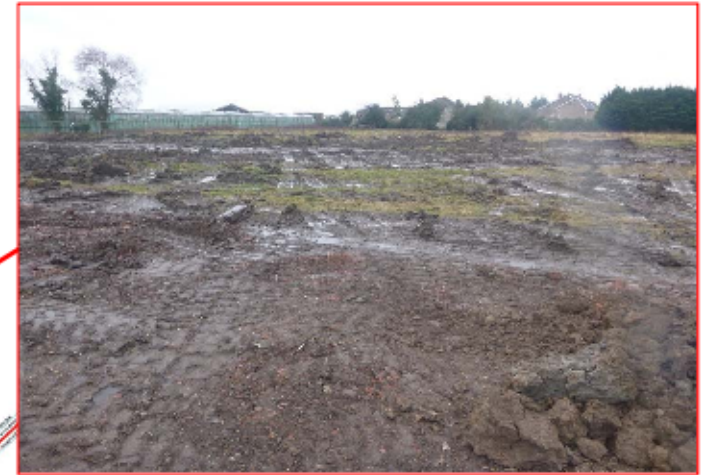
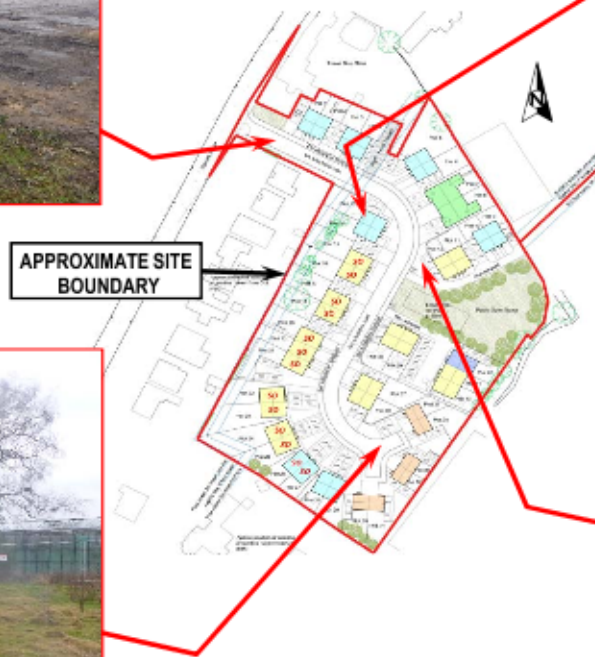
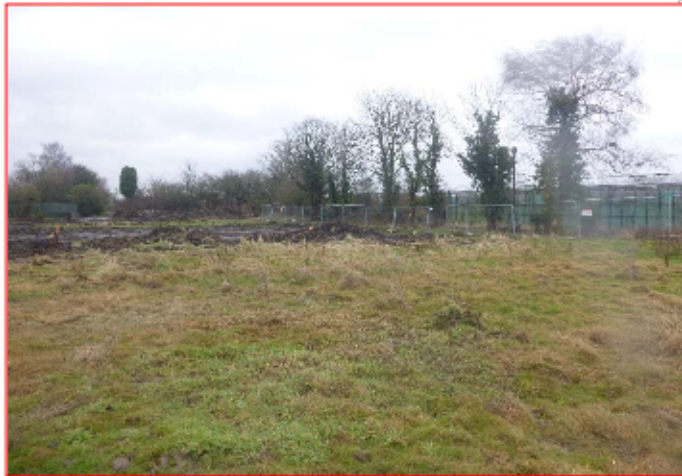
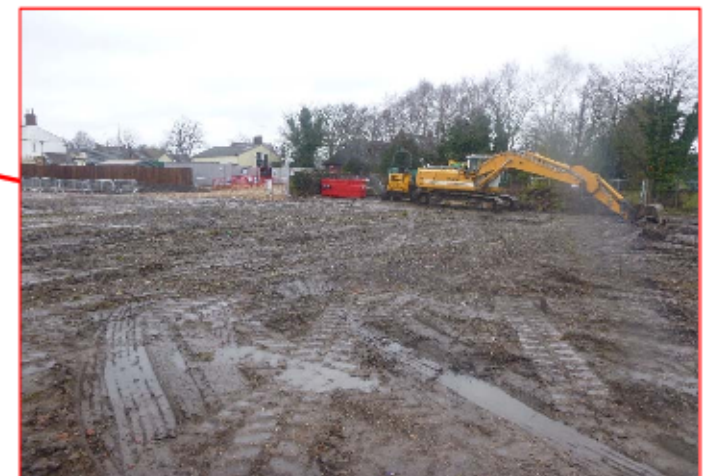
The site (known as Locksmill Farm) essentially comprised, until recently, two open fields with dilapidated farm buildings in the northwest of the site. At the time of our most recent visit (March 2021), the site generally comprised open ground following site clearance works, including the removal of trees, a partial topsoil strip and the demolition / removal of the former buildings in the northwest of the site.

General views of the site (following the site clearance works) are included on the plan in Appendix I of this report (Figure No. D40178/01B). Locksmill Farm is proposed to be developed for a low-rise residential end-use.

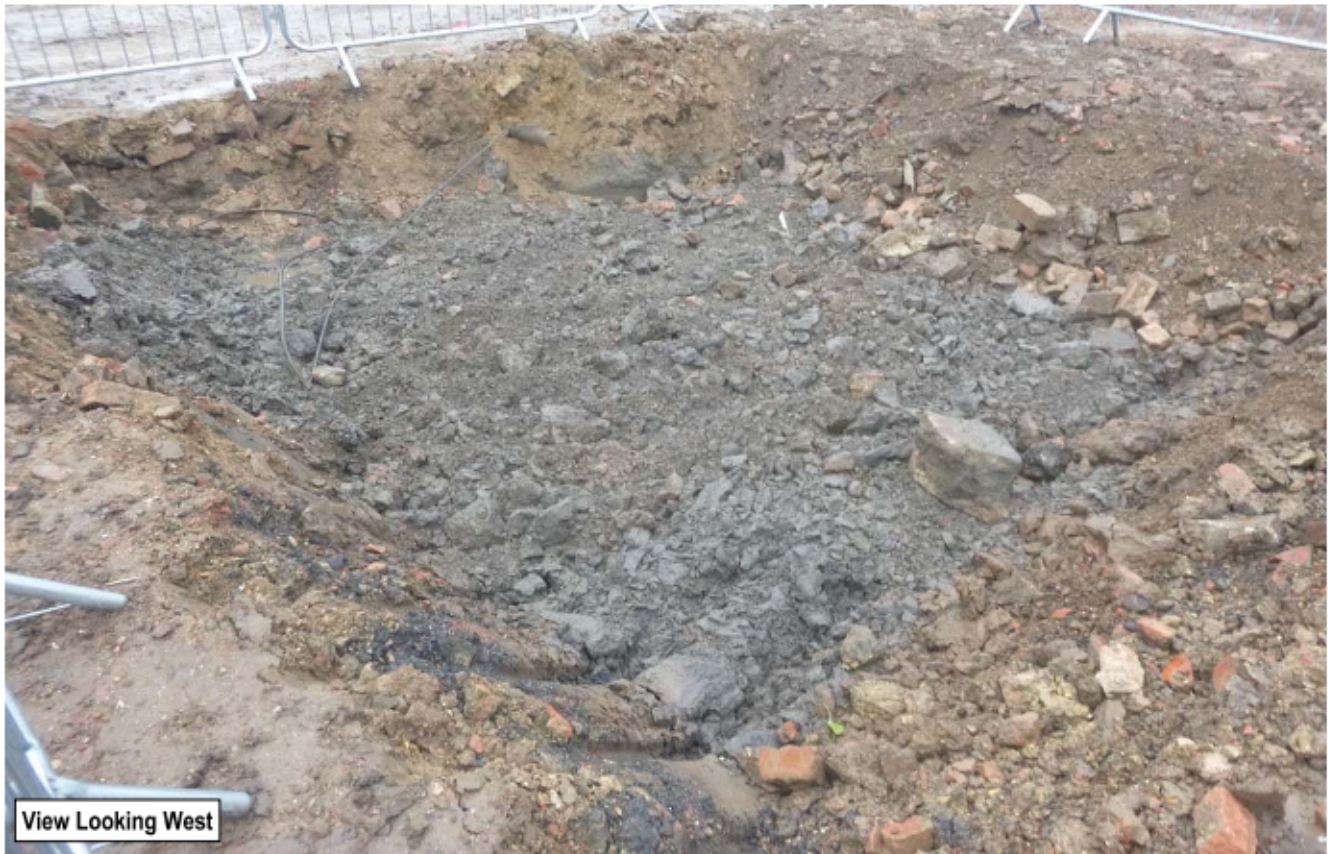
View Looking West

The walls of the excavation were noted to initially comprise Made Ground to depths of circa 0.70m below existing ground level (begl). The Made Ground generally comprised loose to medium dense grey-brown very silty very sandy gravel with occasional broken brick. The underlying Natural Strata generally comprised soft to firm grey-brown sandy SILT, and this also formed the base of the excavation, albeit it with some of the Made Ground at surface which had fallen into the hole following the dig-out. The Natural Strata are considered to be typically representative of the Tidal Flat Deposits, which are indicated from geological information to underlie the site.

Views of the open excavation are included in Plate 1, presented in Appendix IV of this report.

| Title | Views of Open Excavation<br>(following removal of soils from site) | Rev. | |

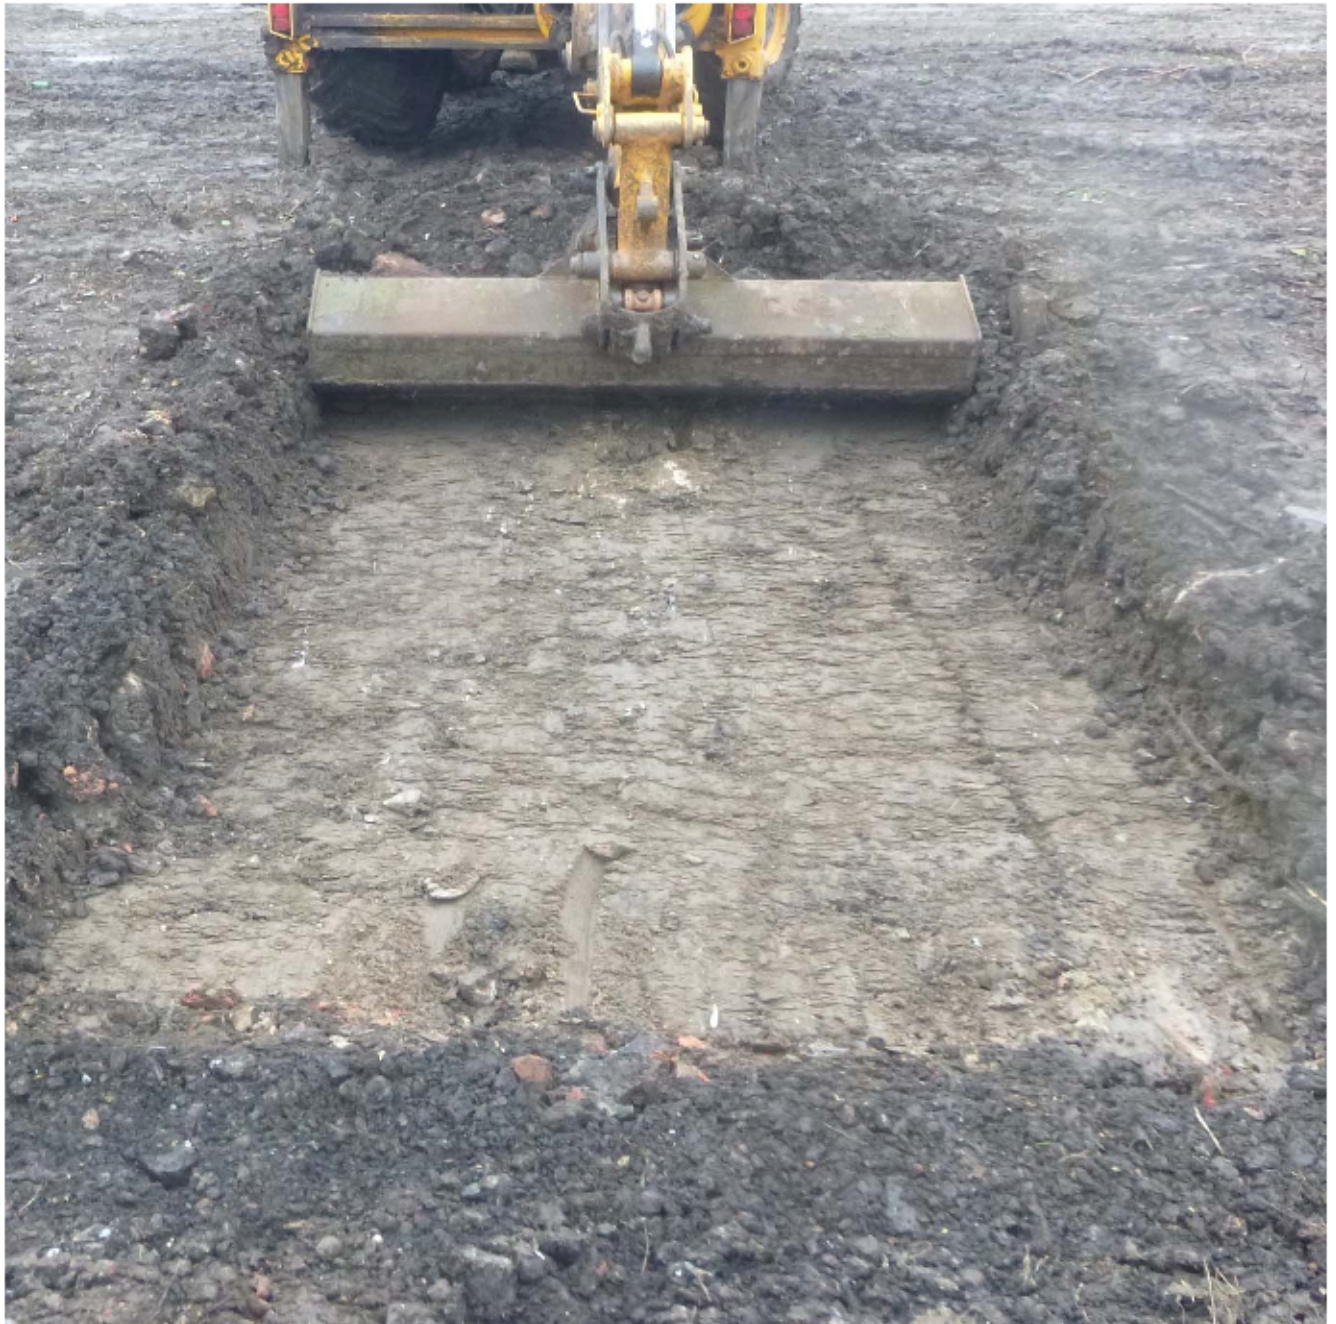
**Plate 3**

In addition to the validation works, it was considered prudent to undertake a visual inspection of the shallow soils beneath the observed ex-situ location of the AST. The tank had been removed from site prior to our visit on 10<sup>th</sup> March 2021. This area of the site was scraped, on the day of our works, with the ditching bucket of the excavator and Natural Strata (firm Silt) was encountered near surface from approximately 0.20m begl. No obvious visual or olfactory evidence of significant hydrocarbon contamination was identified by the attendant engineer. Plate 3 (in Appendix VI) shows these inspections in progress. The plan presented in Appendix II also shows the approximate area of the scrape.

| Title | Ground Scrape in Progress | Plate No. | 3 | |
