### **Paint Analysis**

Ayscoughfee Hall Gates

May 2022

**Client: Oglesby & Limb Architects**

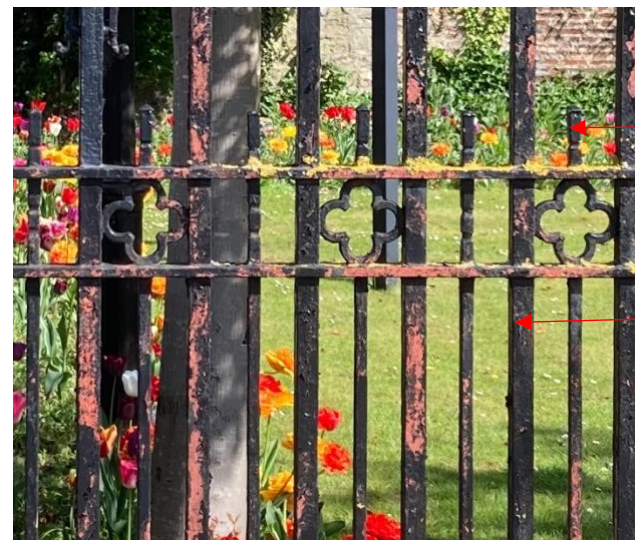
6. tip of thin vertical bar

5. Thick vertical bar

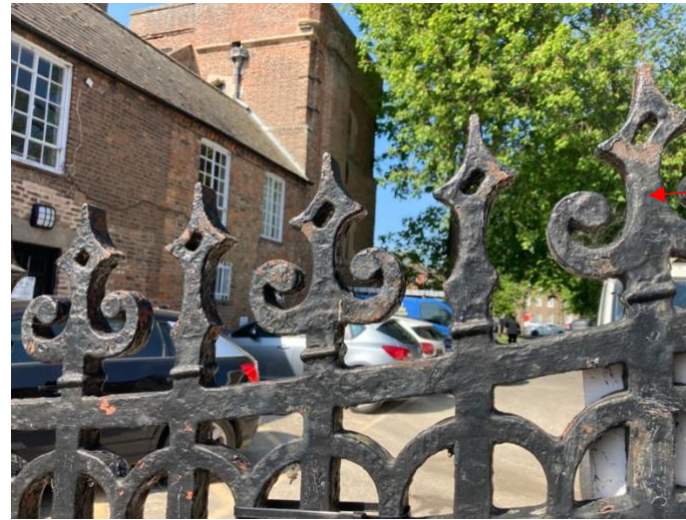
11. scroll tops
