**DESIGN & ACCESS STATEMENT  
INCORPORATING HISTORIC IMPACT ASSESSMENT**

**PROPOSED REFURBISHMENT & MINOR  
INTERNAL RECONFIGURATION OF FLATS**

**No.s 7 & 7a LONDON ROAD  
SPALDING  
LINCOLNSHIRE  
PE11 2TA**

**LISTED BUILDING CONSENT APPLICATION ISSUE**

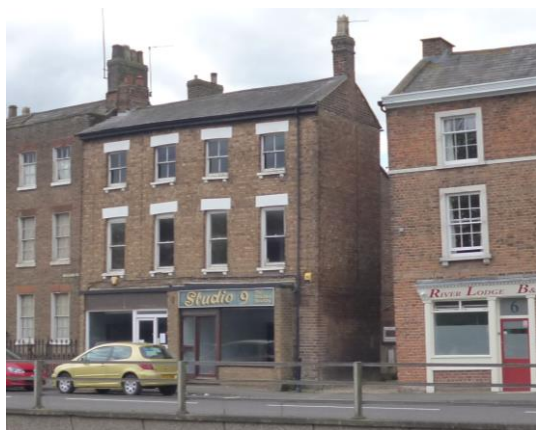
Fig. 01 – 7 & 7a London Road

Numbers 7 and 7a London Road form a semi-detached block which features shops at pavement level with residential accommodation above (fig. 01). The east façade of the main building stands tight to the rear edge of the footpath and, together with neighbouring properties, defines the west side of London Road. Essentially this section of London Road is defined on the west side by two and three storey buildings set close to the pavement and on the east side by the vertical bank of the River Welland. The site of the works here proposed is one of a number of buildings forming a relatively continuous facade, typical of the urban development grain along London Road. Moving slightly south from the site the properties step back from the pavement and form an unbroken terrace; this being known as Welland Terrace (fig. 02). The dominant architectural style in the vicinity of the site is late Georgian (early C18) though the building on the proposal site and those immediately abutting are significantly later.

The main element of the building is the east block which stands parallel to London Road and is a full three storeys in height (fig. 01). Immediately abutting the west elevation of the frontage block is a further three storey block that runs almost the full width of the frontage block (fig. 03). Although also of three storeys, this has a slightly lower overall height and indeed the roof over it is now a lower continuation of that over the frontage block. Moving to the west again is a small block running perpendicular, along the south boundary of the site (fig. 04). This ancillary block contains a communal staircase and stores and is lower at two storeys.

The site boundaries are as defined within the site description above and as indicated on the site plans. The east boundary is formed by the building frontage which directly abuts the rear edge of the footpath to London Road (fig. 01). The south boundary abuts number 8 London Road, the west boundary is formed by the rear elevation of the single storey block. The north boundary is formed by the boundary wall with number 6 London Road (fig. 06).

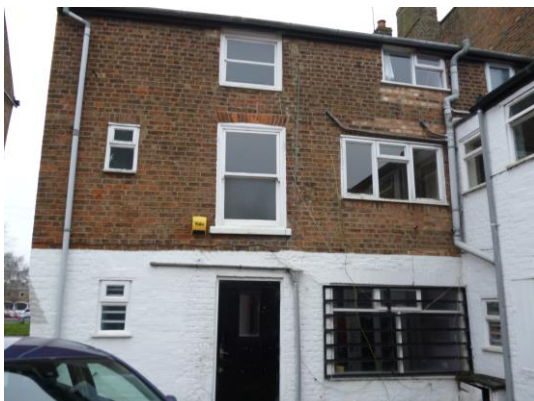
Fig. 03 – Rear block abutting west of frontage block.

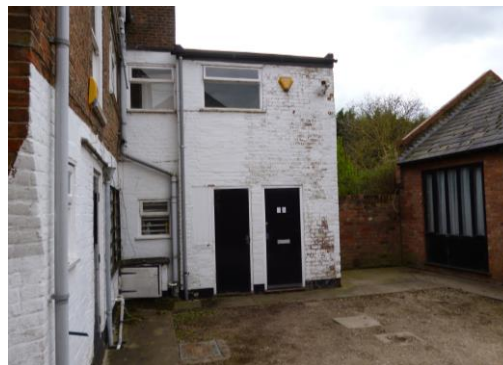
Fig. 04 – Ancillary block to south boundary.

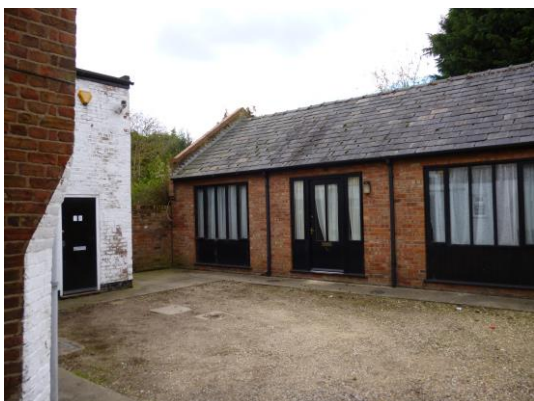
Fig. 05 – Courtyard and single storey rear block.

To the west of the block described above is a partially enclosed courtyard (fig. 05) and to the west of that stands a single storey building which is currently used for residential purposes. Access to the site is direct from London Road in the north-east corner of the site (fig. 06).

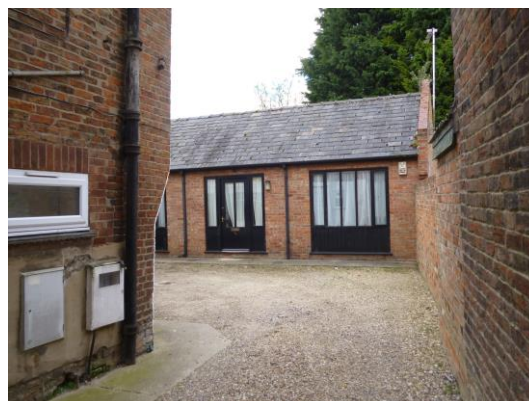
Fig. 06 – Site access point from London Road.

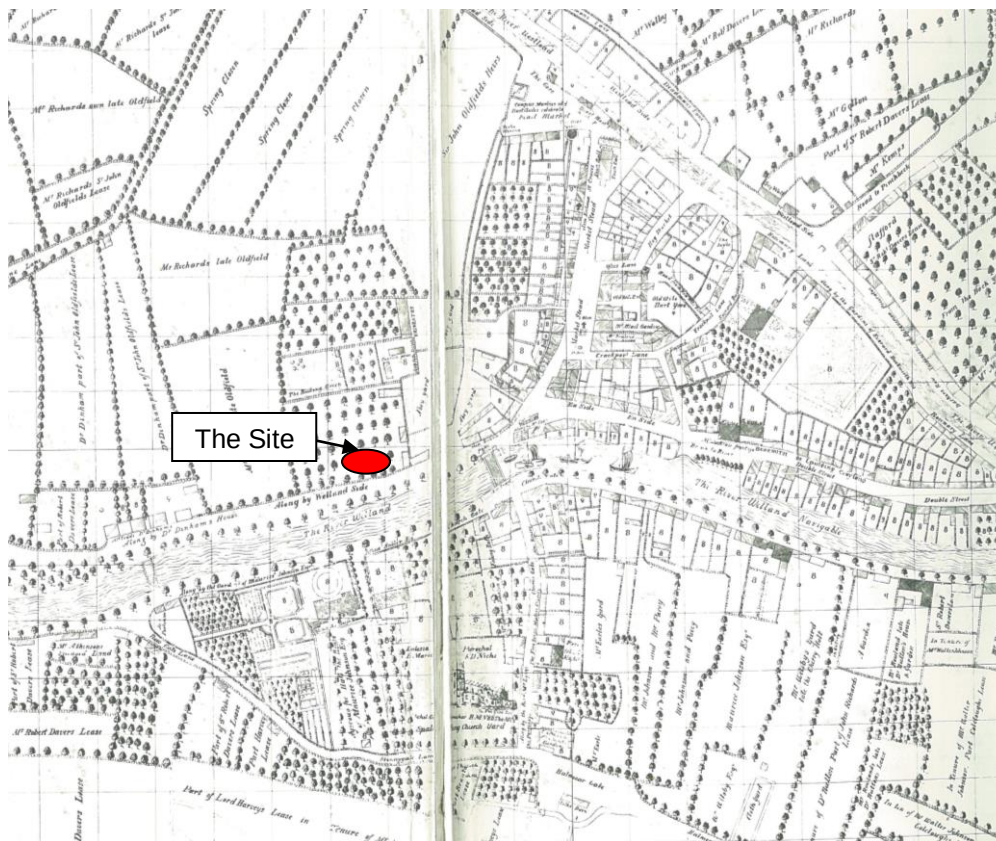
Fig. 07 - The Grundy Map 1732

The earliest map showing development in Spalding was produced in 1732 and is known as the Grundy Map (fig. 07). This shows early development on the river frontage south of the Market Place but the development that existed at the time does not appear to extend as far south as the development site. The nearby development shown to exist at that time appears to be approximately where the offices of Bulley Davy stand now, the footprint does not however reflect the extant buildings. It therefore appears that in 1732 the site was likely orchard associated with the Abbey (which stood a little to the west of the development site).

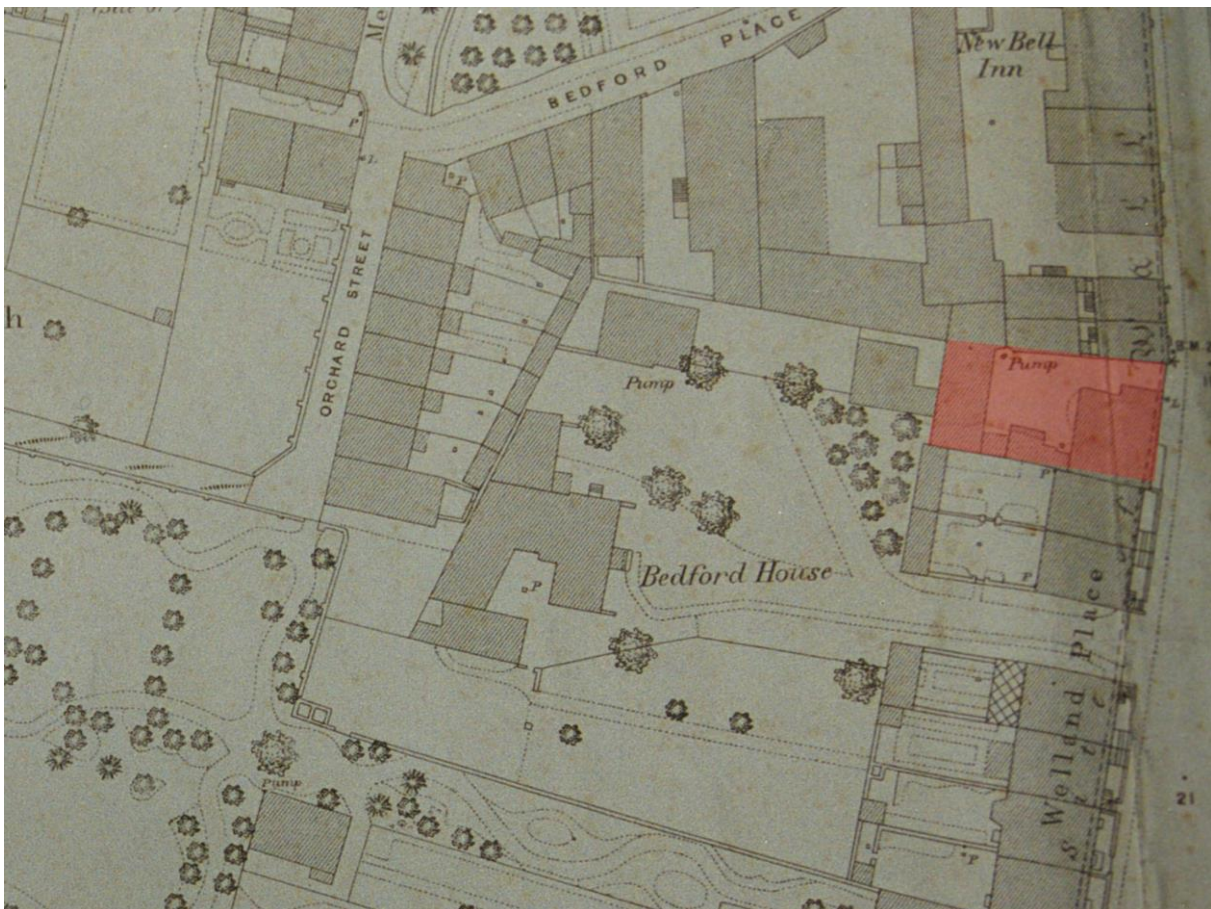
Fig. 08 - The Map of 1887 (site shaded in red)

The next earliest map referred to in this study showing development in Spalding was surveyed in 1887 for publication around the turn of the century. The amount of detail on this map greatly exceeds that on its predecessor and shows that considerable development has occurred by the end of the 19<sup>th</sup> Century. This map shows the general footprint largely as exists today except that there appears to be additional small scale development at the end of the south boundary block that is not evident in 2017. In addition, the single storey block along the west side of the site appears to have extended further north in to the adjacent site. From the evidence provided on this map it can be concluded that the bulk of this building was constructed between 1732 and 1887 which is in line with the listing text which dates it as 'Early to Mid 19<sup>th</sup> Century'.
