**Station House,  
Kings Road, Spalding  
PE11 1QB**

**CLIENT: Oliver Tookman**

**9th August 2021**

**HERITAGE ASSESSMENT**

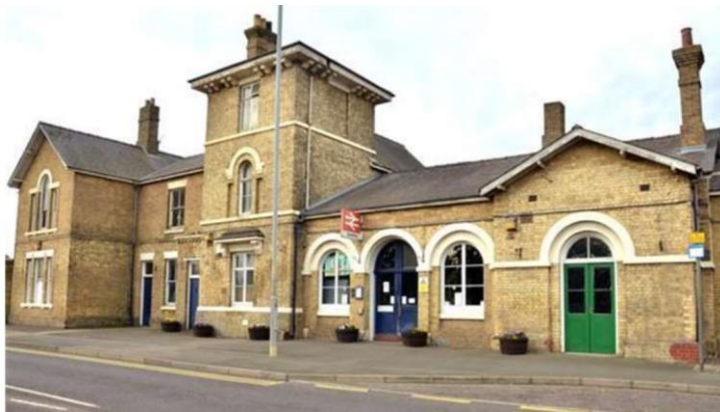
**Railway Station**

Station House is a large example of the housing constructed by the Great Northern Railway in the late 19th century to accommodate senior railway staff and their family. Its architecture demonstrates the high standing that such staff had in society at the time and the importance of the railway to the town's development.

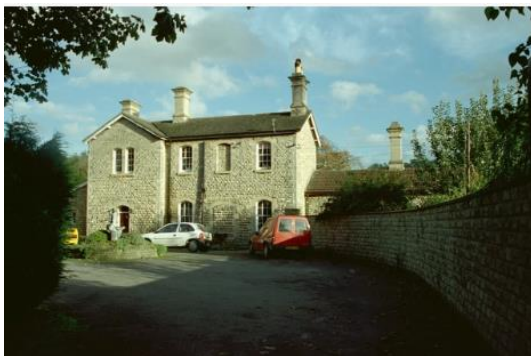
**Old Station House in Leadenham**

The Old Station House in Leadenham was built in 1876 for the Great Northern Railway. It is listed for its architectural interest as a good example of a well-proportioned composition with attractive ashlar dressings. The building has a chamfered plinth, quoins and pitched roofs with exposed rafter feet and plain bargeboards. The two ashlar ridge stacks and single lateral stack have rock-faced stone plinths and moulded oversailing cornices.

Despite its conversion to domestic use, it has kept its original architectural character and remains legible as a former railway station. It shows how the various functions of the railway were integrated into one building, as the central two-storey element has three bays (formerly the waiting room/ lobby) and a slightly projecting crosswing to the north (formerly the station master's house).

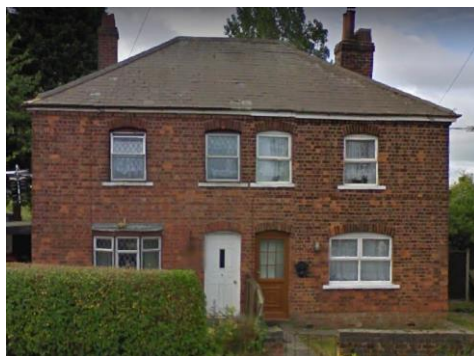
**Station House, Gosberton**

The Station House in Gosberton has a plainer brick front and is likely to have housed the Attendant as well as provide a waiting room area for travelers. Distinctive features of the front elevation are arched window heads over the sash windows.

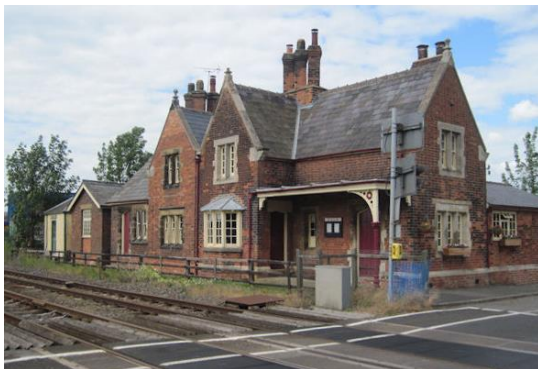
**Moortown**

The station house at Moortown, Market Rasen is another example of where the original waiting room, ticket office and station master's room were all contained in the same building. The building itself is of a grand scale with a pair of gabled bays and a steep roof with huge chimney stack.

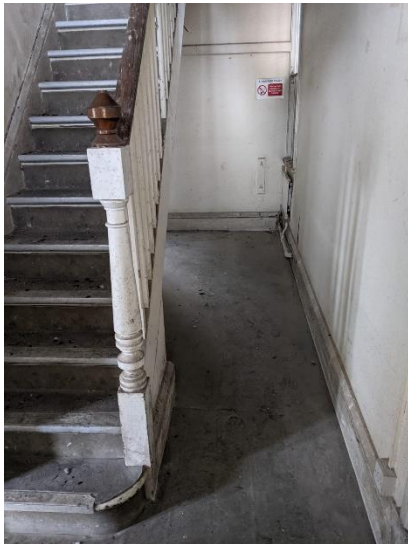
**Staircase**

Of some significance is the evidence of the staircase at the rear in the middle of the building, giving expression to the original vertical extension starting and ending at this point. It also gives an idea of previous movement patterns towards the back part of the building, The balusters and newel posts look 'historic' whilst the floor treads have been clearly strengthened to suit the more intensified uses of the first floor which happened later in the building's history.

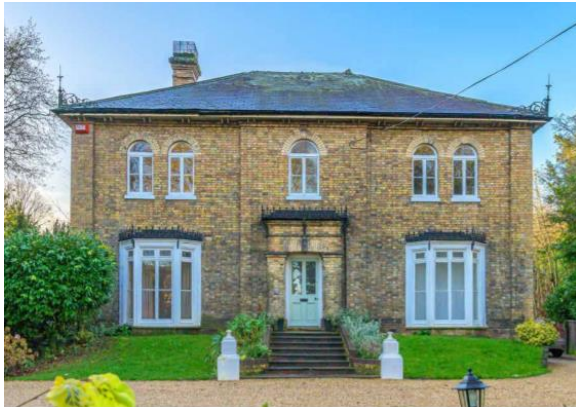
Mercia Lodge on Pinchbeck Road was a house, now offices, built in c.1867. It is built in yellow brick, has a shallow Welsh slate roof with overhanging eaves and is on two storeys with a five window front. This mid-19th century residential building is a distinguished example of the type of high status house being built in Spalding at the time of the towns growth.

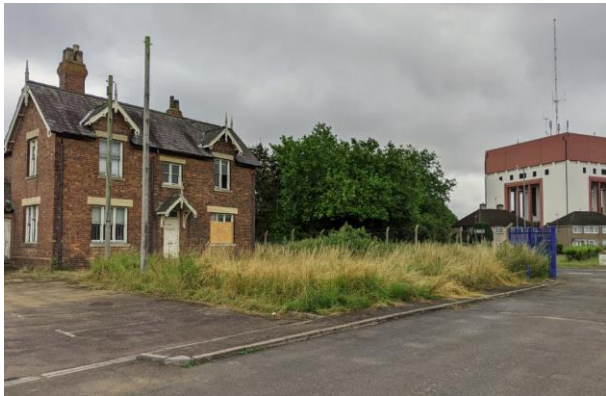
Now, with the inappropriately sized windows on all sides and the stone lintels, Station House does little for the surrounding buildings and their high-quality facades. The Victorian building is isolated in its context and does not warrant consideration as forming 'part of' a group of old buildings that mark the character of this part of Spalding.

**Station House and Chatterton Tower**

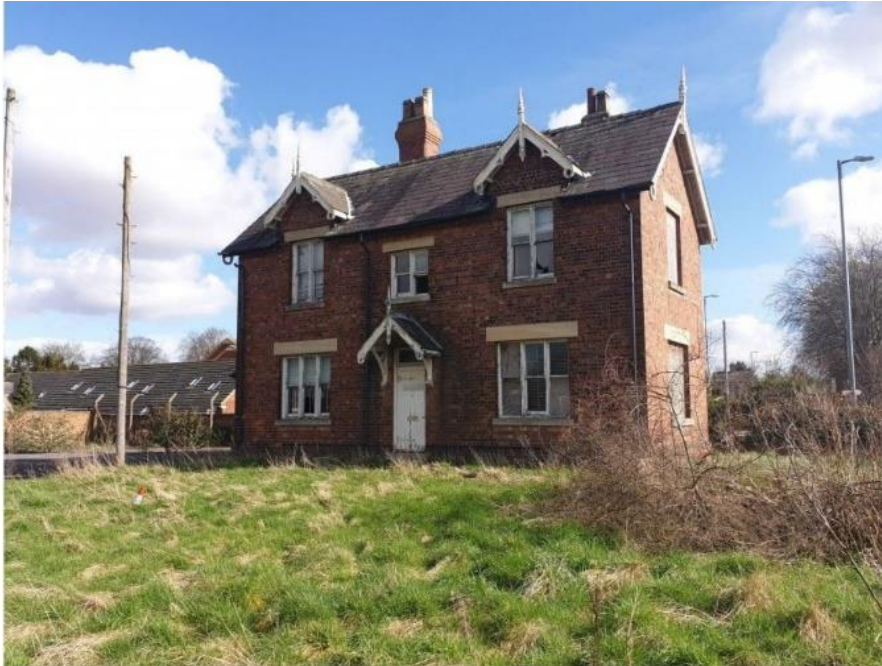
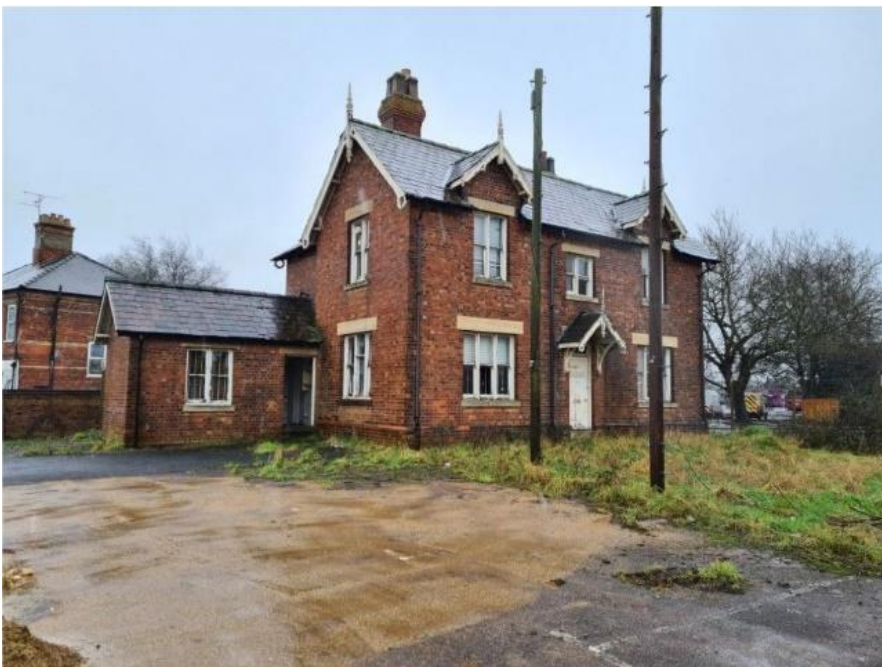
### WEST ELEVATION

The front (west) elevation is prominent and the double front gives it symmetry over the former station yard area. The central door is flush to the ground and a gabled canopy over the top forms a porch that is an architectural detail that is referred to in the roof top where two blind dormers are sited above the eaves. These gabled pediments are positioned off centre where they refer to the position of the ground and first floor windows.

On the ground floor there are two large three light sliding sash windows, whilst on the first floor above there is a smaller central window and a pair of two light sliding sashes. The blind dormers are noted for the decorative bargeboards and timber finials.

The west has mixed brickwork which may be a sign of Victorian creativity where different tones were interspersed in the front. The windows have stone sills and lintels.

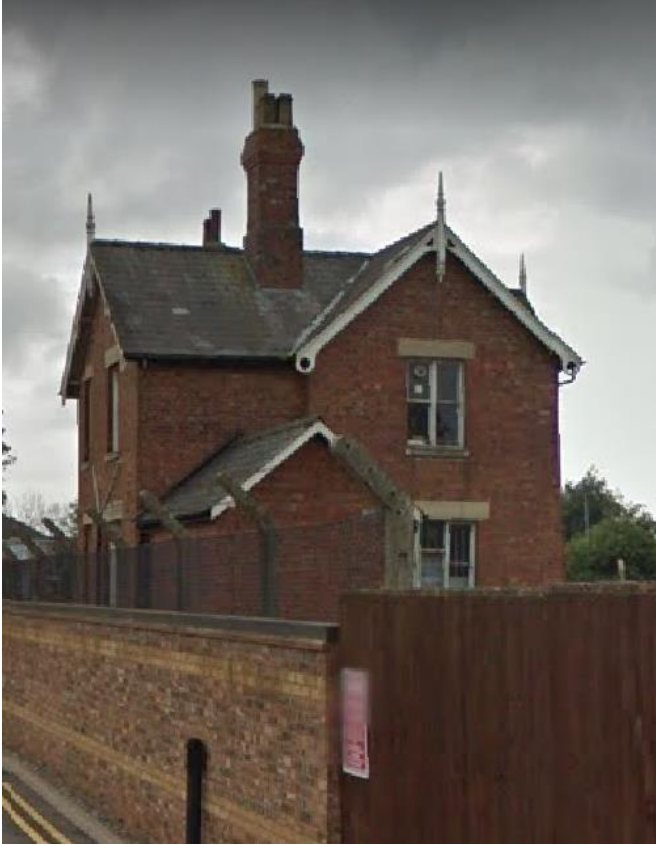
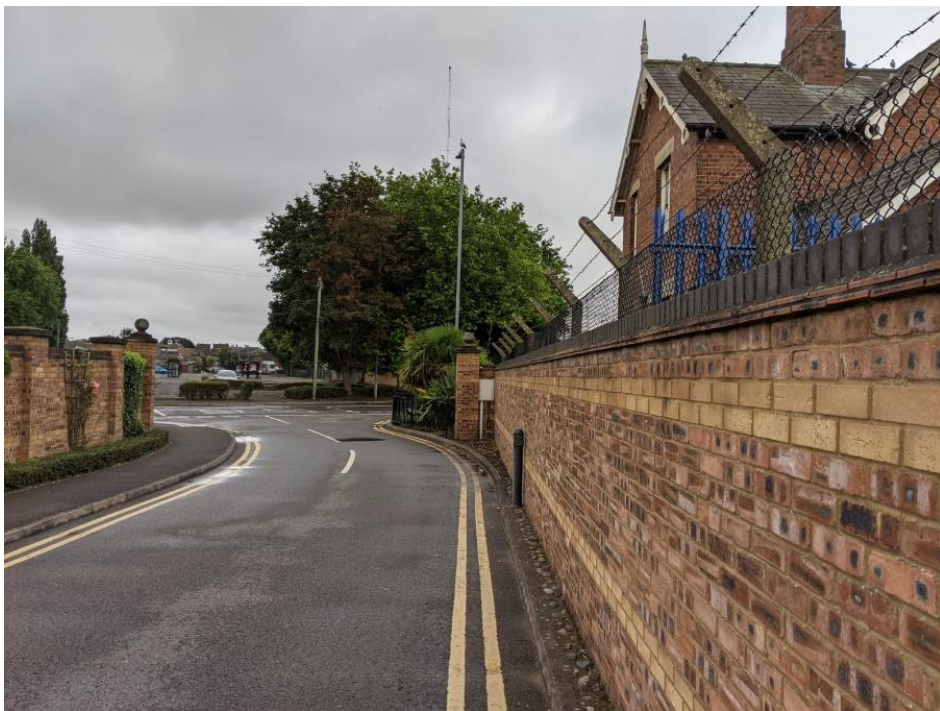
## NORTH ELEVATION

With regards to the brick outbuilding, the roof has been designed to reflect the pitch of the main roof., But the length of the structure does not relate to the proportions of the building it is attached to.

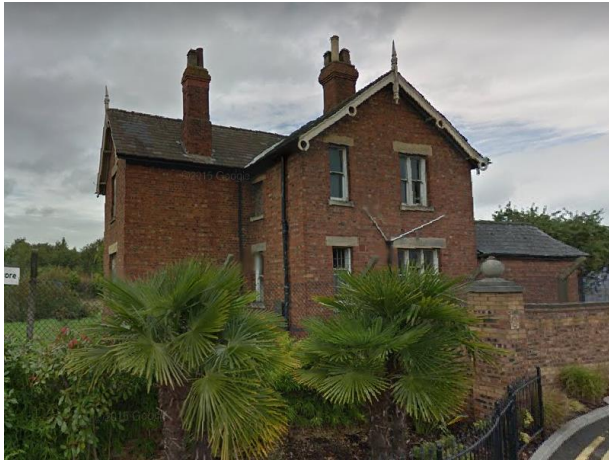
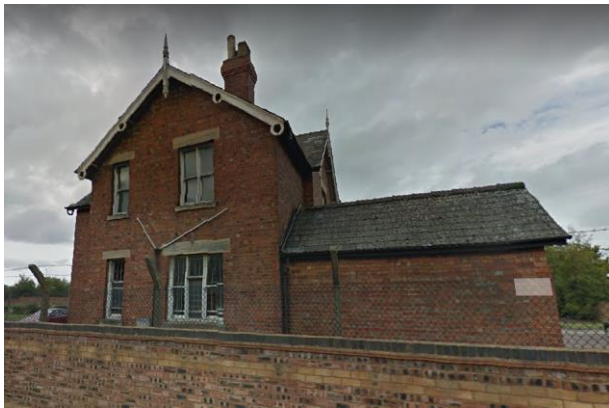
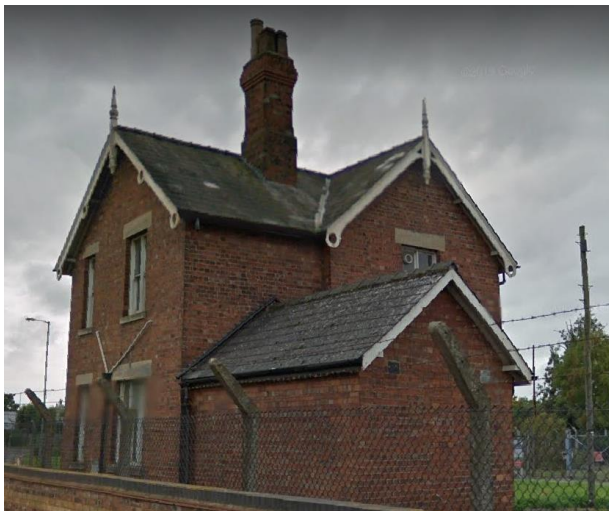
## EAST ELEVATION

Whilst the west side of the building is characterised by the unity in its fenestration, the east side is vastly different. As the gabled bay to the rear has 3 different sized windows on its main wall, whilst on the return wall to the southern part of the building it has 2 different sized windows.

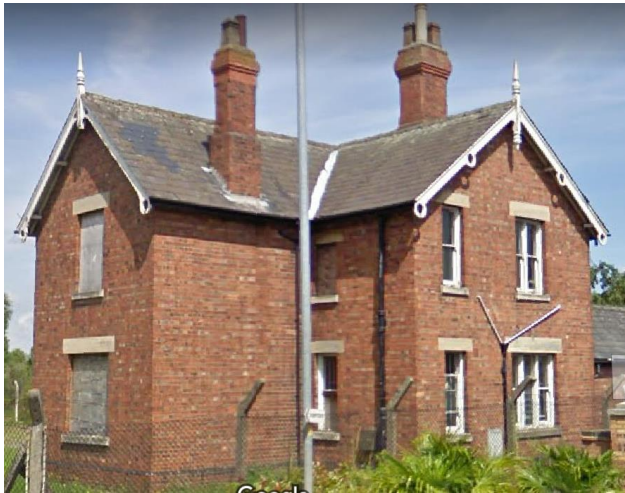
## **SOUTH EAST**

On the southern return to the east side the brickwork appears to be more recent than the older work to the front and there has also been some new brick in the wall that is without windows. This recent brickwork suggests that there may well have been windows here previously. On the main southeast gabled wall, two different window sizes are seen.

The windows here and on the other sides are squared or tapered and bear little relationship to the dimensions and style of the older windows seen on the western elevation.
