Heritage Impact Assessment

Proposed rebuild of collapsed section of Forecourt Wall

Ayscoughfee Hall Museum and Gardens, Church Gate, Spalding

A1572WR – HIA rev P1

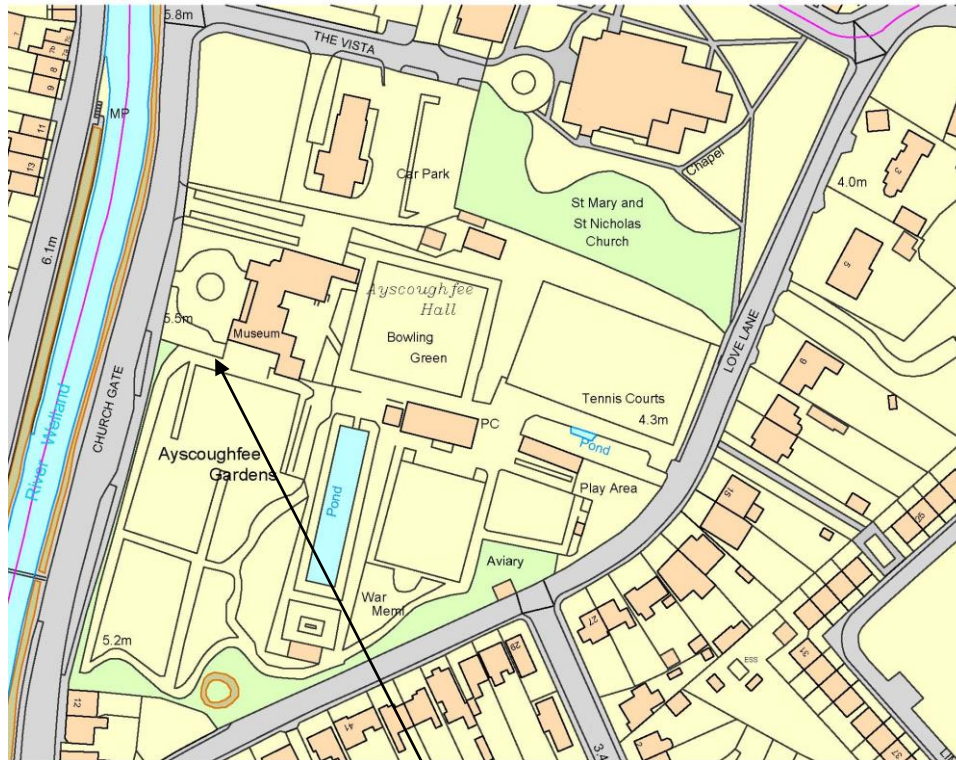
Fig 1. OS plan showing location of forecourt wall

The location of the wall is indicated in fig.01 below. The south face of the section of the collapsed wall to be rebuilt is shown in the fig.02. The locations is:

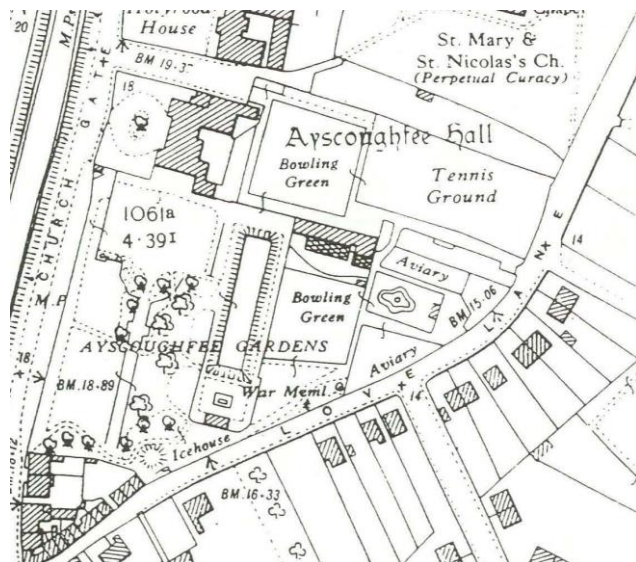
Fig 4. OS map of 1929

An OS map of 1929 (Fig 4) again shows a wall in this location.

This map was revised in 1950 and published in a less detailed version in 1952 but the layout does not change.

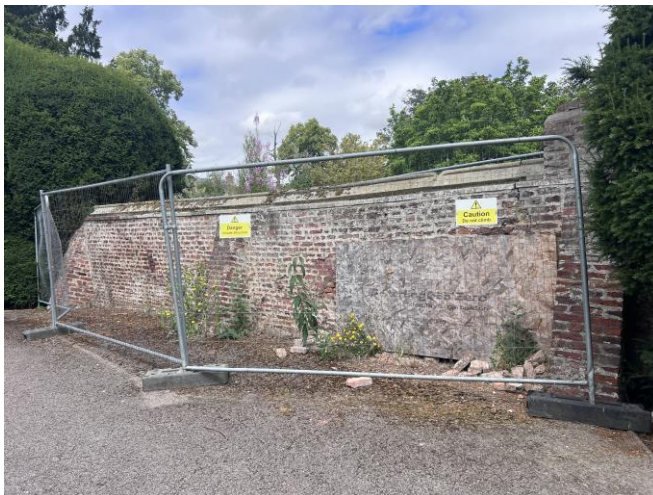
- 5.1.2 Along the whole length of the wall there are signs of repair and replacement.

The wall shows areas with the pointing being missing and of damage caused by the use of inappropriate mortars and poor workmanship.

Fig 5. General Photograph showing south wall of forecourt.

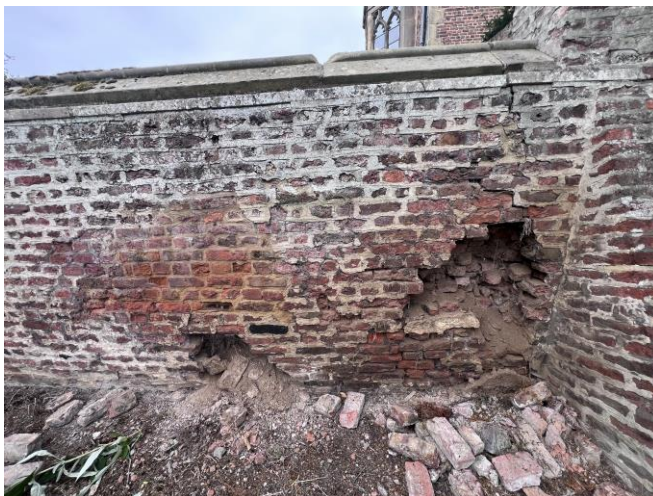
Fig 6. Detailed view showing south wall of forecourt.

- (i) Carefully remove the existing brickwork in so far as it is loose and unsound.
- (ii) Carefully remove all traces of mortar from the bricks to prepare them for reuse.

- (i) Rebuild those areas of the wall that have collapsed, with all brickwork to match and course through with existing abutting in all respects.
