Document Reference  
**876633-1**

# **SPALDING ENERGY EXPANSION**

## **SCHEME OF ENVIRONMENTAL ENHANCEMENT MEASURES**

**Details Pursuant to Condition (43) of the 2015 Deemed Planning  
Permission**

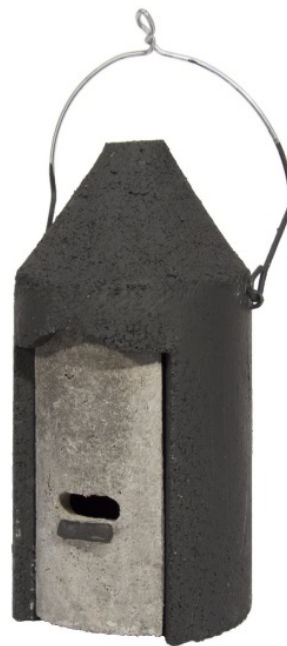
*Material:* Schwegler Woodcrete (a blend of wood, concrete and clay which will not rot, leak, crack or warp, and will last for 20 to 25 years).

The artificial roost box is designed as a summer roosting space and has a simple entrance hole at the front. The material is breathable and allows a stable temperature to be maintained inside the box. The proposed model is also painted black to absorb warmth.

It also provides a good rough surface for bats to cling on to and climb.

- Biannual Bat Activity Survey, and checks of box condition, by a suitably licenced bat ecologist.

- The box should be replaced if its condition deteriorates or if it is damaged. , However, if the box is occupied, bats can only be disturbed by a suitably licenced bat ecologist.

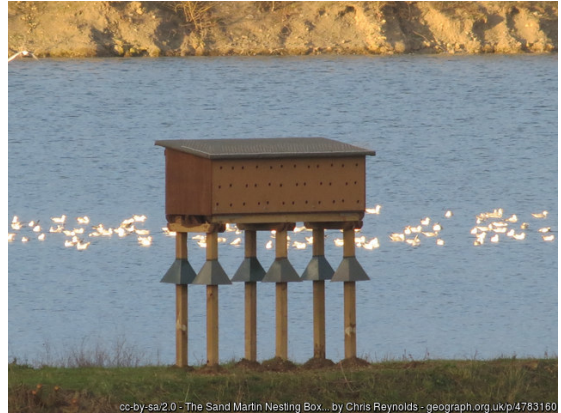
- Six 1 m-deep holes to hold upright posts;
- A timber platform approximately 1.8 m off the ground;
- Anti-predator skirts on the upright posts to deter land predators (e.g. foxes);
- Exterior shell of nest box from treated plywood;
- Approximately 36 PVC pipes fitted into exterior shell, part filled with sand, to mimic nesting preference of sand martin; and,
- A sand-covered front fascia panel to hide PVC pipes and provide rows of offset entrance holes, with each offset hold big enough for the sand martins, but too small for prefatory birds (e.g. gulls).

cc-by-sa/2.0 - The Sand Martin Nesting Box... by Chris Reynolds - geograph.org.uk/p/4763160
**Proposed Locations:** Refer to Figure 1.

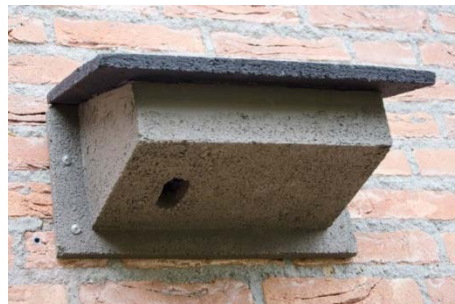
*External Dimensions:* 24.5 cm (h) x 38 cm (w) x 26.5 cm (d)

The nest entrance is on the underside of the box. This type of nest entrance is preferred by swifts, and discourages house sparrows (*Passer domesticus*) and starlings (*Sturnus vulgaris*) from occupying the box.

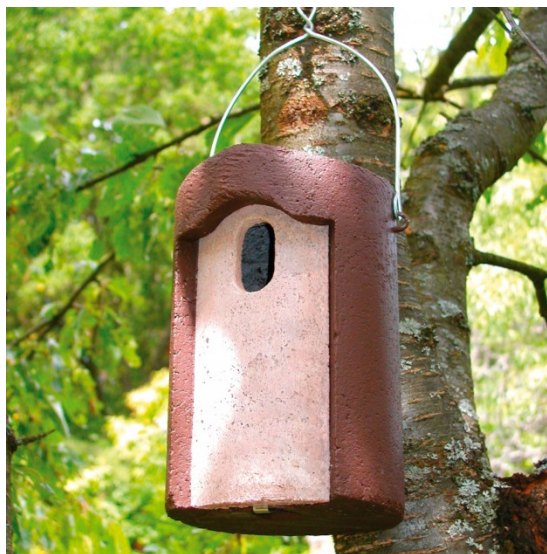
*Hole Diameter:* 32 mm

*Weight:* 3.6 kg

In addition, as house sparrows nest in loose colonies, two or three boxes can be sited in the same area (with appropriate spacing).

- Annual survey.
- Check box condition and fixing every 2 – 3 years (as the tree grows).

- Debris should be removed from boxes outside of the nesting season (i.e. between September to February).
- The box should be replaced if its condition deteriorates or if it is damaged.

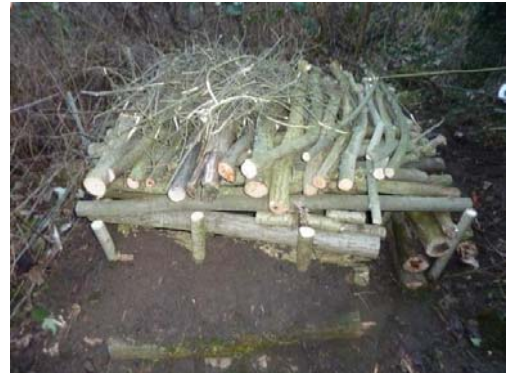
The holt is to be built to incorporate a bedding chamber measuring 450 mm (h) x 600 mm (w) x 600 mm (d) with an internal entrance measuring 200 to 250 mm, and an external corridor with two exits to the outside measuring a minimum of 250 mm.

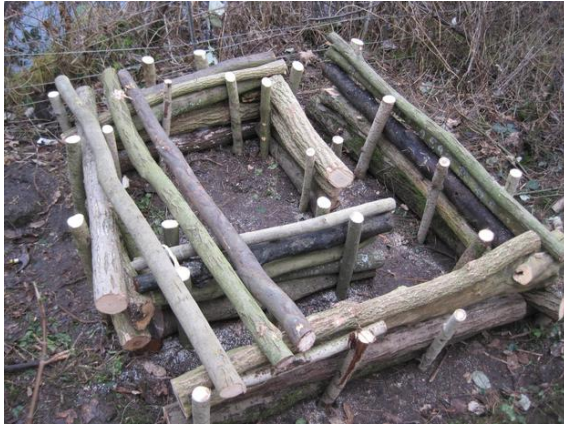
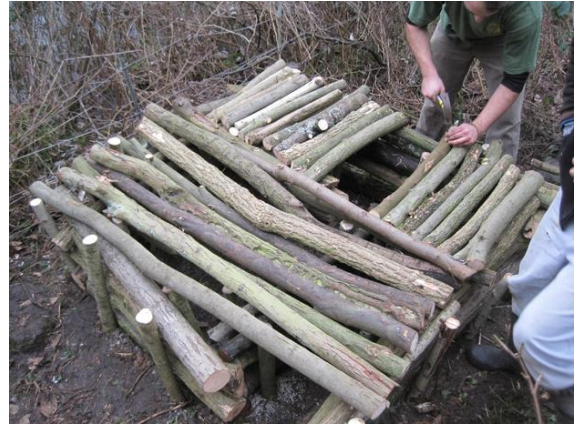
Once the walls are 450 mm high and stabilised, branches 3 – 10 cm diameter should be placed across the top of the logs to form roof struts. These can be nailed on to walls if required. The roof struts should be covered with brash until no light enters the bedding chamber. The roof should be tied down with wire and stakes. Brash should be stacked high, as fresh brash will dry down and disintegrate over time.

In order to provide camouflage, other vegetation can be placed over the holt.
