**REPORT:** PHASE 2 GEO-ENVIRONMENTAL  
INVESTIGATION FOR SITE OFF ROMAN  
BANK, SPALDING

**CLIENT:** ARK PROPERTY CENTRE

## **PHASE II GEO-ENVIRONMENTAL INVESTIGATION: SITE OFF ROMAN BANK, SPALDING**

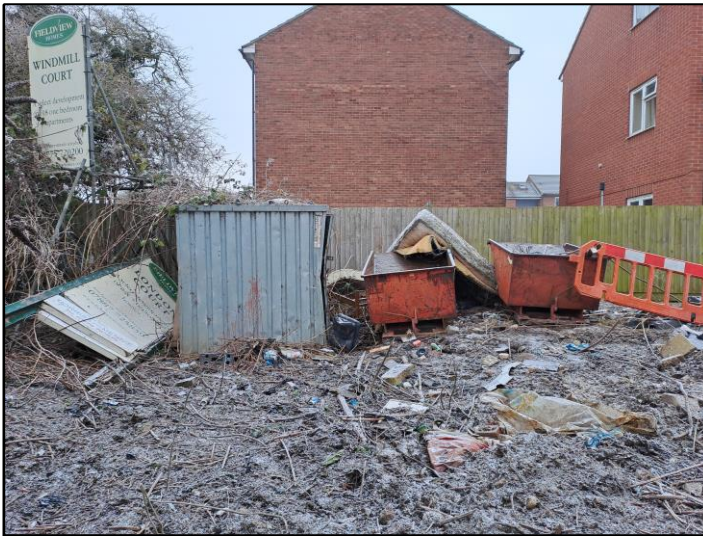
- Mixed waste materials including scrap metal, plastics, construction waste and general waste were found on the surface of the ground in the northern area of the site. A metal shed and 2 No. skips were found in the north-western corner of the site containing mixed waste materials;

Photo 5 - Photo of Shed, Skips and Waste Materials.

Some suspected asbestos containing materials will still require removal from site under controlled conditions as part of the development works. This includes the waste materials present at the site which have been 'tipped', and potentially any contaminated made ground materials which are removed from the ground as part of the construction works.

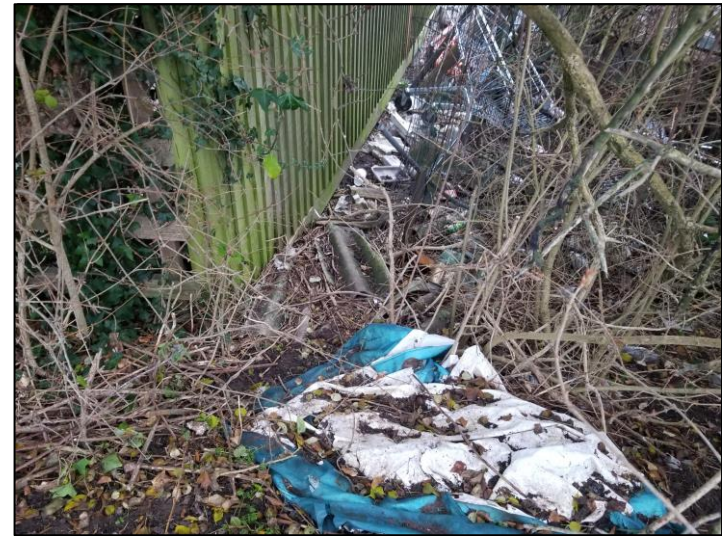
- Suspected asbestos bound cement sheeting was found in the north-western corner of the site between the metal shed and the site's boundary; and
- 2 No. manhole covers were found along the eastern boundary of the site;

Photo 6 - Asbestos Sheetting Found in North-Western Corner.

With regards to the detections of asbestos, any future construction works must fully consider the risks from cross-contamination and creation of 'pathways'. Recommendations and guidance should be sought by the Client from specialist remediation / asbestos contractors who should be appointed to prepare the site before and during construction works.

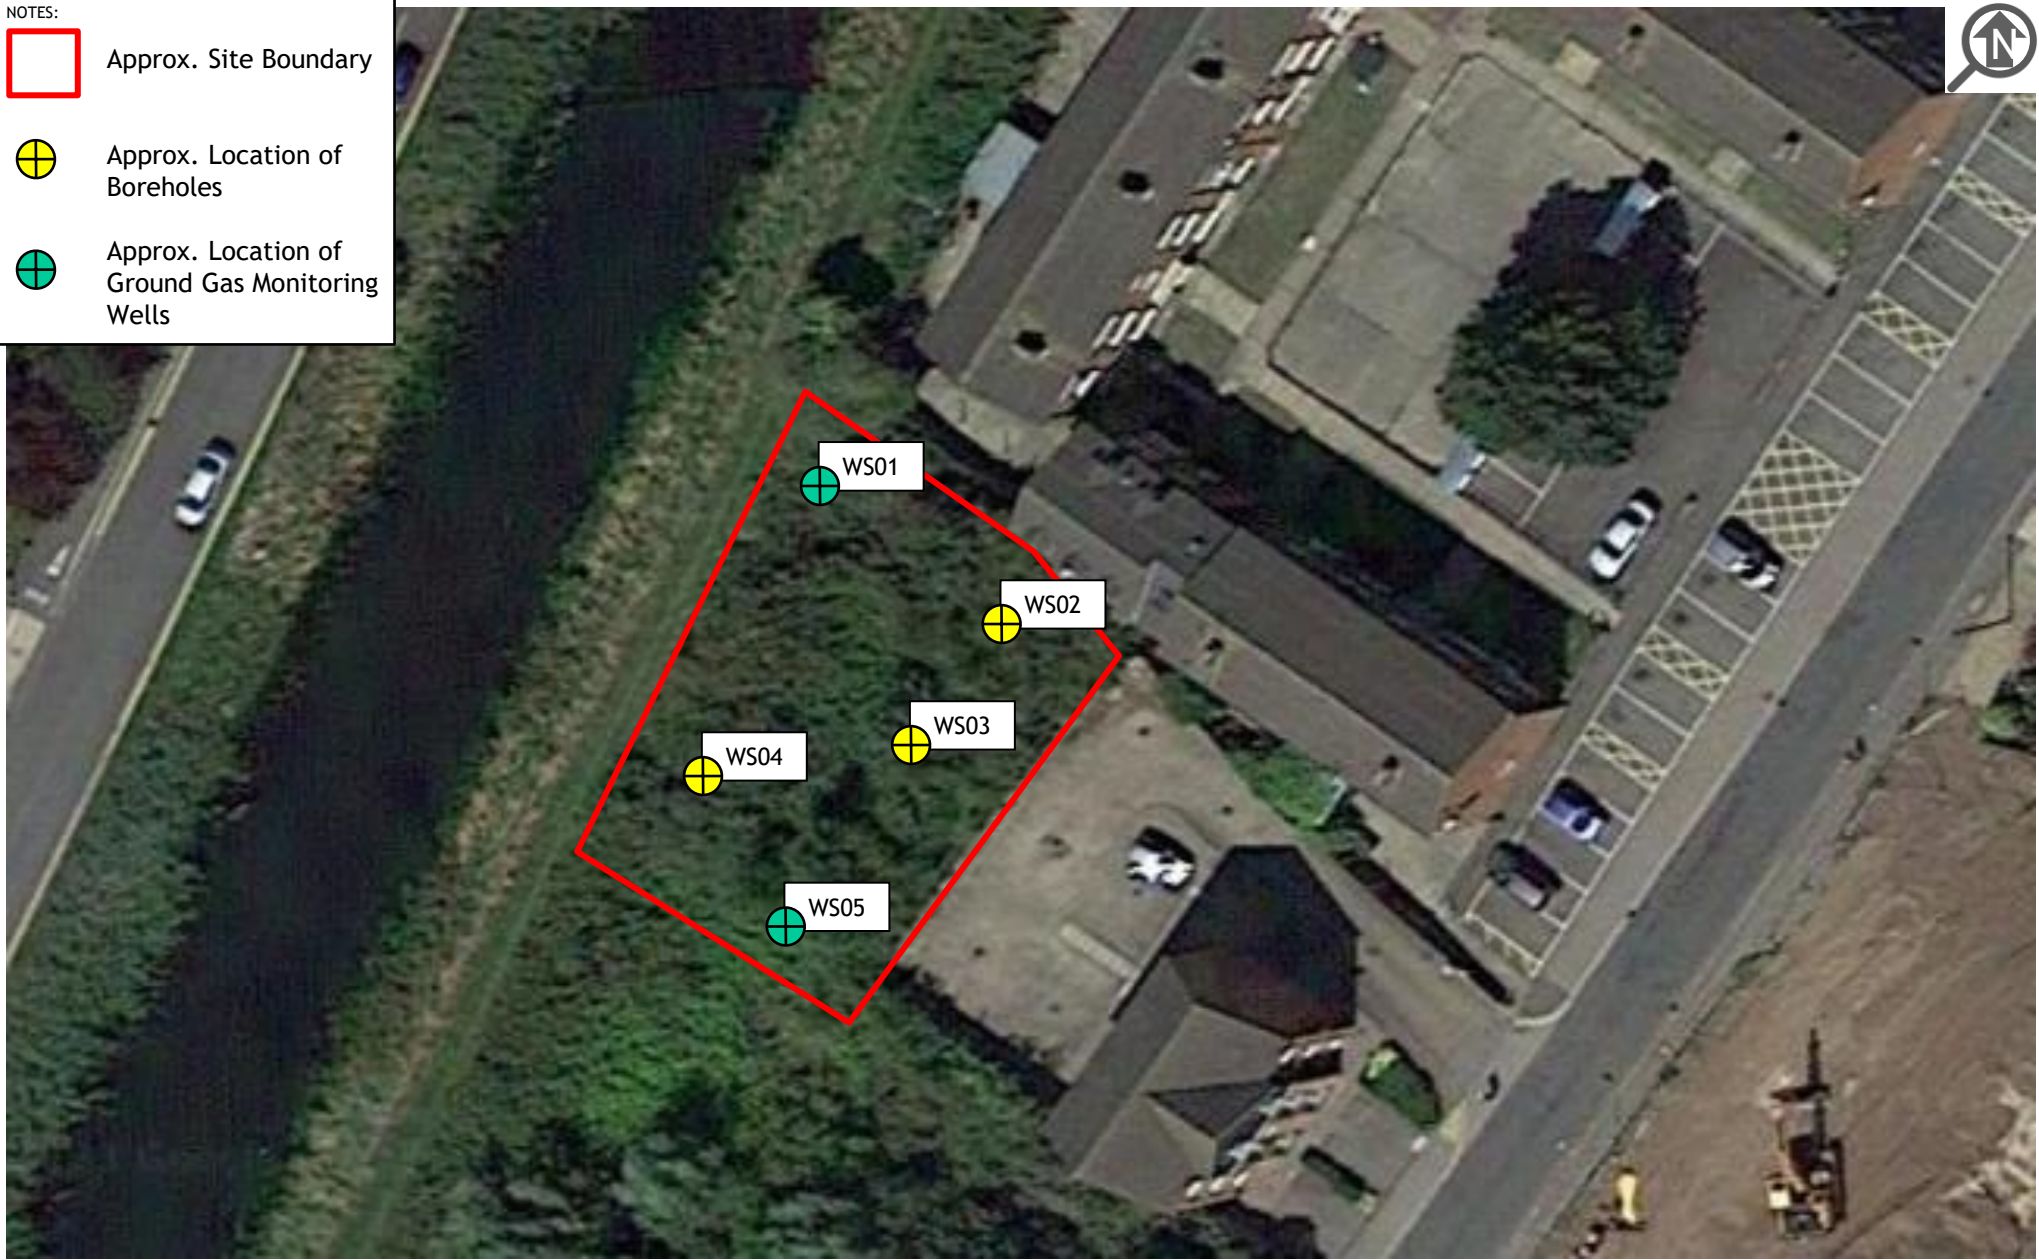
| <div>CLIENT:</div> <div></div> | <div>TITLE:</div> <div>Exploratory Hole Layout Plan</div> | <div>DATE:</div> <div>Jan. 2023</div> <div>DRAWING No:</div> <div>E22209_005</div> | <div>SCALE@SIZE:</div> <div>NOT TO SCALE</div> <div>DESIGN/DRAWN:</div> <div>JR</div> | <div>Elemental GI Ltd</div> |

Approx. Location of Ground Gas Monitoring Wells
